## MEMORANDUM

<b>File:</b>	<b>Sanikiluaq – Improvement of the Existing Wastewater Treatment Facility</b>
<b>To:</b>	<b>Government of Nunavut – Department of Community and Government Services</b>
<b>Attention:</b>	<b>Mr. Grigor Hope, Project Officer</b>
<b>Subject:</b>	<b>General Observations from Initial Site Investigation</b>
<b>Author:</b>	<b>Mr. Jason Thorpe</b>
<b>Page Total:</b>	<b>06</b>
<b>Date:</b>	<b>July 08, 2011</b>

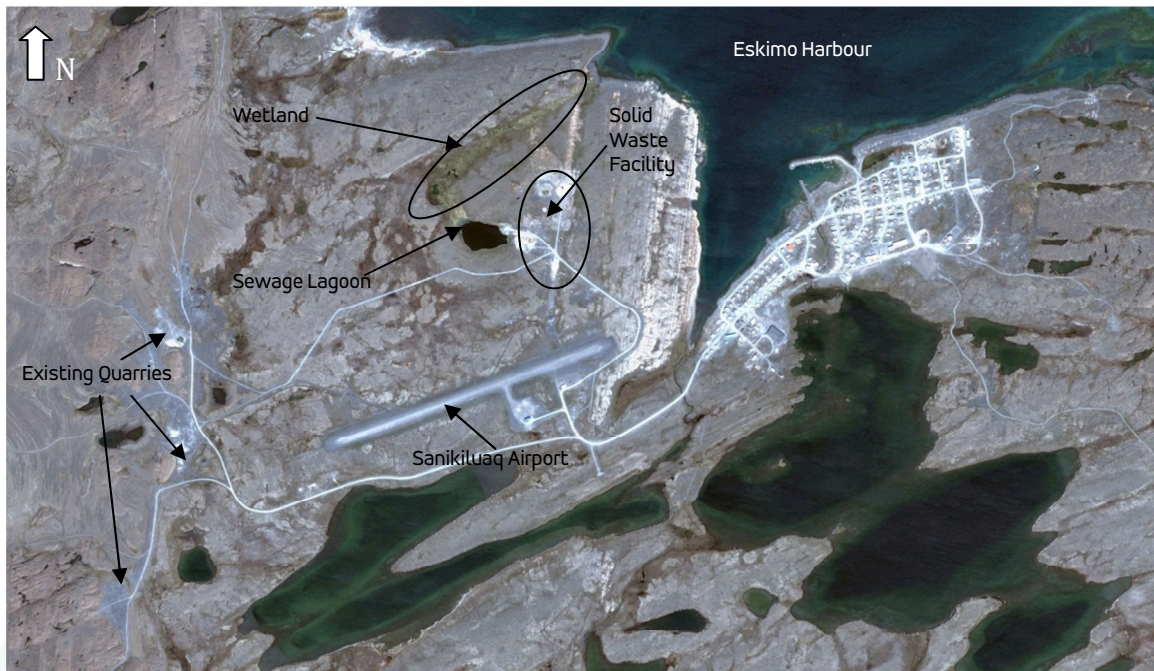
As depicted on **Figure 1**, the facility is comprised of a lake (sewage lagoon) that is roughly oval in shape, measuring approximately 200 m in the long dimension (east-west) and approximately 130 m in the short dimension (north-south) that drains into a vegetated wetland area measuring approximately 1.1 km long that subsequently drains into Eskimo Harbour (part of Hudson Bay). An access road from the community that services both the wastewater and solid waste facilities terminates at the eastern end of the lagoon, which is the point of discharge for raw sewage from the community via trucks that were observed to run continuously between the community and the facility during the week. A berm consisting of gravel and cobbles extends from the access roadway along the northern shore of the lagoon and terminates at the western side of the lagoon. The lagoon discharges through the berm along the northwestern shore into the wetland.

Figure 1: Overall aerial photograph showing key locations around Sanikiluaq, Nunavut.

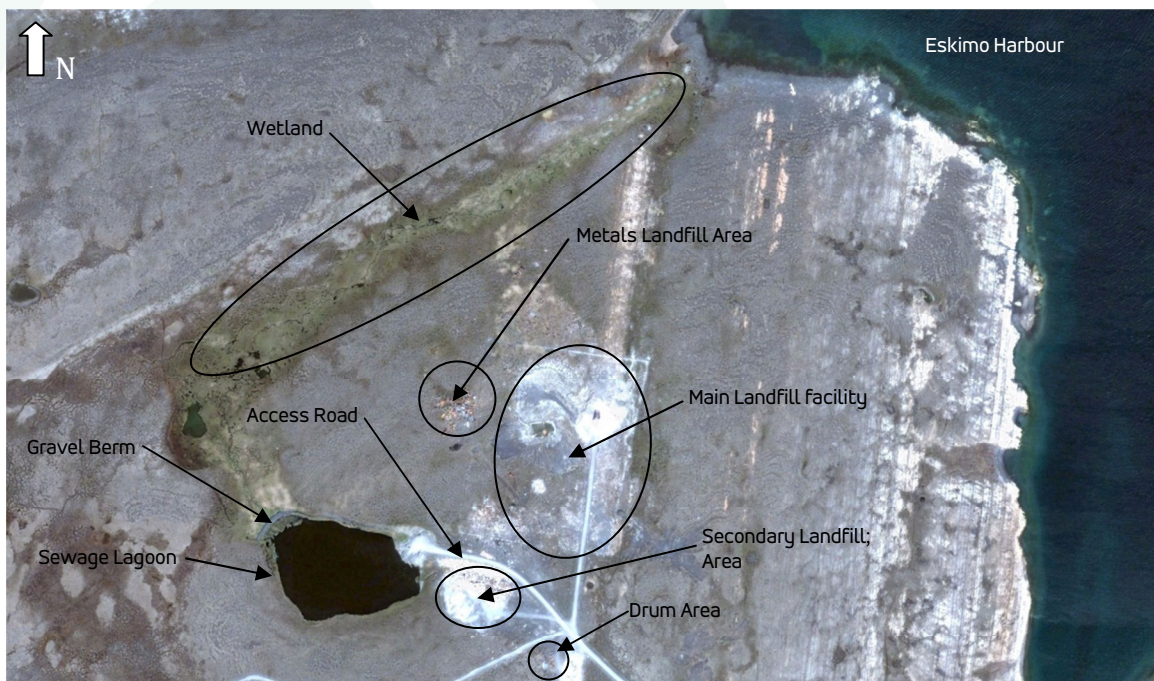
The main facility is located northeast of the sewage lagoon, and due north of the access roadway within a fenced off area measuring approximately 220 m by 260 m in plan view (**Figure 2**). During the site investigation, it was observed that solid waste is deposited within this facility by municipal garbage trucks on a regular basis, with unattended solid waste burned at regular intervals throughout the week within the fenced-in area. It appears that typical household waste is mainly landfilled and burned in this area by the Hamlet. Construction waste and compromised ATVs and vehicles were also noted within this area. The main landfill is situated due west of a ridge that runs roughly north-south towards Eskimo Harbour. The general topography of the main landfill gently slopes away from this ridge and towards the north-northwest towards the wetland and Eskimo Harbour. Visual runoff from the main landfill can be seen in aerial photographs. Also, several surface watercourses were observed within the main landfill facility that drain towards the north-northwest. While at the time of the inspection they did not directly connect to the wetland, dry flow paths were found that indicate direct connection when sufficient runoff is present. No engineering containment, preventing any leachate or runoff from draining into the wetland

and/or Eskimo Harbour, was observed. The fence around this area measures approximately 2.4 m in height, however towards the northwestern and northern sides of the main landfill area, there is a large gap between the bottom of the fence and the ground that allows waste to blow around the surrounding area.

The metals waste area is located approximately 180 m due north of the sewage lagoon along the western boundary of the main solid waste landfill facility, as shown on **Figure 2**. Waste is comprised of used automotive tires, abandoned cars, vans, trucks, busses, and ATVs, some of which have been piled on top of each other. A faint smell of fuel surrounds this area, as most vehicles abandoned here may not have had fuel and other chemicals and fluids drained from them prior to landfilling. Staining of the ground surface was noted in and around this entire area. Similar to the main landfill, this facility has similar topography that gently slopes towards the north-northwest, with no engineering containment to prevent surface runoff/leachate from flowing into the wetland and Eskimo Harbour.

The secondary waste area is located due east of the sewage lagoon and due south of the access roadway in a surface depression created by the south shoulder of the roadway (see **Figure 2**), measuring approximately 2.0 m deep from the road surface at the edge of the lagoon. The topography generally rises towards the south and east. It was observed during the site investigation that municipal garbage trucks, local businesses, and local community members dispose of waste in this area on a regular basis. The waste landfilled in this area varies from typical household waste to abandoned ATVs, white appliances, construction debris, and dead animals (caribou skins, dogs, birds, etc.). It appears that a berm was once constructed to prevent leachate/runoff from the secondary landfill area from flowing directly into the lagoon, however waste has been subsequently placed on top of, and beyond, this berm. An orange-coloured stream of leachate was observed flowing directly into the sewage lagoon towards the sewage discharge point. Preliminary analysis of the samples taken during the site inspection indicates that this leachate contributes metals and hydrocarbons into the wastewater treatment facility that are not found in the raw effluent entering the facility. ARKTIS believes that a precipitation event will further negatively affect the water quality. There is no fence around this area, and landfilled waste blows around the entire surrounding area.

The drum area is located approximately 180 m southeast of the sewage lagoon, just southeast of the secondary landfill area, as shown on **Figure 2**. It is located on top of a hill that slopes towards the secondary area and subsequently the sewage lagoon. The drum area consists of about 120 55-gallon steel and plastic drums that are mostly filled with unknown liquids, with some drums showing evidence of leaking and bulging. Visual staining of the ground was also observed. A small berm was noted along the northwestern end of this area, however it appeared that surface runoff has eroded areas within the berm that may allow the flow spilled fuels and liquids towards the sewage lagoon. A strong smell of fuel was noted in the air around this area.

Figure 2: Aerial photograph showing areas within the wastewater and solid waste facility complex.

Due to the impact of the solid waste facility on the wastewater facility in terms of direct leachate runoff into the sewage lagoon, wetland area, and Eskimo Harbour, ARKTIS recommends that the clean-up, rehabilitation, and subsequent operations and maintenance of the solid waste facility be addressed concurrently with the improvement of the wastewater treatment facility. It is ARKTIS' opinion that upgrades and improvements to the existing wastewater facility will not be as optimal in terms of improving the wastewater quality discharged into Eskimo Harbour if they are negatively impacted by the solid waste landfill facility. There is risk that the GN-CGS and Hamlet will not be able to comply with future water license limits. Further, typical passive northern wastewater treatment facilities are not designed to remove water contaminants from solid waste facilities (i.e. metals and hydrocarbons). There are several courses of action ARKTIS believes that can be taken to mitigate this concern. ARKTIS recommends discussing this matter further. ARKTIS will continue in its original design of the wastewater treatment facility.
