WATER LICENCE INSPECTION FORM

Licensee	Licensee Representative
Hamlet of Sanikiluaq	Bhabesh Roy
Licence No. / Expiry	Representative's Title
3BM-SAN1520	Municipal Engineer & Senior Administrative Officer
Land / Other Authorizations	Land / Other Authorizations
Date of Inspection	Inspector
September 11, 2018	Joseph Monteith
Activities Inspected	
<div><input type="checkbox"/> Camp<input type="checkbox"/> Drilling<input type="checkbox"/> Mining<input type="checkbox"/> Construction<input type="checkbox"/> Reclamation<input type="checkbox"/> Fuel Storage</div> <div><input type="checkbox"/> Roads/Hauling<input checked="" type="checkbox"/> Other: Water Treatment Facility, Solid Waste Facility, and Waste Water Treatment Facility<input type="checkbox"/> Other:</div>

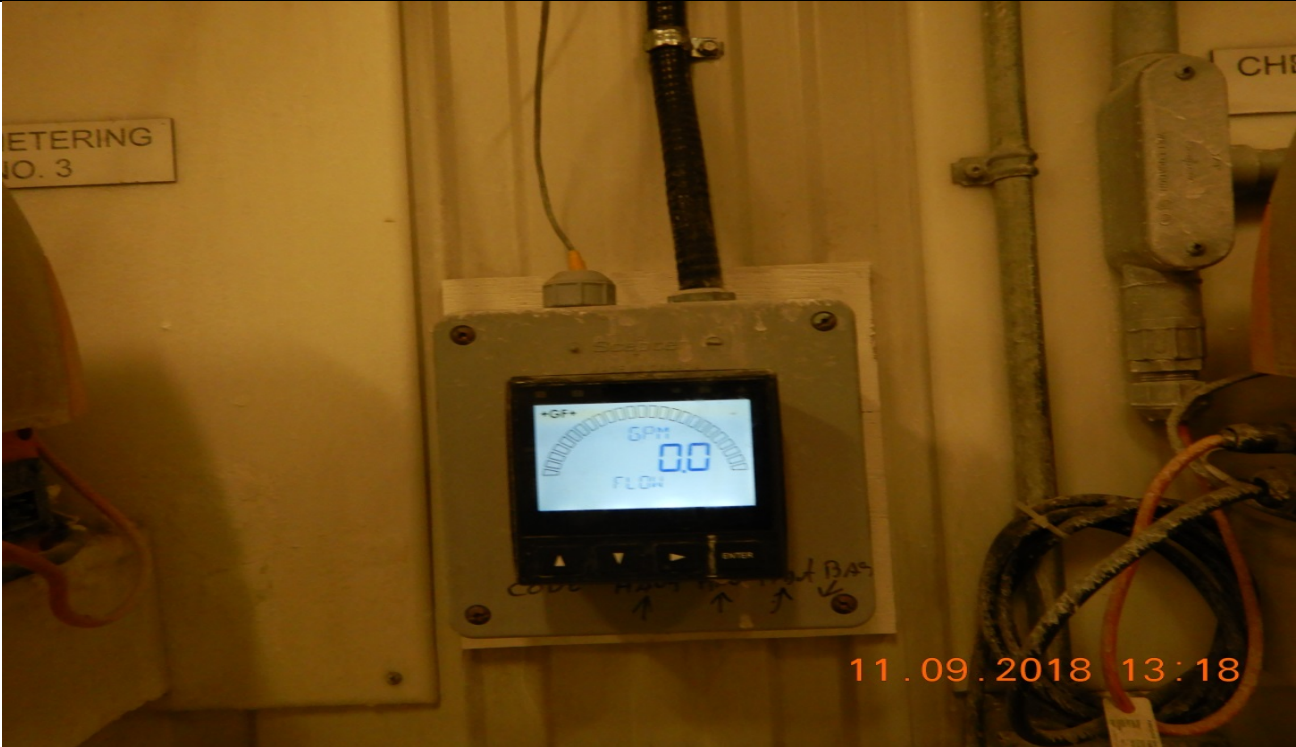
Photo 2

Broken flow metre (Photo 2);

Description: Water or Flow metre.

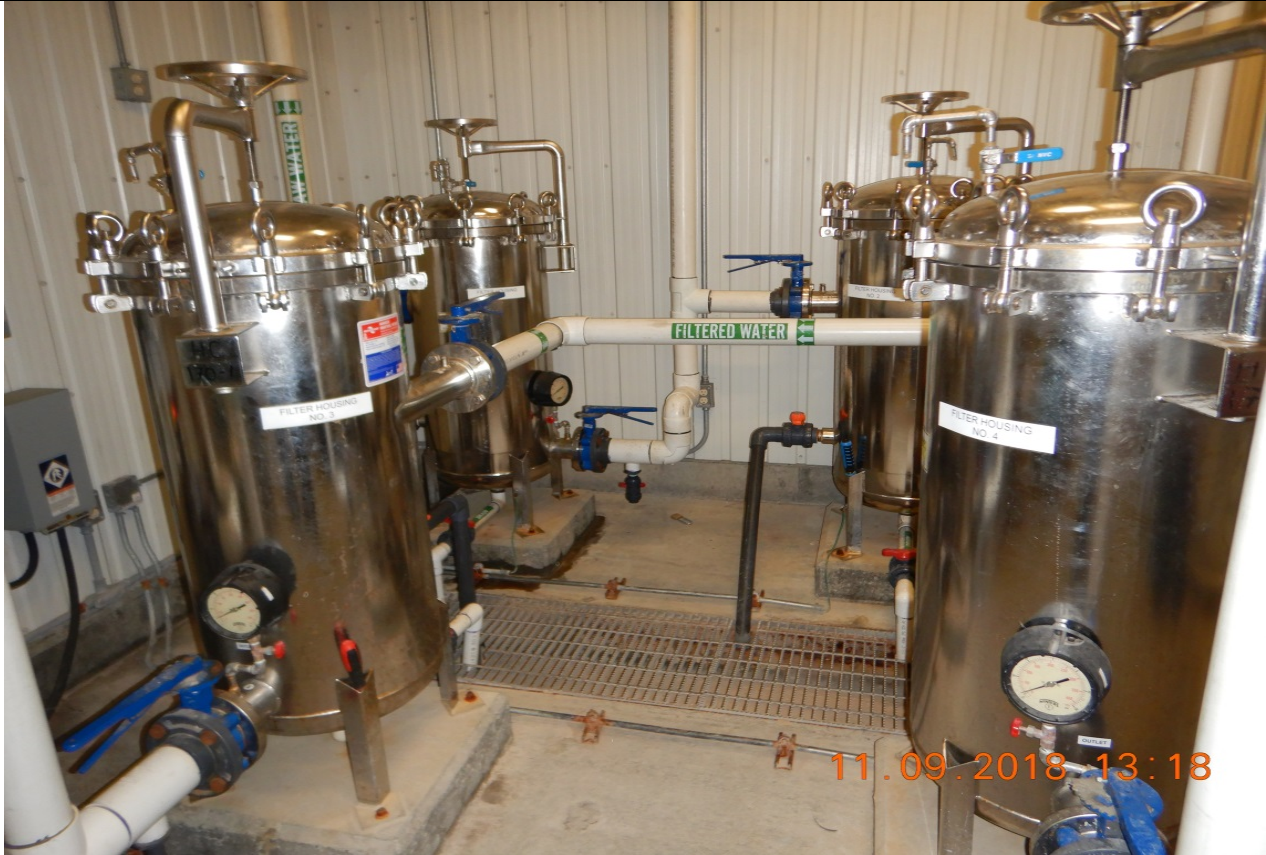
Photo 3

Four water filter housing units(Photo 3);

Description: Four Filter Housing Units

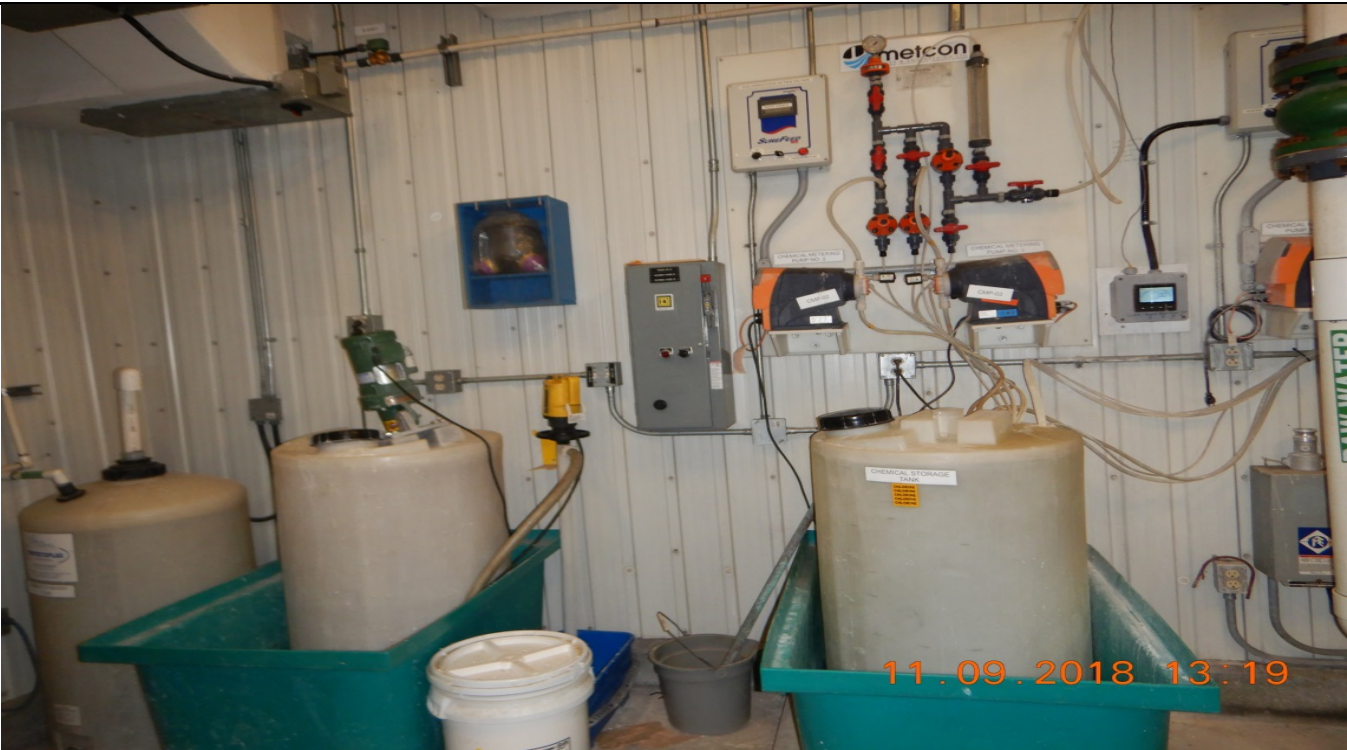
Photo Log #1
Photo 4

Three Chlorine mixing tub(Photo 4);

Description: Two Chlorine Mixing drums

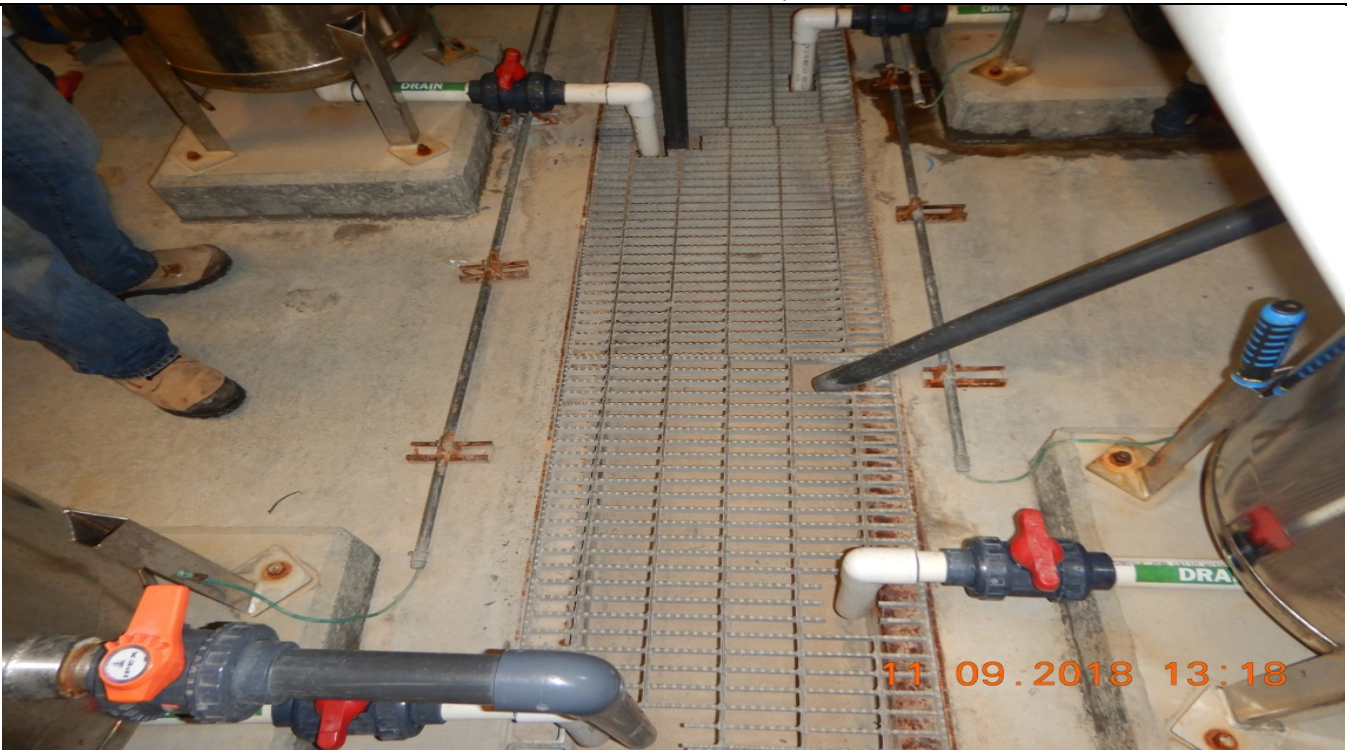
Photo Log #1
Photo 5

Sump Pit (Photo 5).
3.

Description: Sump Pit at the base of the water filters

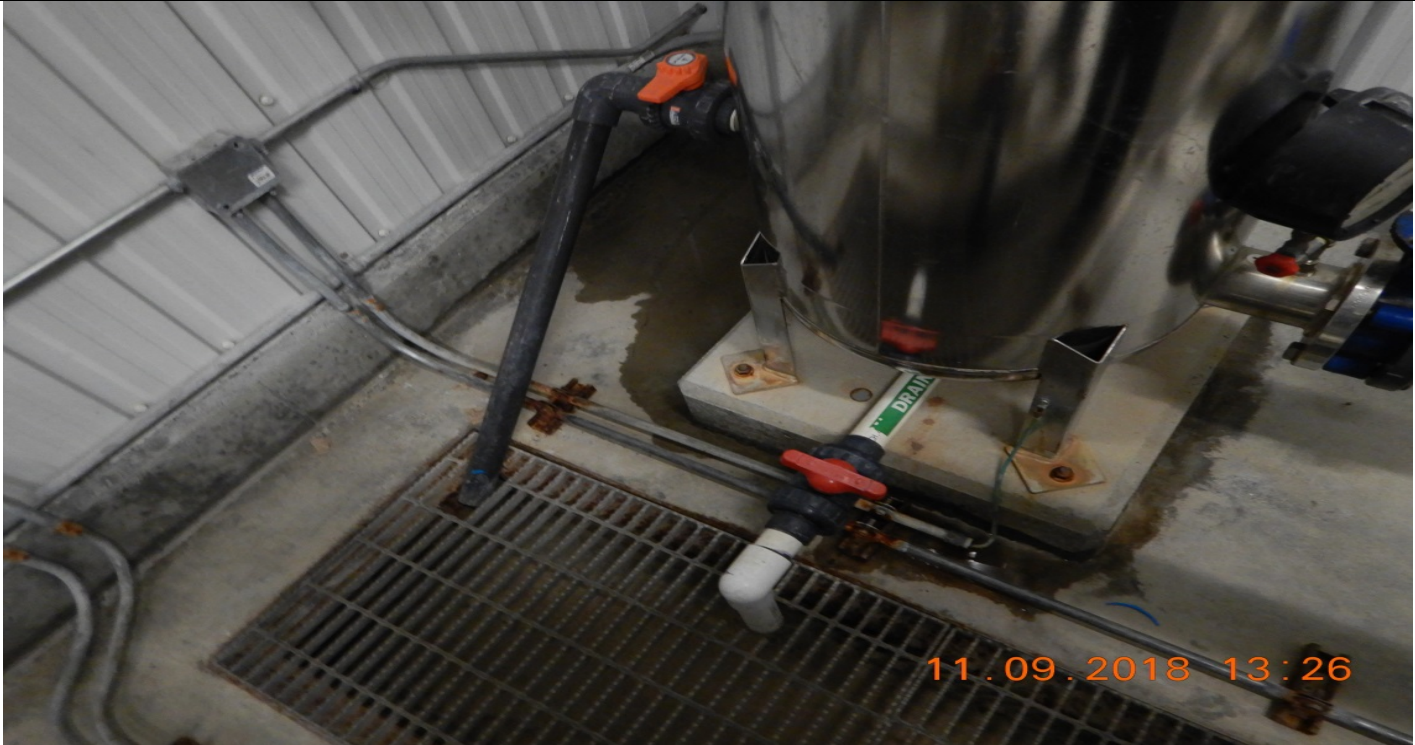
Photo 6

Signs of water leak in filter housing #1 (Photo 6).
4.

Description: sign of a leak in filter housing #1

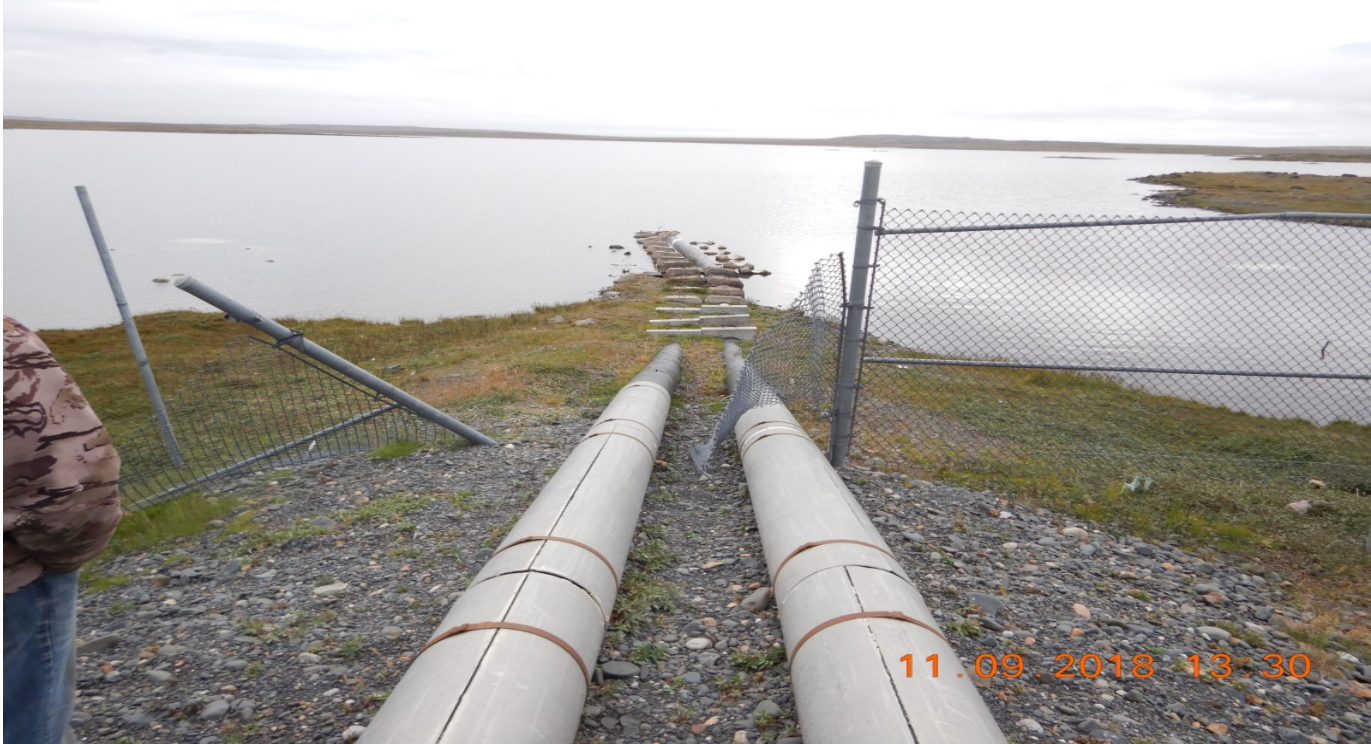
Photo 7

Fencing requires maintenance as it appears to be in a state of disrepair (Photo 7).
5.

Description: Water Intake Facility – Fencing requires maintenance

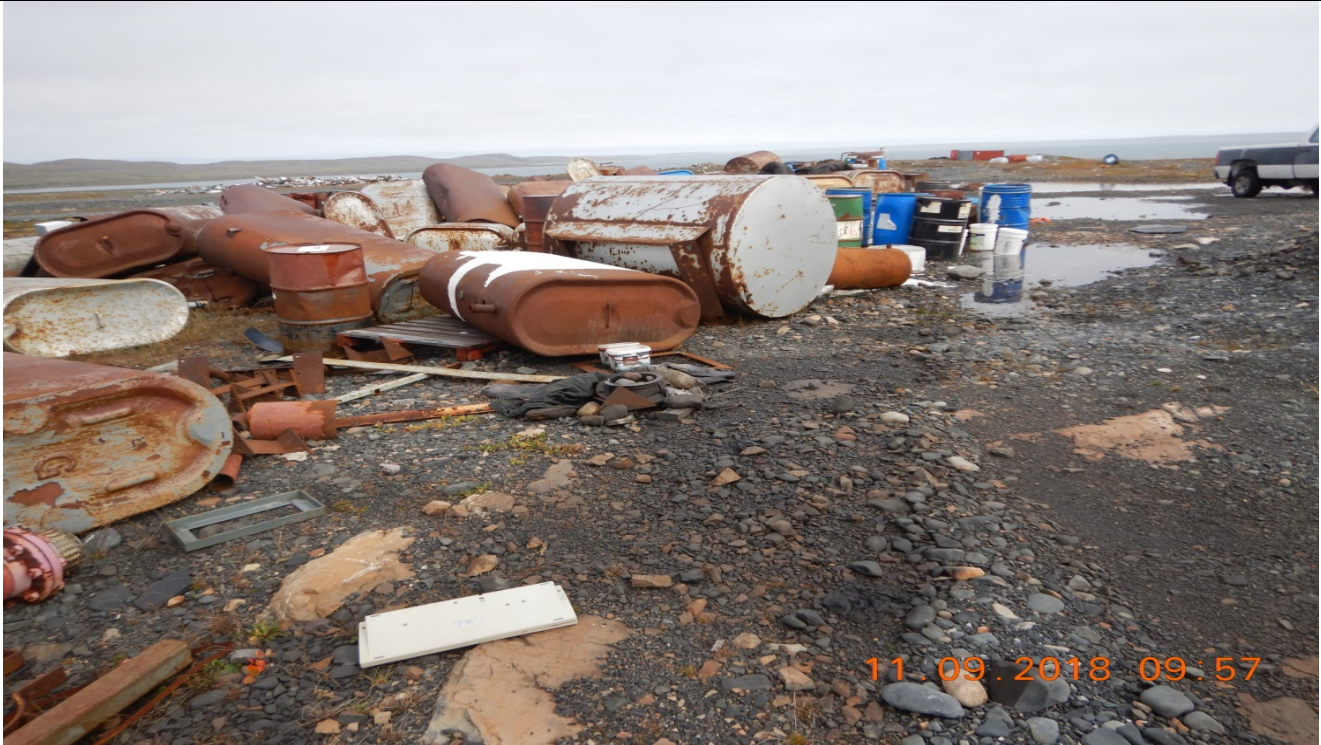
Photo 19

Hazardous Waste Section is exposed to the elements with no berm to limit any migration of leaks. Multiple pools of water surround the Hazardous Waste Area (See photo 18). Contrary to Part D: Item 10, and Part D: Item 9.
19.

Multiple signs of leaks and spills that appear to be migrating down slope (Photo 19 and 20).
20.

Description: Three Pools of water in the mid ground and background on the right hand side of the hazardous waste. Signs of spills in the foreground

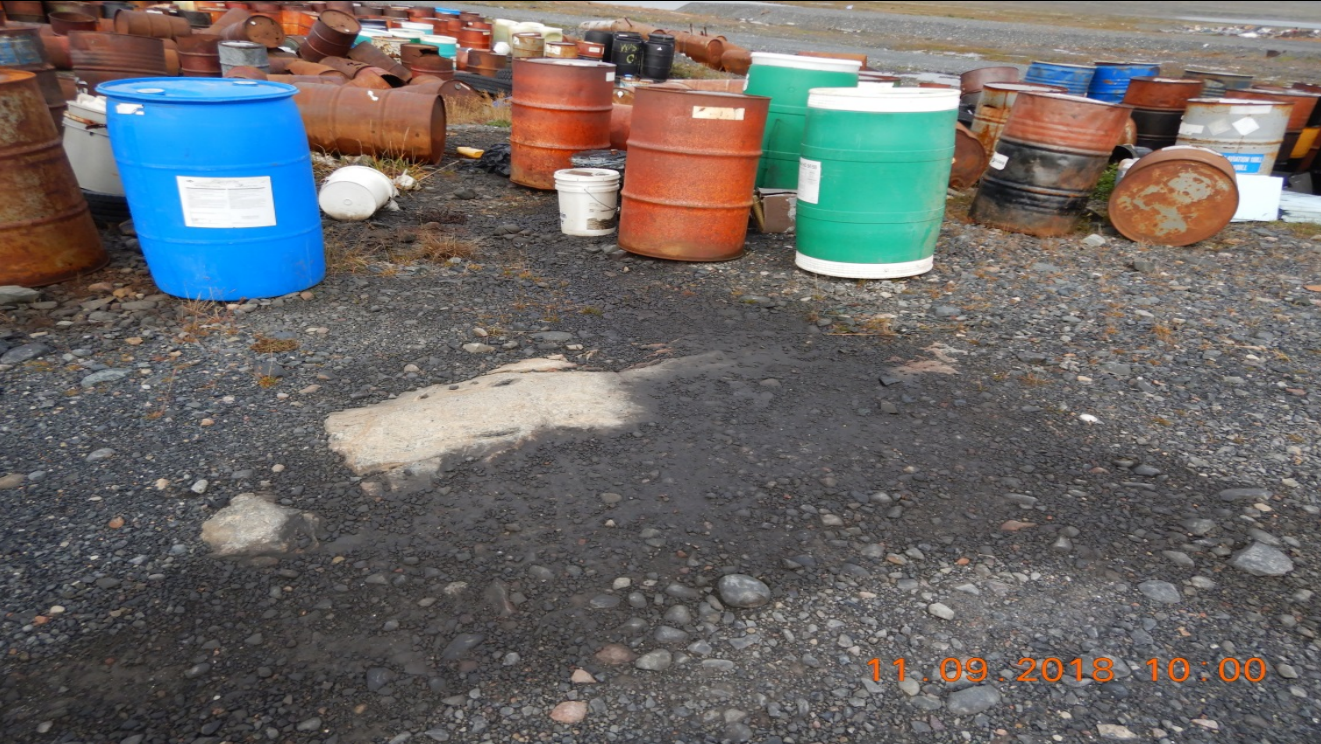
Photo 20

Description: oil leak migration

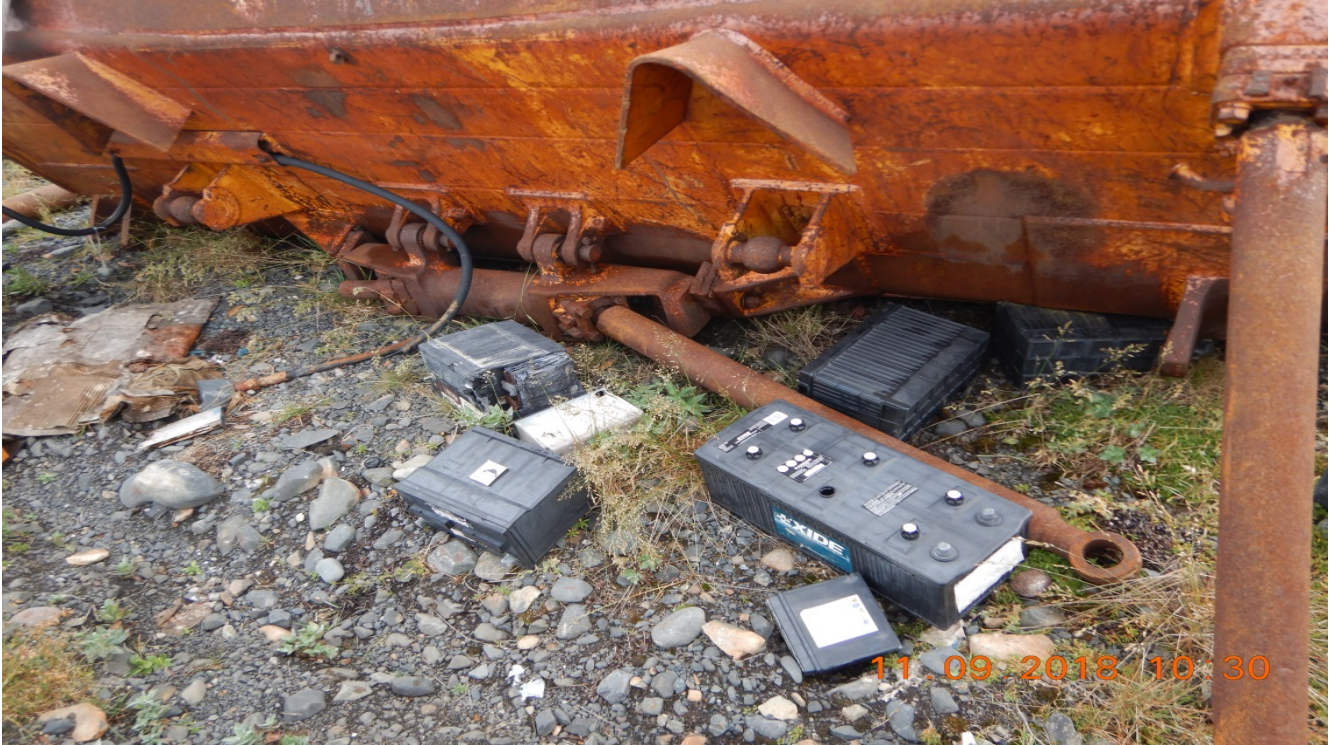
Photo 21

There were numerous observations of hazardous waste such as batteries, and waste oil drums throughout the Bulk Metal section (Photo 21, 22, and 23).

Description: 6 batteries within the Bulk Metals section of the Solid Waste Facility.

Due to the Hazardous Waste within the Bulk Metal Storage area, please review below Part D: Item 9.

- The Licensee shall segregate and store all hazardous materials and/or Hazardous Waste within the Solid Waste Disposal Facility in such a manner as to prevent the deposit of deleterious substances into any Water, until such a time that the materials have been removed for proper disposal at an approved facility.

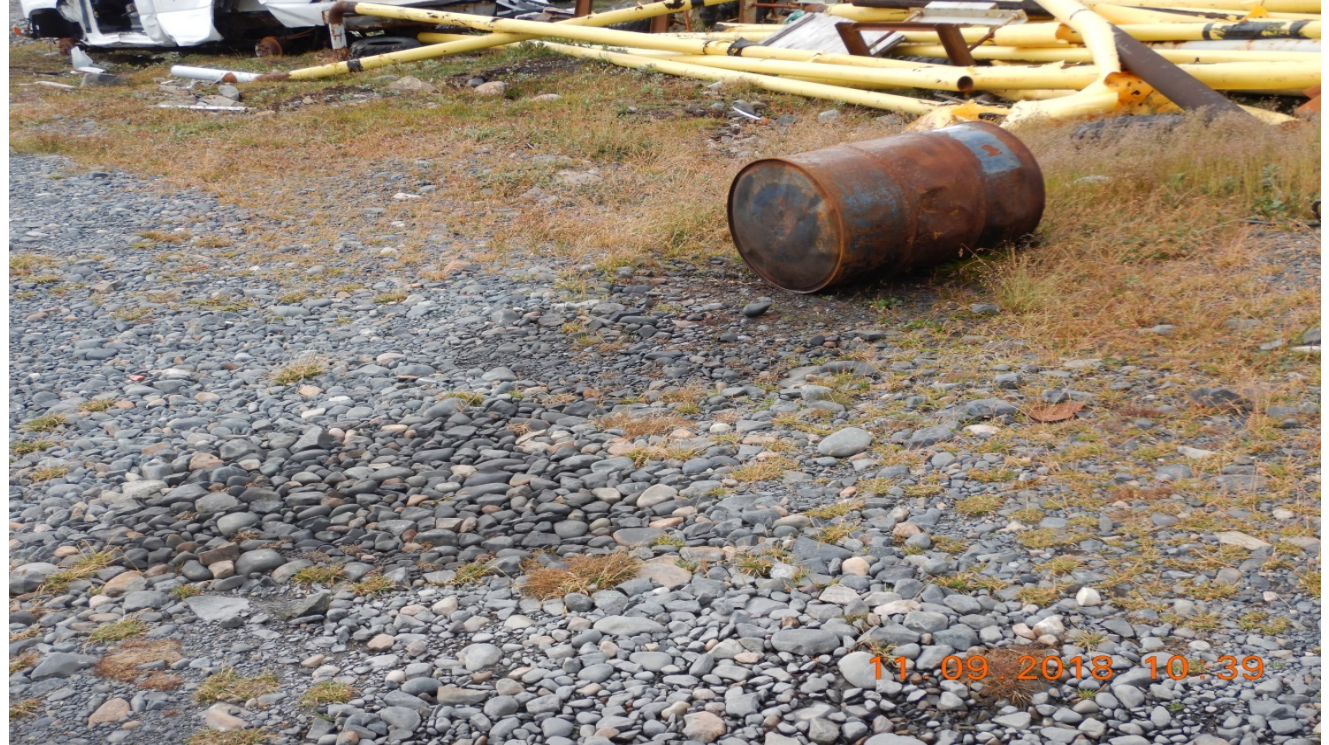
Photo 22

Description: Waste oil drum in Bulk Metals Section of the Solid Waste Facility, appears to have leaked.

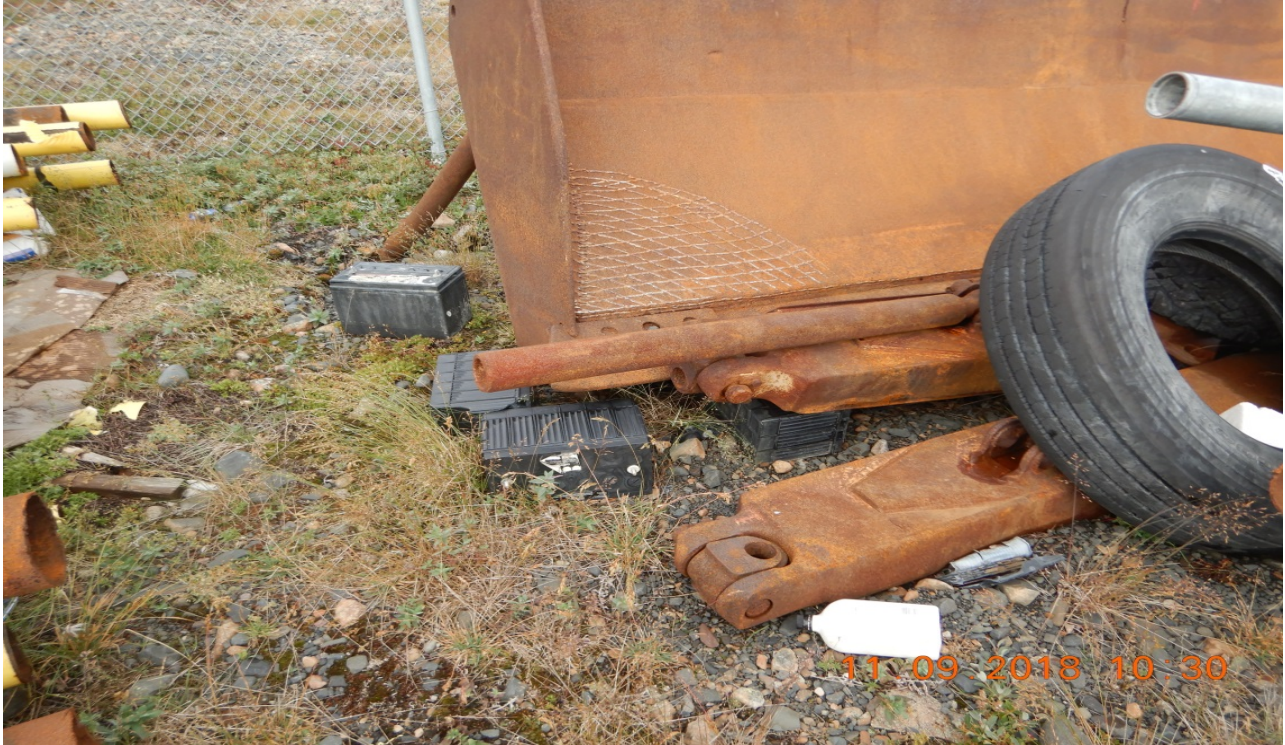
Photo 23

Description: 4 vehicle batteries in the Bulk Metals section of the Solid Waste Facility.
