## **ENVIRONMENTAL INSPECTION FORM**

Hamlet of Sanikiluaq				Licensee Representative Kenny Pearce (Hamlet) & Bhabesh Roy (CGS) Representative's Title					
3BM-SAN1214 (Expired)				Assistant Foreman & Municipal Planning

•	,		gineer		•		J	
Land / Other Authorization	ıs			/ Other Authoria	zations				
N/A			N/						
Date of Inspection									
02/09/2014			Eri	k Allain					
Camp Roads/Hauling									
Conditions: A - A	Acceptable	e	C - Concern U - Una	cceptable	NA -	- Not Applicable	NI –	Not Insp	ected
Water Use	Condition	Comment	Site Conditions	Condition	Comment	Haz/Mat Manage	ment	Condition	Comment
Intake/Screen	Α		Water Management Struct	ures A		Storage		U	
Flow Measure. Device	С	1	Culverts / Bridges		NA	Spills		С	
Source:	А		Drainage		NI	Spill Plan			
Water Use:	Α		Erosion / Sediment	А					
Recirculation ( y /n)			Mitigation Measures		NA	Administrative			
			Reclamation Activities		NA	Records		Α	
			Materials Storage	С		Reports			
Waste Disposal			Signage			Plans			
Waste Water	С	3				Notifications			
Solid Waste	-		Monitoring	lucio A		Other			
Hazardous Waste	U	2	Sample Collection / Ana	ysis A

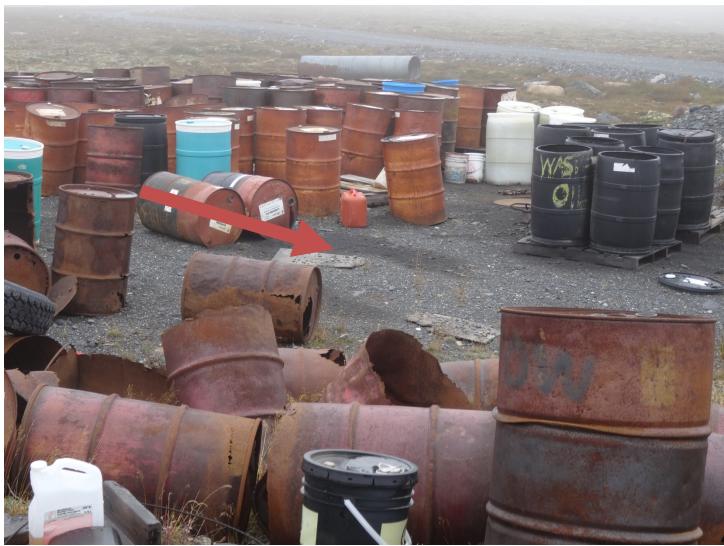
- 2) The hazardous waste storage area is inadequate. The area is not lined and no secondary containment is in place to capture any spills. Waste such as glycol and waste oil are stored in barrels with no plan of removing them from site and sent to a licensed waste disposal facility as per Part D item 9 of the Water License. During the inspection, spills were observed onsite which is an area of concern that required attention. Several barrels are significantly rusted suggesting that leaks will continue occur.

**Photo 1:** Hazardous Waste improperly stored, spill stains visible on the ground.

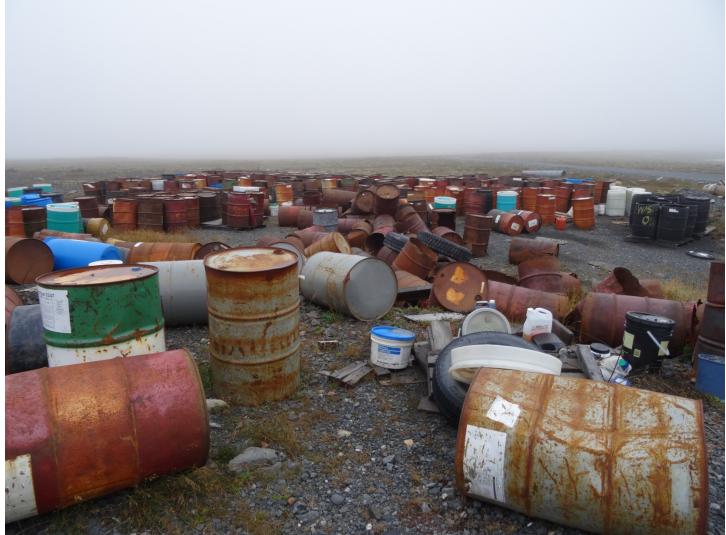
Photo 2: Hazardous waste storage area.
