WATER LICENCE INSPECTION FORM

Licensee		Licensee Representative	
Hamlet of Sanikiluaq		Mike Rowan	
Licence No. / Expiry		Representative's Title	
3BM-SAN1520		Senior Executive Administrator	
Land / Other Authorizations		Land / Other Authorizations	
Date of Inspection		Inspector	
August 16, 2016		Justin Hack	
Activities Inspected			
<input type="checkbox"/> Camp	<input type="checkbox"/> Drilling	<input type="checkbox"/> Mining	<input type="checkbox"/> Construction
<input type="checkbox"/> Roads/Hauling	<input type="checkbox"/> Other: Water Discharge	<input type="checkbox"/> Reclamation	<input checked="" type="checkbox"/> Fuel Storage
<input checked="" type="checkbox"/> Other: Municipal

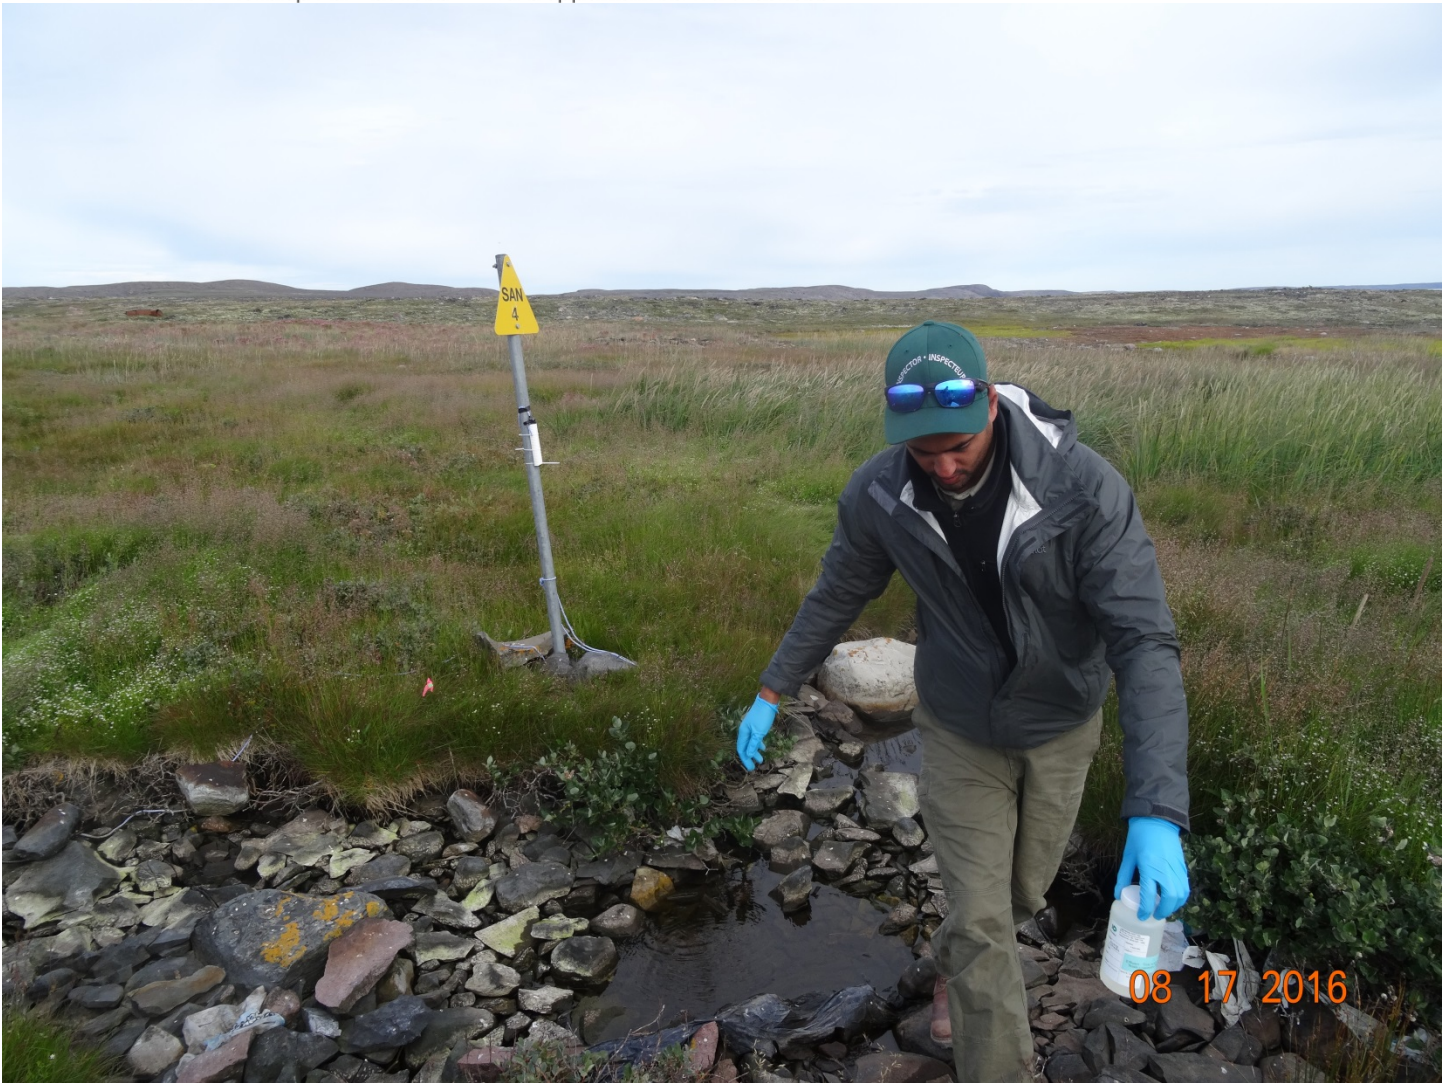
this sampling point is significantly further downstream of the lagoon than originally intended. It is recommended that either the SAN-4 monitoring location is moved closer to the passive outflow location of the sewage lagoon or another station is created at this location to capture the effluent quality at the point after exfiltration/overflow.

Figure 1 (sampling at SAN 4)

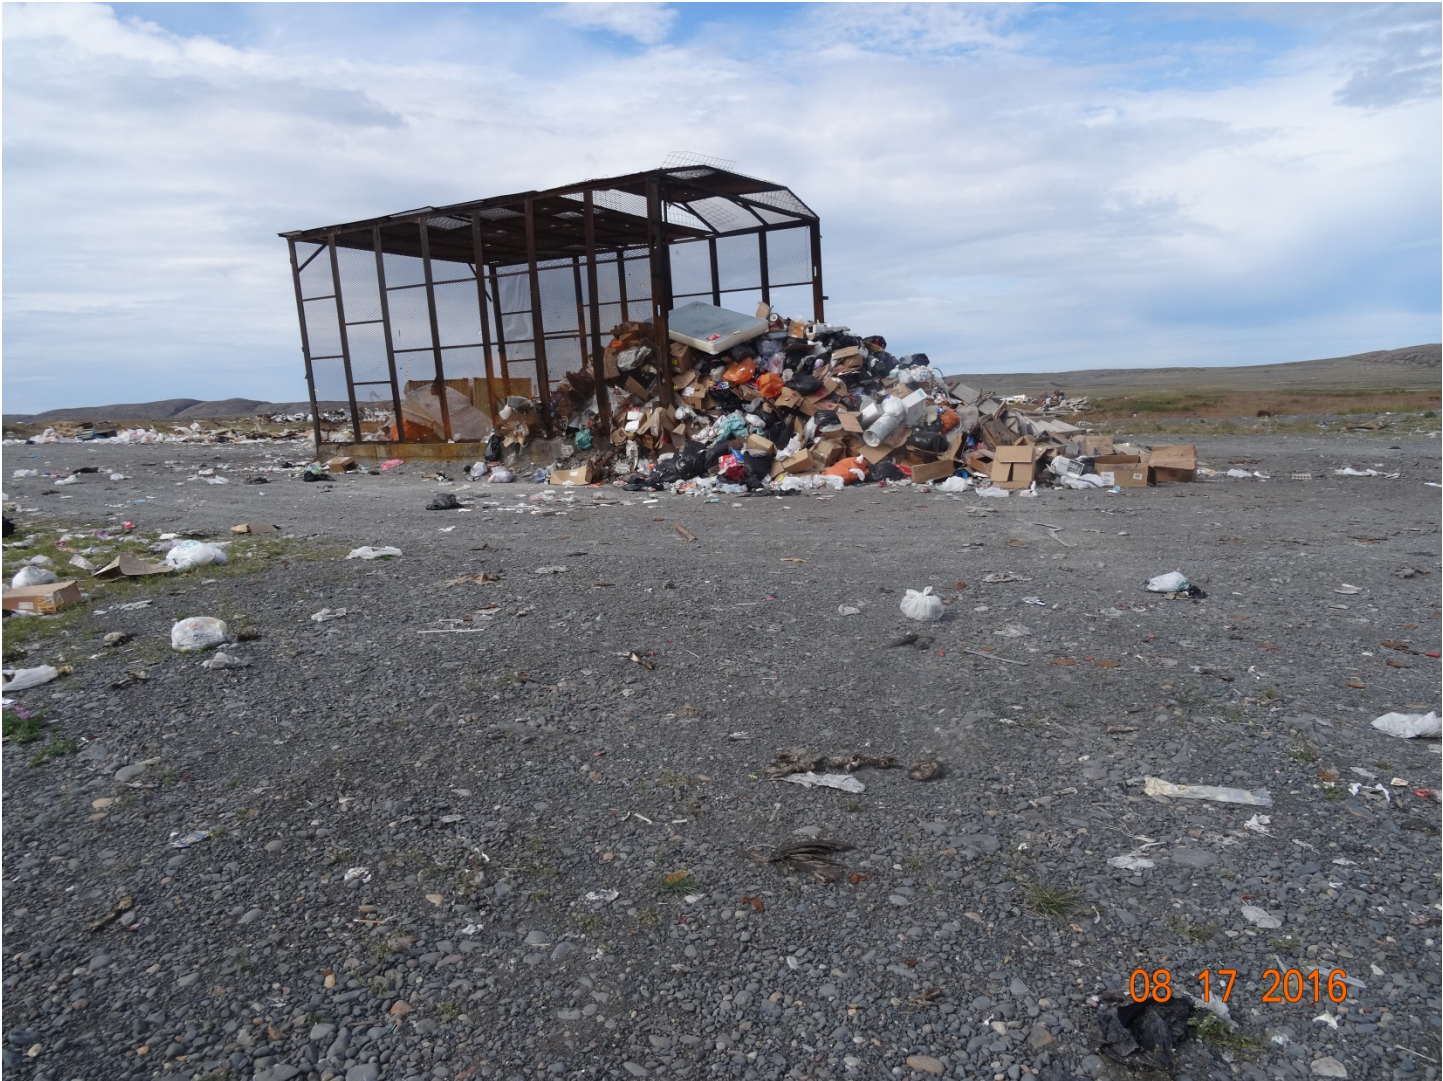
5. Waste within the domestic waste facility is burned in an open burn box.
6. There is a ditch adjacent to the facility that captures the surface water from this facility. This ditch is filled with water and significant quantities of domestic refuse. Some of the ash from the open burn box likely enters this ditch before it flows downstream into the wetland.

Figure 2 (Burn box)

- To conduct sampling of the surface water originating from the Domestic Waste Facility at the location discussed during the inspection.
- Relocate the sampling location SAN-2 to this location.

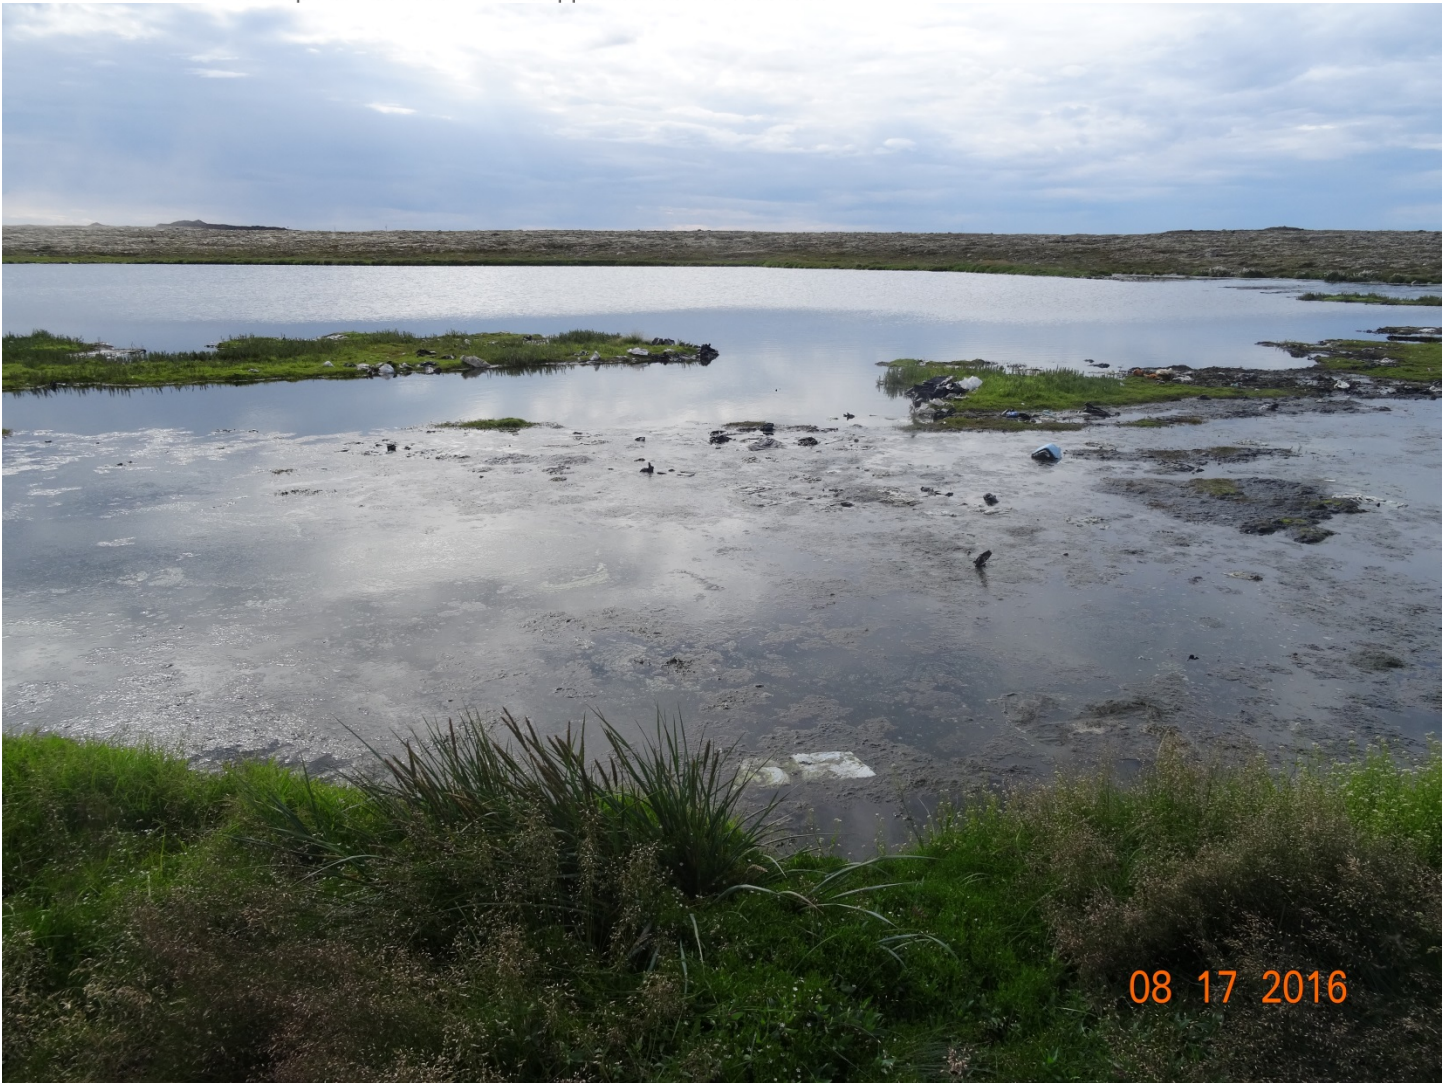
Waste Water Treatment Facility:			
<ol style="list-style-type: none">The lagoon operates by passive exfiltration and overflow of a berm wall. The effluent then travels through a wetland for approximately 500m before it reaches SAN-4 Monitoring Location. The effluent then continues to flow through the wetland for another 500m before it enters the ocean.<ol style="list-style-type: none">Due to the intended design of this facility, maintaining a sufficient freeboard (as required in the licence) is not possible. <i>This condition should be amended or removed from the licence.</i>Samples were taken at SAN-4 to ensure compliance with the licence criteria. However, it appears that

Figure 3(Lagoon overflow berm facing lagoon)

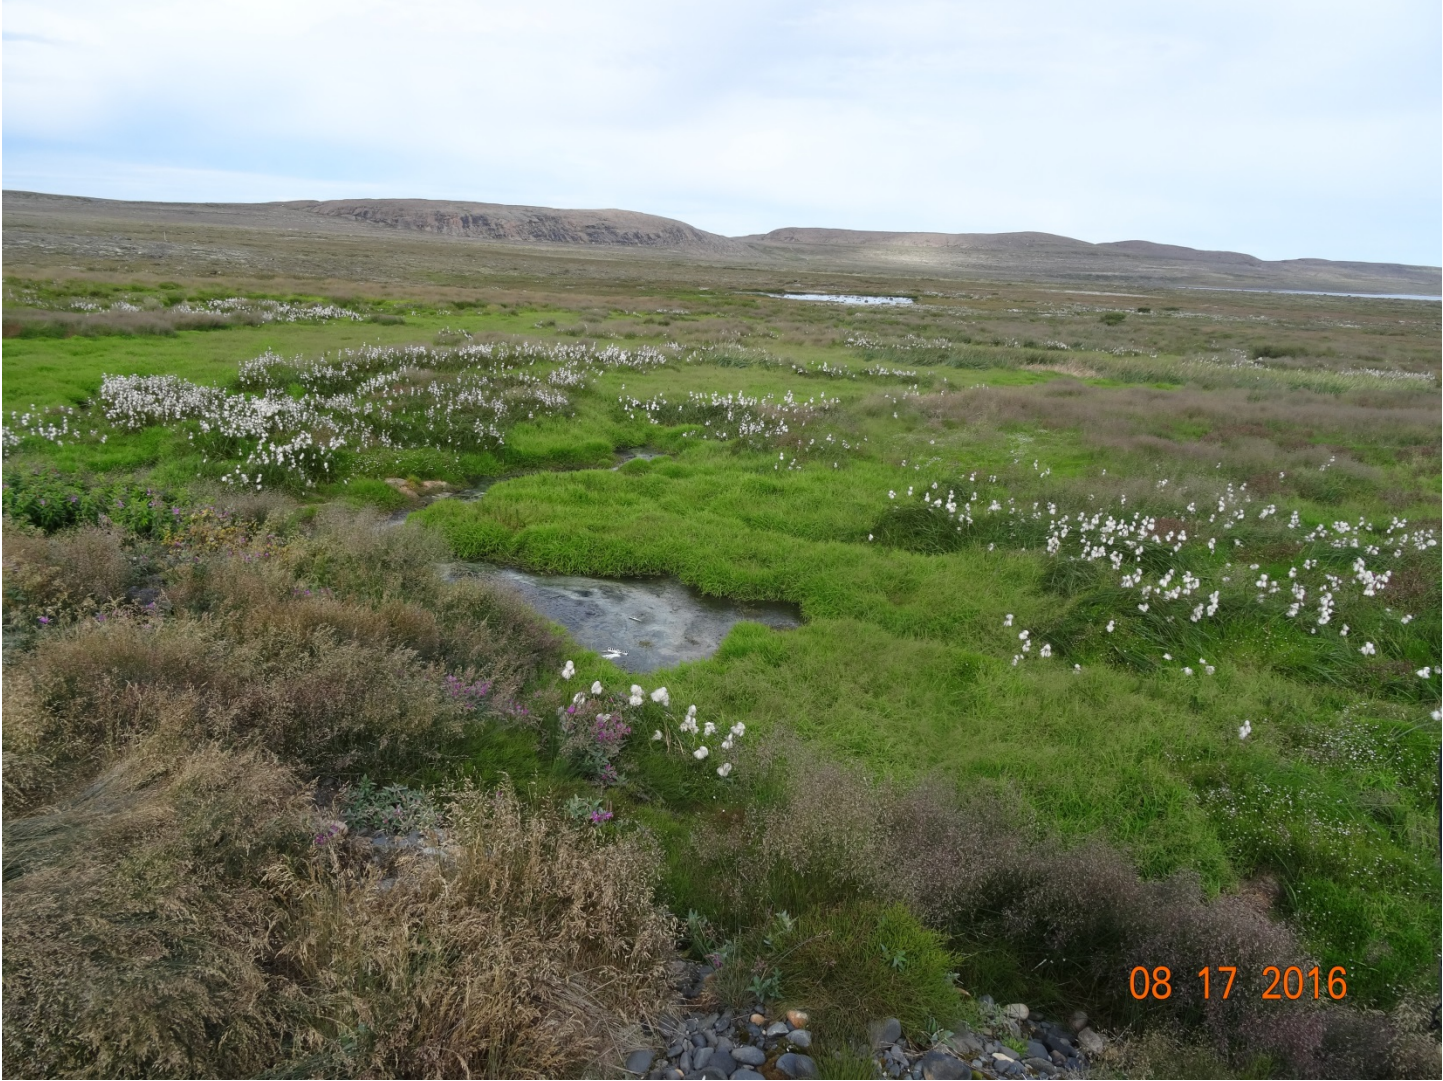
Figure 4 (Lagoon overflow area facing downstream)
