WATER LICENCE INSPECTION FORM

Licensee		Licensee Representative	
Hamlet of Sanikiluaq		Bhabesh Roy	
Licence No. / Expiry		Representative's Title	
3BM-SAN1520		Regional Planning Engineer	
Land / Other Authorizations		Land / Other Authorizations	
None			
Date of Inspection		Inspector	
13/06/2017		Jonathan MESHER	
Activities Inspected			
<input checked="" type="checkbox"/> Camp/municipality	<input type="checkbox"/> Drilling	<input type="checkbox"/> Mining	<input type="checkbox"/> Construction
<input type="checkbox"/> Roads/Hauling	<input type="checkbox"/> Other:	<input type="checkbox"/> Other:	<input type="checkbox"/> Reclamation
			<input type="checkbox"/> Fuel Storage

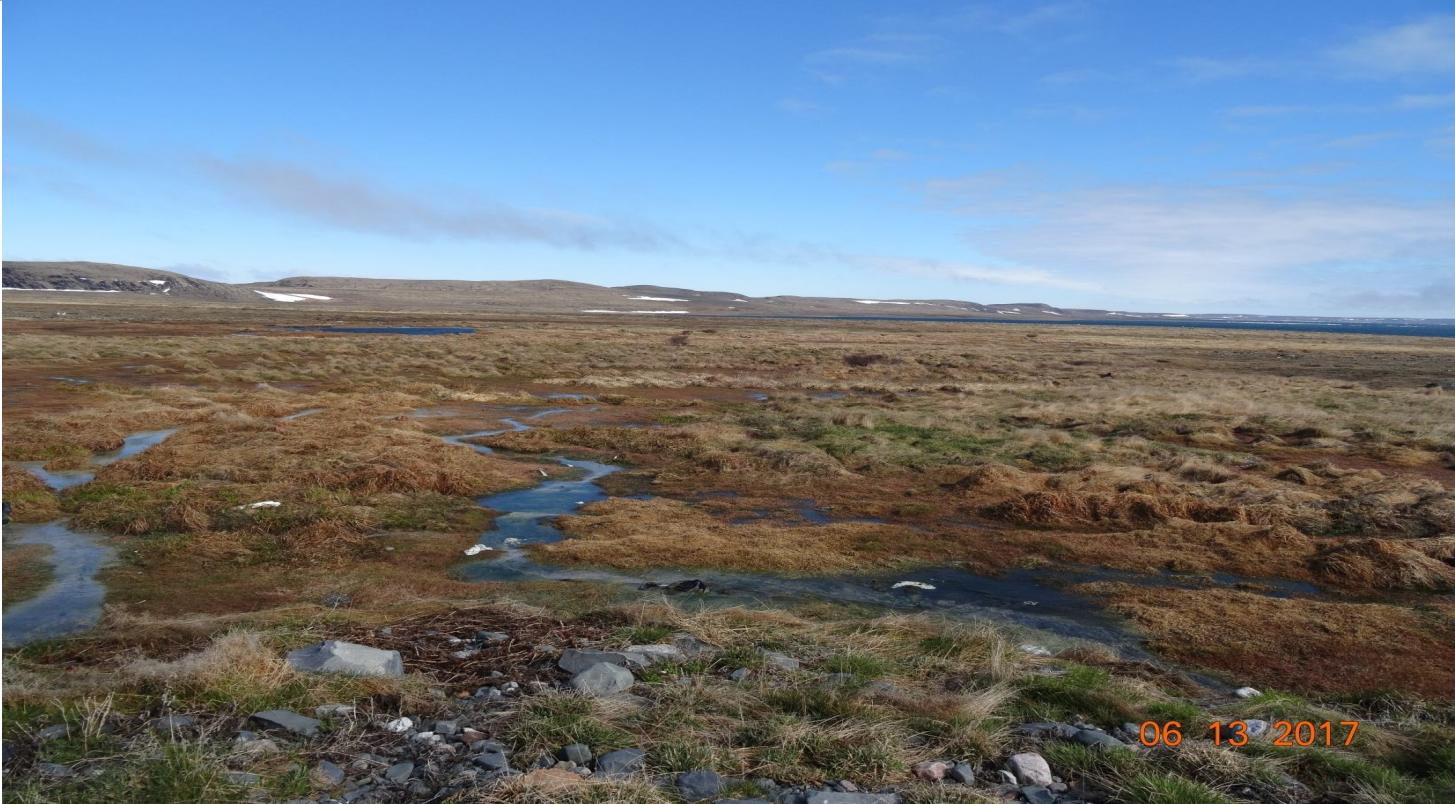
- c) Samples were taken at SAN-4 to ensure compliance with the Water Licence criteria.
- d) The Location at SAN-4 has not been moved as recommended in the last Inspection, The licensee has agreed to move it before the 2018 inspection.

Figure 1: flow path of effluent from non-engineered lagoon.

- The Licensee is asked to relocate the sampling point SAN-4, in order to accurately record the Effluent quality as it leaves the lagoon.

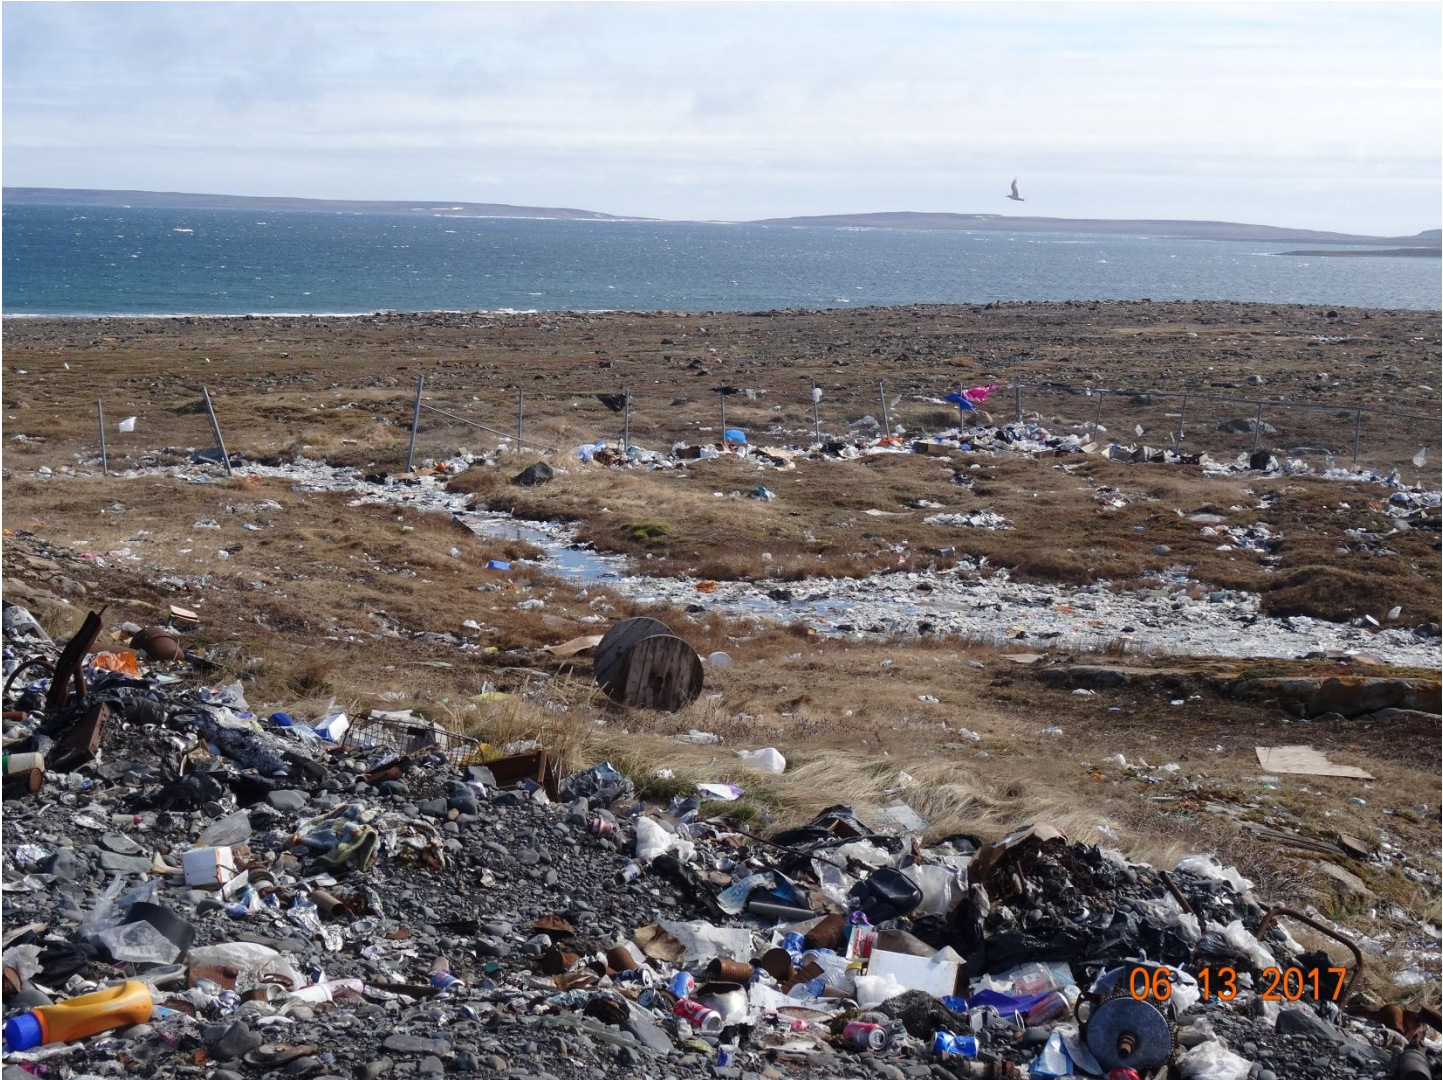
- a) The licensee disposes domestic waste through a burn and cover procedure.
- b) The unlined facility has a ditch on the NE side as you can see in figure 2 below, this ditch gathers surface water from in and around the facility.

i. It was recommended in the last inspection report that the sampling location for SAN-2 be moved to where the water leaves the facility.

ii. This work has not been complete, the previous inspector and I agree that this will give a more representative samples of the leachate leaving the facility.

iii. If the water leaving the facility is proven to be detrimental to the environment, the licensee will need to amend the current water licence to allow for this deposit of a waste or properly divert water away from this facility.

Figure 2: Leachate leaving the solid waste disposal facility.

- The licensee is asked to relocate the sampling point SAN-2, in order to determine if this facility will require leachate criteria.
