Indian and Northern Affairs Canada
Nunavut District Office
Box 100
Iqaluit, Nunavut
XOA OHO

January 11, 2008

Re: Hamlet of Taloyoak Water Licence Inspection September 11, 2007.

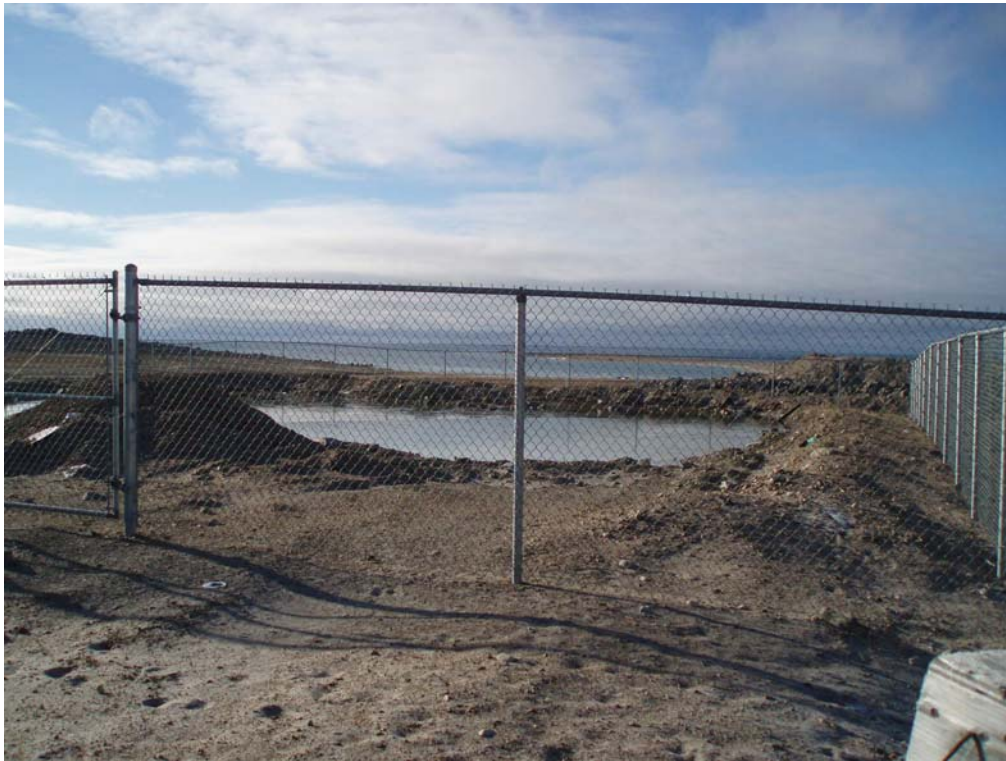
Waste oils storage was not expected at this time. Contaminated soils are stored in a lined bermed facility which is completely fenced in. However, a substantial amount standing water was inside of the bermed facility which shouldn't happen. This water, which will be contaminated with hydrocarbons, may unacceptably seep or flow over the berms in time.

Photo 1. Standing water in the contaminated soil containment area.

- 2) The capacity of the sewage lagoon needs to be increased in order to increase retention time and improve treatment. Ammonia levels are extremely high and need to be lowered before being released. Berms and a downstream could be used to increase available storage and retention times.
- 3) Fencing needs to be put around the landfill site and better segregation is needed for general and metal wastes.
- 4) A solution is needed to the standing water in the contaminated soil facility.

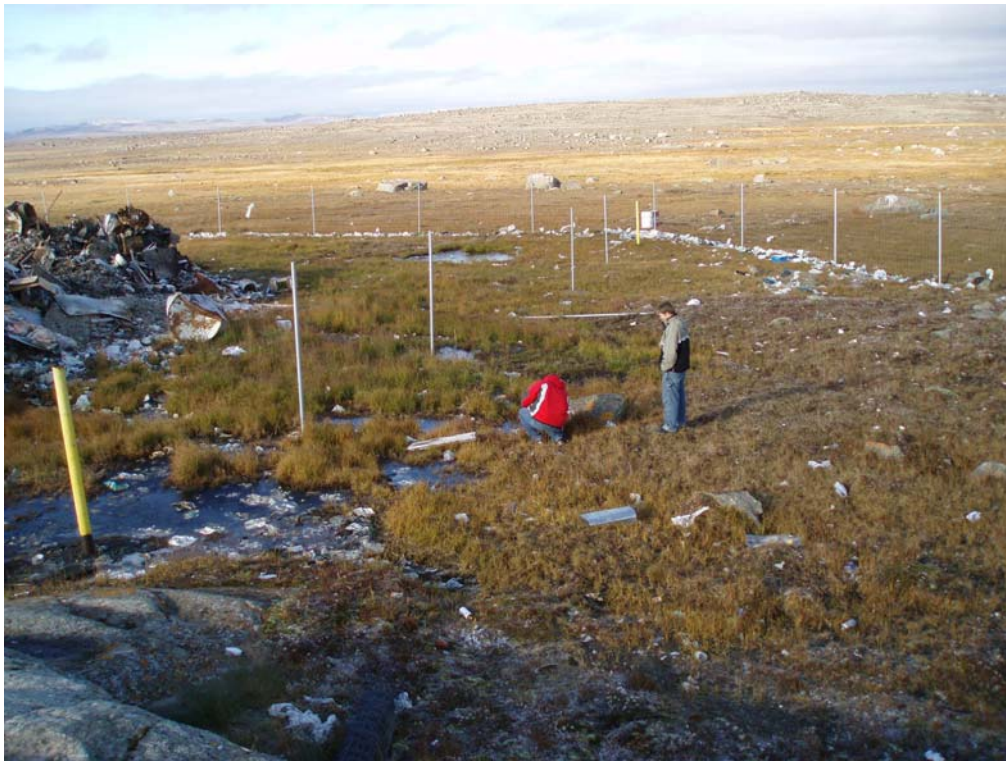
The landfill is poorly operated and wastes are not segregated. The landfill is not fenced and signs do not identify the site. Garbage is widely distributed. Hazardous waste, such as waste fuel/oil, batteries, propane or pressurized gas bottles, solvents and paint, are not segregated from the general waste stream and stored in a separate location until they can be transported to a licensed facility for disposal.

Photo 2. No fencing surrounding the landfill; windblown garbage all over.

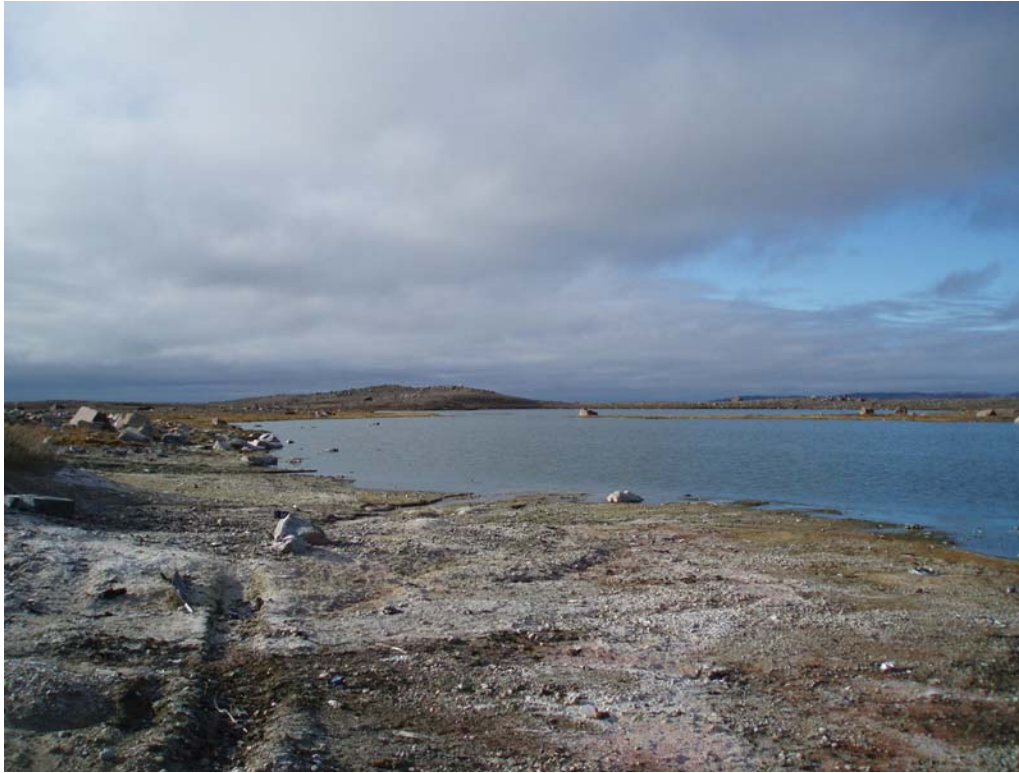
The sewage lagoon is a natural pond that appears to be achieving some level of treatment, but I am unsure about the retention time and the success in removal of

solids. Ammonia concentrations from the downstream sample were extremely high and unacceptable. High ammonia concentrations may be from lack of sewage retention and further treatment is needed to lower the concentrations of ammonia.

Photo 3. No berms surrounding the lagoon creating very little retention time.
