WATER LICENCE INSPECTION FORM

Licensee		Licensee Representative	
Hamlet of Taloyoak		David Irqut	
Licence No. / Expiry		Representative's Title	
3BM-TAL1926		Assistant Senior Administrative Officer	
Land / Other Authorizations		Land / Other Authorizations	
Date of Inspection		Inspector	
2020 August 13		Baba Pedersen	
Activities Inspected			
<input type="checkbox"/> Camp	<input type="checkbox"/> Drilling	<input type="checkbox"/> Mining	<input type="checkbox"/> Construction
<input type="checkbox"/> Roads/Hauling	<input type="checkbox"/> Other:	<input checked="" type="checkbox"/> Other: Municipal	<input type="checkbox"/> Reclamation
<input type="checkbox"/> Fuel Storage

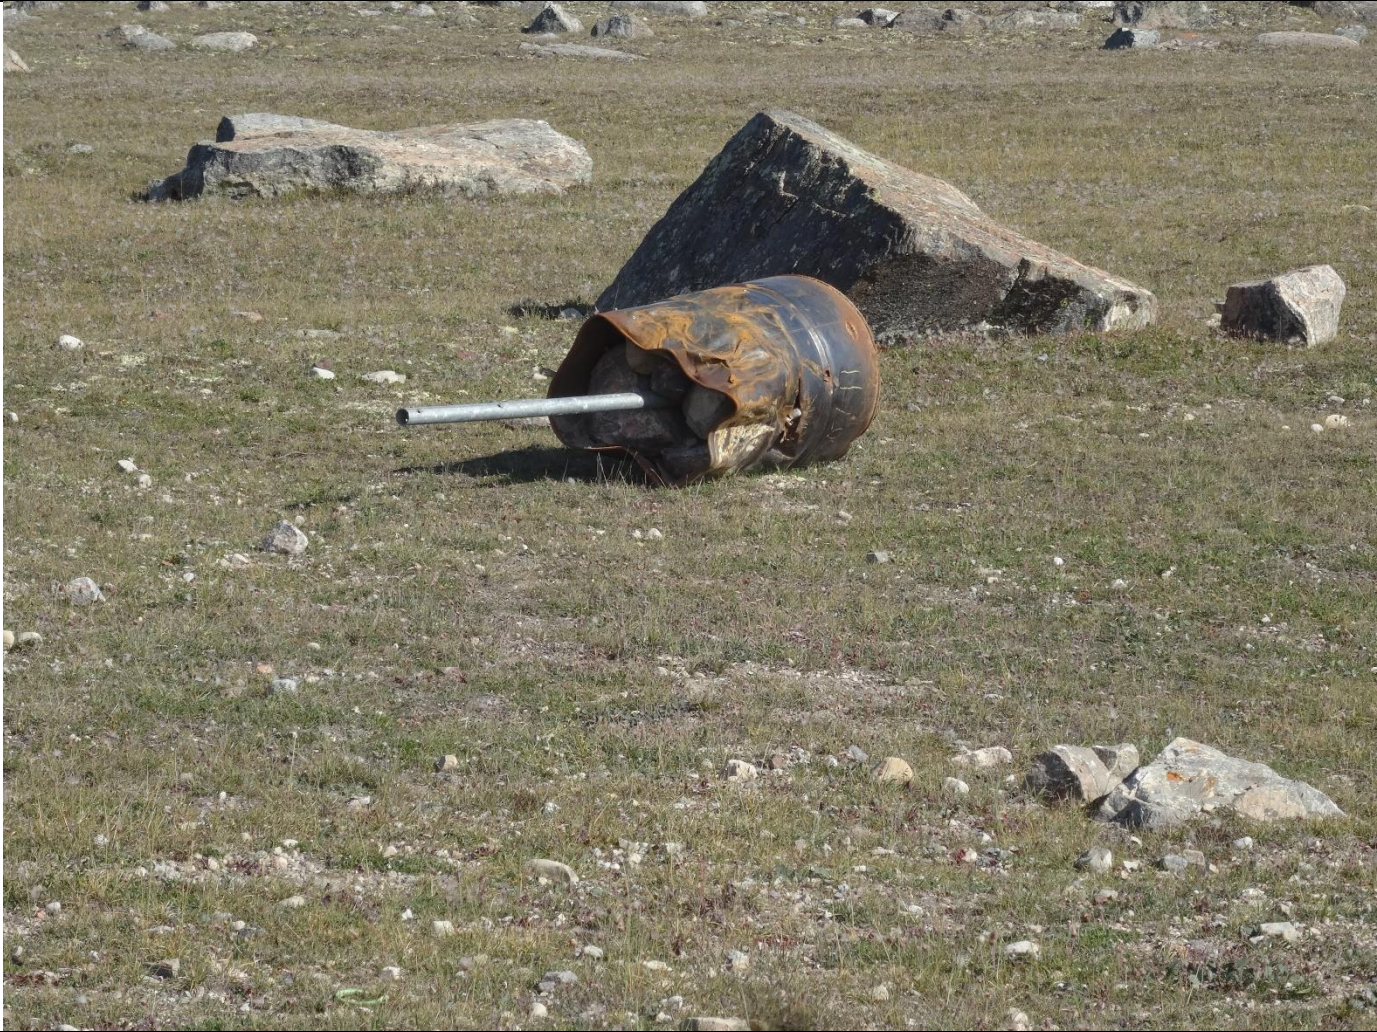
Photo 3

Description: The Sewage Lagoon Signage at the Access Area has been Removed and MUST be Re-installed

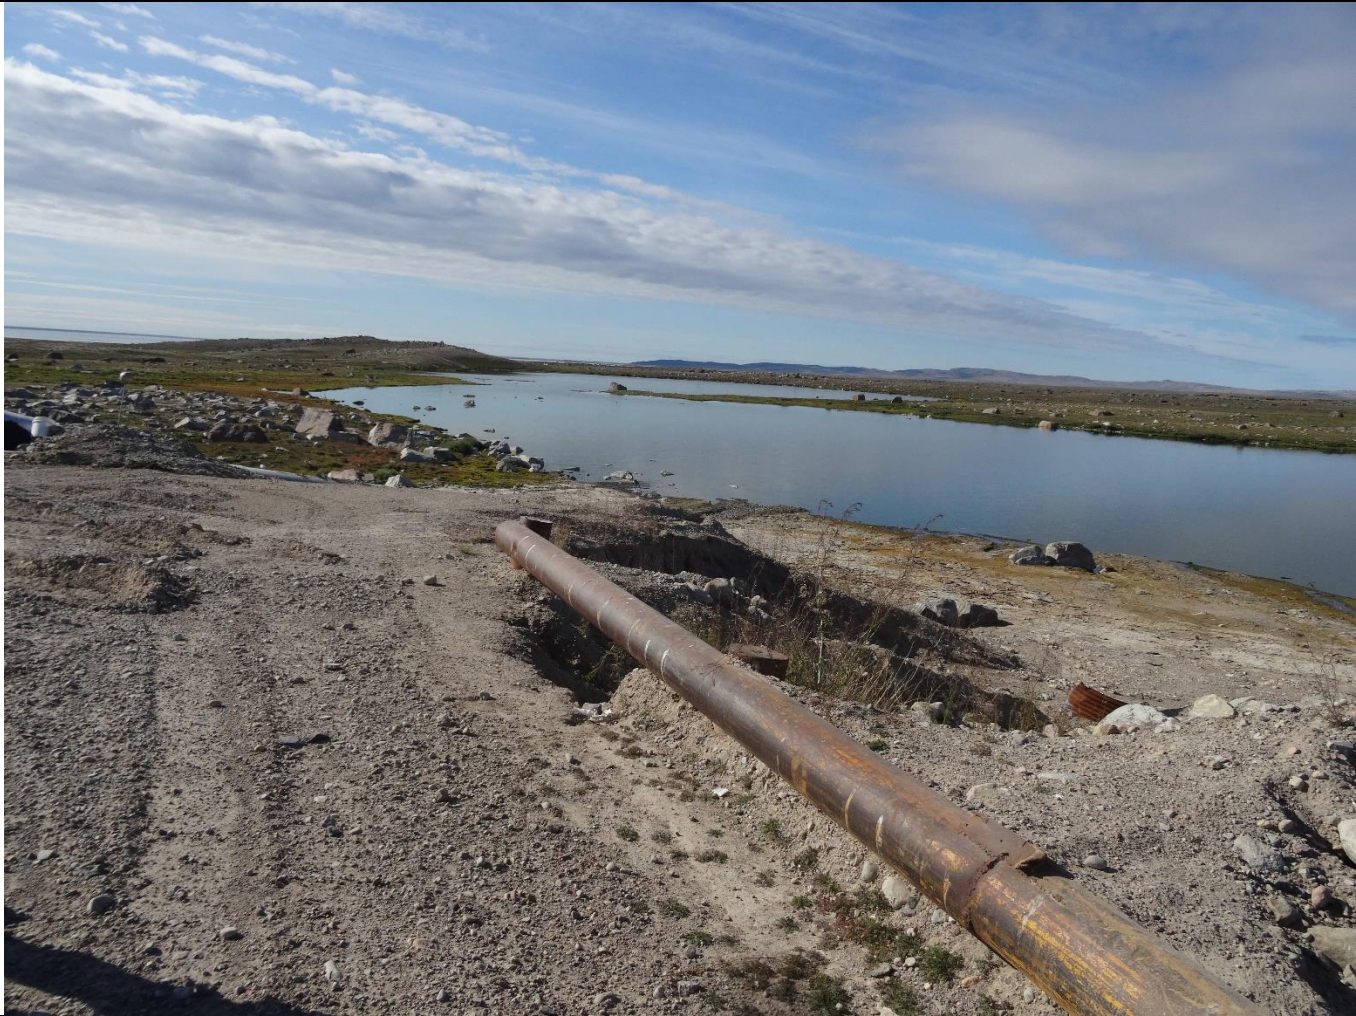
Photo 4

Description: Sewage Lagoon Wetlands Area – No Concerns here

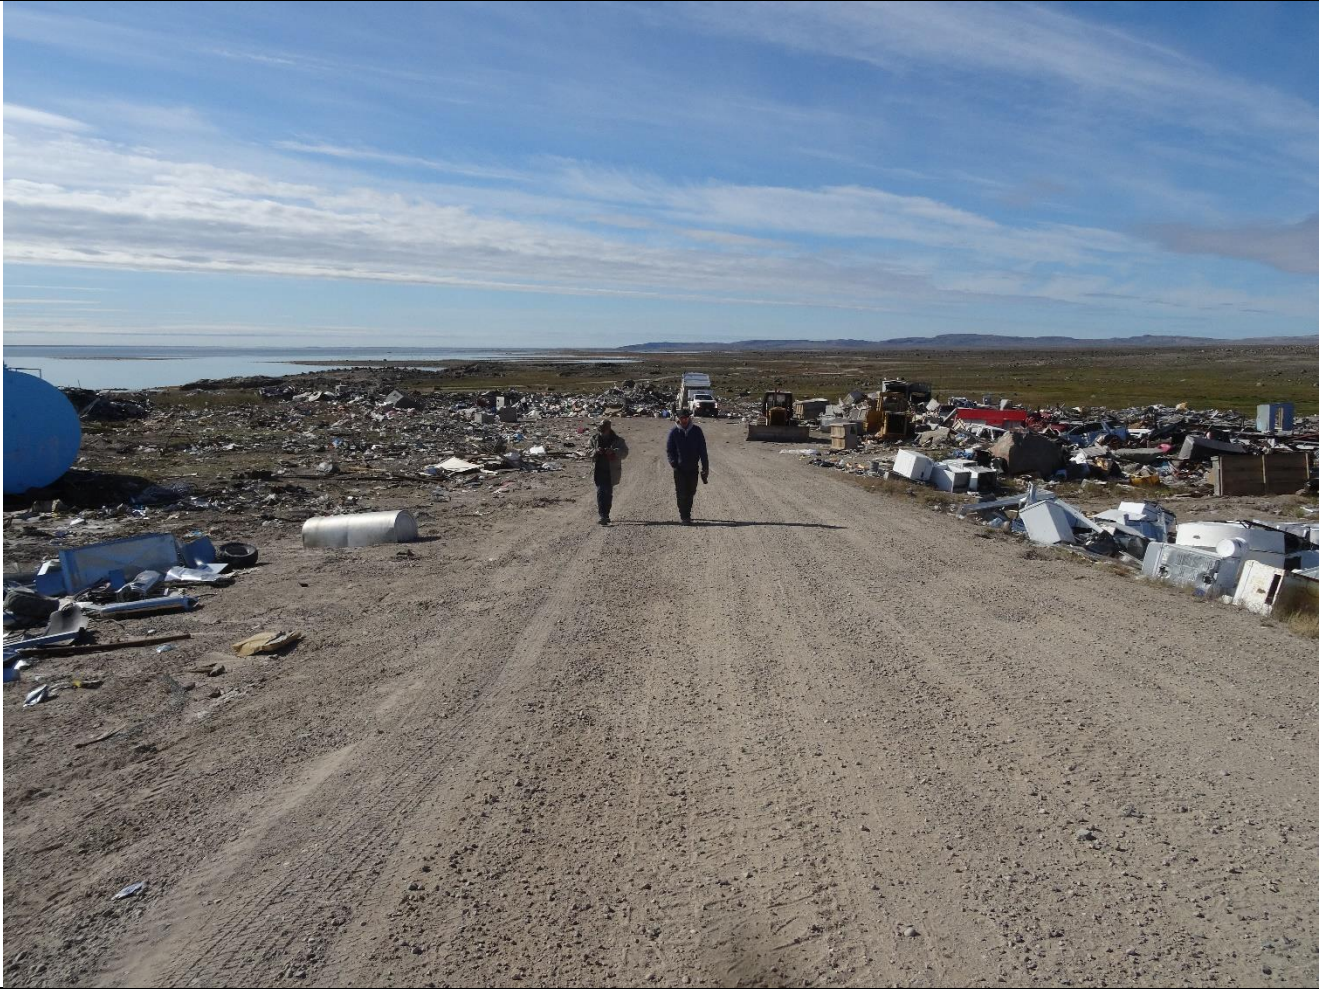
Photo 5

5. The Licence Holder maintains adequate segregation, a routine Burn Program and routine Maintenance within the Garbage Dump Area. The Inspector has no concerns in this area at this time

Description: Garbage Dump showing adequate Segregation and Routine Maintenance – Thank you

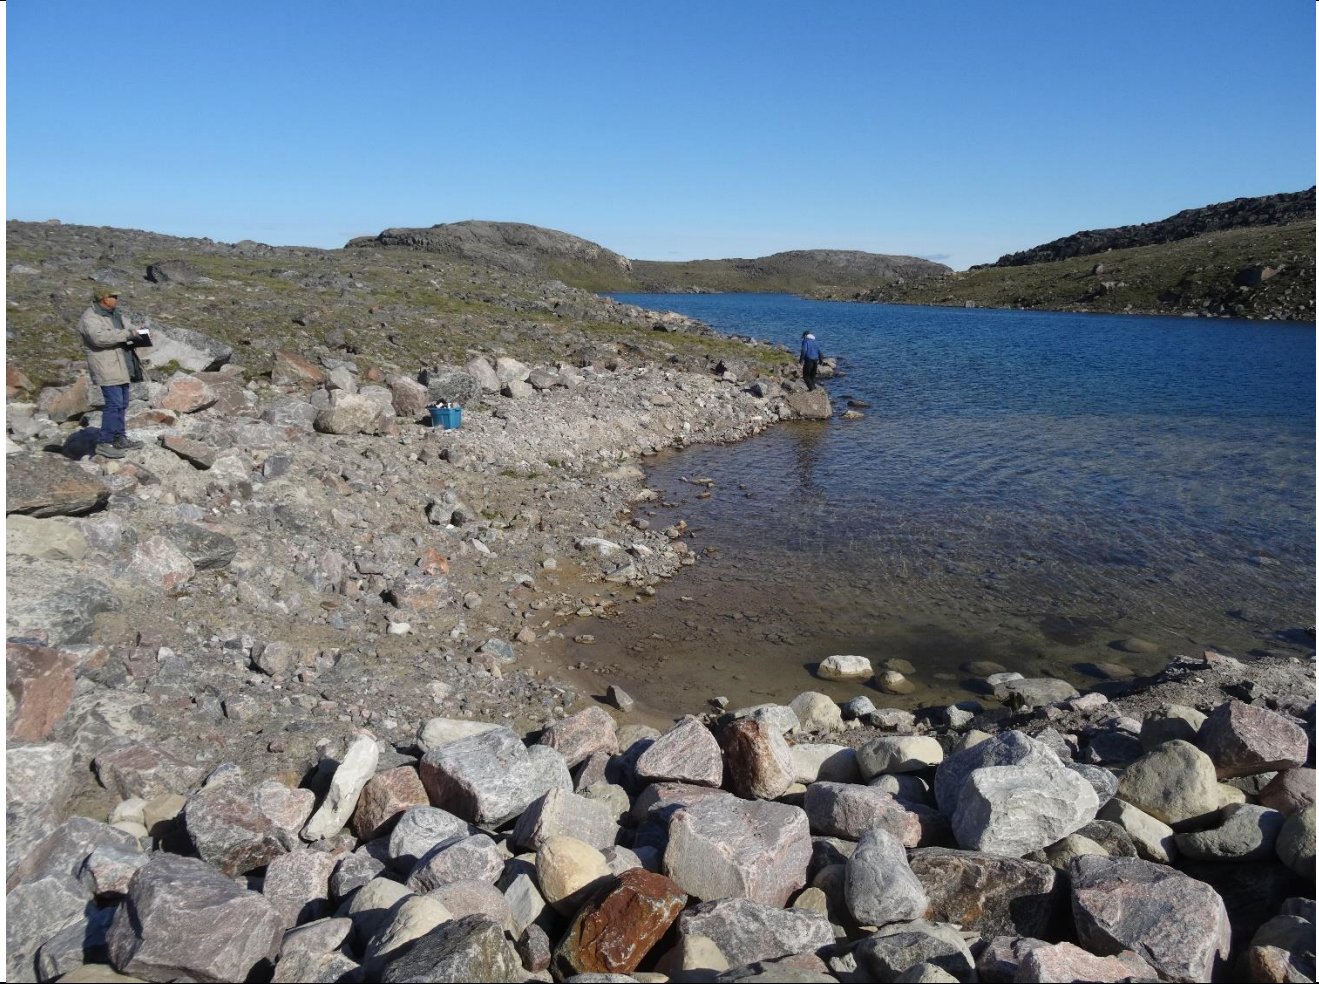
Photo 6

6. The TAL-1 Signage has been Removed and MUST be re-installed

Description: Signage for Sample Station TAL-1 at the Water Intake and Pump House Location has been Removed and MUST be Re-installed

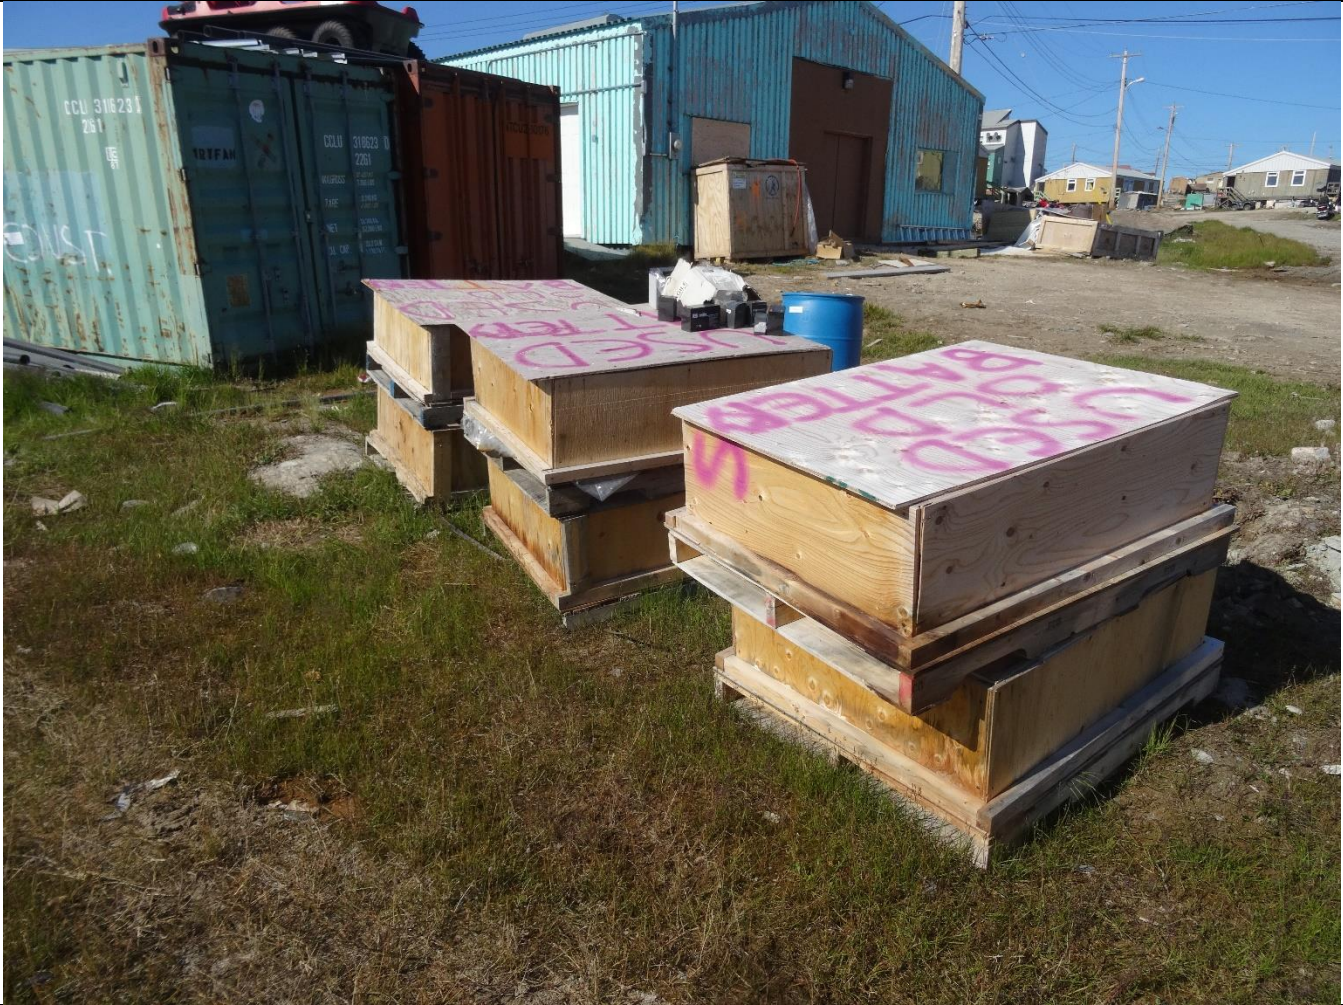
Photo 7

7. The Licence Holder has Crated and Stored their own stock of Used Batteries very nicely. Going forward, the Inspector has directed the Licence Holder to do the same with the Public’s Used Batteries stored within the Garbage Dump Area

Description: Used Batteries well Crated waiting for Shipment South for proper Disposal

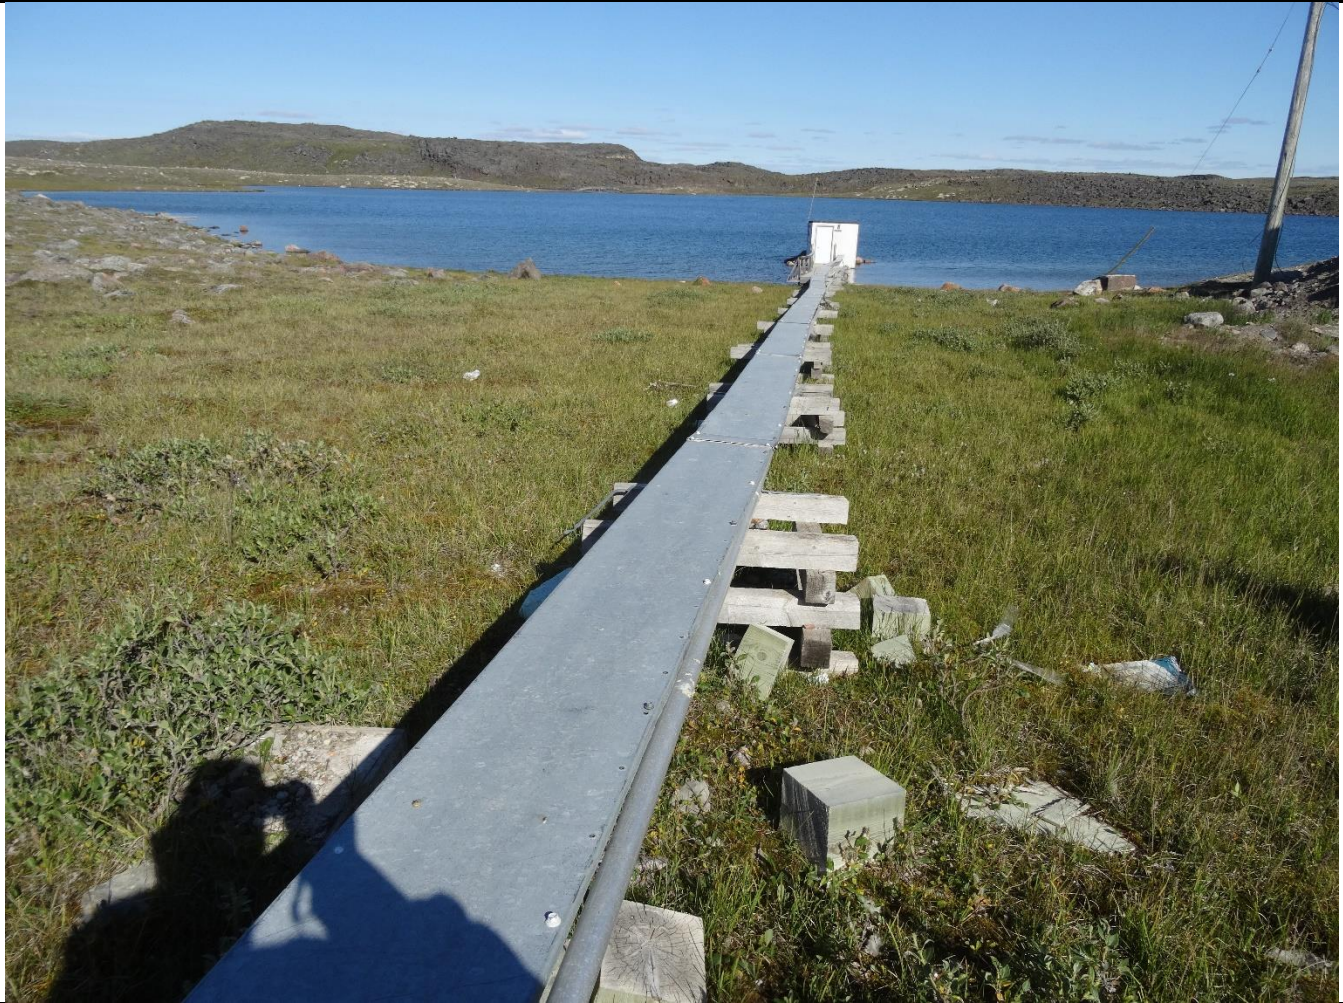
Photo 8

8. The Inspector has brought up the requirement for the Licence Holder to work with the GN CGS to Remove and Reclaim the old Water Intake Pump House and Utilidor System in numerous previous Inspection Reports. The claim of a lack of funding to carry out the required Reclamation is neither adequate nor acceptable. The Licence Holder MUST find appropriate funding and complete Reclamation of the old Water Intake Pump House and Utilidor System PRIOR TO July 31, 2021 or the Inspector may have to consider further Enforcement Action

Description: Old Pump House and Utilidor System requiring Reclamation – View 1

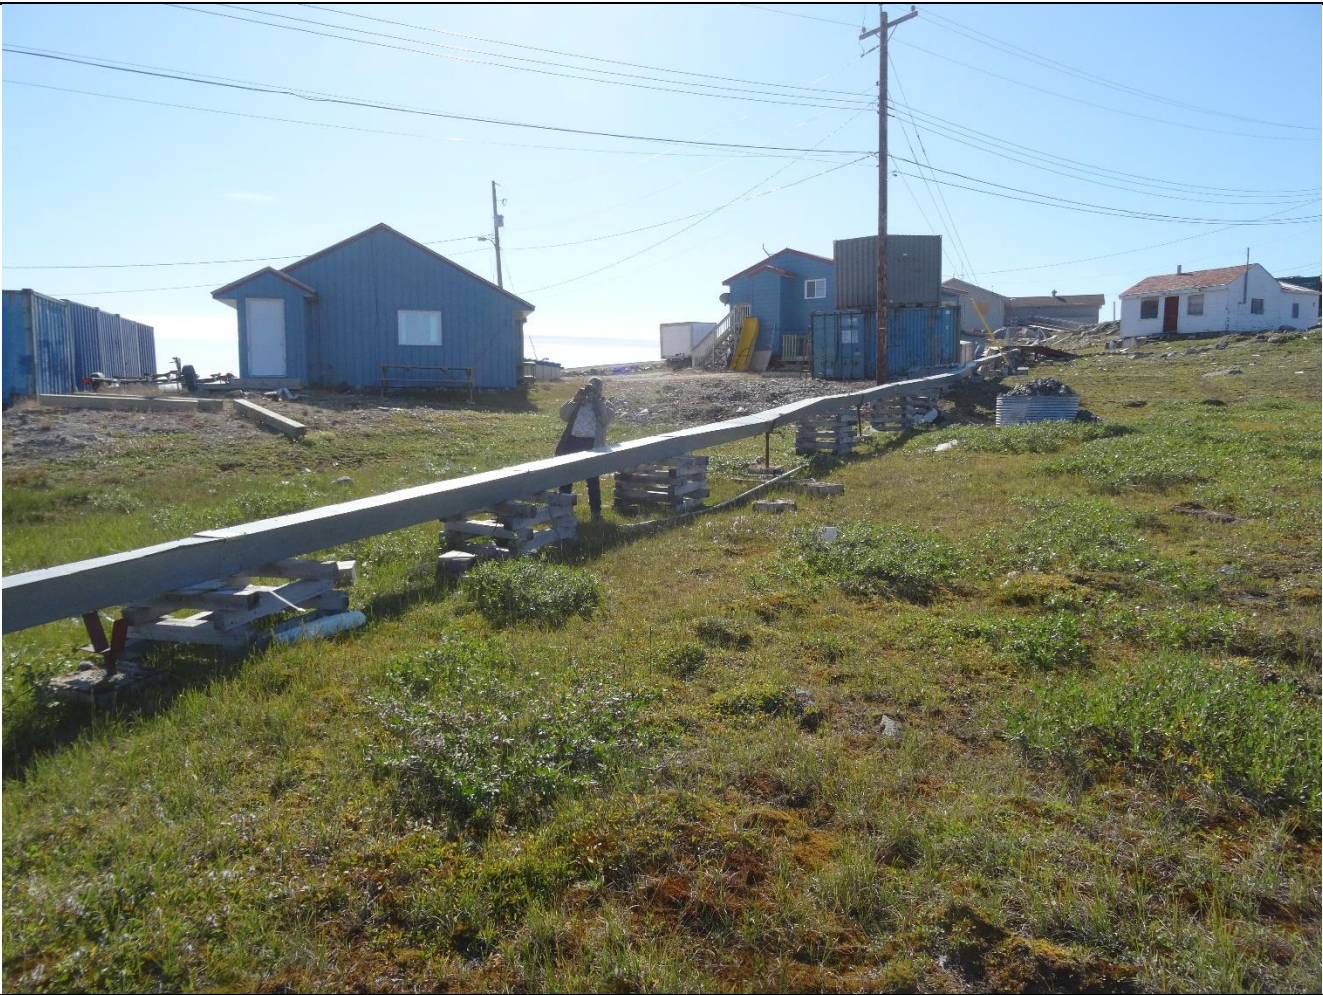
Photo 9

Description: Old Pump House and Utilidor System requiring Reclamation – View 2

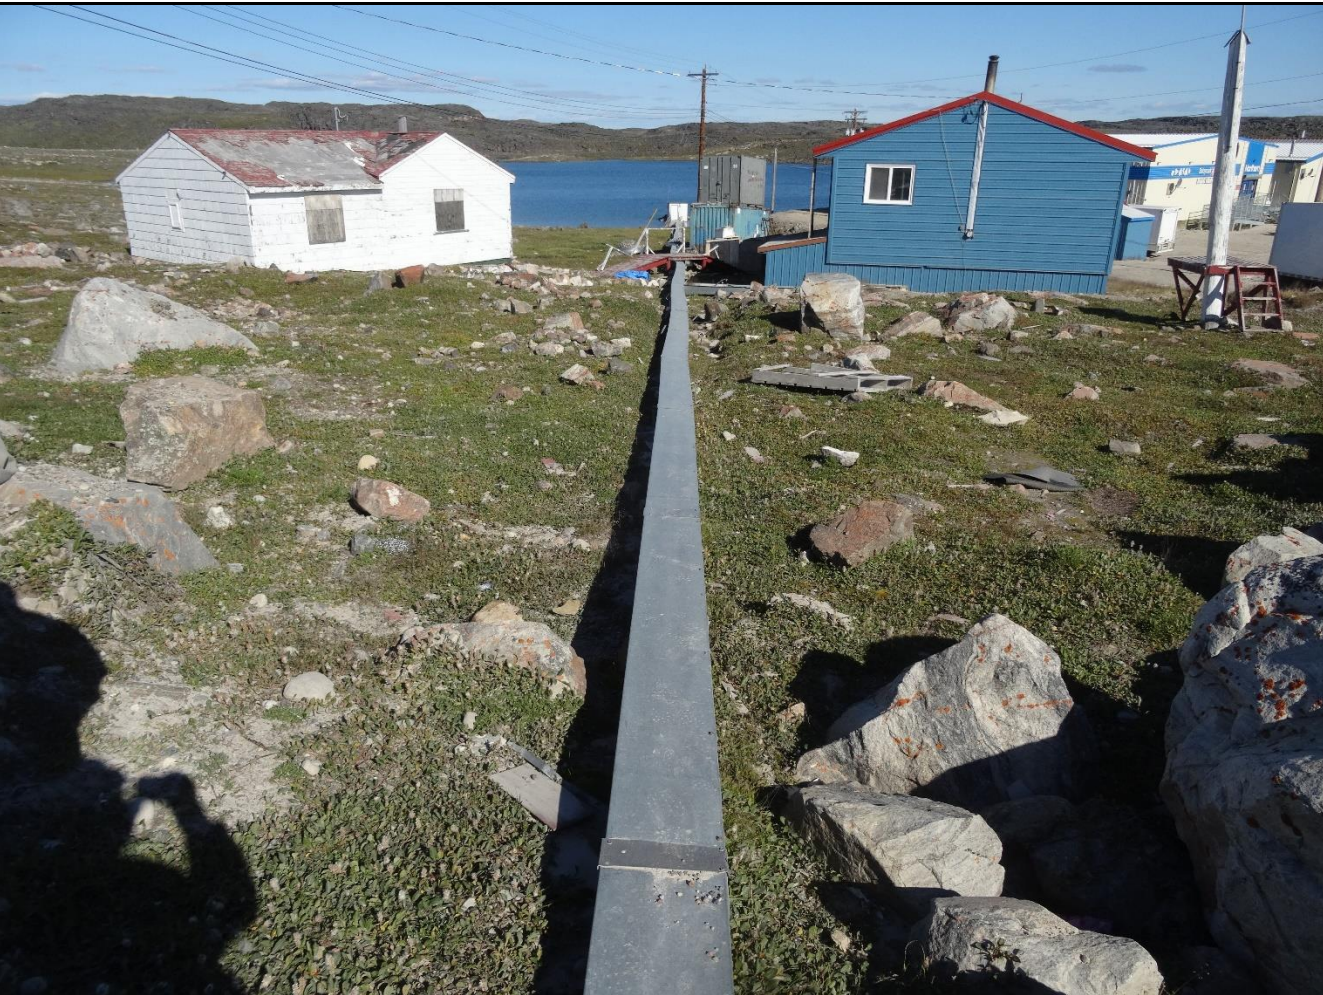
Photo 10

Description: Old Pump House and Utilidor System requiring Reclamation – View 3
