WATER LICENCE INSPECTION FORM

Licensee		Licensee Representative	
Hamlet of Taloyoak		Larry Banks	
Licence No. / Expiry		Representative's Title	
3BM-TAL-1419		Director of Public Works	
Land / Other Authorizations		Land / Other Authorizations	
Date of Inspection		Inspector	
7 July 2016		Baba Pedersen	
Activities Inspected			
<input type="checkbox"/> Camp	<input type="checkbox"/> Drilling	<input type="checkbox"/> Mining	<input type="checkbox"/> Construction
<input type="checkbox"/> Roads/Hauling	<input checked="" type="checkbox"/> Other: Municipal	<input type="checkbox"/> Reclamation	<input type="checkbox"/> Fuel Storage

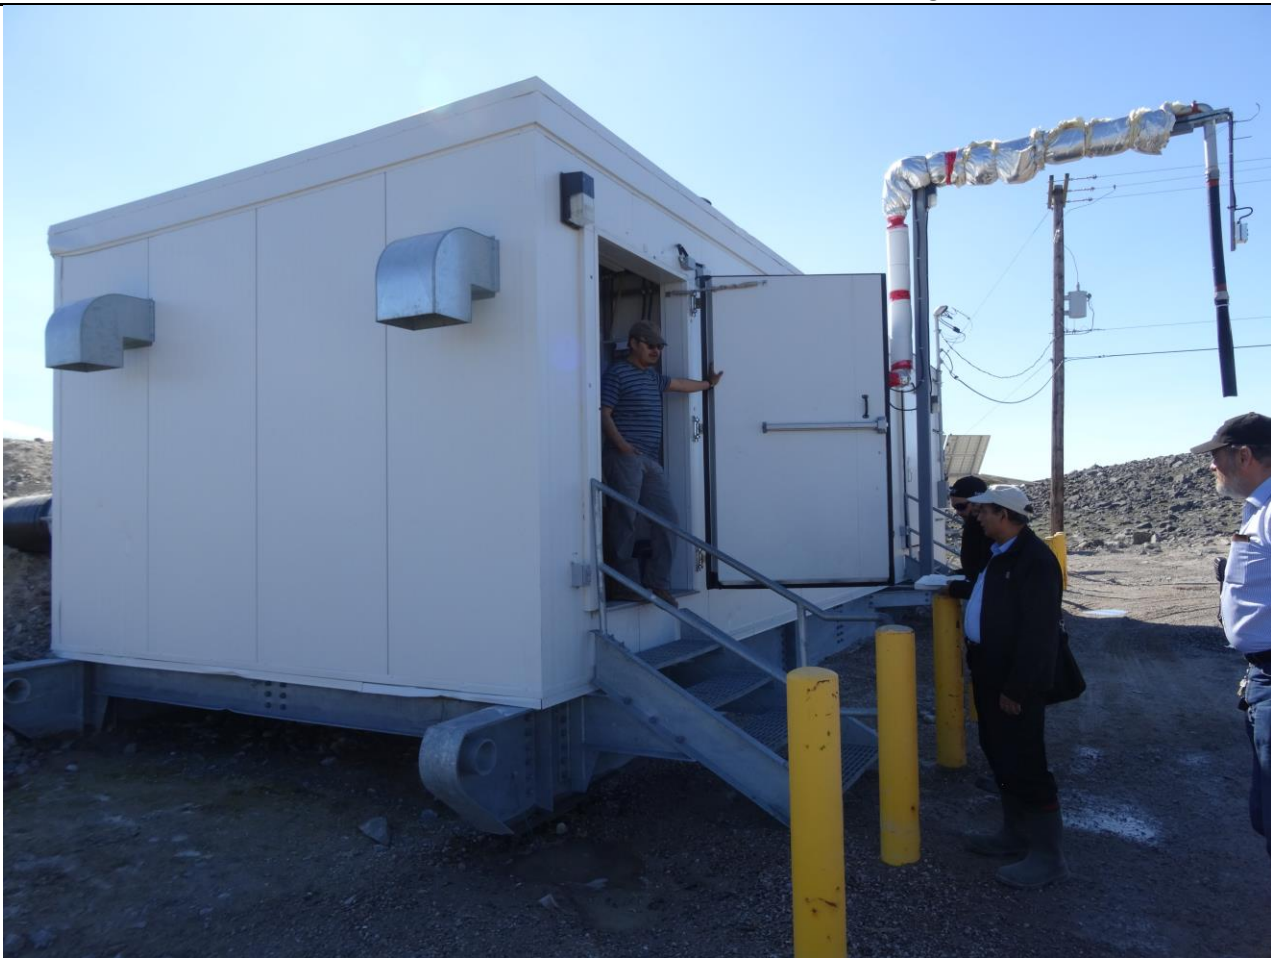
Date	Camera	Inspector	Authorization
7 July 2016		Baba Pedersen	3BM-TAL-1419
Photo Log # 6000		Location	
Photo 1		Water Intake Building

Description: Outside view of Water Intake Building

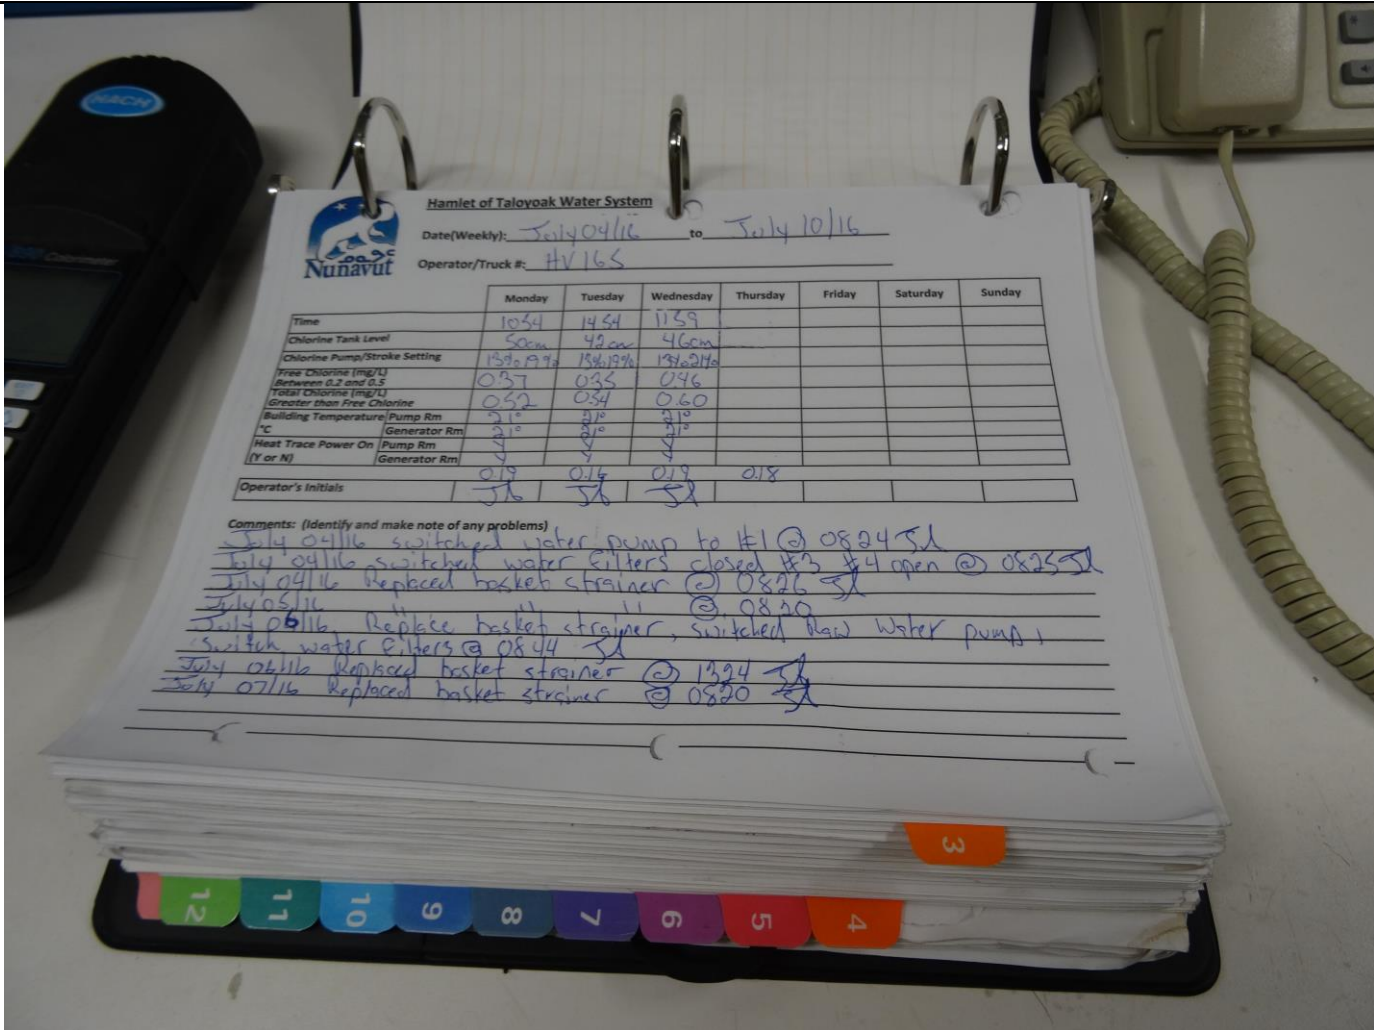
Photo Log # 6005	Location
Photo 2	Water Intake Building

1. The Hamlet uses the Fluid Manager Computer System and the Flow Meter had been sent out for Repairs. The Hamlet Staff were taking Manual Records (Photo 2) but were unable to provide Consumption Records as is required by the Water Licence. Staff MUST be able to provide Consumption Records to the Inspector on request. This needs to be rectified prior to next year's Inspection. 2. The Inspector strongly recommends the Hamlet build a Land Farm to properly handle Contaminated Soils. 3. Samples need to be taken by Hamlet Staff regularly and recorded as and when the Water Licence Stipulates. 4. The Dump Effluent Sample Location needs to be changed from Station TAL 5 to Station TAL 4 because the Station TAL 5 location is 100% dry and has no signs of any flow and there is sufficient flow and liquid to sample at Station TAL 4. 5. Signage needs to be posted in the Dump area to aid the public and Hamlet in properly segregating materials brought to the Dump as per the Water Licence. This needs to be installed prior to next year's Inspection.

Description: Manual Records inside Water Intake Building DO NOT show Consumption Records and/or Amounts

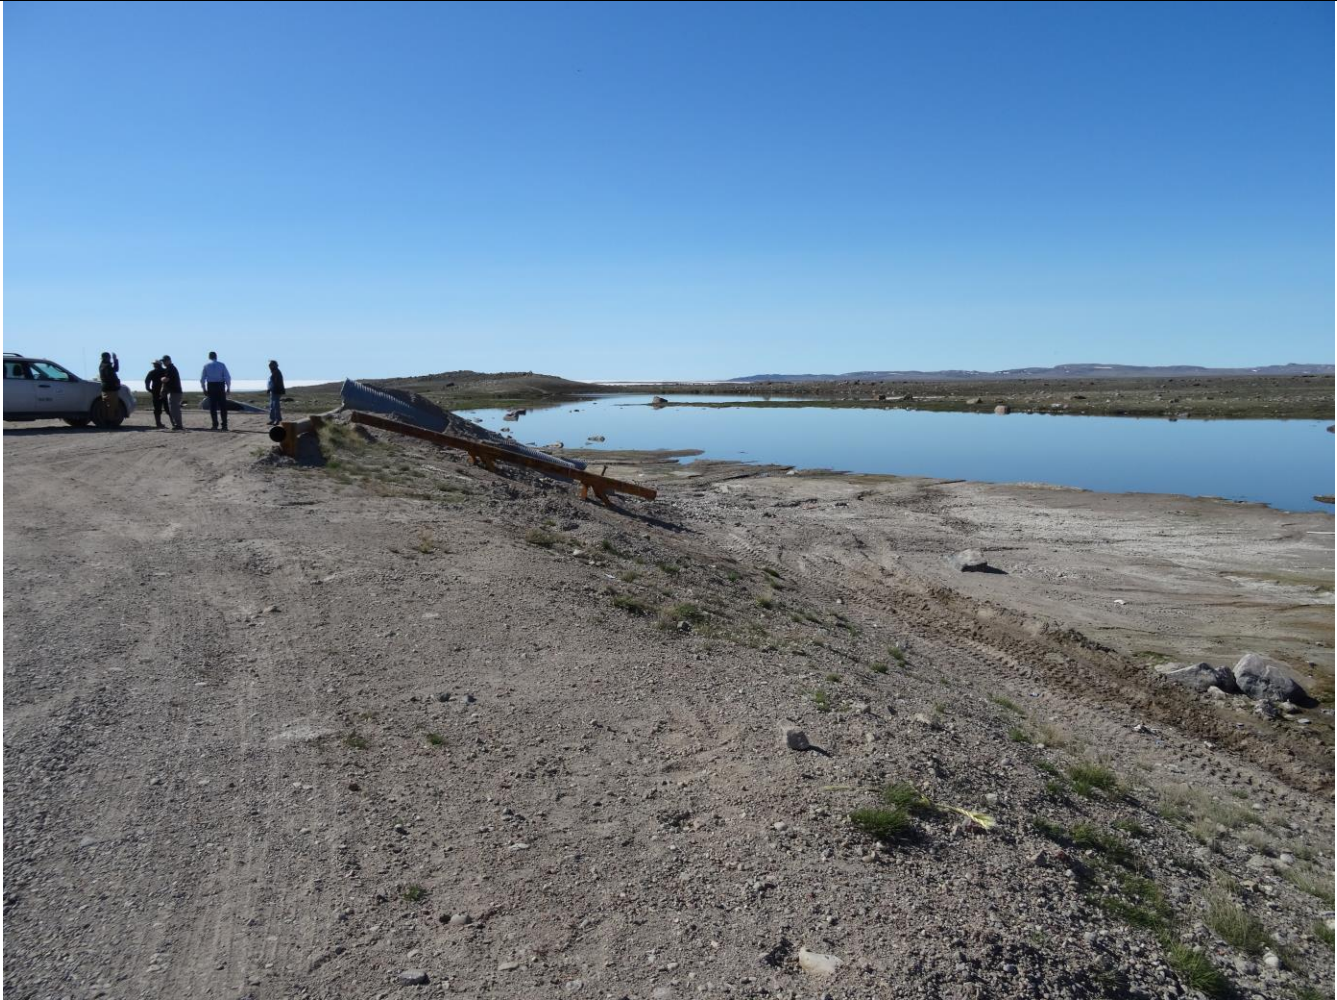
Photo 3

Description: View of Sewage Lagoon and Truck Dumping Station

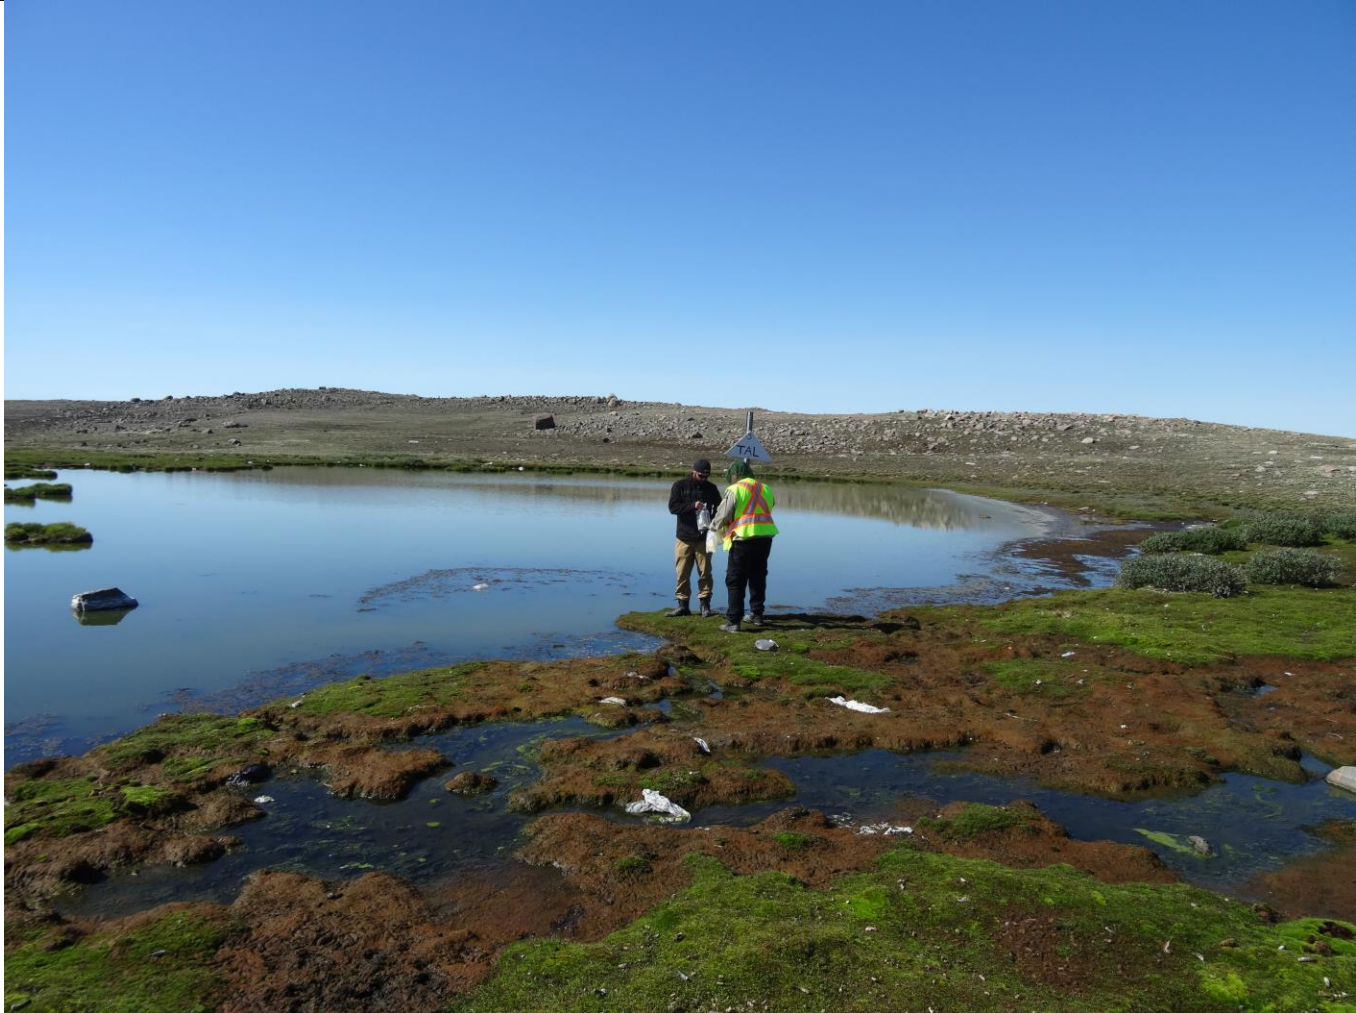
Photo 4

Description: INAC Inspectors taking samples at TAL 3 Sample Location
