WATER LICENCE INSPECTION FORM

| Hamlet of Taloyoak | | Ted Laszczak | |
| 3BM-TAL1419 | | Senior Administrative Officer | |
| 12 July 2018 | | Baba Pedersen | |

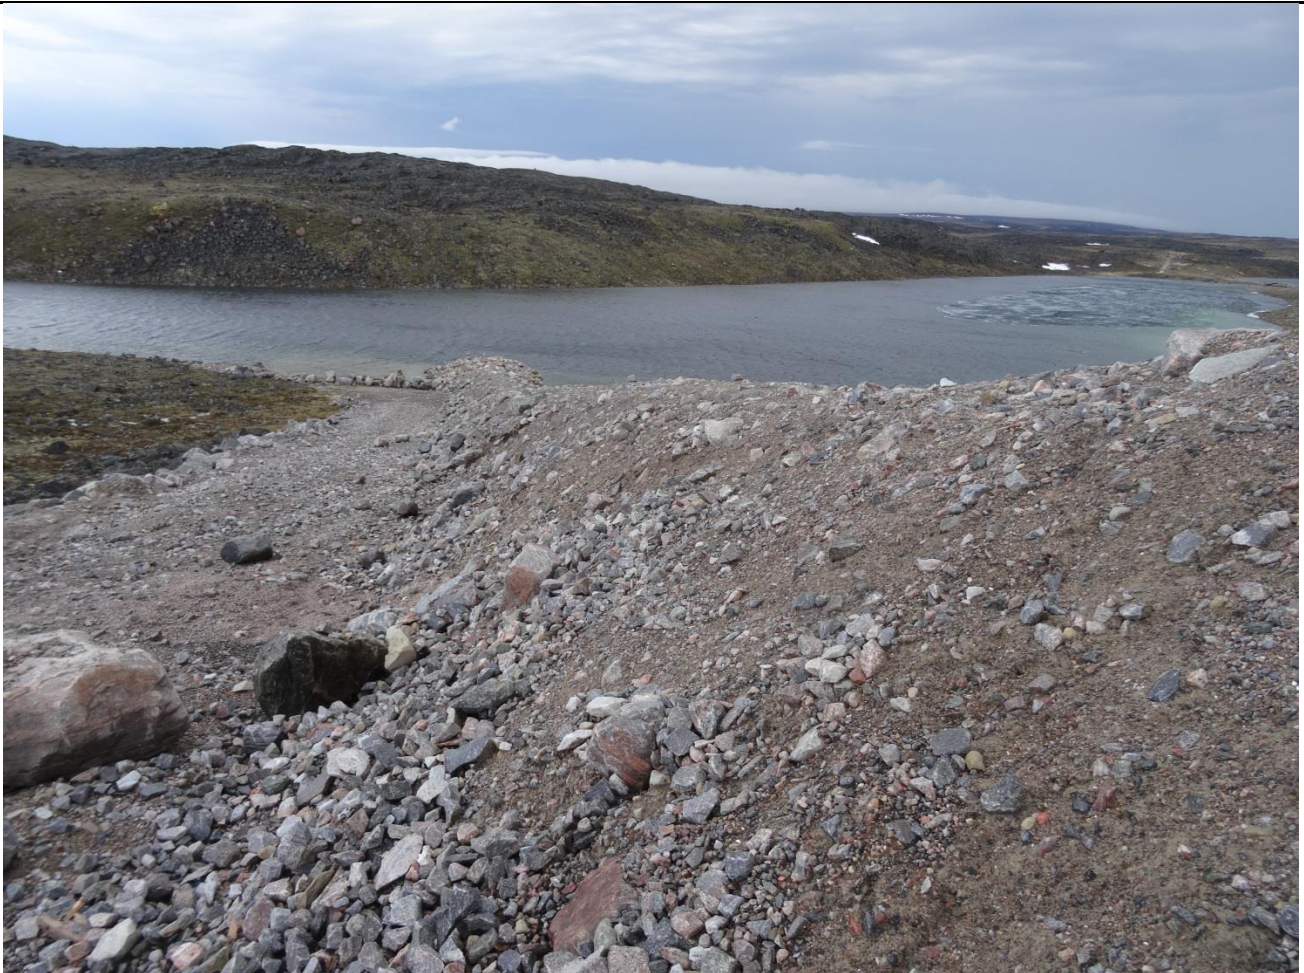
Photo 1

Description: TAL-1 Outdoor Sample Area at end of Raw Water Intake Pipe – No Visible Signage

1. Signage needs to be placed to allow identification of the exact spot of the TAL-1 Outdoor Sample Location, 2. The TAL-1 Indoor Sample Location is clearly marked as requested – Thank you very much, 3. YTD Consumption Amounts (23,625 Cubic Meters, well within their 60,000 allowable limits) were provided upon request – Thank you very much, 4. I applaud the Hamlet's efforts to send items south for recycling, such as the Disposable Water Filters, to reduce volumes at the Garbage Dump, 5. I applaud the Hamlet's (and GN) plan to add a Cell to the existing Sewage Lagoon in order to enhance the Natural Wetlands processing capabilities, 6. The TAL-6 Signage needs to be replaced as the existing one has disappeared, 7. The Hamlet is directed to update the Inspector when the Decommissioning of the old Water Plant starts, and 8. The Hamlet is encouraged to start the planning process to Renew this Water Licence as it is due to Expire in 2019.

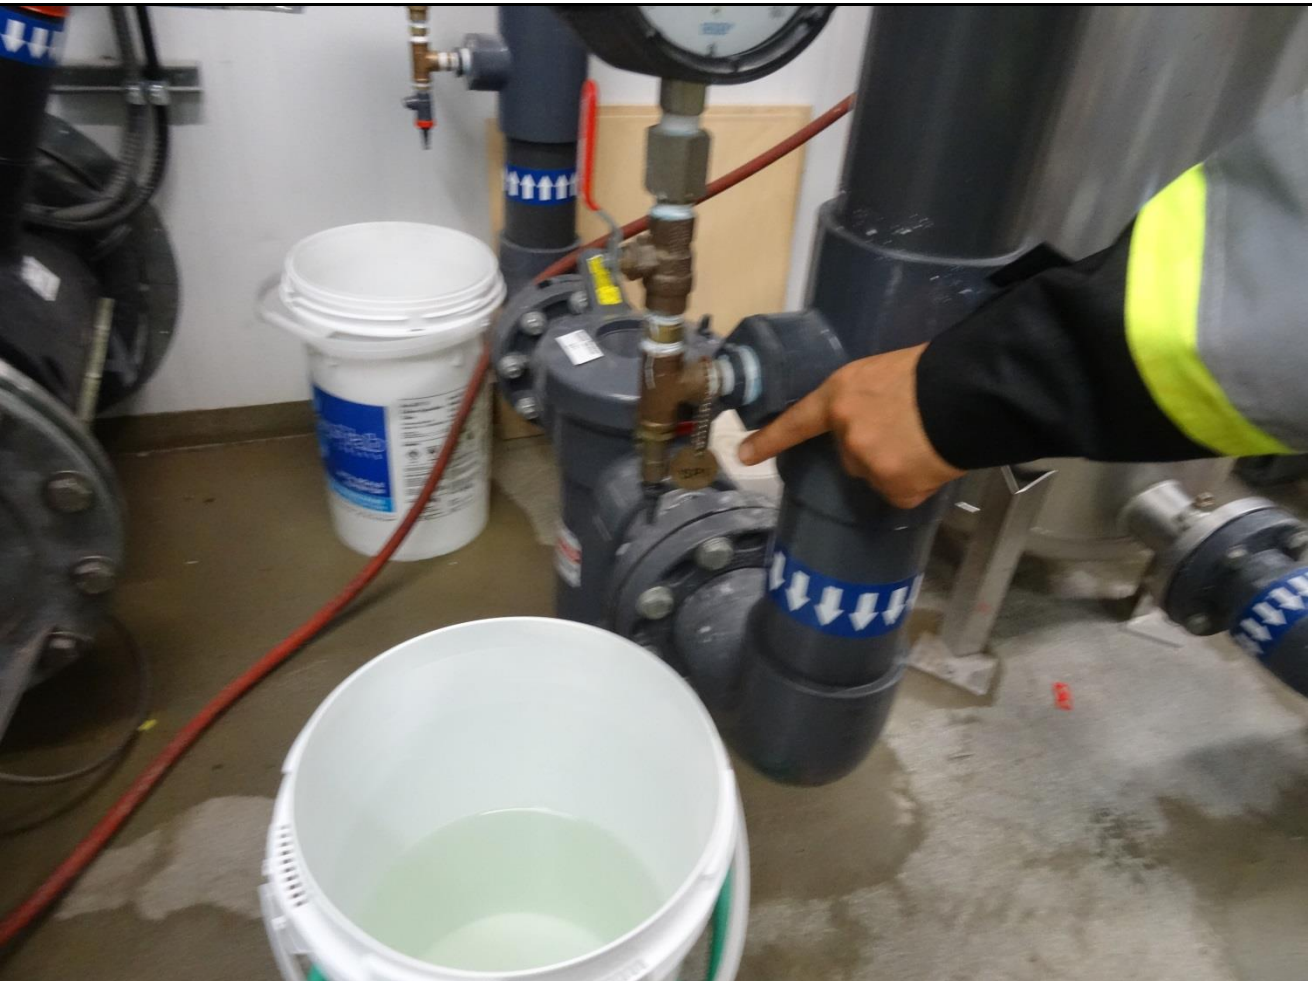
Photo 2

Description: TAL-1 Indoor Sample Area inside Water Treatment Plant – with Brass Tag Signage

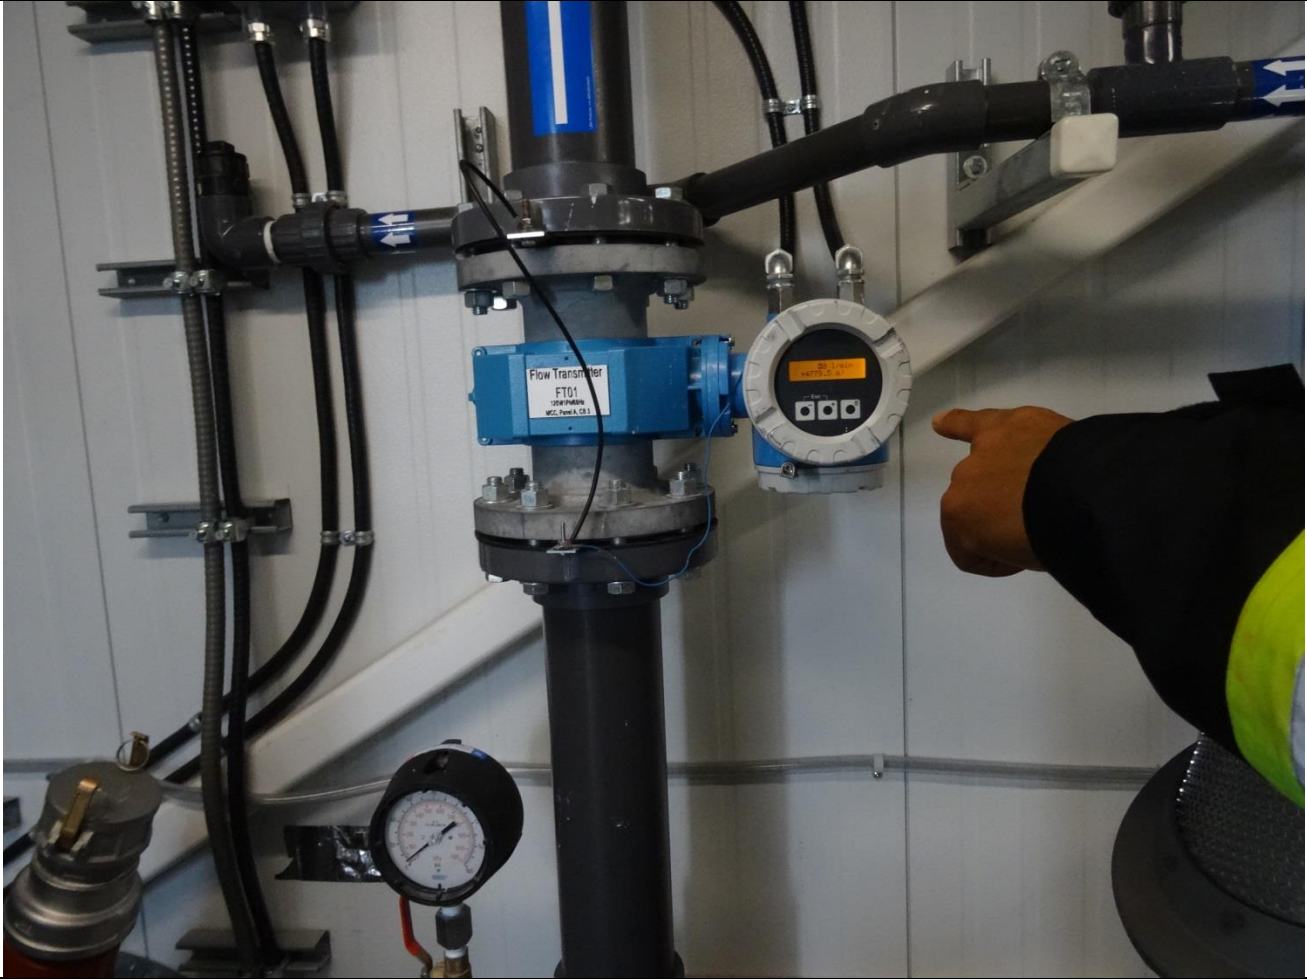
Photo 3

Description: Raw Water Intake Flow Meter used by the Hamlet to Calculate/Record overall Consumption amounts

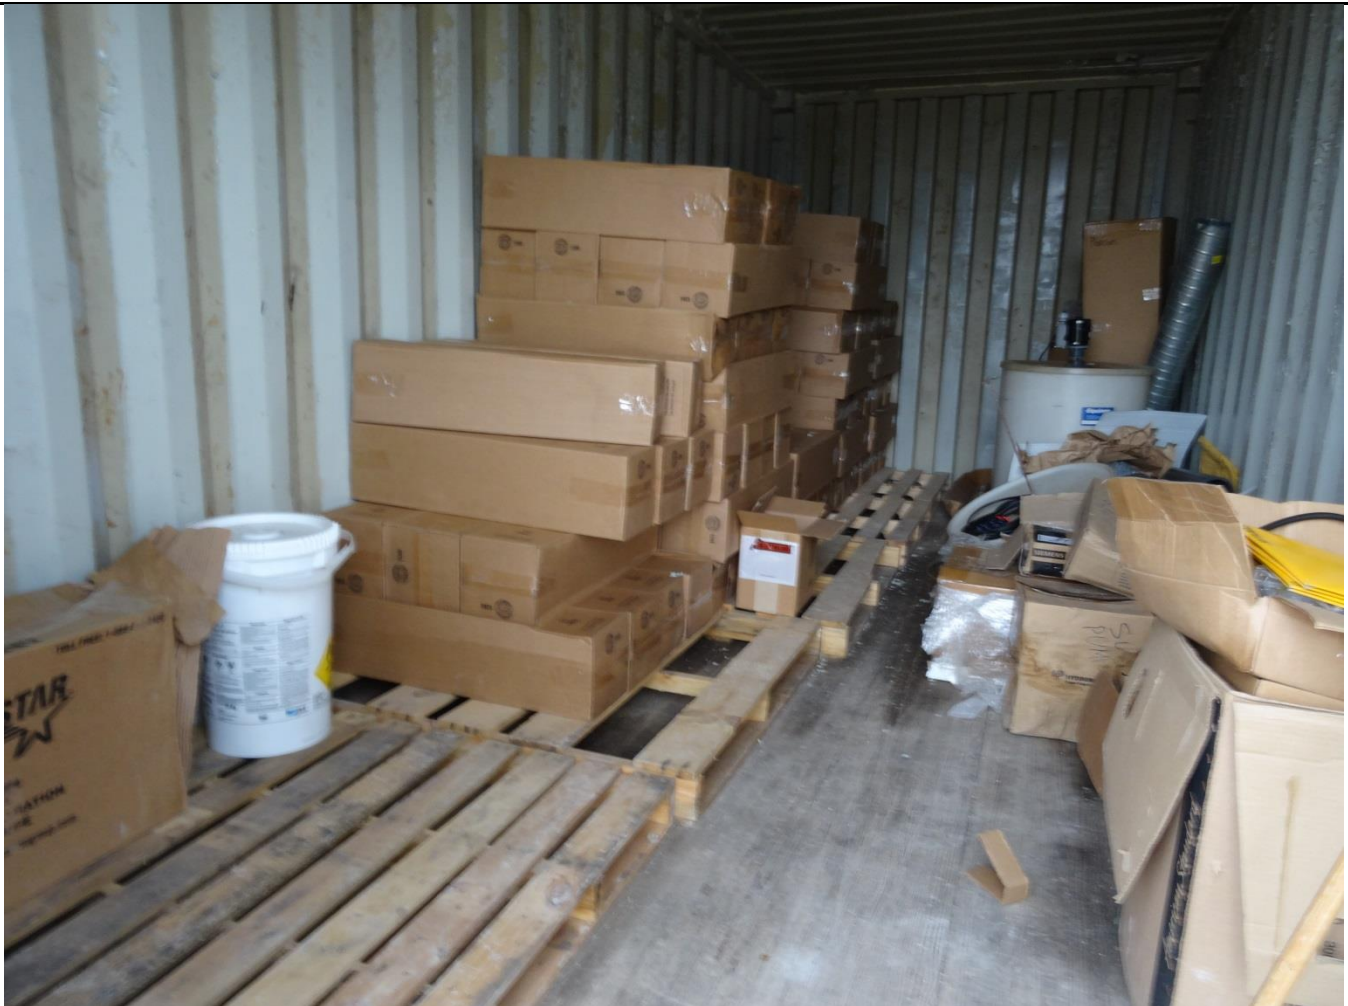
Photo 4

Description: 1 year supply of Water Filters in original boxes – Hamlet will re-box Used Filters for planned Recycling Shipment

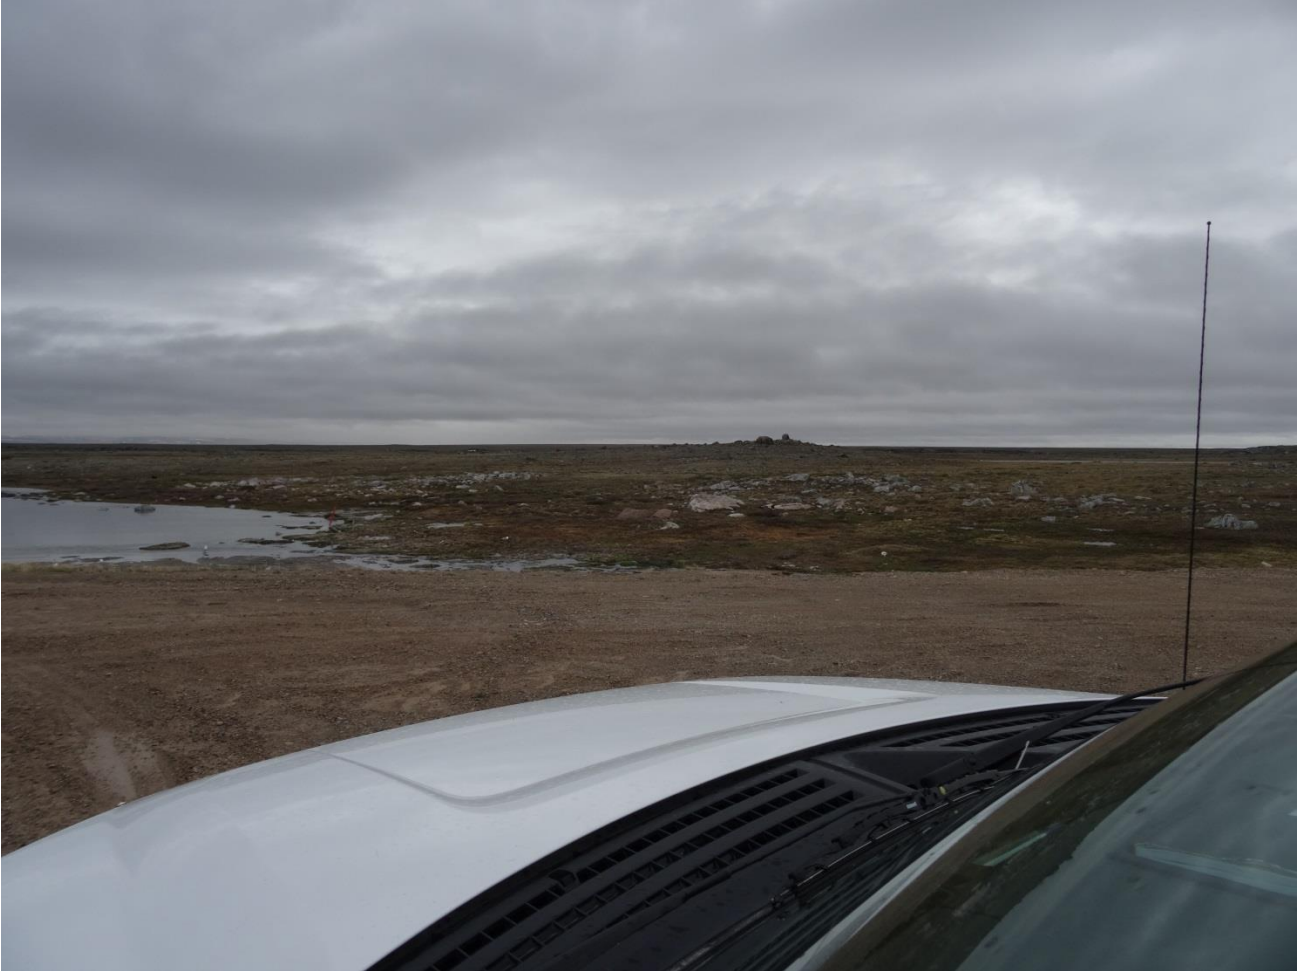
Photo 5

Description: Area above Sewage Lagoon where GN/Hamlet plan to build new Containment Cell in near future

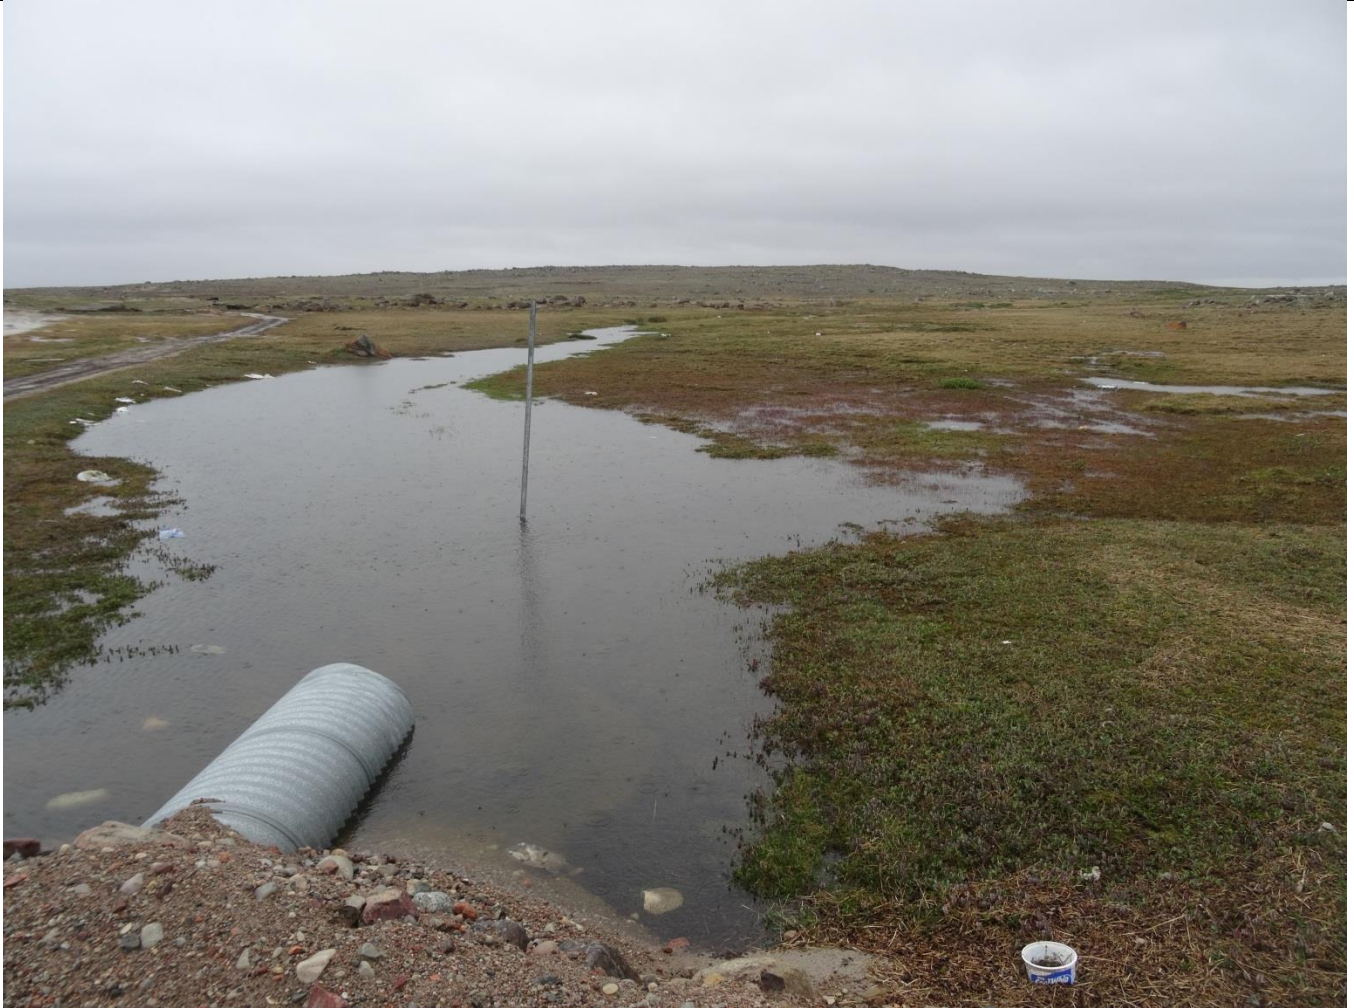
Photo 6

Description: TAL-6 Sample Location missing Signage – Requires Replacement
