WATER LICENCE INSPECTION FORM

Licensee		Licensee Representative	
Hamlet of Taloyoak		Ashoona Irqquit	
Licence No. / Expiry		Representative's Title	
3BM-TAL1926		Foreman	
Land / Other Authorizations		Land / Other Authorizations	
		--	
Date of Inspection		Inspector	
July 31, 2024		Jonathan MESHER	
Activities Inspected			
<input type="checkbox"/> Camp	<input type="checkbox"/> Drilling	<input type="checkbox"/> Mining	<input type="checkbox"/> Construction
<input type="checkbox"/> Roads/Hauling	<input type="checkbox"/> Other:	<input type="checkbox"/> Reclamation	
		<input type="checkbox"/> Fuel Storage	
		<input checked="" type="checkbox"/> Other: Hamlet waste storage.

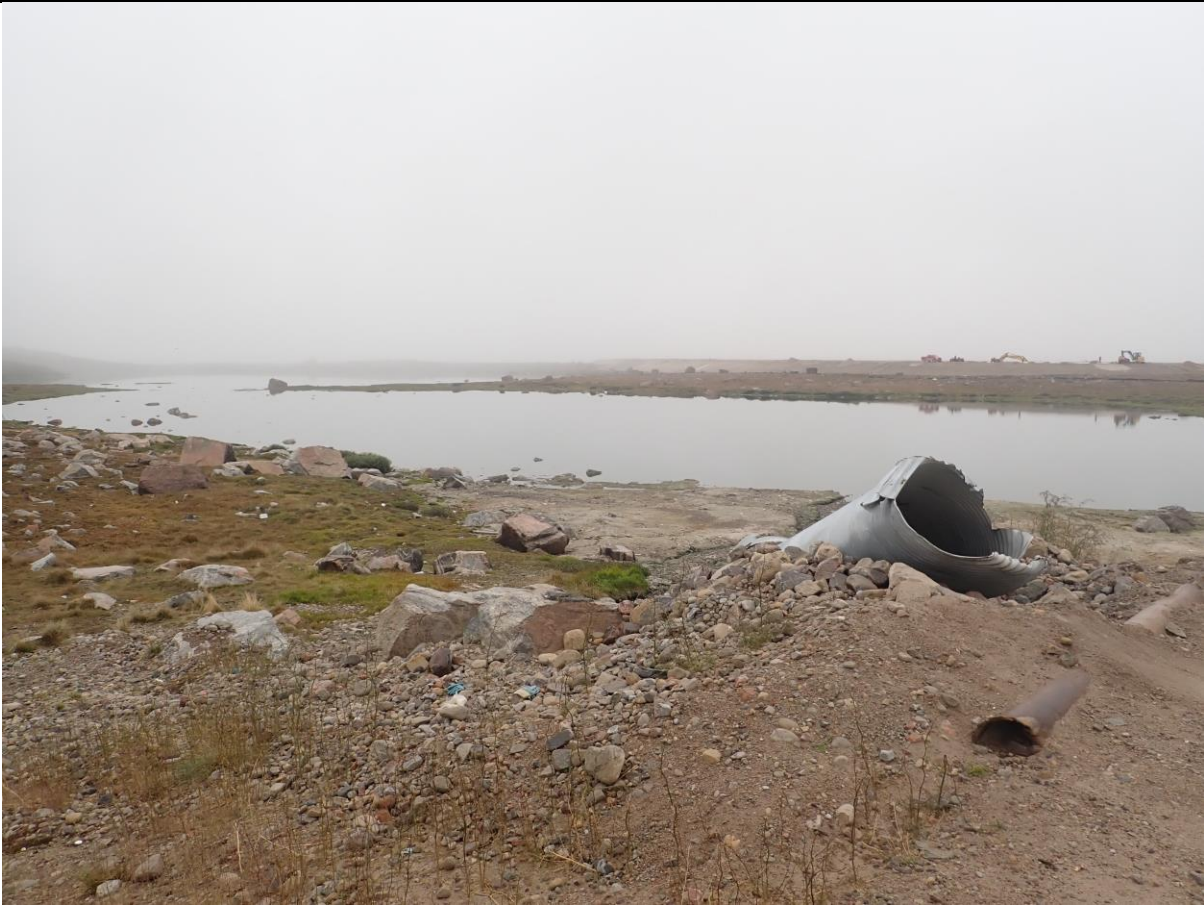
Photo 3

Description: current lagoon.

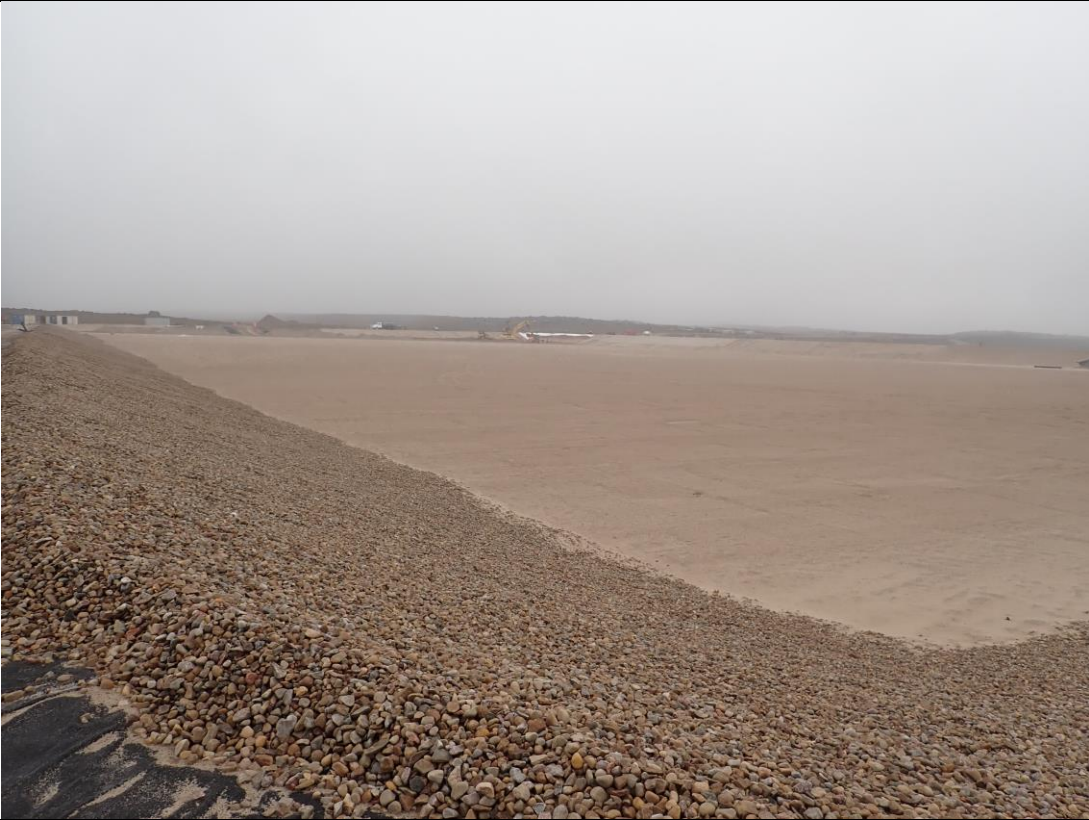
Photo 4

Description: new lagoon under construction at the time of the inspection.
