WATER LICENCE INSPECTION FORM

Linnan			Linear	as Danusanta	4			
				Licensee Representative Bhabesh Roy —				
· · · · · · · · · · · · · · · · · · ·				,				
Government of Nunavut			3101	Steve Piercey- Airport Manager				
			Repre	sentative's Titl	e			
3BM-YRB0308 Ex	pired		Reg	ional Eng	gineer

Photo Log			
Date	Authorization	Camera	Inspector
July 7, 2016	3BM-YRB0308 EXPIRED	Sony Cyber shot	A. Keim

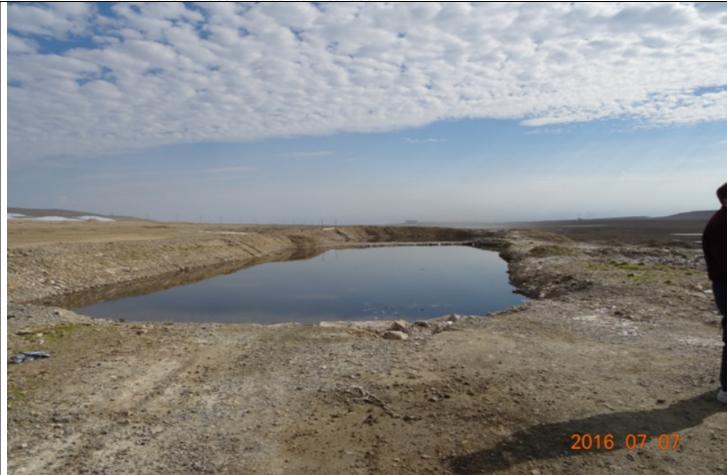
Figure 1 Newer of the lagoon cells where truck drops off

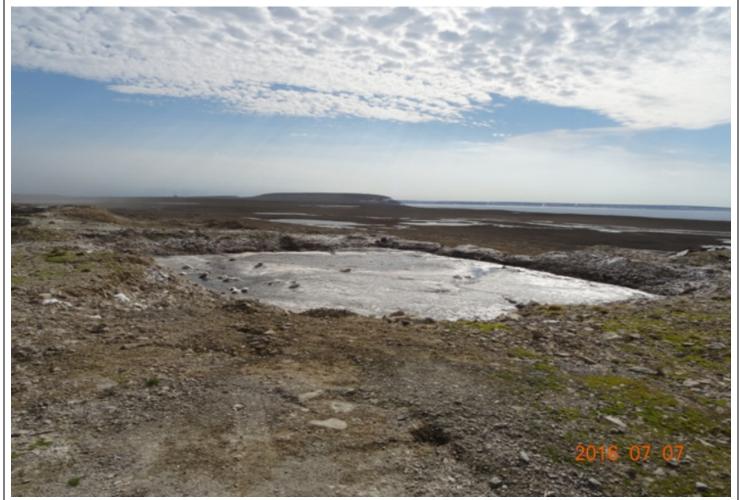
Figure 2 Older cell, shallow and frozen to bottom during period of inspection

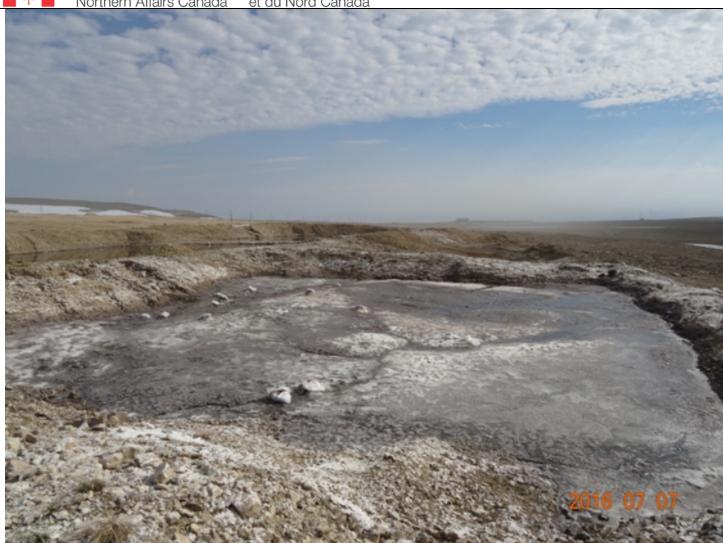
Figure 3 Older cell with newer cell (N) in the background

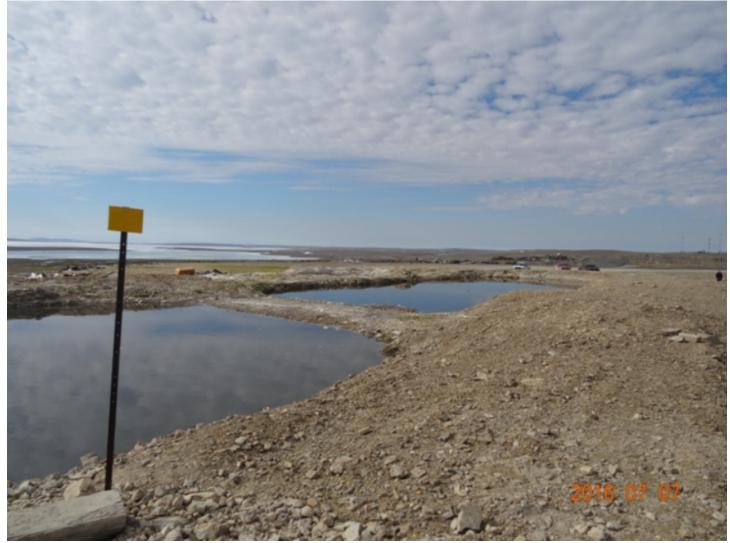
Figure 4 Newer cell is divided into two, original cell to left of farther cell

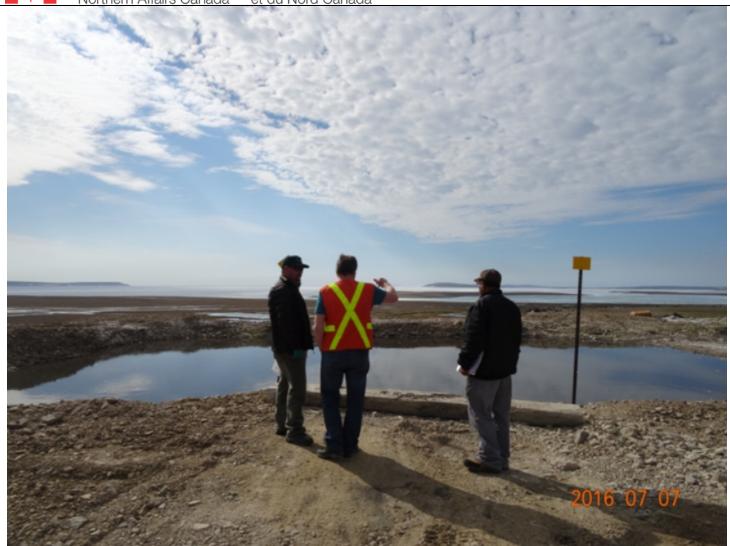
Figure 5 Truck drop off point that required up-grades and maintenance to facilitate off loading

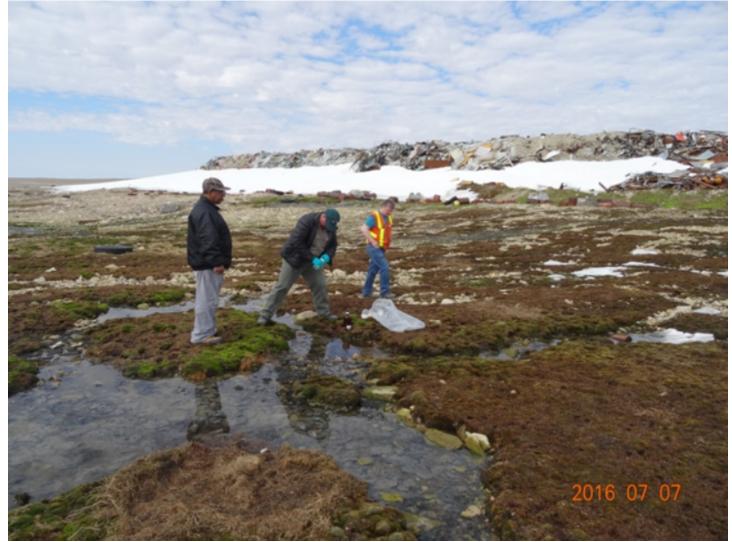
Figure 6 sampling site below lagoon. Samples collected during period of inspection.
