WATER LICENCE INSPECTION FORM

Original
 Follow-Up Report

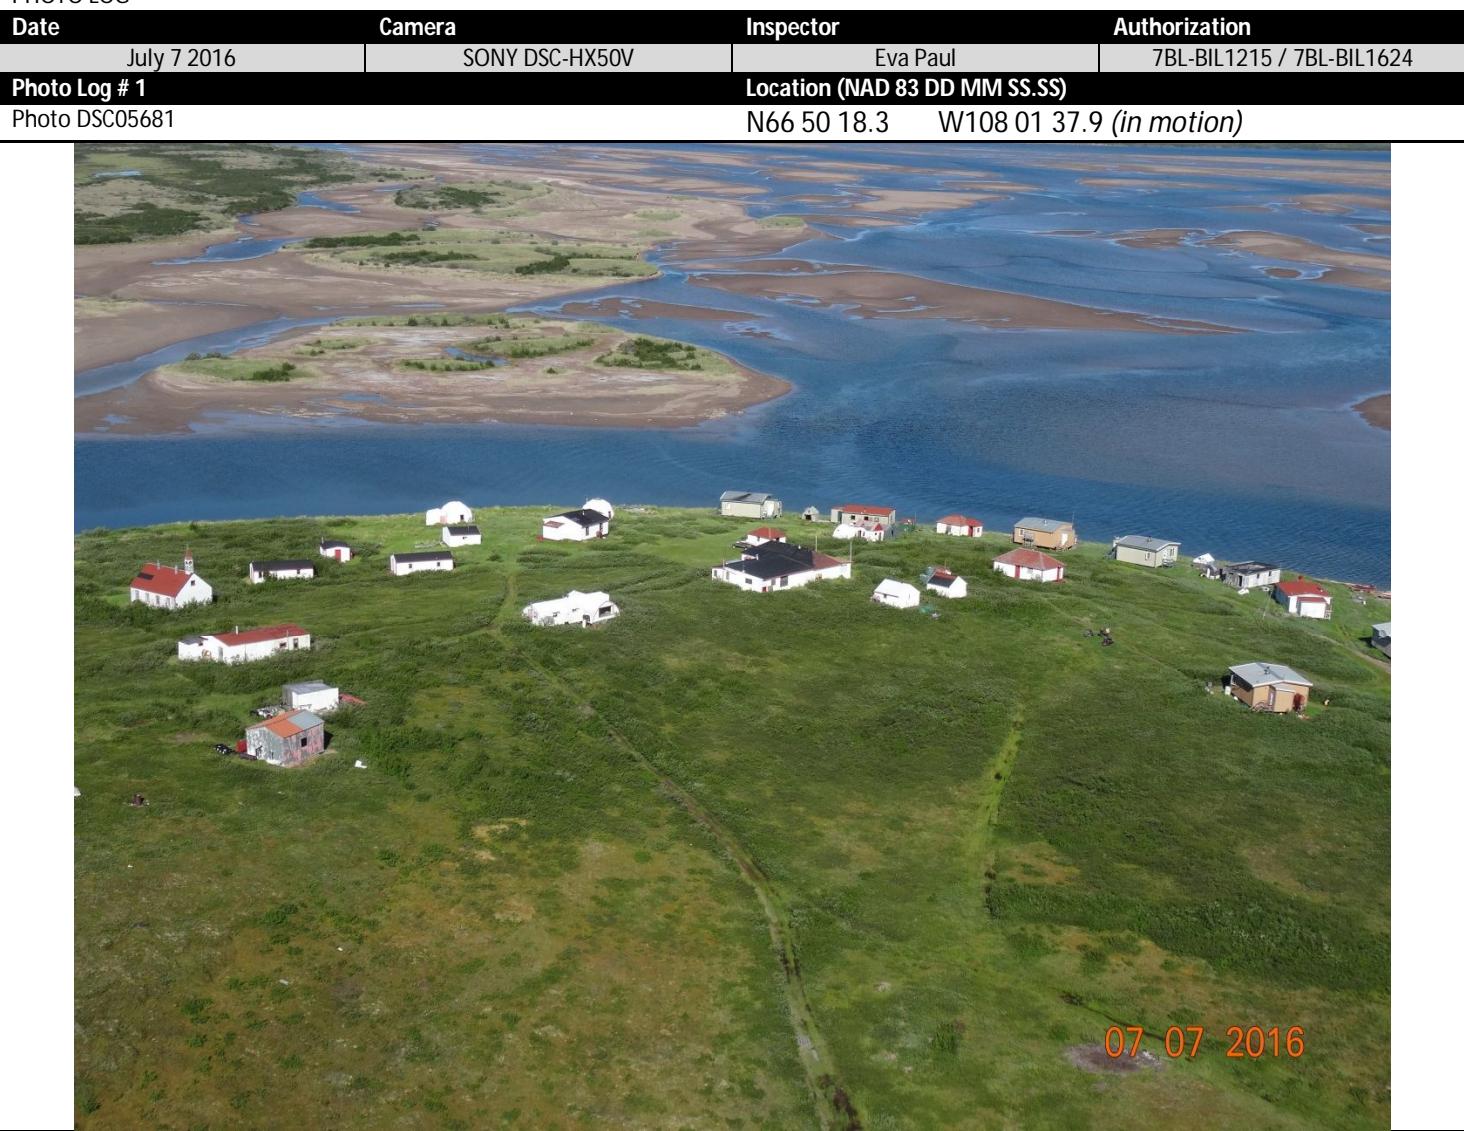
Description: Aerial view of Bathurst Inlet Lodge and community houses closest to the water. Bulk fuel storage is off the left of the photo.

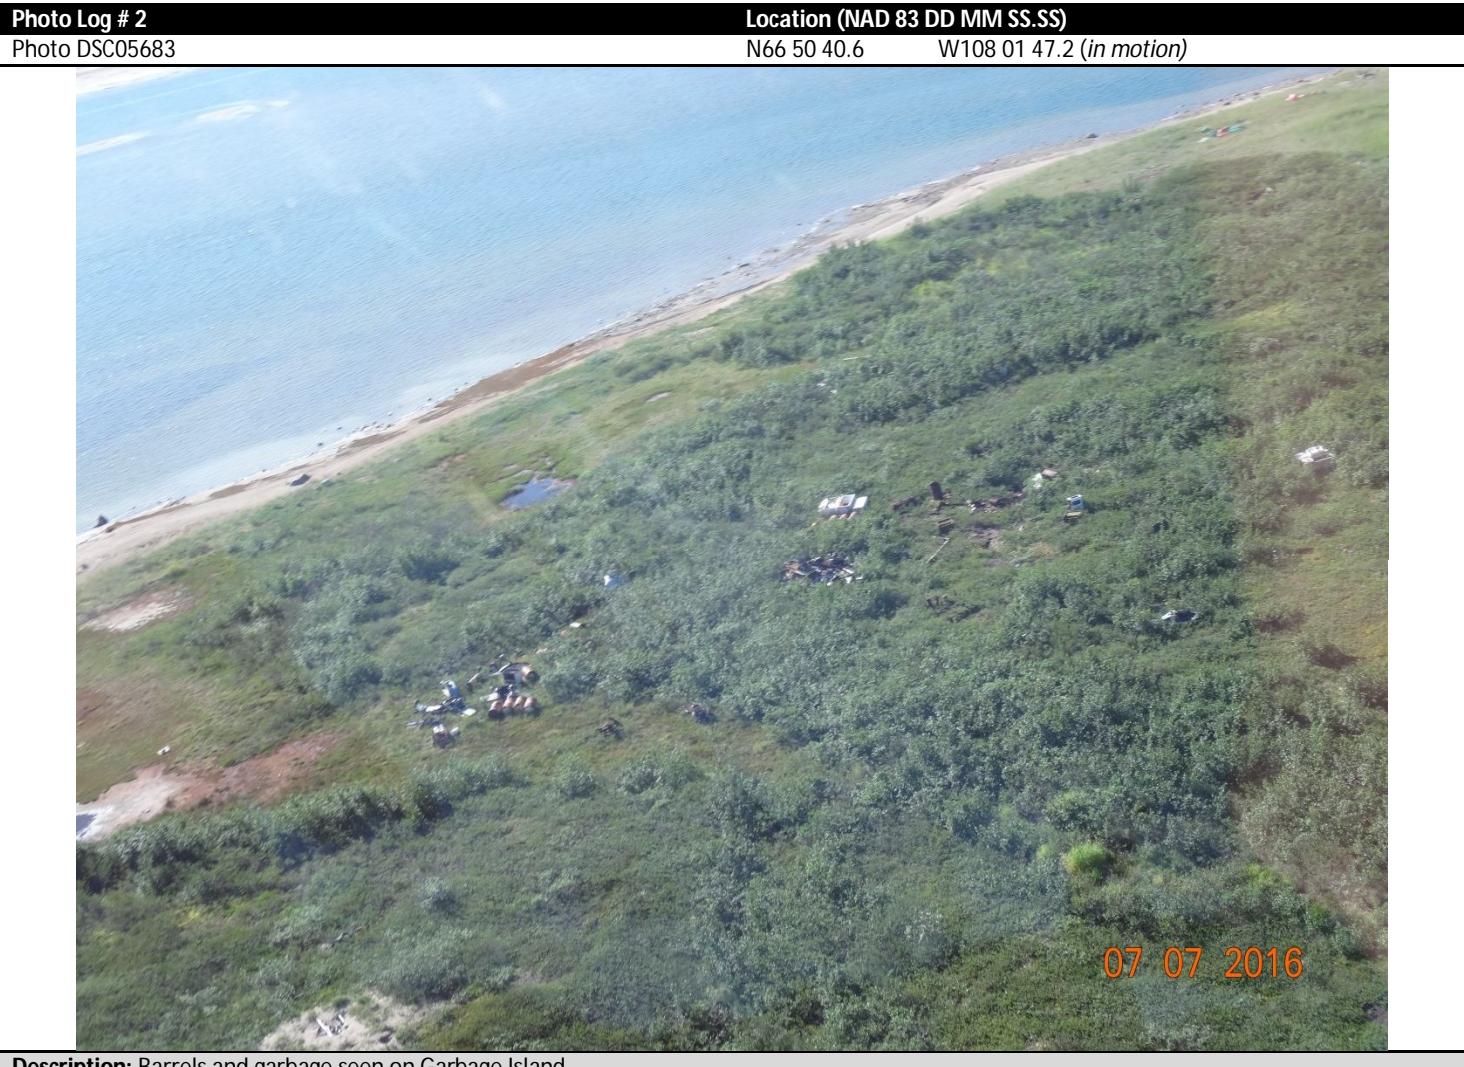
Description: Barrels and garbage seen on Garbage Island.

2. As discussed during the inspection, absolutely no waste is to be deposited on Garbage Island. The river delta would fall under several federal Acts, and no authorization would be given for this activity. Any recoverable waste left there by BIL historically should be removed and handled according to the licence conditions. BIL will separate and backhaul non-combustible waste, and any burning will occur within the property, >30m from the OHWM and in such a fashion that no resulting wastes will enter water.

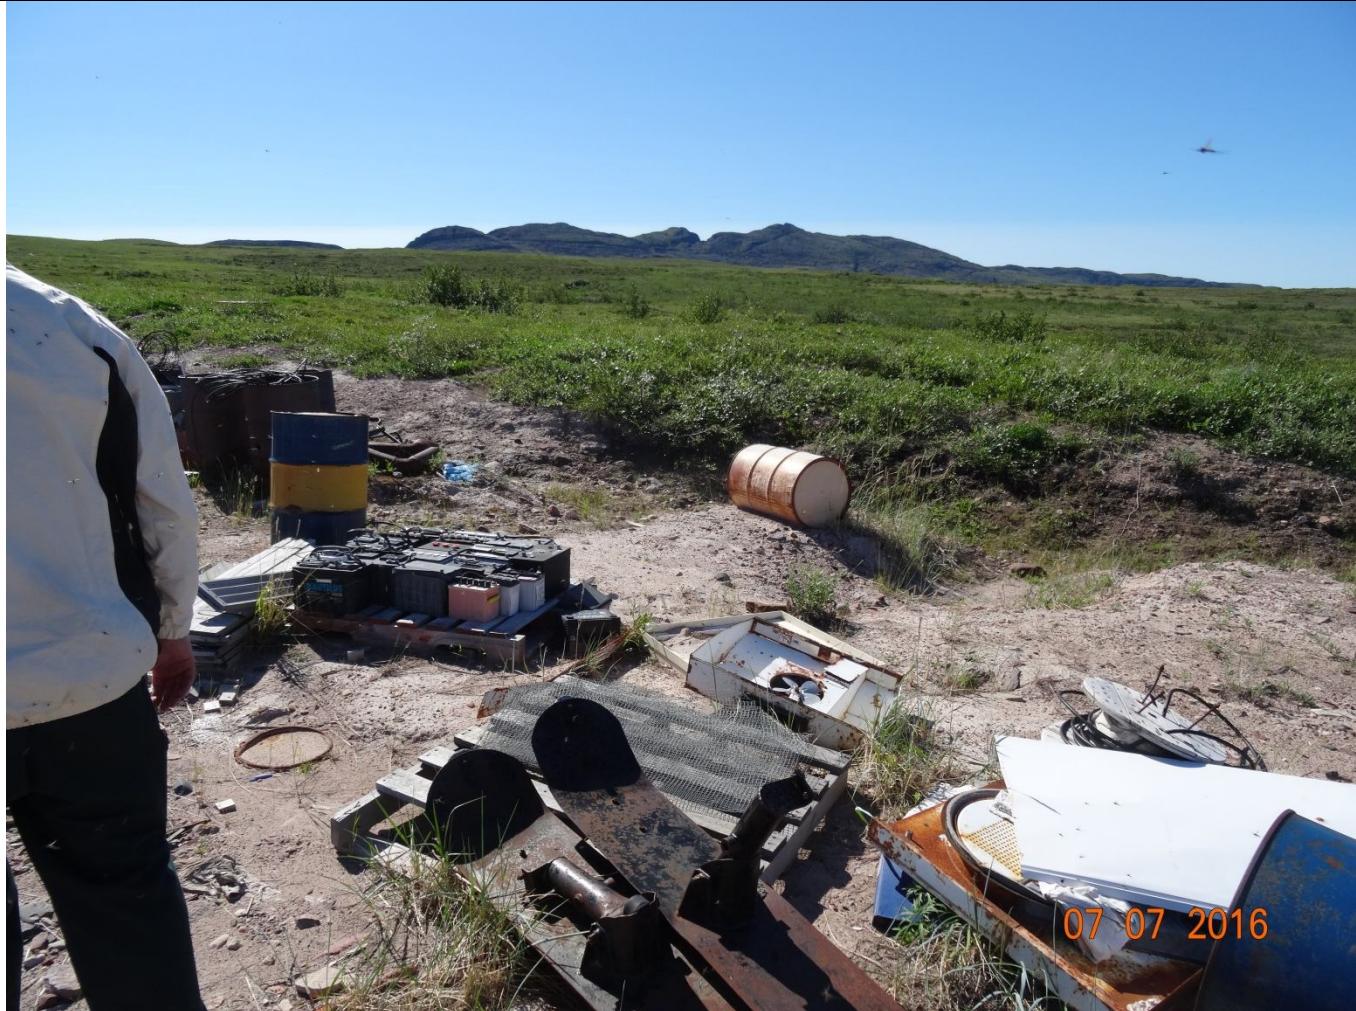
Photo Log # 3

Description: Pallet of batteries located at the airstrip.

3. All hazardous and non-combustible waste generated by BIL is to be backhauled as per the licence. Records of disposal with a licenced facility are to be maintained and provided at the request of the Inspector. If the Licensee contemplates taking any waste to a community within Nunavut, this constitutes a modification (from proposed practices) as per Part F of the licence. In general, authorization from the hamlet is first required to be submitted to the Board.

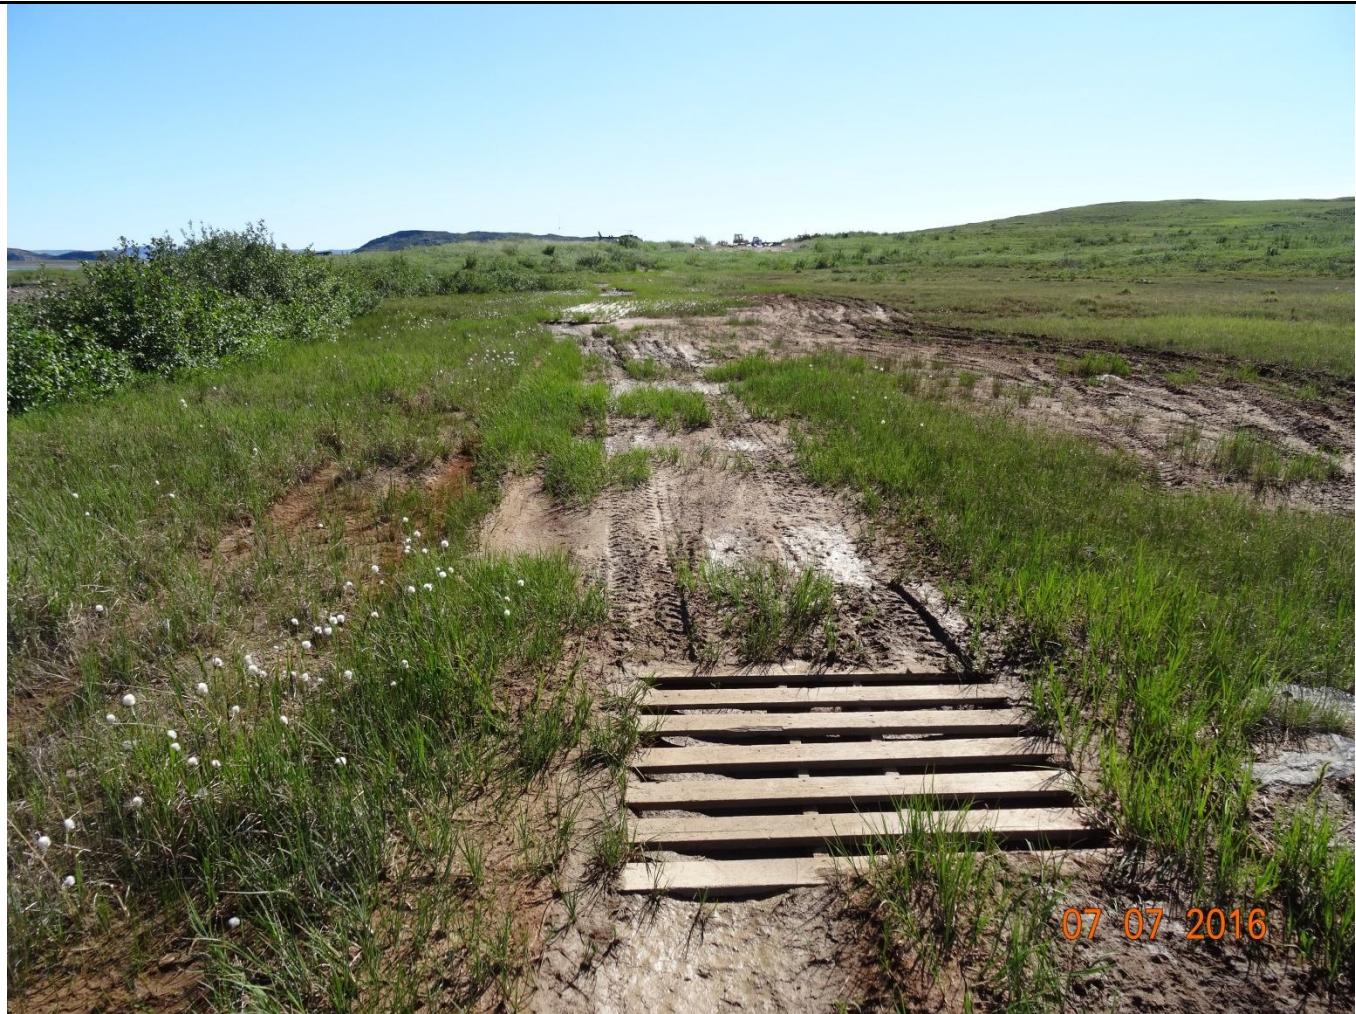
Photo Log # 4

Description: Trail to the airstrip; passes through marshy lowland areas.

5. The new licence includes provisions regarding rutting and gouging. Use of the lowland trail (by BIL) to the airstrip is to be discontinued and a trail on higher dry ground established.

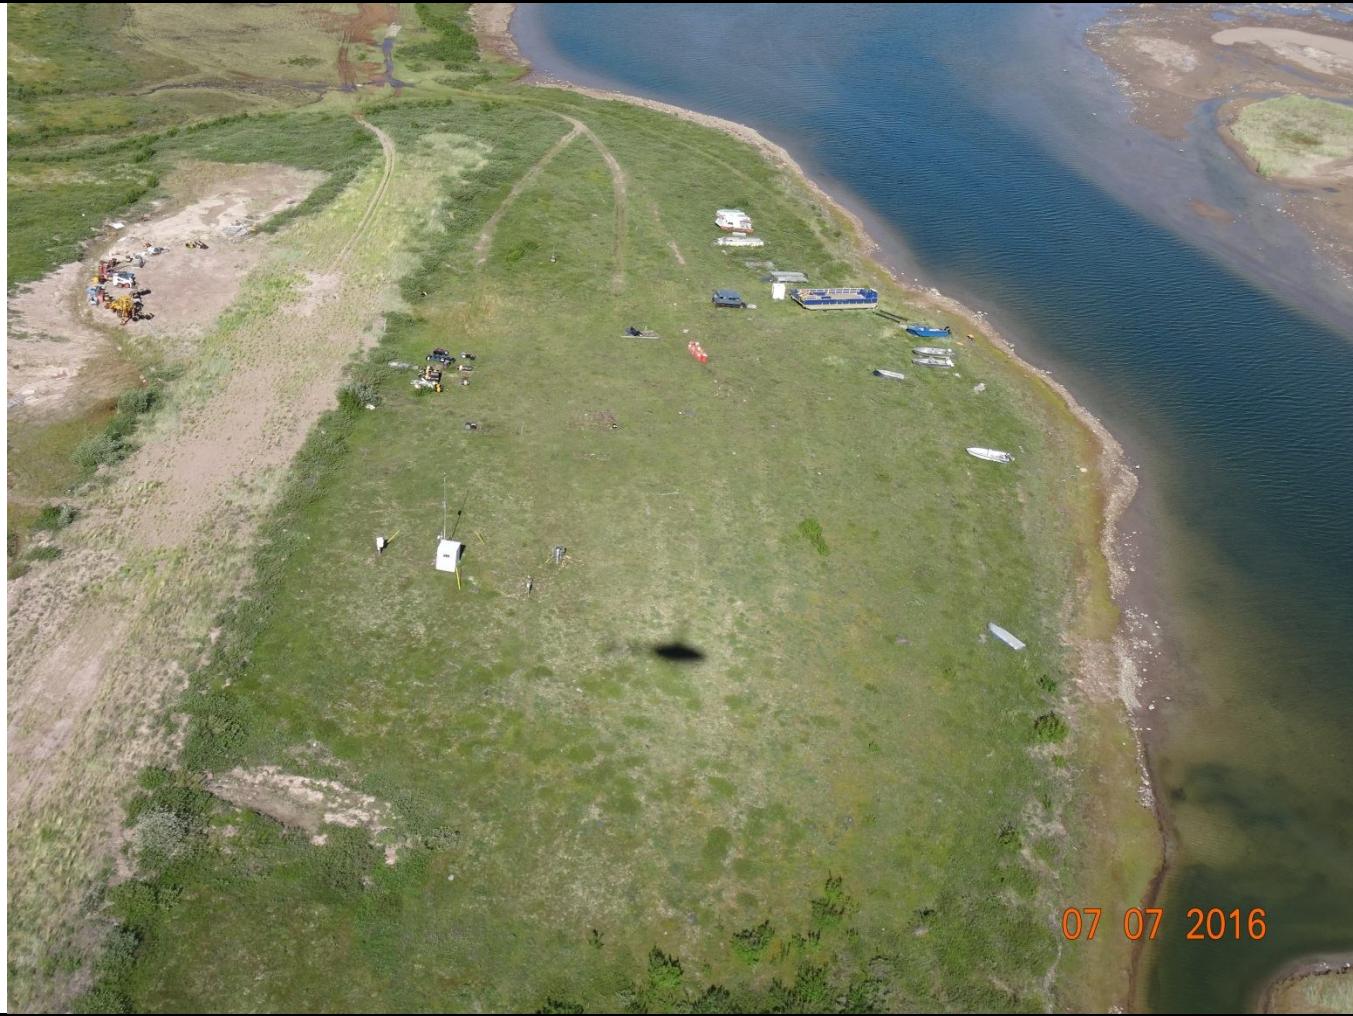
Photo Log # 5

Description: Airstrip, fuel storage, and boats/barges. To the top of the photo, the trail passes through a small creek.

4. Ensure that all fuel stored at BIL and for BIL (at the airstrip) are >30m from the OHWM and stored within secondary containment or a surface liner as per G.4 of the new licence.

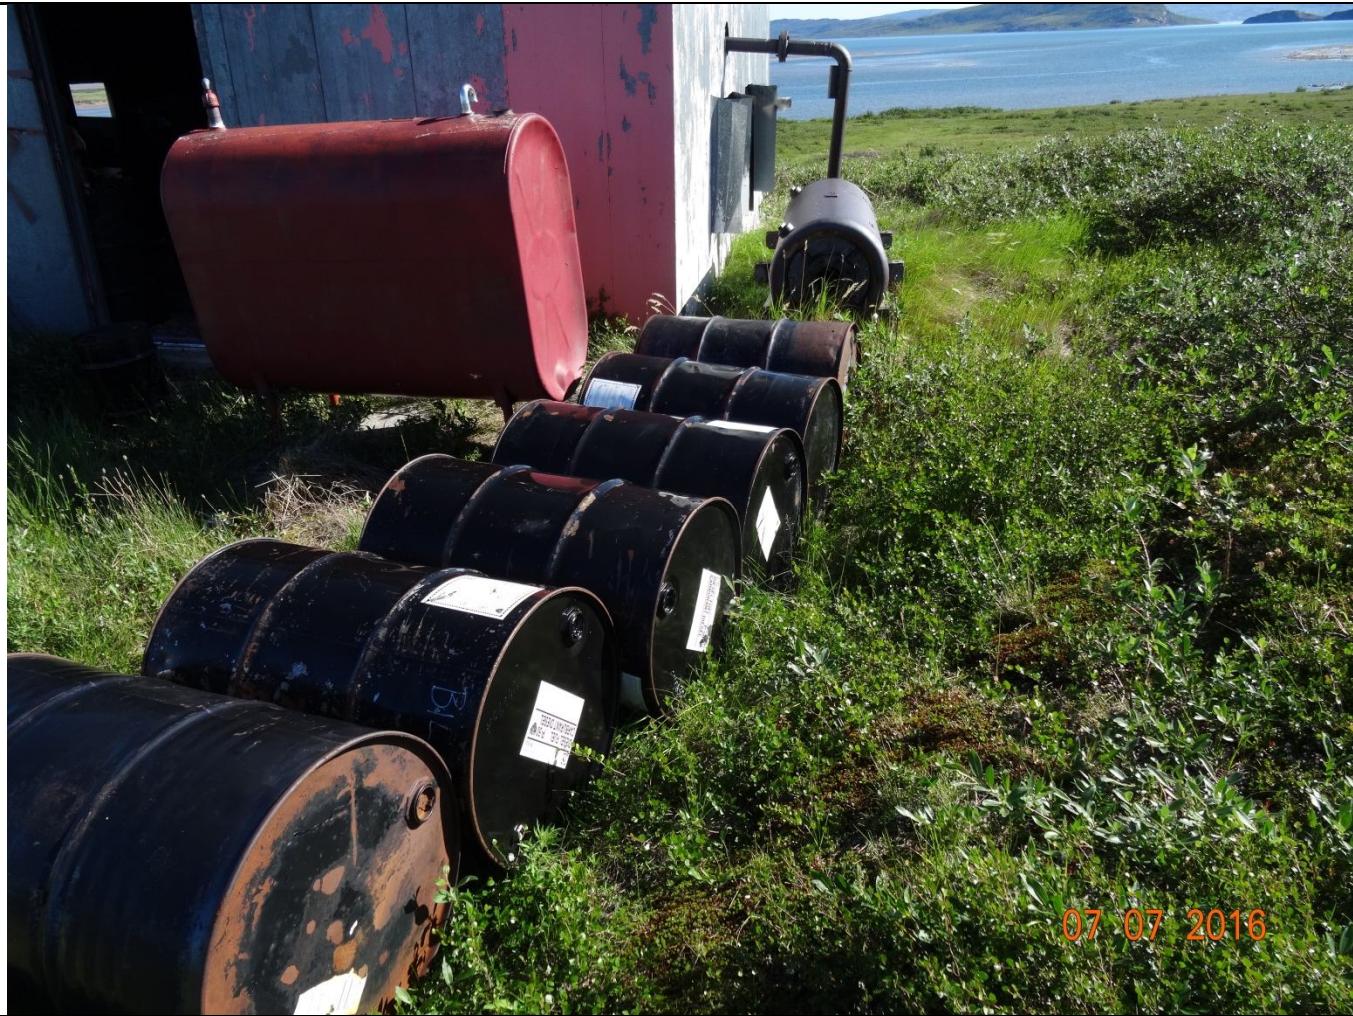
Photo Log # 6

6. No obvious provisions are made to prevent spills at the generator shack: tanks are single-walled and no containment is provided beneath them, although a spill kit is present. While quantities of fuel stored by BIL are small enough not to trigger storage tank regulations, a spill in this remote location would be costly and difficult to remedy. No spill kit or drip tray were visible at the river where re-fuelling of the float plane was taking place. The air strip is on Inuit Owned Land. BIL and other operators (such as Air Tlndi) store fuel in reasonable quantities. I noted approximately 18 drums (mix of diesel, avgas, and jet) that were marked BIL at the time of the inspection. I did not see a spill kit, but Mr. Warner indicates that one is present. The bulk fuel tanks are located up-slope of BIL, and I would encourage BIL to insist that PPD and community members take all reasonable precautions to prevent contamination that may impact BIL property or that may enter water by any means.

Description: Generator shack with single-walled tanks. Barrels of diesel awaiting use.

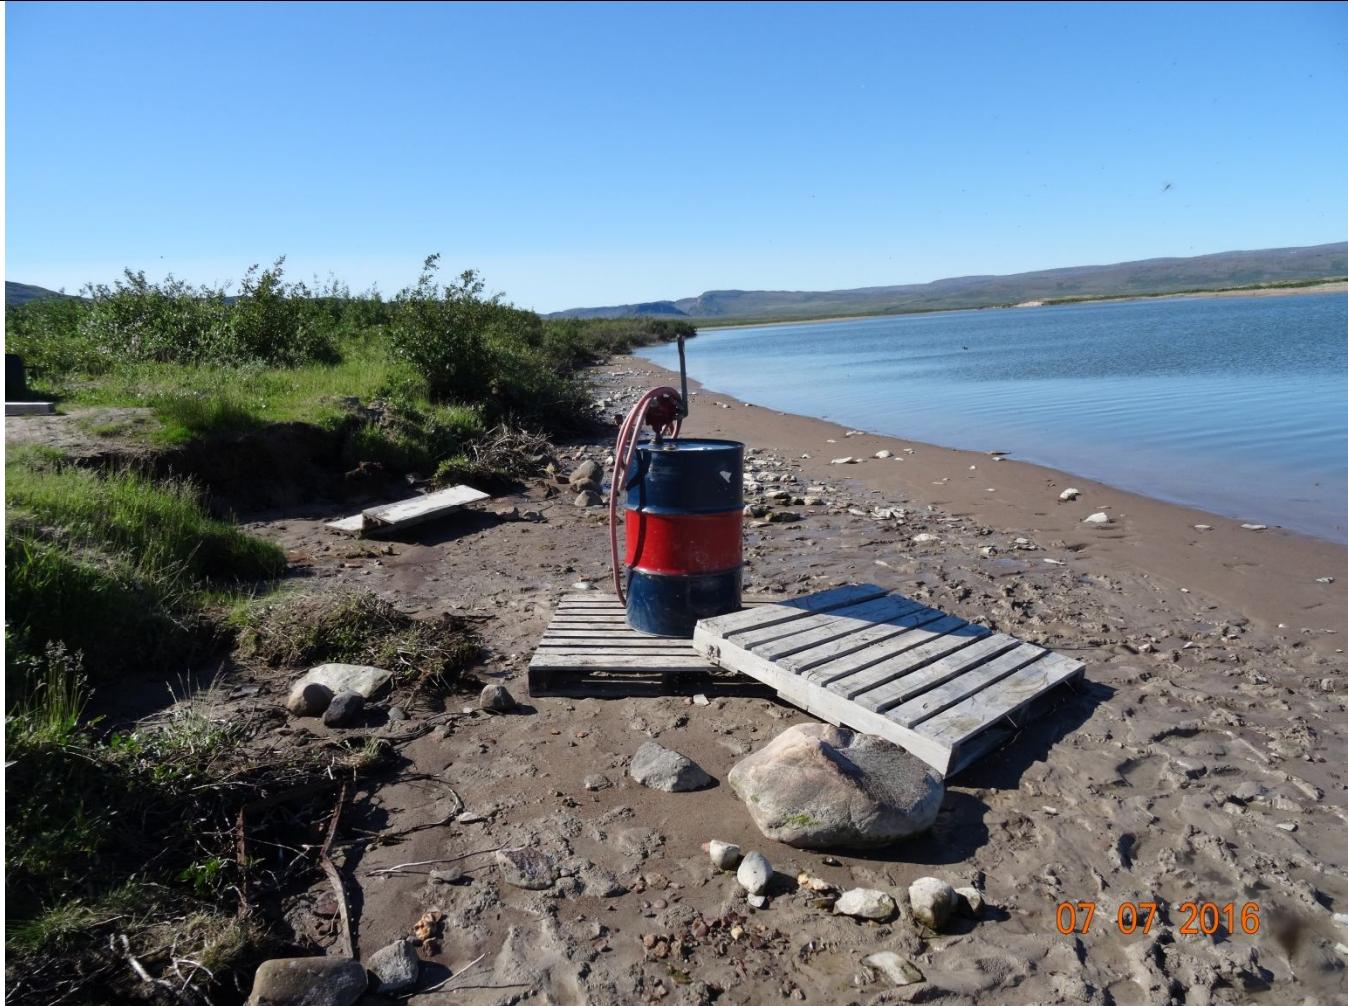
Photo Log # 7

Description: Mr. Warner indicates he was in the process of fueling his plane when we arrived. Barrel is for immediate use. No spill kit noted.
