## WATER LICENCE INSPECTION FORM

On July 12<sup>th</sup>, 2019 Crown-Indigenous Relations and Northern Affairs Canada's Resource Management Officer, Christine Wilson completed a compliance inspection on Arctic Haven Lodge's water licence no.7BL-ENN1828.

Photo Log 7BL-ENN1828  
July 12<sup>th</sup>, 2019  
C. Wilson

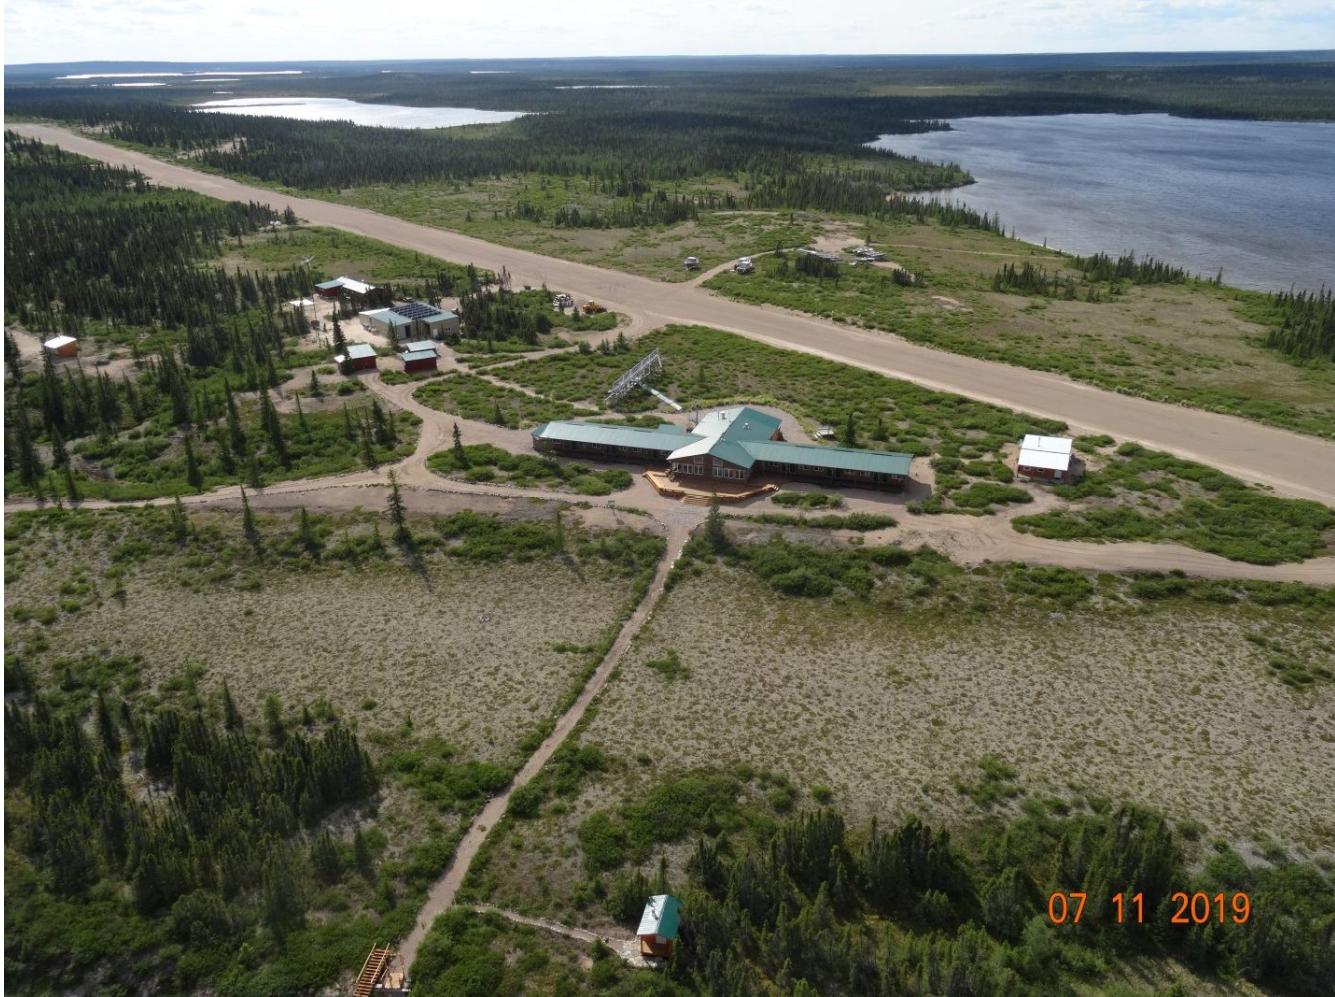
**Photo Log # 1**

1. Freshwater is drawn on demand from Ennadai Lake and stored in tank at the lodge (photo 1).
2. The lodge used approximately 4.2 cubic meters for water the for month of July (photo 2)

Arctic Haven Lodge

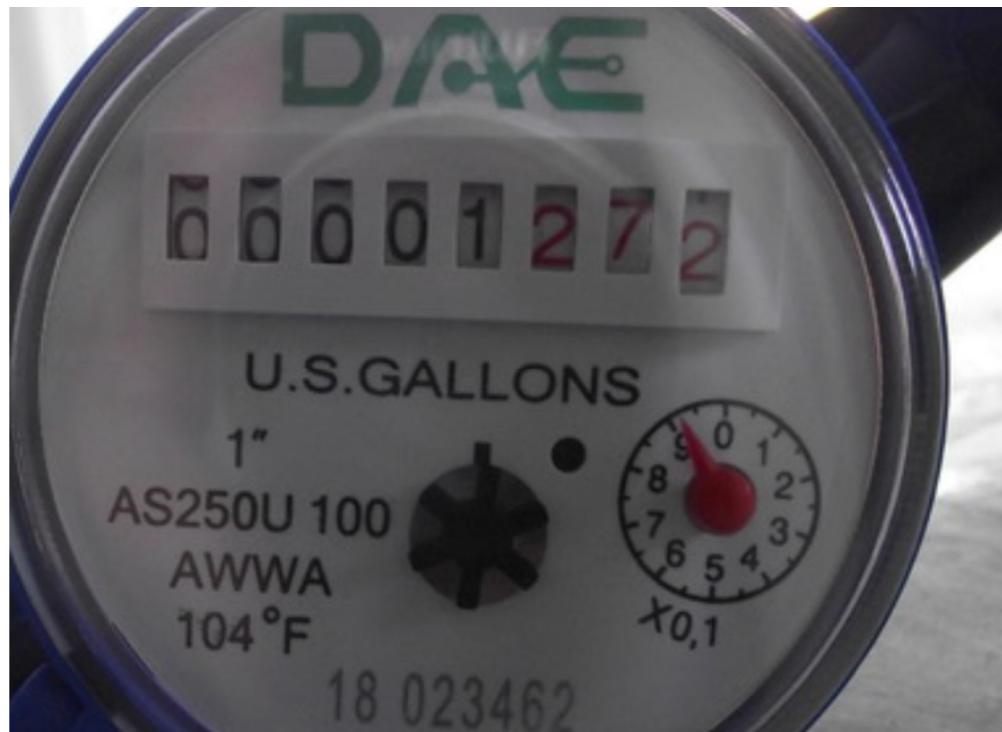
**Photo Log # 2**

Water Meter

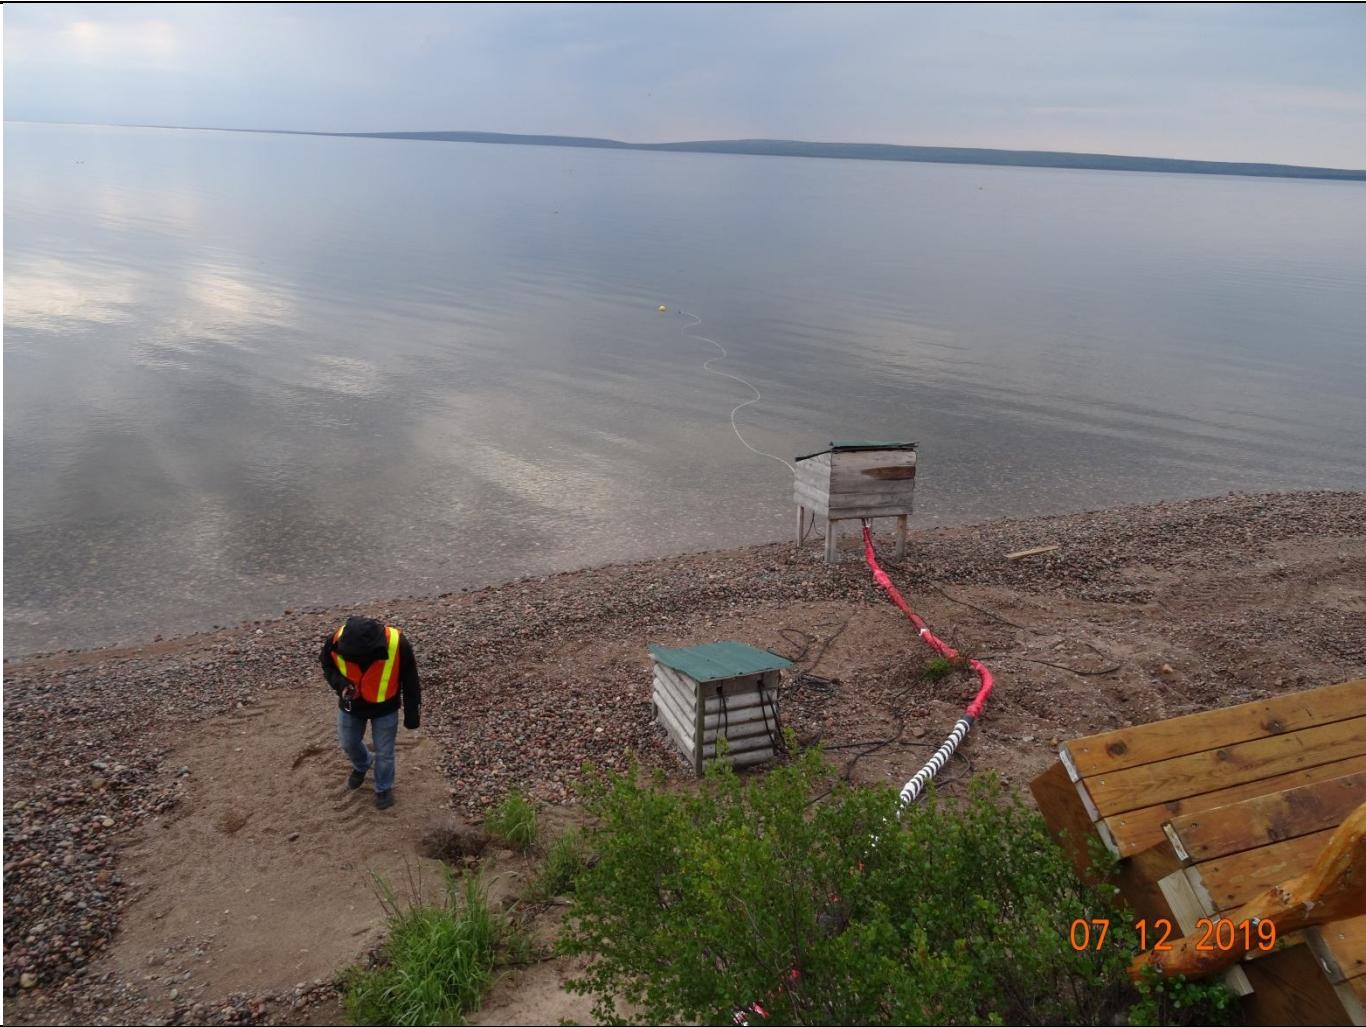
**Photo Log # 3**

3. Grey and black water is deposited into septic tanks. The sewage sludge is removed from the septic tanks annually and shipped out.
4. The freshwater intake is equipped with a screen (photo 3).

Fresh water intake

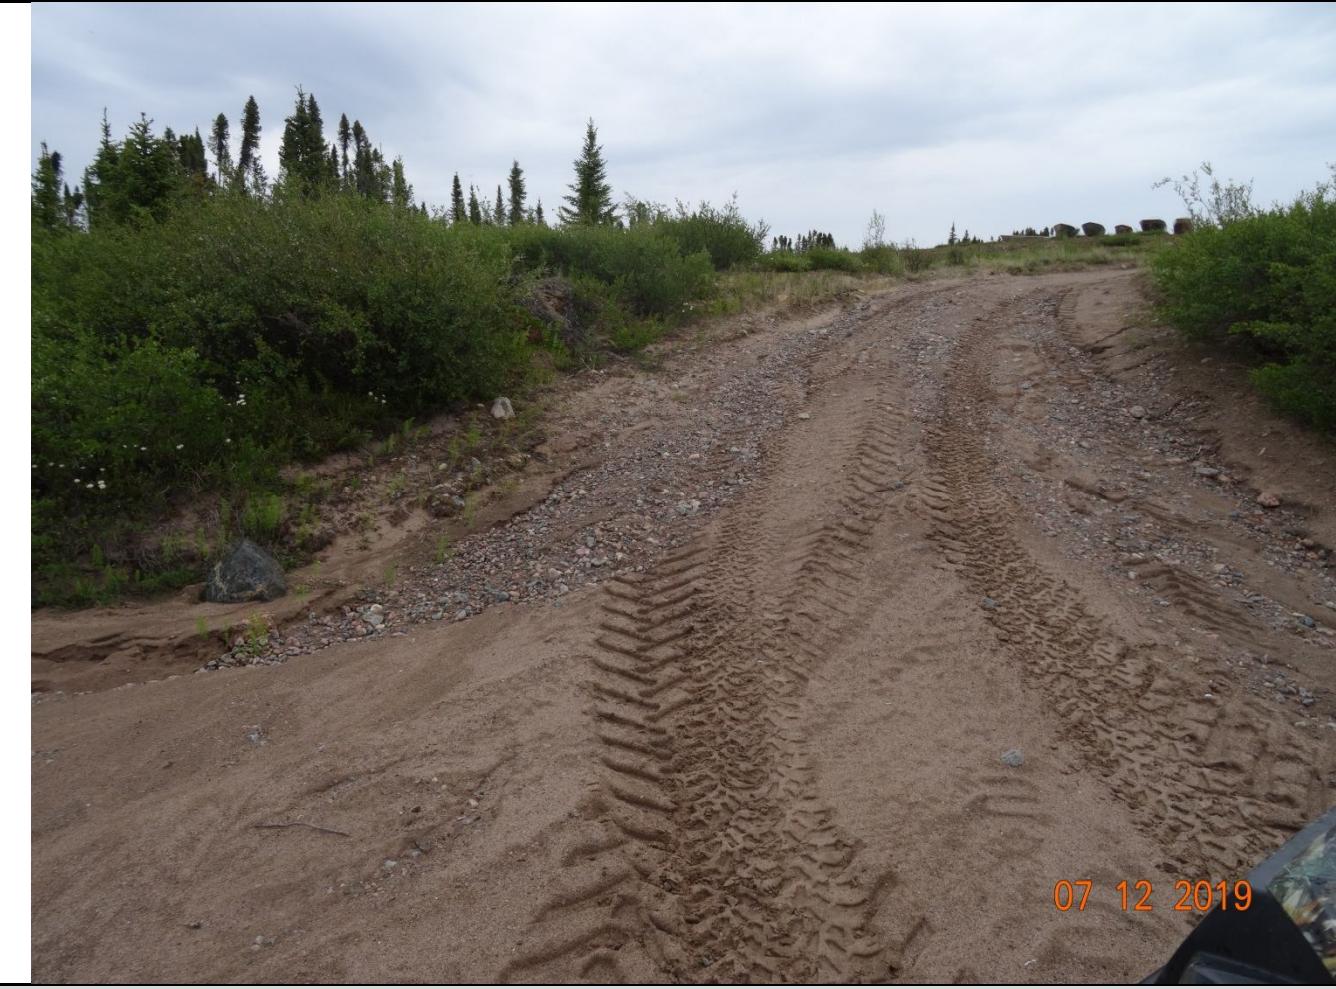
**Photo Log # 4**

5. There is visible erosion on the trails that lead north to the floating boating dock (photo 4) and east from the Care-taker's cabin to the Lake (photo 5).

North Trail to Boat Dock

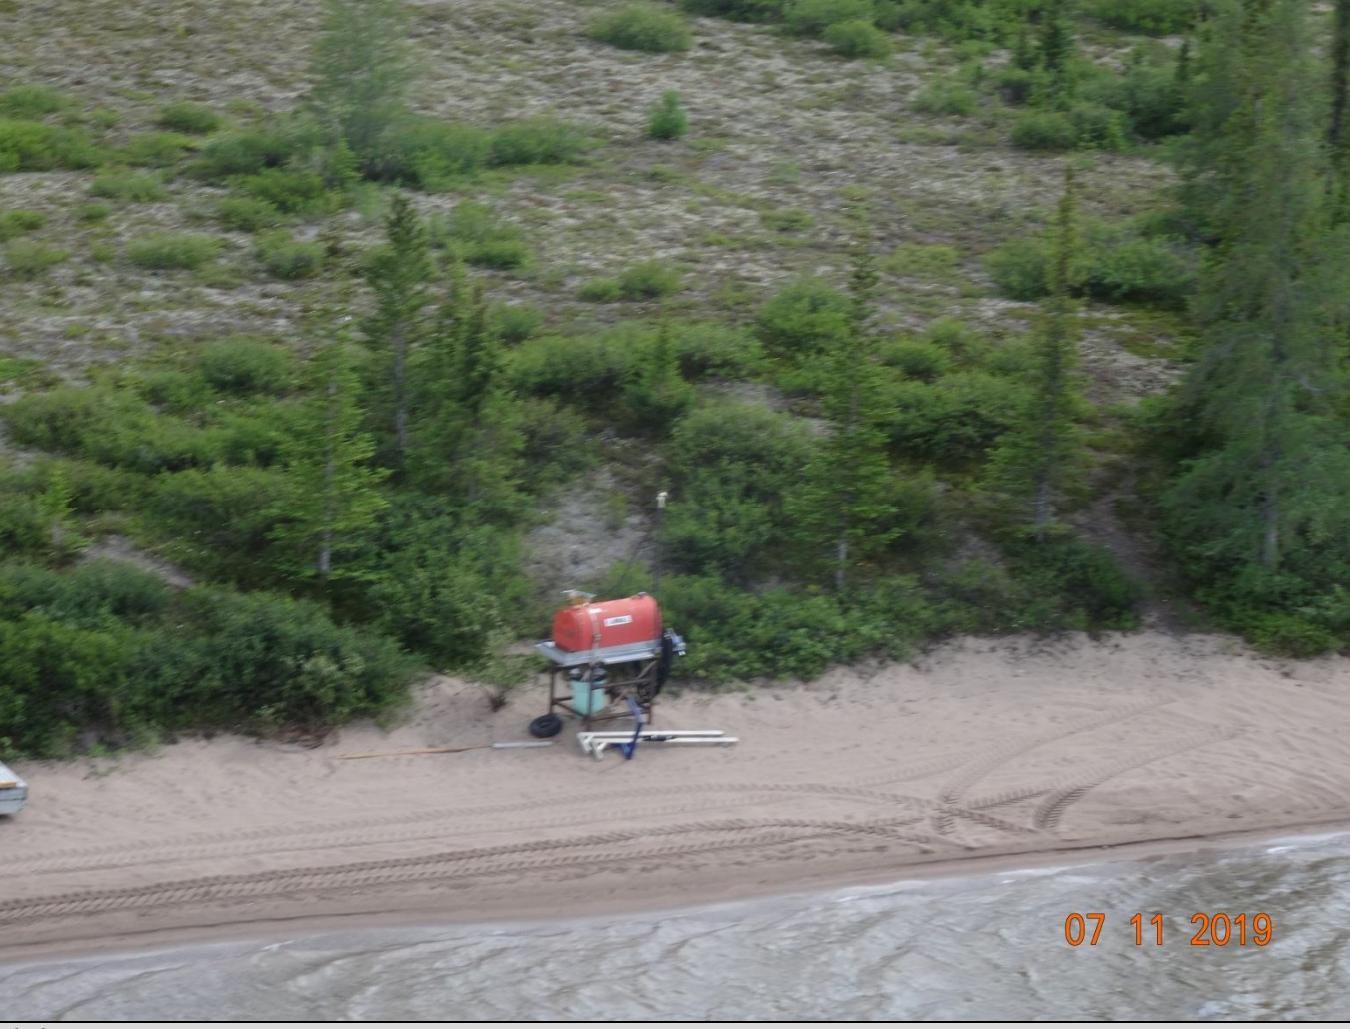
Photo Log # 6

6. A temporary fuel storage container is located near the floating dock to refuel boats. In accordance with PART H, item 2, fuel must be stored at a minimum distance of 31 meters from the ordinary high water mark. All fuel containers and lines must have secondary containment and moved out of the 31 meter buffer zone when not in use (photo 6).

Fuel storage

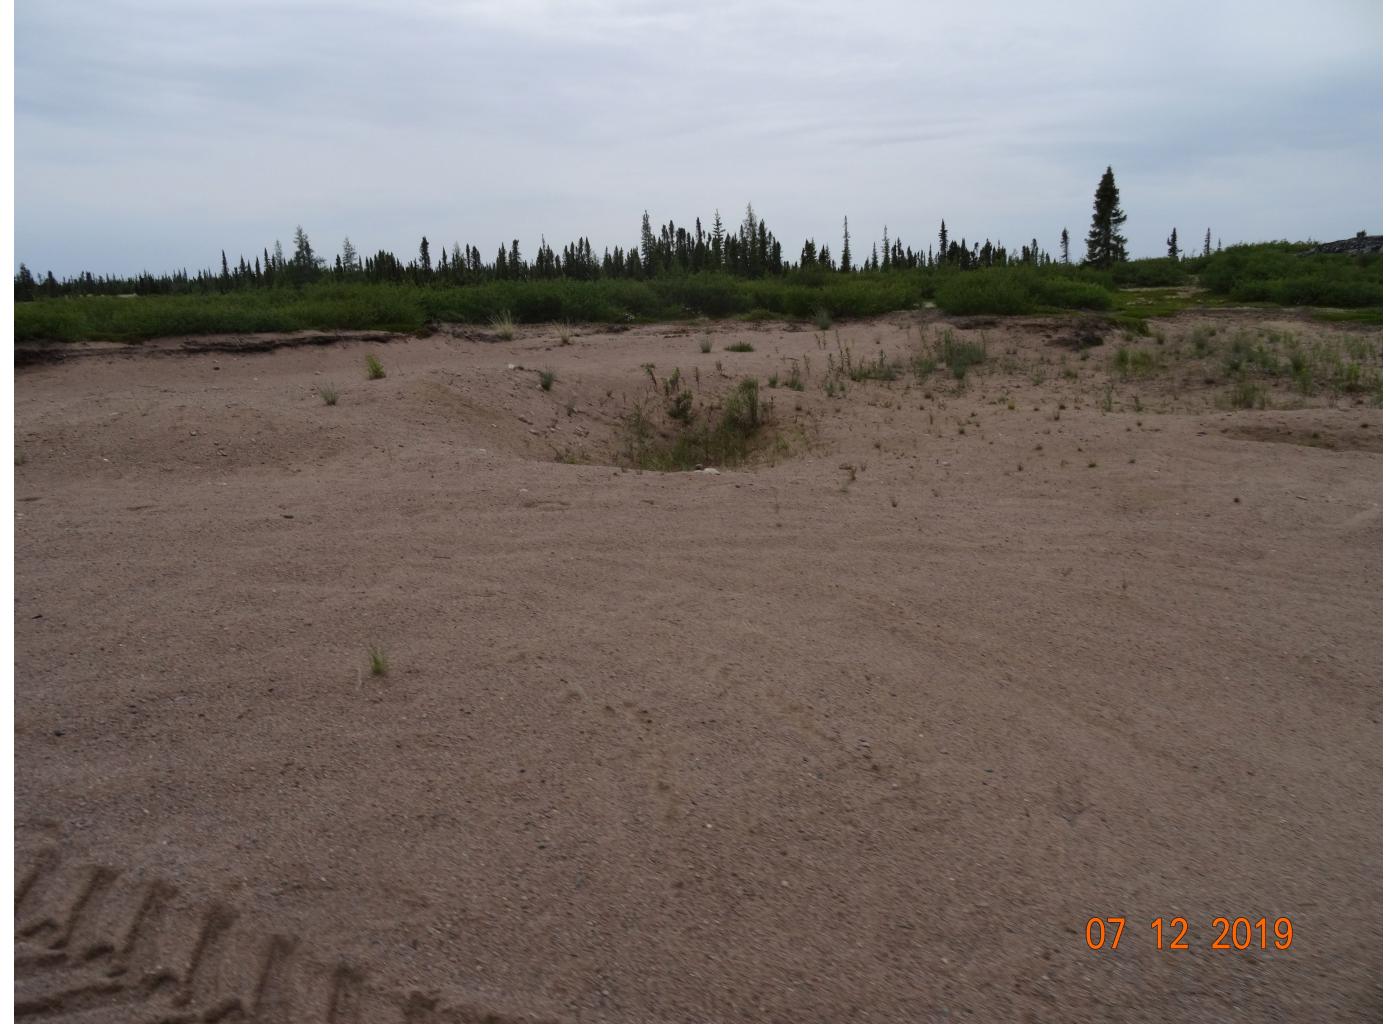
Photo Log # 7

7. The pit that was used during the airstrip improvements needs to be graded flat with the surrounding topography (photo 7).

- Part I item 3, Failure to restore land to pre-existing contour to reduce erosion and permafrost degradation.

Water transfer pit

The Licensee shall restore the pit noted in observation seven before the end of 2019 season and provide pictures to the inspector no later than November 30<sup>th</sup>, 2019.
