WATER LICENCE INSPECTION FORM

Licensee		Licensee Representative	
Hakongak Outfitting		N/A	
Licence No. / Expiry		Representative's Title	
7BL-HKO1015		-	
Land / Other Authorizations		Land / Other Authorizations	
Date of Inspection		Inspector	
18/07/2014		Eva Paul	
Activities Inspected			
<input checked="" type="checkbox"/> Camp	<input type="checkbox"/> Drilling	<input type="checkbox"/> Mining	<input type="checkbox"/> Construction
<input type="checkbox"/> Roads/Hauling	<input type="checkbox"/> Other:	<input type="checkbox"/> Other:	<input type="checkbox"/> Reclamation
<input checked="" type="checkbox"/> Fuel Storage

Photos of July 18 2014 Inspection

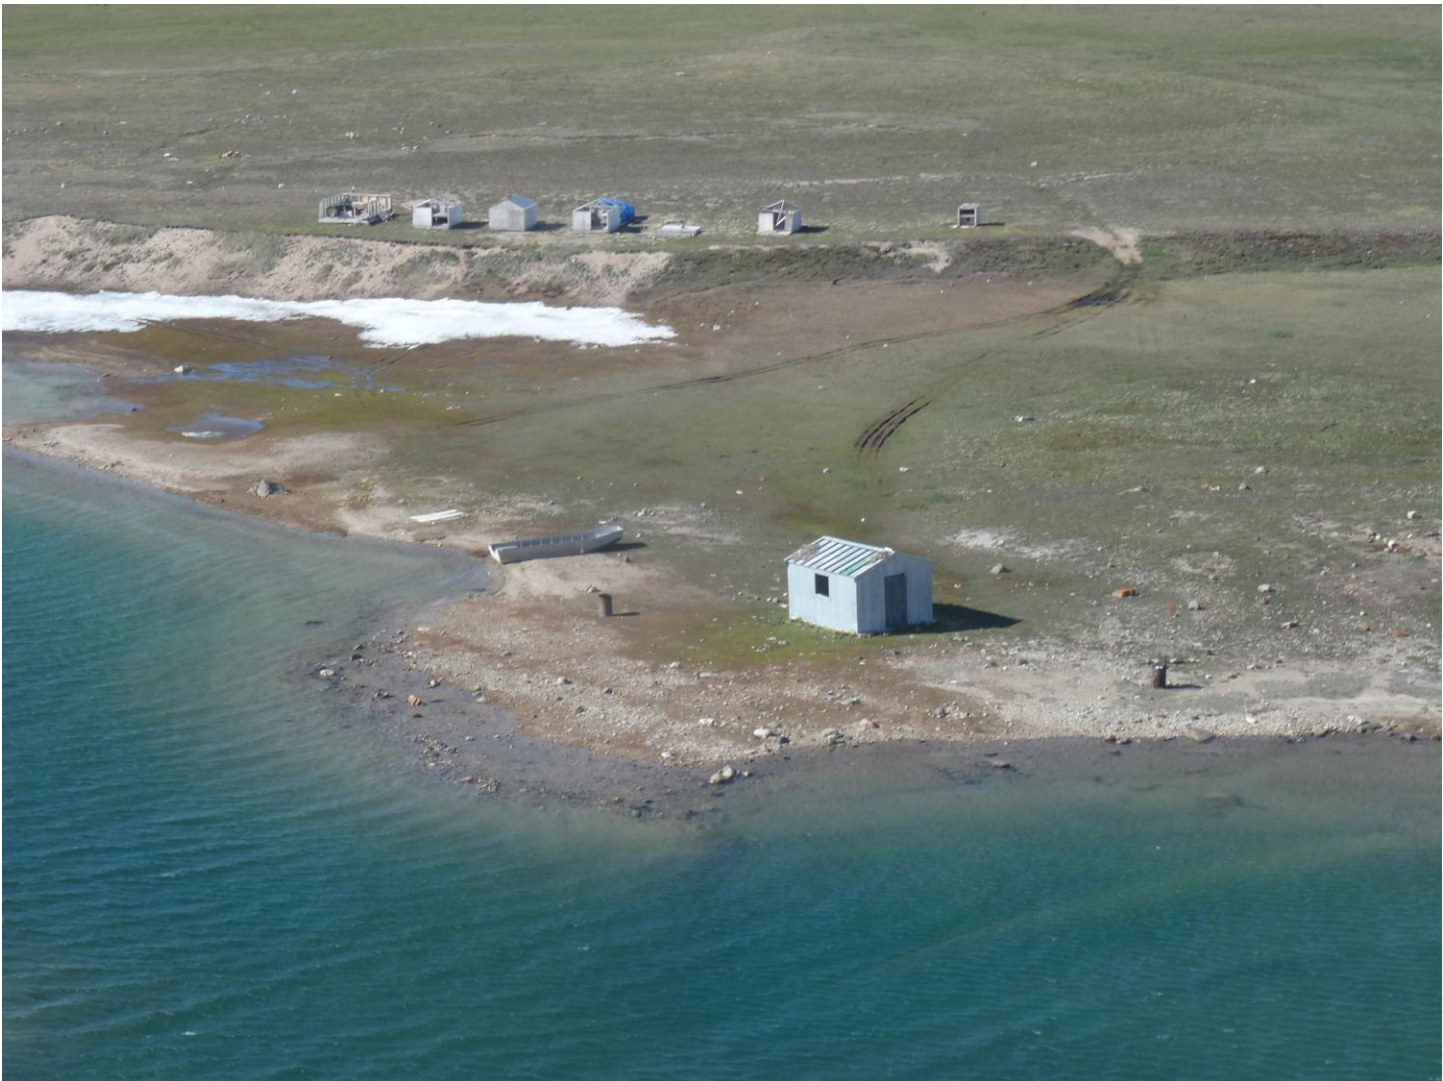
2. ATV use along the shore is causing rutting that could lead to sedimentation or impacts to surface drainage. Metal shed is constructed on the immediate banks of the river contrary to the licence.

Figure 1. Mr. Hakongak's outfitting camp from the air. Large metal shed constructed, and other materials are stored, below the high water mark.

3. Metal shed and burn barrels must be moved to more than 30m from the high water mark of the river.			
4. Annual reports are required whether or not the camp is active in a given year. Please submit reports for past years and 2014 by March 31, 2015. Please include a report on the work done to remediate the items identified above.

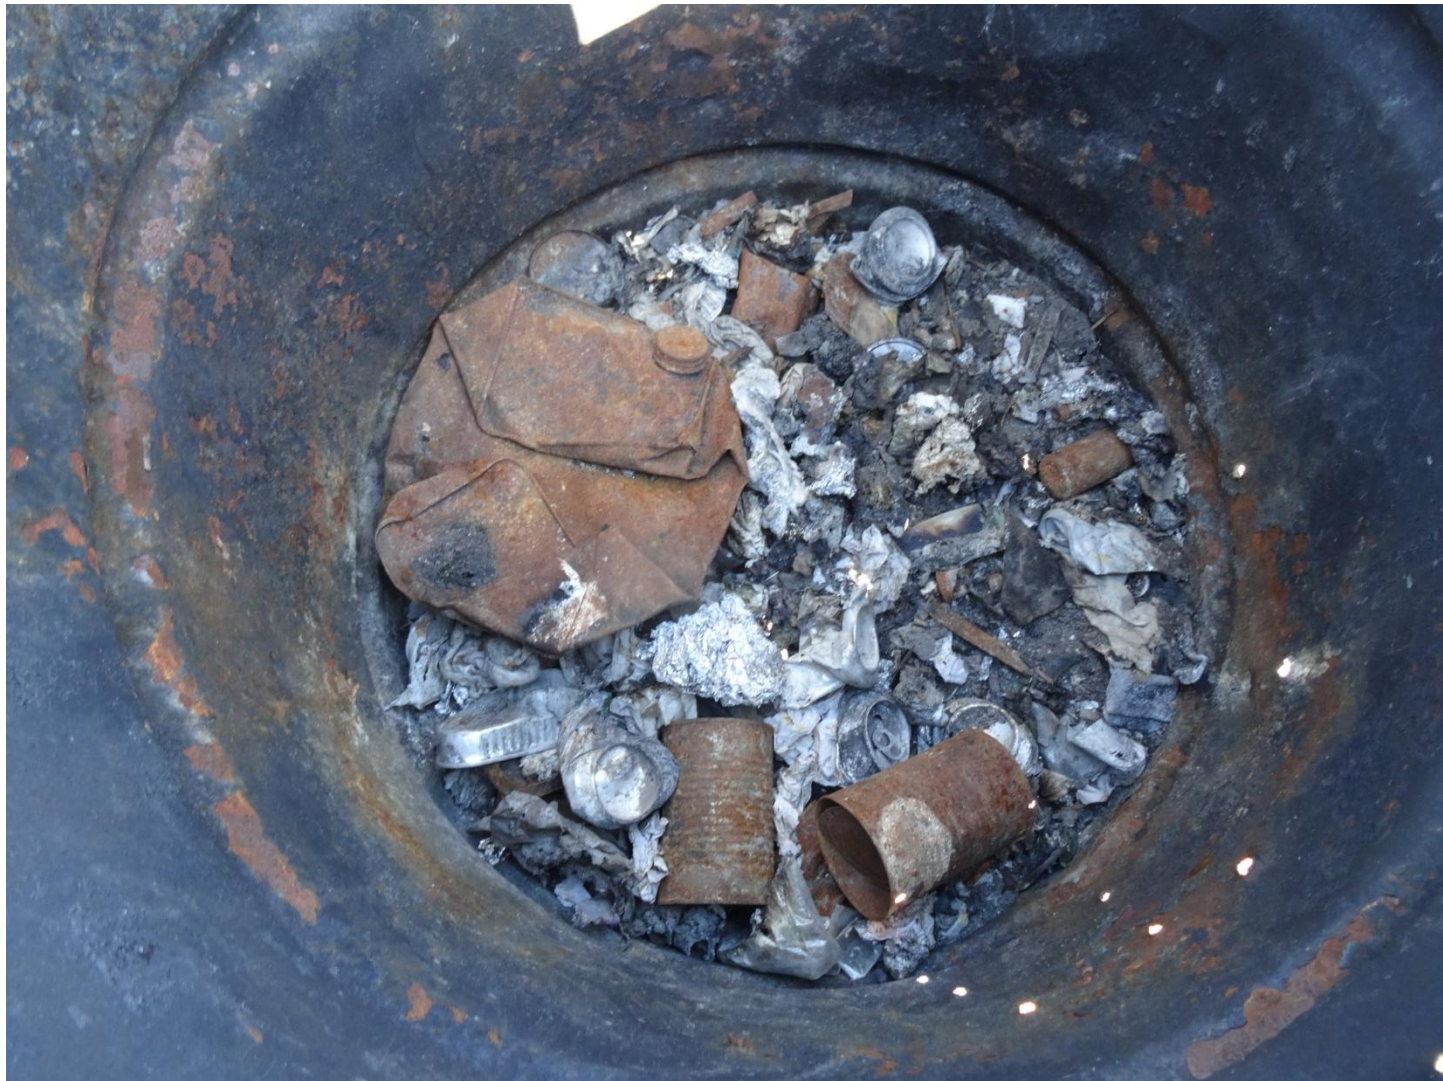
1. The burn barrel contains fuel cans and naptha cans that have been burned. Other waste remains to be backhauled. Please note that as per your water licence application, you indicated that only paper will be incinerated in an open barrel and all other waste brought back to Cambridge Bay. No fuel was seen on-site.

Figure 2. Contents of burn barrel.

1. Remove all solid waste back to Cambridge Bay as soon as possible.			
2. Discontinue ATV use along shore during wet times. Licensee should travel on dry, hard ground and minimize activity within 31m of all water bodies.

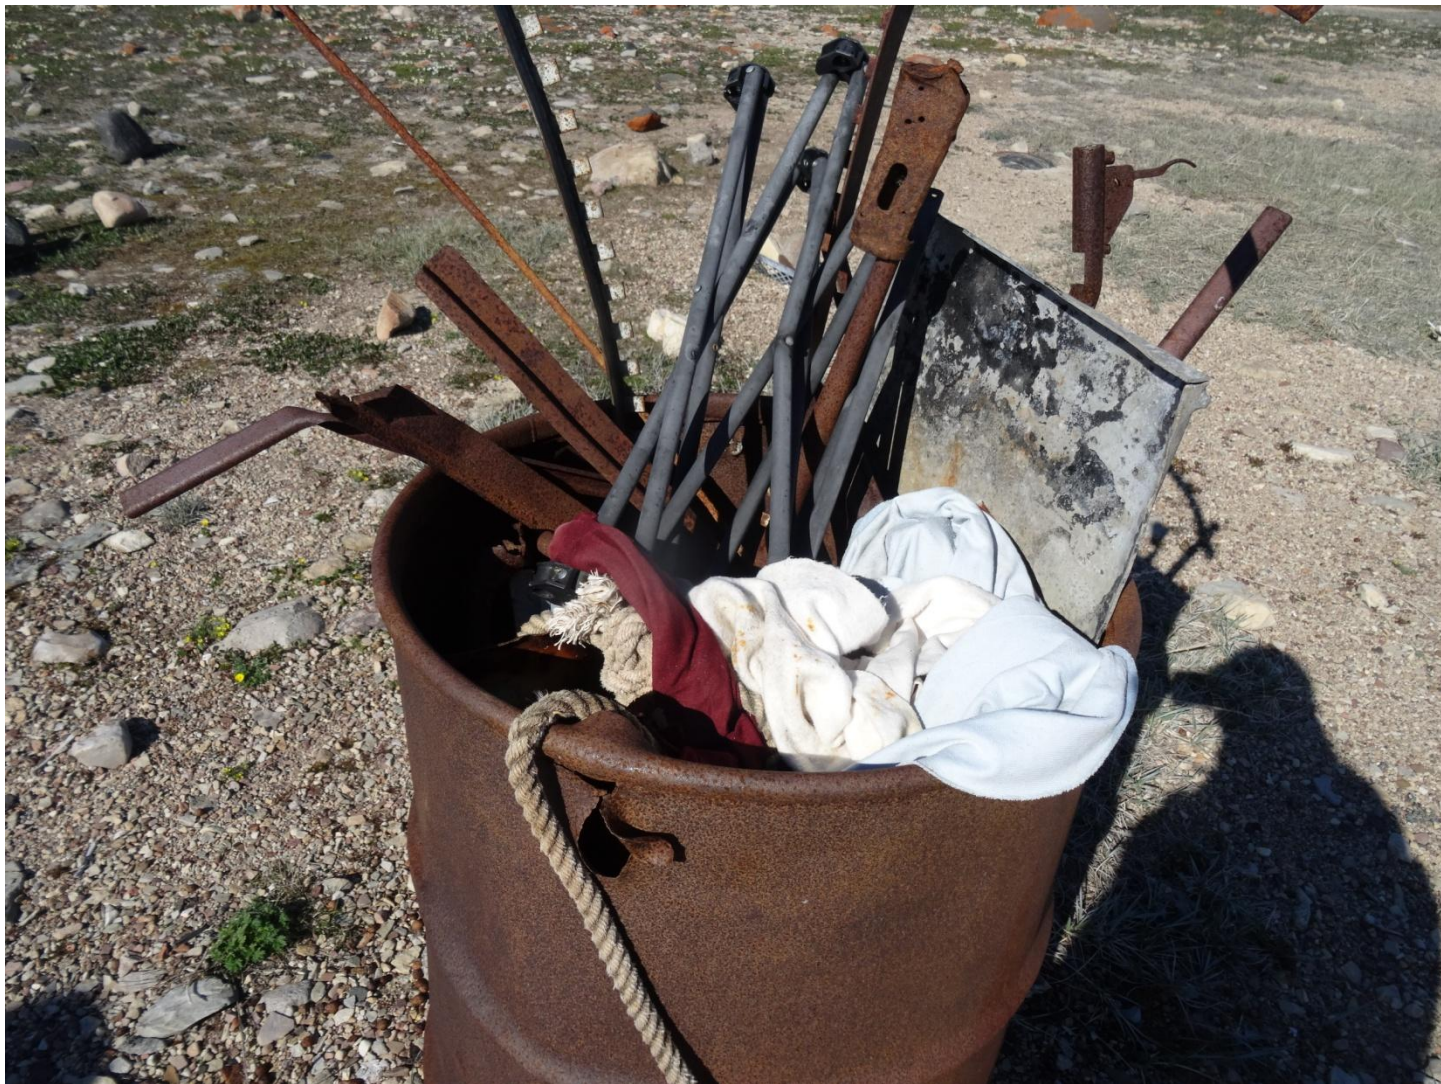
Figure 3. Contents of waste barrel.

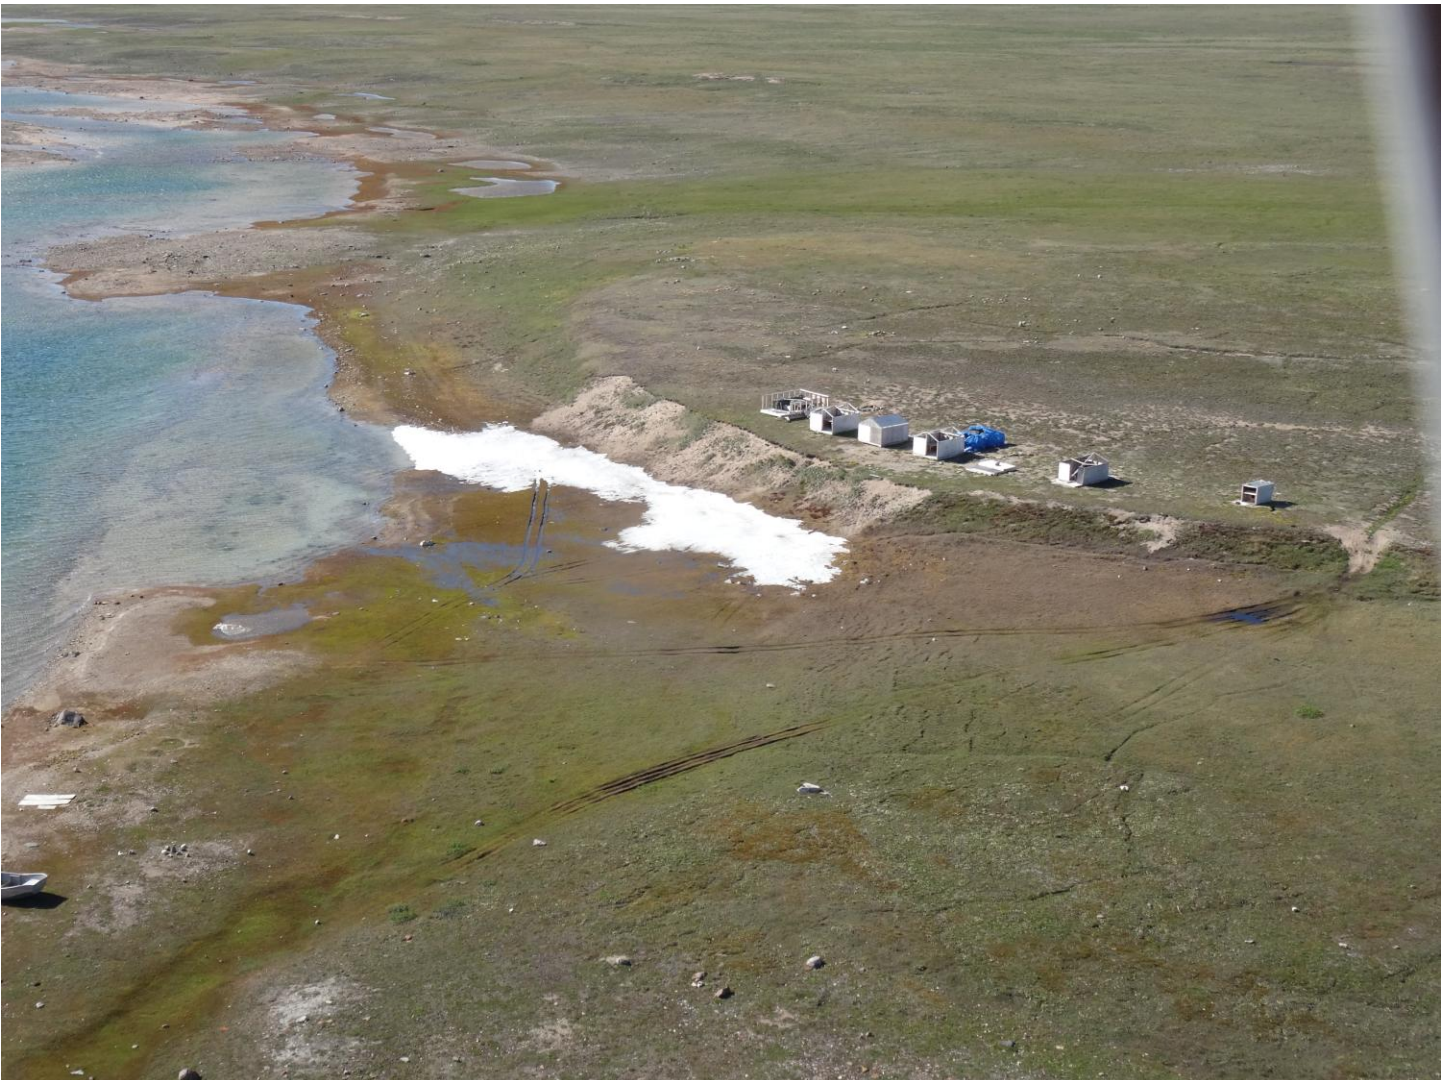
Figure 4. Rutting caused by ATV use.
