WATER LICENCE INSPECTION FORM

Licensee		Licensee Representative	
Plummer's Arctic Lodges		Chuk Coulter	
Licence No. / Expiry		Representative's Title	
Unlicensed			
Land / Other Authorizations		Land / Other Authorizations	
Date of Inspection		Inspector	
07/07/2016		Eva Paul	
Activities Inspected			
<input checked="" type="checkbox"/> Camp	<input type="checkbox"/> Drilling	<input type="checkbox"/> Mining	<input type="checkbox"/> Construction
<input type="checkbox"/> Roads/Hauling	<input type="checkbox"/> Other:	<input type="checkbox"/> Reclamation	<input checked="" type="checkbox"/> Fuel Storage

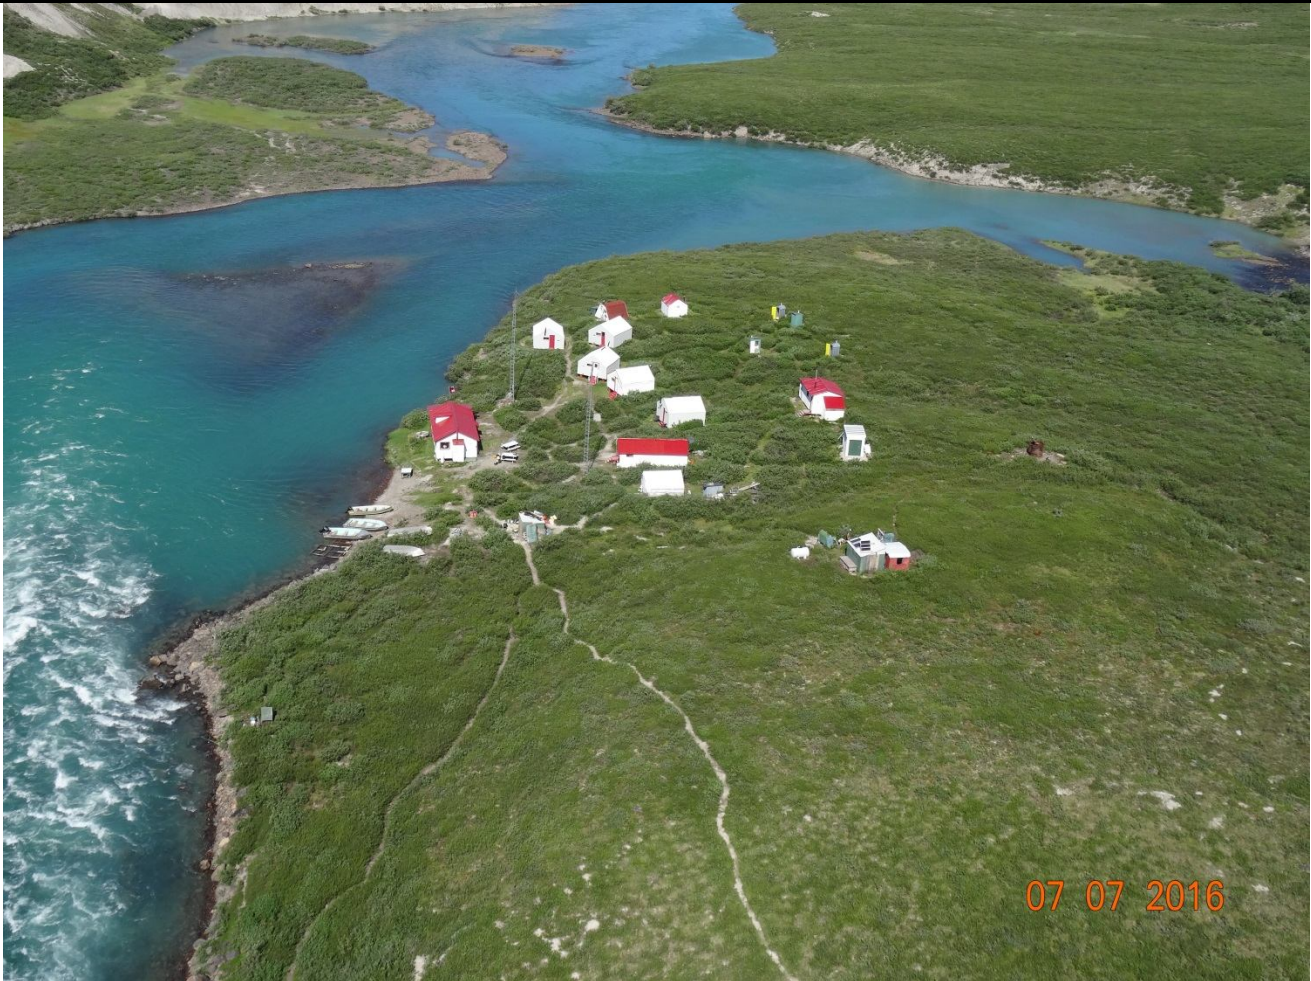
Date	Camera	Inspector	Authorization
July 7, 2016	SONY DSC-HX50V	Eva Paul	Unlicenced
Photo Log # 1		Location (NAD 83 DD MM SS.SS)	
Photo DSC05859		N67 38 03	W111 54 08 (<i>in motion</i>)

Description: Aerial view of Tree River Lodge looking approximately North. The grey shed with fuels and lubricants shows to the right of the boats, and the generator shack is the building to the bottom right. The kitchen shows above the boats, with the sump to the left of it. The white-roofed structures are the guest cabins, and the outhouses are to the top right. The old incinerator appears to the far right.

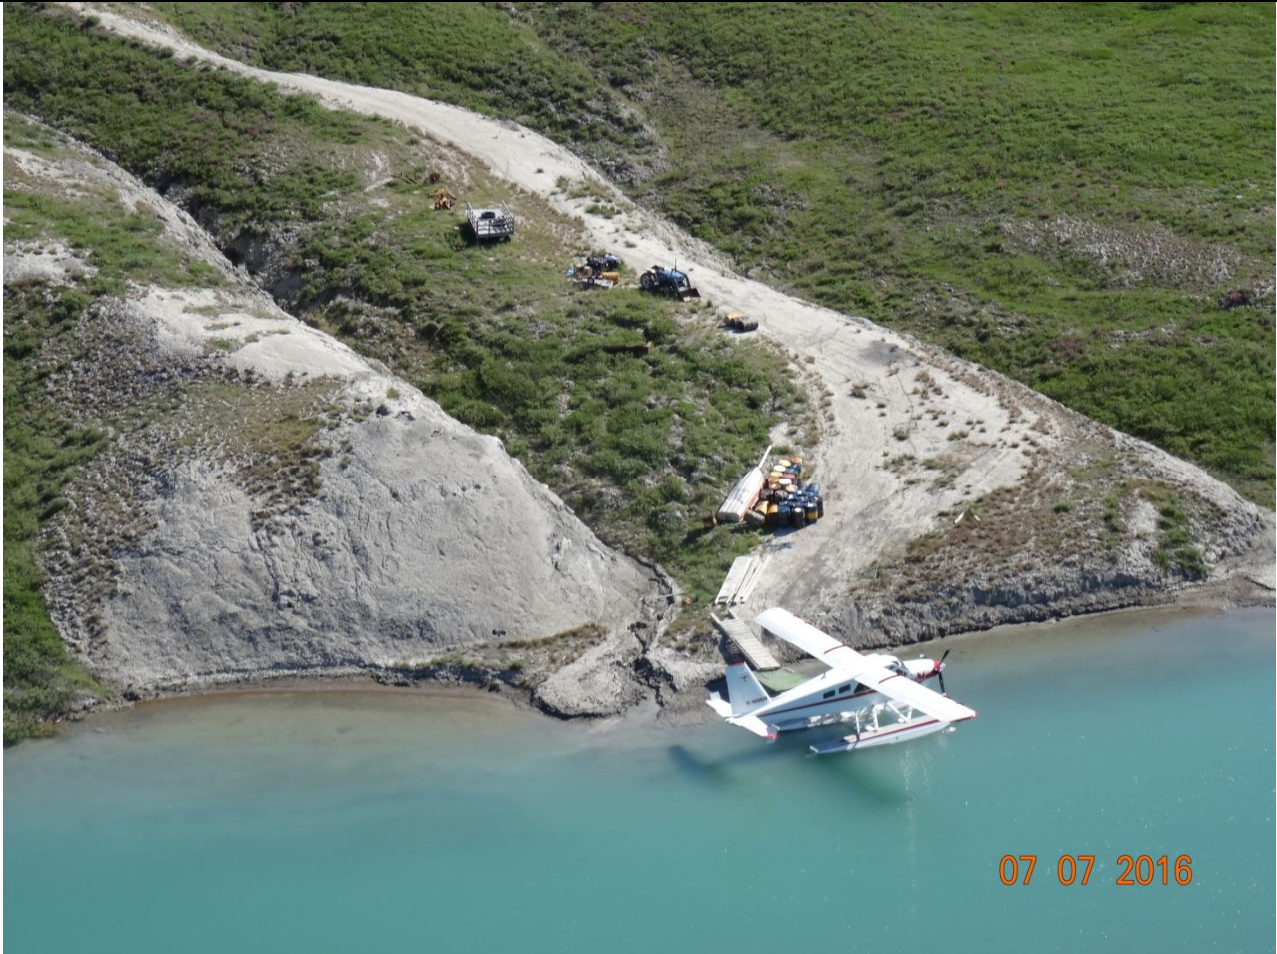
Photo Log # 2	Location (NAD 83 DD MM SS.SS)
Photo DSC05851	N67 38 45 W111 54 12 (<i>in motion</i>)

Description: Float plane dock. Barrels to the toe of the slope were empties; 3 full barrels farther up-slope near the equipment.

F. Extreme caution should be used for storage of all fuel, empty barrels, and other equipment on the plateau. Storage should be well away (>100m) from the OHWM of the river in case of a shift or collapse of the plateau. All fuel and lubricants at camp should be stored >30m from the OHWM and within drip trays/containment.

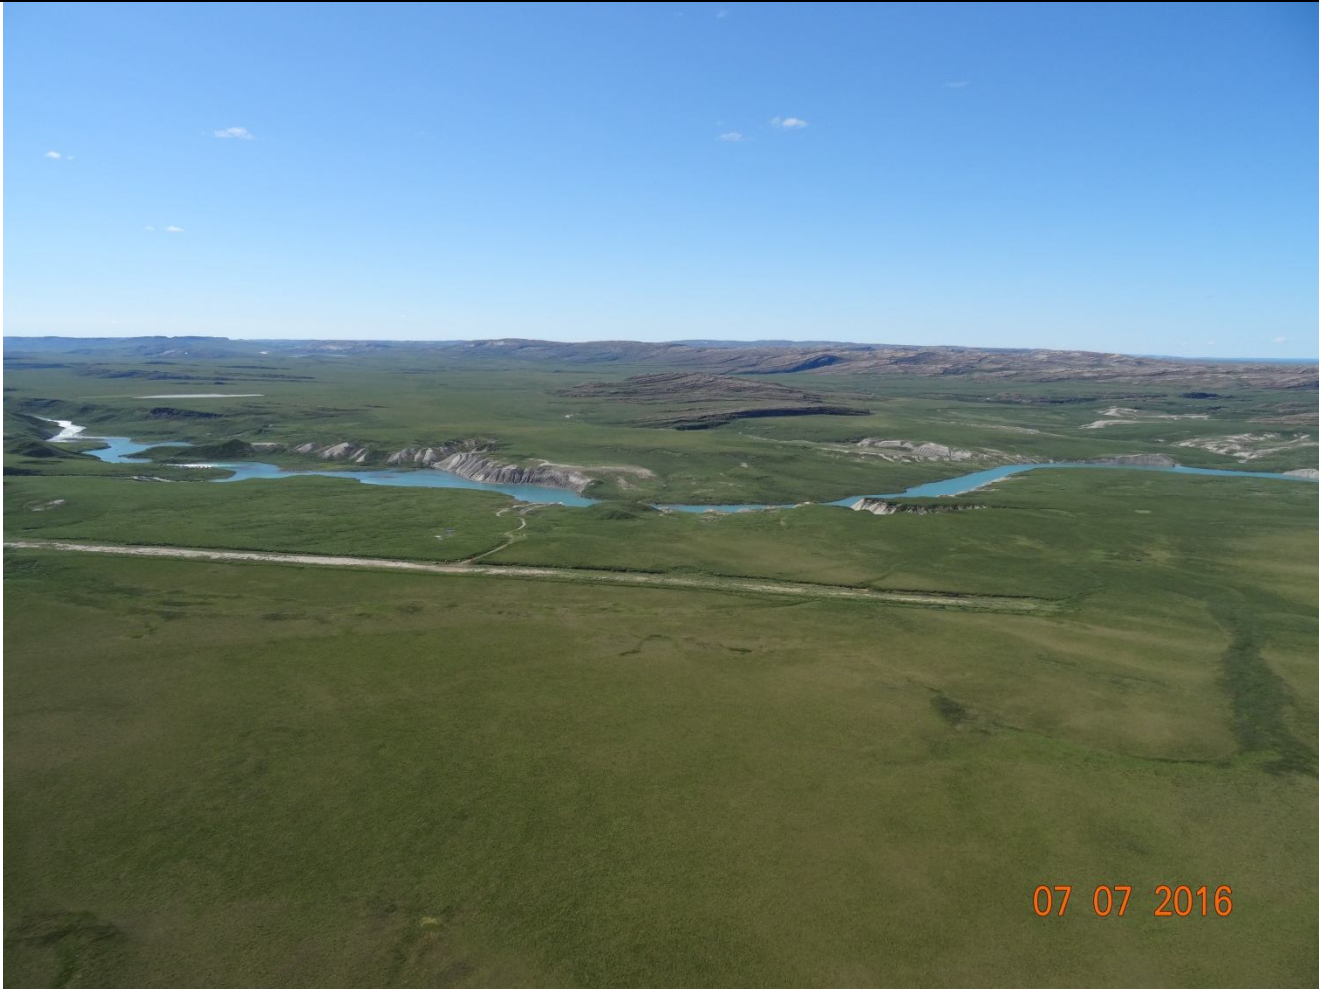
Photo Log # 3

Description: Airstrip and road, looking approximately west. 11 full barrels belonging to Water Survey Canada were noted.

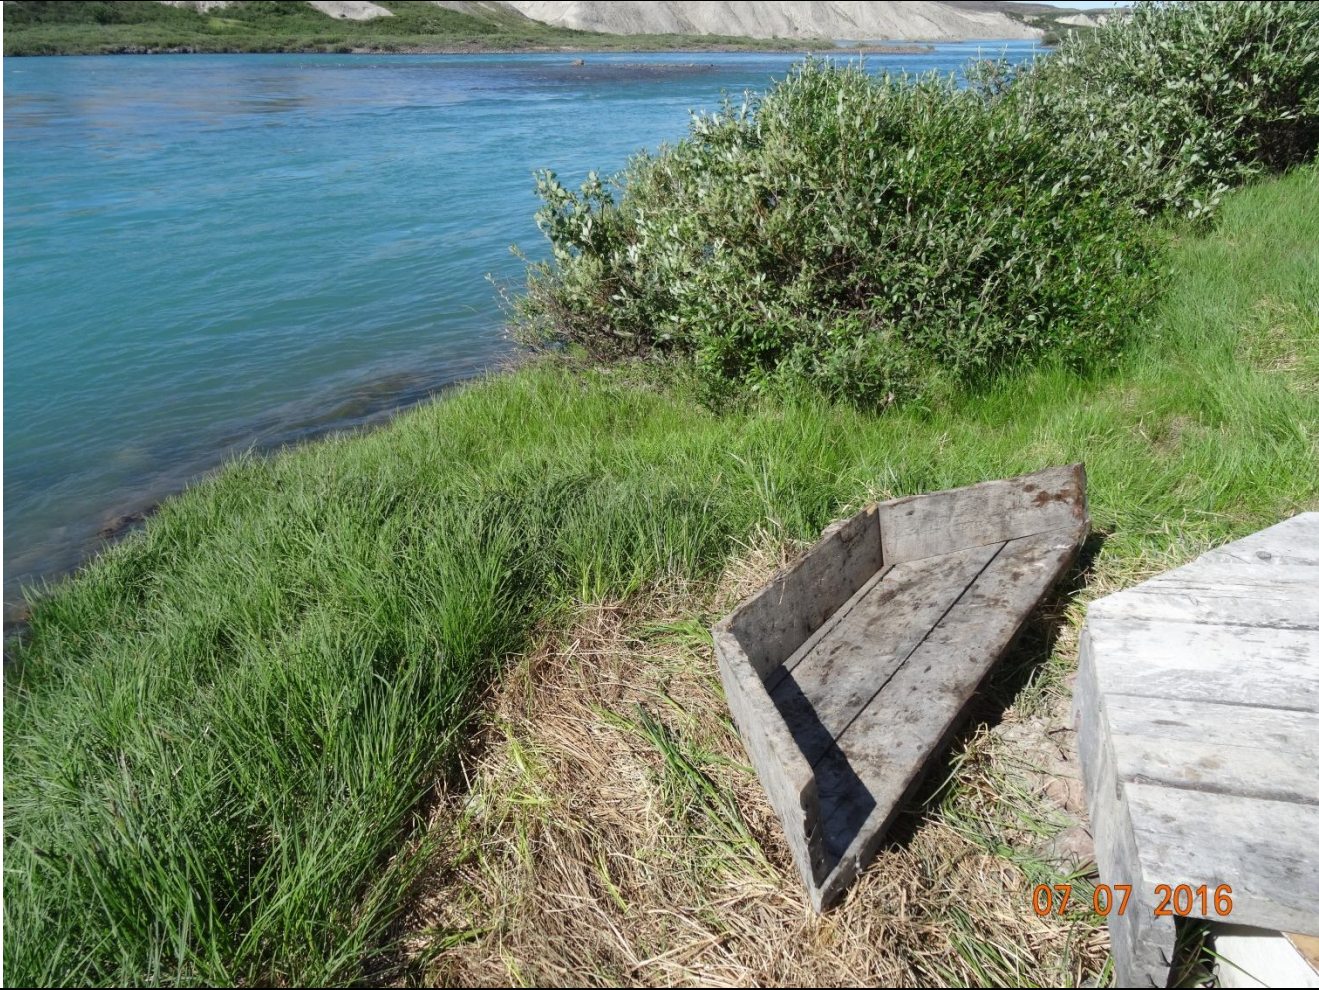
Photo Log # 4

Description: Kitchen sump; proximal to the river.

D. Upon return to Tree River, the greywater sump must be re-located >30m from the OHWM of the river and managed to ensure that no greywater can enter water. Sump/disposal location(s) are to be recorded by GPS. Confirmation this has been carried out is to be confirmed with the Inspector in writing by **July 31, 2017**.

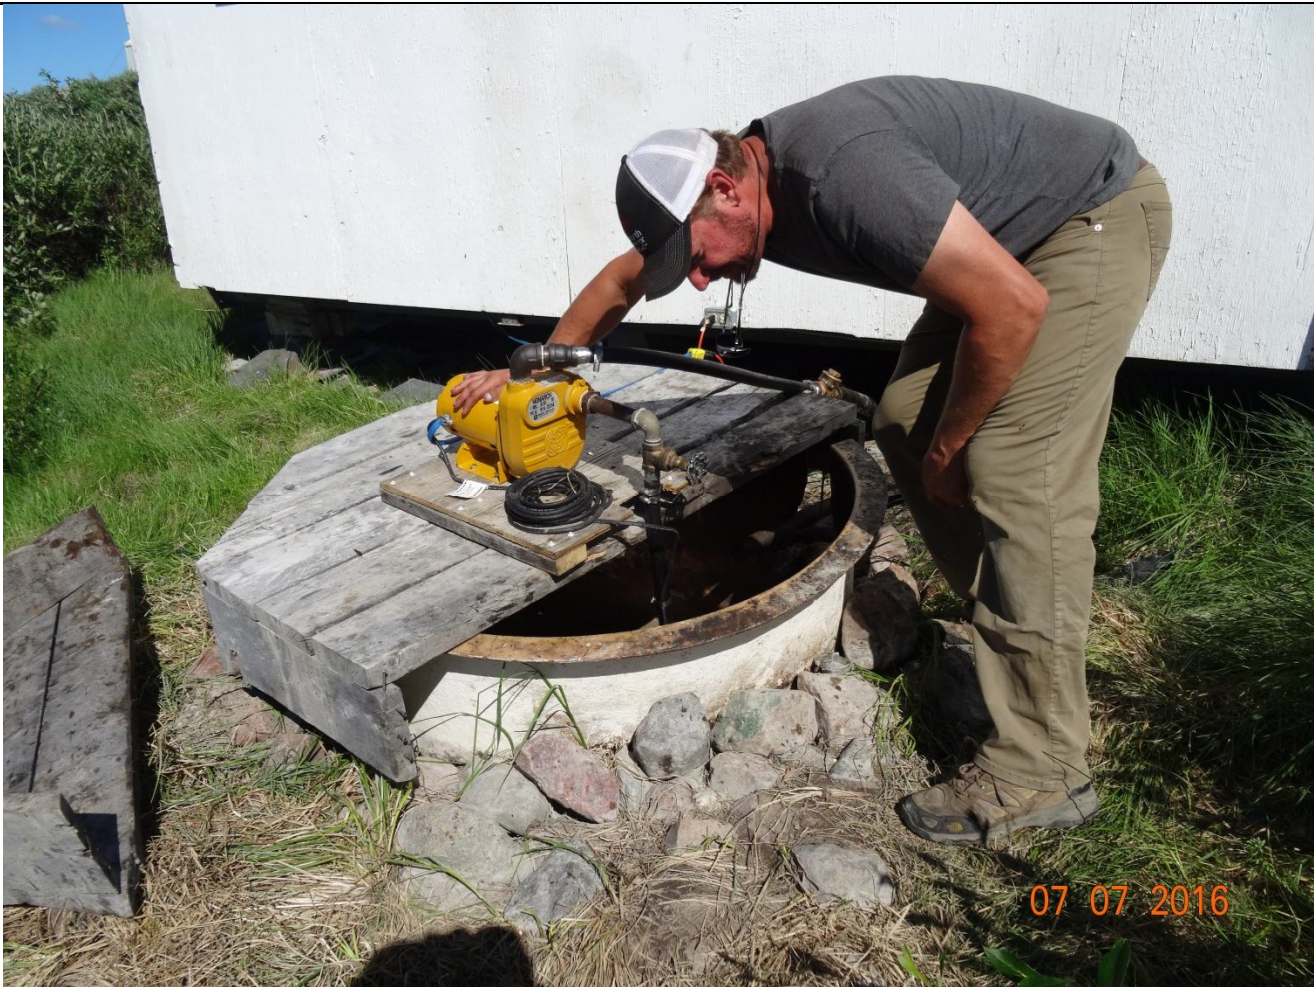
Photo Log # 5

Description: Kitchen sump, with overflowed material in the grass due to a pump malfunction.

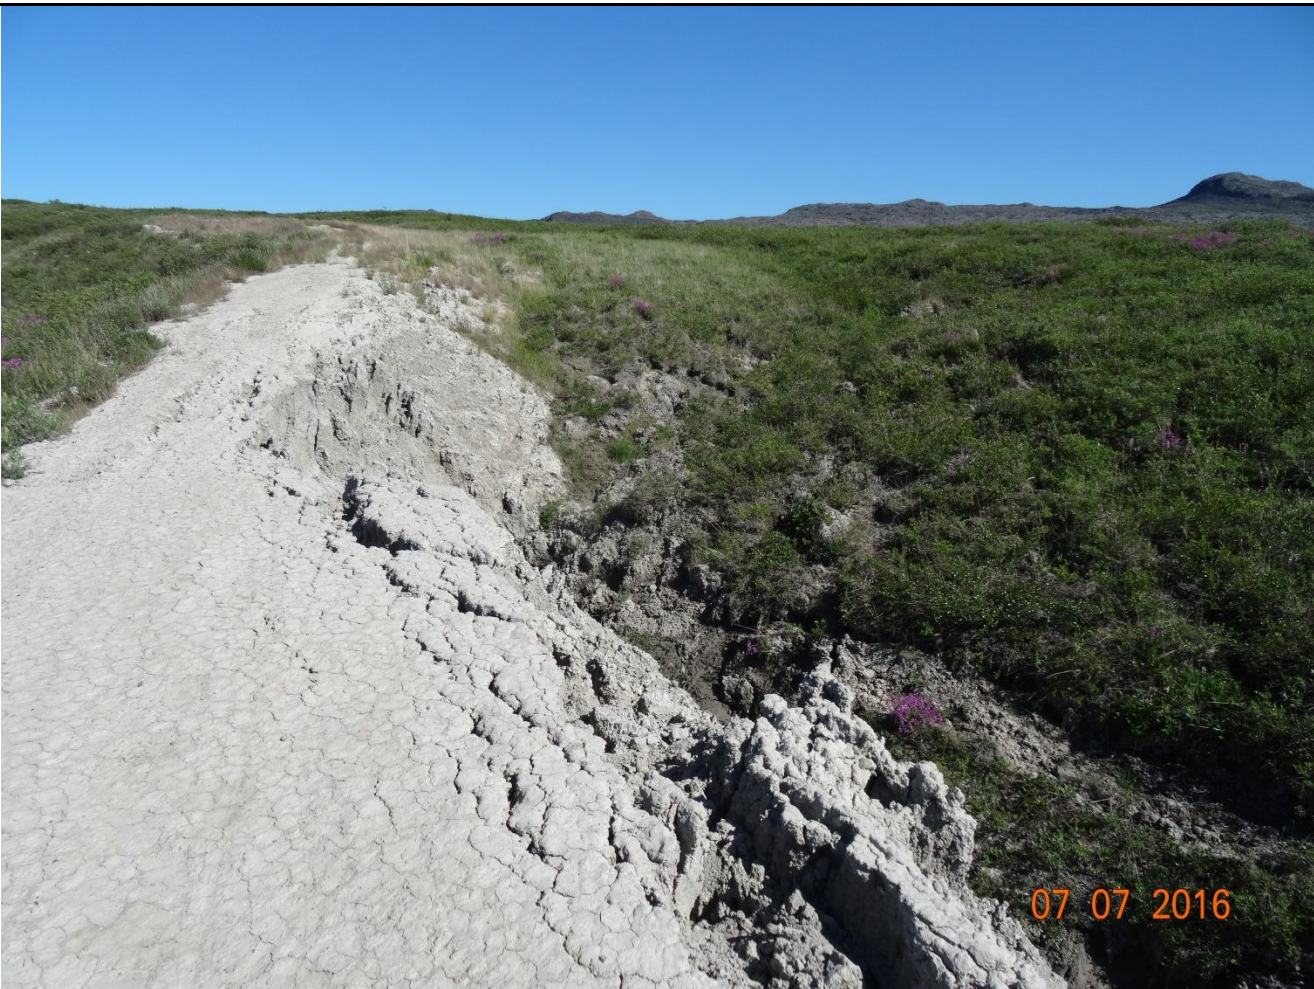
Photo Log # 6

Description: Slumping of sand from the south side of the road leading to the airstrip.

E. Immediate removal of the piece of equipment at risk of burial beside the river. Confirmation this has been carried out is to be confirmed with the Inspector in writing by **July 31, 2017**. When using the ‘road’, efforts should be made to preserve the remaining vegetation and prevent further man-made impacts that result in sediment deposition.

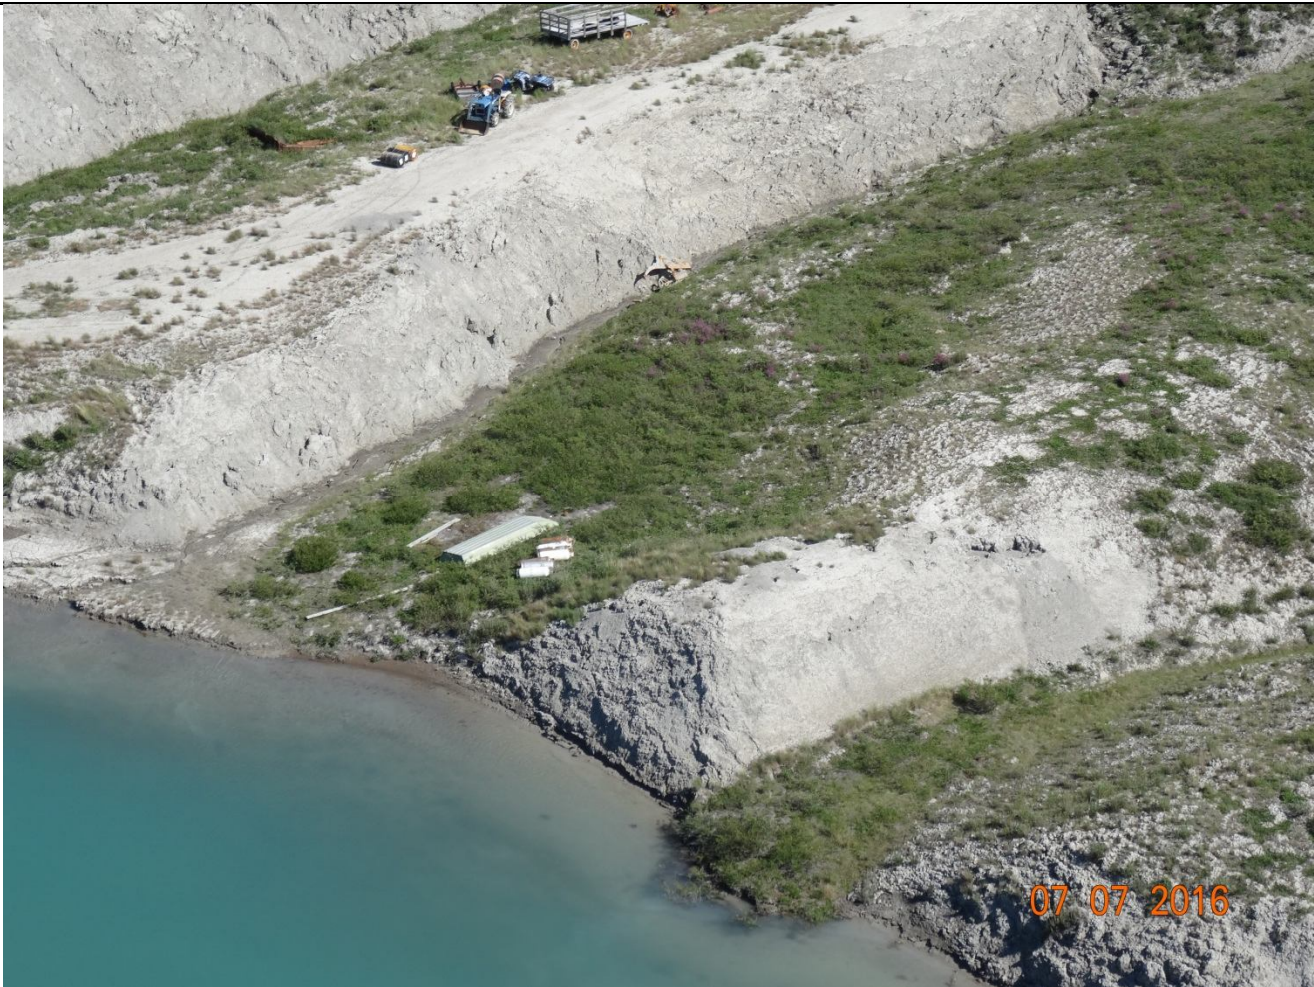
Photo Log # 7

Description: Same slope, seen from the south. Note equipment in the ‘ravine’ that must be removed before it is buried. Also note propane tanks near the river bank.
