8 Wing Environmental Management
Canadian Forces Base Trenton
74 Polaris Avenue, Room 305
PO Box 1000 Stn Main
Astra ON K0K 3W0

06 May 2016

DETAILED REPORT: HYDRAULIC OIL SPILL-CFS ALERT, 10 APRIL 2016

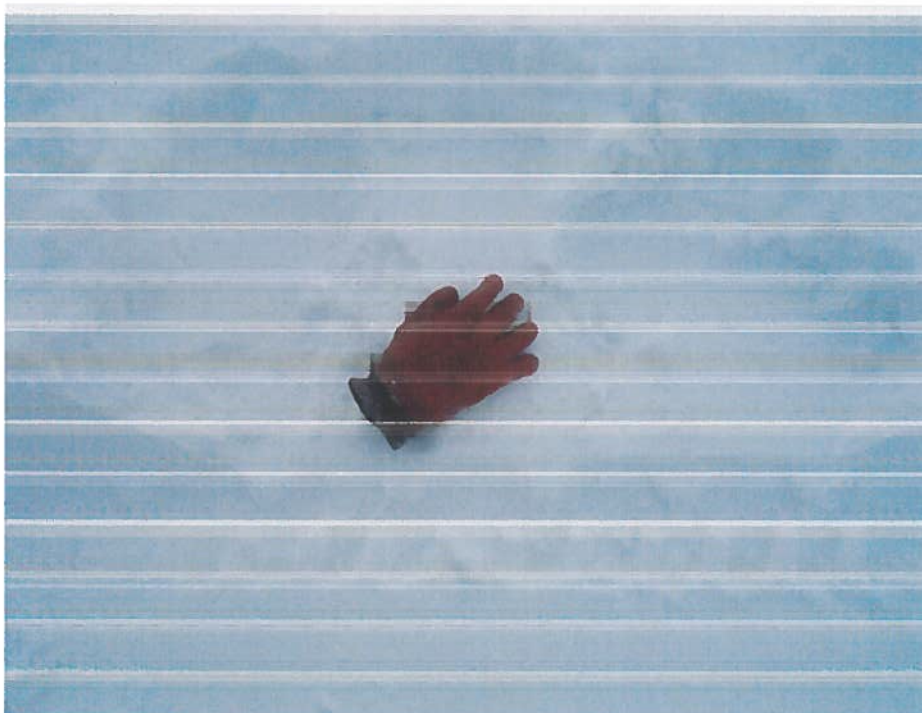
- b. The spill area was 1 square metre (Figure 2).
 - c. All contaminated snow and ice was removed until there were no visual traces of the hydraulic oil.

Figure 2 – Photo of the cleaned up spill site near CFS Alert (12 April 2016).

4. Measures taken to contain and clean up the spill site.
 - a. Upon discovery of the spill, hydraulic oil contaminated snow was removed and placed into a barrel as hazardous waste for proper incineration.
