WATER LICENCE INSPECTION FORM

On July 5, 2022 at 10:35am, a Water Licence Inspection was conducted by Water Resource Officer (WRO) Joseph Monteith at Eureka, Ellesmere Island, Qikiqtani Region, Nunavut, for water licence 8BC-EUR2126.

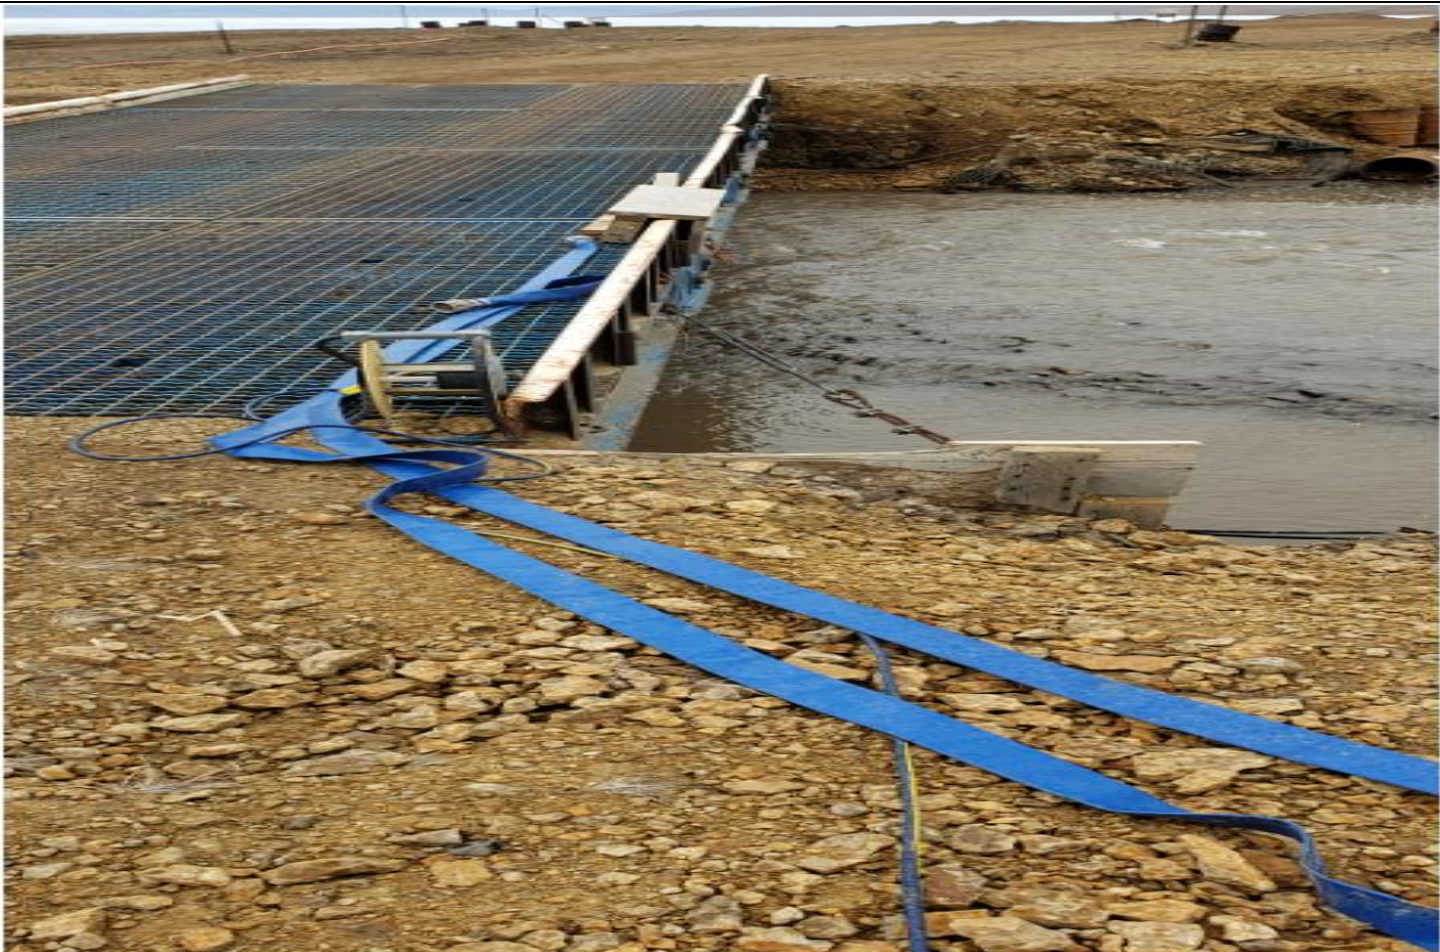
Date	Camera	Inspector	
July 5, 2022	Nikon Cool Pix	Joseph Monteith	
Photo Log #	Location		
Photo 1	Eureka, Ellesmere Island

1. Eureka obtains its water for domestic purposes from a bridge at Station Creek (photo 1). The water is pumped from Station Creek (photo 1) into the water reservoir (photo 3& 5) using a submersible pump in a milk crate with holes(photo 2) in order to reduce the transfer of silt, and potentially fish from the creek to the reservoir. The raw water is then pumped from a pump house at the water reservoir (photo 3) to holding tanks within the Eureka complex building, treated by filtration and Reverse Osmosis and chlorination prior to use for drinking and food preparation. It is estimated that the reservoir holds approximately 12,000 cubic metres of water. An amendment to the water license has been issued to increase its capacity. The work to expand the capacity was observed (photo 5,6,7)).

Description: Bridge at Creek stream. Water is withdrawn from within milk crates, covered with a fish mesh screen(photo 2) to reduce the intake of soil and fish into the pump, and as per regulation.

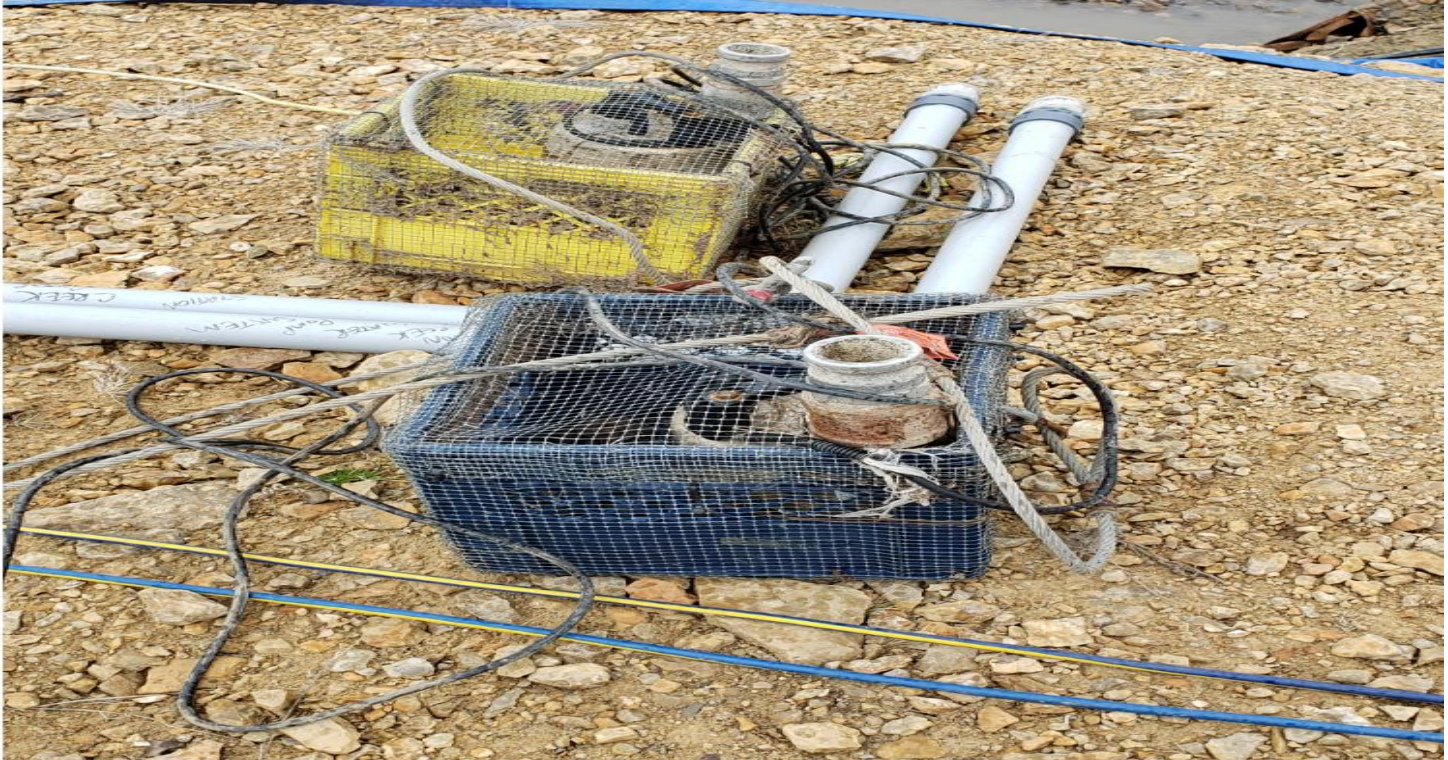
Photo 2

2. 2x water pumps observed on site. Fish Mesh Screen observed on the hose. The box with lots of holes was not observed to be hanging from the bridge. ECCC is using small milk crates and the intake hose was within the milk crate, with an acceptable sized fish meshed screen (photo 2).

Description: 2 x Water Pumps with Fish Mesh Screens

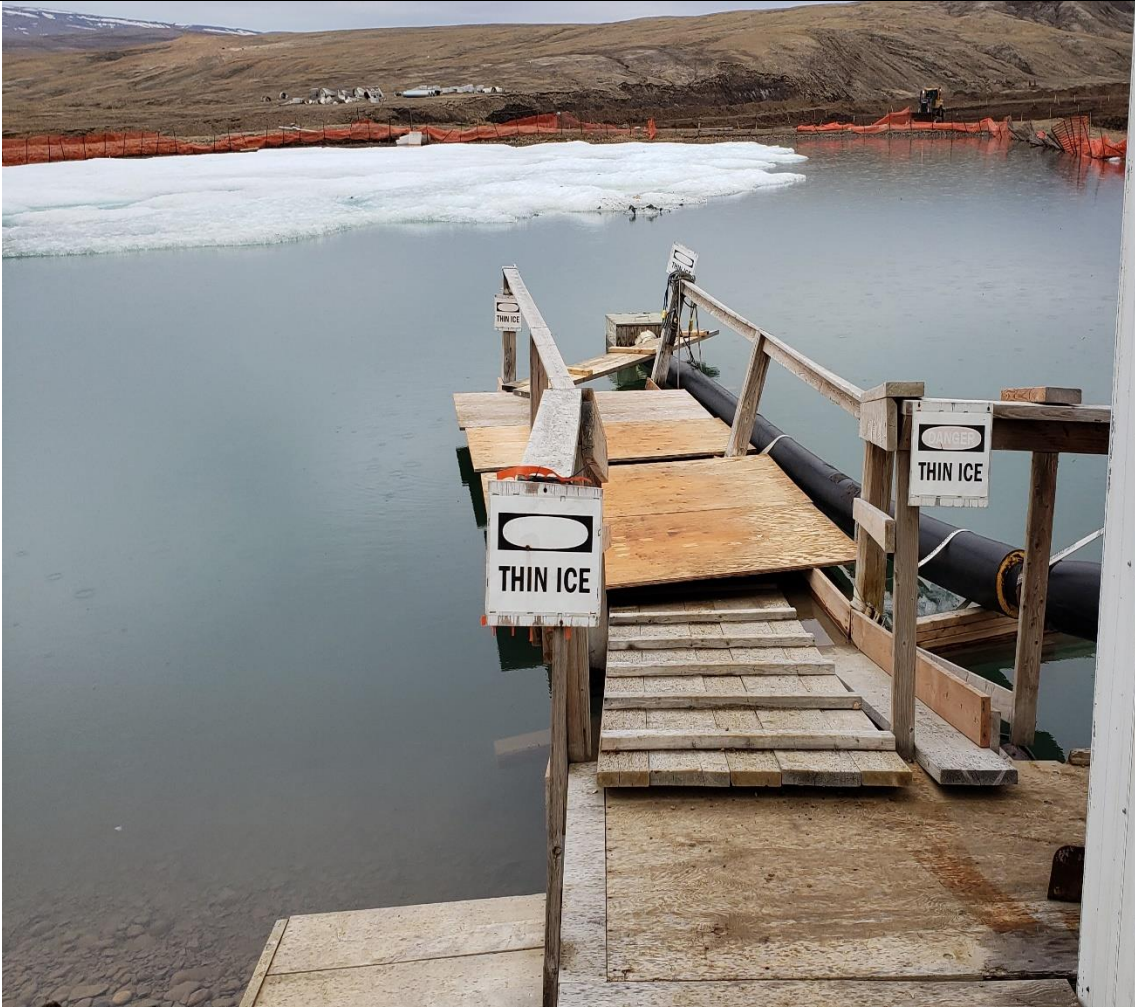
Photo 3

Description: Water reservoir pump house

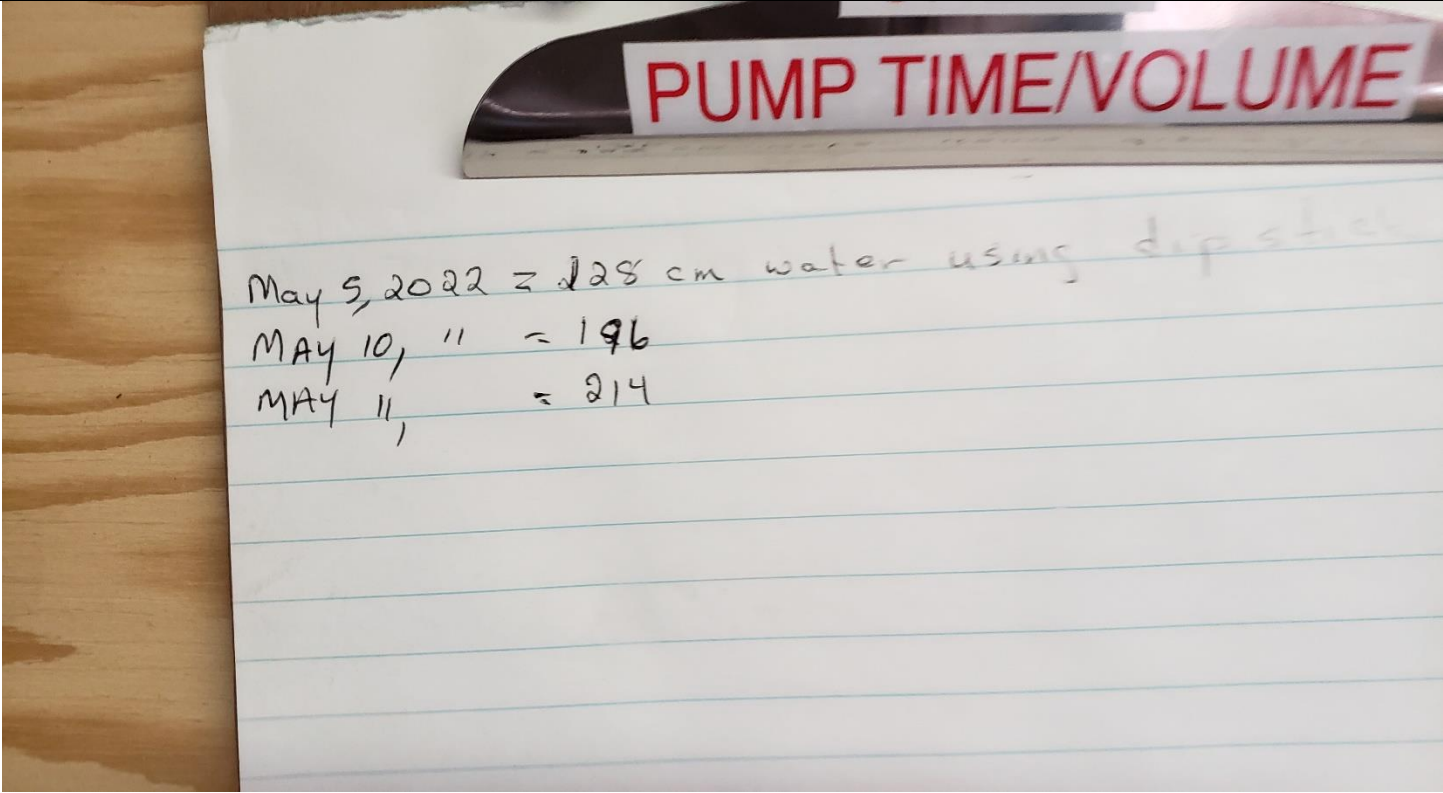
Photo 4

3. Water usage Logs was observed in the pump house (photo 4).
4. Jean-Phillipe-Cloutier-Dussault, ECCC, emailed WRO Monteith a copy of Eureka ECCC's Water Consumption Records showing a total of 1739.9m<sup>3</sup> consumed between January 1, 2022, and October31, 2022.

Description: Water reservoir pump house. From reservoir to buildings. No sign of water meter. Water depth appears to be measure.

Install silt fencing between the expansion of the water reservoir construction, and the river. Install a water meter at the point of withdrawal to measures all uses of water.

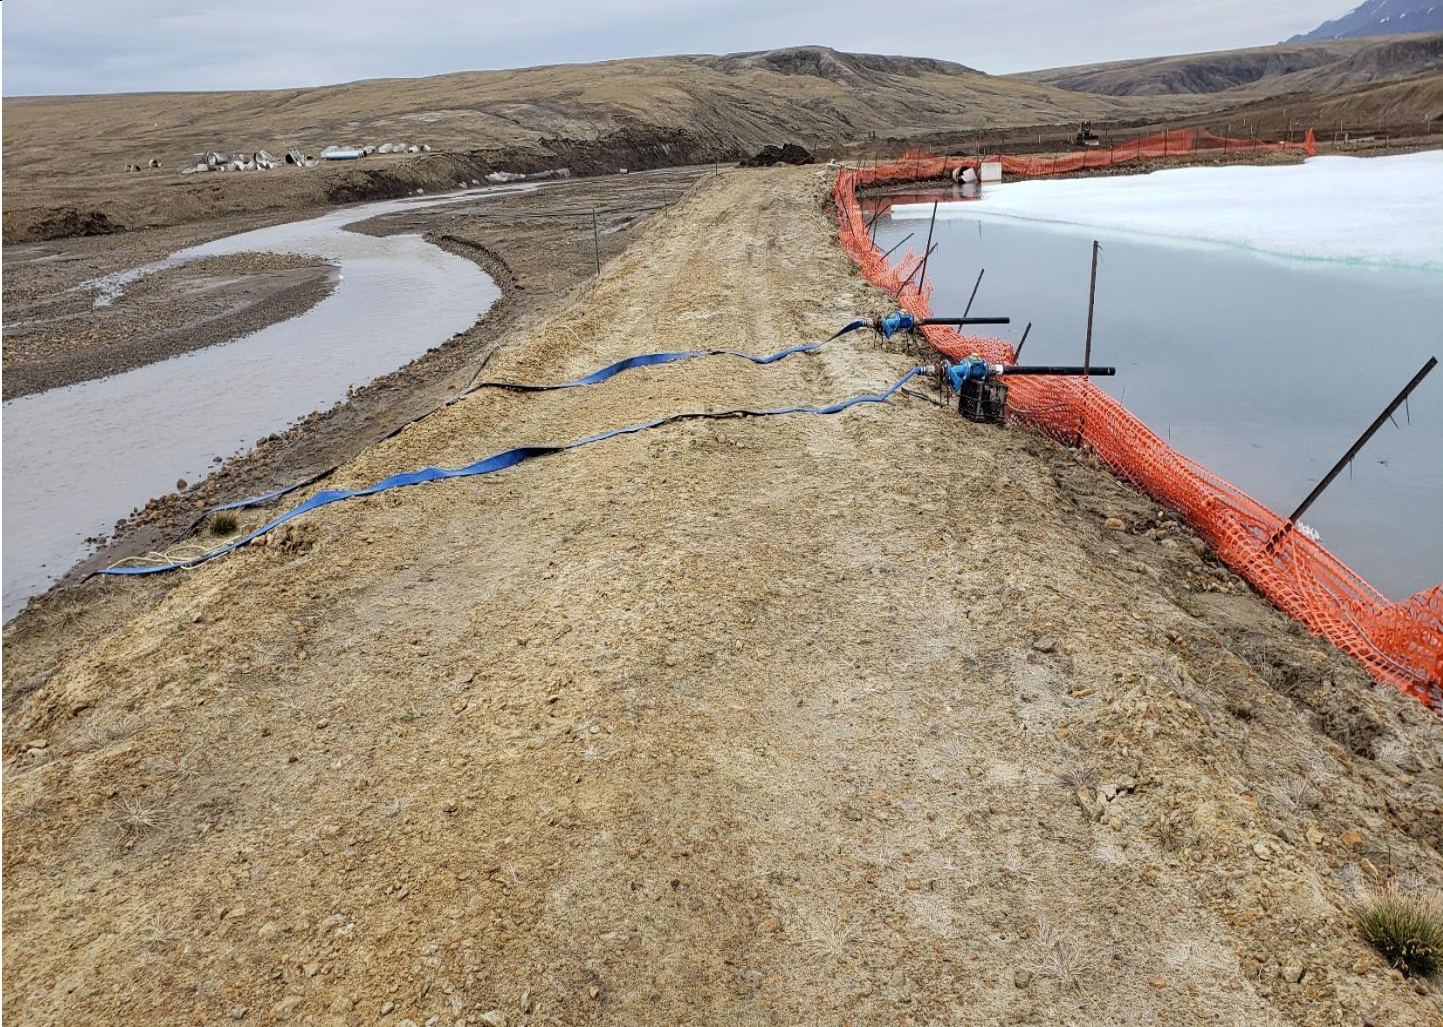
Photo 5

Description: Water reservoir recharge location for 2022. Some parts of the reservoir was less than 1 metre freeboard. No sign of water meter.

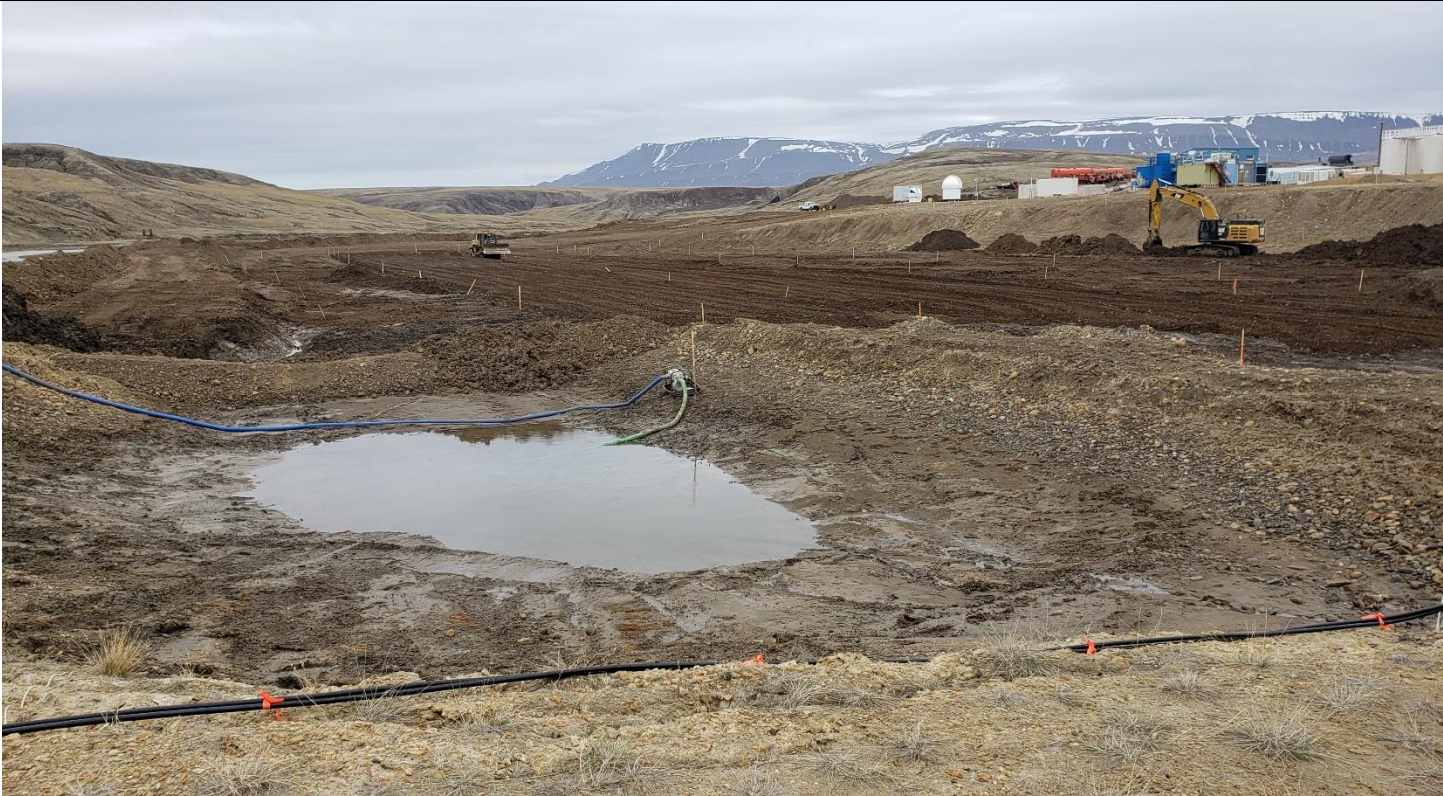
Photo 6

Description: At the time of the inspection, work was being done to expand the capacity of the water reservoir.

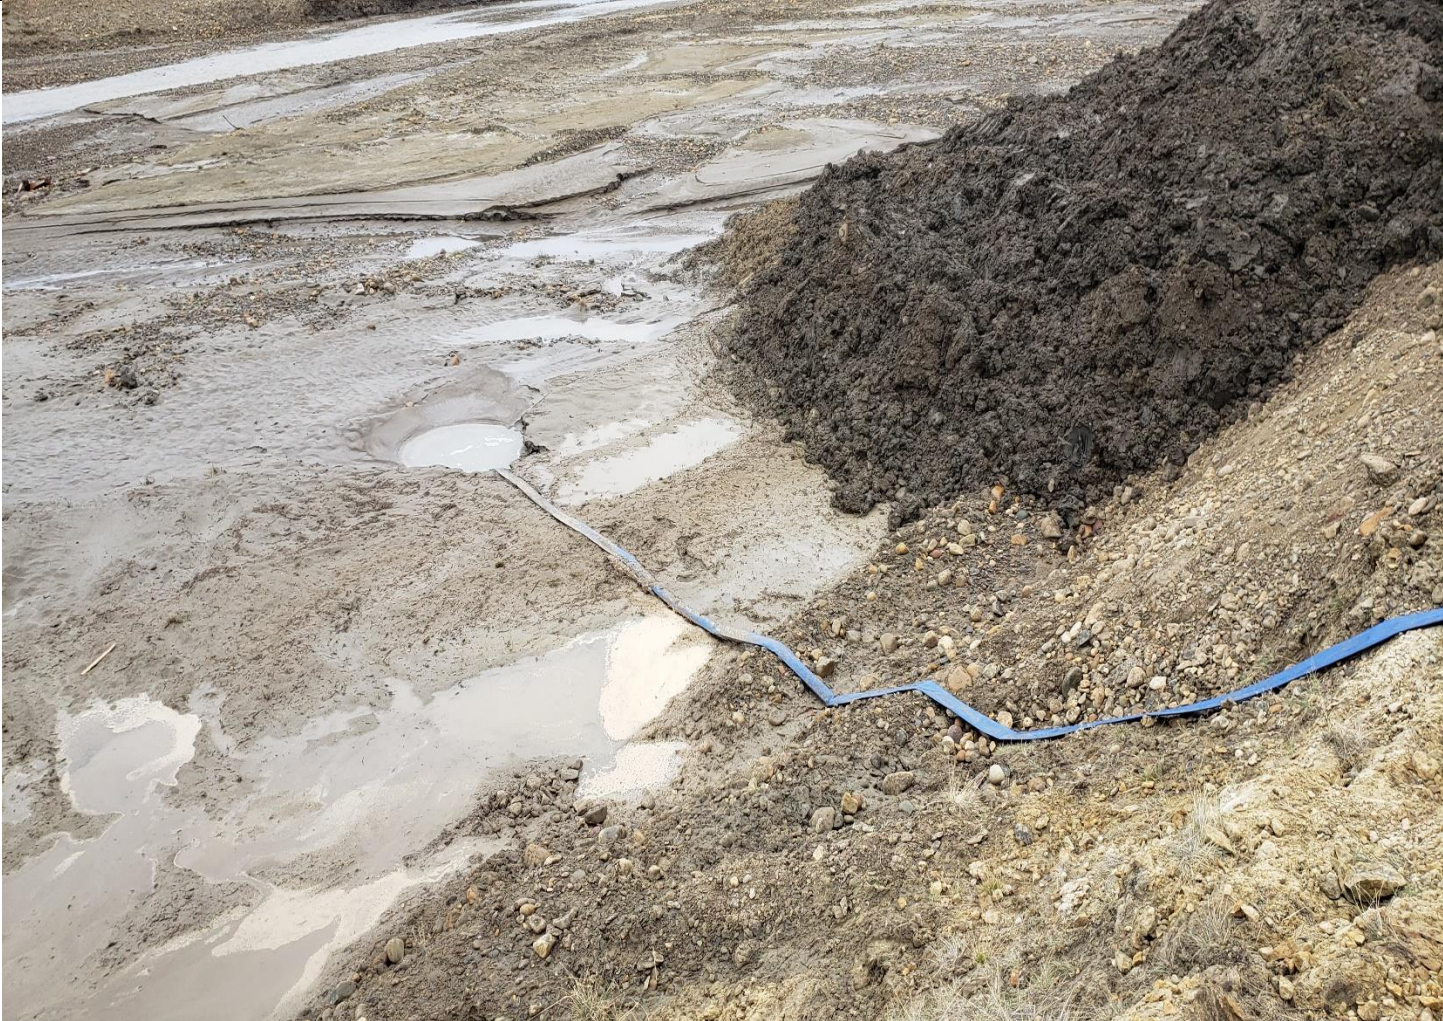
Photo 7

compliance with their water license.			
Section 1	<input checked="" type="checkbox"/> Comments	<input type="checkbox"/> Non-Compliance with Act or Licence	<input type="checkbox"/> Action Required
<div><div><div>•</div><div>During the expansion of the water reservoir it was observed that water was pumped out of the expansion site, and wet soil was laid down to form up the walls. I’ve added the action required to install silk fencing to mitigate the potential of sedimentation, since the activity is within the high water mark of the river.</div></div><div><div>•</div><div>8BC-EUR2126 Part B: General Conditions 3. The Licensee shall install flow meters or other such devices, or implement suitable methods required for the measuring of Water volumes as required under Part J, Item 1.</div></div></div>			
SECTION 2	<input type="checkbox"/> Comments	<input type="checkbox"/> Non-Compliance with Act or Licence	<input checked="" type="checkbox"/> Action Required

Description: Wet loam observed. install silt fencing to mitigate the potential for sedimentation in the river. River at low mark in the top right background. Sedimentation observed along the base of the newly laid reservoir walls, within the high mark of the river. No direct observation of sedimentation into the river.

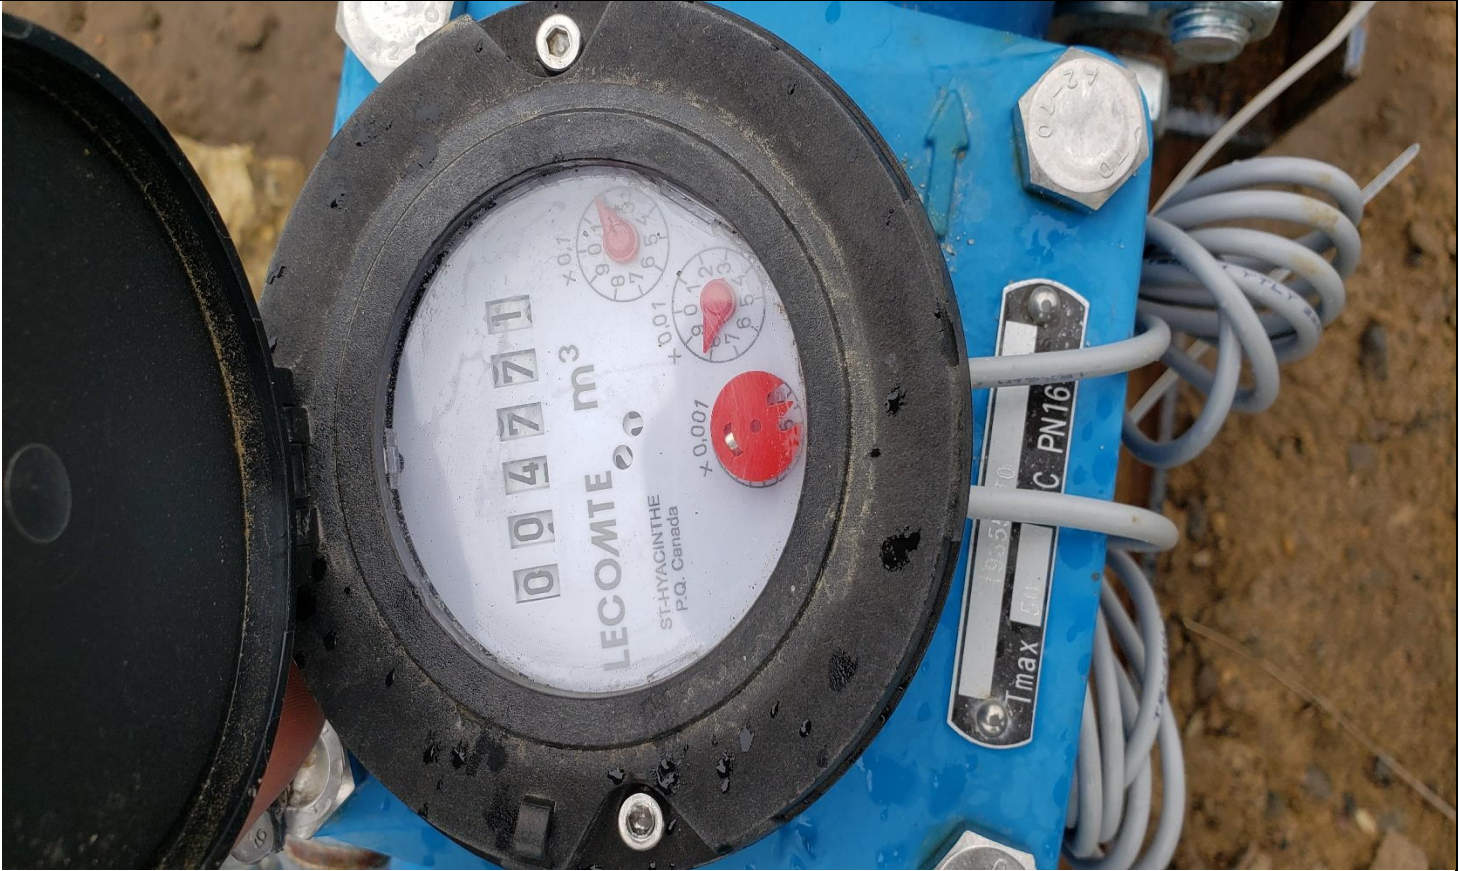
Photo Log #	Location
Photo 12	Eureka, NU

Description: Flow Meter observed on site for decanting sewage lagoon. Lecomte Meter says 4771m³.

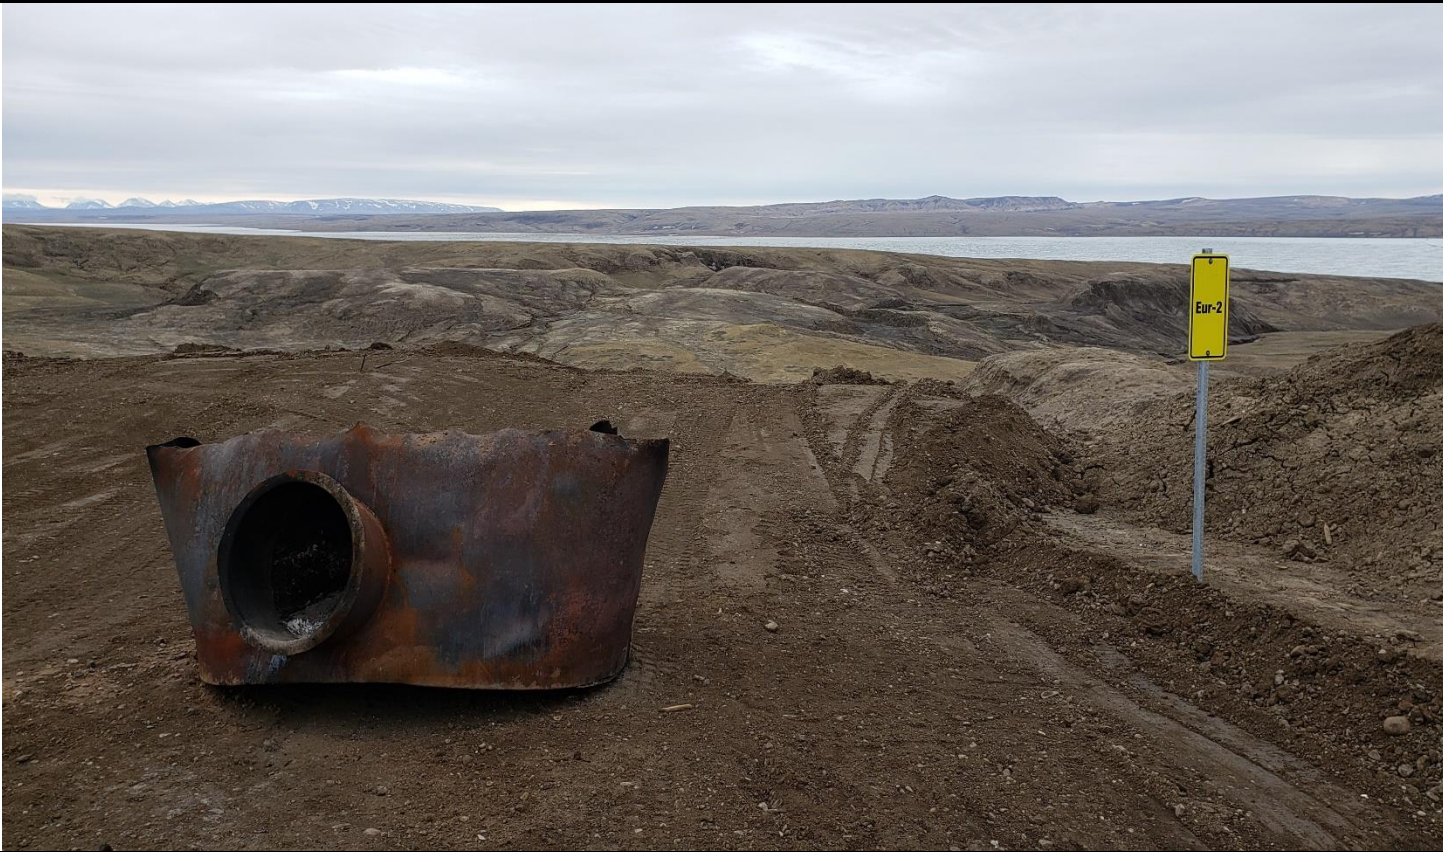
Photo 14

9. A solid waste facility was observed on site (photo 14).
10. A Bulk Metal Storage of empty storage drums was observed on site (photo 22).
11. Open Burning in an old cut out metal storage tank was observed (photo 14). No Signs of prohibited materials such as plastics, metals, and hazardous waste in the open burn bin(photo 13).

Description: landfill, burn and cap. Solid waste is pushed off the left hand side of the sign, and capped with gravel. EUR-2 is observed as the monitoring station.

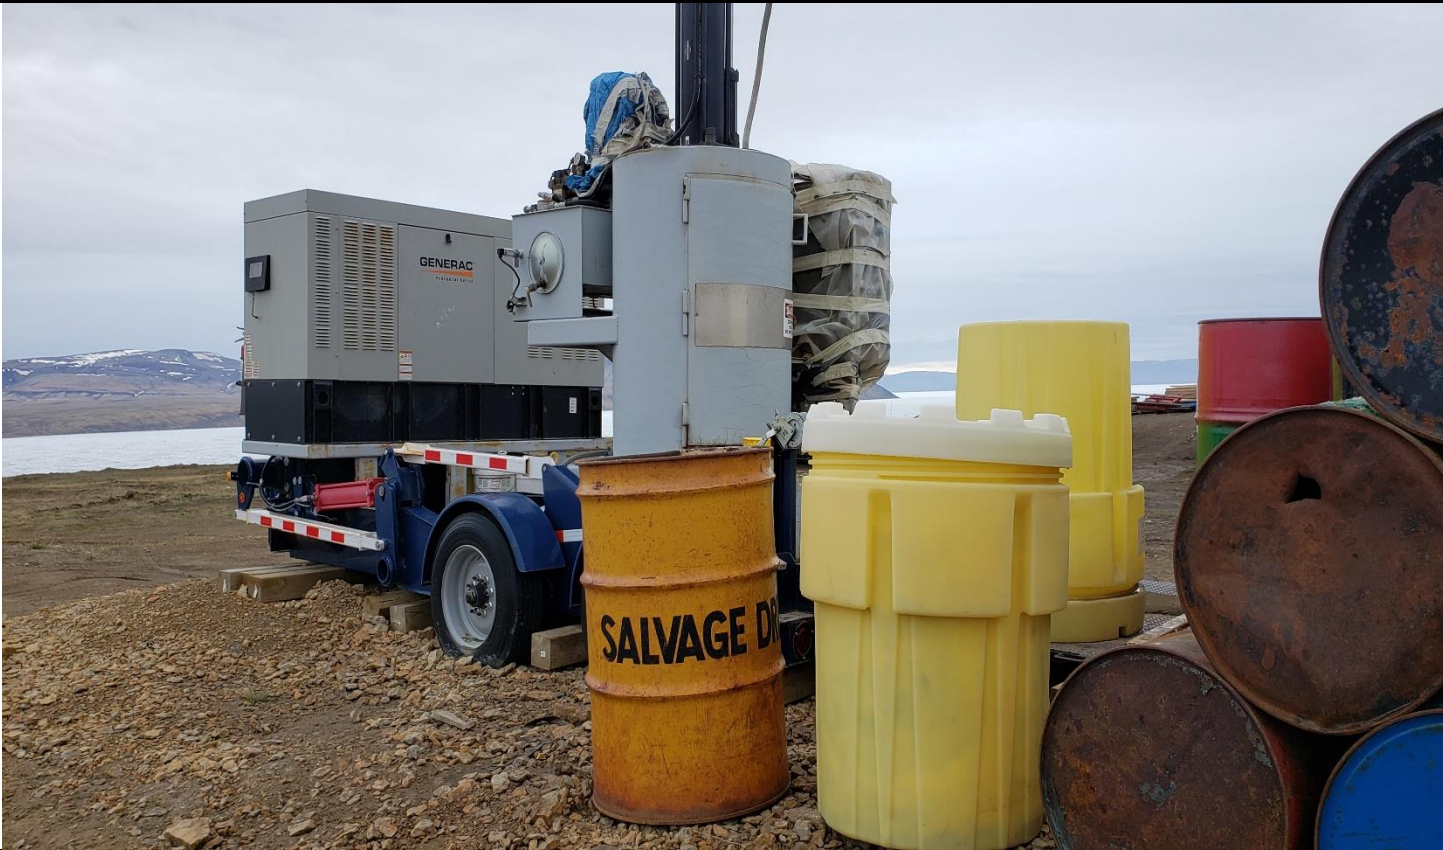
Photo 15

12. A drum washer and crusher was observed on site (photo 15).
13. A solid waste facility for capping solid waste was observed with a sign Eur-2. At the time of the inspection, fresh gravel was laid on top of site where waste was pushed off the side. Waste capped. (photo 17).

Description: Drum washer and crusher. After washing a drum, it is suitable for burial underground.

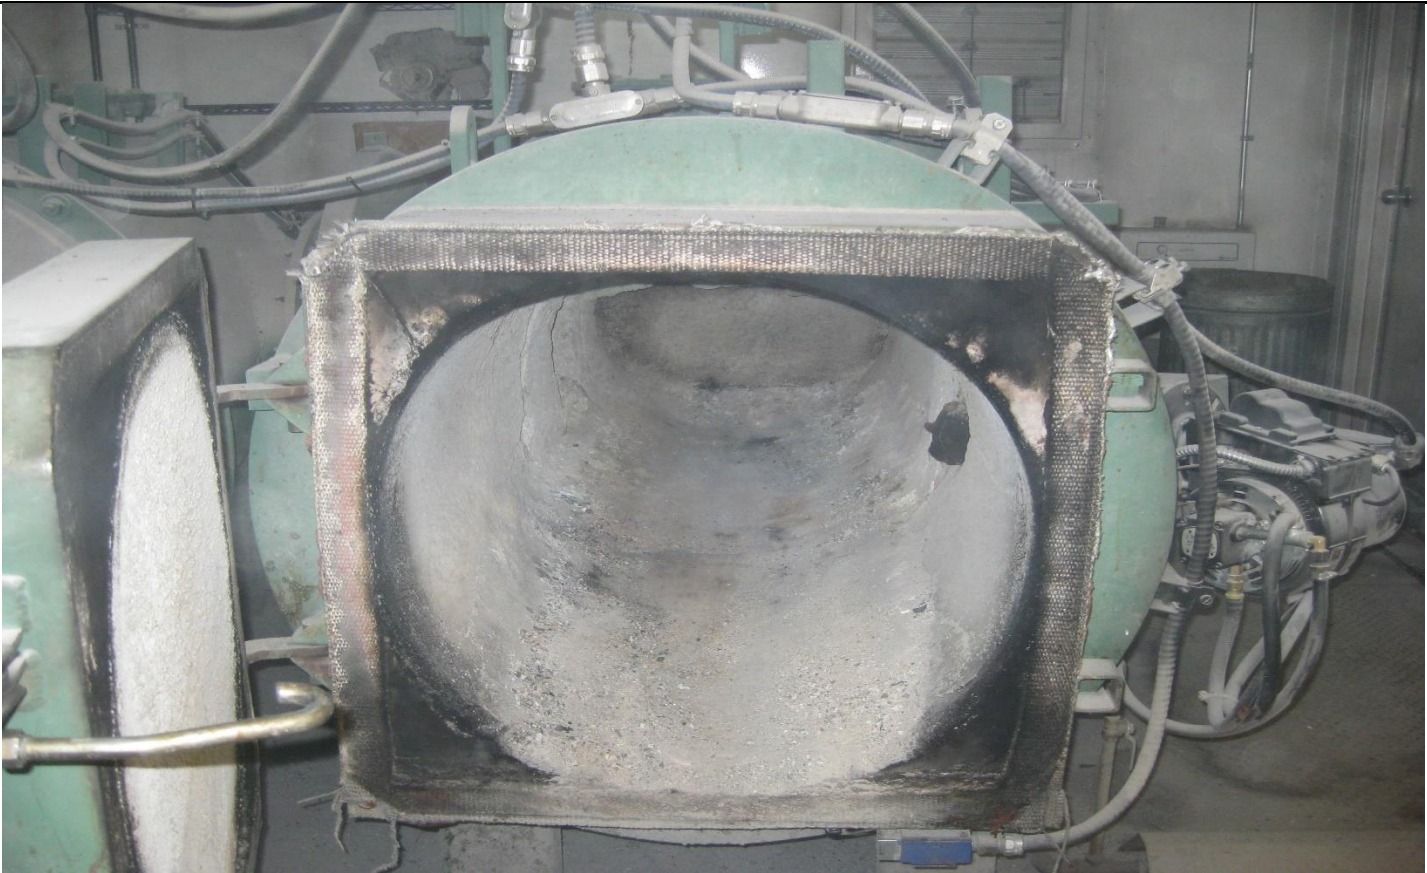
Photo Log #  
Photo 18

Description: Inside the incinerator. No concerns Photo submitted by ECCC

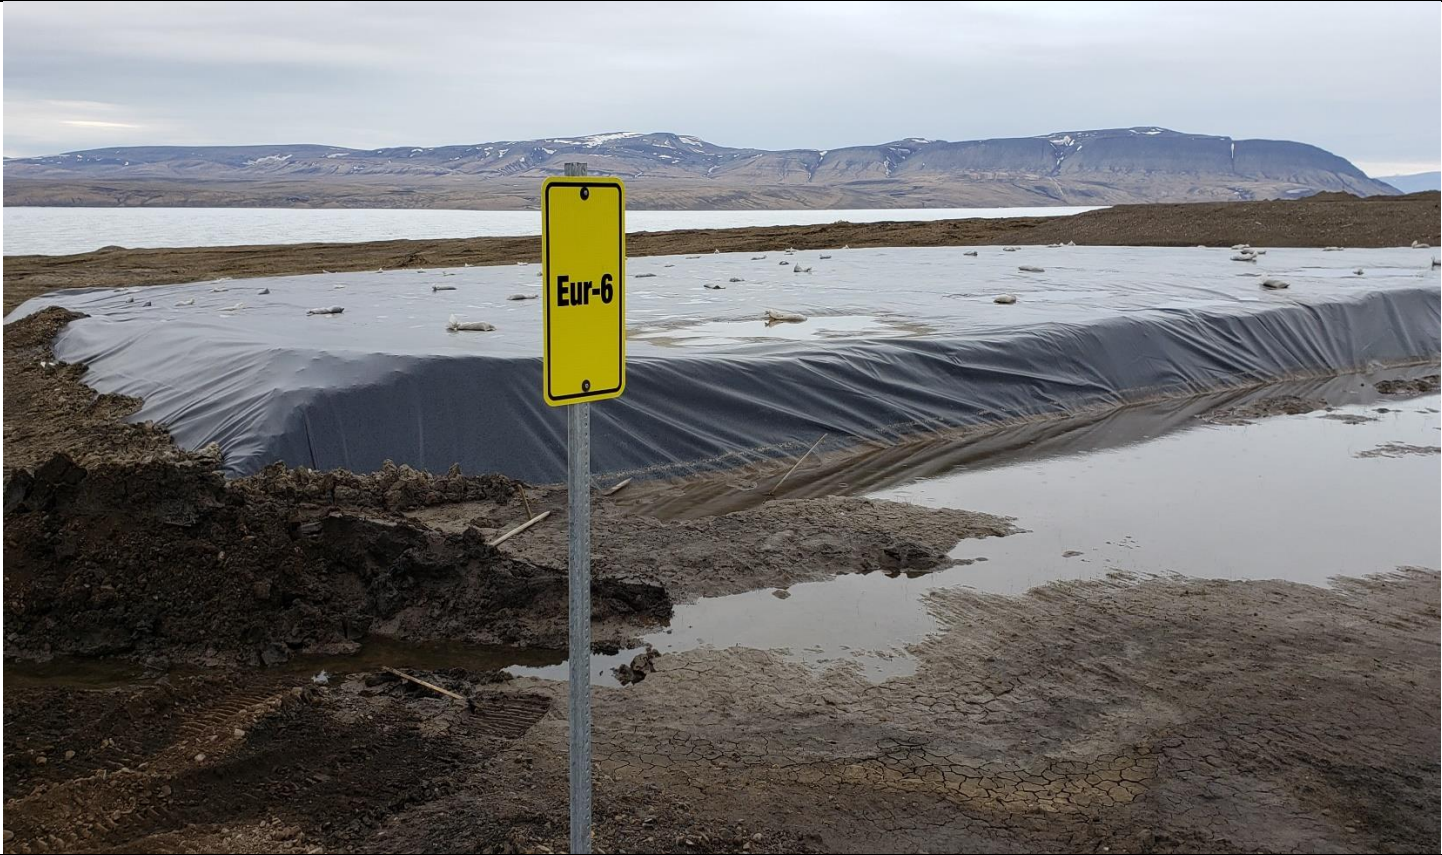
Photo Log #  
Photo 20

18. A monitoring station sign was observed at 1 of the 2 soil remediation farms observed on site (photo 20).
19. No observation of monitoring station sign at the 2<sup>nd</sup> of 2 soil remediation farms observed on site (photo 21).

Description: Monitoring Station Eur-6. Observed at a soil remediation farm.

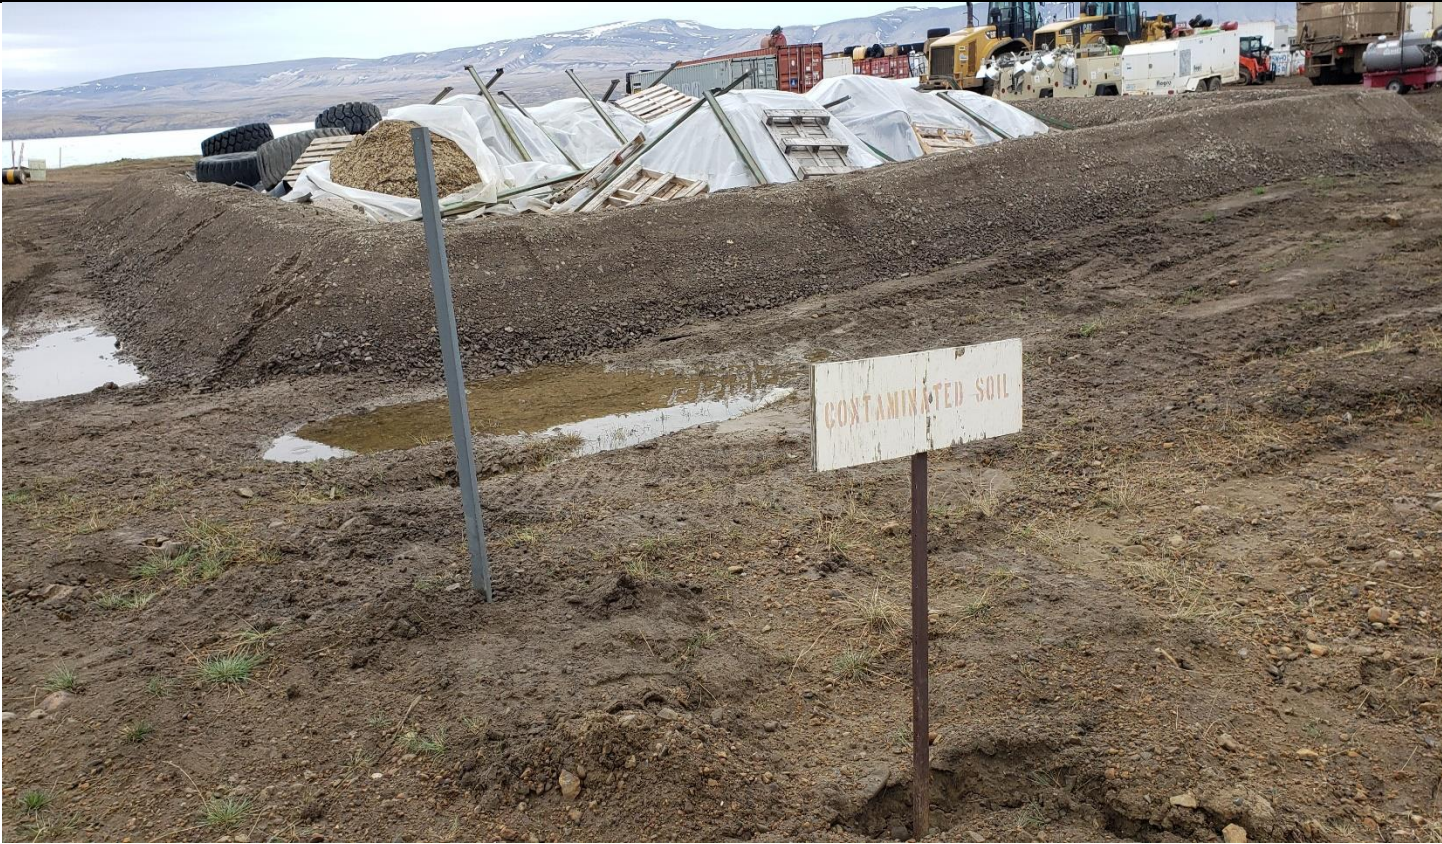
Photo Log #  
Photo 21

Description: Aeration farm for soil remediation. No sign of Monitoring Station sign. Contamination Soil sign observed.

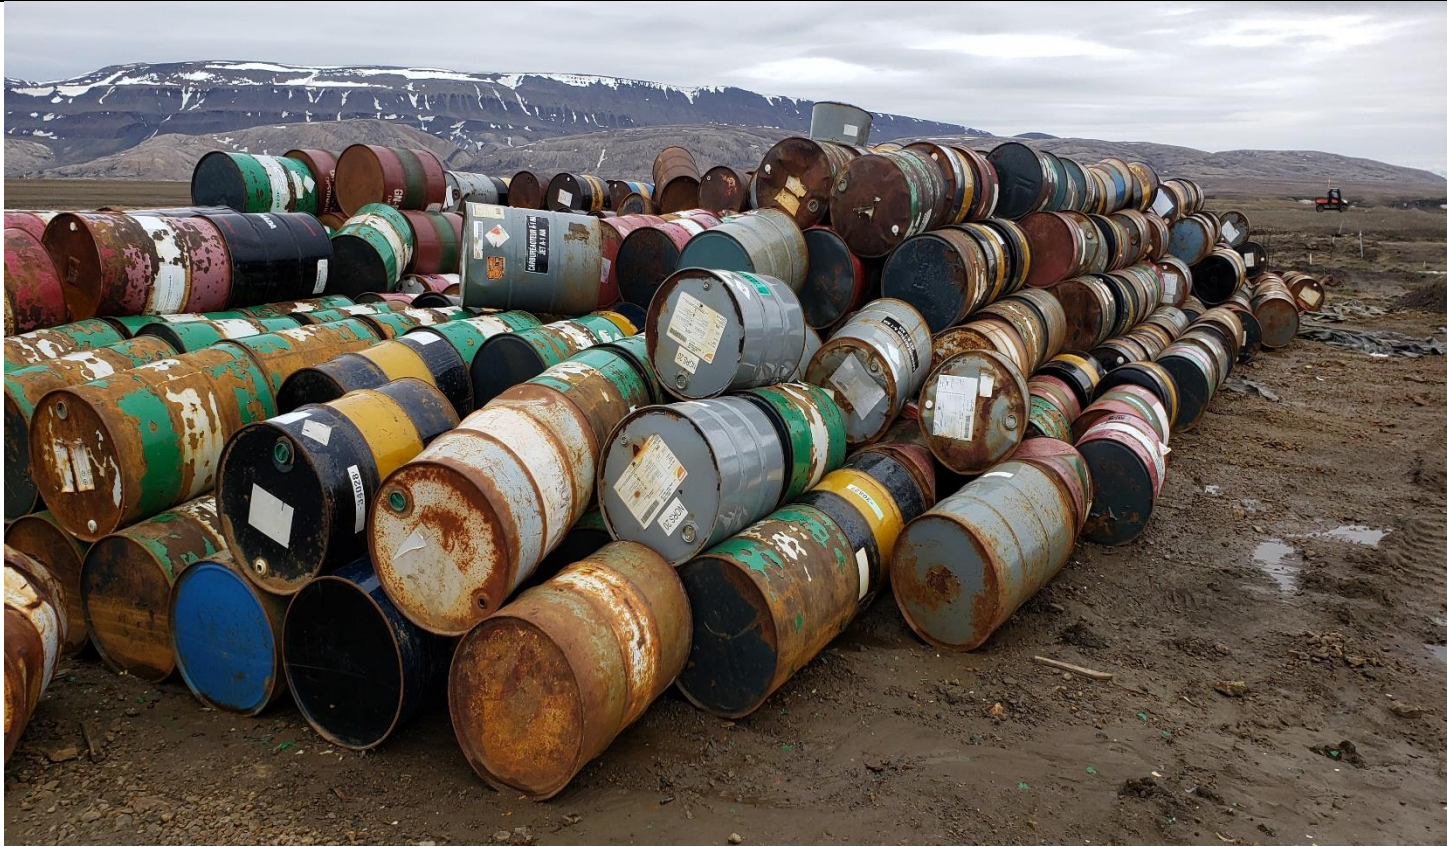
Photo 22

Description: Empty Hazardous Material Storage Drums. In line for washing and crushing.
