WATER LICENCE INSPECTION FORM

Licensee	Licensee Representative
Environment and Climate Change Canada	Jean-Phillipe-Cloutier-Dussault
Licence No. / Expiry	Representative's Title
8BC-EUR2131	Director
Land / Other Authorizations	Land / Other Authorizations
Date of Inspection	Inspector
July 5, 2022	Joseph Monteith
Activities Inspected	
<input checked="" type="checkbox"/> Camp	<input type="checkbox"/> Drilling
<input type="checkbox"/> Roads/Hauling	<input type="checkbox"/> Mining
	<input type="checkbox"/> Construction
	<input checked="" type="checkbox"/> Reclamation
	<input checked="" type="checkbox"/> Fuel Storage
	<input type="checkbox"/> Other: Water Storage
	<input type="checkbox"/> Other: Waste Disposal

On July 5, 2022 at 10:35am, a Water Licence Inspection was conducted by Water Resource Officer (WRO) Joseph Monteith at Eureka, Ellesmere Island, Qikiqtani Region, Nunavut, for water licence 8BC-EUR2126.

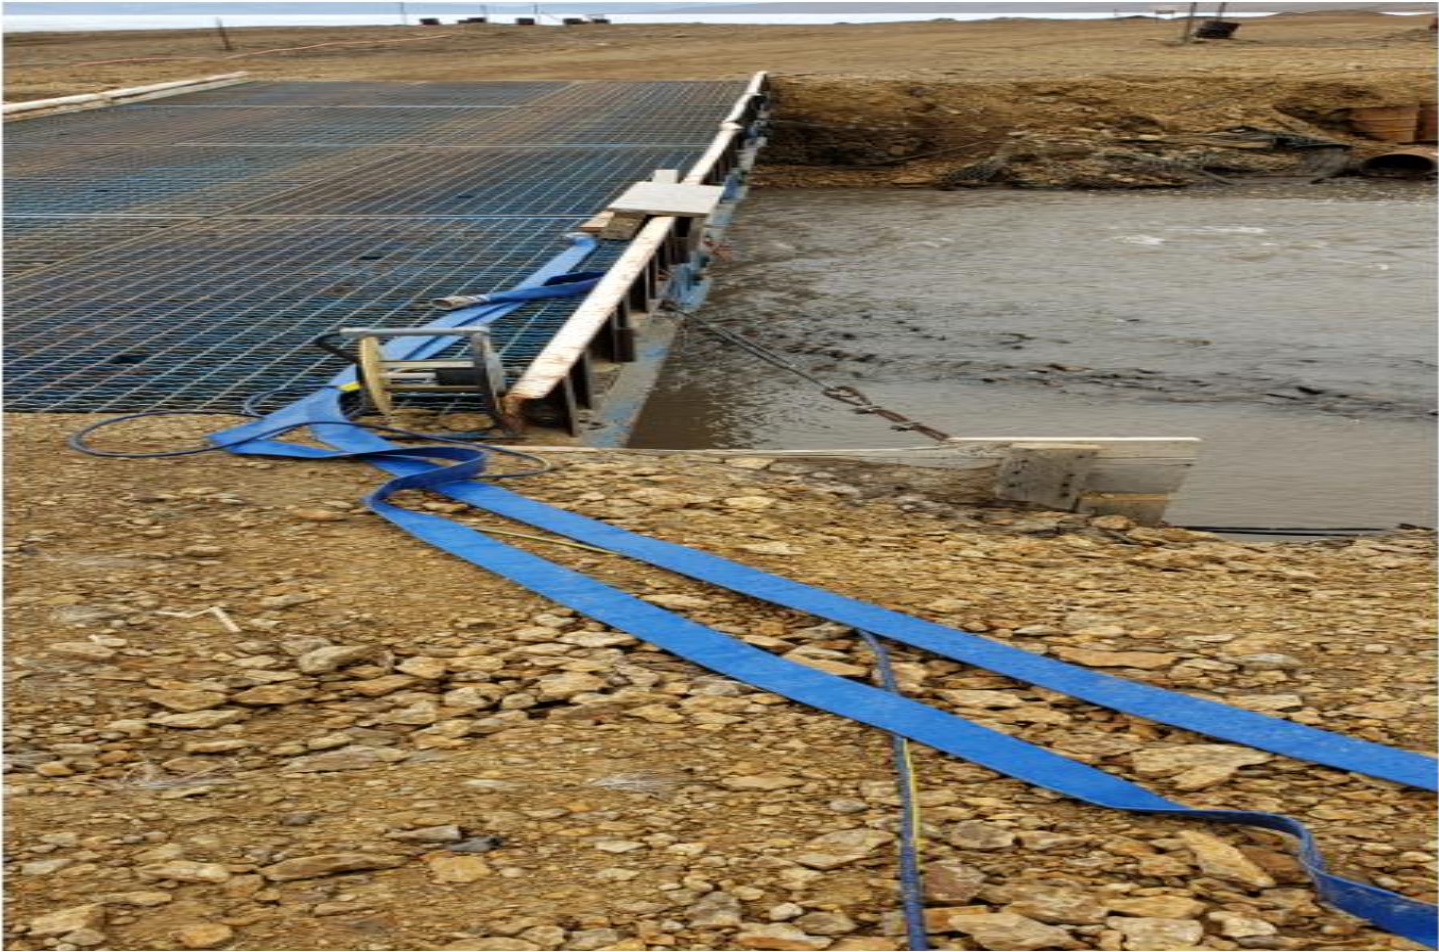
Date	Camera	Inspector	
July 5, 2022	Nikon Cool Pix	Joseph Monteith	
Photo Log #	Location		
Photo 1	Eureka, Ellesmere Island

Description: Bridge at Creek stream. Water is withdrawn from within milk crates, covered with a fish mesh screen(photo 2) to reduce the intake of soil and fish into the pump, and as per regulation.

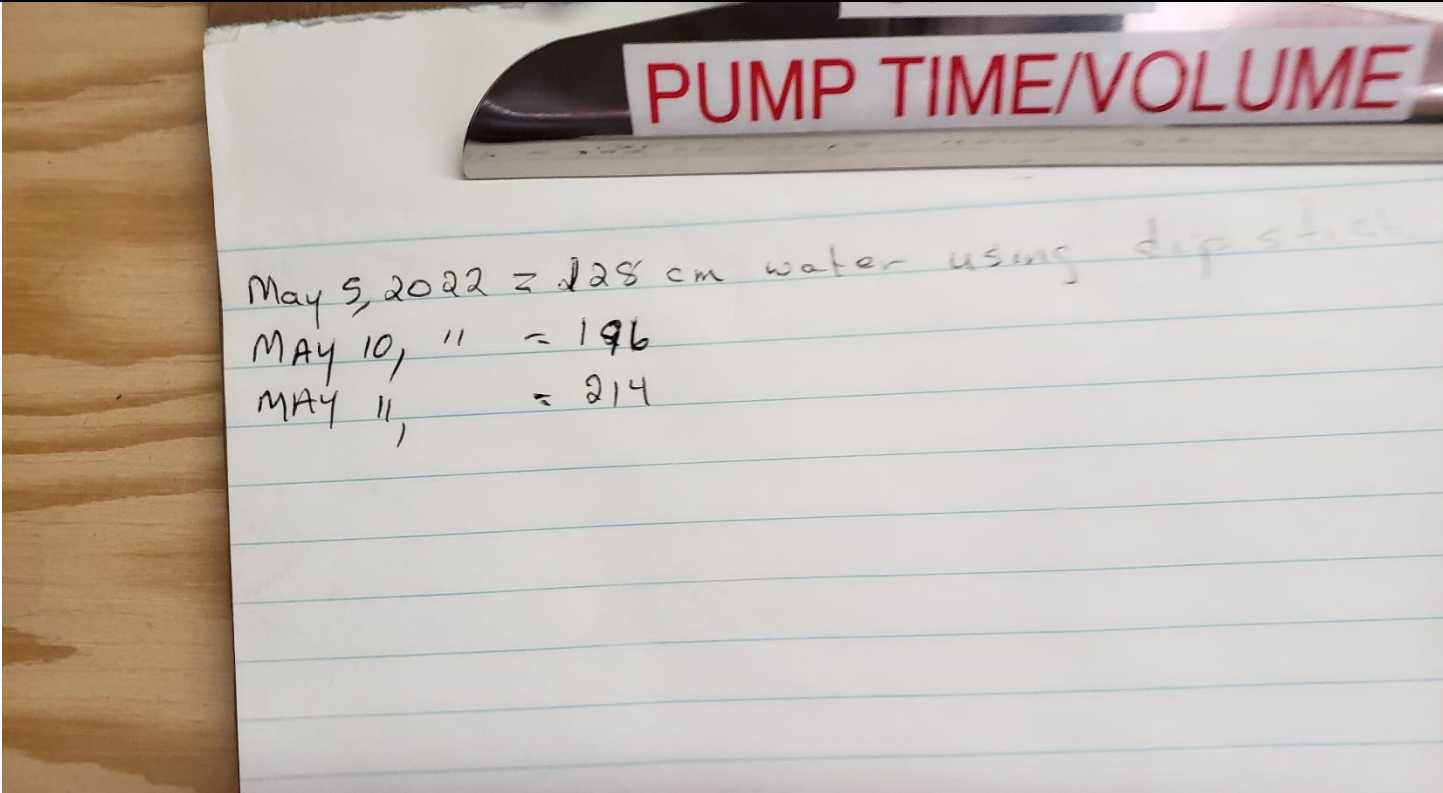
Photo Log #	Location
Photo 4	Eureka

3. Water usage Logs was observed in the pump house (photo 4).
4. Jean-Phillipe-Cloutier-Dussault, ECCC, emailed WRO Monteith a copy of Eureka ECCC’s Water Consumption Records showing a total of 1739.9m³ consumed between January 1, 2022, and October31, 2022.

Description: Water reservoir pump house. From reservoir to buildings. No sign of water meter. Water depth appears to be measure.

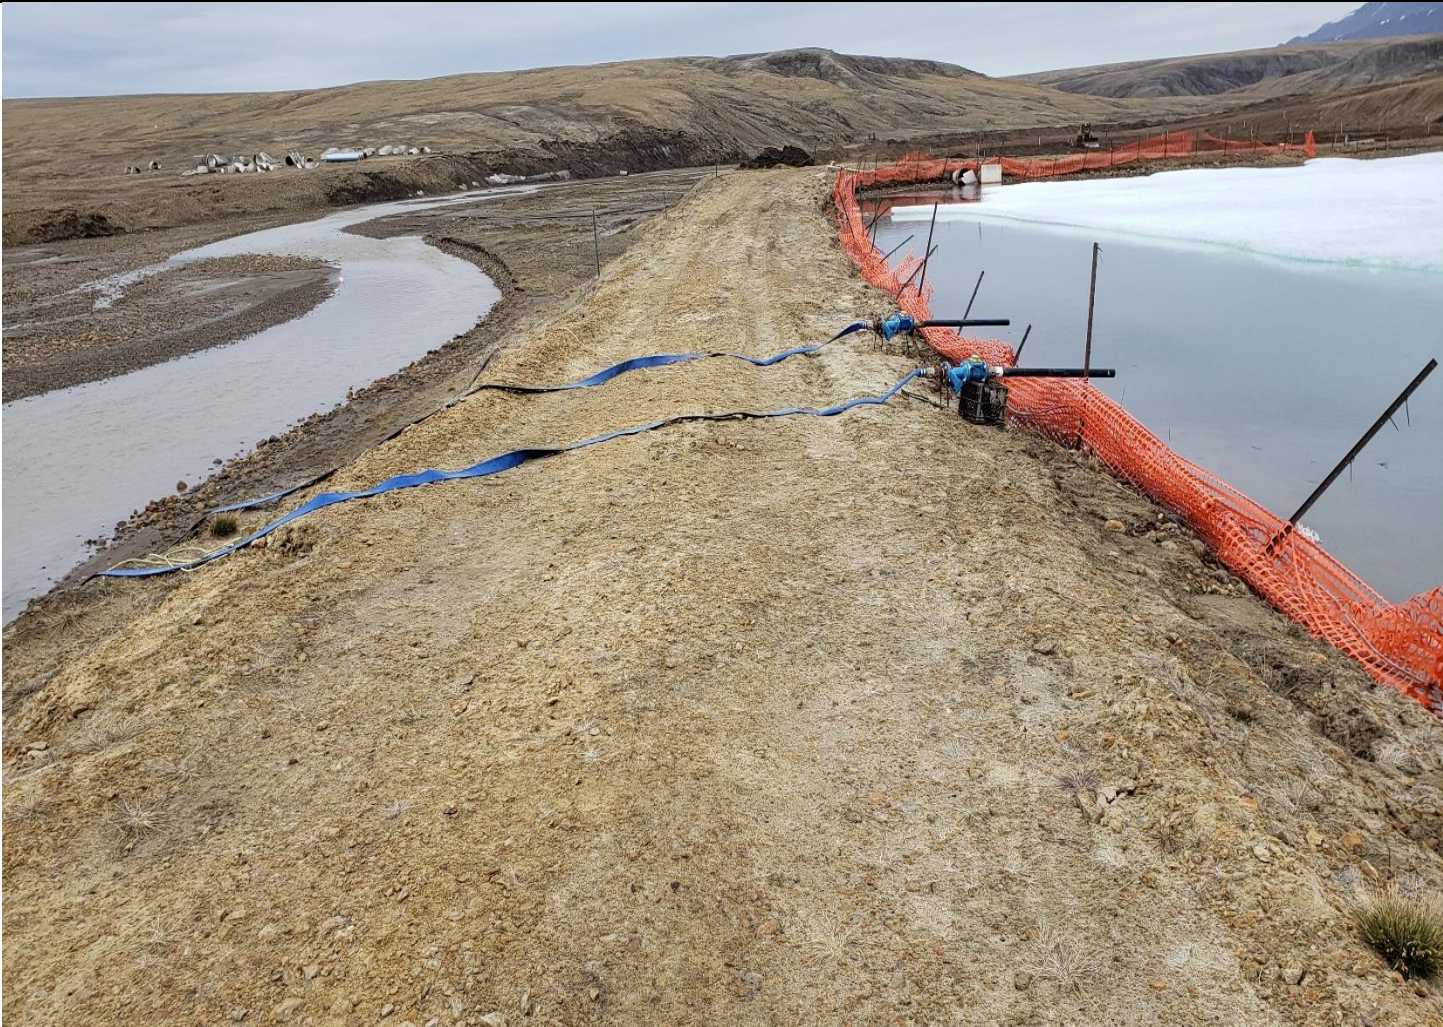
Photo Log #
Photo 5

Description: Water reservoir recharge location for 2022. Some parts of the reservoir was less than 1 metre freeboard. Water meters on pump.

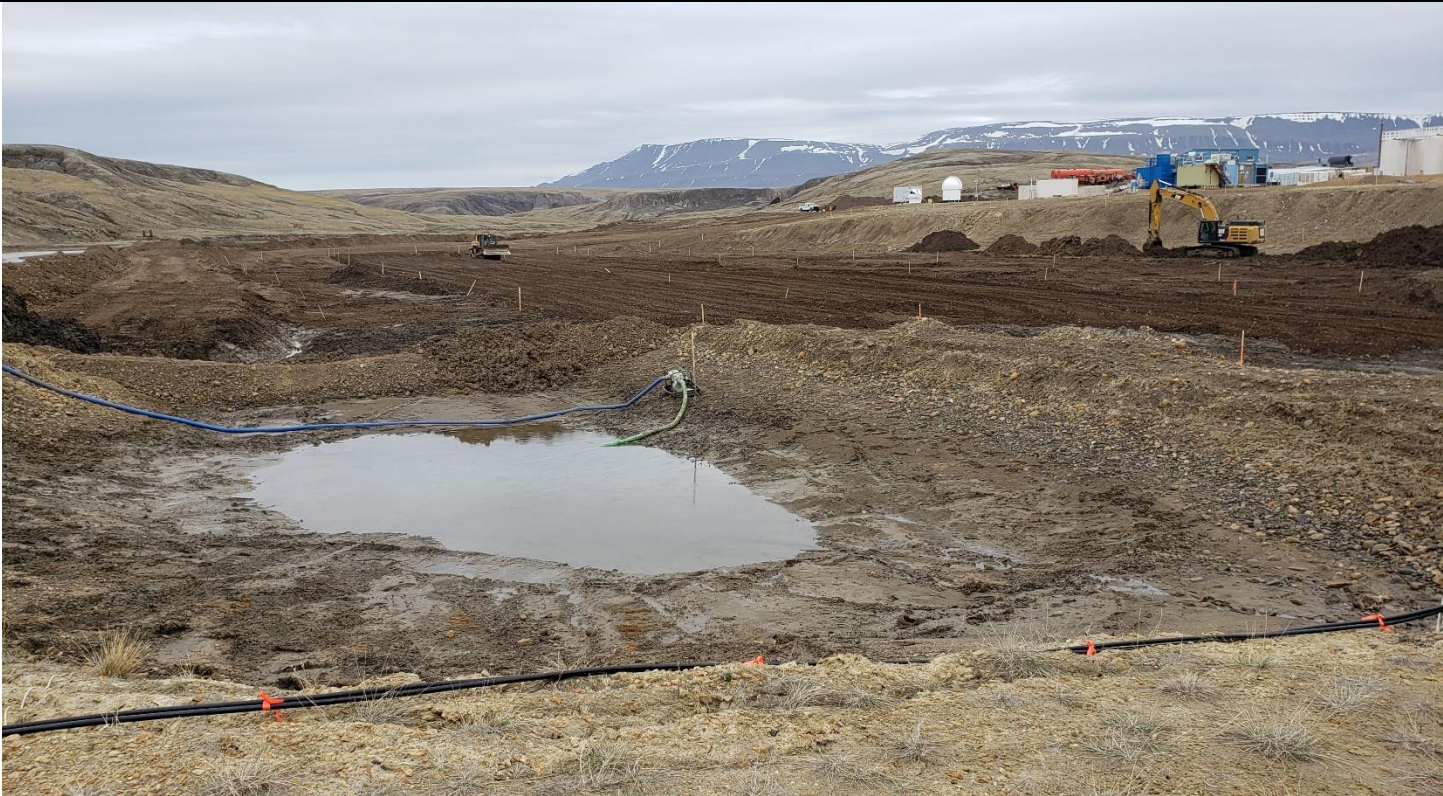
Photo Log #
Photo 6

Description: At the time of the inspection, work was being done to expand the capacity of the water reservoir.

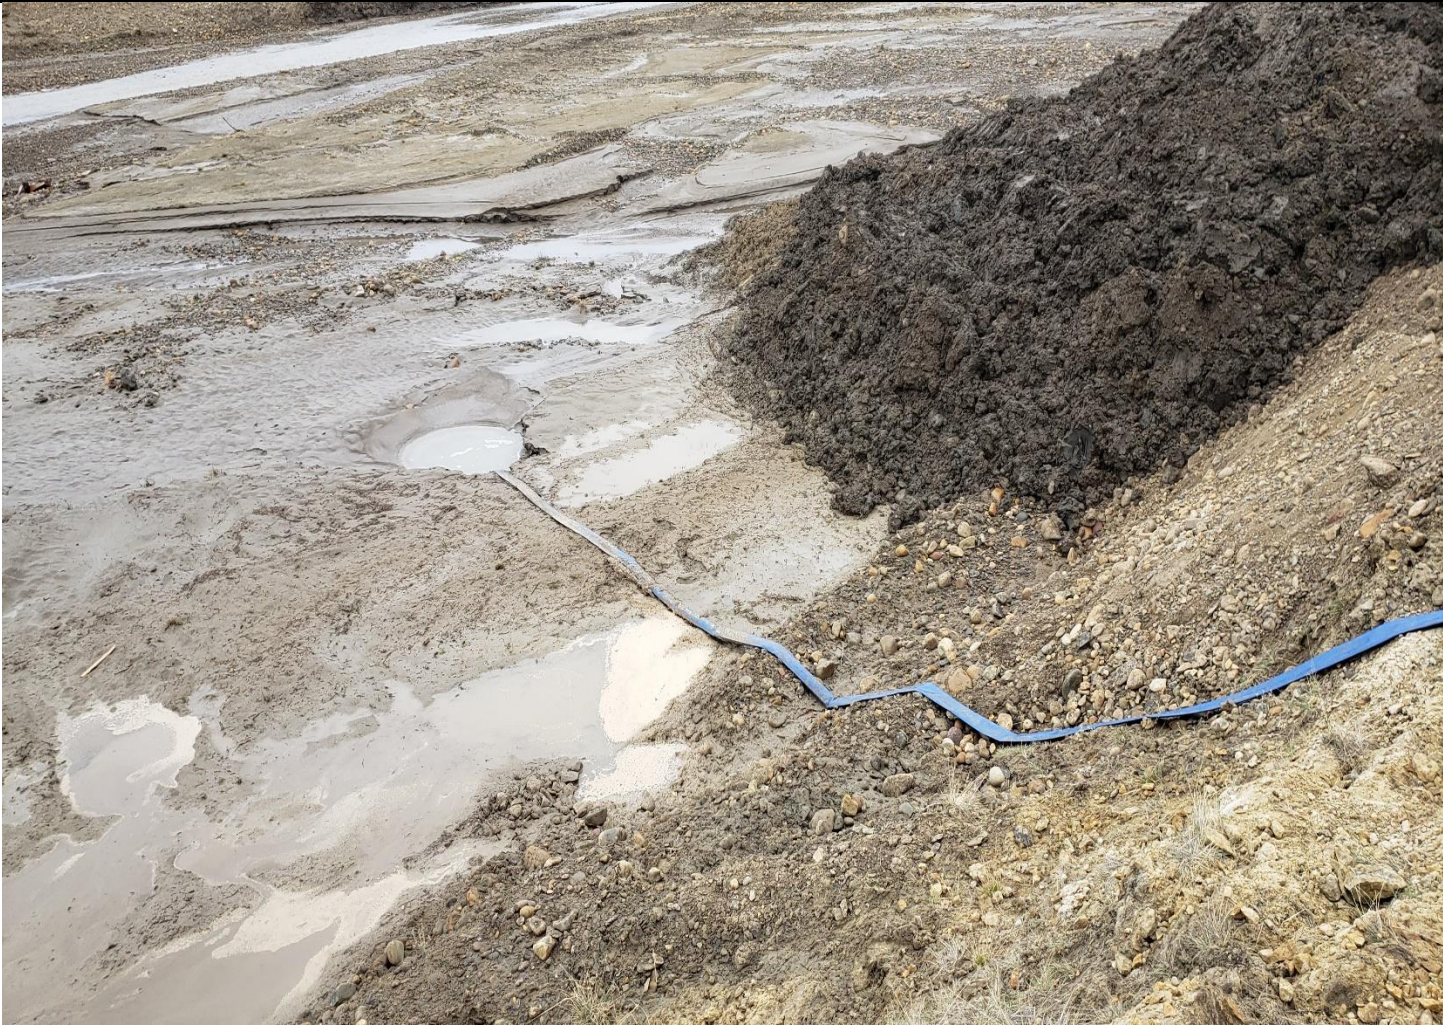
Photo 7

Section 1	<input checked="" type="checkbox"/> Comments	<input type="checkbox"/> Non-Compliance with Act or Licence	<input type="checkbox"/> Action Required
<ul style="list-style-type: none">• During the expansion of the water reservoir it was observed that water was pumped out of the expansion site, and wet soil was laid down to form up the walls. I’ve added the action required to install silk fencing to mitigate the potential of sedimentation, since the activity is within the high water mark of the river.

Description: Wet loam observed. install silt fencing to mitigate the potential for sedimentation in the river. River at low mark in the top right background. Sedimentation observed along the base of the newly laid reservoir walls, within the high mark of the river. No direct observation of sedimentation into the river.

SECTION 2	<input type="checkbox"/> Comments	<input type="checkbox"/> Non-Compliance with Act or Licence	<input checked="" type="checkbox"/> Action Required
Install silt fencing between the expansion of the water reservoir construction, and the river.

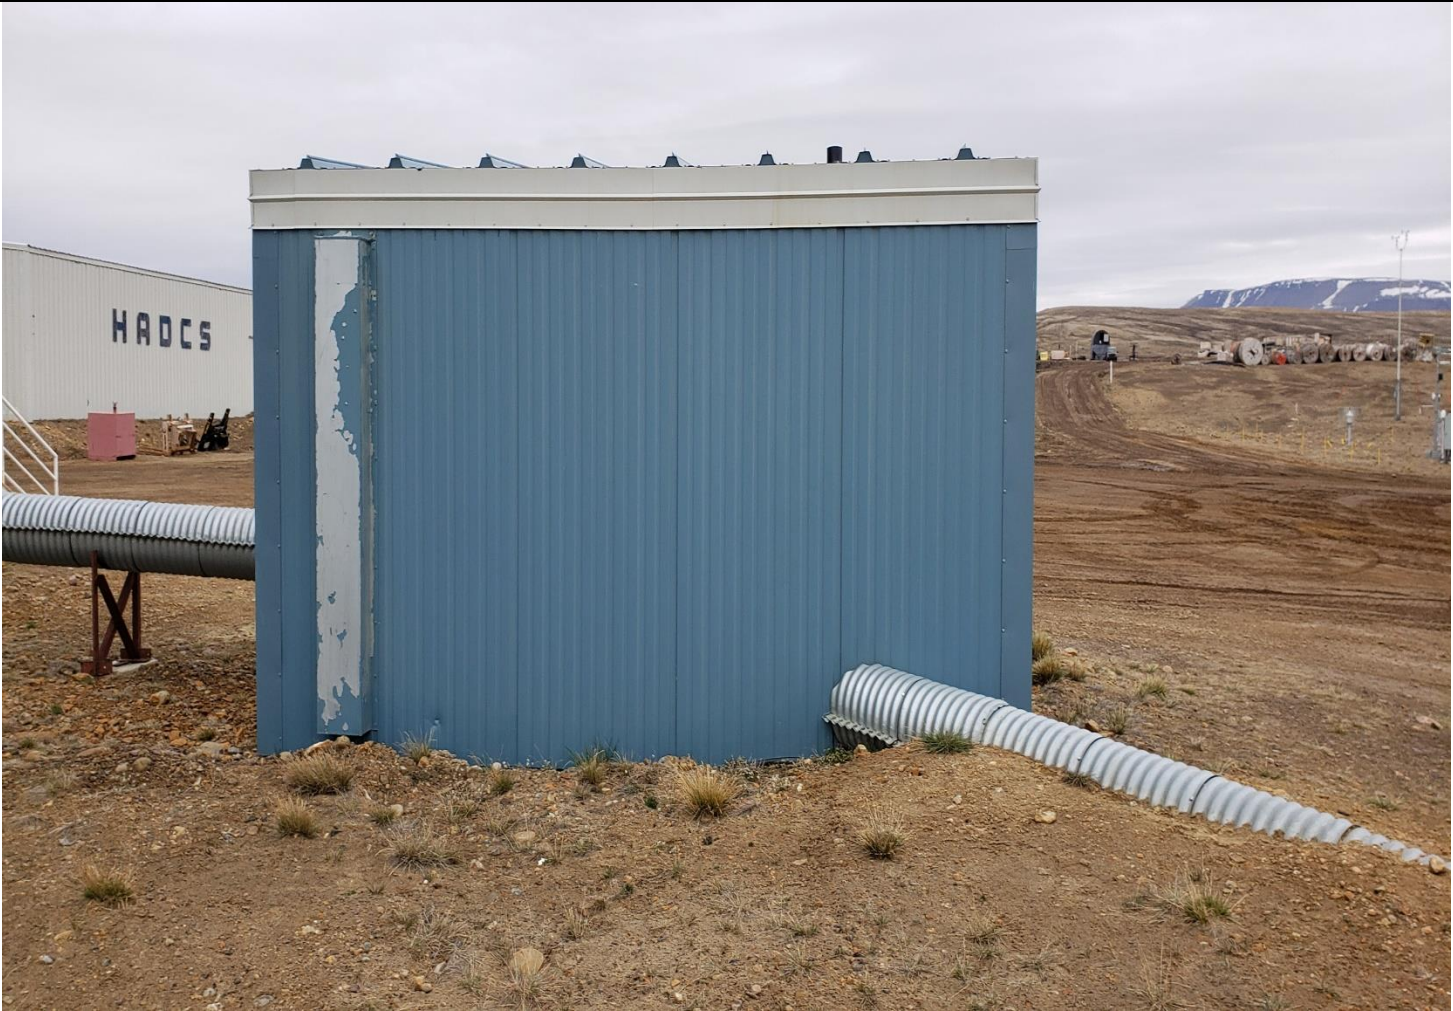
Photo 8

Description: liquid waste, and solid was exit the accommodations, and office building into the sump tank building.

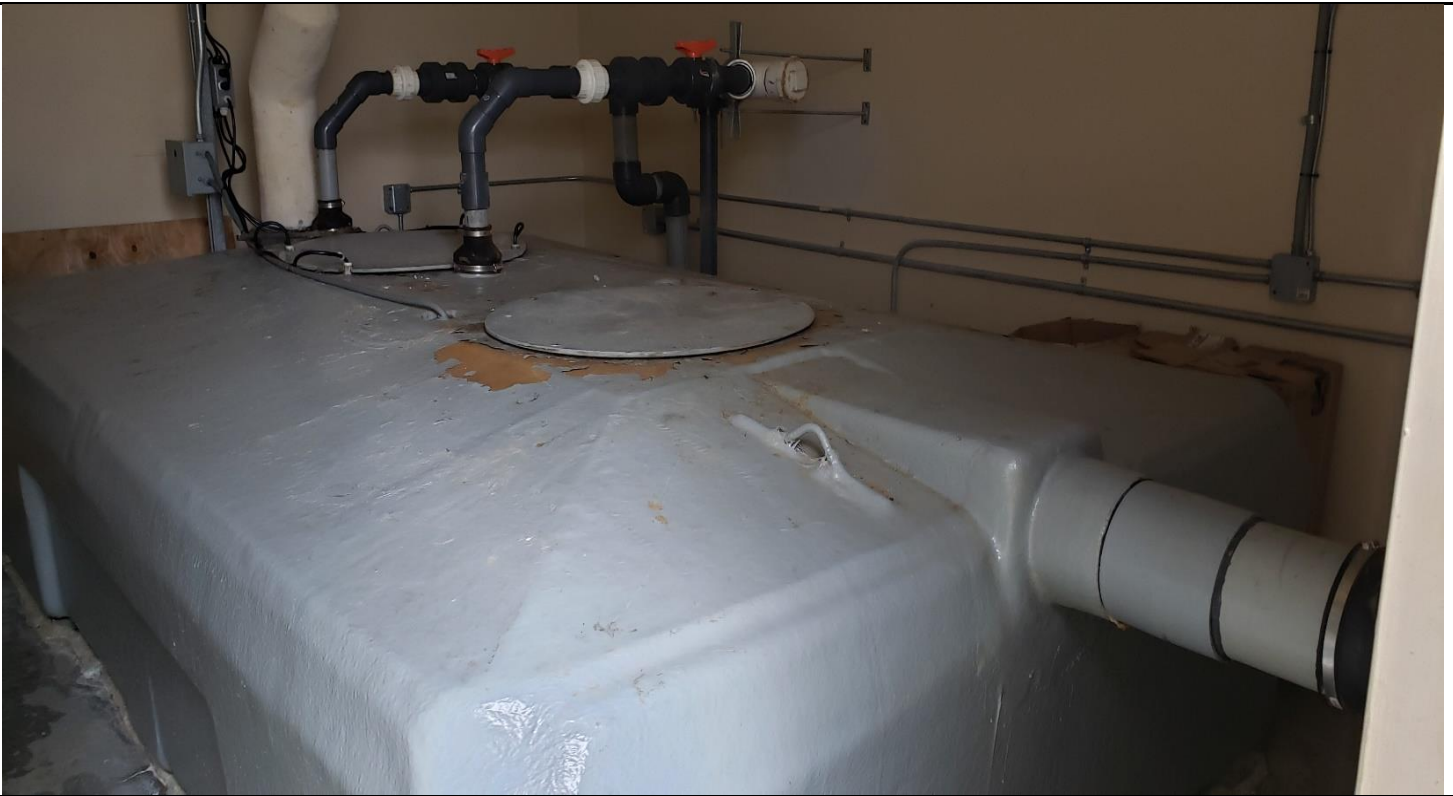
Photo 9

Description: Sump tank, before being discharged to the sewage lagoon.

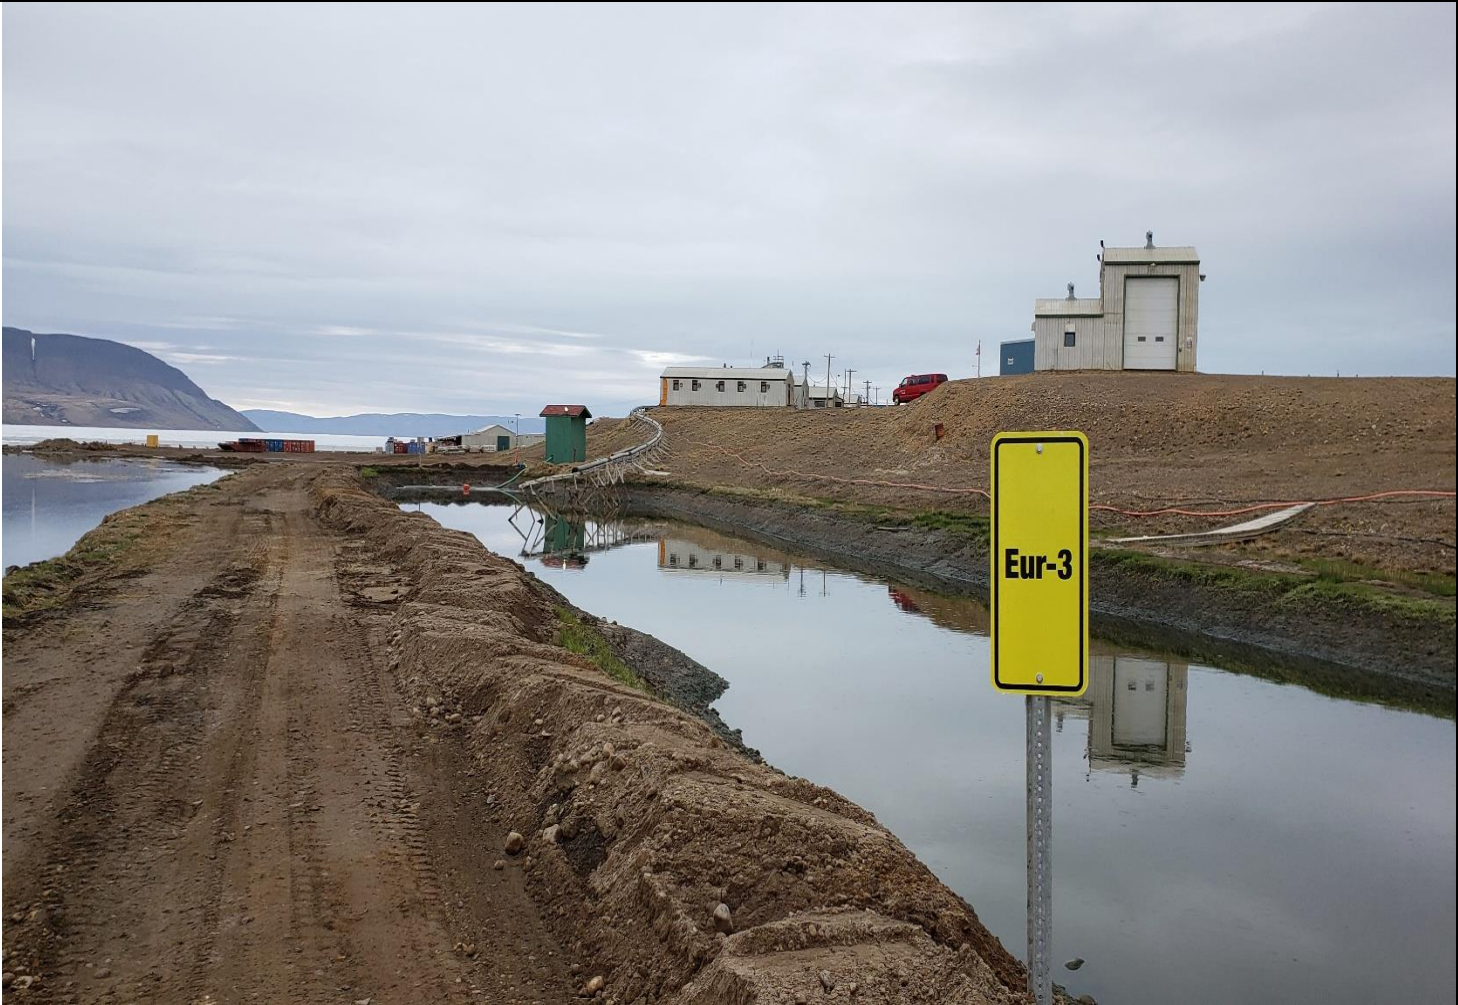
Photo 10

Description: Eur-3 monitoring station. sewage lagoon fills up by pipe, and trucks.

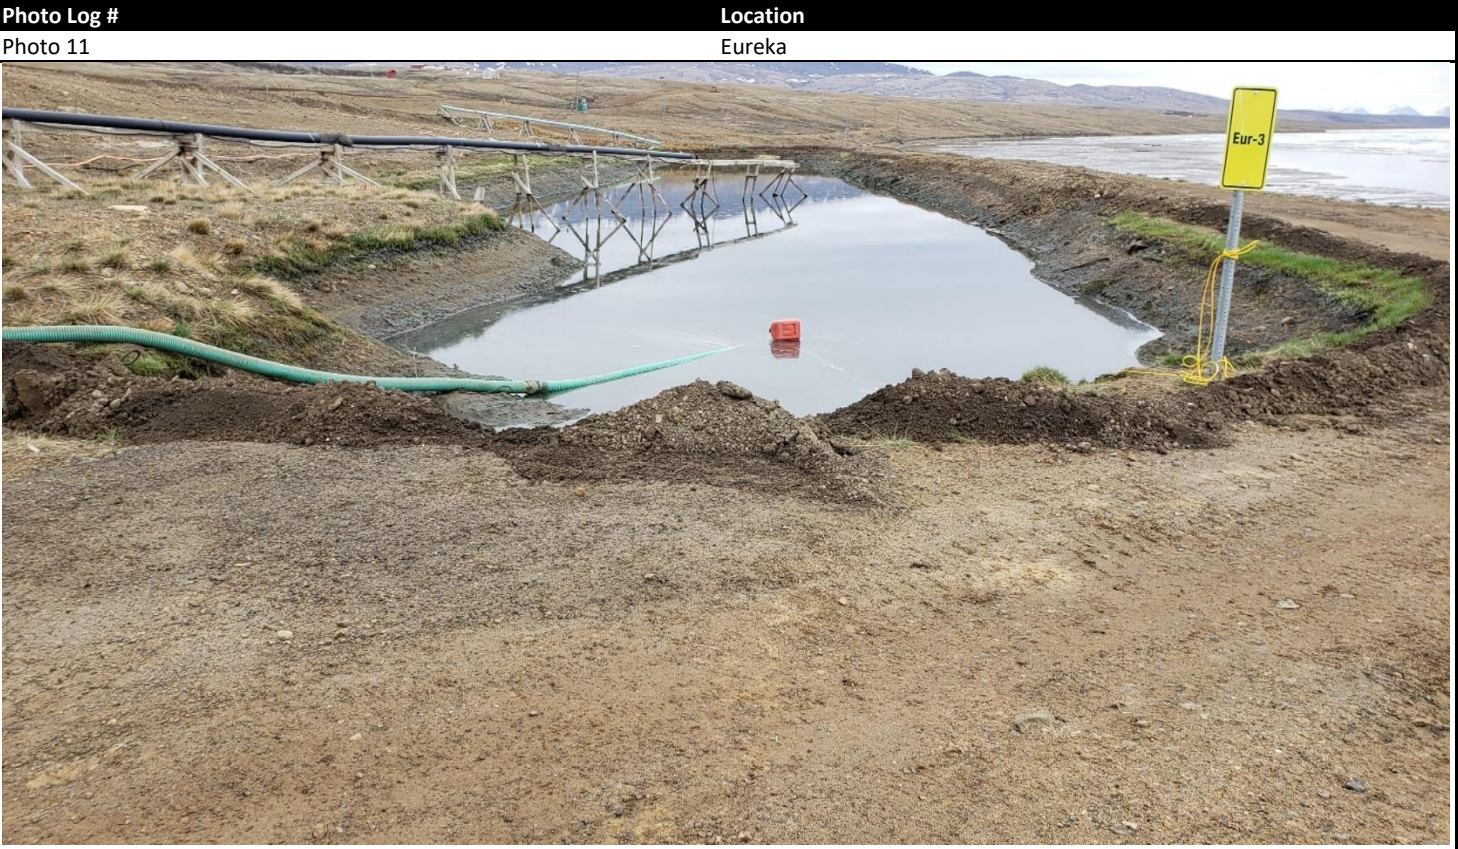
Description: Site where erosion and slumping on the walls of the sewage Lagoon/road was observed in 2019, was repaired. Eur-3 monitoring station observed.

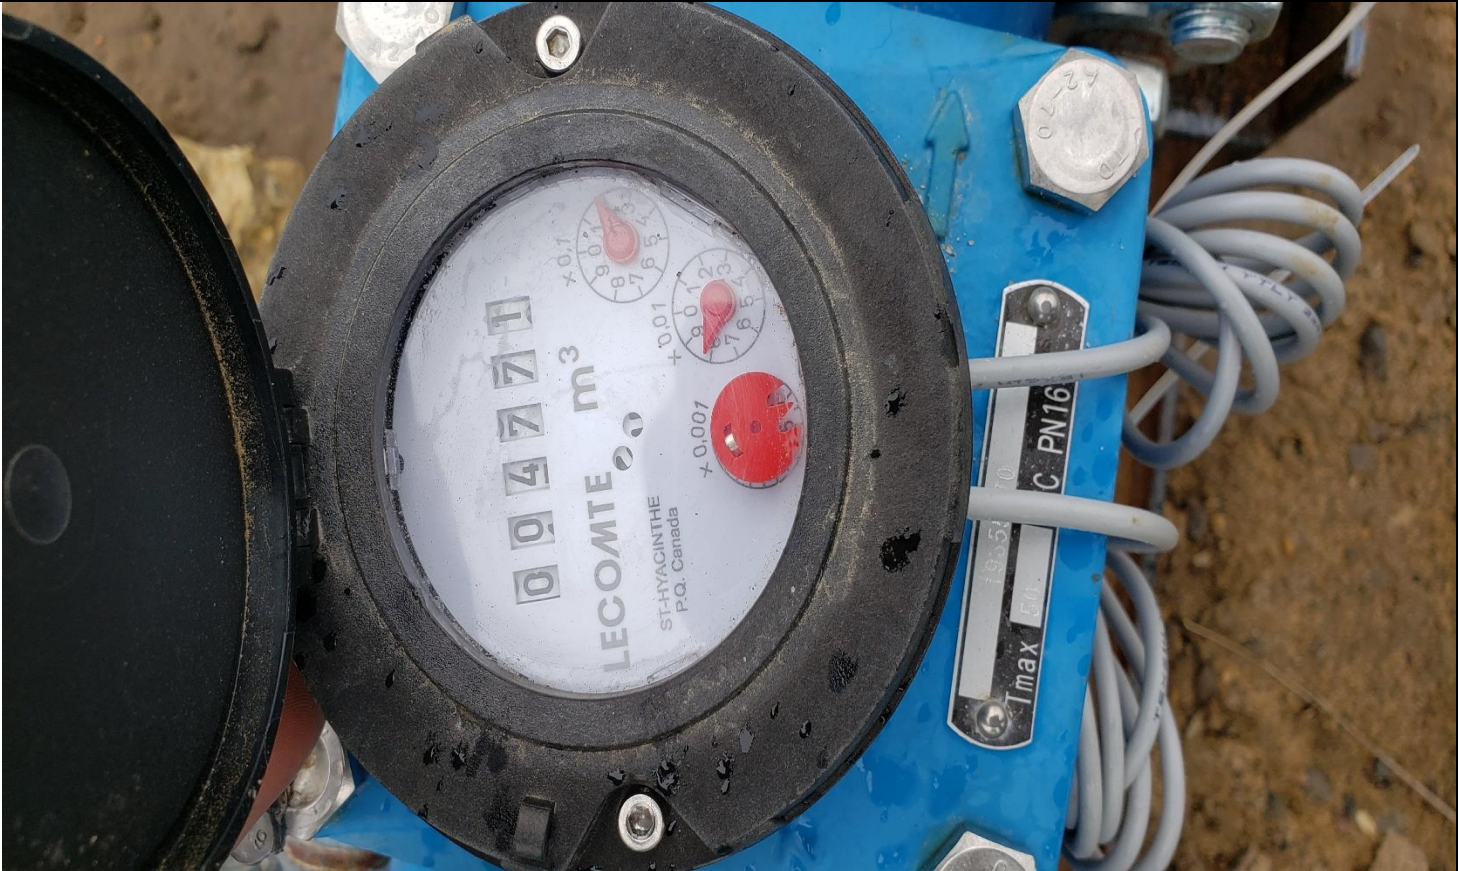
Photo Log #	Location
Photo 12	Eureka

Description: Flow Meter observed on site for decanting sewage lagoon. Lecomte Meter says 4771m³.

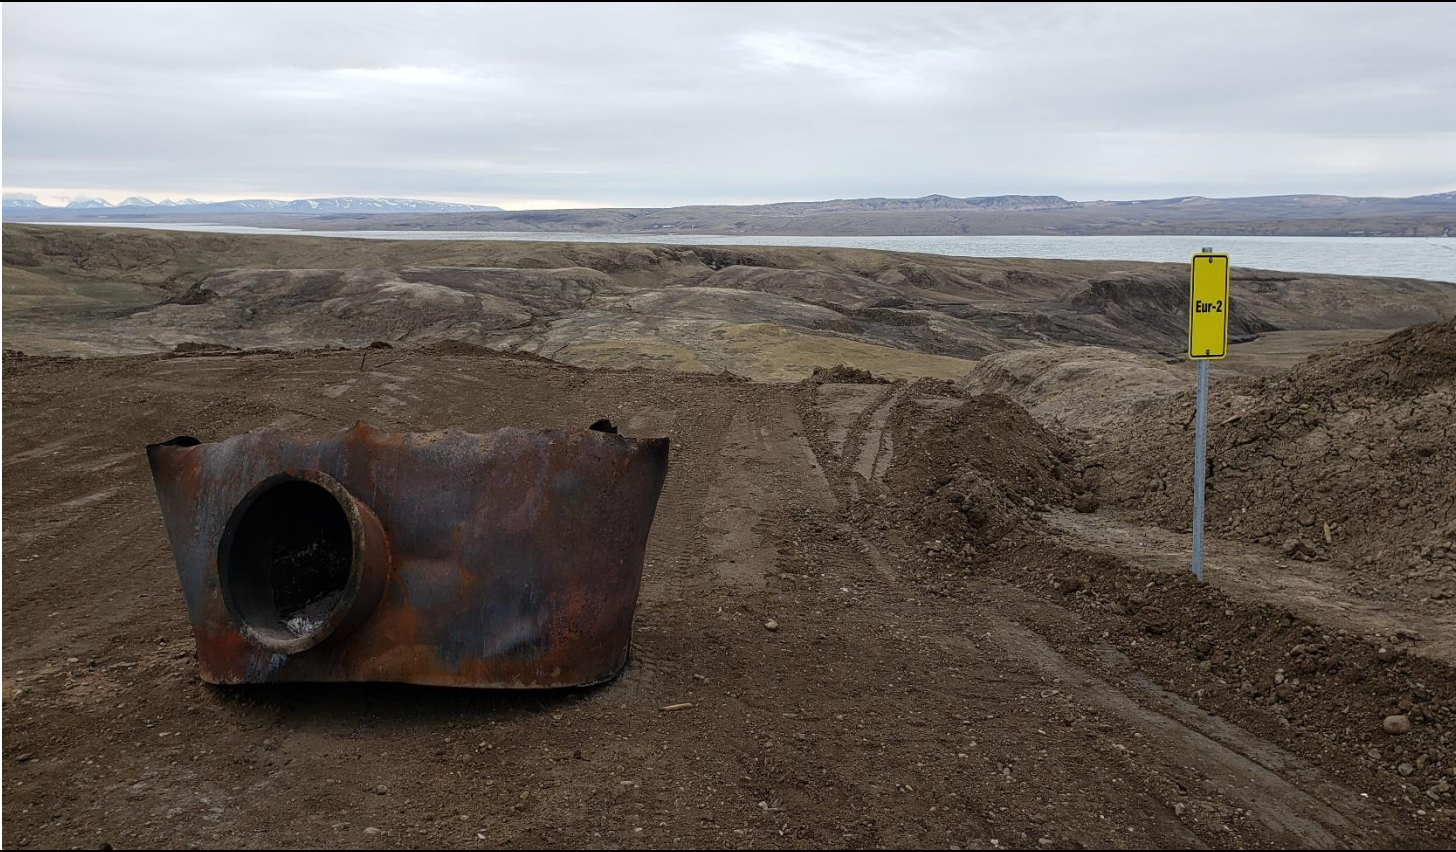
Photo Log #	Location
Photo 14	Eureka

Description: landfill, burn and cap. Solid waste is pushed off the left hand side of the sign, and capped with gravel. EUR-2 is observed as the monitoring station.

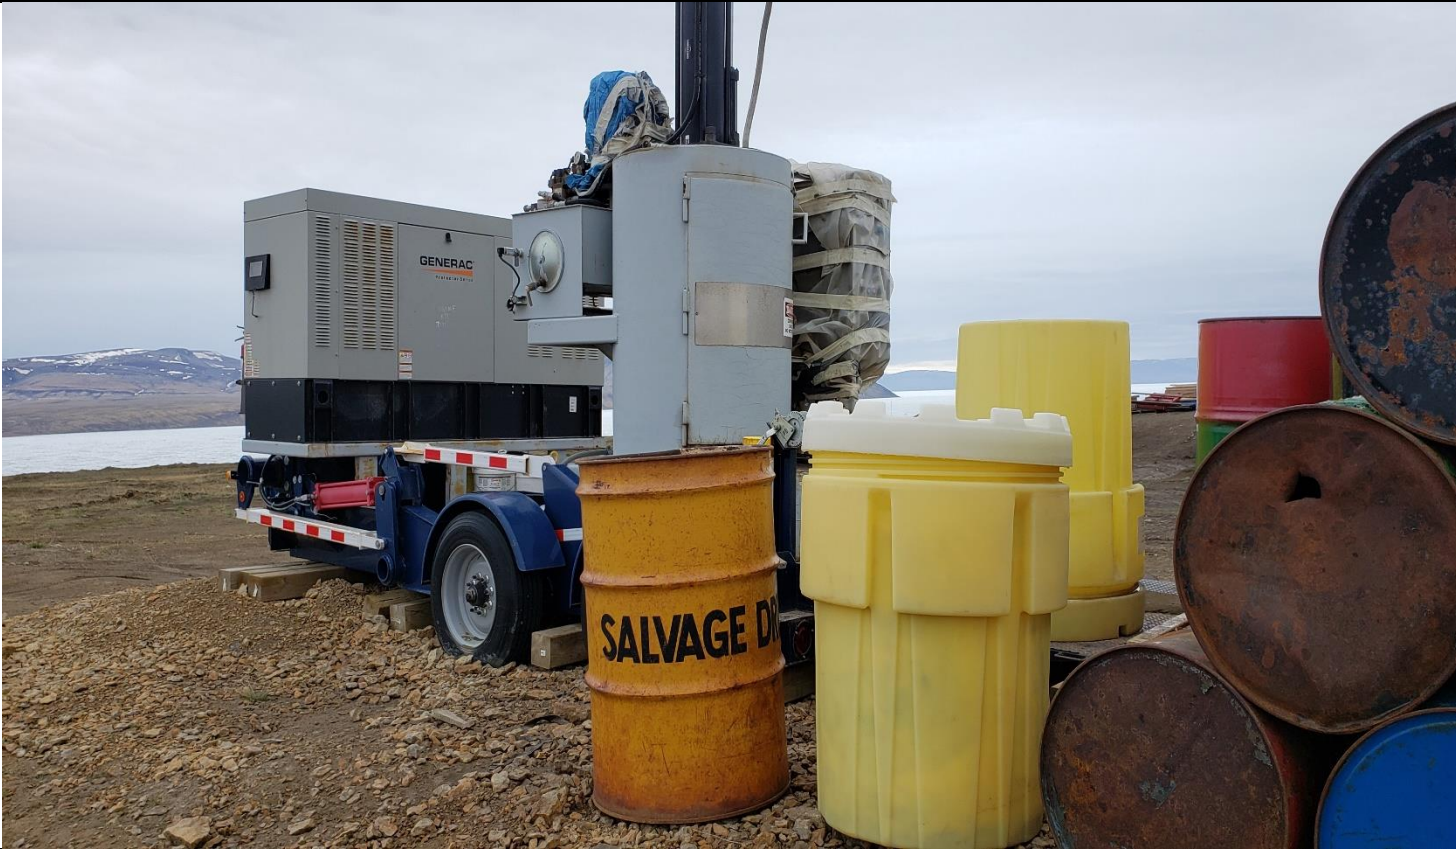
Photo Log #
Photo 15

Description: Drum washer and crusher. After washing a drum, it is suitable for burial underground.

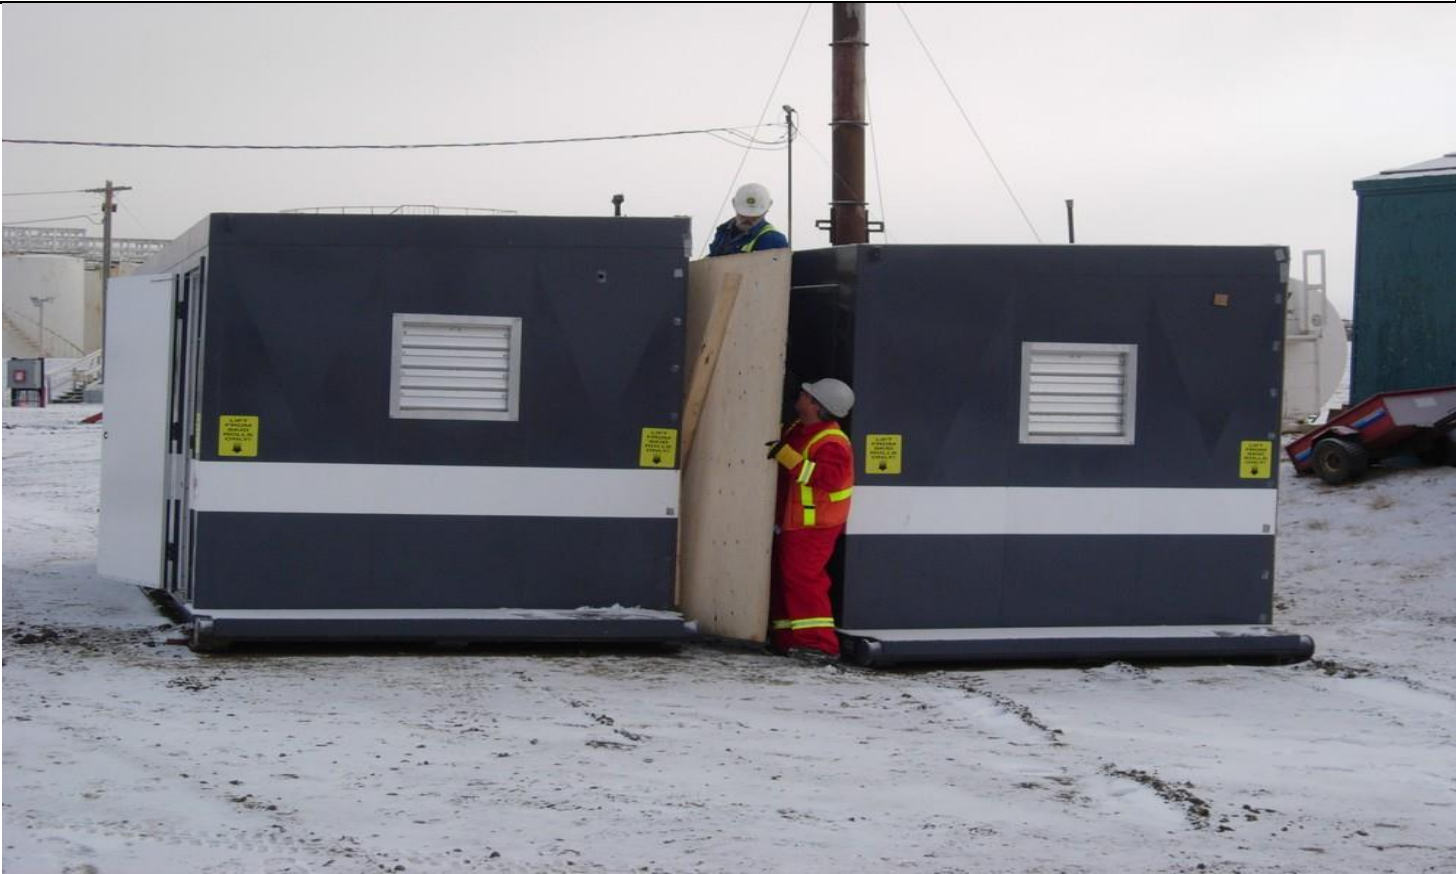
Photo 16

Description: Incinerator building. Photo submitted by ECCC.

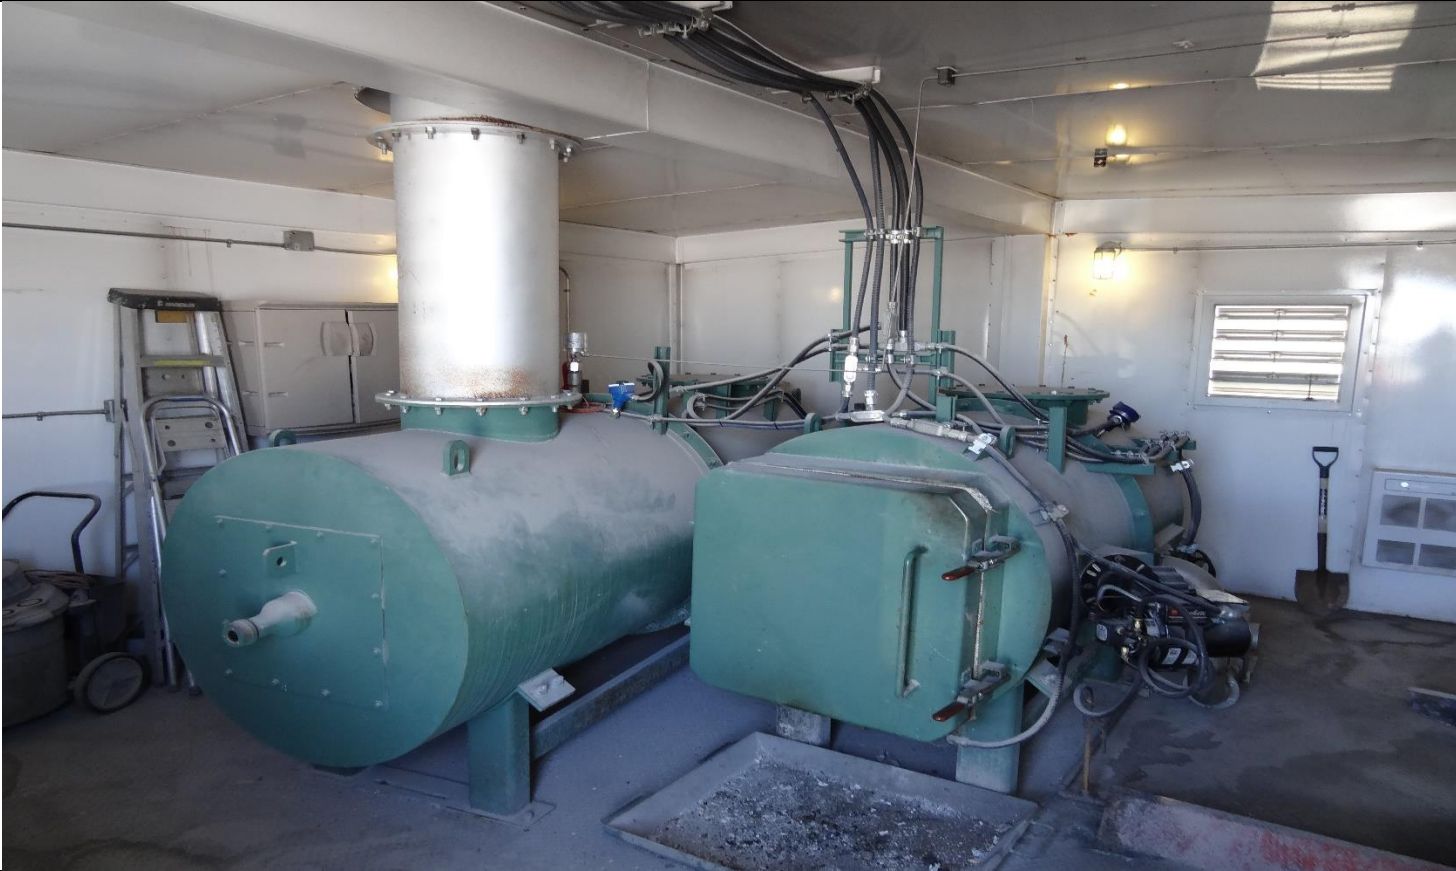
Photo 17

Description: Forced Air Incinerator on site. Photo submitted by ECCC. All waste ash appears to be contained within building.

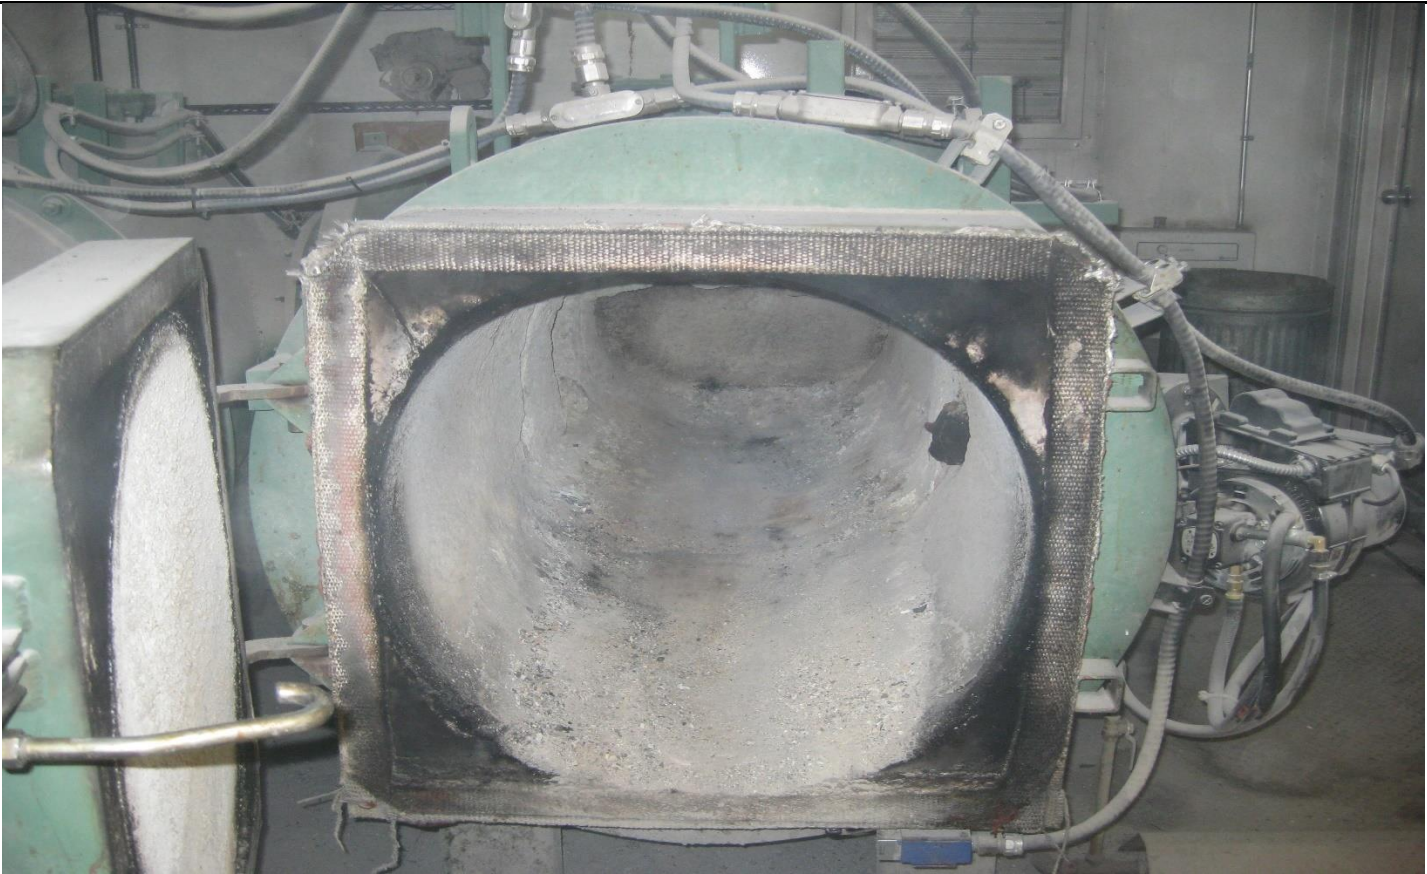
Photo 18

Description: Inside the incinerator. No concerns Photo submitted by ECCC
