Water Licence Inspection Report

Authorization	Representative
Environment and Climate Change Canada	Asif Mohammed
Authorization No. / Expiry	Representative's Title
8BC-EUR2131, April 29,2025	Chief Administrative Officer
Other Authorization/s	
Activities Inspected	
<input type="checkbox"/> Camp, Commercial <input type="checkbox"/> Drilling <input type="checkbox"/> Mining <input type="checkbox"/> Construction <input type="checkbox"/> Reclamation <input type="checkbox"/> Fuel Storage <input type="checkbox"/> Roads/Hauling <input type="checkbox"/> Winter Hauling <input type="checkbox"/> Camp, Private <input checked="" type="checkbox"/> Other ,Potable Water source, Solid Waste facility, hazardous waste facility, Domestic waste/sewage

On July 09, 2023, I, Isaiah James Bolt, Inspector with the Crown Indigenous Relations and Northern Affairs Canada, (CIRNAC and for the purpose of this report hereafter referred as the "Inspector"), Along with Fellow Inspector Joseph Monteith, completed an on site inspection of 8BC-EUR2131.

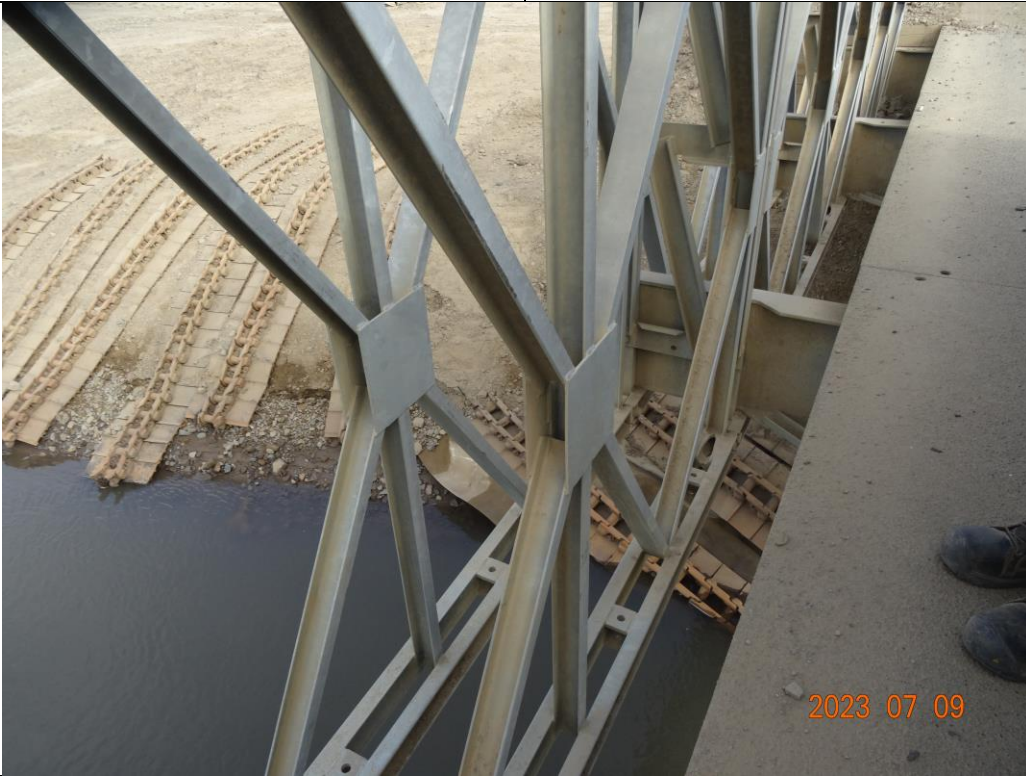
Photo #3

4. At Blacktop creek bridge, inspectors observed installed dozer tracks up stream of the bridge to help mitigate erosion (Photo #2).
5. 3:00pm The Inspectors arrived at West Remus Creek. no concerns with the culverts or erosion mitigation at the time of arrival. (photo #3).

This image shows the upstream side of blacktop creek bridge and the erosion mitigation of the banks. No mesh to stop sedimentation.

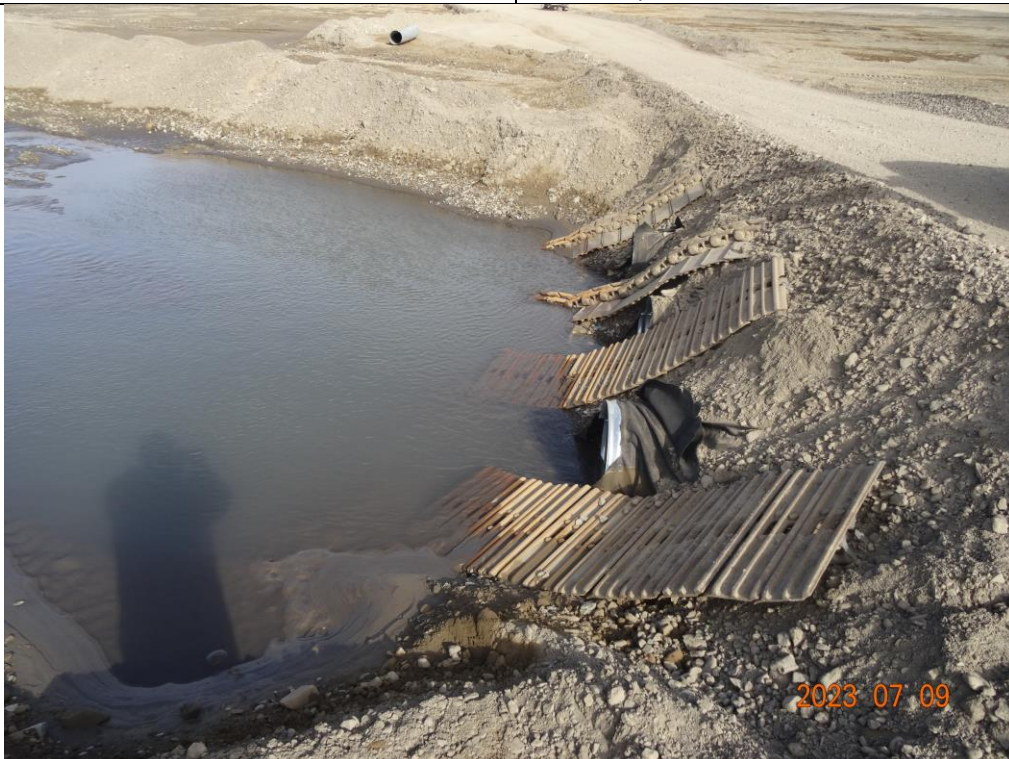
Photo #4

West Remus Creek Erosion control, upstream side of the culverts.

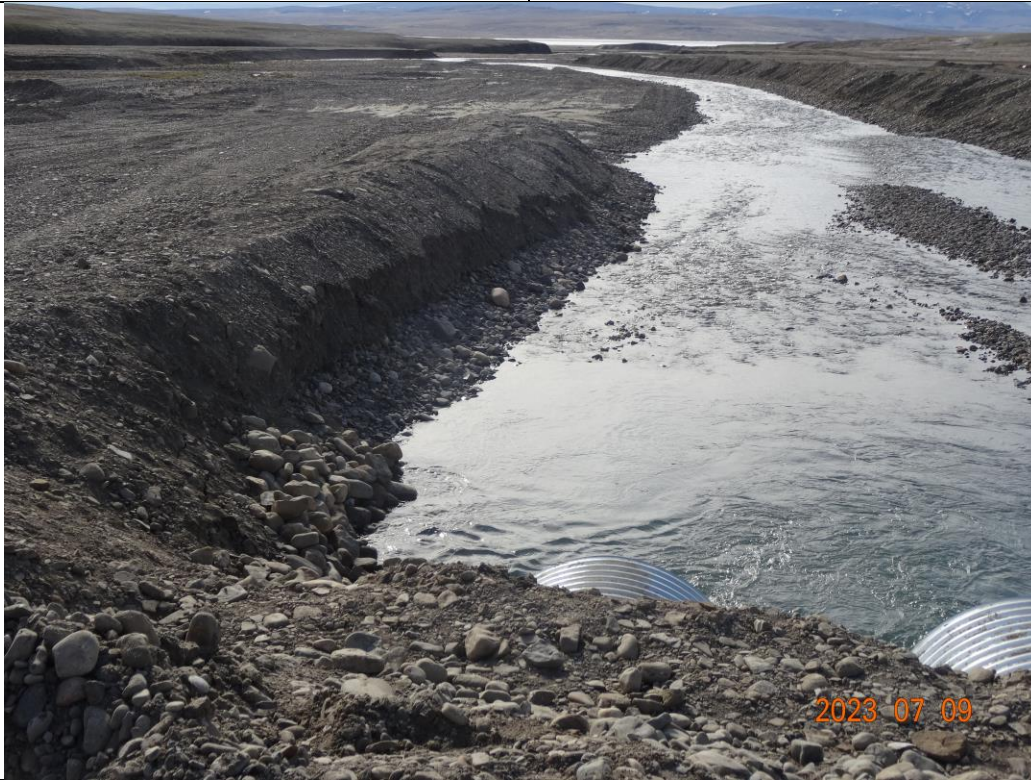
Photo #5

6. 3:08pm The Inspectors arrive at Remus Creek. Inspector BOLT noted that the walls on the down stream side of the culverts were very steep and show signs of erosion at the high water mark (Photo #4). large rocks have been placed at the bottom of the walls to help mitigate erosion. Part C-Subsection 6 of the issued water license states: *"The Licensee shall not cause erosion to the banks of any water body and shall provide necessary controls to prevent such erosion."*

Photo showing downstream of the Remus Creek culvert and the steep walls that have eroded away.

1. Address sedimentation mitigations at Station Creek and Blacktop Creek.
2. Address the erosion of the downstream banks at Remus Creek.
3. Review Part D, Item 5 and Items 6, a-j. of 8BC-EUR2131 to become familiar with open burning conditions.
4. Report all spills to the NWT/NU Spill line.
5. Ensure the end of the effluent lines/decanting hoses are over 31 metres from the high water mark of any water body before pumping. Ensure all effluent parameter quality limits are not in exceedance.

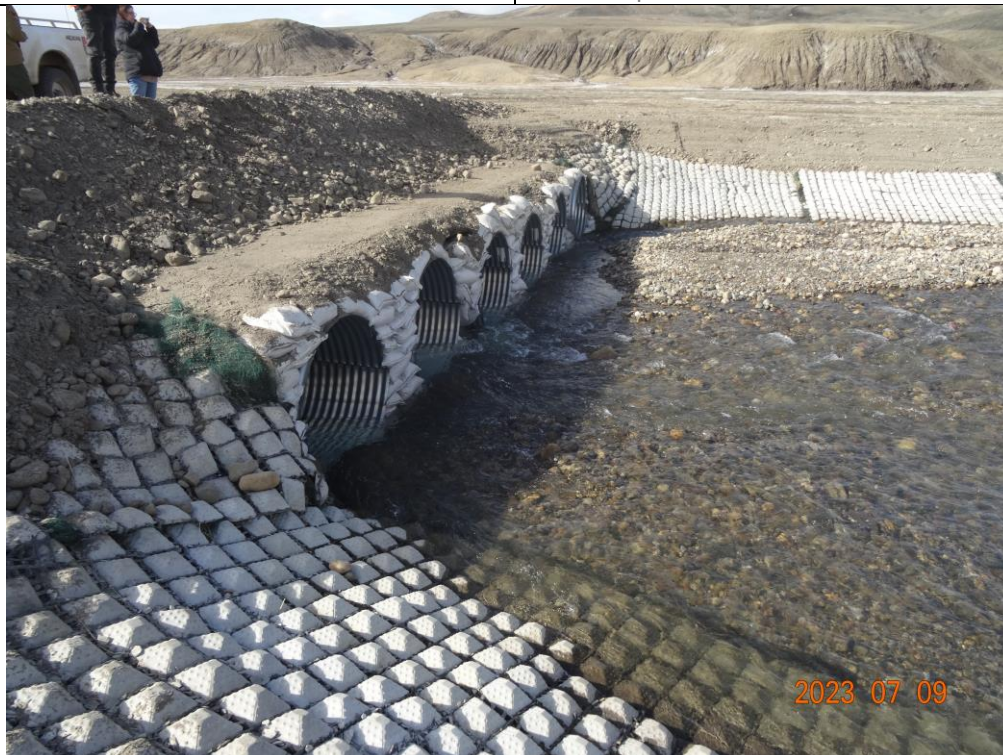
Photo #6

7. Inspector BOLT at Remus Creek observed the erosion control measures on the upstream side of the culverts are very well designed. (photo #5)
8. 3:34pm At the Nuna Logistics storage laydown area: an articulating rock truck was observed with a spill tray underneath. (Photo #6). Upon closer inspection, it was apparent there was staining on the ground. (Photo #7)

Photo shows excellent erosion control on the upstream side of the culverts at Remus Creek

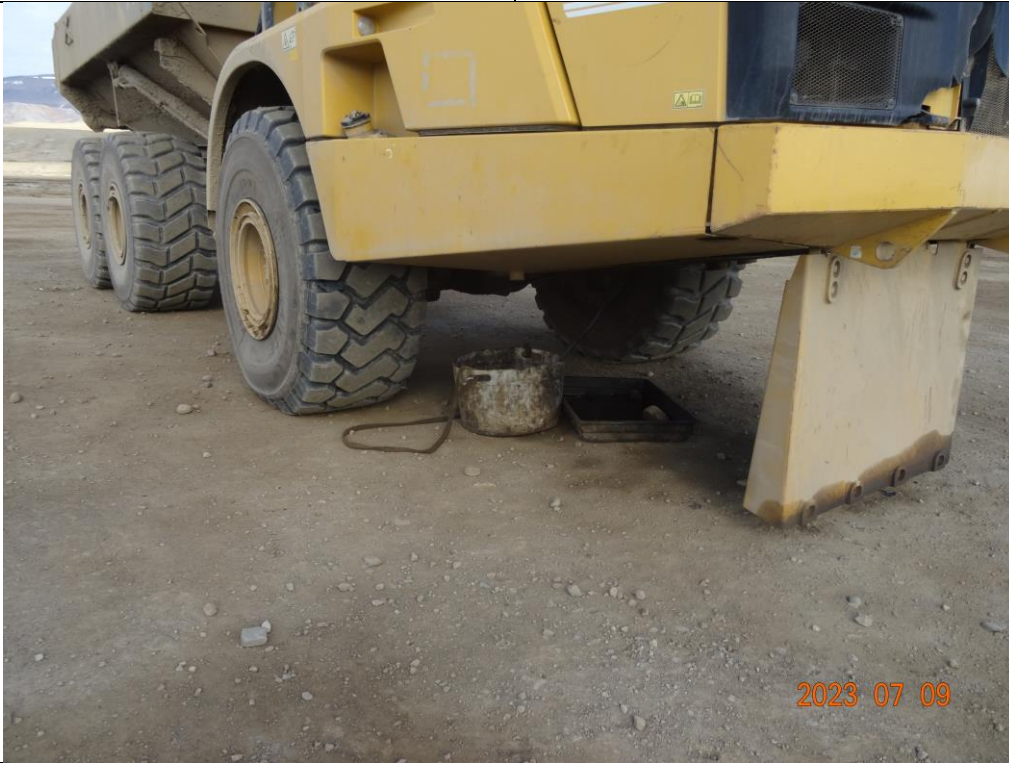
Photo #7

Image shows an articulating rock truck with a leak tray placed under it.

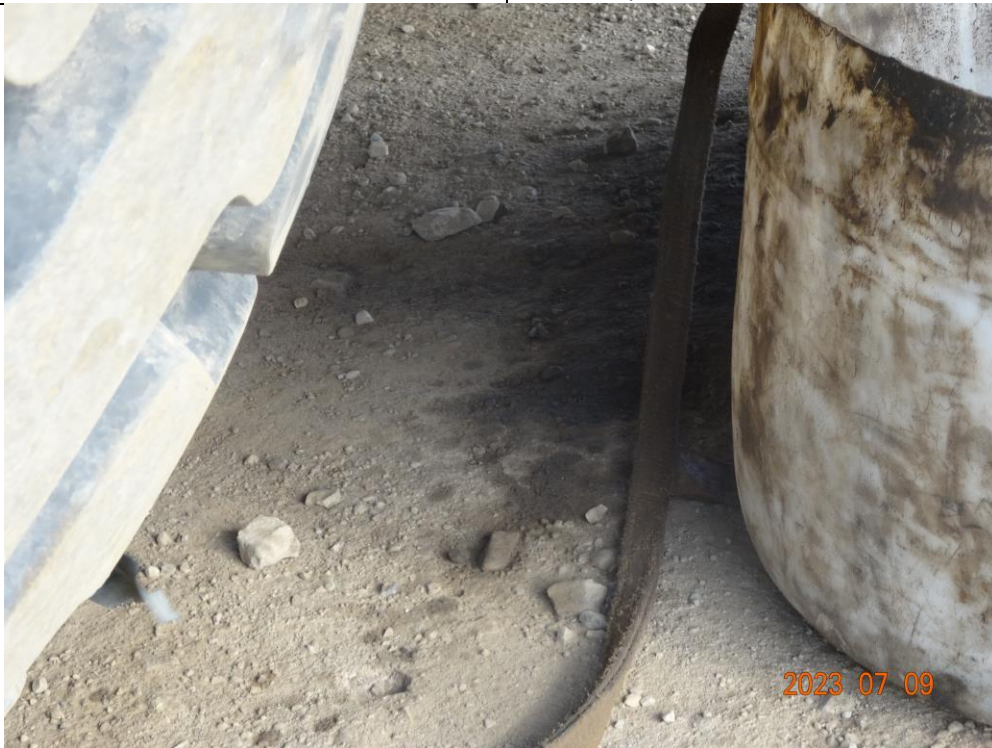
Up close image shows stains under the articulating rock truck.

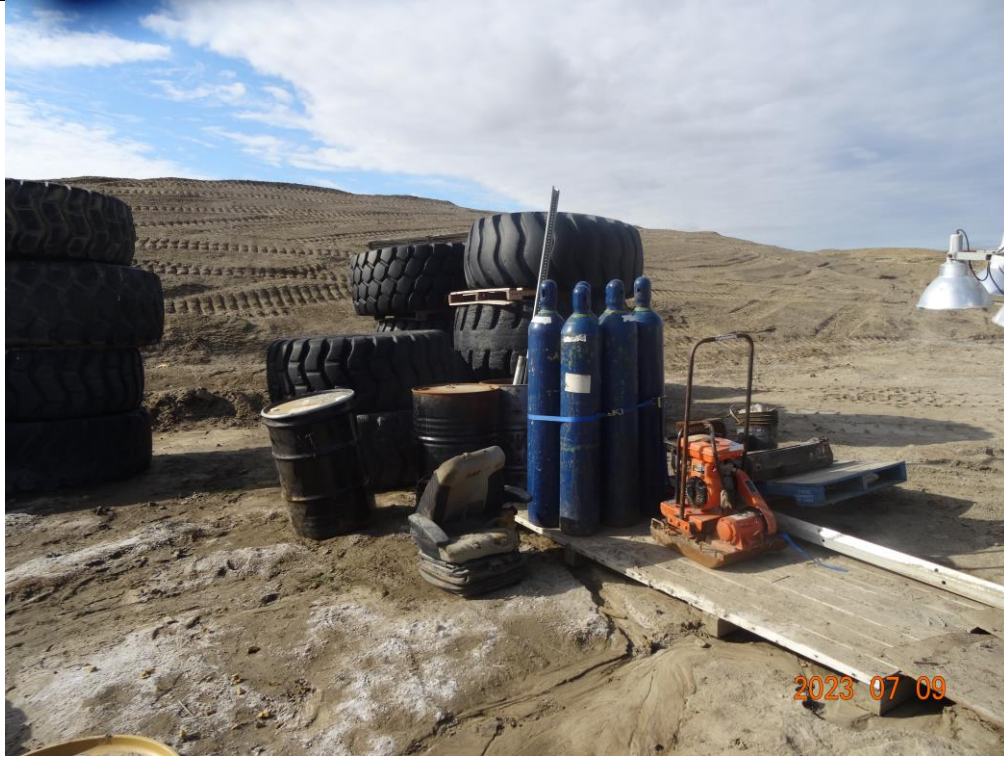
Photo #10

10. In the Nuna storage laydown area near the stack of truck tires, 6 Acetylene tanks, a barrel and an ash barrel are stored. (photo #10)
11. A large 200lbs propane tank was observed in the Nuna Storage Laydown (Photo #11).

Improper storage of Acetylene tanks at the Nuna storage laydown. Also, a fuel drum and an ash barrel is stored beside the cylinders.

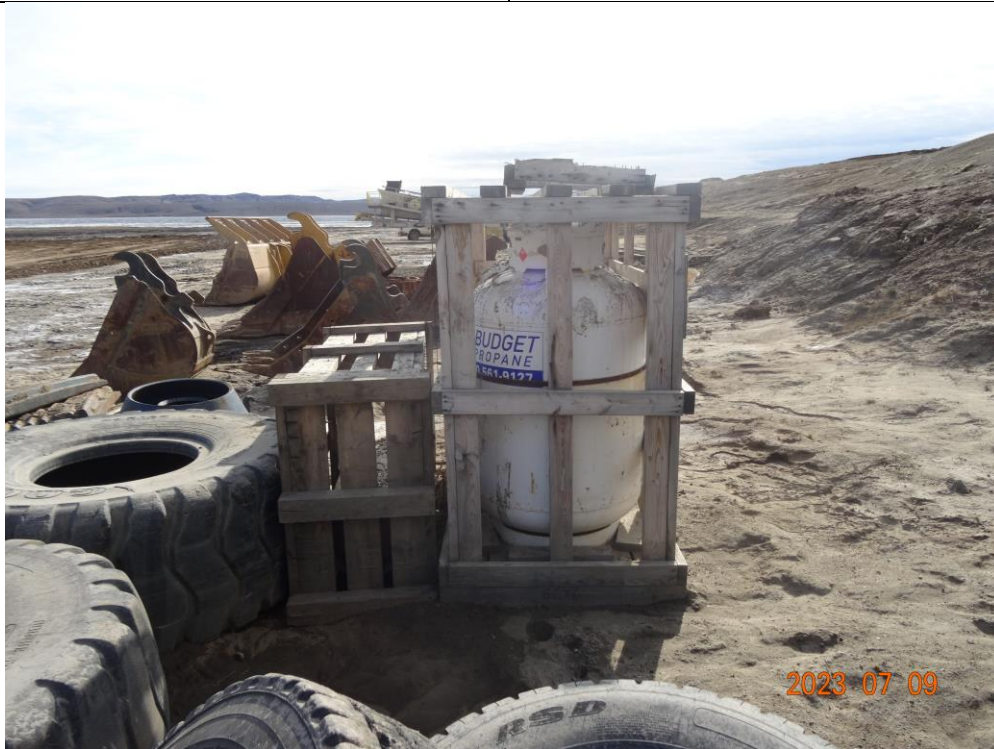
Photo #11

Photo shows a large propane tank stored in the same area as the acetylene tanks at the Nuna storage laydown area.

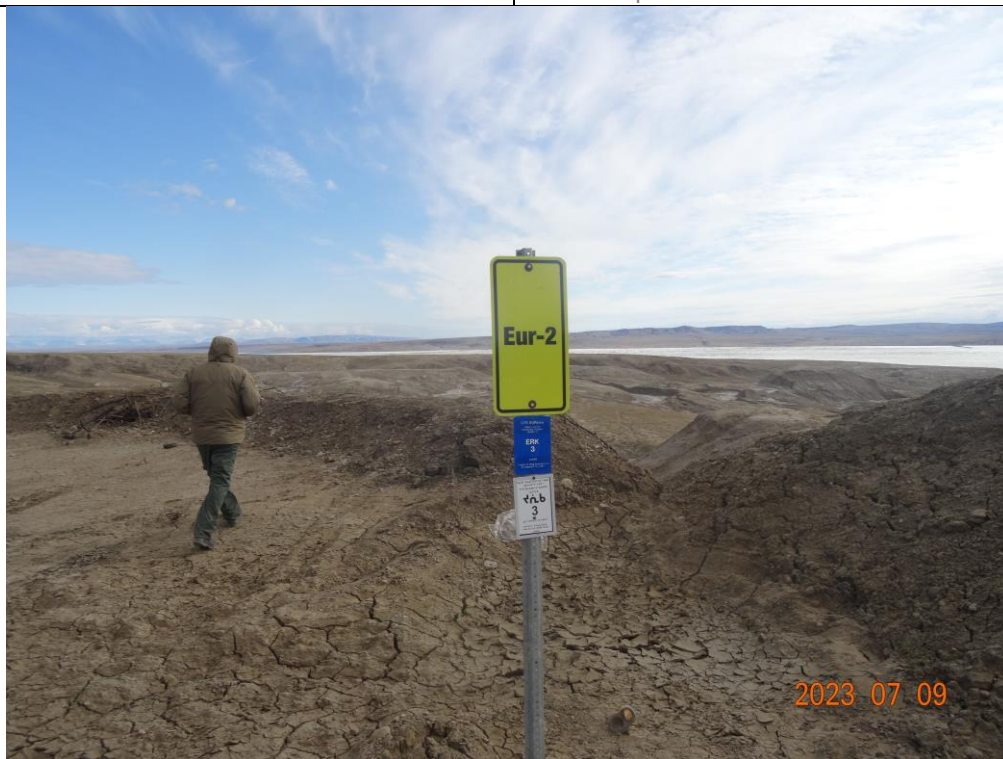
Photo #14

Image shows EUR-2/ERK-3 singage. Some loose debris on site.

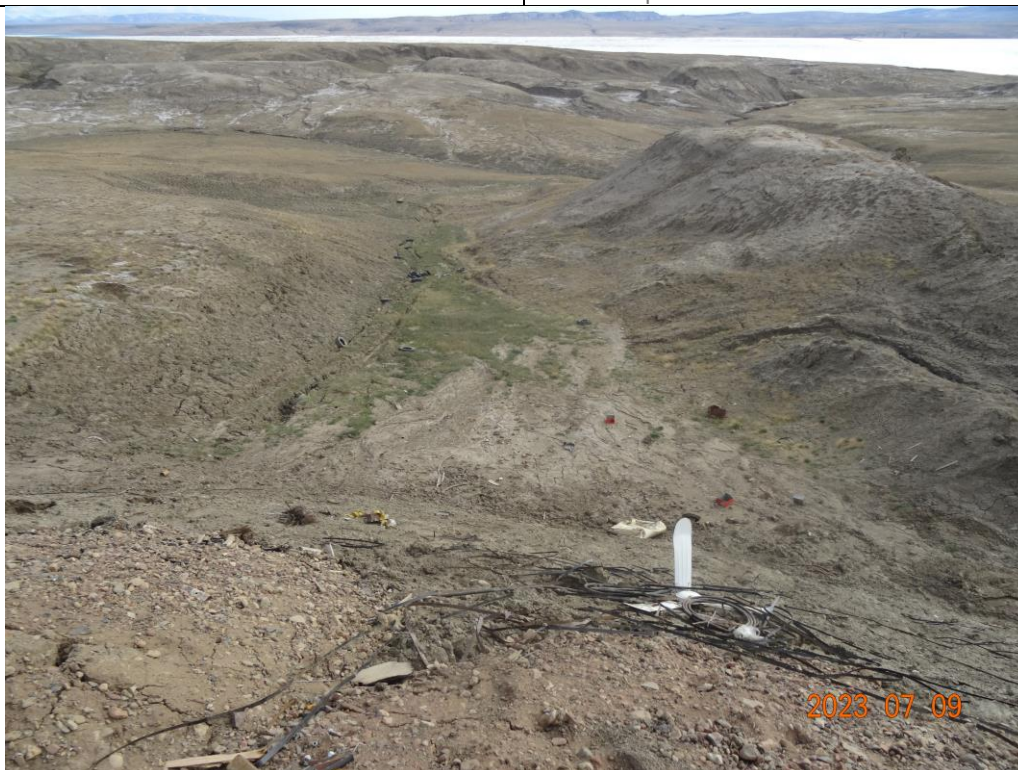
Photo #15

Photo is taken from on top of metal dump looking over the edge to the basin below. Tires, metals, wires, plastic are all present.

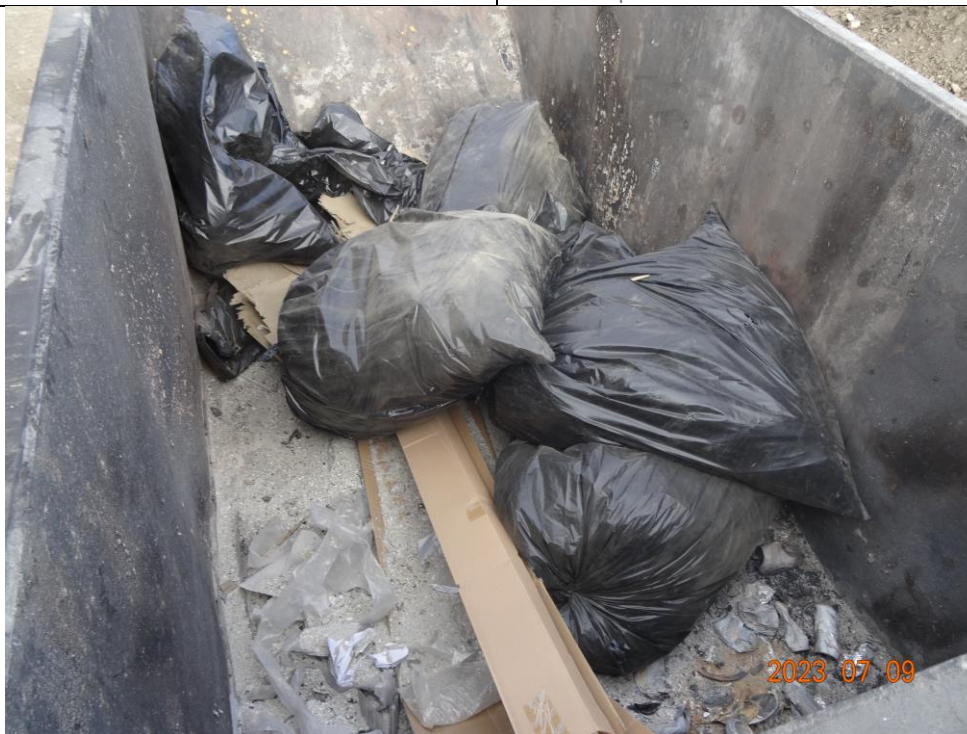
Photo #16

13. Solid Waste Facility: (EUR-02/ERK-03) (Photo #14), wind blown litter observed. No concerns (Photo #15)
14. 3:57pm At the landfill, EUR-02, the open burn facility (metal dumpster) contained plastics and plastic bags filled with domestic wastes. (Photo #16) Domestic wastes appear to have been burned there before. (Part D-Item 5 of the issued water license states: *"The Licensee shall not open burn plastics, wood treated with preservatives, electric wire, Styrofoam, asbestos or painted wood to prevent the deposition of Waste materials of incomplete combustion and/or leachate from contaminated ash residual, from impacting any surrounding Waters, unless otherwise approved by the Board in writing."*)

2. Erosion of the banks at West Remus creek shall be prevented and mitigated.
3. In regard to observation of plastics in the open burn dumpster, Part D-subsection #5 of the issued water license states: *"The Licensee shall not open burn plastics, wood treated with preservatives, electric wire, Styrofoam, asbestos or painted wood to prevent the deposition of Waste materials of incomplete combustion and/or leachate from contaminated ash residual, from impacting any surrounding Waters, unless otherwise approved by the Board in writing."*

A photo of the inside of the burn dumpster at the open burn facility. Observed Plastic bags of garbage, clear plastic from construction activities, beer cans and unknown ash in the bottom right corner of the photo.

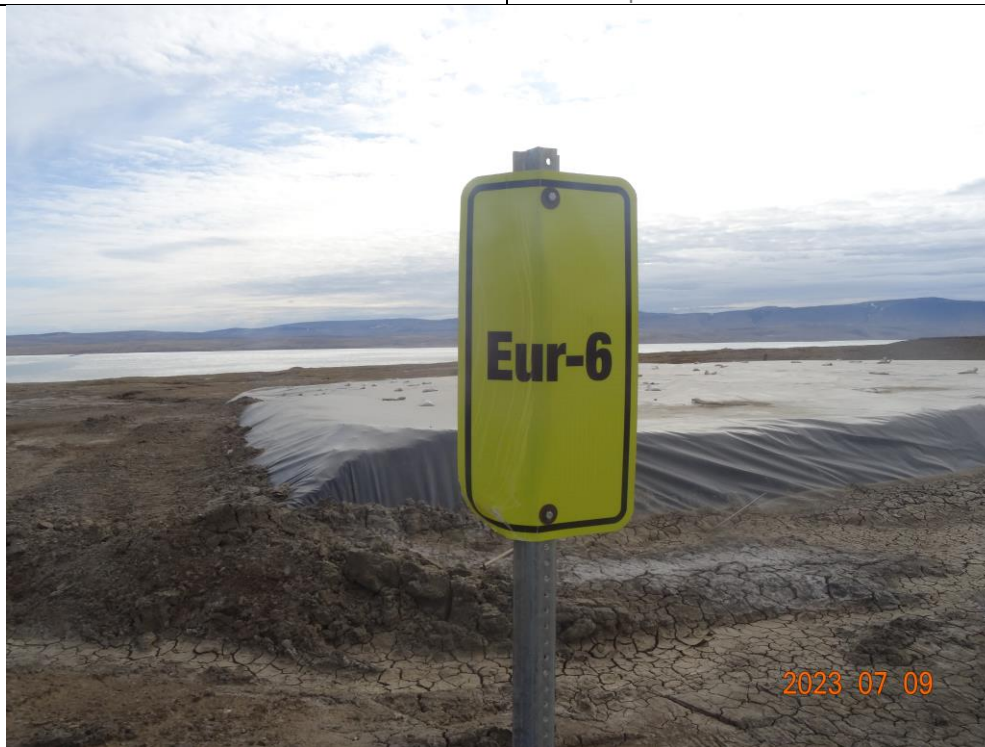
Photo #17

Photo shows the EUR-06 facility. In the background, a lined berm stores contaminated soil. The berm has been covered and the cover weighed down.

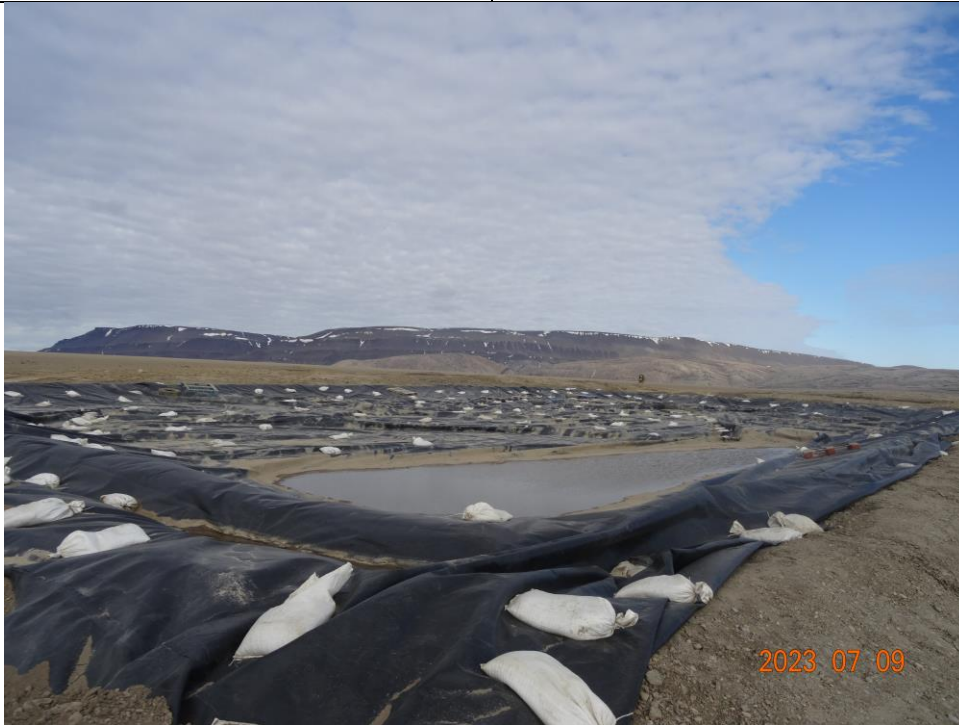
Photo #18

15. 4:04pm arrival at EUR-06. Temporary contaminated soil storage. No concerns with EUR-06 (Photo #17)
16. In the same area as EUR-06, a new contaminated soil storage berm is being built. At the time of inspection the berm walls had been constructed and the rubber liner had been placed on top and weighted down to ensure the wind doesn't blow it away. Completion of the berm will enable Nuna-logistics to store more contaminated soils on site. (Photo #18)

Contruction of a new contaminated soil berm is underway. The liner has not been secured, but is weighed down with the white bags of dirt. Adjustments of the liner will be made and then the new berm will be filled with contaminated soils that have been discovered near the new raw water containment resevoir.

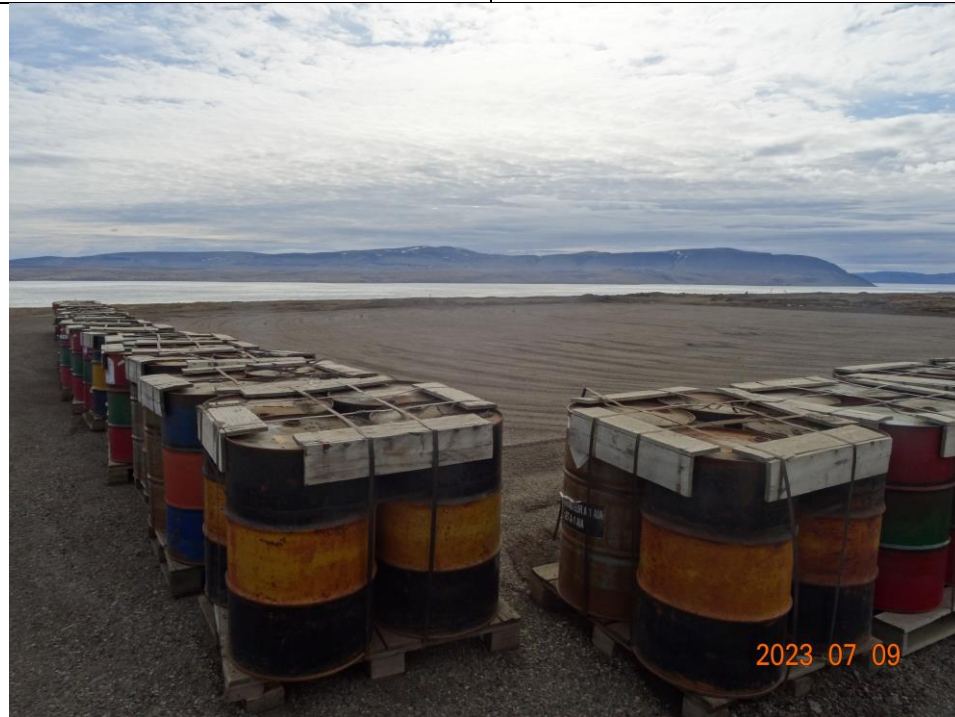
Photo #19

17. Inspectors BOLT and MONTEITH arrived at the Nuna logistics waste fuel laydown. This area is for storage of drums. Approx 112 drums were placed on this storage pad at the time of inspection. All barrels observed were placed on pallets and not secondary containment. No spills observed (Photo #19).

Beside the contaminated soil berms is a waste fuel storage pad. All barrels were sitting on pallets, with no secondary containment. Approx. 112 barrels.

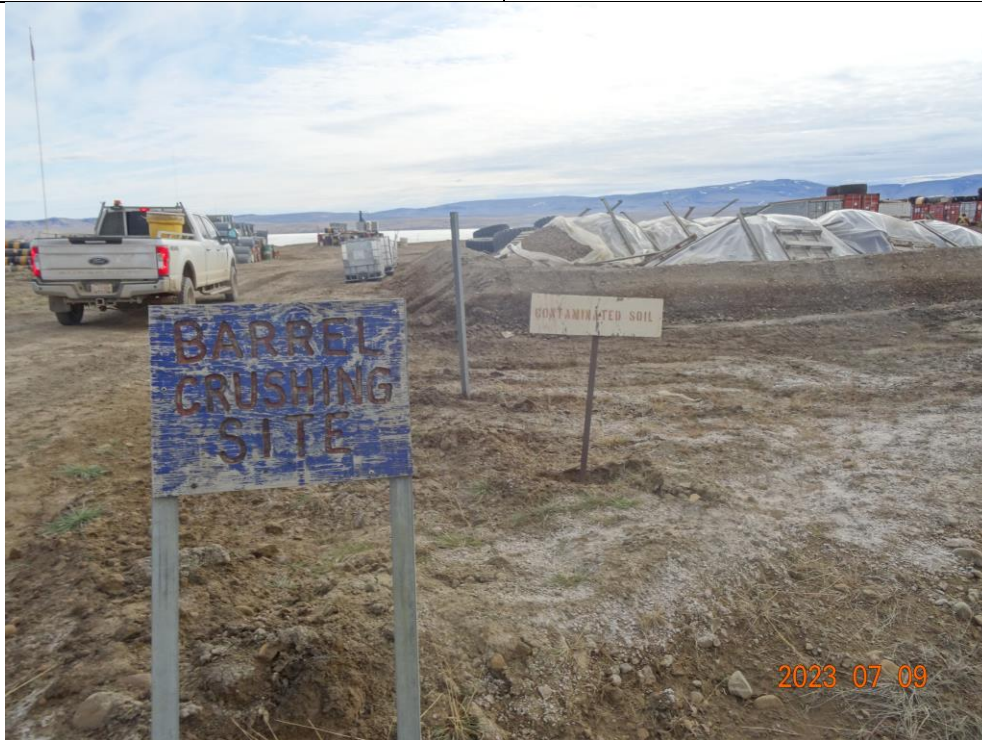
Photo #20

Photo shows the barrel crushing site. The "Landfarm Facility" is located in this area as well.

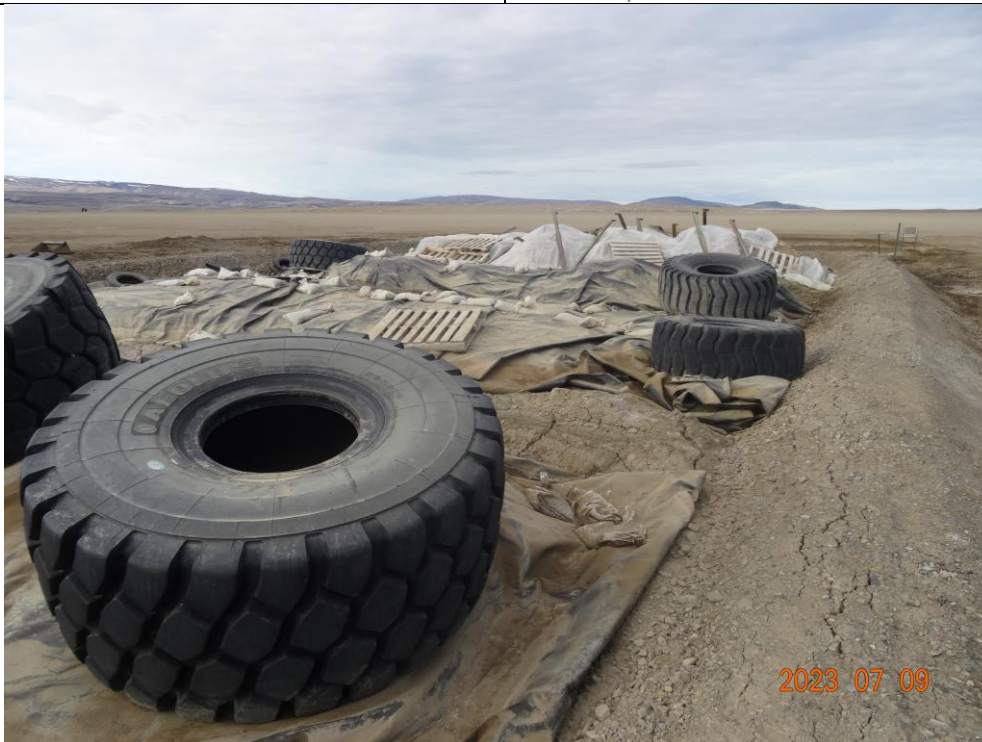
Photo #21

18. 4:09pm Arrival at the Barrel Crushing site that is also in the same area as the Land farm Facility (Photo #20).
19. A contaminated soil berm (Photo #21) in the land farm facility appears to have compromised berm walls. (Photo #22 and #23).

Photo of the contaminated soil storage berm near the barrel crusher. Tires and pallets hold the plastic and rubber in place. Some cracking on the berm walls. Water does not seem to stay contained inside the berm. See next photo.

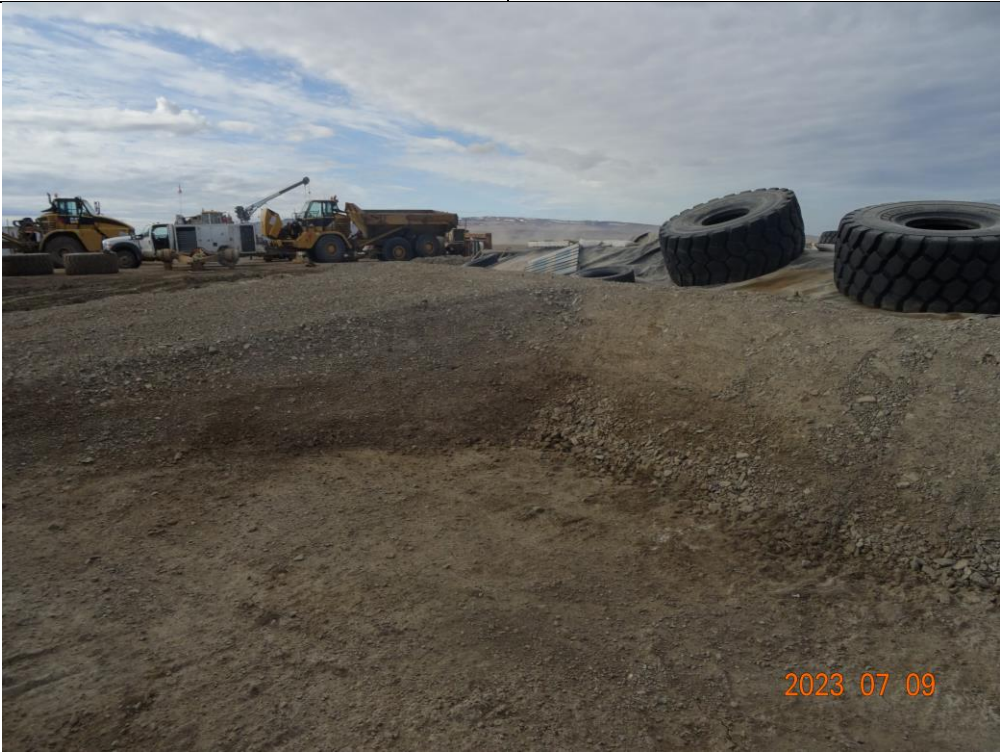
Photo No. Photo #23	Lat/Long (DD.MM.SS.SS, NAD83) Click or tap here to enter text.

Description: This photo is taken of the entrance of the berm. Dark staining of the soil on the base of the berm wall can be an indication of a compromised berm liner.

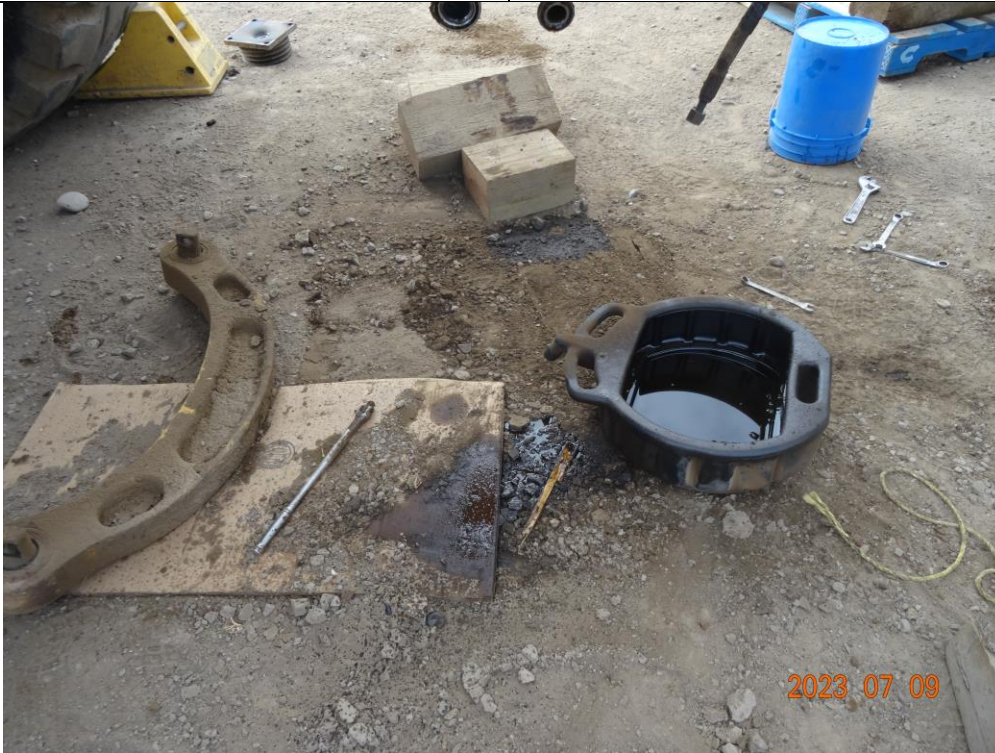
Photo No.
Photo #26

21. 4:25pm At the Nuna mechanic Laydown area. Both Inspectors noted there were many, varying in size, oil spills. (Photos #26,27,28), Inspector MONTEITH mentioned that he did not see enough spill reports to correspond with the amount of spills observed, Inspector MONTEITH requested that spills be reported to the Spills line.

4. Many unreported spills were observed on site. Part G, Item 4, subsection b and c of the water license states: *"If during the term of this Licence, an unauthorized discharge of Waste occurs, or if such a discharge is foreseeable, the Licensee shall: b. Report the spill immediately to the NWT/NU 24-Hour Spill Line at (867) 920-8130 and to the Inspector at (867) 975-4295; and c. For each spill occurrence, submit to the Inspector, no later than thirty (30) days after initially reporting the event, a detailed report that will include the amount and type of spilled product, the GPS location of the spill, and the measures taken to contain and clean up the spill site."*

Signs of leaks and spills on the ground at Nuna Mechanic laydown area.

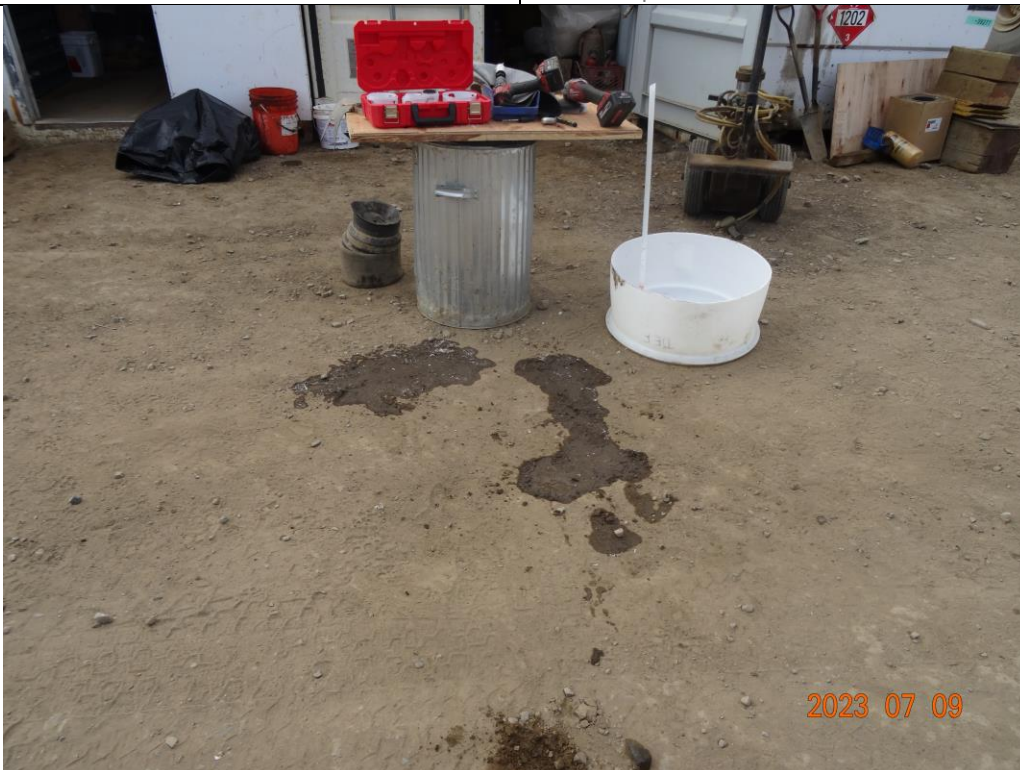
Photo No.
Photo #27

More staining at the Nuna mechanic Laydown.

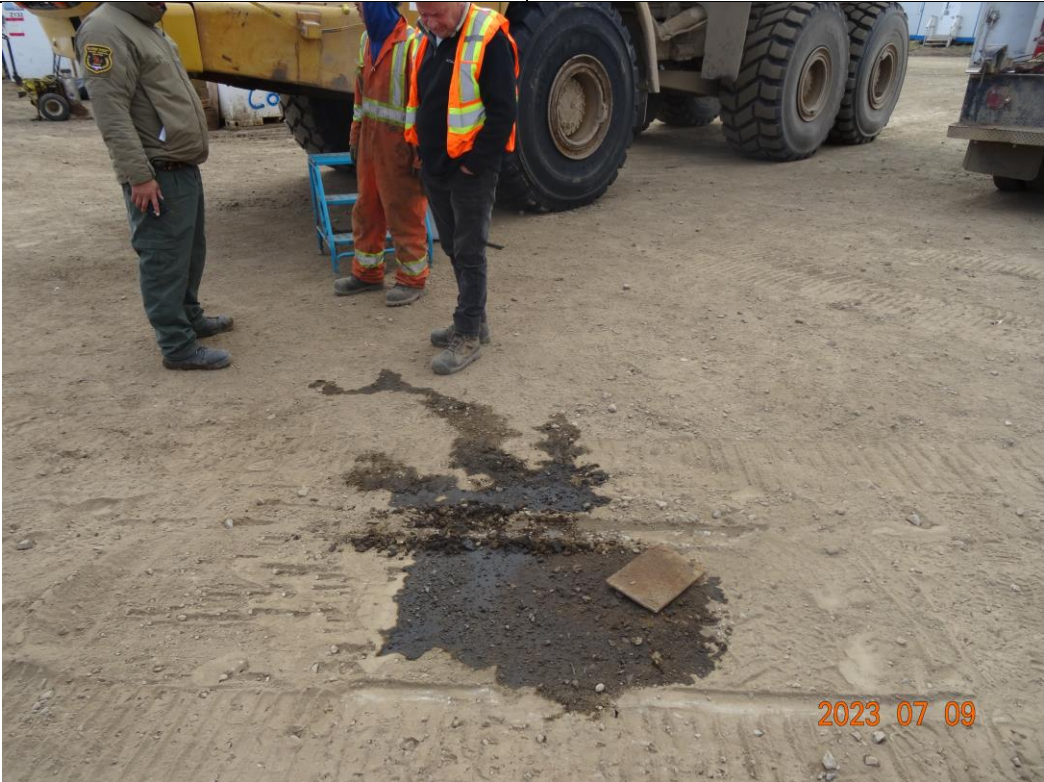
Photo No.
Photo #28

Description:
Third observed spill at Nunas Mechanic Laydown area.

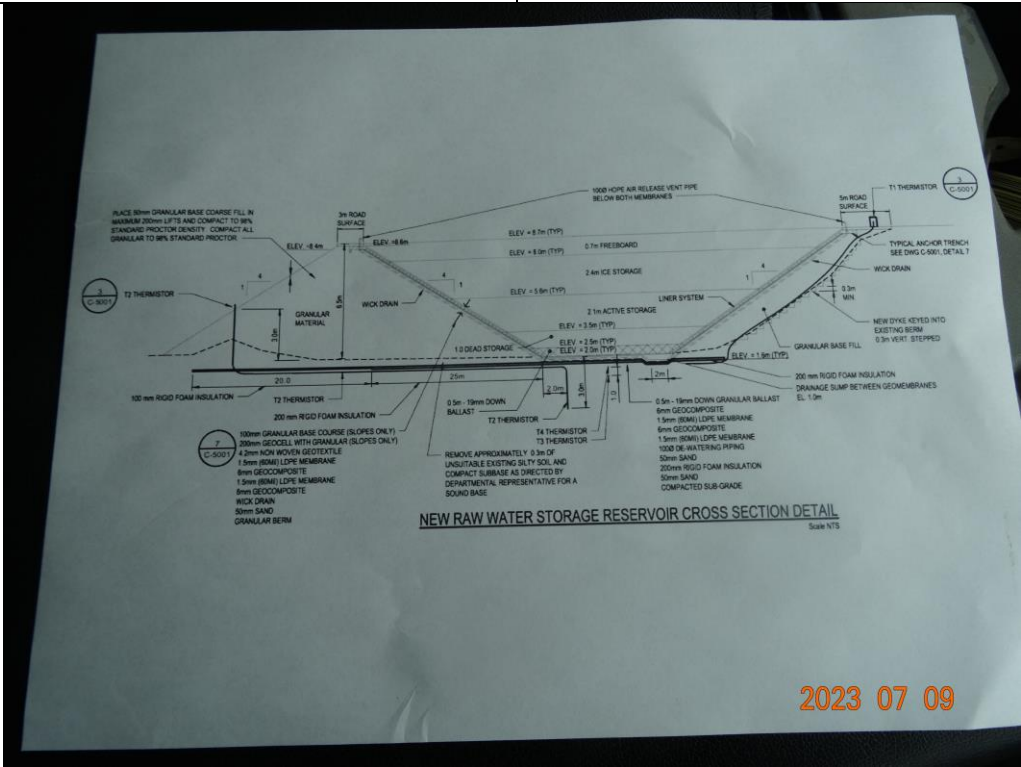
Photo No.
Photo #29

Description:
Image shows the cross section of the new reservoir being built.

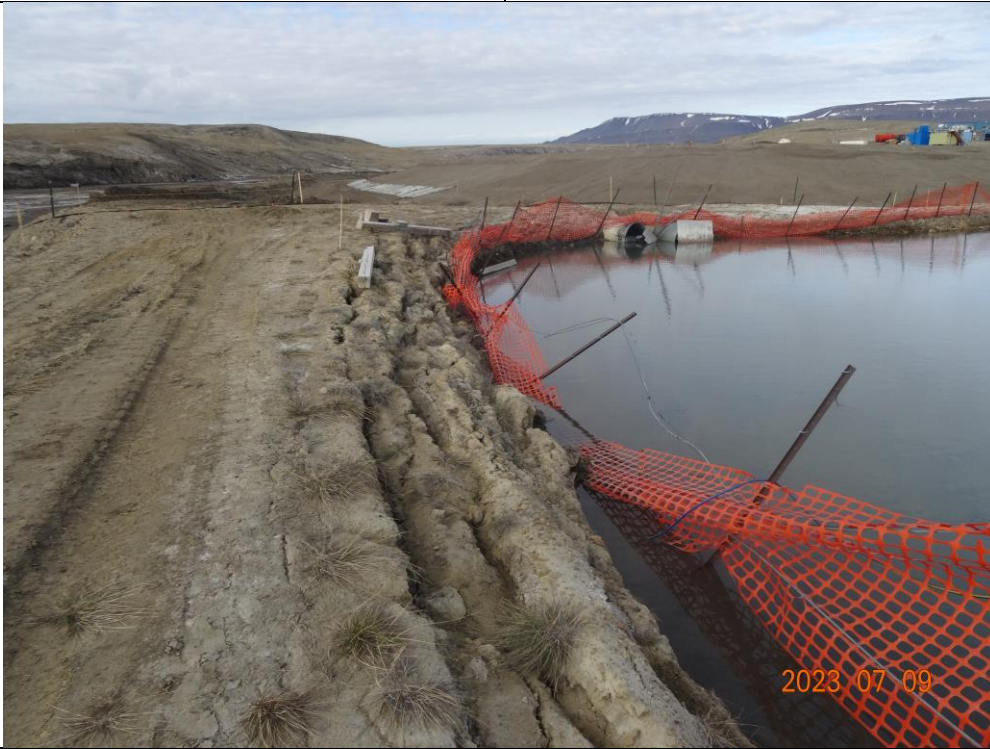
Photo #32

25. The inner walls of the old water reservoir have been slumping inwards over time and may eventually cause the structure to fail. (Photo #32) The new water reservoir is scheduled to be completed in August 2024 according to the amended water license.

Image shows the inside walls of the old water reservoir slumping inward.

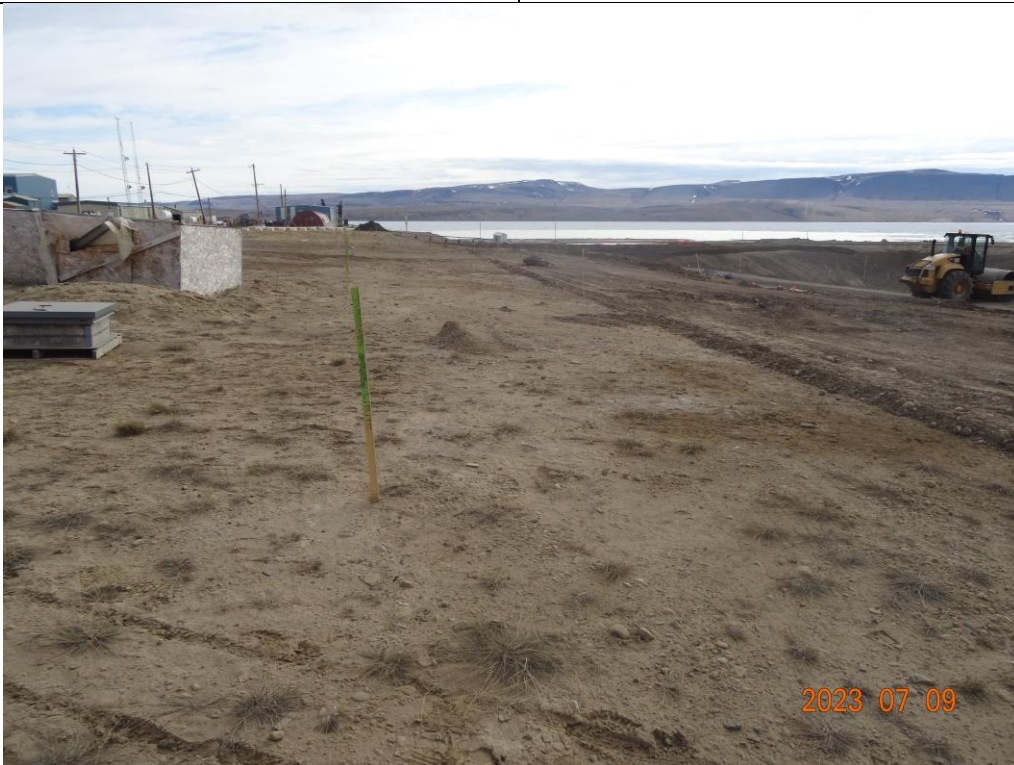
Photo #33

27. Close by the new water reservoir is a site that has been staked and labelled as contaminated soil. This contaminated soil is considered a waste and will be brought to the new temporary contaminated soil berms for treatment. Contamination is very old and may come from leaks from the fuel tank farm area. (Photo #33)

Image shows the limits of the contaminated soils. The new water reservoir is seen on the right hand side of the image. This soil will be deposited into the new temporary contaminated soil berm, as stated by the Nuna manager.

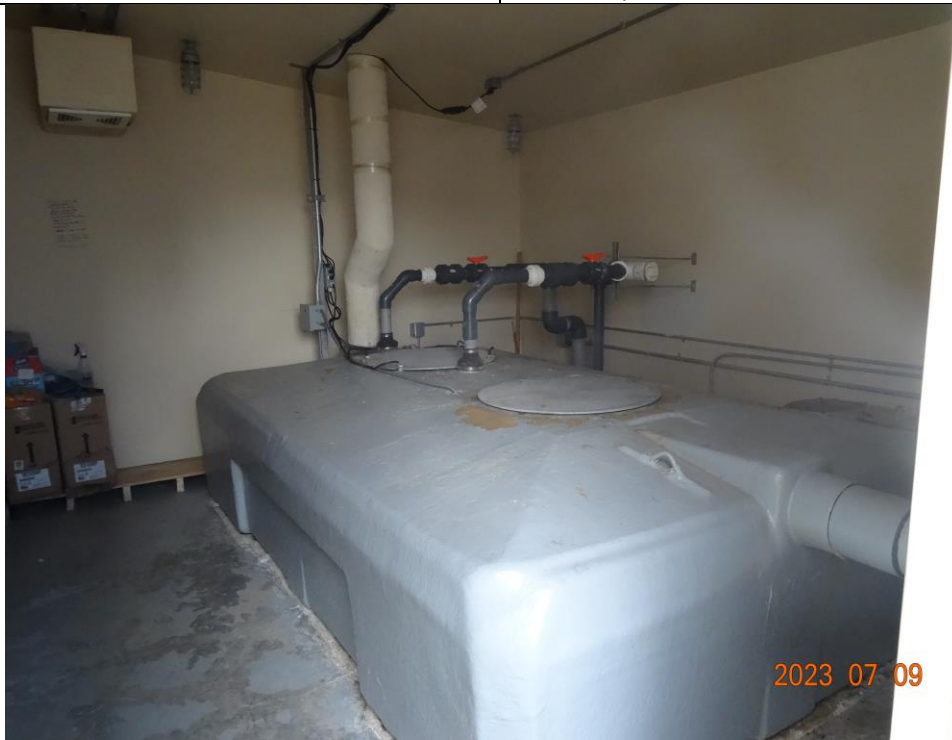
Photo #34

Photo shows a sewage sump in a small building before going to the sewage lagoon

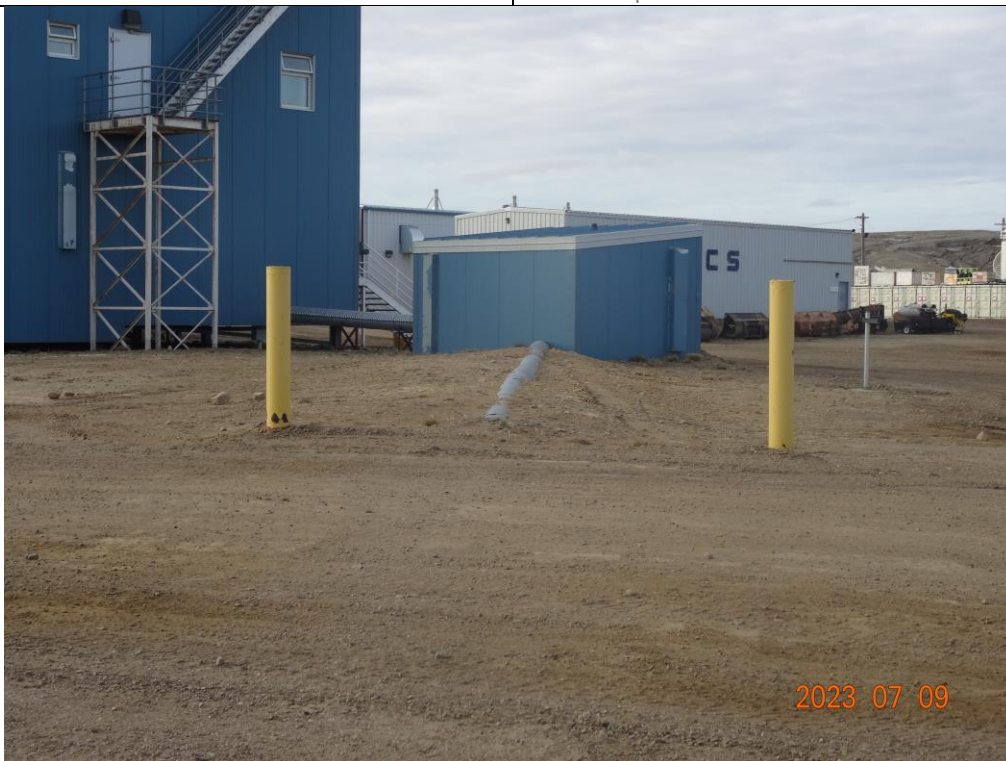
Photo #35

This image shows the small building with the sewage sump inside of it. Sewage flows from the building through an underground pipe to the lagoon.

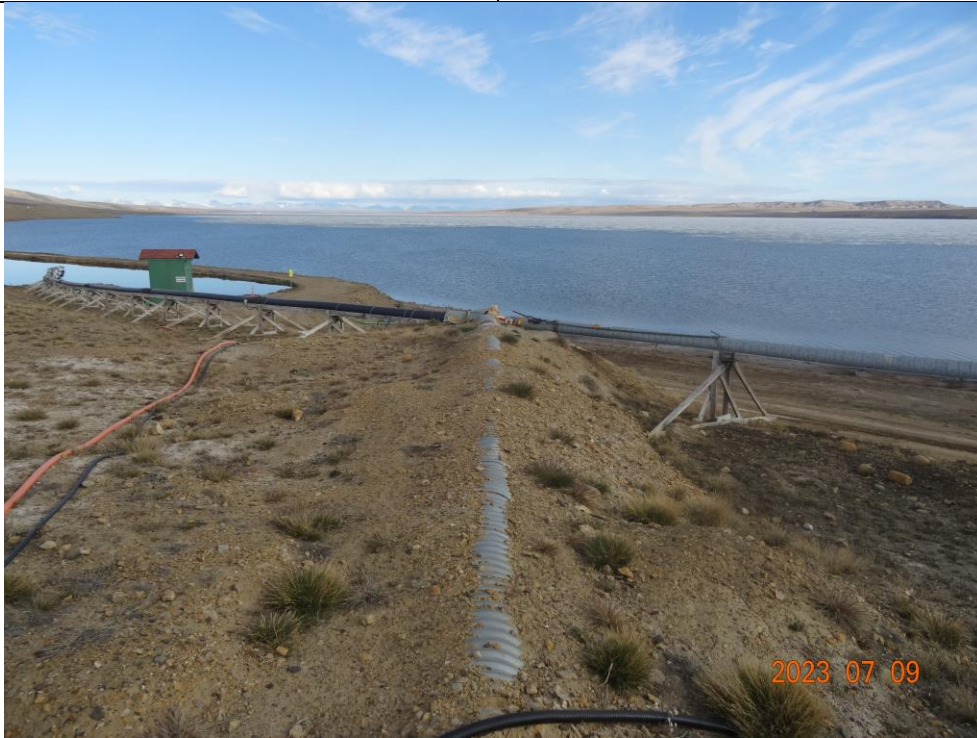
Photo #36

The underground pipe resurfaces on the otherside of the road and joins into another waste pipe. The end of the piping is directly over the sewage lagoon.
