Water Licence Inspection Report

Authorization	Representative
Environment and Climate Change Canada	Asif Mohammed
Authorization No. / Expiry	Representative's Title
8BC-EUR2131, April 29,2025	Chief Administrative Officer
Other Authorization/s	
Activities Inspected	
<input type="checkbox"/> Camp, Commercial <input type="checkbox"/> Drilling <input type="checkbox"/> Mining <input type="checkbox"/> Construction <input type="checkbox"/> Reclamation <input type="checkbox"/> Fuel Storage <input type="checkbox"/> Roads/Hauling <input type="checkbox"/> Winter Hauling <input type="checkbox"/> Camp, Private <input checked="" type="checkbox"/> Other ,Potable Water source, Solid Waste facility, hazardous waste facility, Domestic waste/sewage

On July 09, 2023, I, Isaiah James Bolt, Inspector with the Crown Indigenous Relations and Northern Affairs Canada, (CIRNAC and for the purpose of this report hereafter referred as the "Inspector"), Along with Fellow Inspector Joseph Monteith, completed an on site inspection of 8BC-EUR2131.

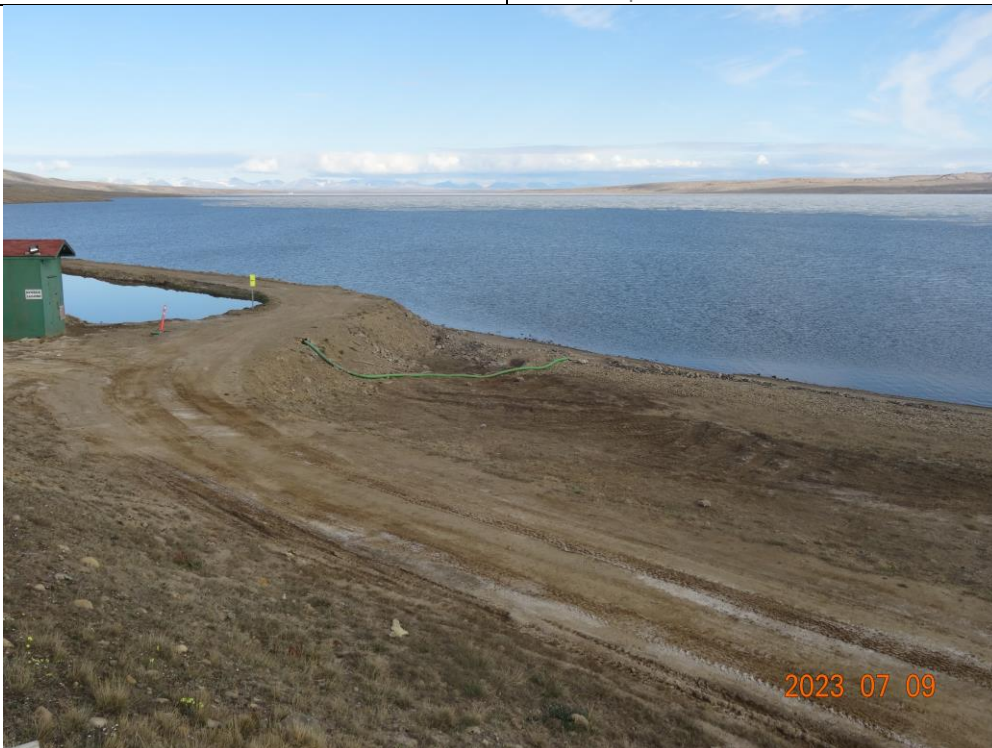
Photo #37

30. The sewage lagoon decanting hose was observed to be too close to the ocean. (approx. 5 Metres) When decanting, the end of the decanting effluent line should be at least 31 metres or more from the high water mark (Photo #37)

5. Regarding the decanting of the sewage lagoon and the effluent line not being 31metres from the high water mark. Part D - Item 1 of the license states: *"The Licensee shall locate areas designated for Waste disposal at a minimum distance of thirty-one (31) metres from the ordinary High Water Mark of any water body such that the quality, quantity or flow of Water is not impaired, unless otherwise approved by the Board in writing."*

In this image, the hoses that are used to decant the sewage lagoon. The end of this hose approximately 5metres from the high water mark. The end of the hose should be above 31metres way from the high water mark.

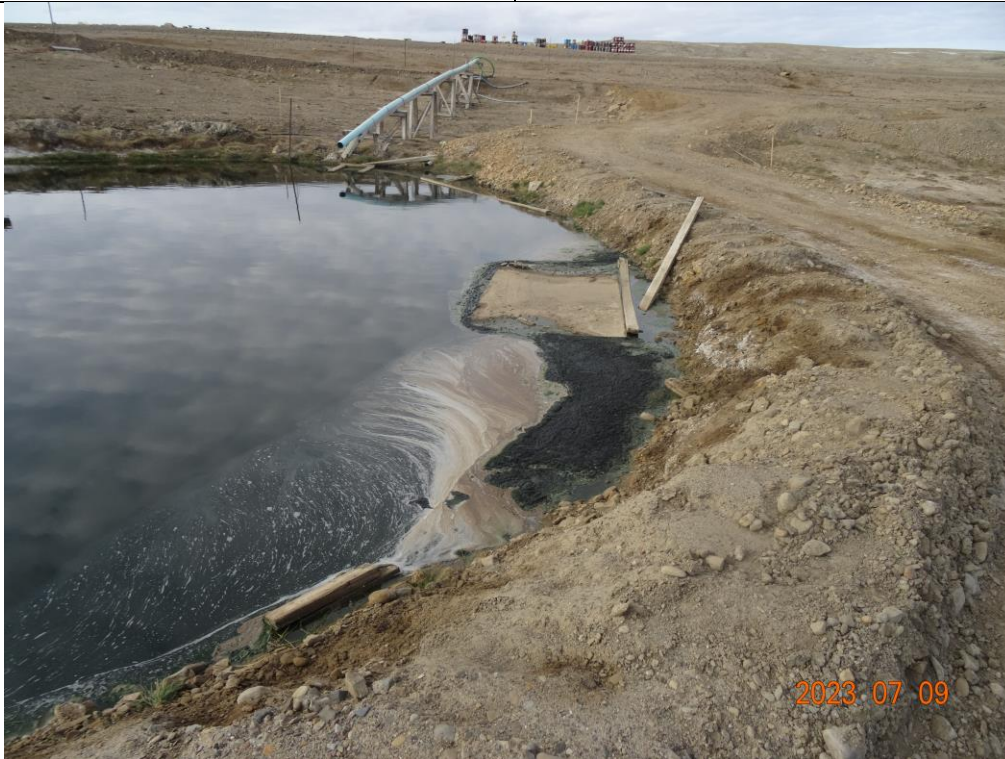
Photo #38

28. Inspectors BOLT and MONTEITH inspected the sewage lagoon and a small building with a sump located in side (Photo #34)
29. The sewage lagoon was observed with floating debris of wood and some sludge build up on the surface. (Photo#38)

Loose debris and sludging observed in the sewage lagoon.

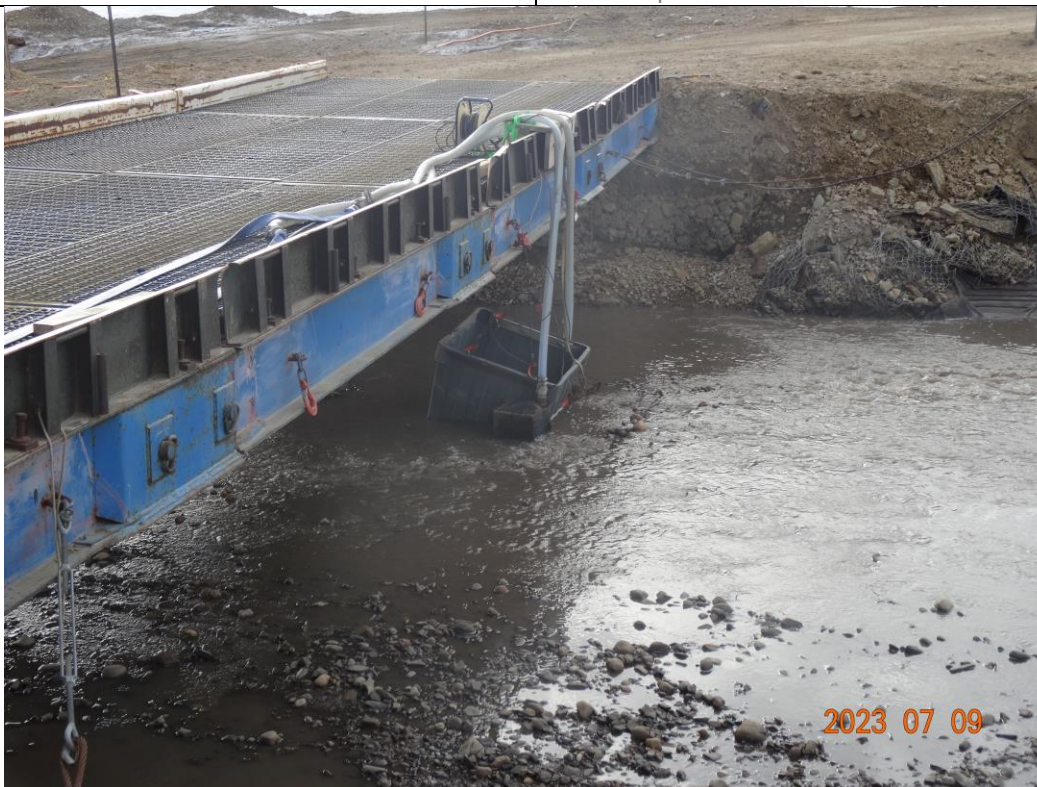
Photo #39

Raw water intake at Station creek.

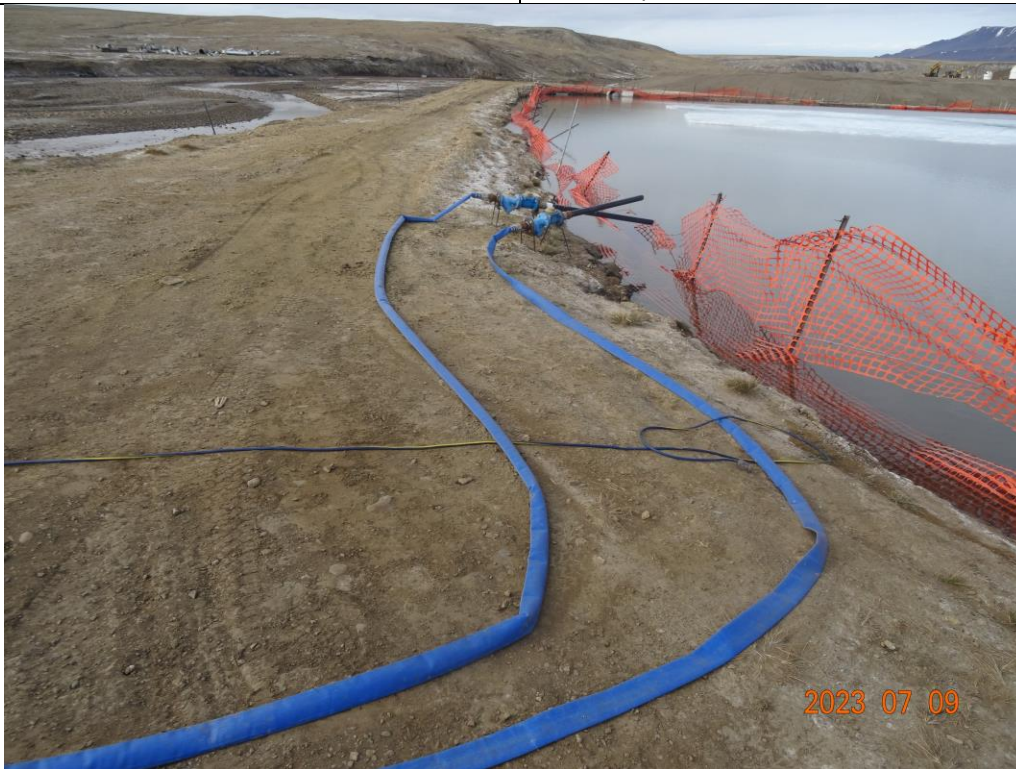
Raw water pumped from station creek to the water reservoir.

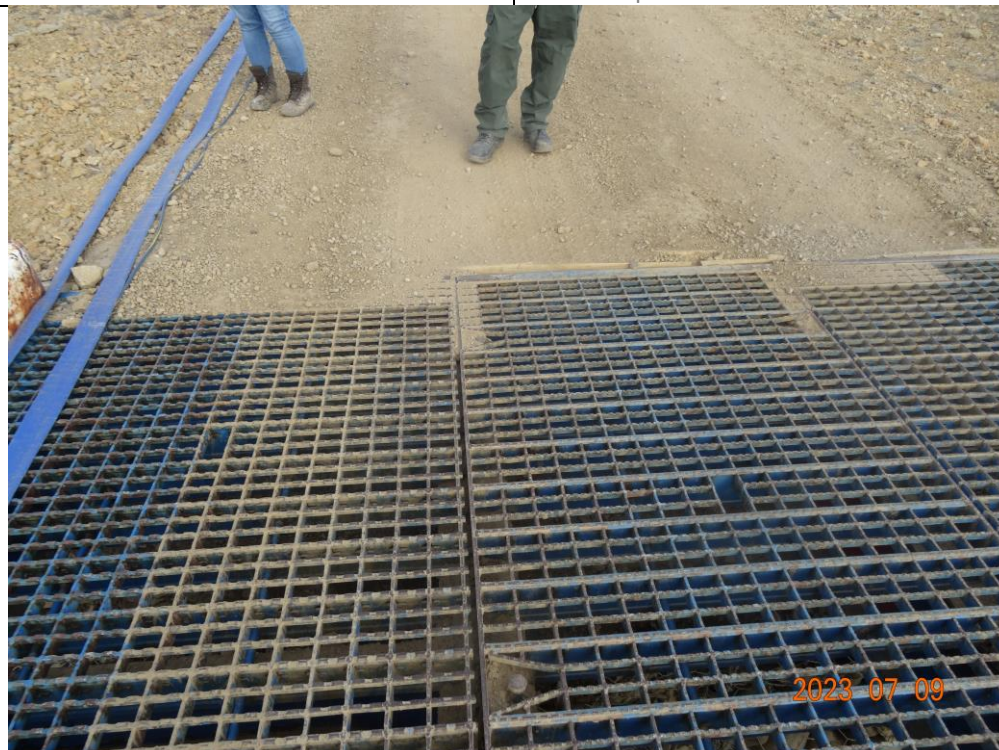
31. The Station Creek Bridge has sedimentation issues. Trucks driving over the bridge deposit sediment onto the bridge and it builds up over time. This build up then falls into the water down below which changes the characteristics of the water and while at the same time depositing sediments. (Photo # 41 and #42)

The bridge that crosses Station Creek is causing sedimentation.

1. Address sedimentation mitigations at Station Creek and Blacktop Creek.
2. Address the erosion of the downstream banks at Remus Creek.
3. Review Part D, Item 5 and Items 6, a-j. of 8BC-EUR2131 to become familiar with open burning conditions.
4. Report all spills to the NWT/NU Spill line.
5. Ensure the end of the effluent lines/decanting hoses are over 31 metres from the high water mark of any water body before pumping. Ensure all effluent parameter quality limits are not in exceedance.

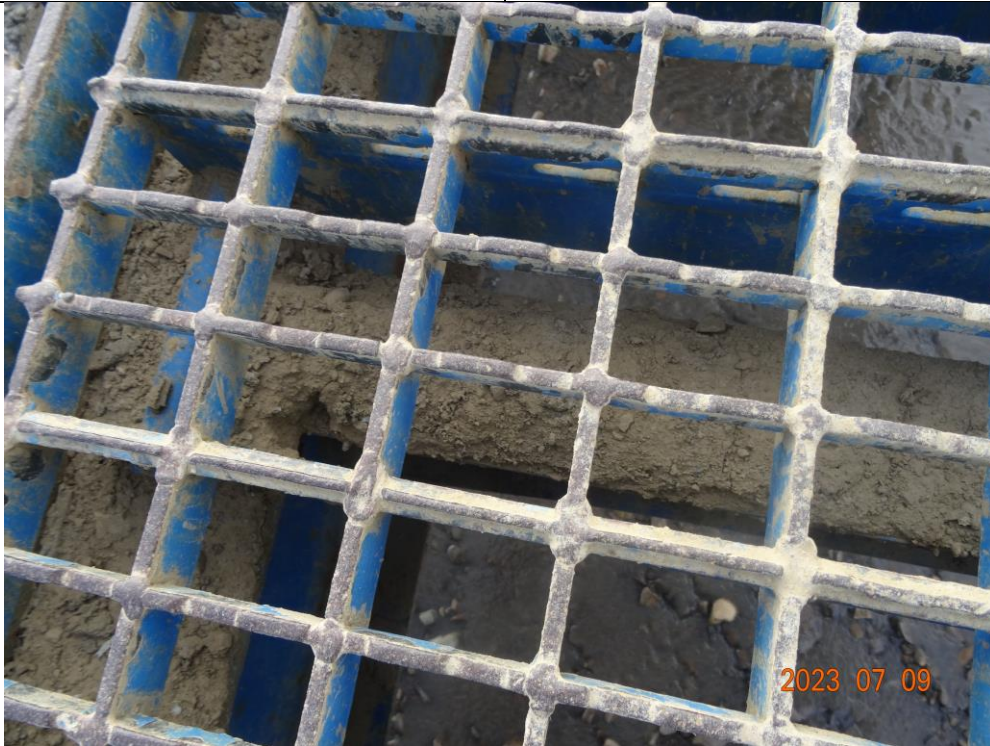
An example of the build up of sediment on the Station Creek bridge.

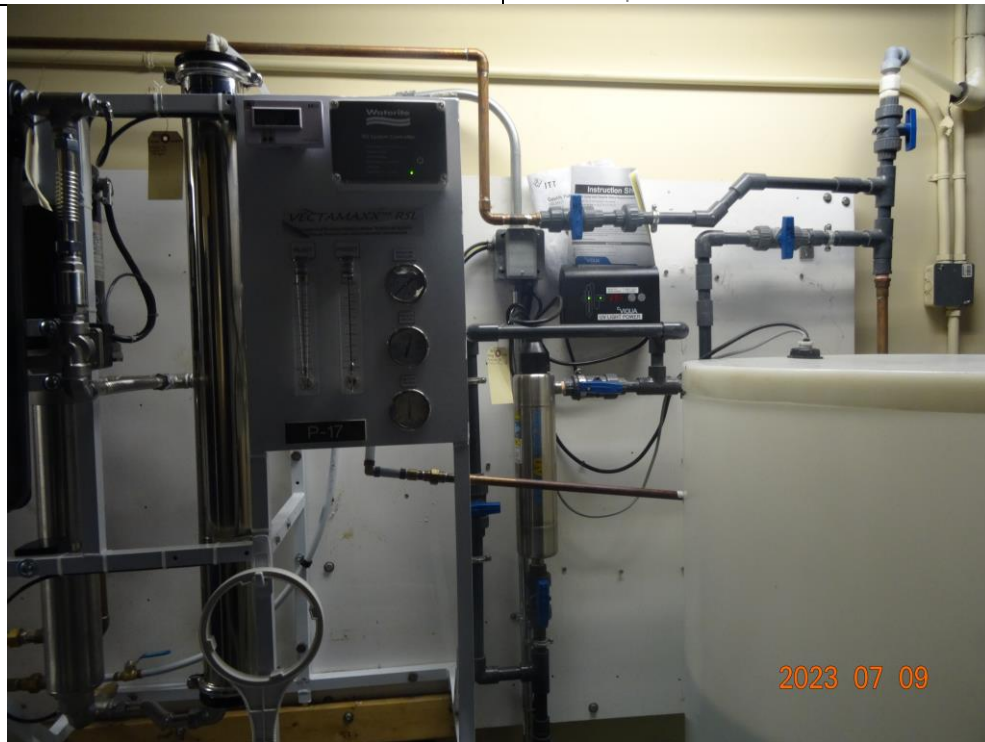
Inside the accomodations building is the water treatment plant. Raw water is treated using a variety of techniques. In the photo, a reverse osmosis machine and a UV filter is shown.
