Water Licence 8BC- EUR2131

2023 Annual Report

Eureka High Arctic Weather Station

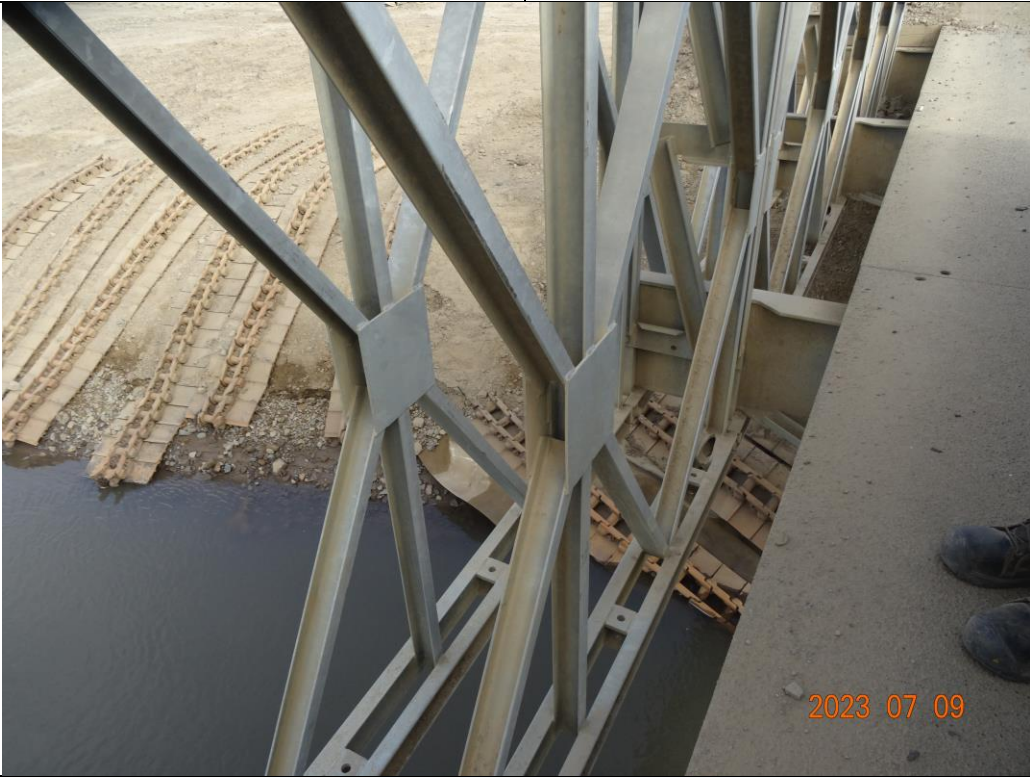
Photo No. Photo #2	Lat/Long (DD.MM.SS.SS, NAD83) Click or tap here to enter text.

4. At Blacktop creek bridge, inspectors observed installed dozer tracks up stream of the bridge to help mitigate erosion (Photo #2).
5. 3:00pm The Inspectors arrived at West Remus Creek. no concerns with the culverts or erosion mitigation at the time of arrival. (photo #3).

<div>2023 07 09</div>	
Description: This image shows the upstream side of blacktop creek bridge and the erosion mitigation of the banks. No mesh to stop sedimentation.

1. Address sedimentation mitigations at Station Creek and Blacktop Creek.
2. Address the erosion of the downstream banks at Remus Creek.
3. Review Part D, Item 5 and Items 6, a-j. of 8BC-EUR2131 to become familiar with open burning conditions.
4. Report all spills to the NWT/NU Spill line.
5. Ensure the end of the effluent lines/decanting hoses are over 31 metres from the high water mark of any water body before pumping. Ensure all effluent parameter quality limits are not in exceedance.

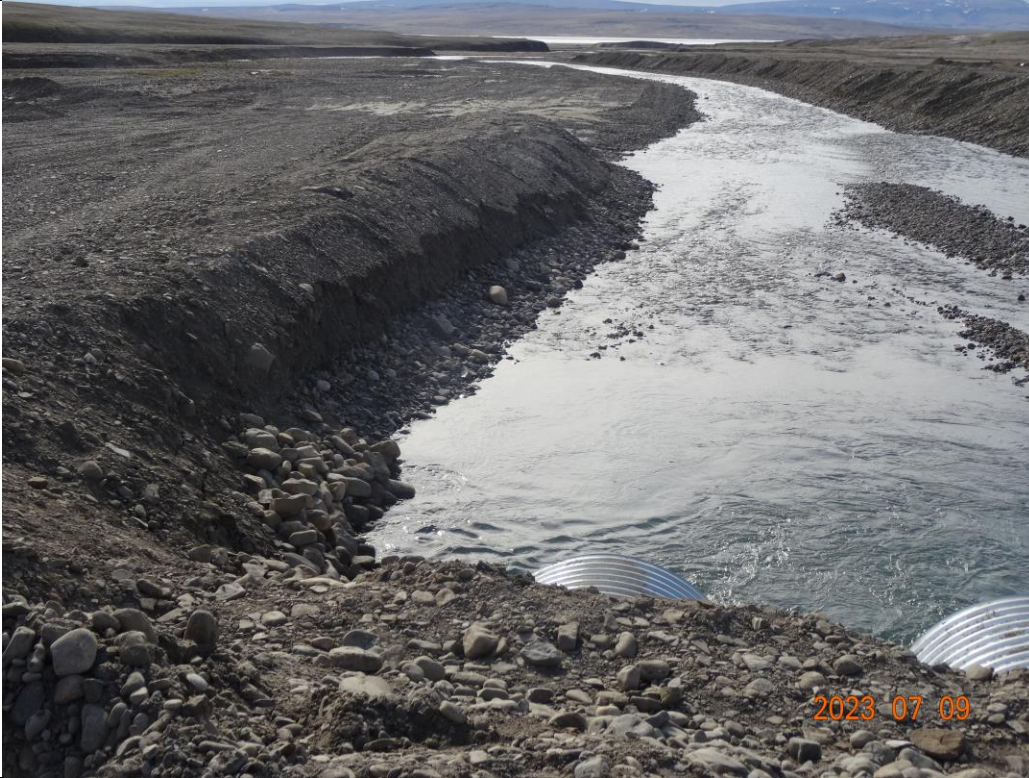
6. 3:08pm The Inspectors arrive at Remus Creek. Inspector BOLT noted that the walls on the down stream side of the culverts were very steep and show signs of erosion at the high water mark (Photo #4). large rocks have been placed at the bottom of the walls to help mitigate erosion. Part C-Subsection 6 of the issued water license states: *"The Licensee shall not cause erosion to the banks of any water body and shall provide necessary controls to prevent such erosion."*

Photo showing downstream of the Remus Creek culvert and the steep walls that have eroded away.

anchored appropriately to prevent further erosion at the culvert outlet. Minor reshaping of the banks to flatten the slopes will be incorporated as required to achieve the installation of erosion control materials. Reshaping will be confined to areas above the water line at the time of installation.

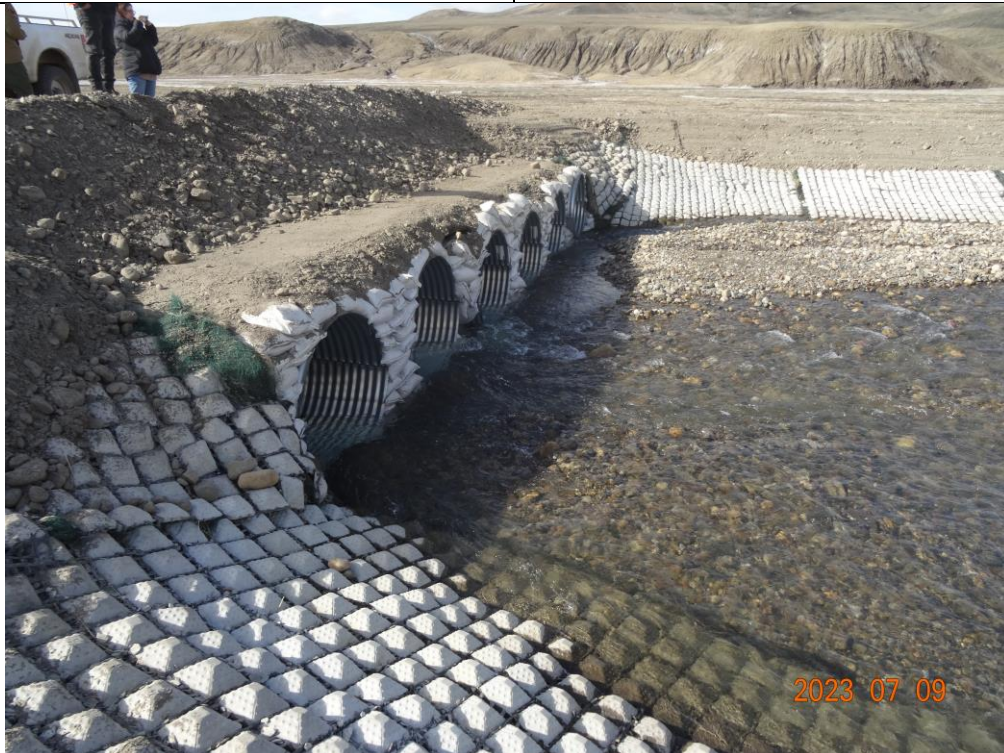
7. Inspector BOLT at Remus Creek observed the erosion control measures on the upstream side of the culverts are very well designed. (photo #5)
8. 3:34pm At the Nuna Logistics storage laydown area: an articulating rock truck was observed with a spill tray underneath. (Photo #6). Upon closer inspection, it was apparent there was staining on the ground. (Photo #7)

Photo shows excellent erosion control on the upstream side of the culverts at Remus Creek

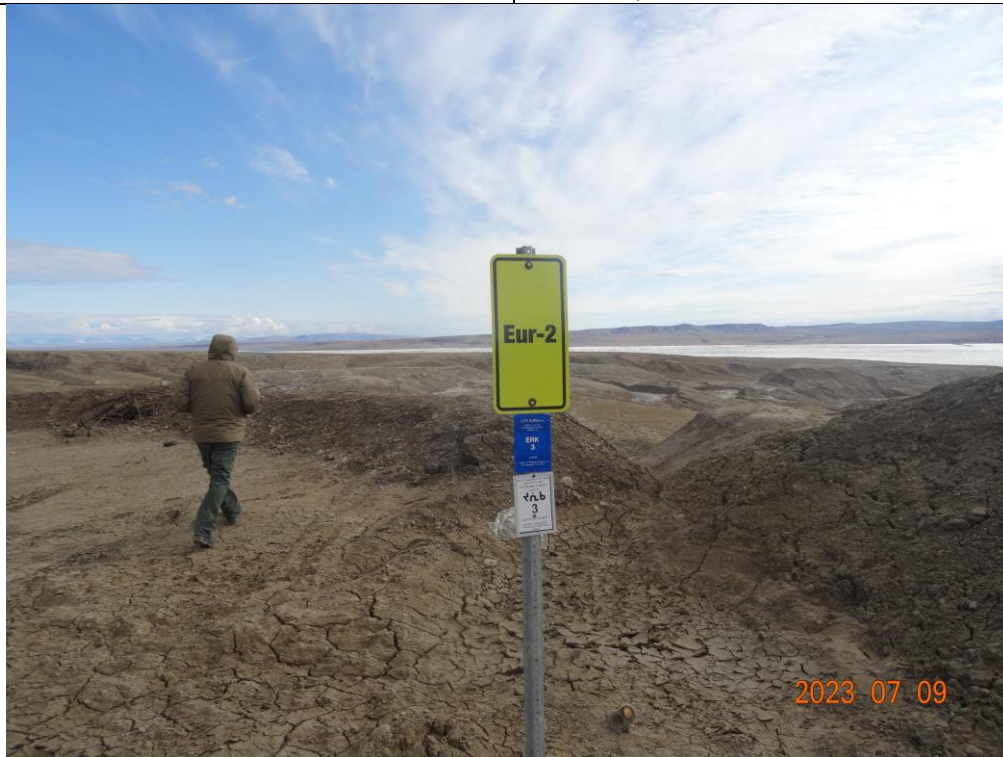
Image shows EUR-2/ERK-3 singage. Some loose debris on site.

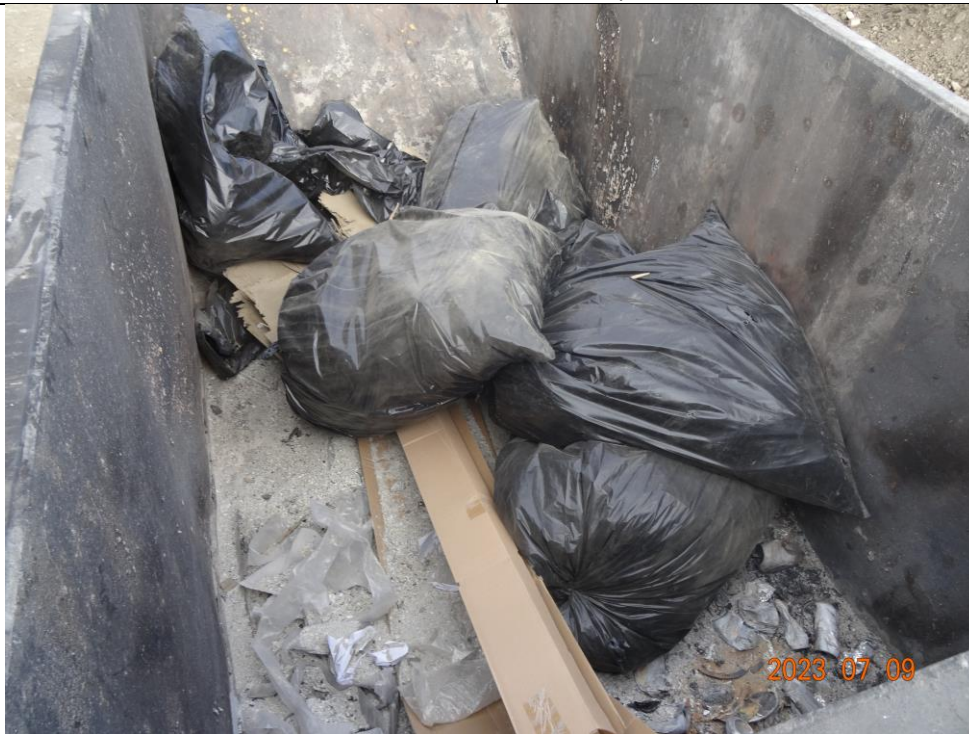
2. Erosion of the banks at West Remus creek shall be prevented and mitigated.
3. In regard to observation of plastics in the open burn dumpster, Part D-subsection #5 of the issued water license states: *"The Licensee shall not open burn plastics, wood treated with preservatives, electric wire, Styrofoam, asbestos or painted wood to prevent the deposition of Waste materials of incomplete combustion and/or leachate from contaminated ash residual, from impacting any surrounding Waters, unless otherwise approved by the Board in writing."*

A photo of the inside of the burn dumpster at the open burn facility. Observed Plastic bags of garbage, clear plastic from construction activities, beer cans and unknown ash in the bottom right corner of the photo.

Item 3: All Eureka Station personnel and contractors have been clearly reminded about the terms and conditions of our water license. Furthermore, ECCC has ordered the sign below, which will be installed visibly next to the burning location. If problem persists, ECCC will install a cover with a locking mechanism to enforce the rules.

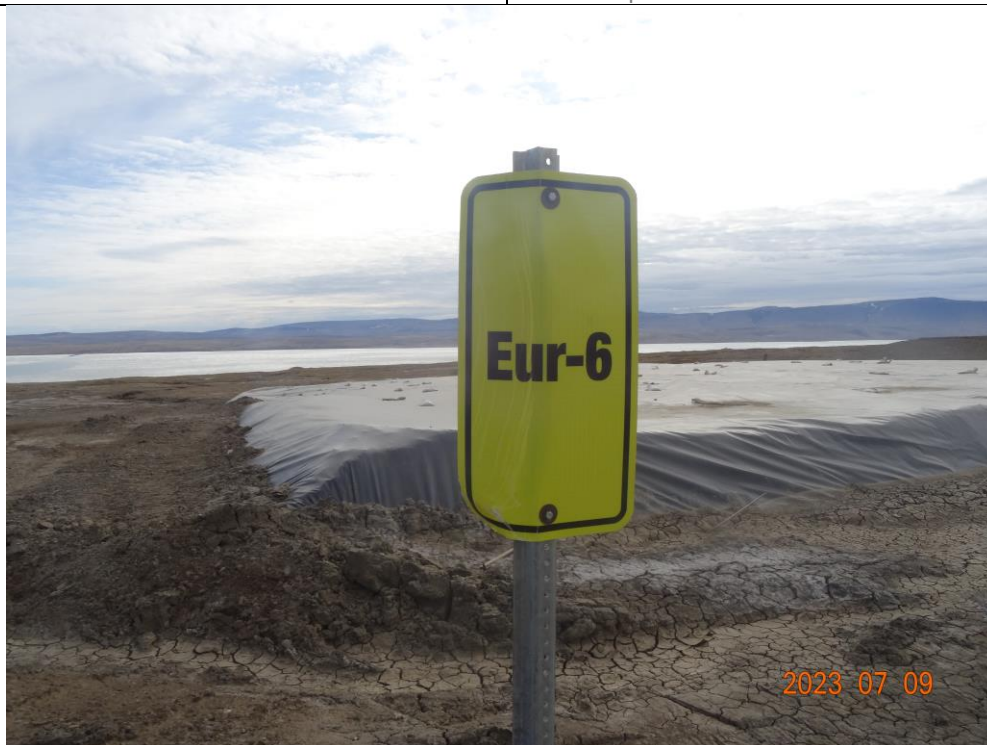
Photo shows the EUR-06 facility. In the background, a lined berm stores contaminated soil. The berm has been covered and the cover weighed down.

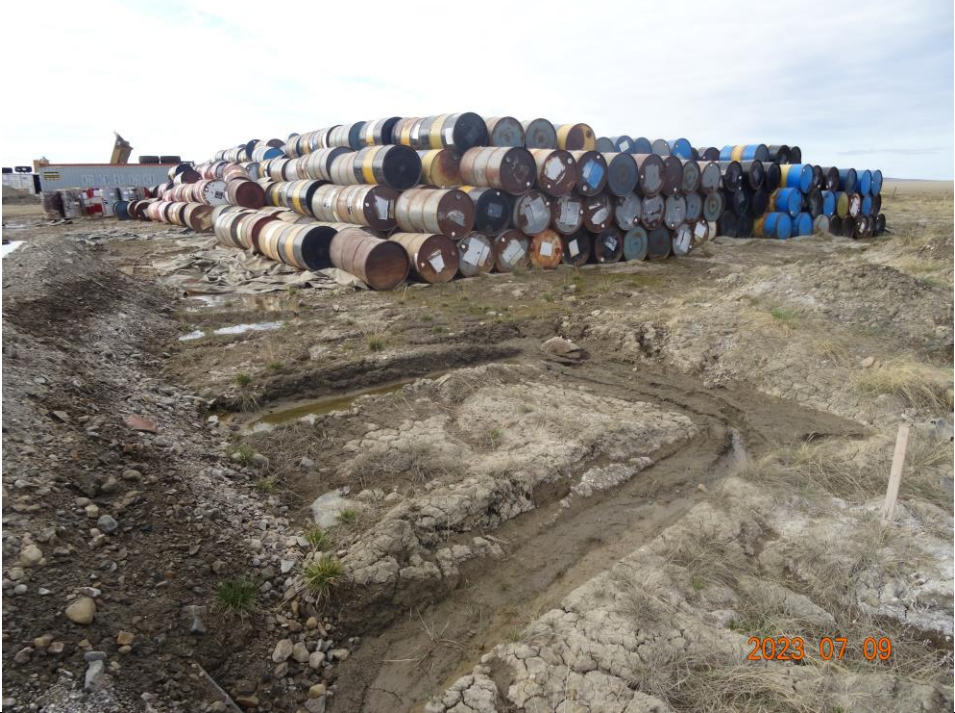
Photo No. Photo #24	Lat/Long (DD.MM.SS.SS, NAD83) Click or tap here to enter text.

<p>Description:</p> <p>Image shows a stockpile of barrels in the barrel crusher site. This stockpile is separate from the barrels directly adjacent to the washer/crusher. Also, In the photo the path of drainage is shown.</p>

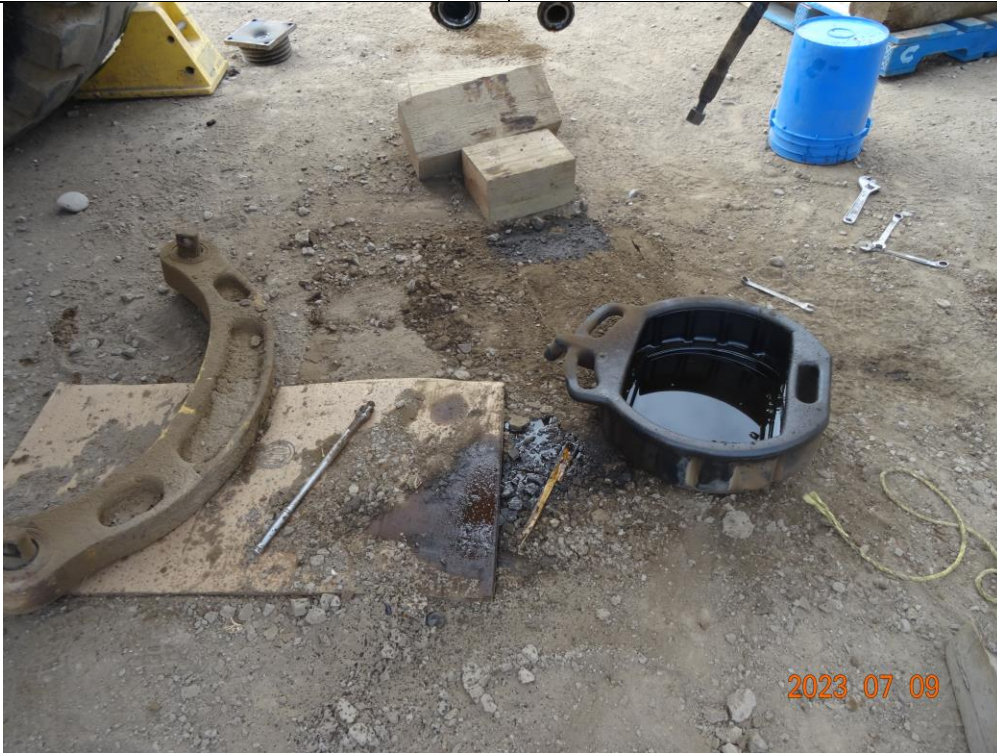
Photo No.
Photo #26

21. 4:25pm At the Nuna mechanic Laydown area. Both Inspectors noted there were many, varying in size, oil spills. (Photos #26,27,28), Inspector MONTEITH mentioned that he did not see enough spill reports to correspond with the amount of spills observed, Inspector MONTEITH requested that spills be reported to the Spills line.

4. Many unreported spills were observed on site. Part G, Item 4, subsection b and c of the water license states: *"If during the term of this Licence, an unauthorized discharge of Waste occurs, or if such a discharge is foreseeable, the Licensee shall: b. Report the spill immediately to the NWT/NU 24-Hour Spill Line at (867) 920-8130 and to the Inspector at (867) 975-4295; and c. For each spill occurrence, submit to the Inspector, no later than thirty (30) days after initially reporting the event, a detailed report that will include the amount and type of spilled product, the GPS location of the spill, and the measures taken to contain and clean up the spill site."*

Signs of leaks and spills on the ground at Nuna Mechanic laydown area.

Item 4: Based on the photos in the report, the stains observed and categorized as unreported spills appear to be related to maintenance activities with inadequate spill control and containment devices in place. Increased diligence will be incorporated in 2024 with all operational and maintenance crews during start up, site orientation and frequently throughout the operational season to ensure that these occurrences are eliminated. It will be further enforced to report all spill to the 24-hr spill line, regardless of the spill volume, and cleaned up immediately. Detailed reports will be provided for each spill within the required 30-day requirement.

Previous spills will be cleaned up and contaminated soil properly disposed of upon our return to site in June 2024 and when ground thaw allows for proper clean up efforts.

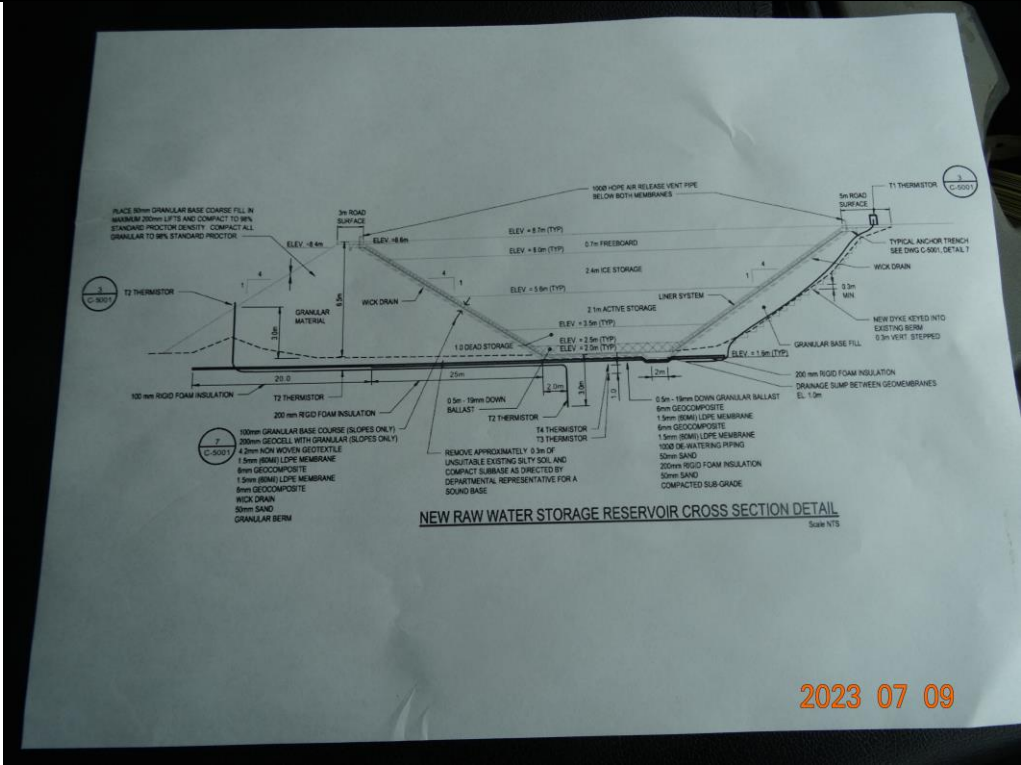
Photo No. Photo #29	Lat/Long (DD.MM.SS.SS, NAD83) Click or tap here to enter text.
-------------------------------	--

Description:
Image shows the cross section of the new reservoir being built.

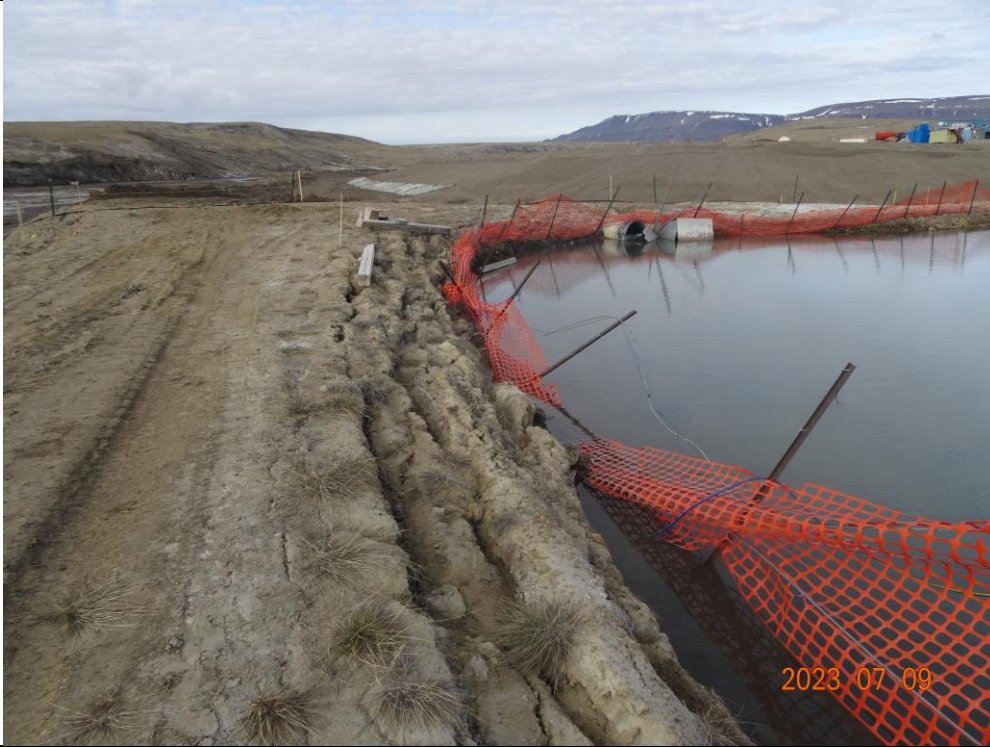
Photo No.
Photo #32

25. The inner walls of the old water reservoir have been slumping inwards over time and may eventually cause the structure to fail. (Photo #32) The new water reservoir is scheduled to be completed in August 2024 according to the amended water license.

Image shows the inside walls of the old water reservoir slumping inward.

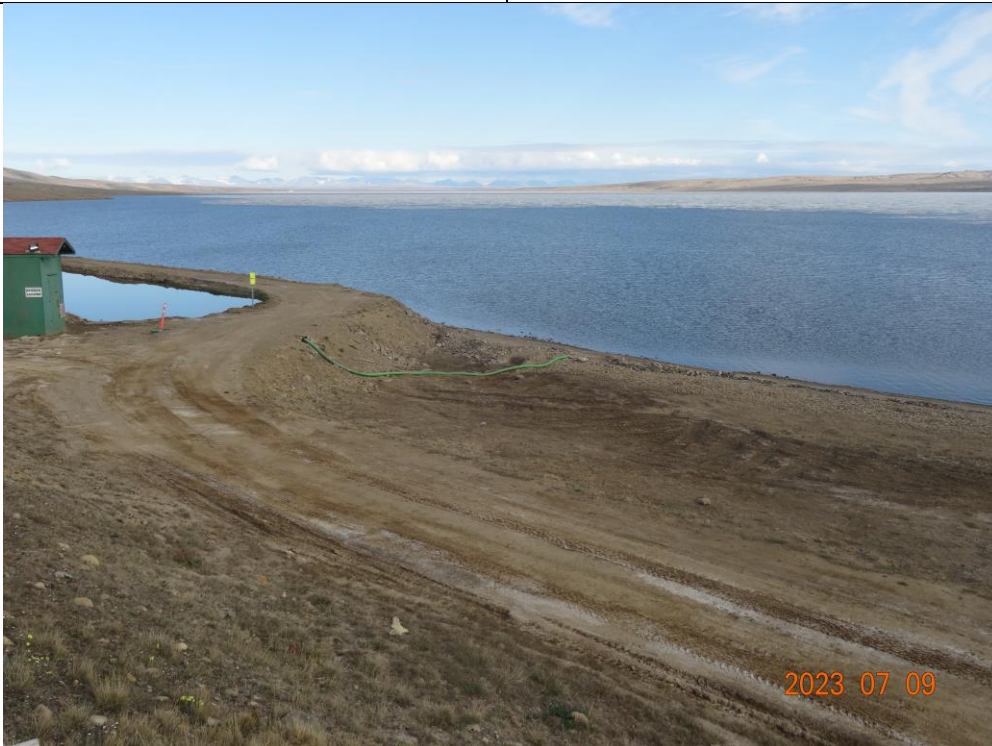
Photo No.	Lat/Long (DD.MM.SS.SS, NAD83)
Photo #37	Click or tap here to enter text.

30. The sewage lagoon decanting hose was observed to be too close to the ocean. (approx. 5 Metres) When decanting, the end of the decanting effluent line should be at least 31 metres or more from the high water mark (Photo #37)

In this image, the hoses that are used to decant the sewage lagoon. The end of this hose approximately 5metres from the high water mark. The end of the hose should be above 31metres way from the high water mark.

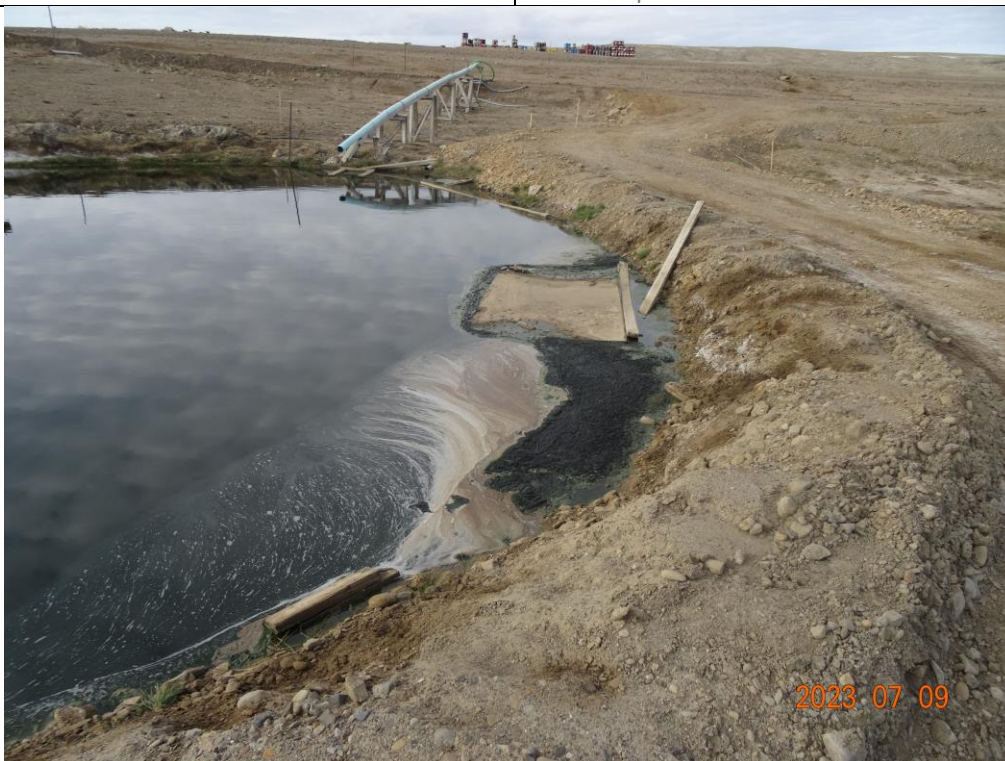
Photo No.
Photo #38

28. Inspectors BOLT and MONTEITH inspected the sewage lagoon and a small building with a sump located in side (Photo #34)
29. The sewage lagoon was observed with floating debris of wood and some sludge build up on the surface. (Photo#38)

Loose debris and sludging observed in the sewage lagoon.

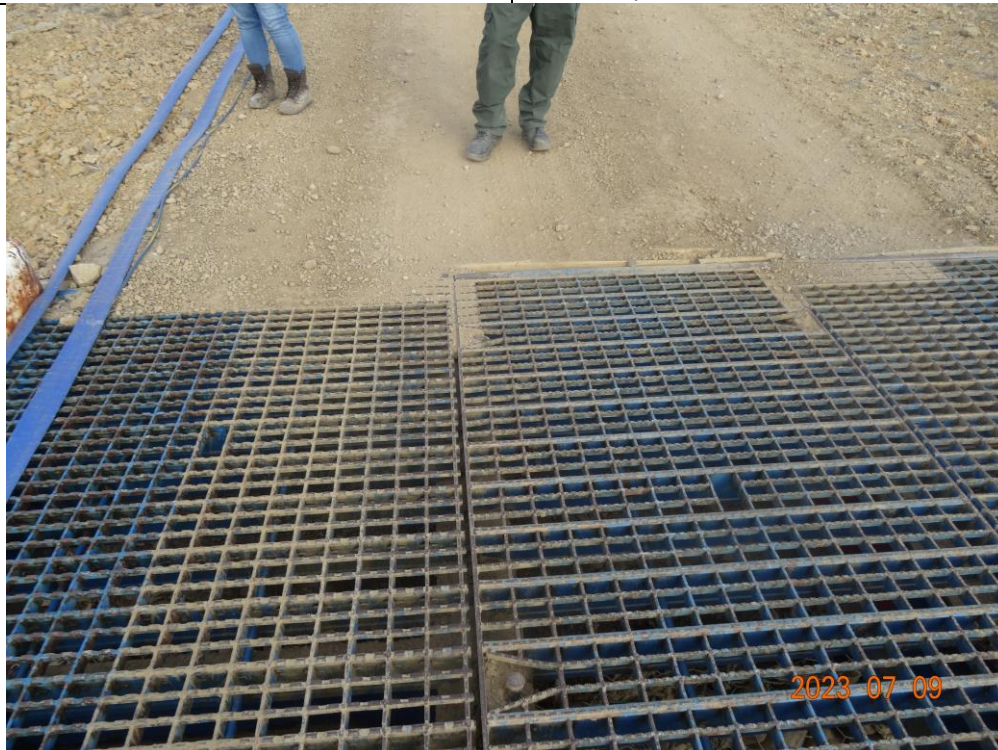
Photo No.
Photo #41

The bridge that that crosses Station Creek is causing sedimentation.

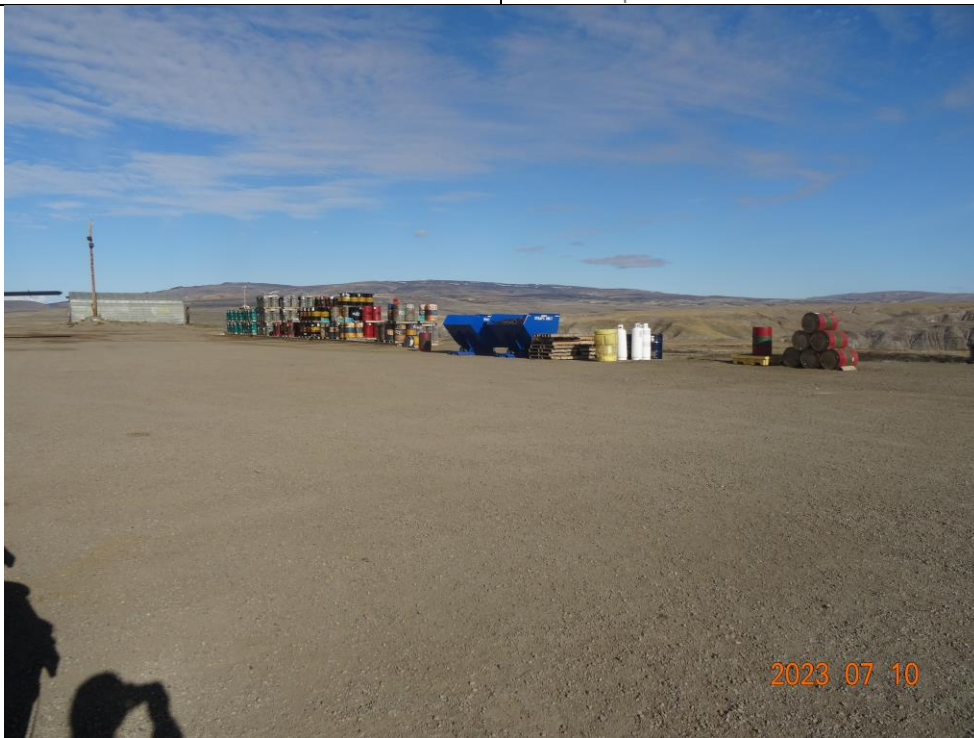
Photo No.
Photo #45

33. The fuel cache located on the apron at the airstrip is acceptable to the inspectors. Almost all barrels are in secondary containment. Sorting and signage is very well done. No Concerns noted. (Photo #45)

This image was taken from the apron of the airstrip. Image tries to capture the Tidiness of the fuel storage. Majority of the fuel is in secondary containment and spill kits are present in the area. All the barrels are stacked on top of a steel spill containment platform.
