WATER LICENCE INSPECTION FORM

Licensee	Licensee Representative
Department of National Defence	William Wyman
Licence No. / Expiry	Representative's Title
3BC-BAF1929	Environmental Officer
Land / Other Authorizations	Land / Other Authorizations
Date of Inspection	Inspector
September 7, 2021	Joseph Monteith
Activities Inspected	
<input type="checkbox"/> Camp <input type="checkbox"/> Drilling <input type="checkbox"/> Mining <input type="checkbox"/> Construction <input type="checkbox"/> Reclamation <input type="checkbox"/> Fuel Storage	
<input type="checkbox"/> Roads/Hauling <input checked="" type="checkbox"/> Other: Potable Water Source, Hazardous Waste Facility, Sewage Disposal Facility, incinerator. <input type="checkbox"/> Other: remediation site, bulk metal

On September 7, 2021, a Water Licence inspection was conducted at the North Warning Sites' BAF-3 Long Range Station on Brevoort Island, Qikiqtani Region, Nunavut to verify compliance with Water Licence 8BC-BAF1929.

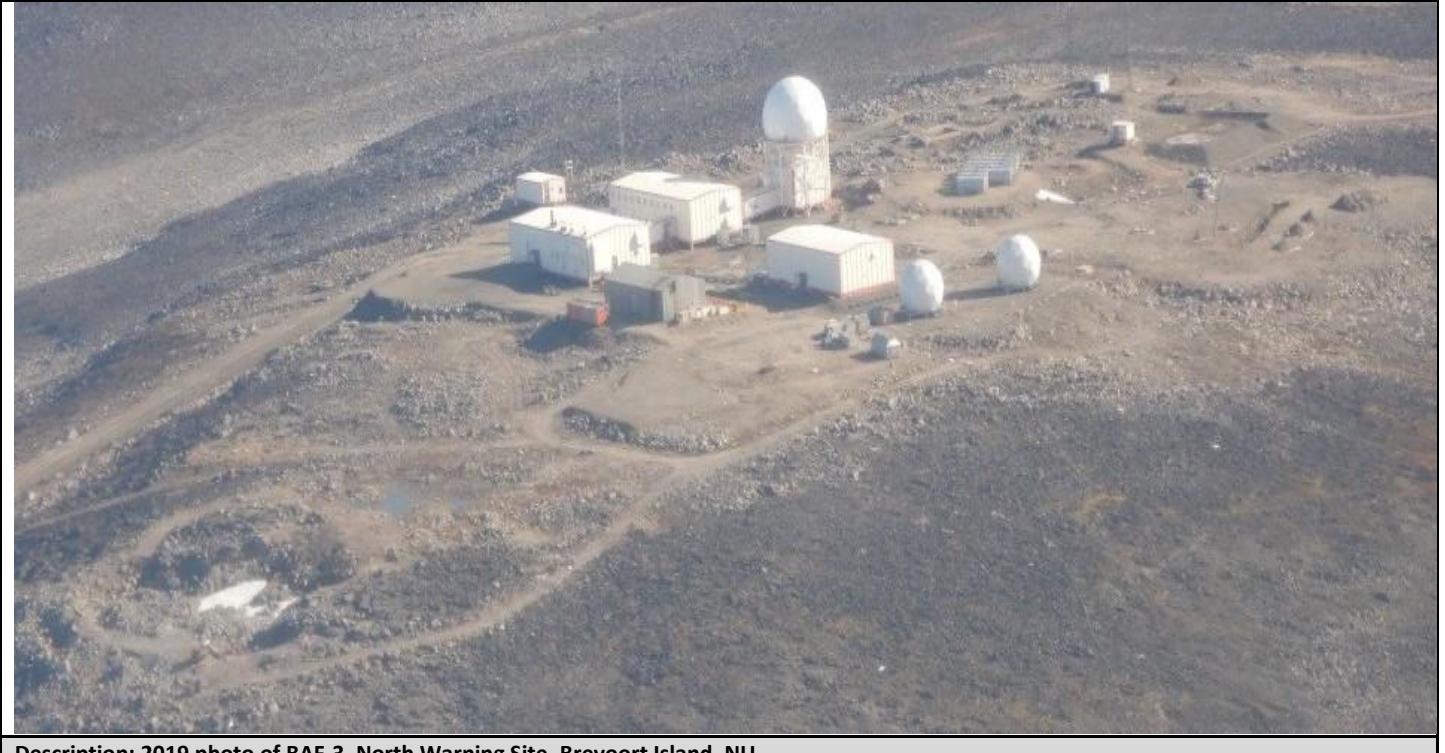
Date	Camera	Inspector
September 7, 2021	Nikon Coolpix	Joseph Monteith
Photo Log #1	Location	
Photo 1	Brevoort Island, NU

The BAF-3 Long Range Radar Station (BAF-3) is located at an elevation of 366 m above sea level on the southern end of Brevoort Island. (See photo 1). Brevoort Island is 40-km long and 10-km wide. It is found off the east coast of Baffin Island, approximately 250 km Northeast of Iqaluit.

Description: 2019 photo of BAF-3, North Warning Site, Brevoort Island, NU

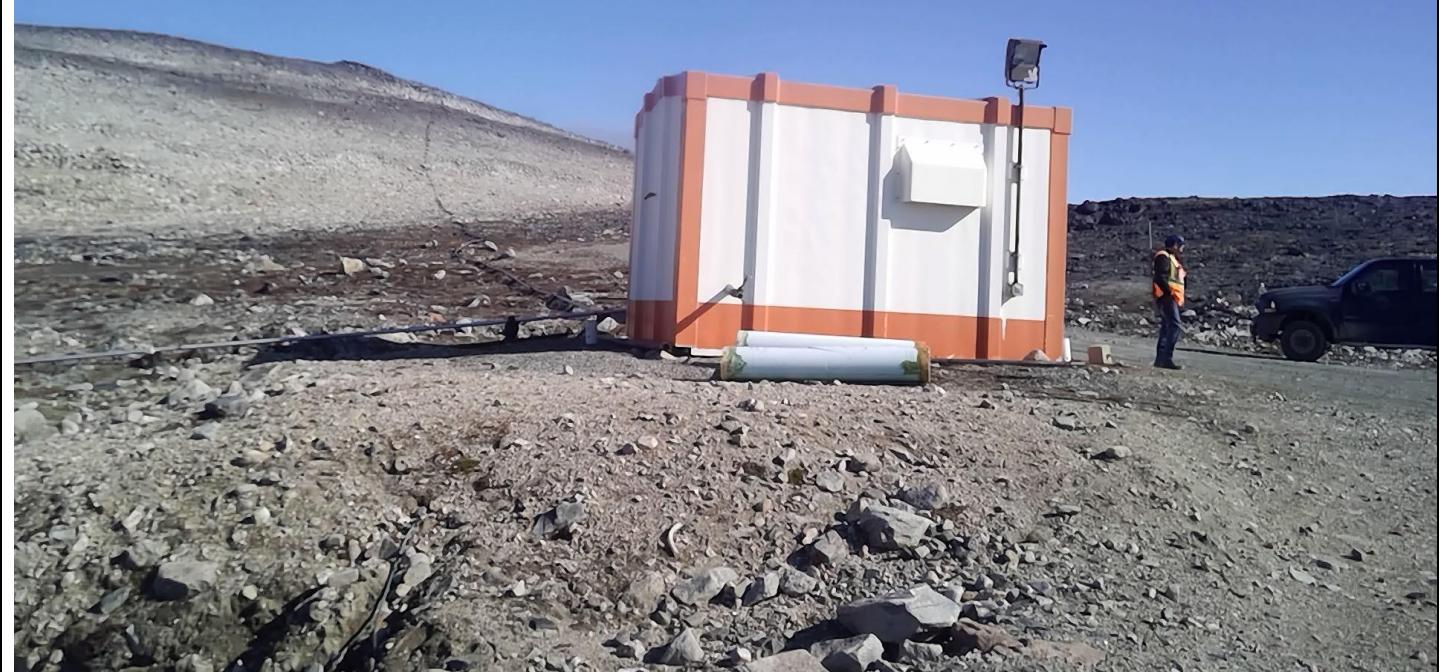
Photo Log	Location
Photo 2	Brevoort Island, NU

Description: Pump house recharges pipes which transfers water to the BAF-3 facility.

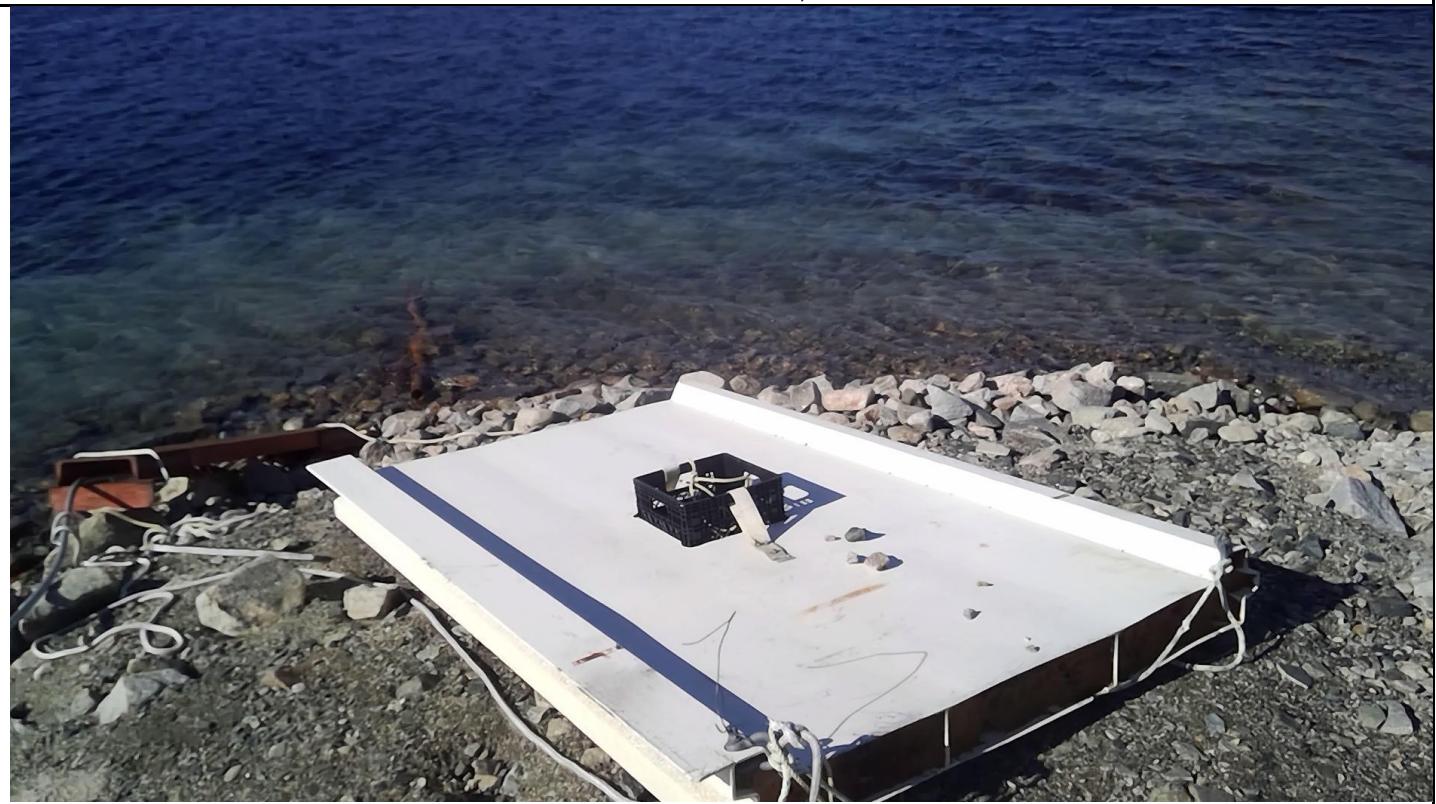
Photo 3

Description: Floating dock with milk carton installed to act as a fish mesh screen when withdrawing from the freshwater source.

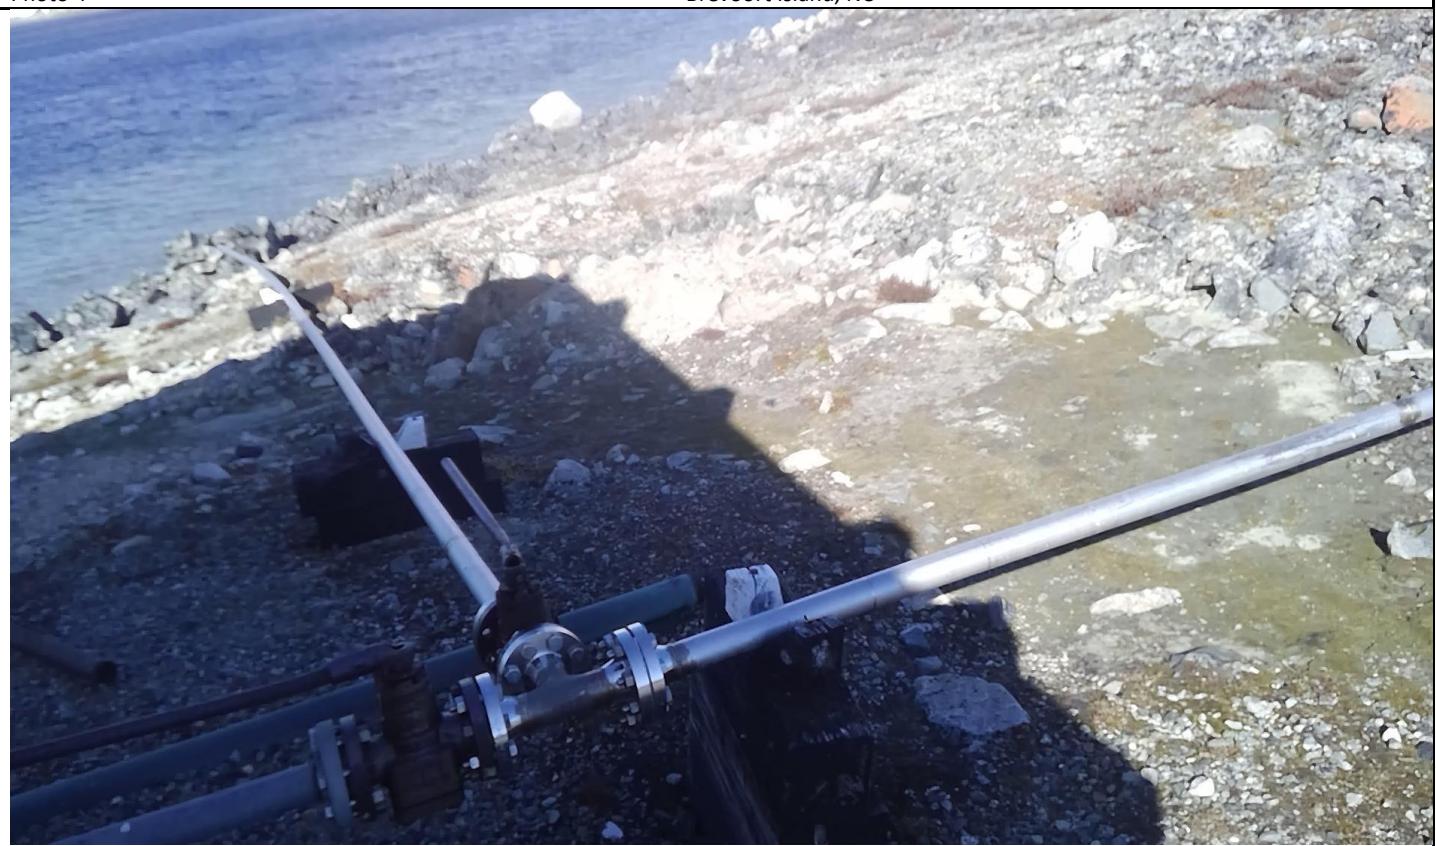
Photo 4

Description: intake pipe to pump house.

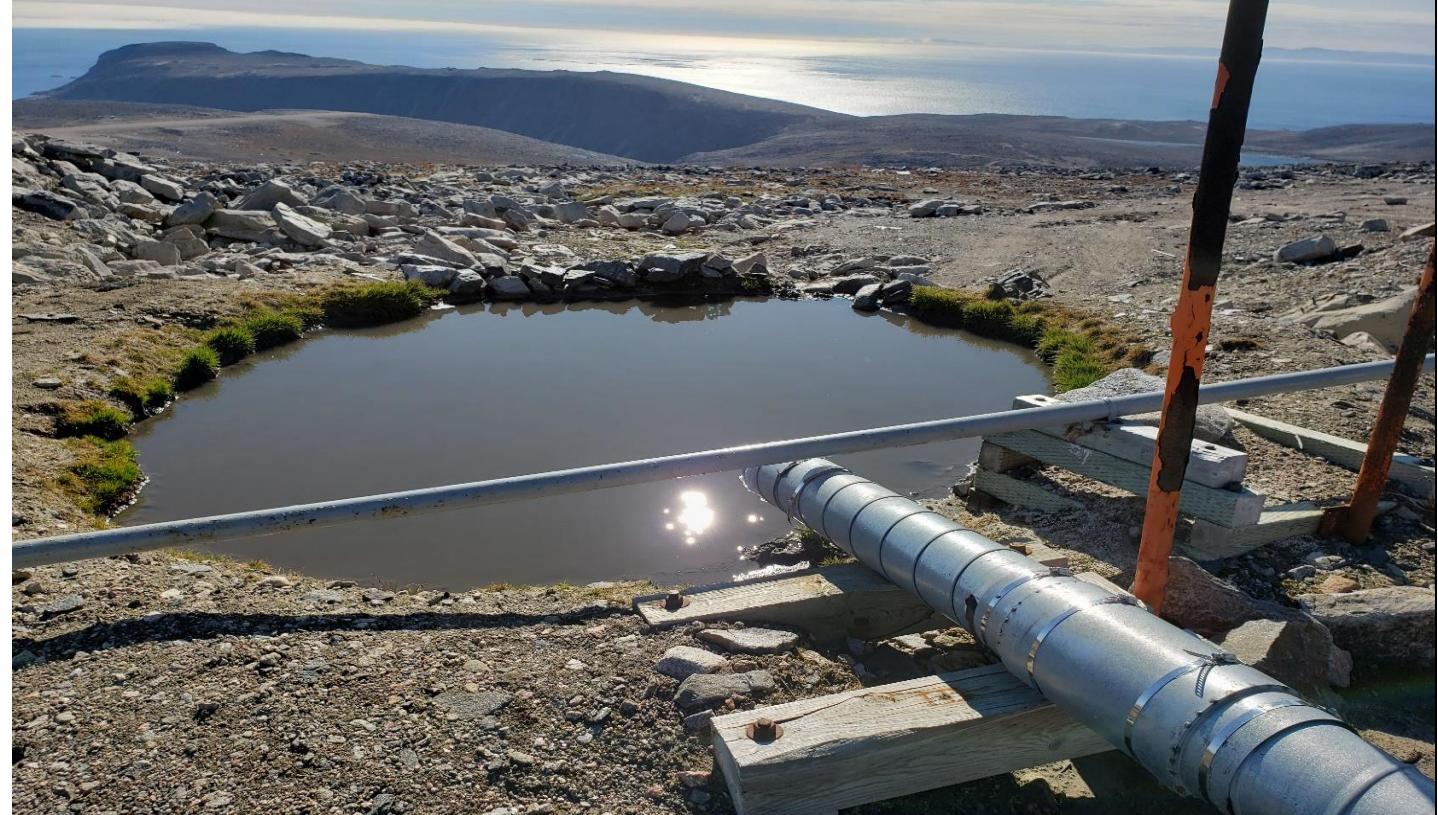
Photo 8

10. The Sewage system consists of a septic tank, and an outfall pipe that drops its waste into a sump.
11. No observations were made of the septic tank during the inspection.
12. The outfall pipe end was above the sewage waste water table in the sump (See photo 8).
13. The Sump pit appeared to be full, and was built up on one side of the wall with rocks. Seepage appears to have leaked through the rocks (See photo 8).
14. Pacto Incinerator toilet (photo 14).

Description: Outfall pipe for sewage

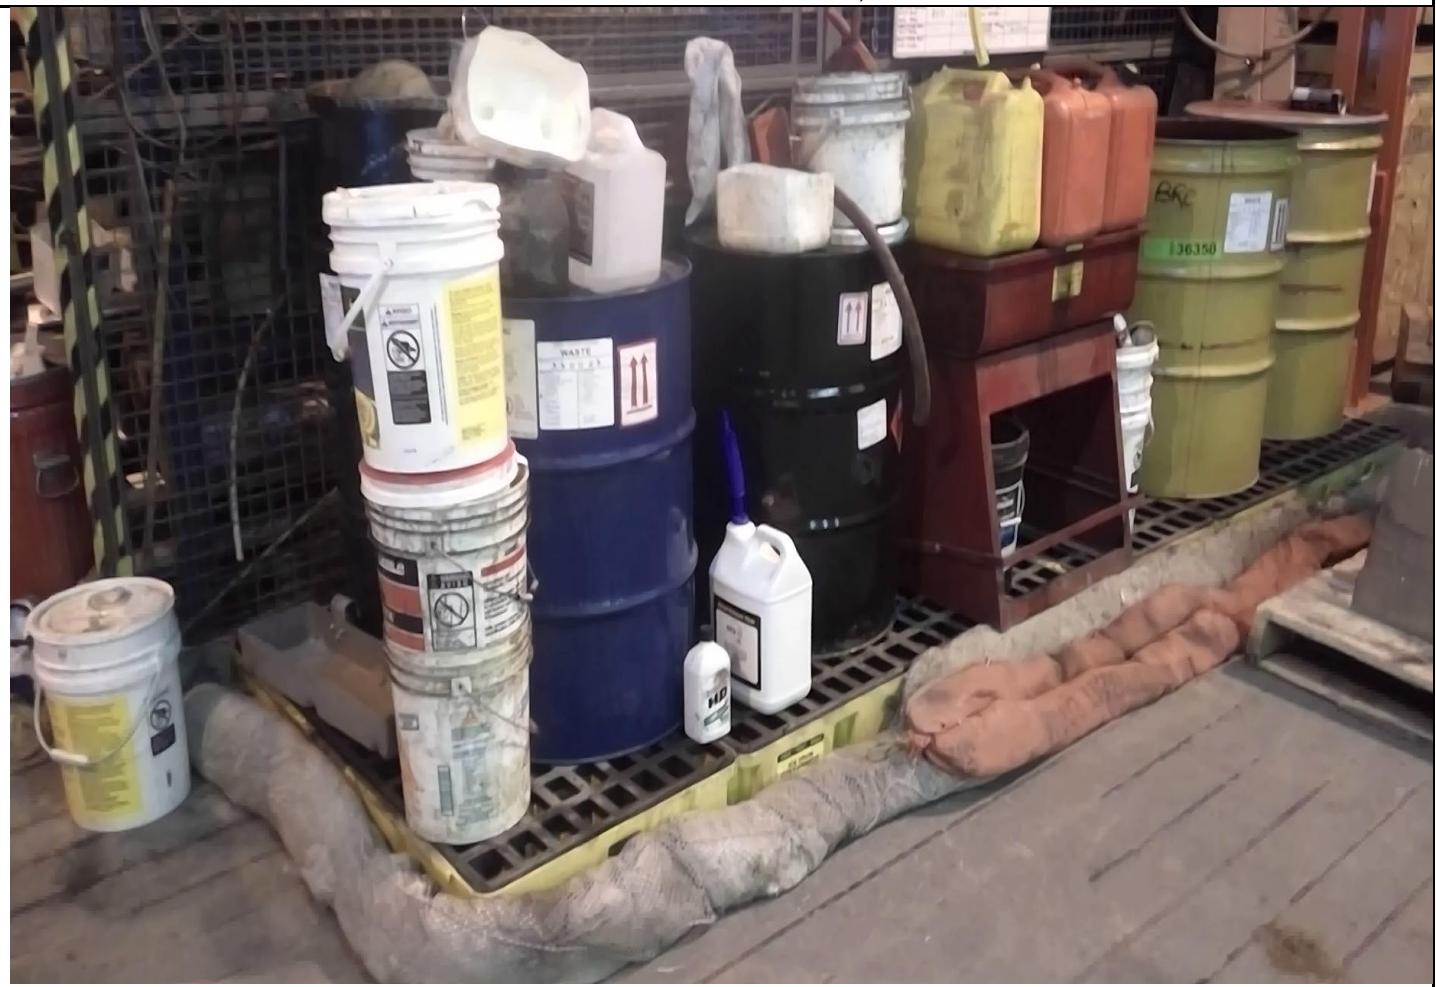
Photo 9

17. Hazardous Waste was observed on site. BAF-3 stores hazardous waste from surrounding sites at BAF-3 before shipping it to a proper hazardous waste disposal facility in Quebec (See photo 9, 10, 11).

Description: Hazardous Materials, and waste storage and transfer station. Material is stored in secondary containment, and with hydrocarbon booms to capture any small spills.

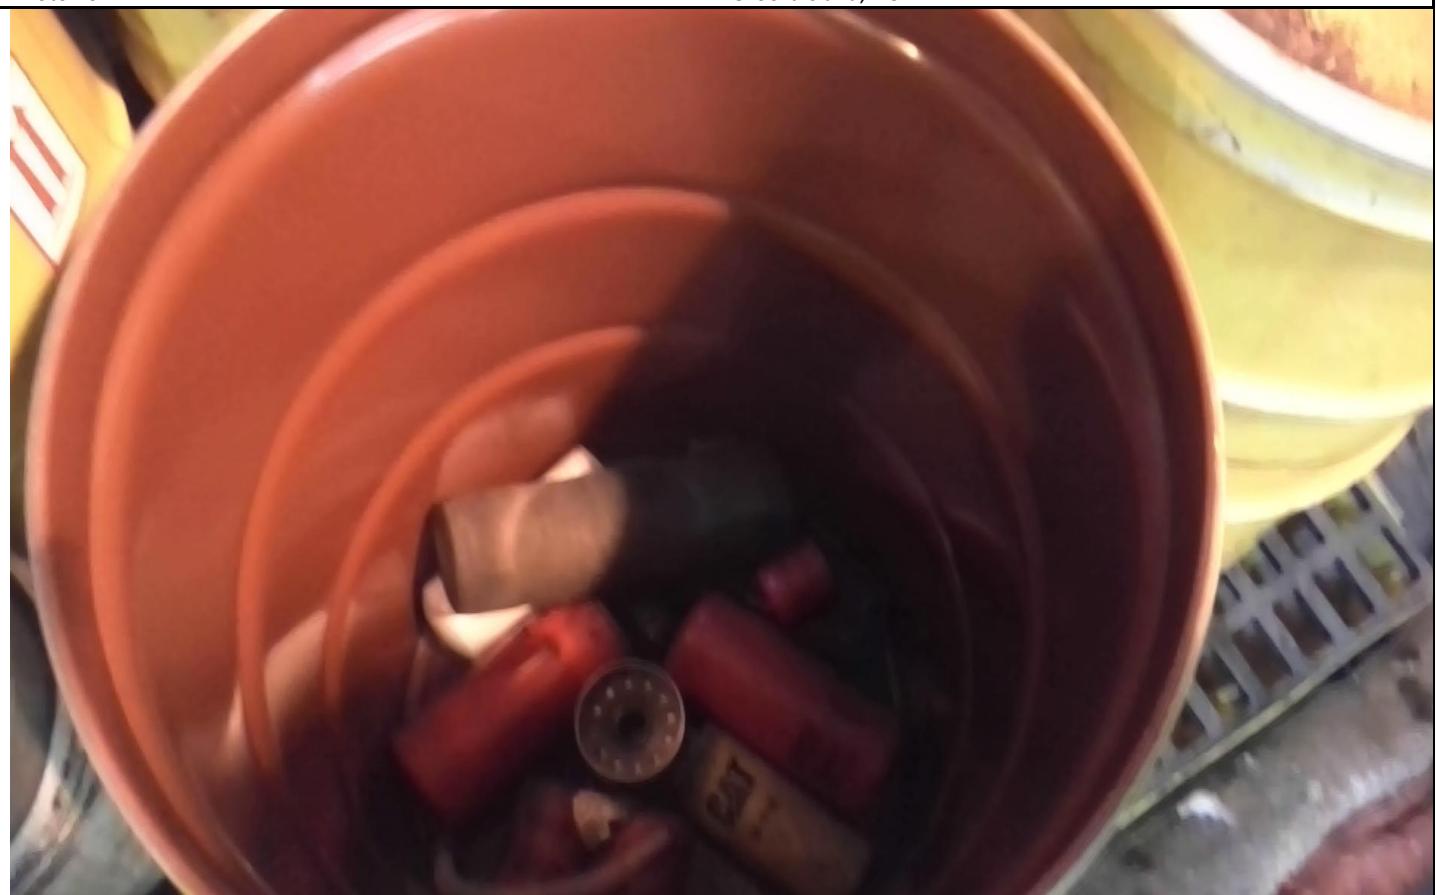
Photo 10

Description: Old oil filters and empty grease cans inside of hazardous waste drums. Used to store and transport hazardous waste.

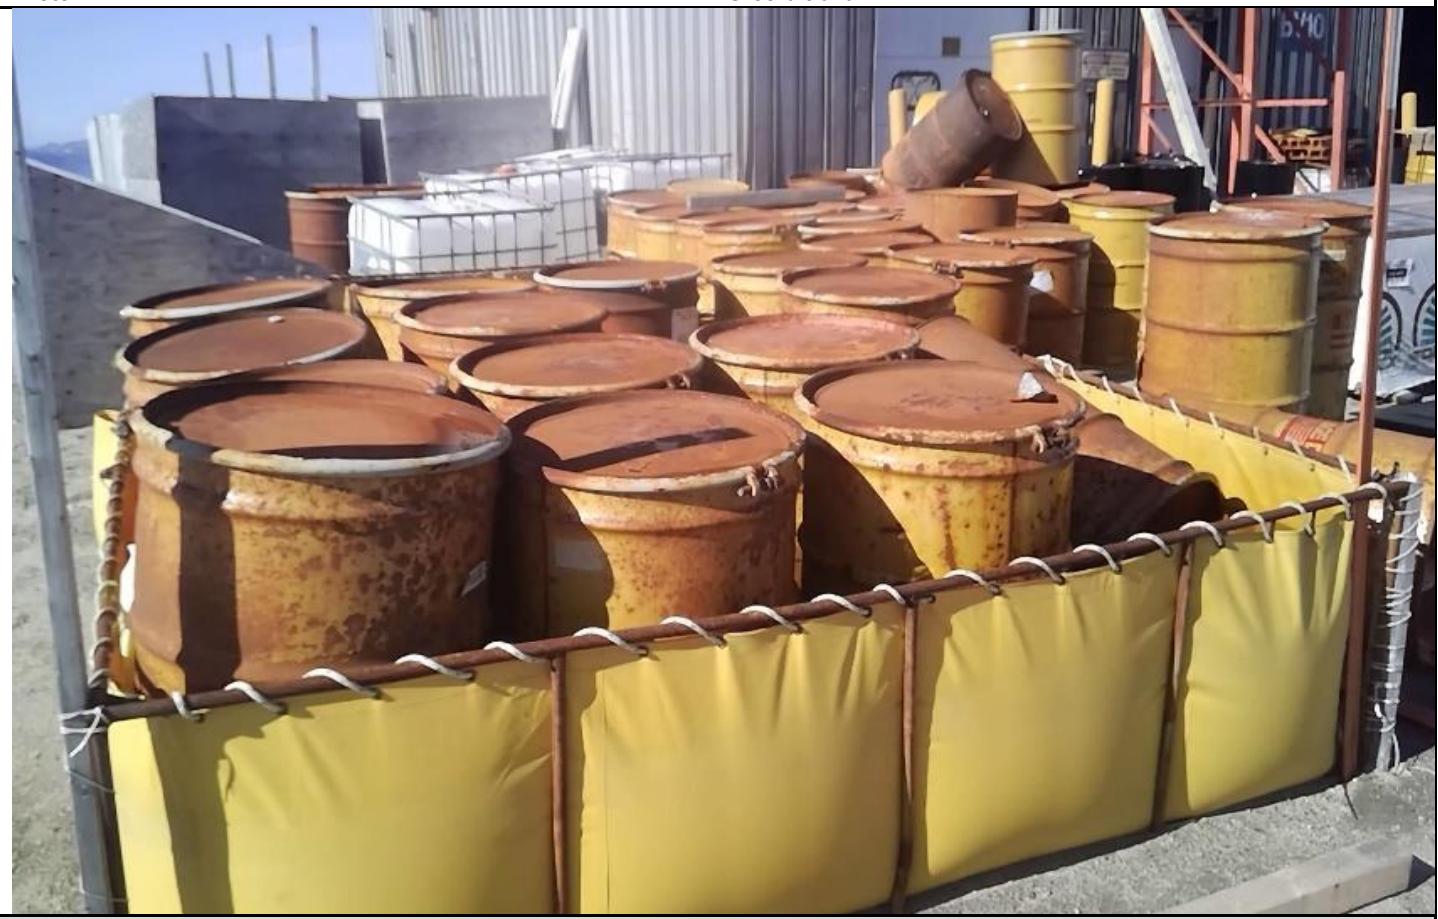
Photo 11

Description: Contaminated soil from spill. Secondary containment is filled with water.

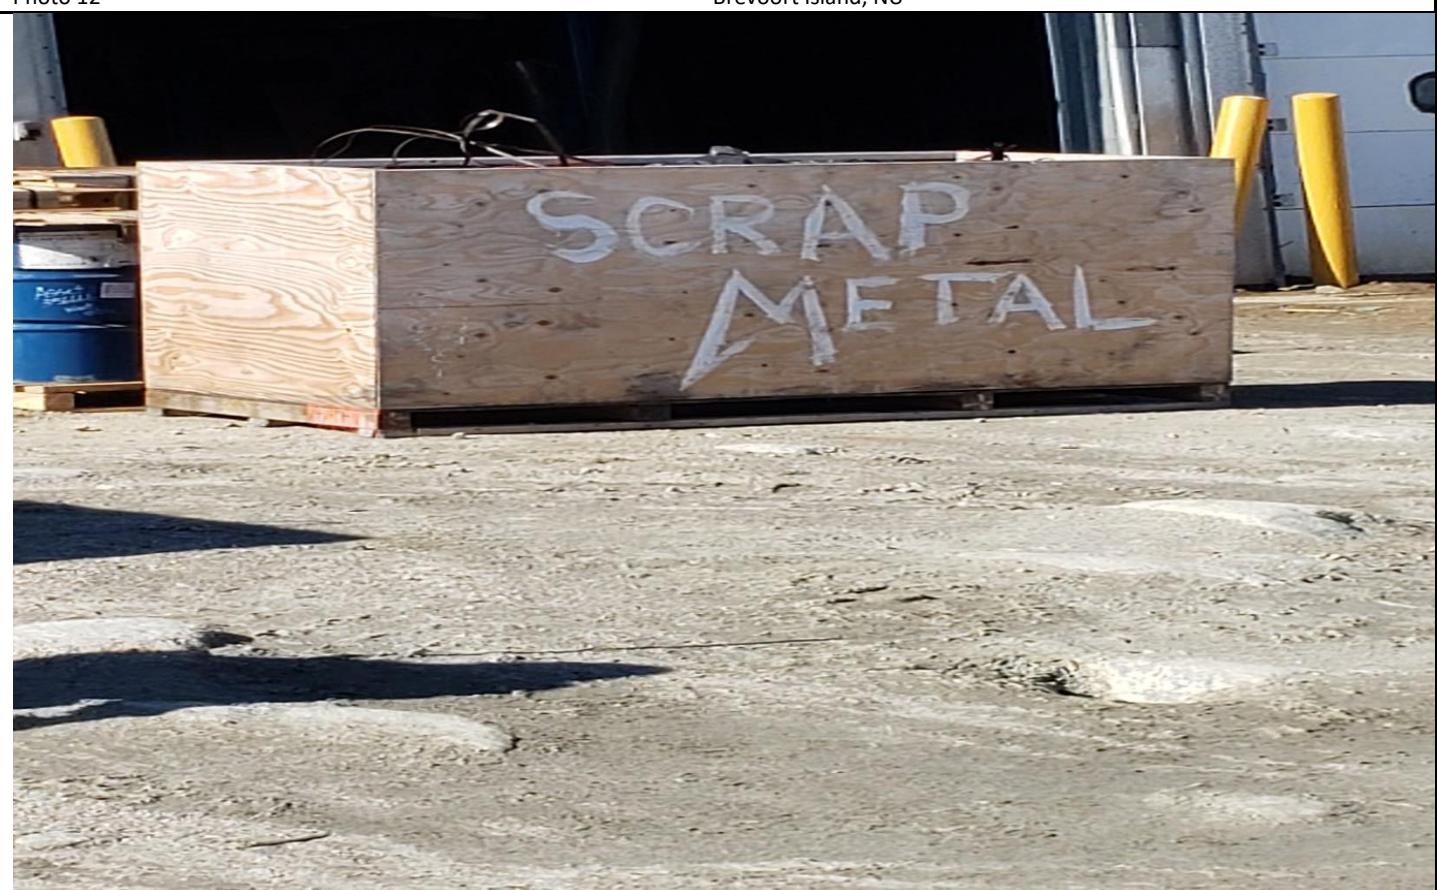
Photo 12

16. A box which contains the sites bulk metal waste. All bulk metal is transported south on sealift.

Description: Box of Scrap Metal – Bulk metal waste is transported out on sealift.

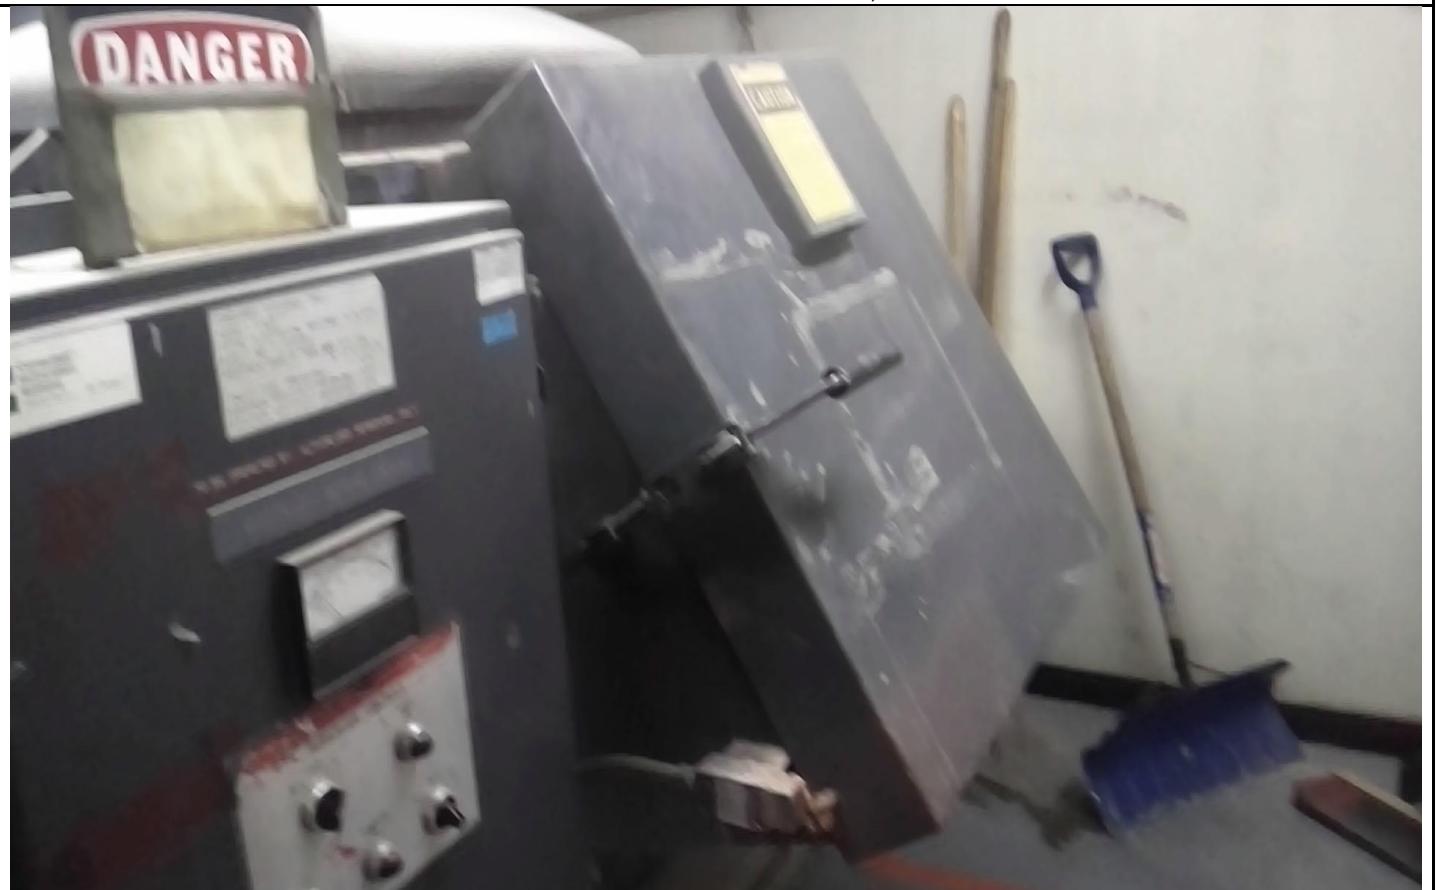
Photo 13

15. An incinerator was observed at the time of the inspection. Active and operating as intended (photo 13).

Description: Incinerator

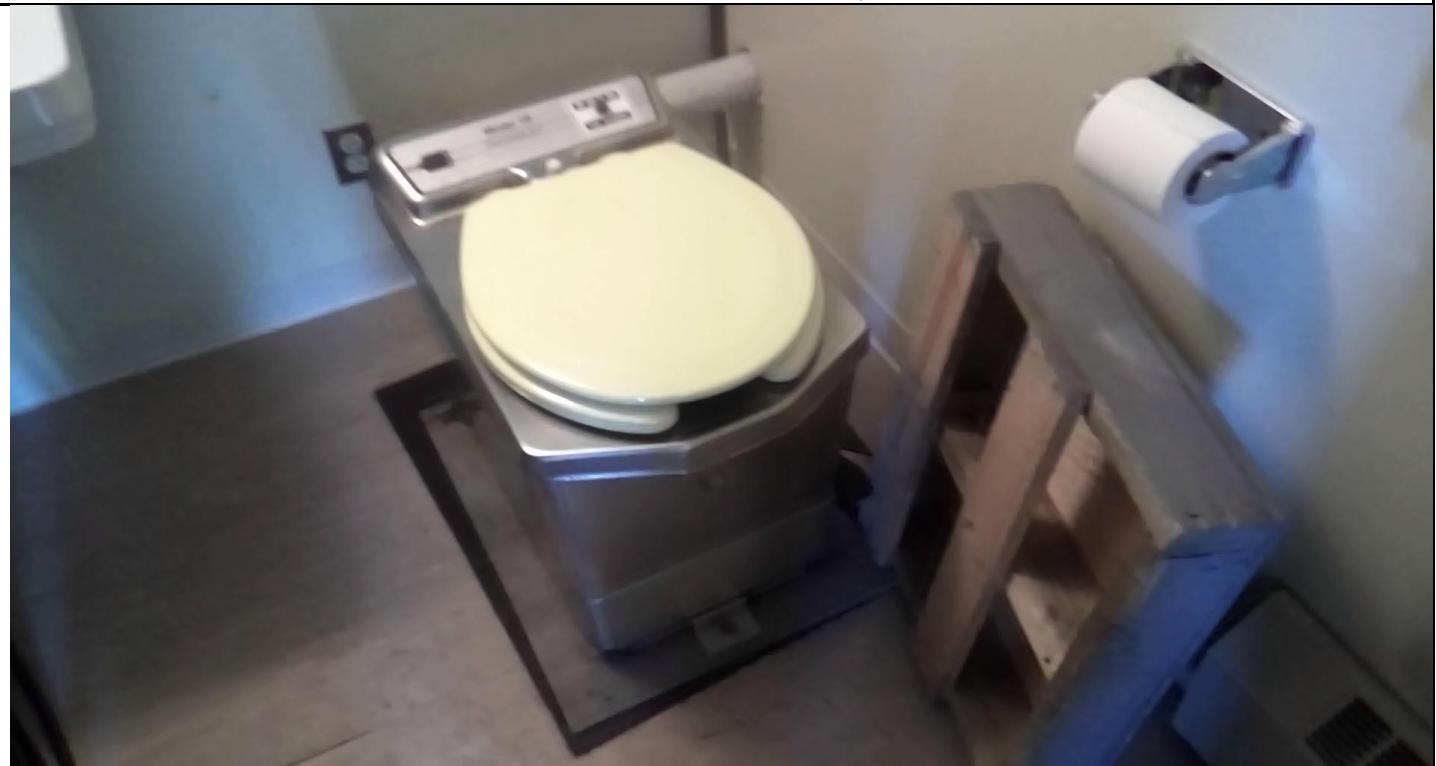
Photo 14

Description: Pacto Incinerator toilet – "Pacto Incineroilet"

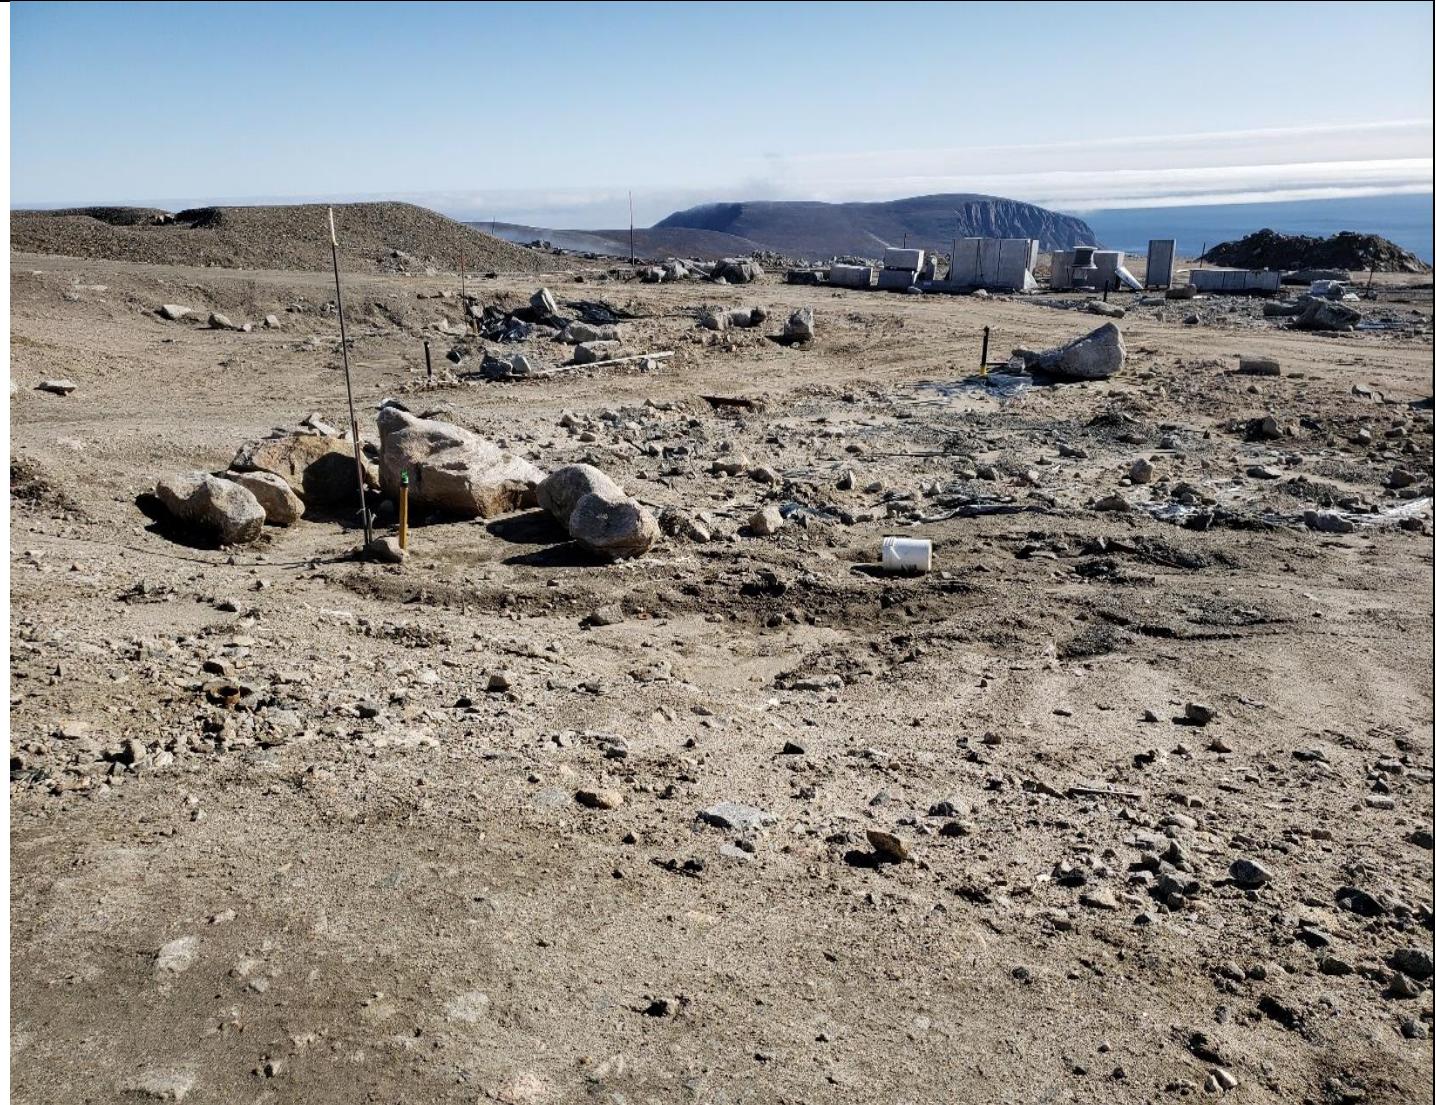
Photo 15

Description: Site of remediation. Spill Report will be in long term monitoring. Most captured fuel was being treated.
