## WATER LICENCE INSPECTION FORM

Licensee Major Creighton North Warning System Office 455 Boulevard de la Carrière, Gatineau, Quebec, J8Y 6W6		Licensee Representative Scott Charland – NWS A/Environmental officer - NWS Don Beattie – Raytheon Manager, Environmental, Health and Safety- Raytheon Canada	
Licence No. / Expiry 3BC-BAF0919		Representative's Title Acting Environmental Officer	
Land / Other Authorizations NIL		Land / Other Authorizations Nil	
Date of Inspection July 19, 2016		Inspector A.Keim	
Activities Inspected <input checked="" type="checkbox"/> Camp <input type="checkbox"/> Roads/Hauling		<input type="checkbox"/> Drilling <input type="checkbox"/> Mining <input type="checkbox"/> Construction <input type="checkbox"/> Reclamation <input type="checkbox"/> Fuel Storage <input type="checkbox"/> Other: Water Discharge <input type="checkbox"/> Other: Municipal

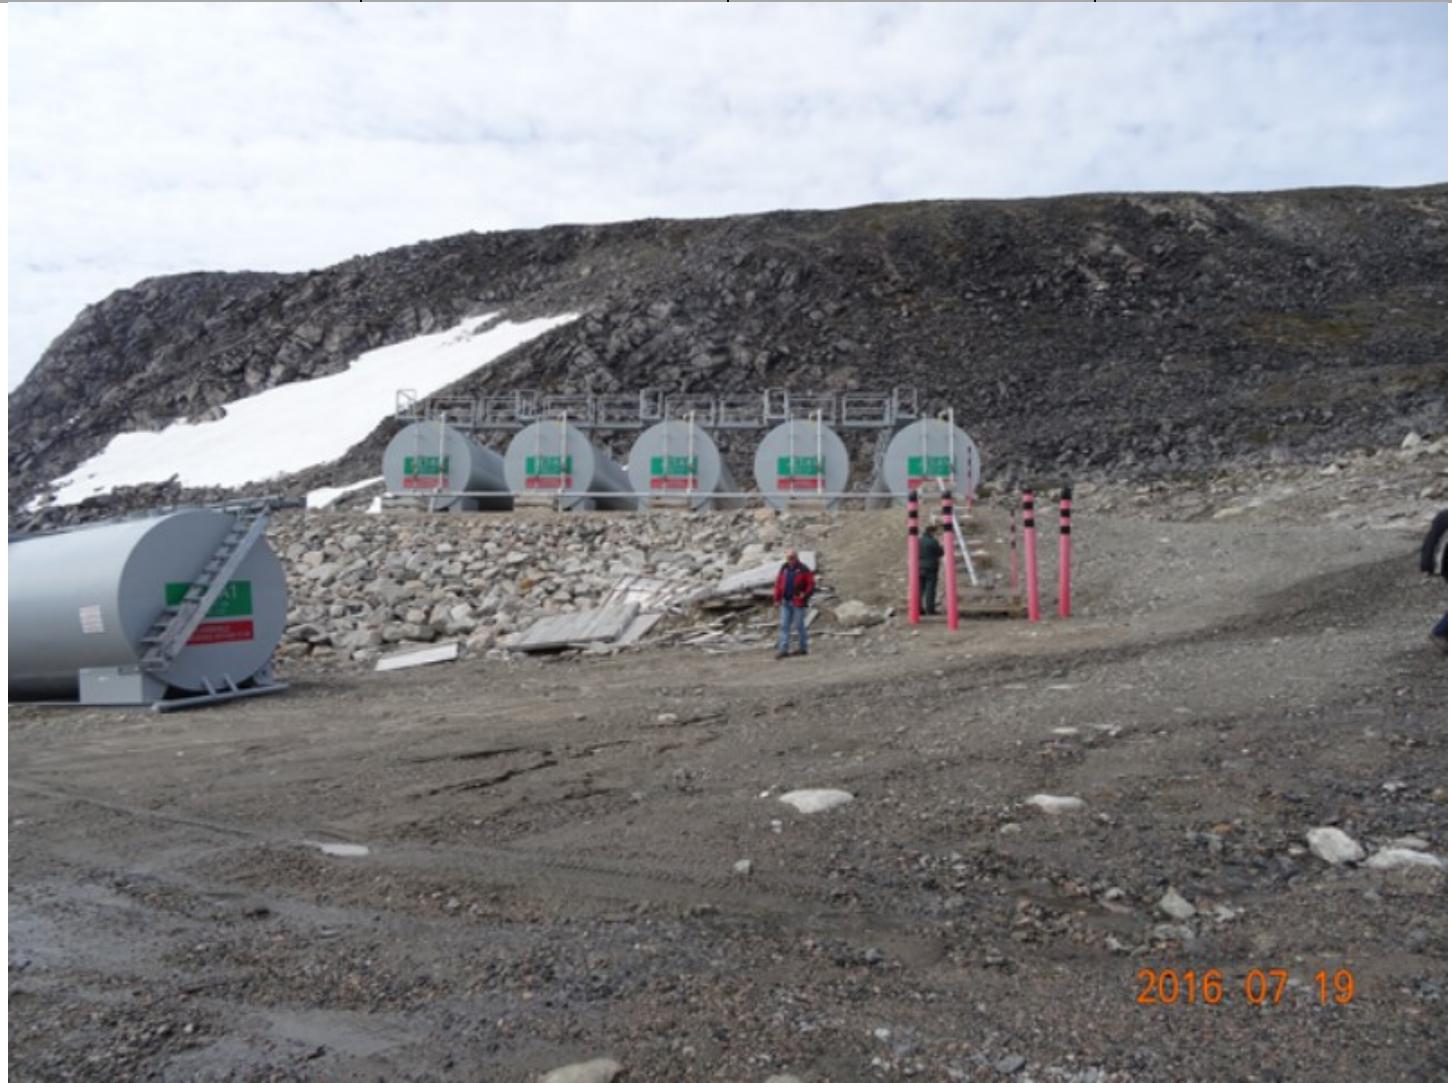
Figure 1 Beach tank farm. New tanks (5) Five in-service and two awaiting installation

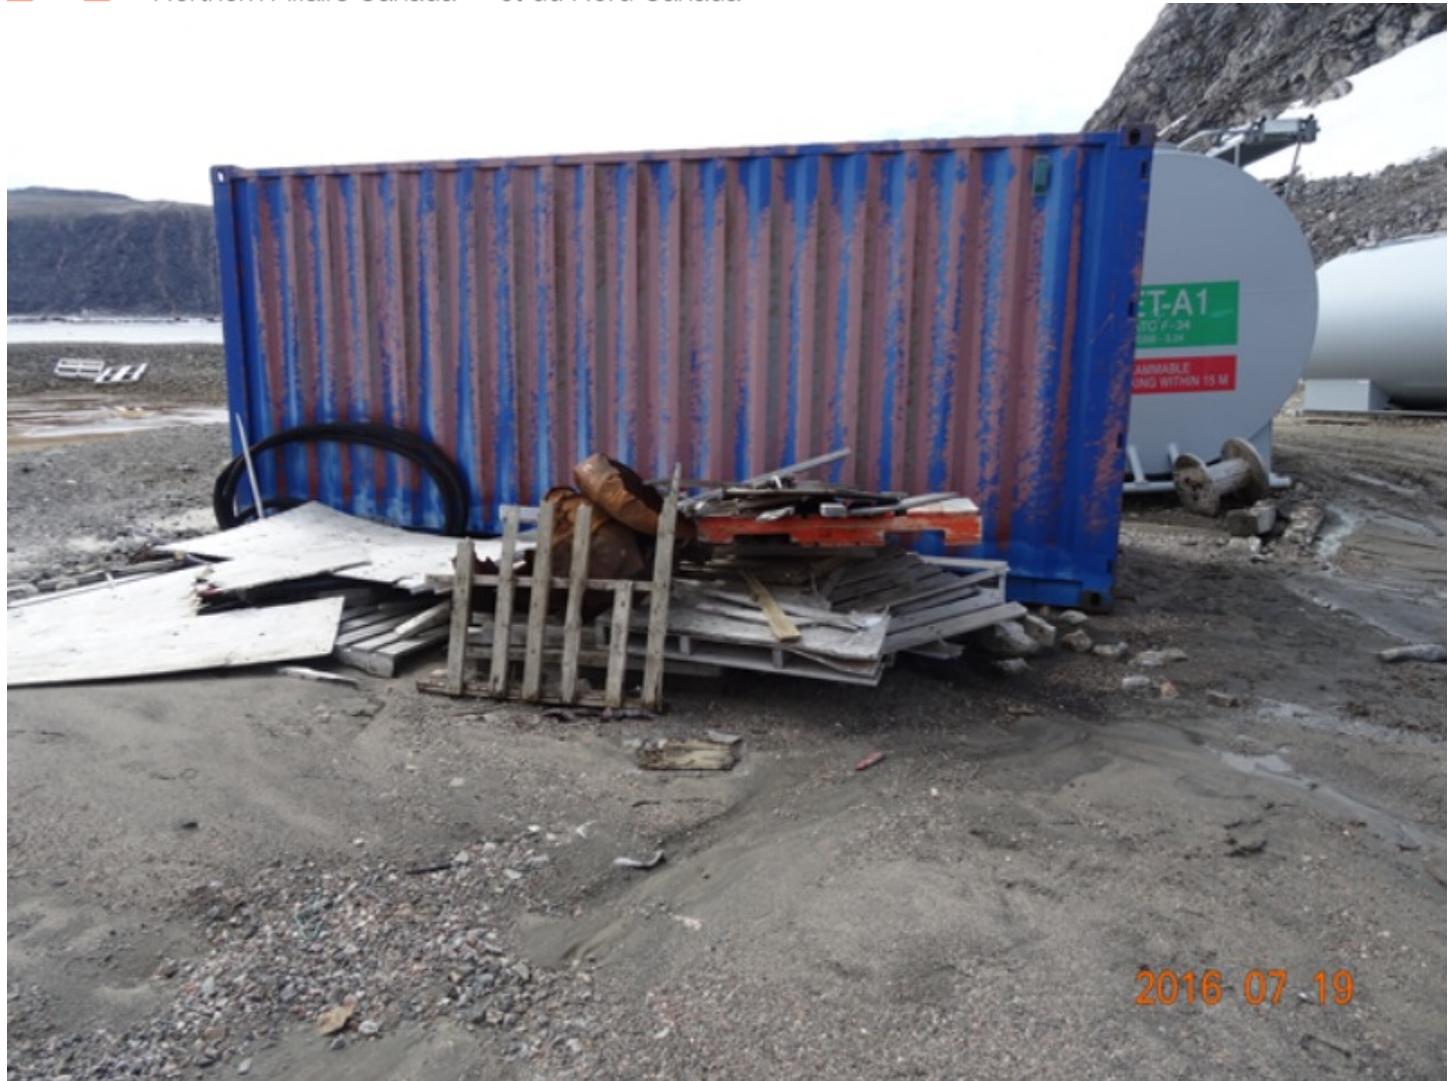
Figure 2 Pump station at Beach

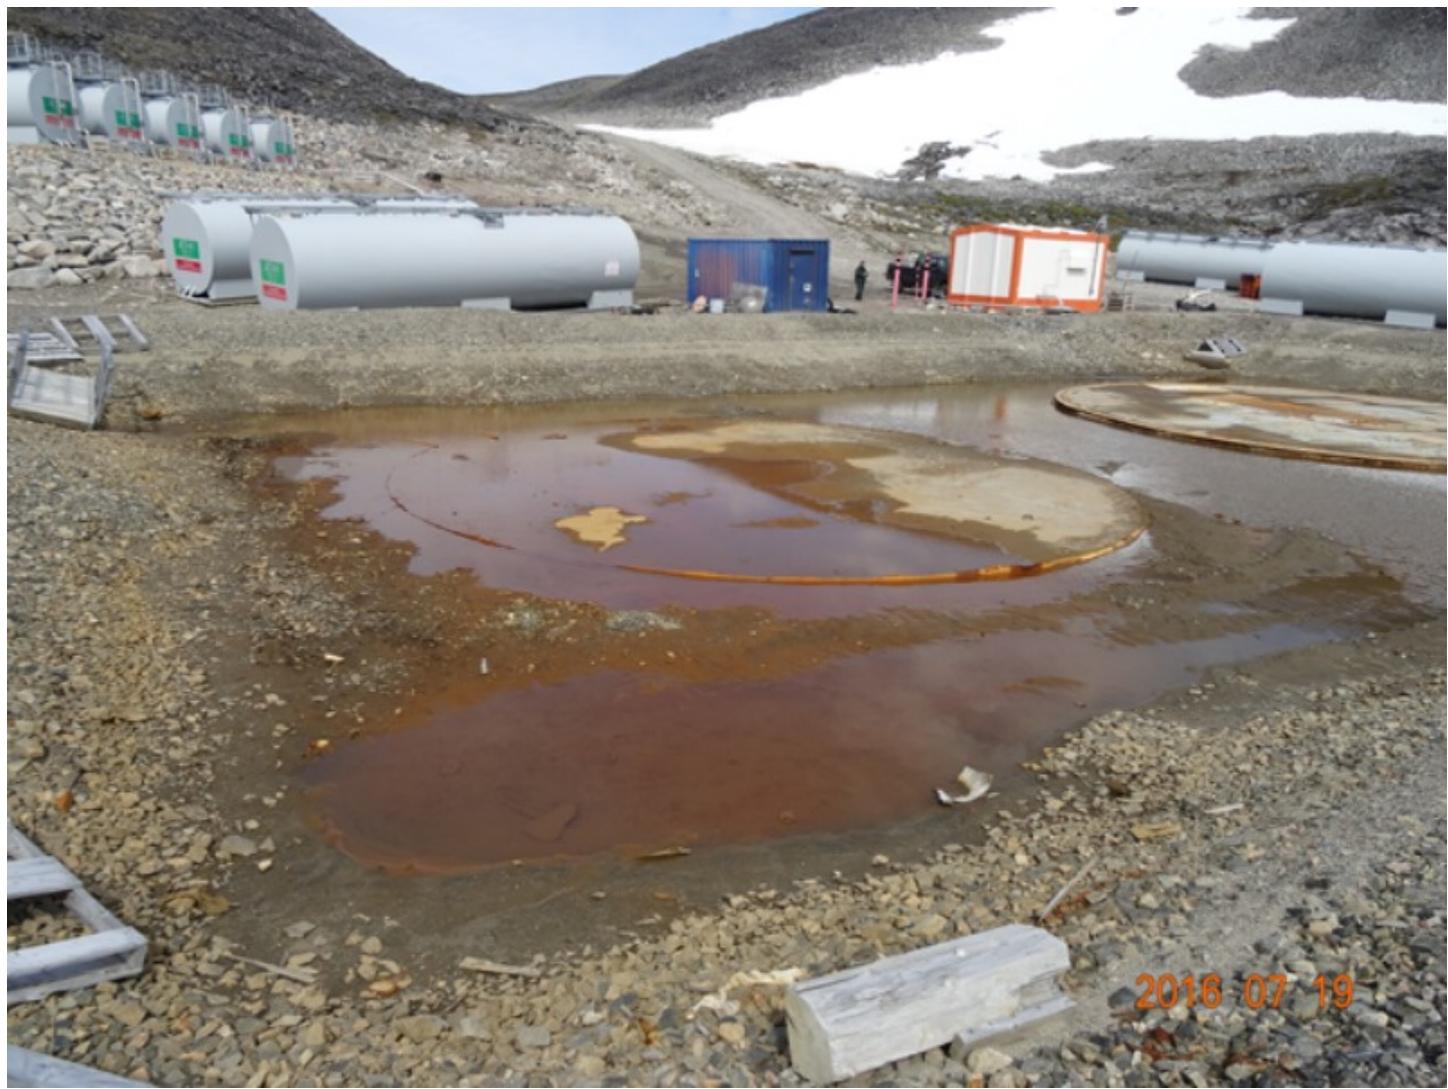
Figure 3 Legacy- Beach tank removal project

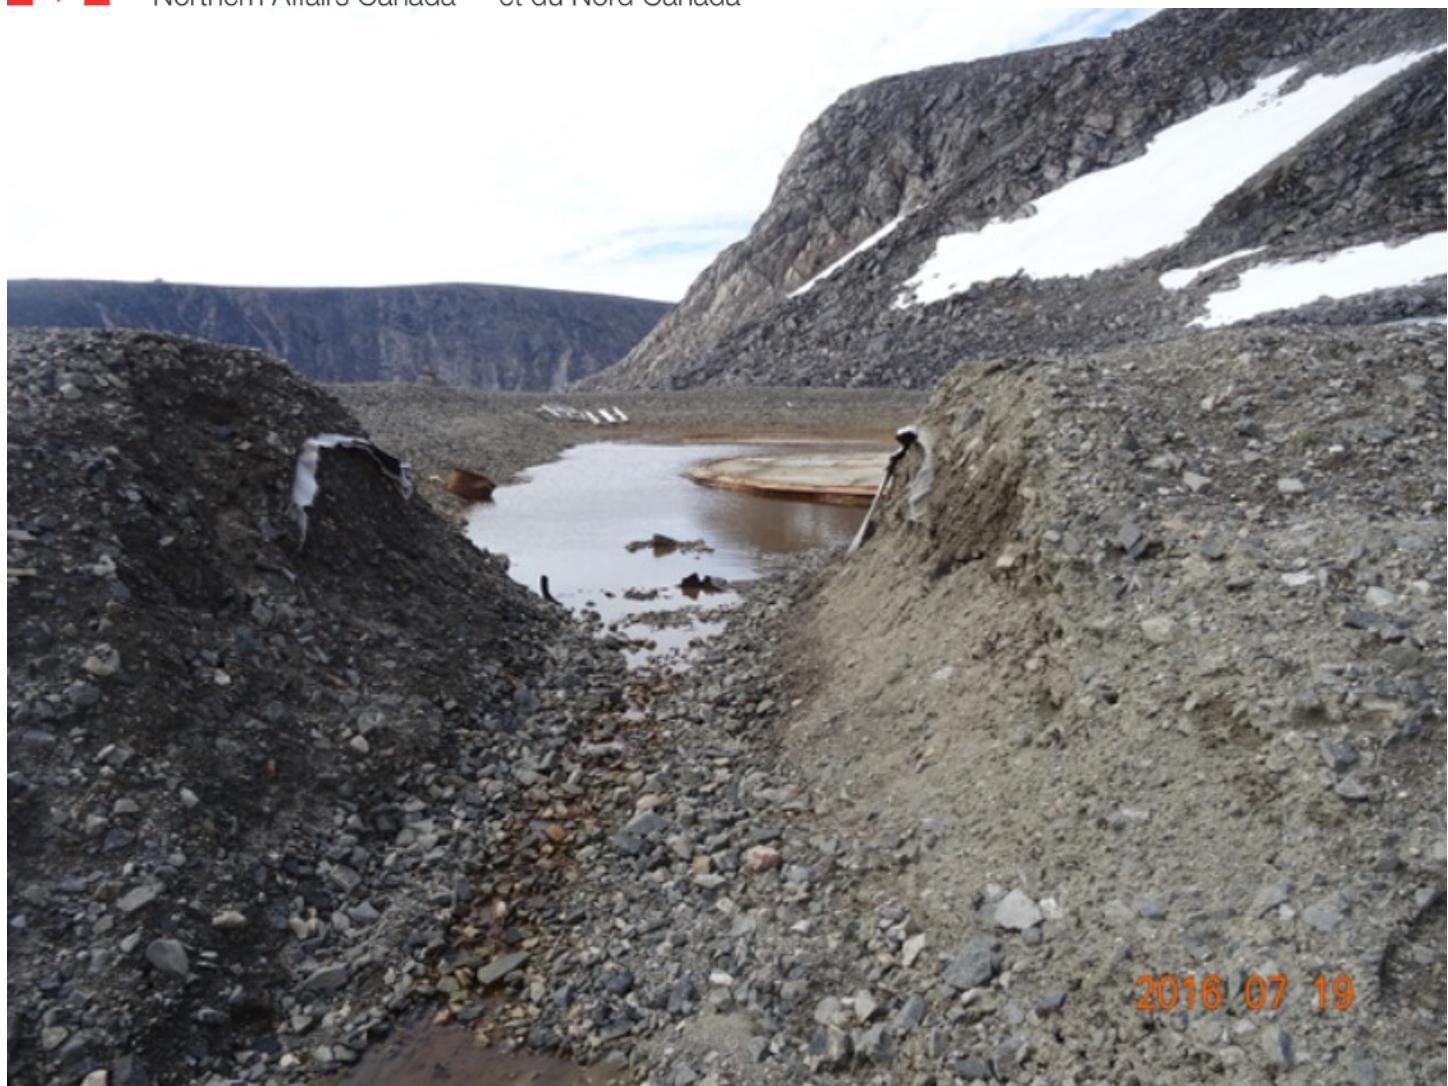
Figure 4 Legacy Beach tank removal project - Berm wall breach to remove water (2015)

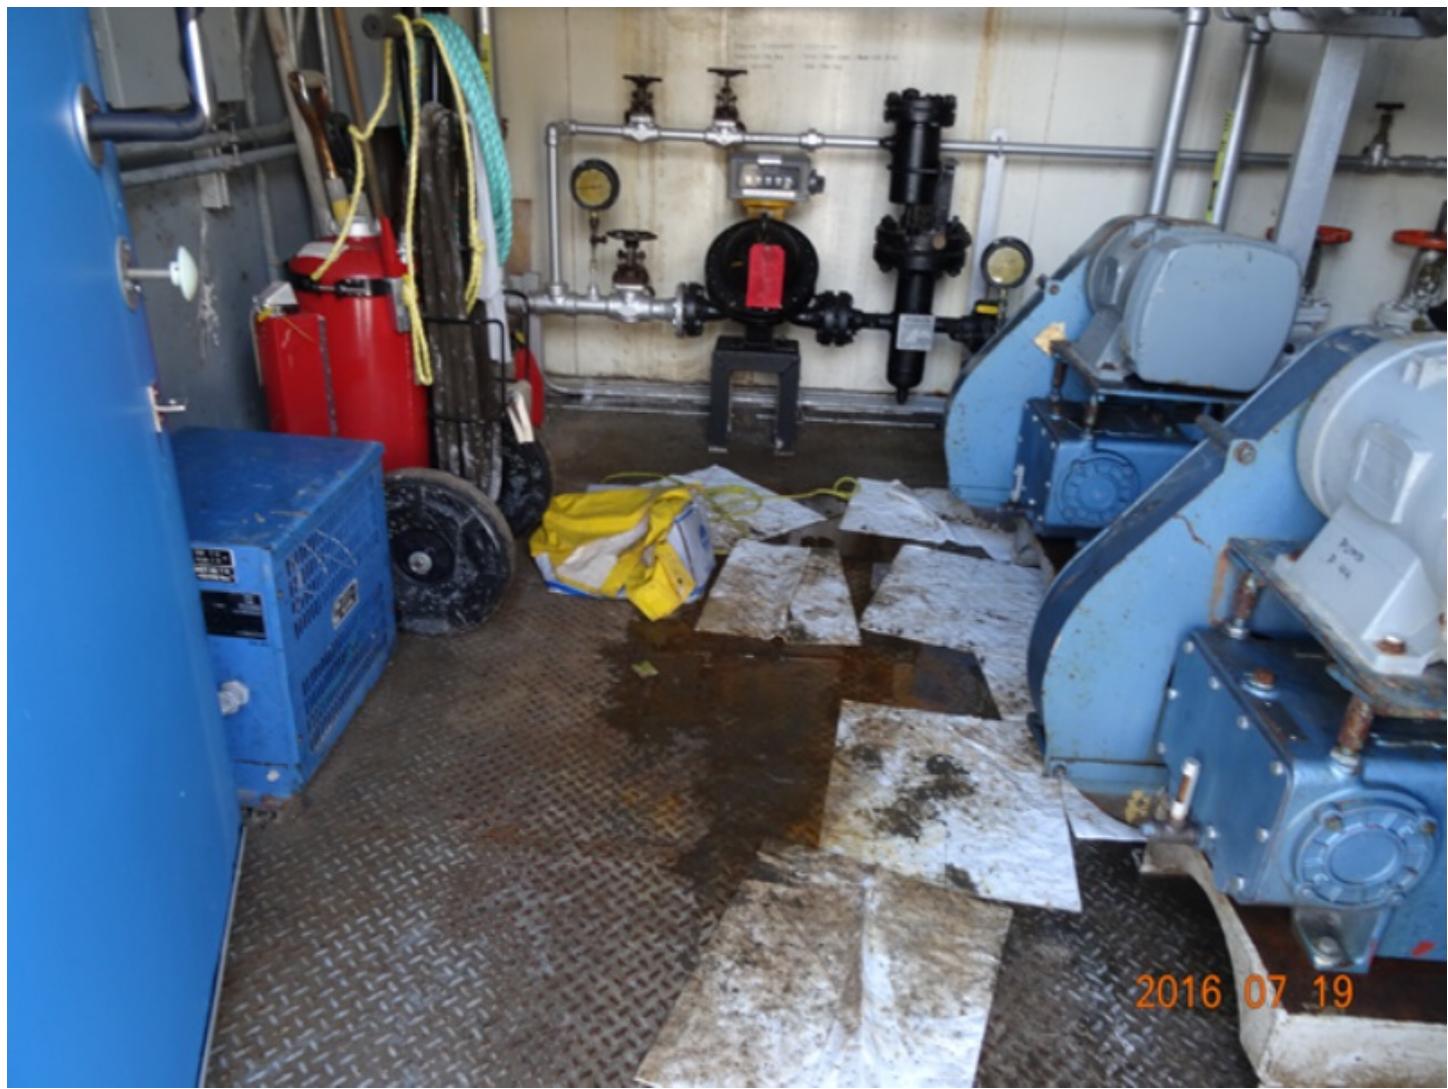
Figure 5 Beach pump house July 19,2016

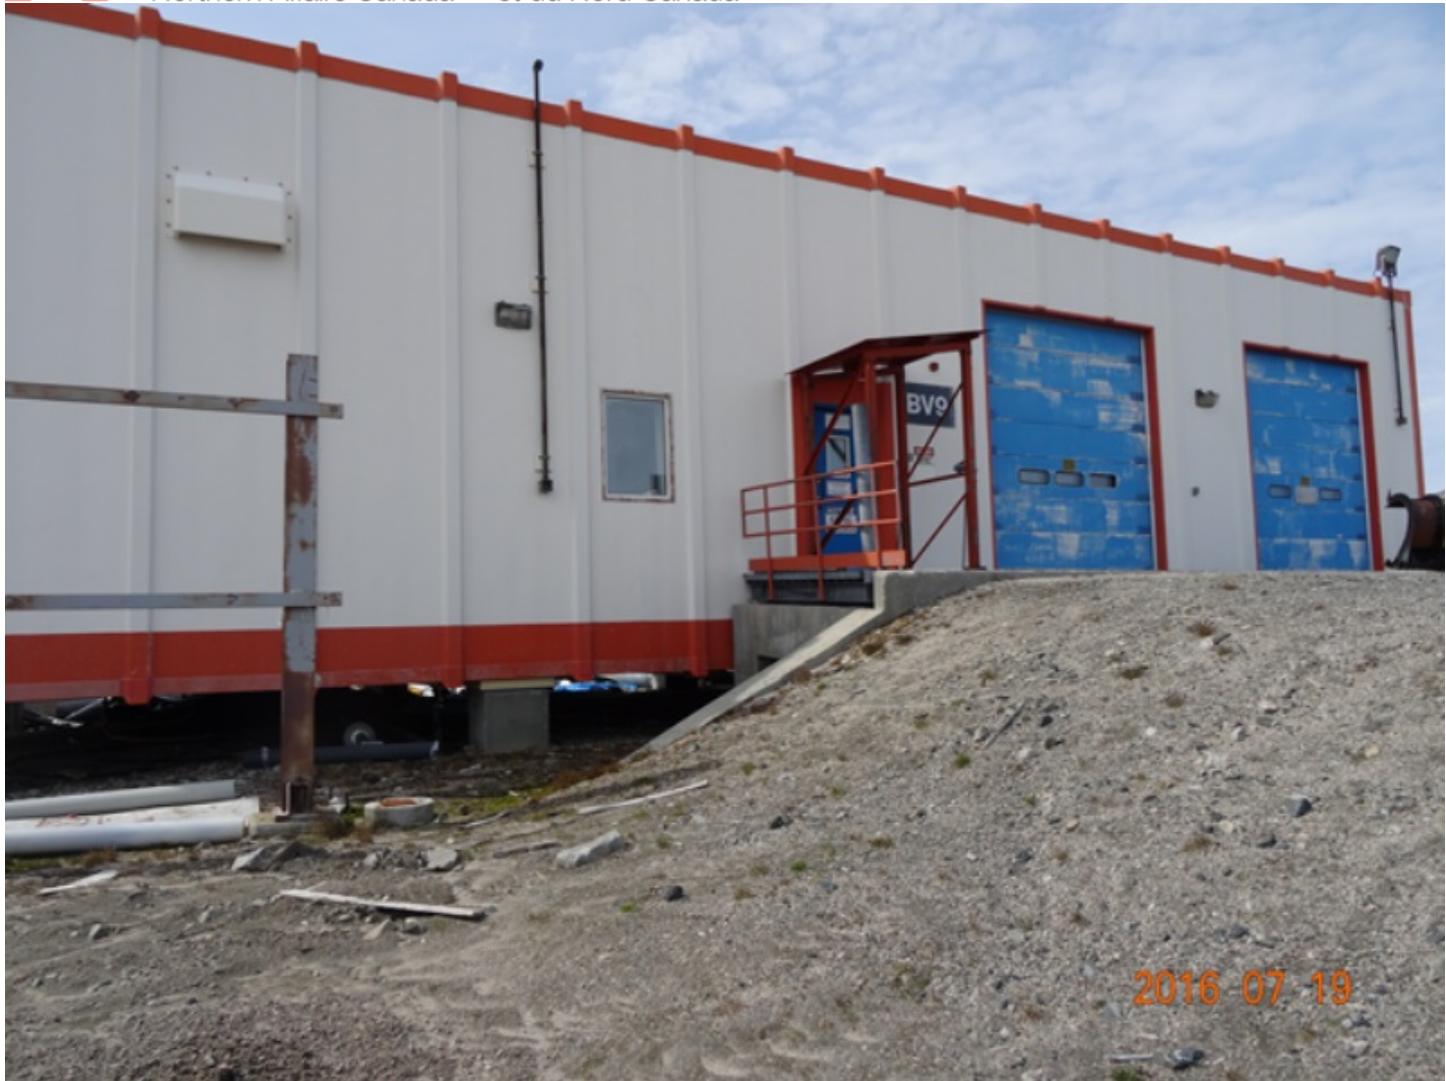
Figure 6 Baf -3 Air terminal building / Storage

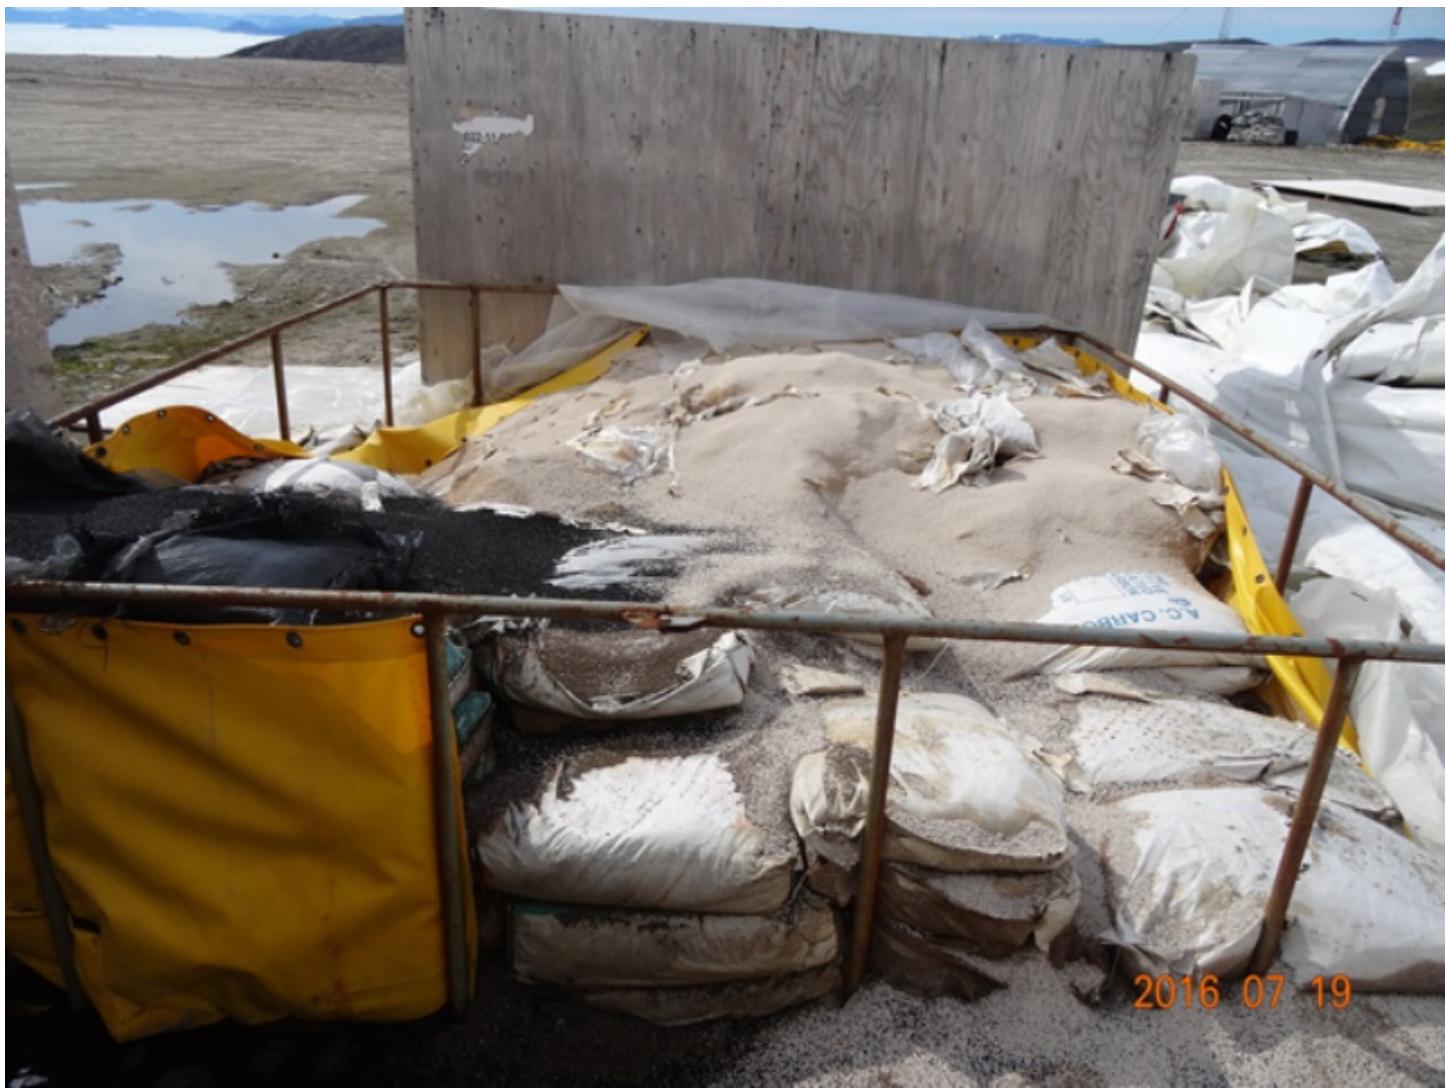
Figure 7- Behind ATB Building - Absorbant material bags to be cleaned up

Waste materials that are no longer in use and are left over from previous activities should be consolidated and if no longer required either stored or shipped off site. Materials left open to the elements are subject to deterioration and to be windblown / ejected off site. This can be avoided and is to be addressed prior to the period of the next Inspection.

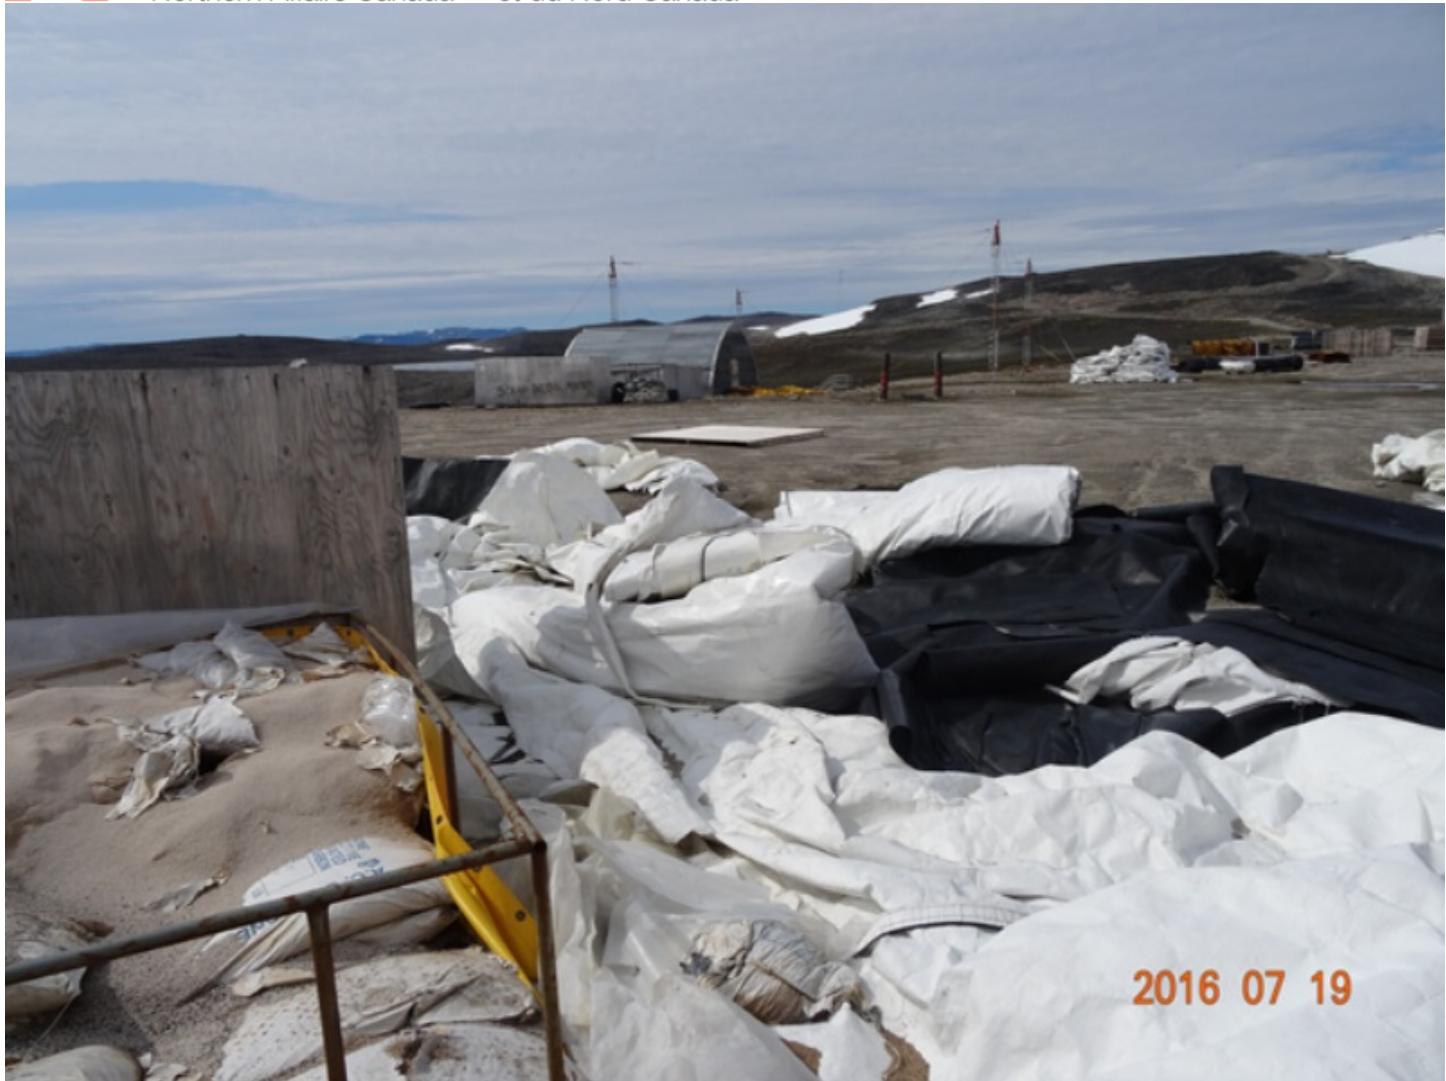
Figure 8 Behind Baf-3 ATB waste plastics liner to be consolidated and shipped off site

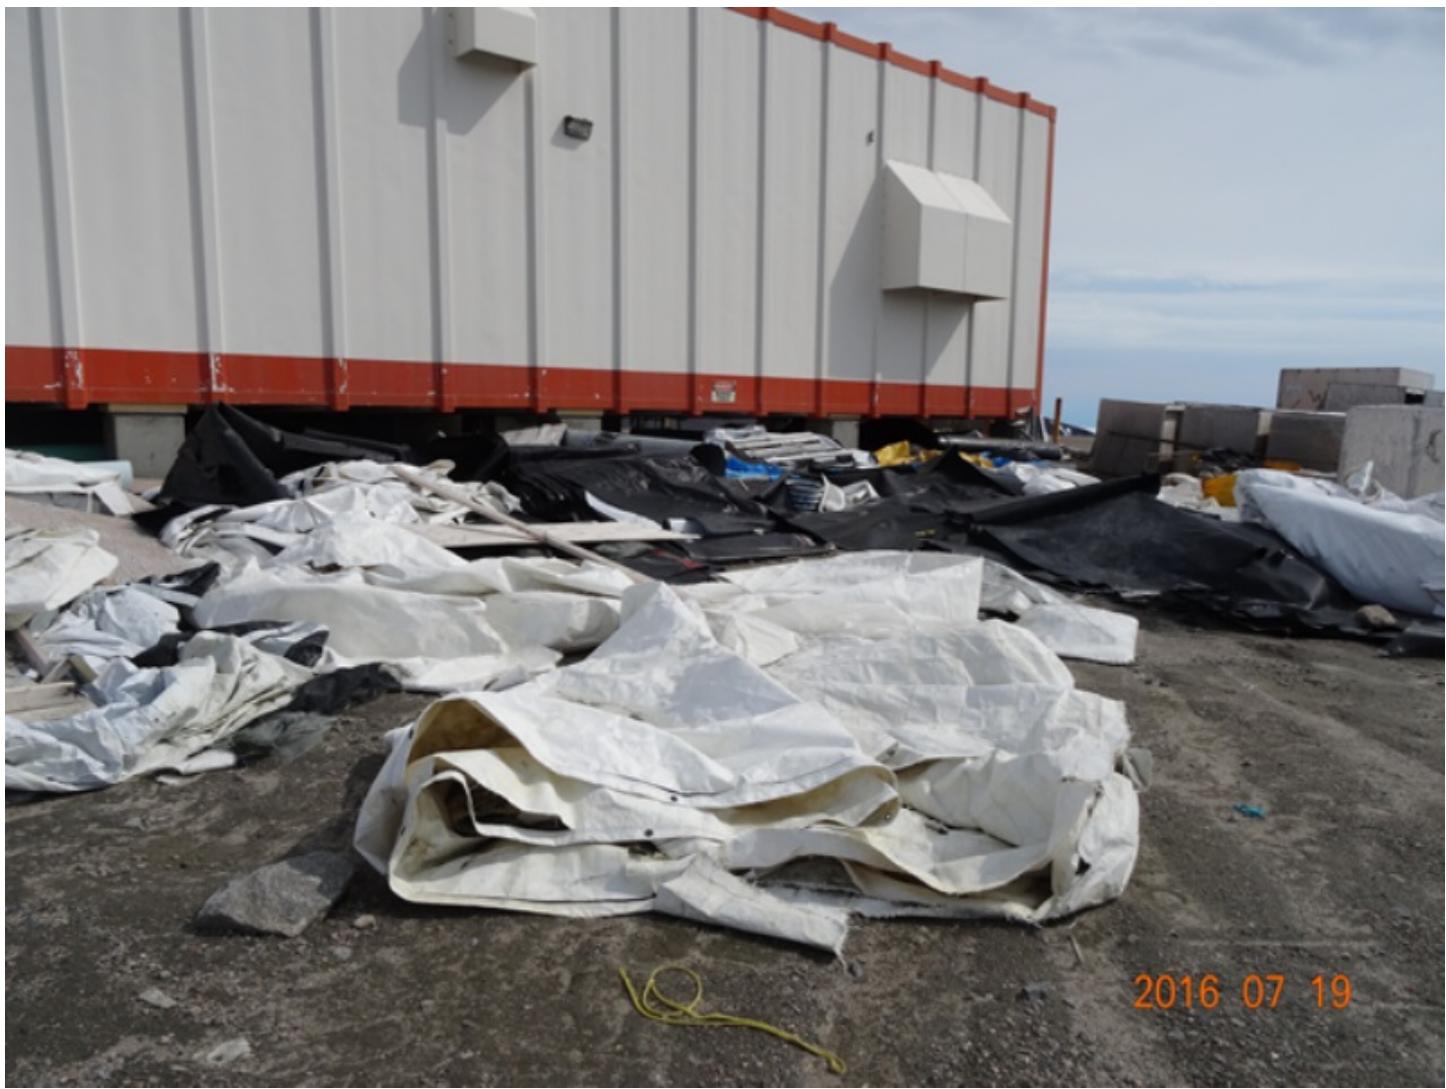
Figure 9 Behind ATB - Waste Plastic and liner - To be consolidated and waste shipped off site

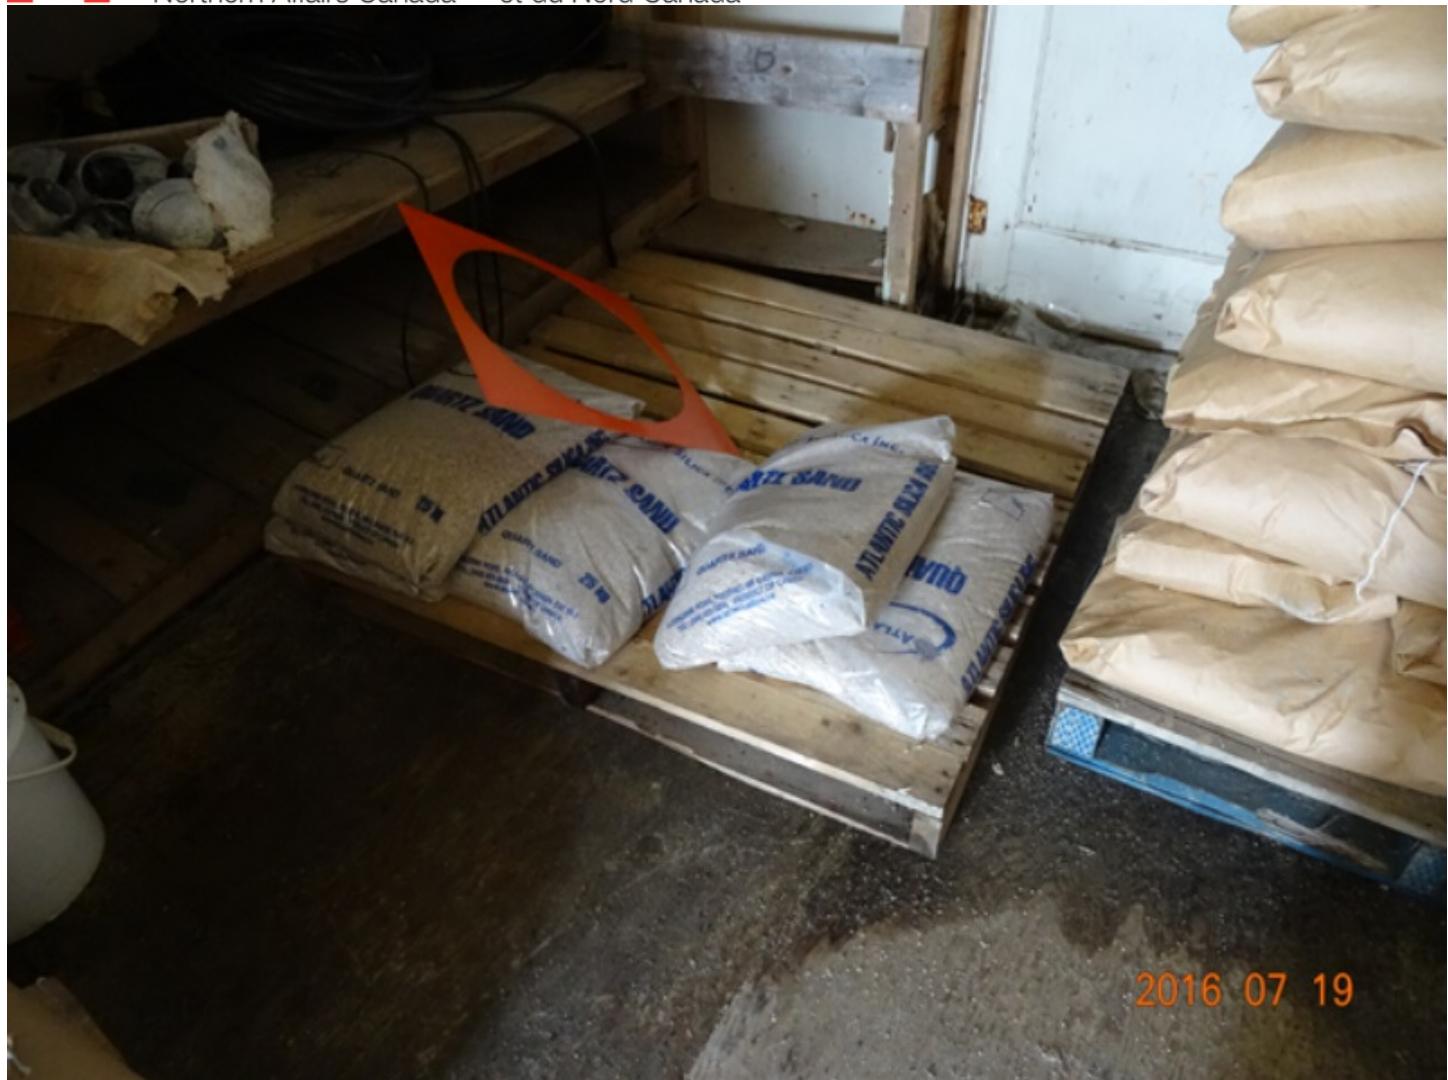
Figure 10 ATB Storage - Activated charcoal for filters

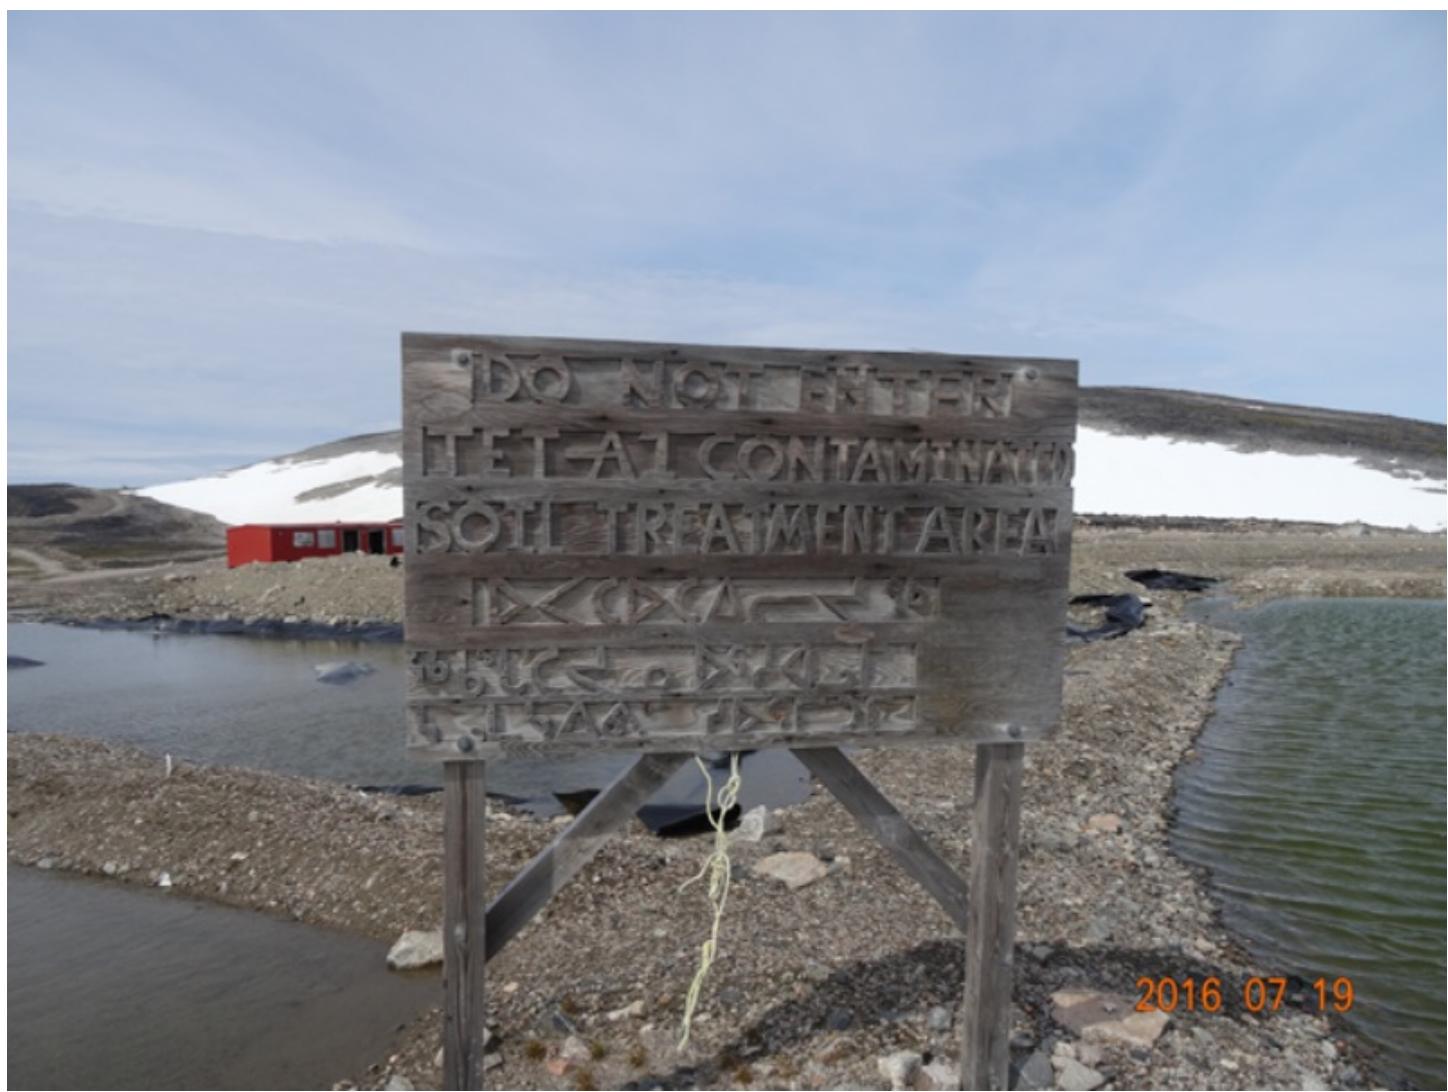
With respect to the 07-011 spill; ruminants of that spill remain on site in the form of waste liner, plastics, portable containment berms, bags of activated carbon, hoses and contaminated soils stored beside the airstrip. The inspector noted that the wastes from the clean up associated with 07-011 remain on site behind the ATB. These waste items should be containerized and hauled off site or stored properly. The contaminated soils piles were documents and one sample was collected from the ponded water. That sample did not return any results in exceedance of the water license. The Licensee also was scheduled to have a contractor attend the site to examine the piles to ensure the impacted soils were now free of contamination and could be used for fill on site. The results of this testing are still outstanding.

Figure 11 Land farmed contaminated soils from a spill in 2007, (07-011)

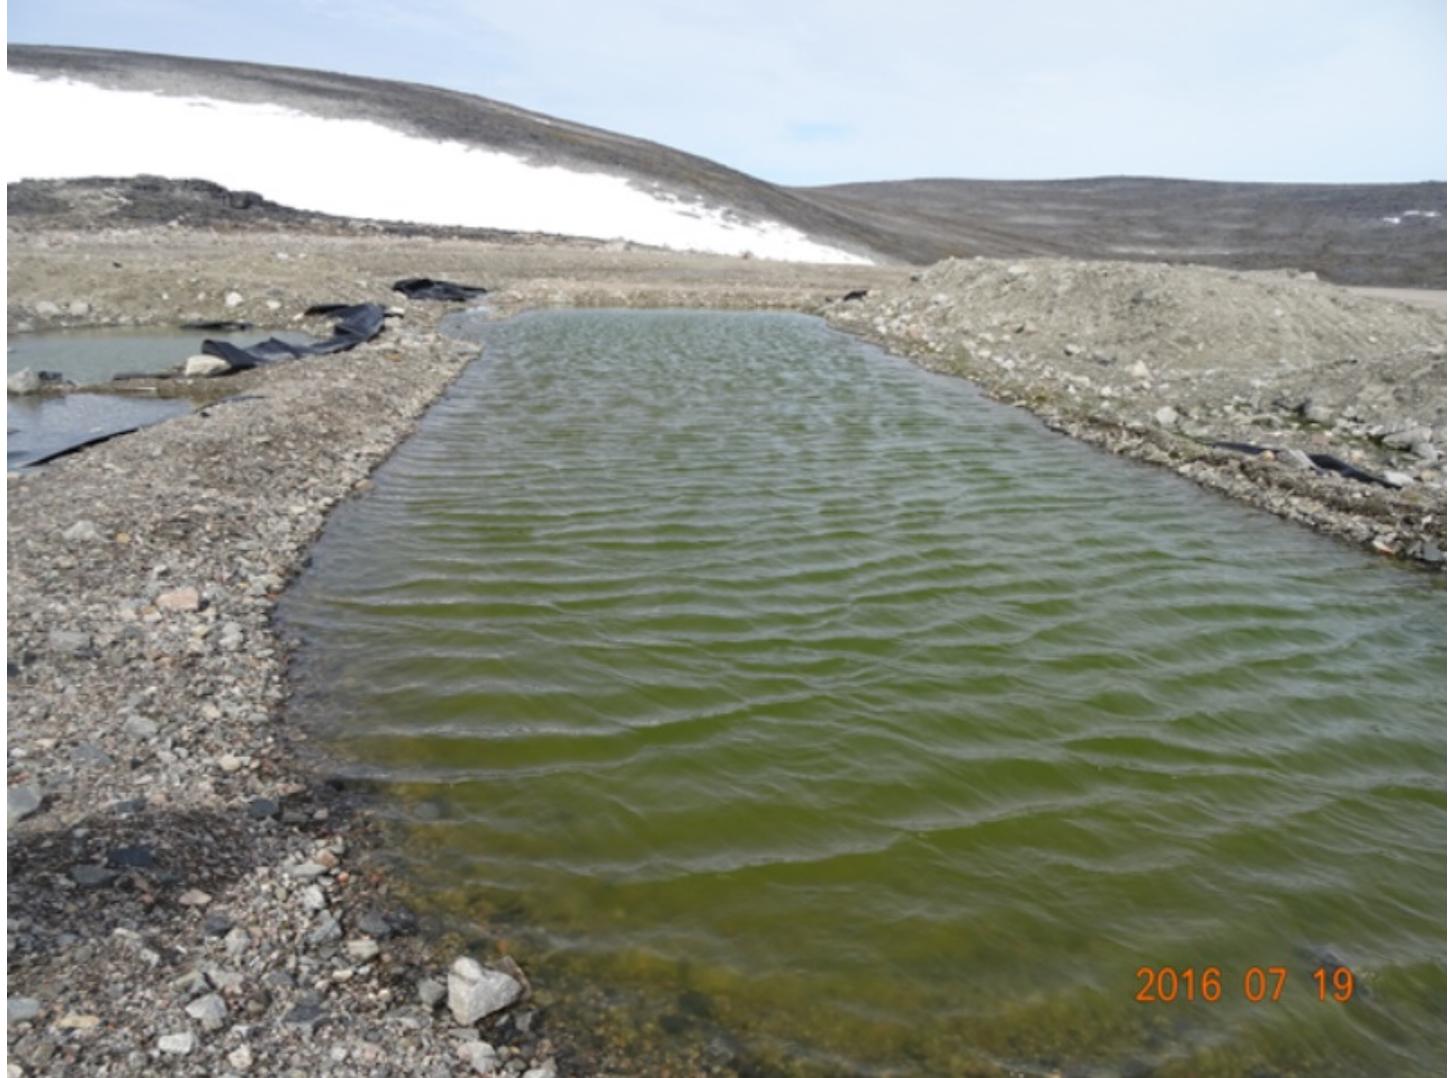
Figure 12 Land farmed soils/ contact water collected from a spill in 2007, (07-011)

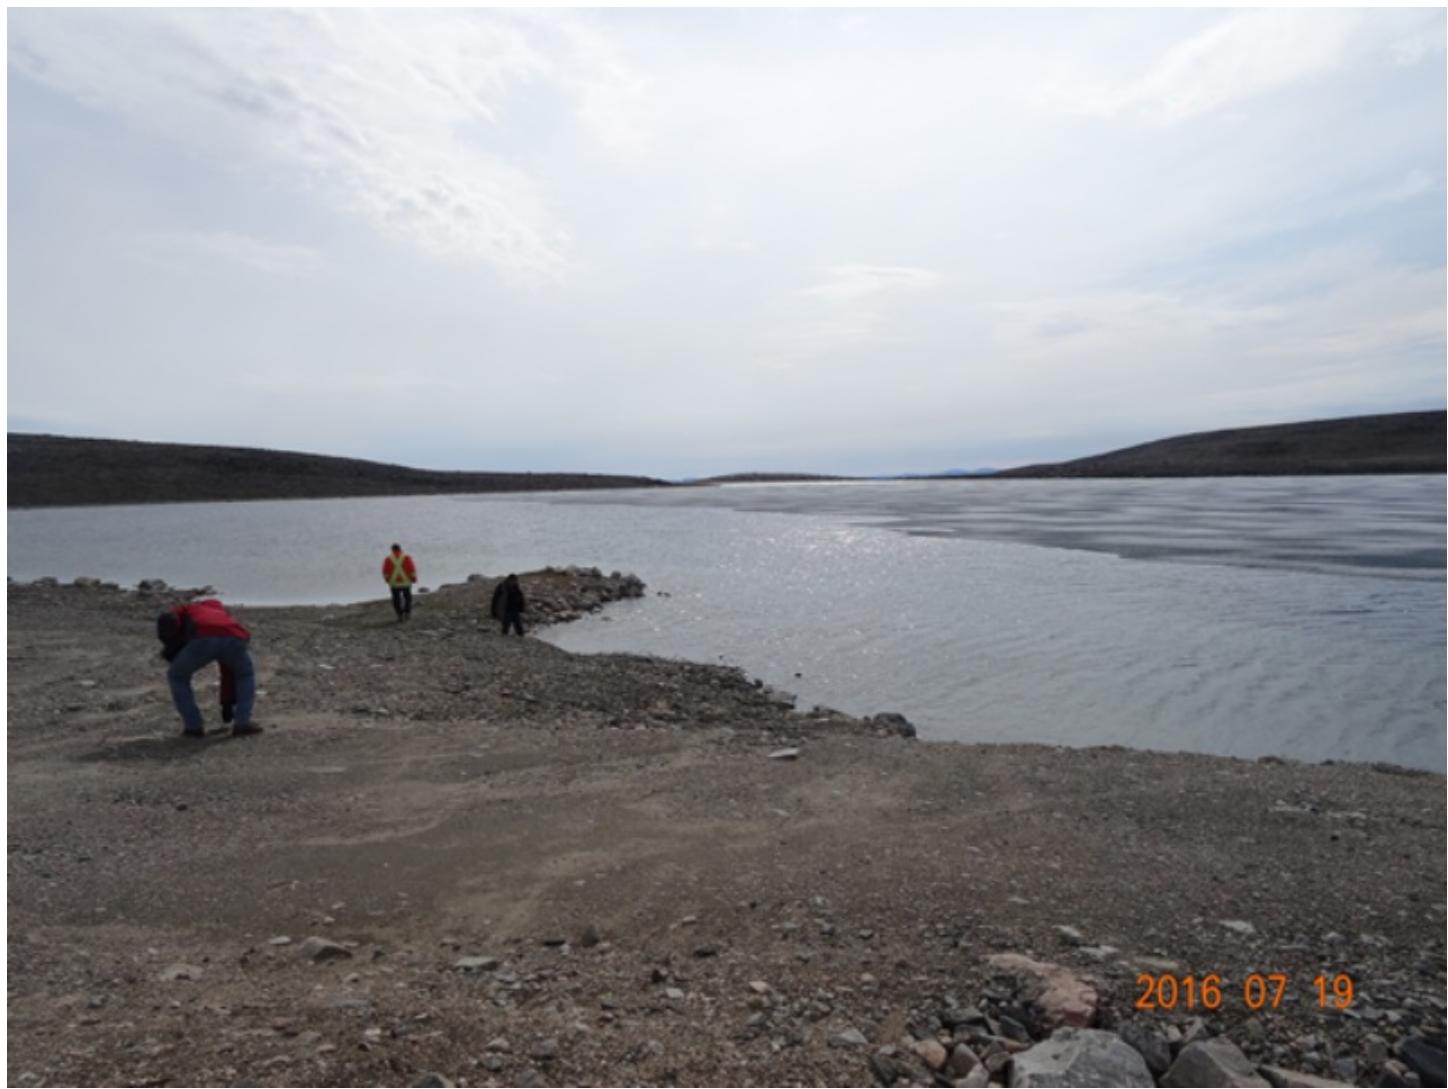
Figure 13 Raw water source

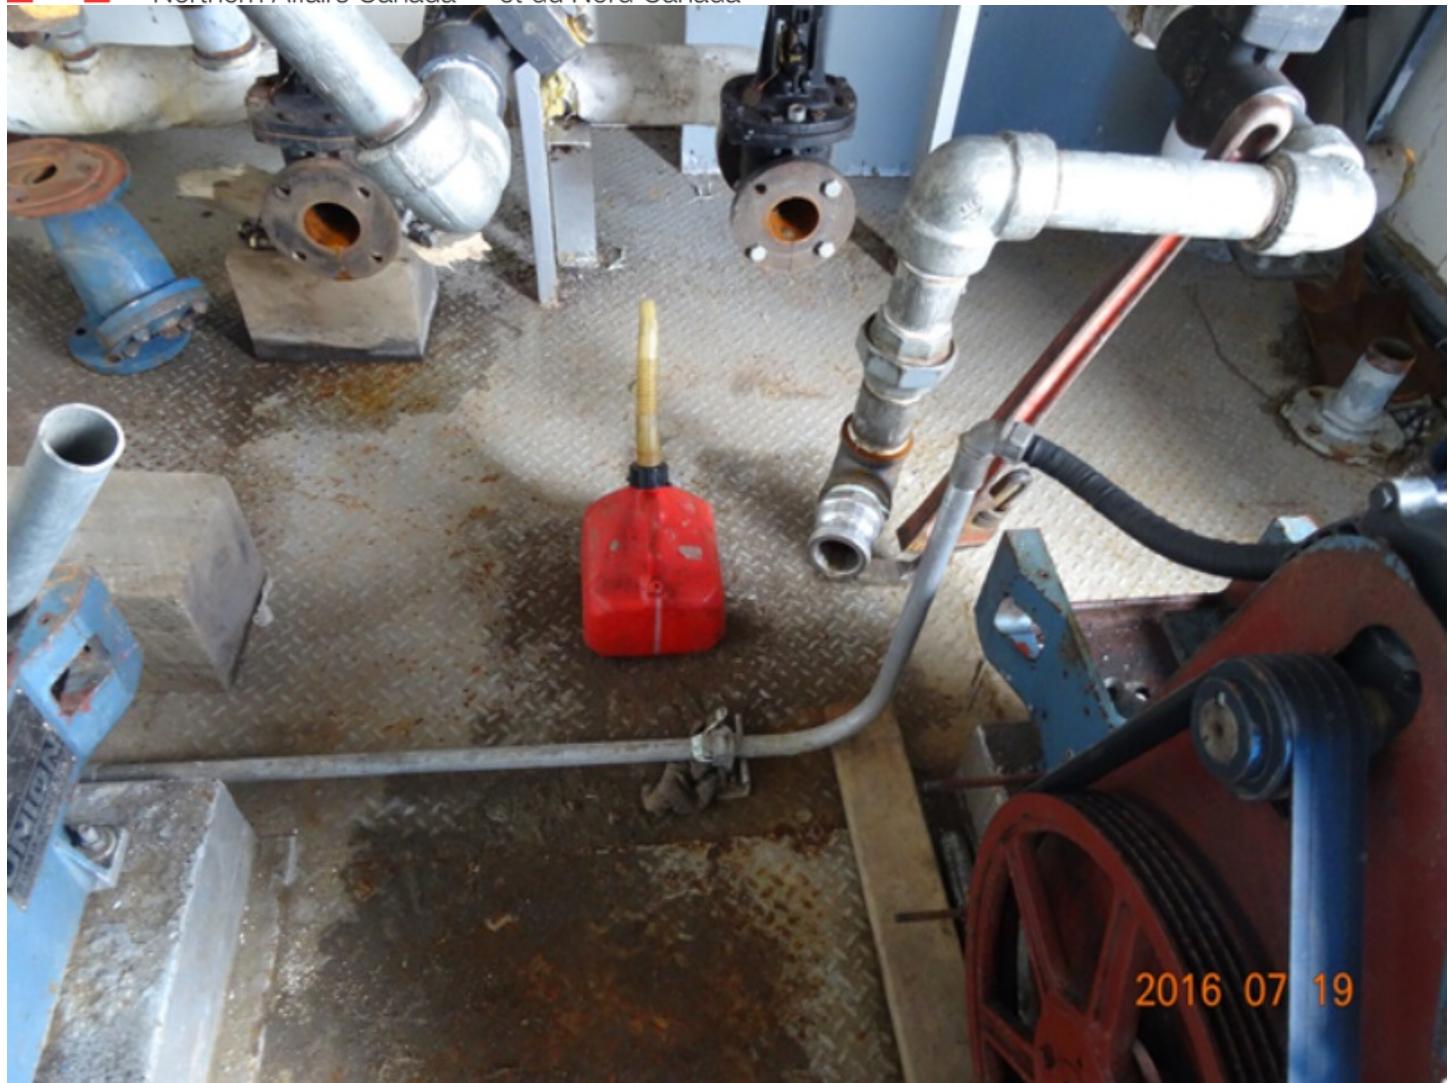
Figure 14 Raw water Pumping station
