## WATER LICENCE INSPECTION FORM

Licensee Major Creighton North Warning System Office 455 Boulevard de la Carrière, Gatineau, Quebec, J8Y 6W6		Licensee Representative Scott Charland – NWS A/Environmental officer - NWS Don Beattie – Raytheon Manager, Environmental, Health and Safety- Raytheon Canada	
Licence No. / Expiry 3BC-BAF0919		Representative's Title Acting Environmental Officer	
Land / Other Authorizations NIL		Land / Other Authorizations Nil	
Date of Inspection July 19, 2016		Inspector A.Keim	
Activities Inspected <input checked="" type="checkbox"/> Camp <input type="checkbox"/> Roads/Hauling		<input type="checkbox"/> Drilling <input type="checkbox"/> Mining <input type="checkbox"/> Construction <input type="checkbox"/> Reclamation <input type="checkbox"/> Fuel Storage <input type="checkbox"/> Other: Water Discharge <input type="checkbox"/> Other: Municipal

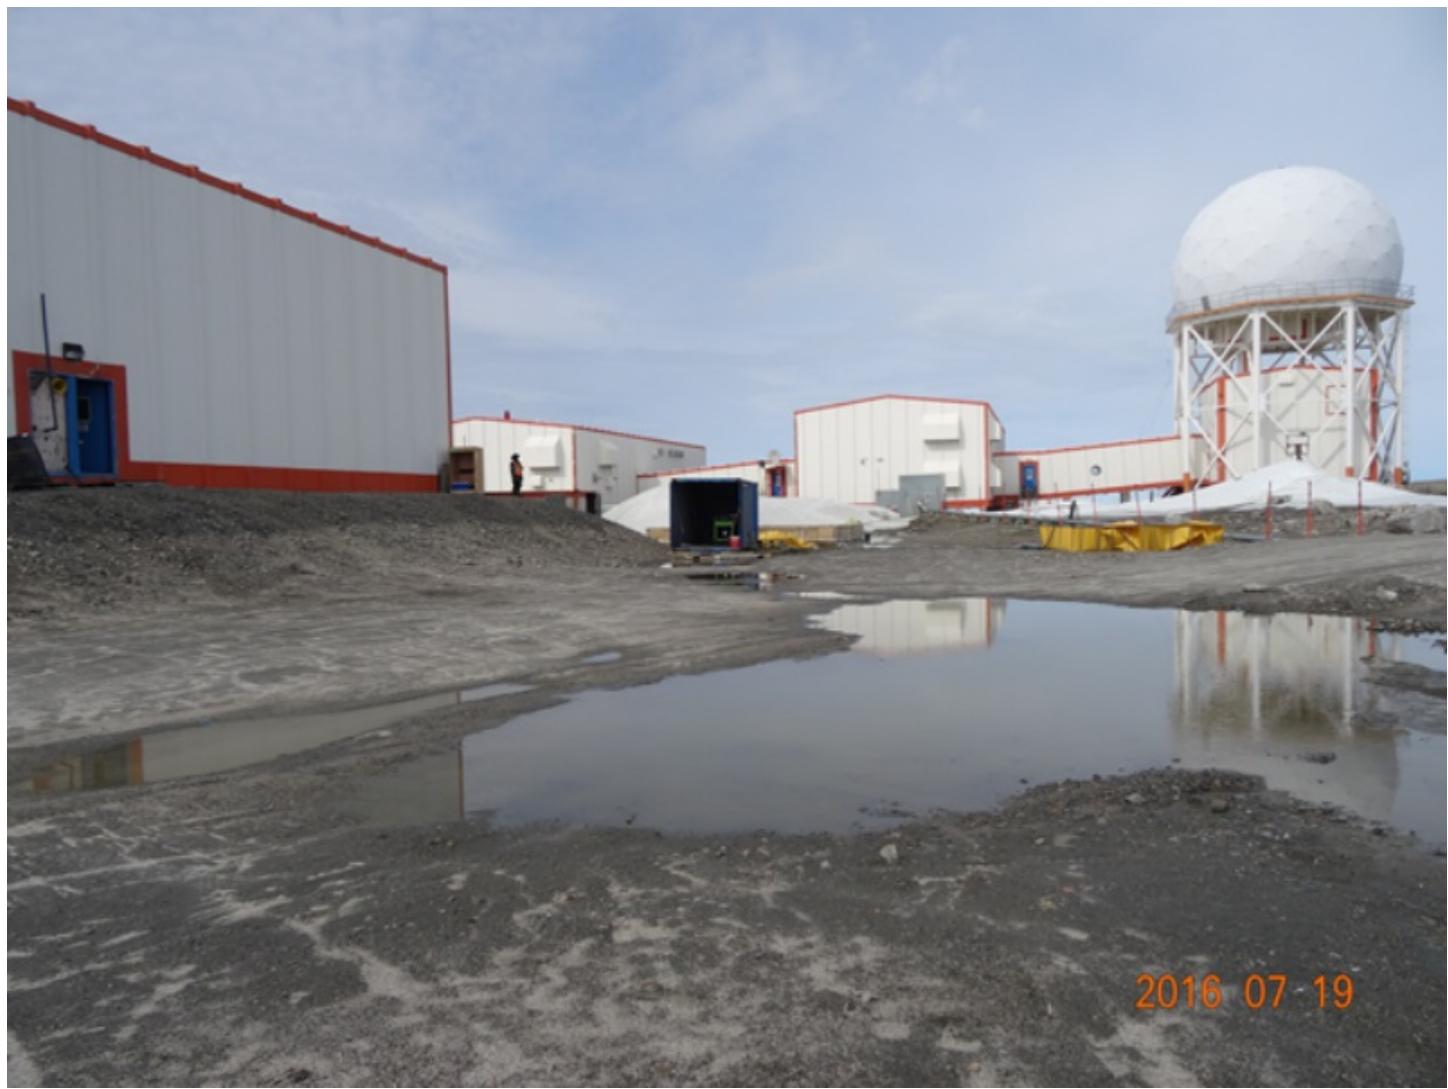
Figure 15 BAF-3 upper site- fuel clean up and containment of contact water

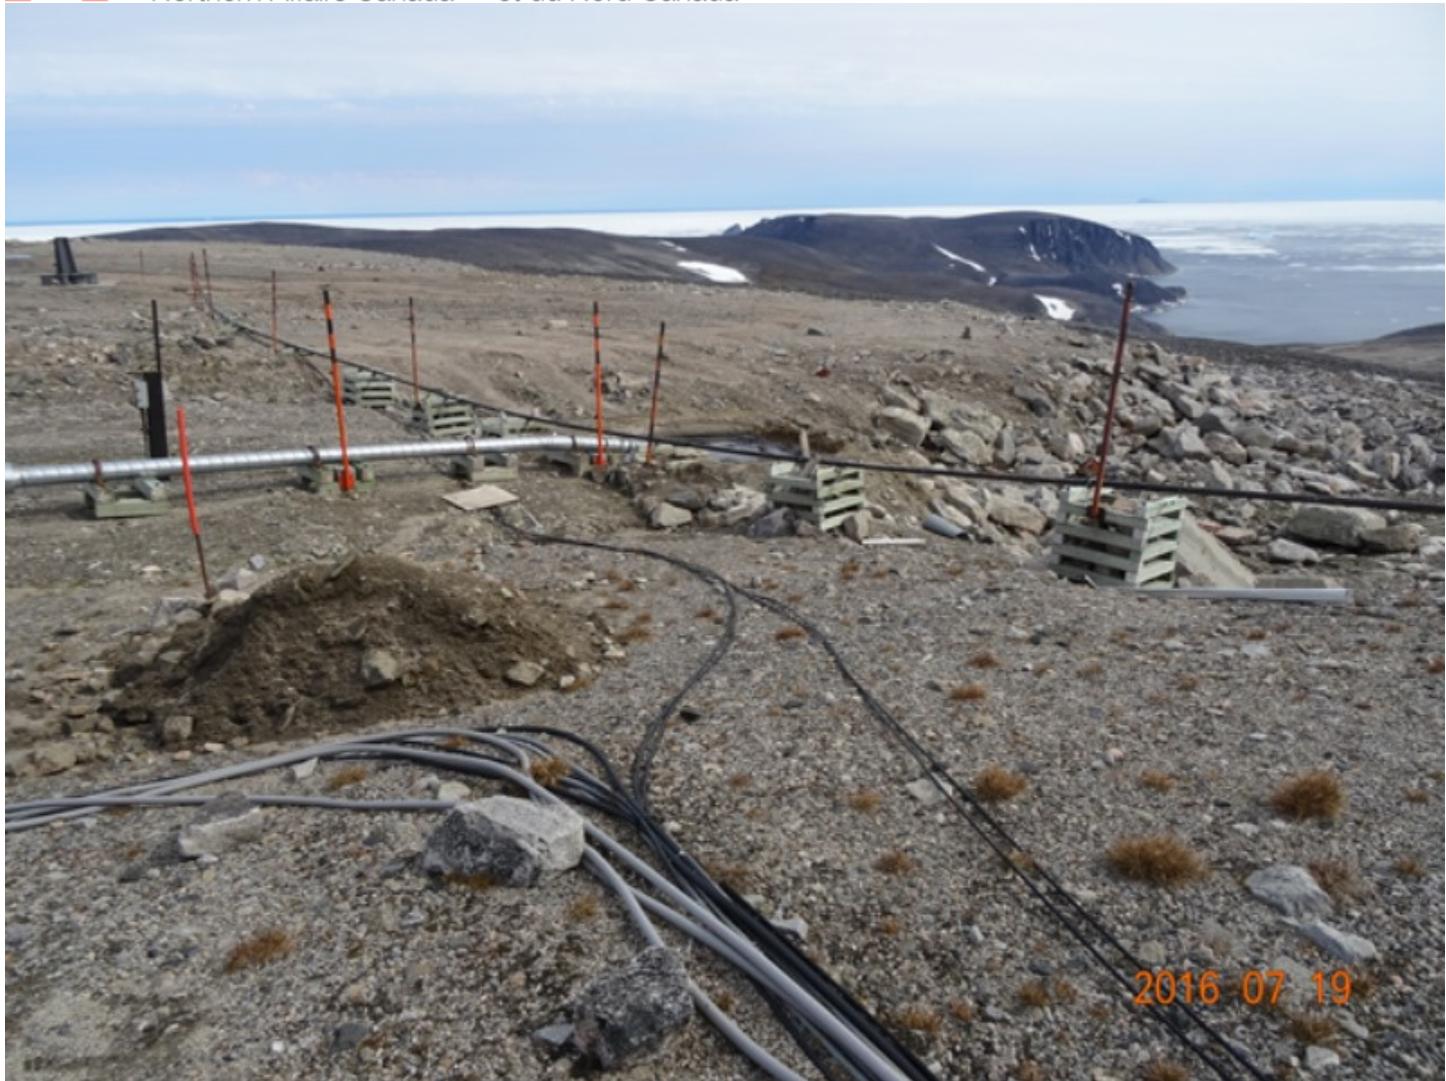
Figure 16 Effluent lagoon site at Baf-3

On-going and continued maintenance of the sewage treatment/Lagoon systems are to be maintained. Wash outs and overtopping of these facilities can be avoided through regular inspections. It is recommended that the Licensee and the contactor on site develop some schedule for regular inspections of these facilities.

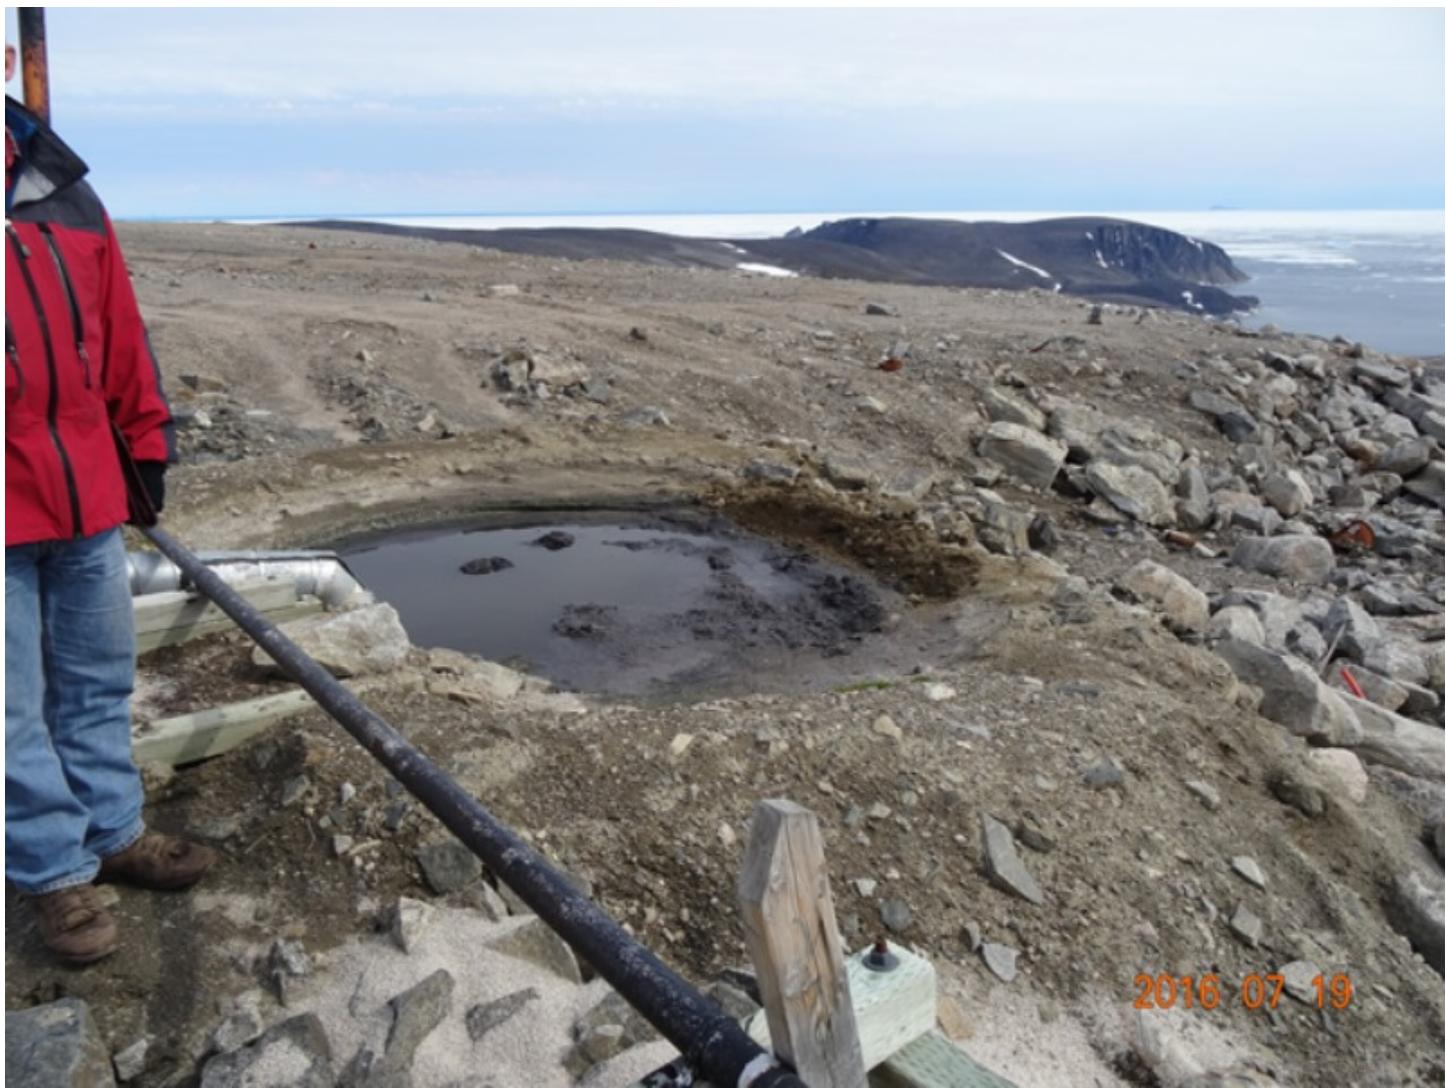
Figure 17 On going maintenance required to maintain Baf-3 Effluent lagoon

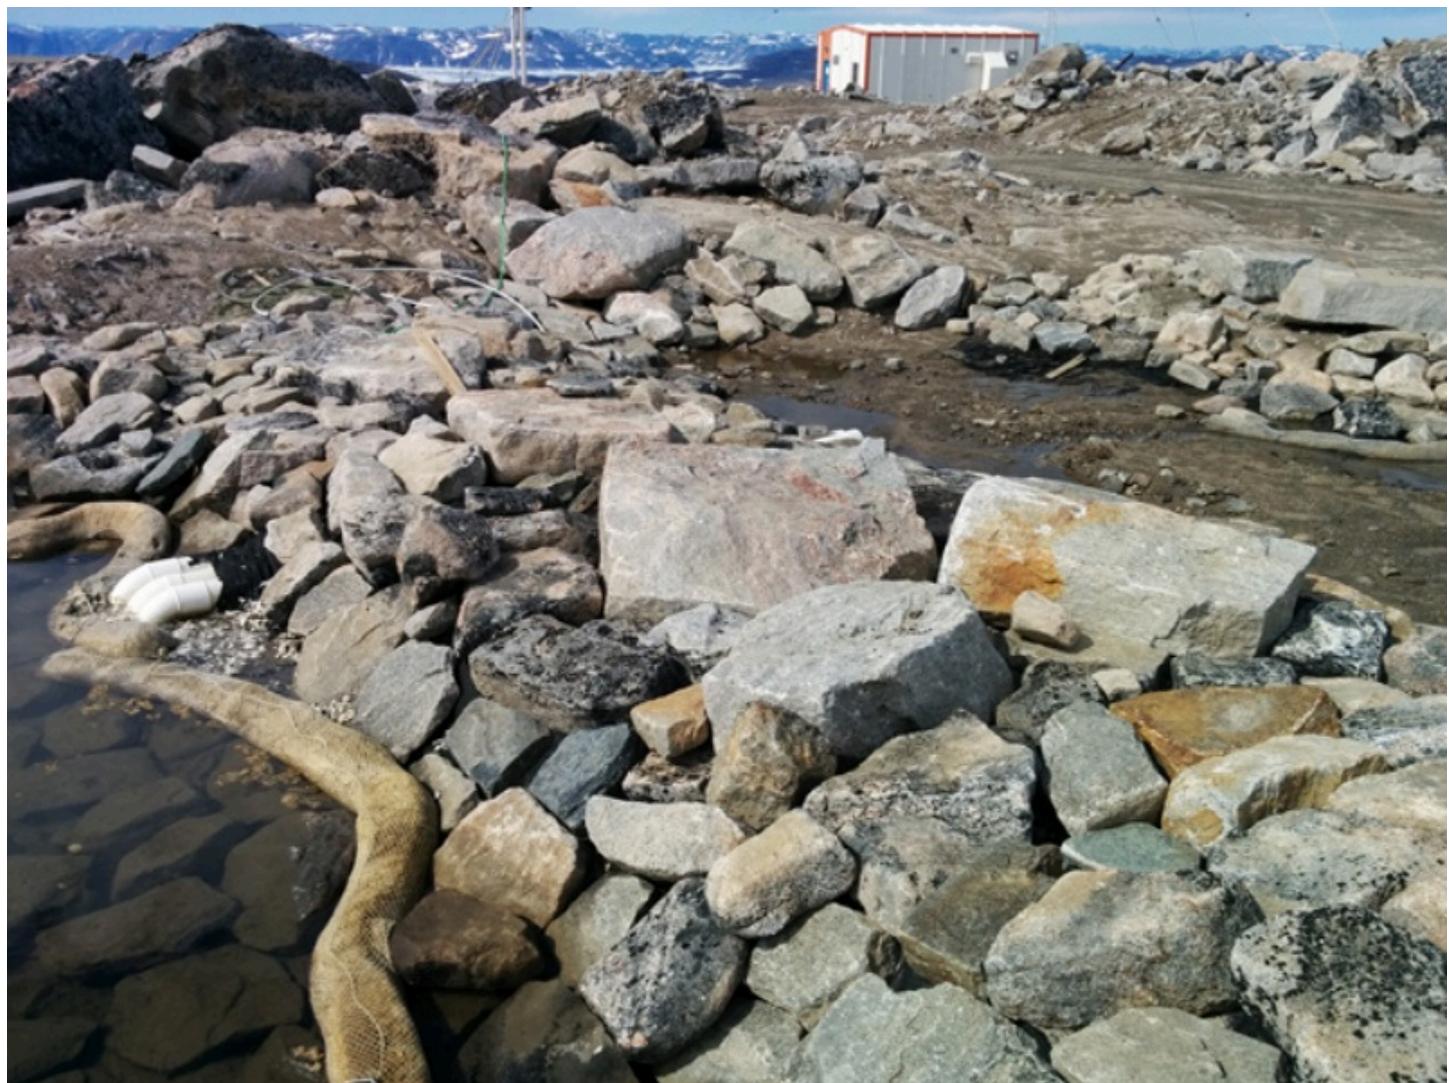
Figure 18 Cofferdams -North side - A.Winegardener

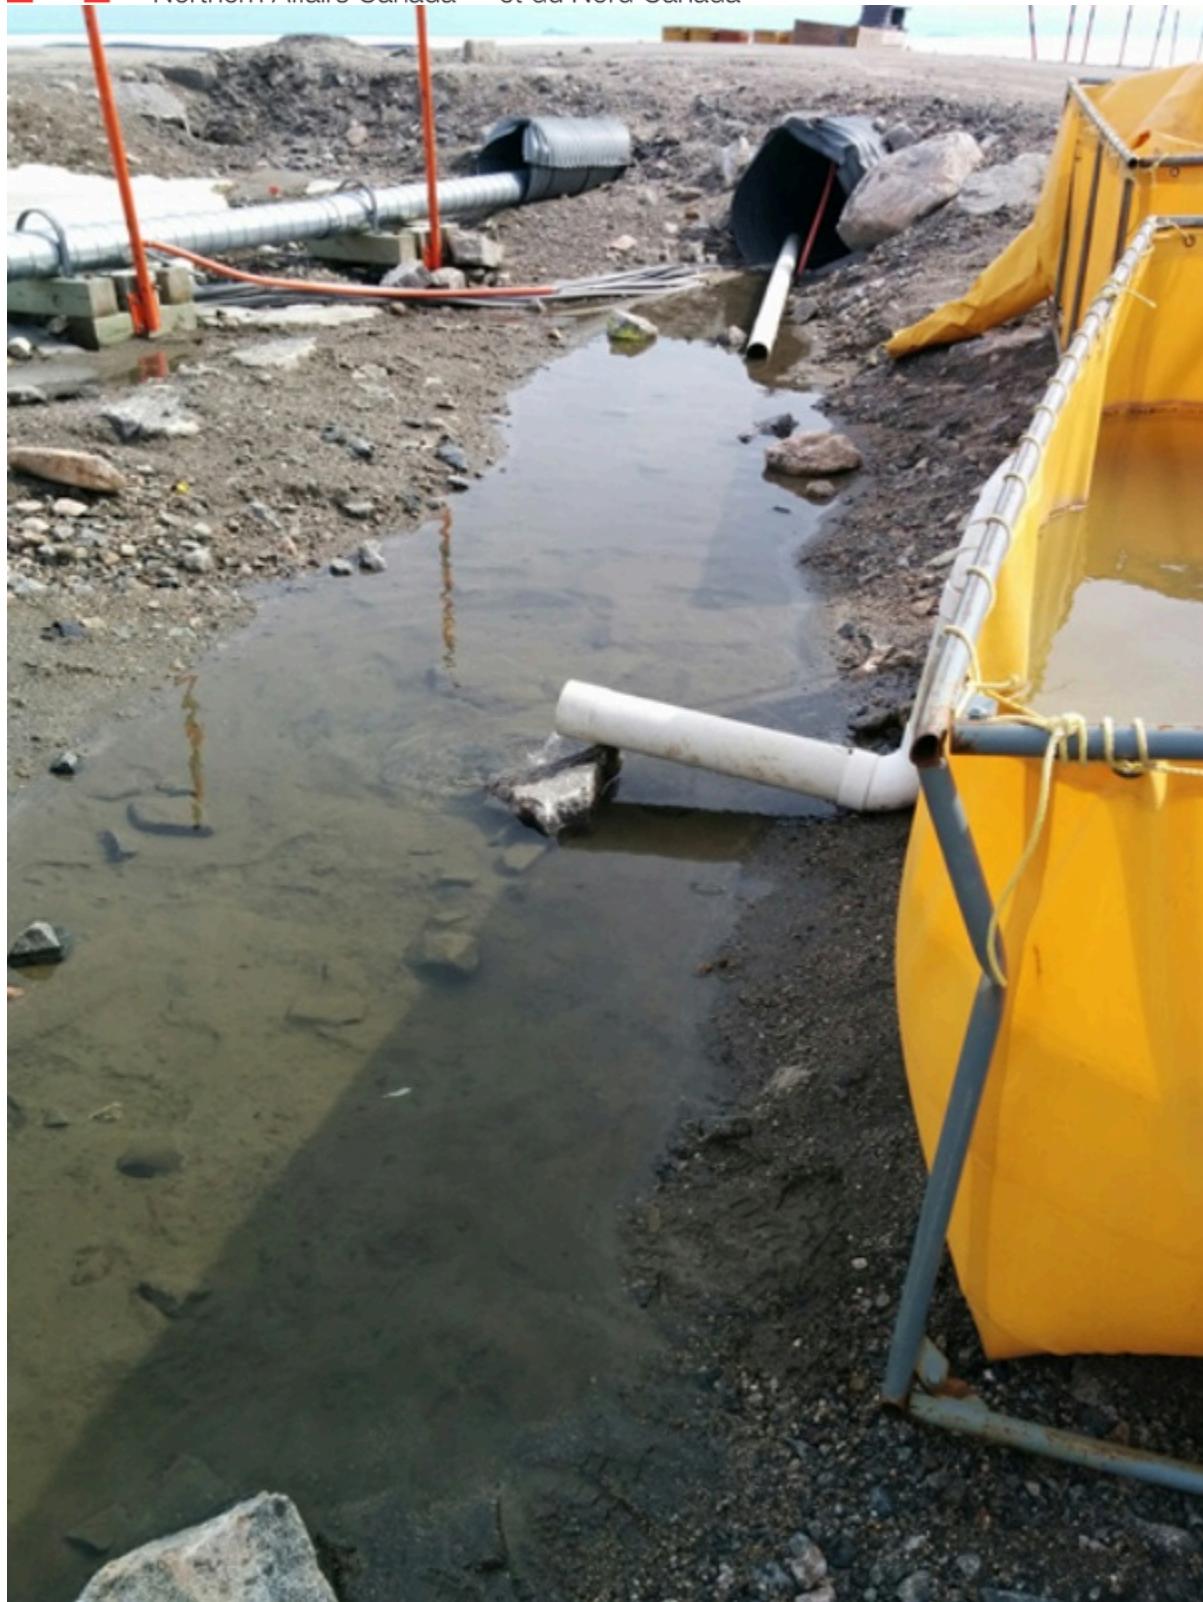
Figure 19 Direct discharge of treated hydrocarbon impacted water

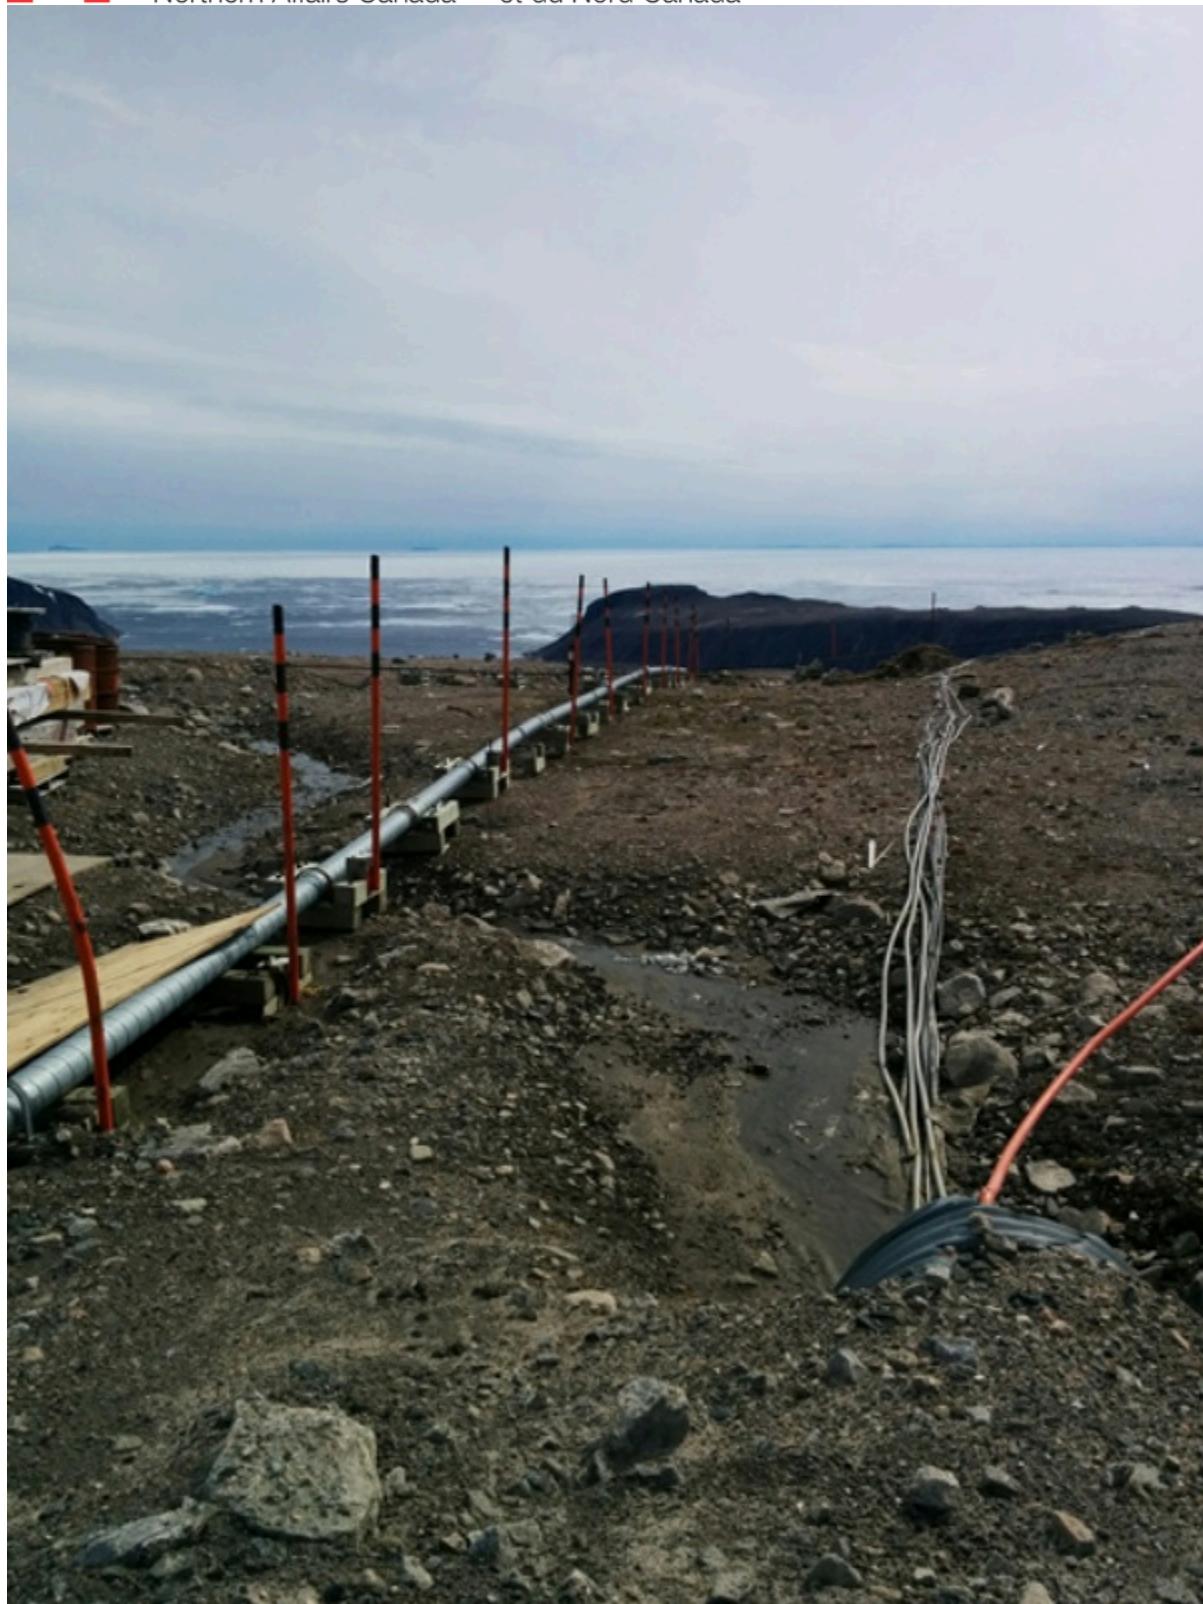
Figure 20 Direct discharge flow pathway - A.Winegardener

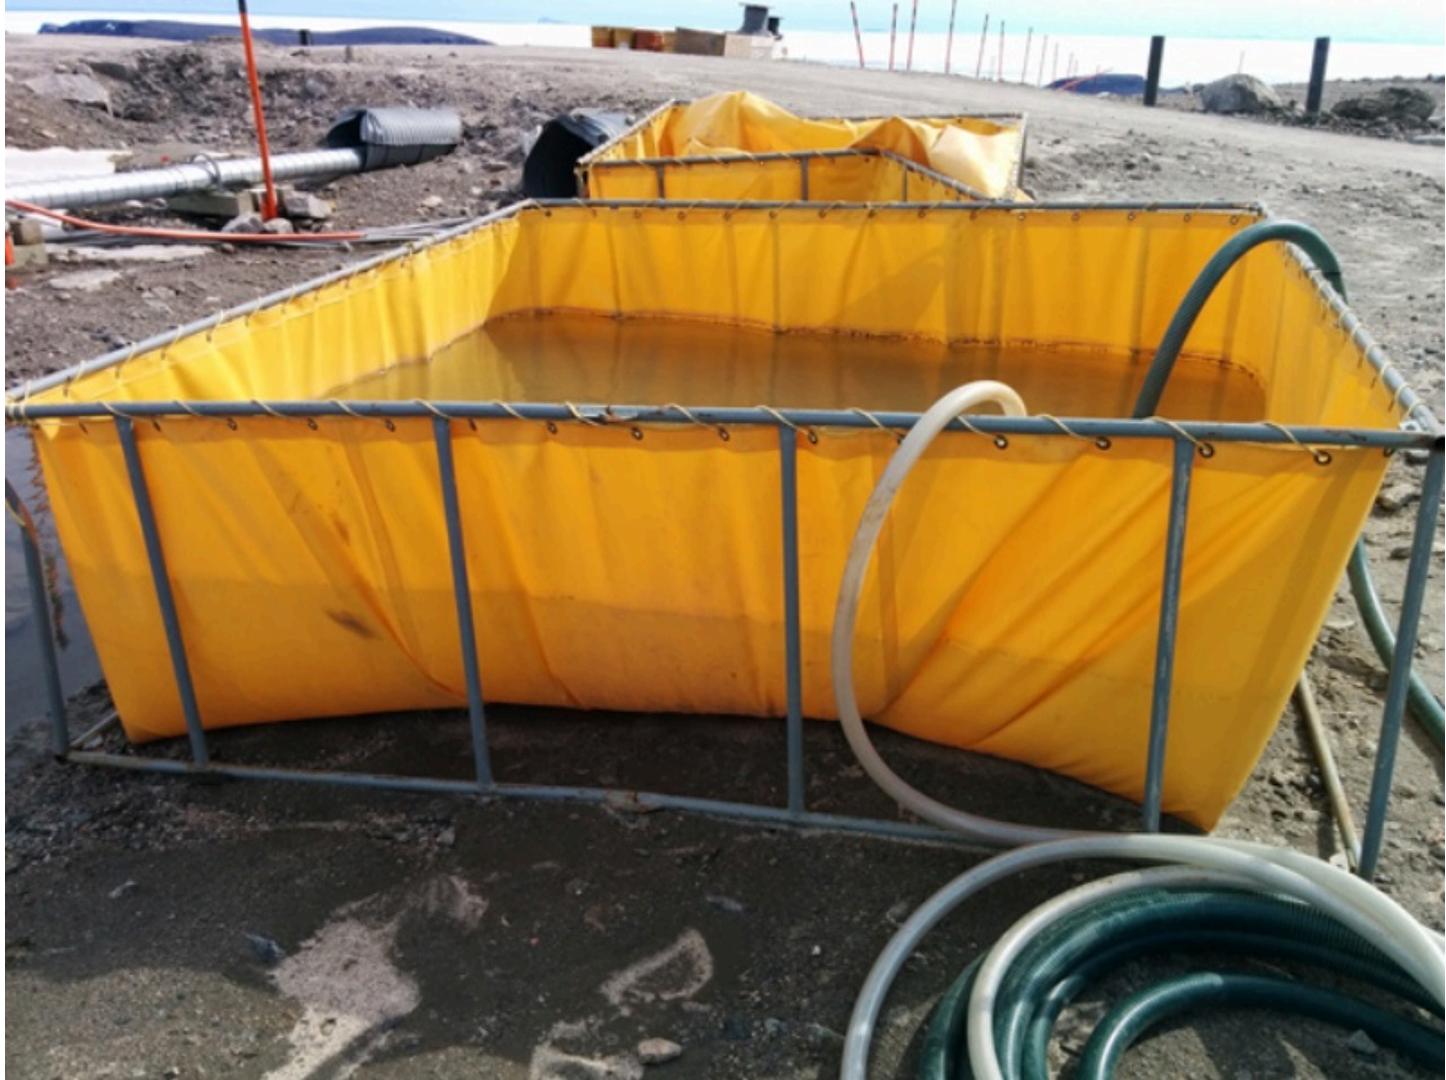
Figure 21 Effluent containment Berm for impacted water A.Winegardener

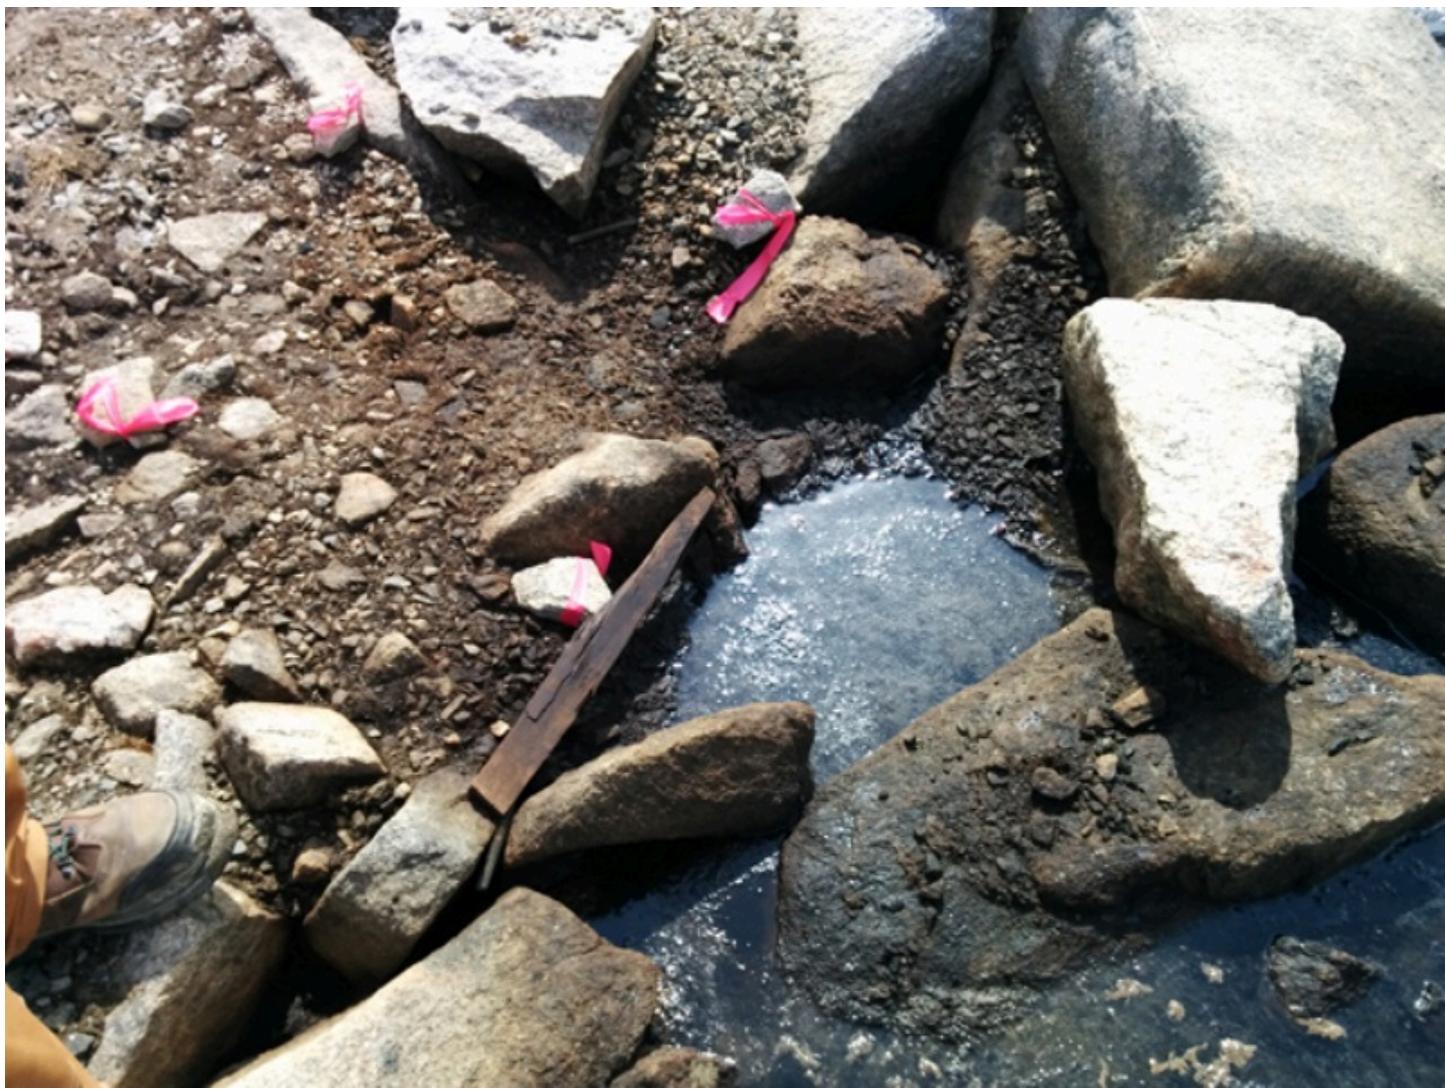
Figure 22 Hydrogen peroxide testing area A. Winegardener

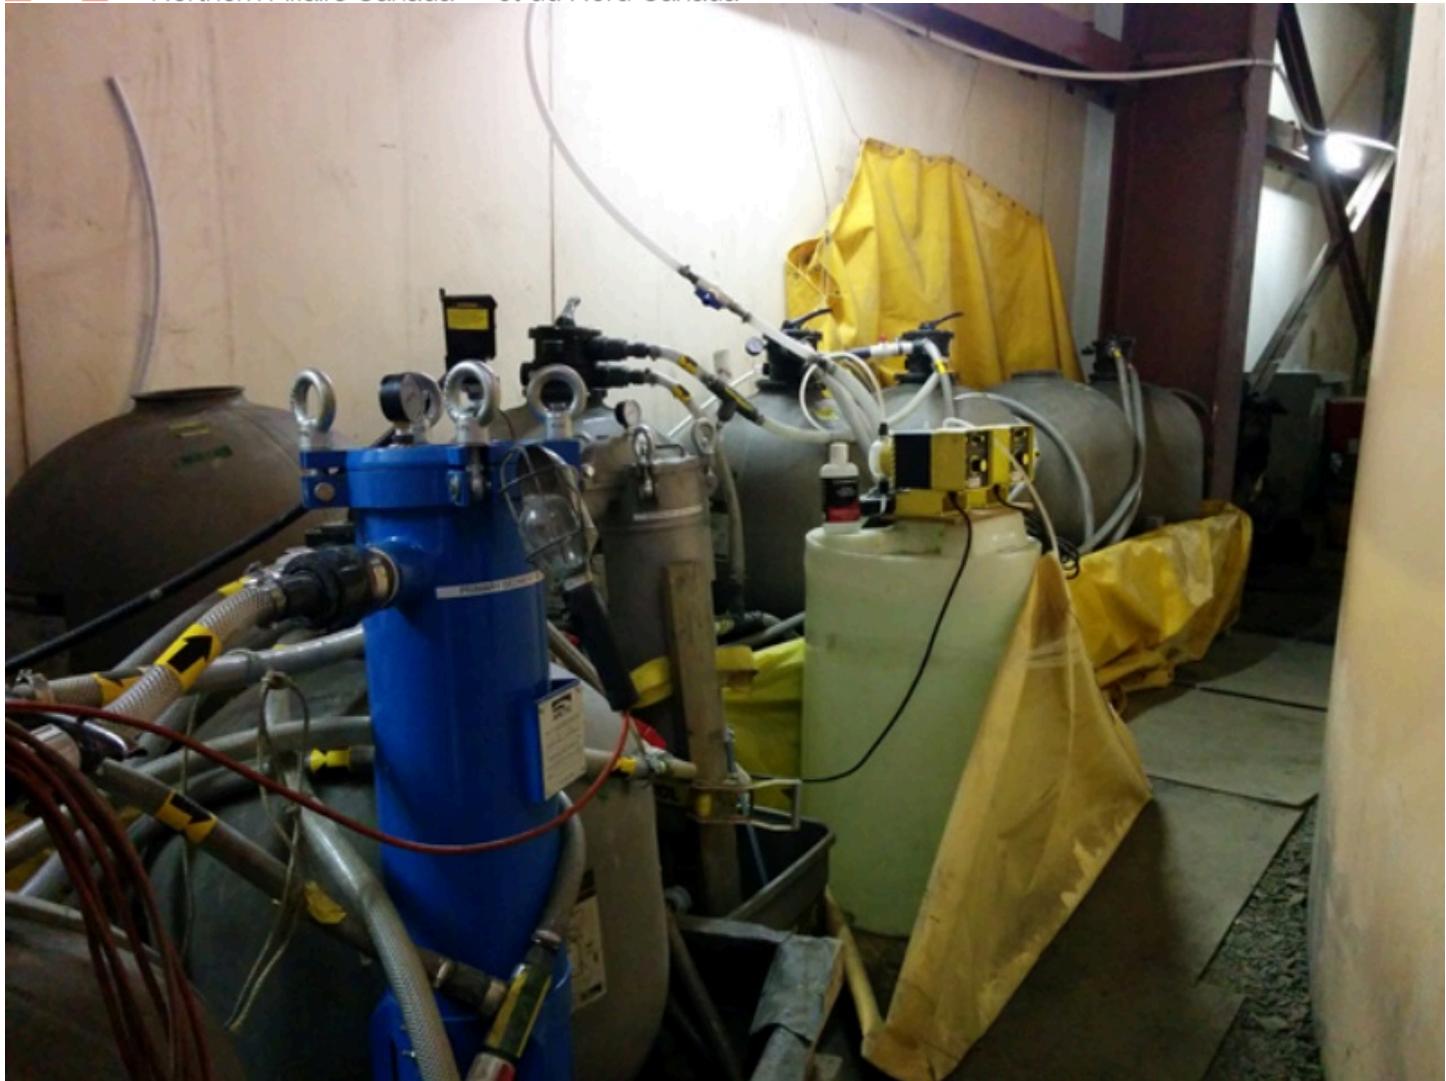
- This water is then heated to between 32° and 38°C and passes through a forced air (Air stripper) system where the higher fractions are mostly volatilized. The addition of a highly concentrated (40%) Hydrogen Peroxide mixture is then added to the treated contact water. The addition of the Hydrogen peroxide at this stage assists in the breakdown of remaining phenols. The water is then cooled and run through activated carbon filters.

Figure 23 Hydrogen Peroxide infusion and carbon filtration systems in place on site A.Wingardener

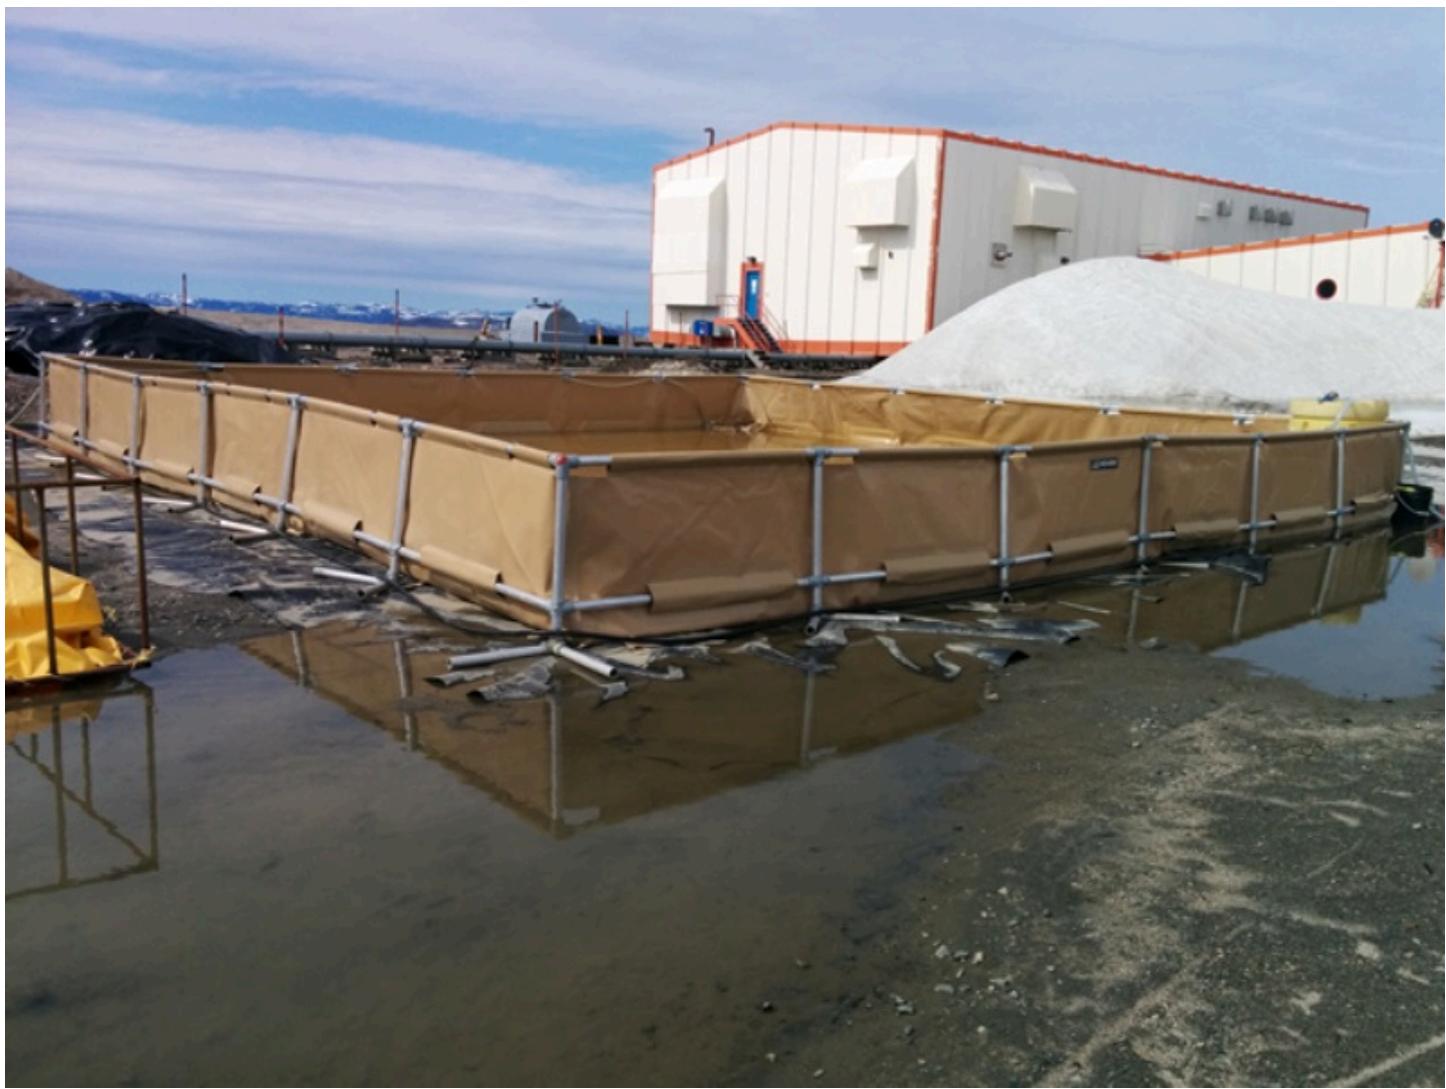
Figure 24 Influent containment A. Winegardener

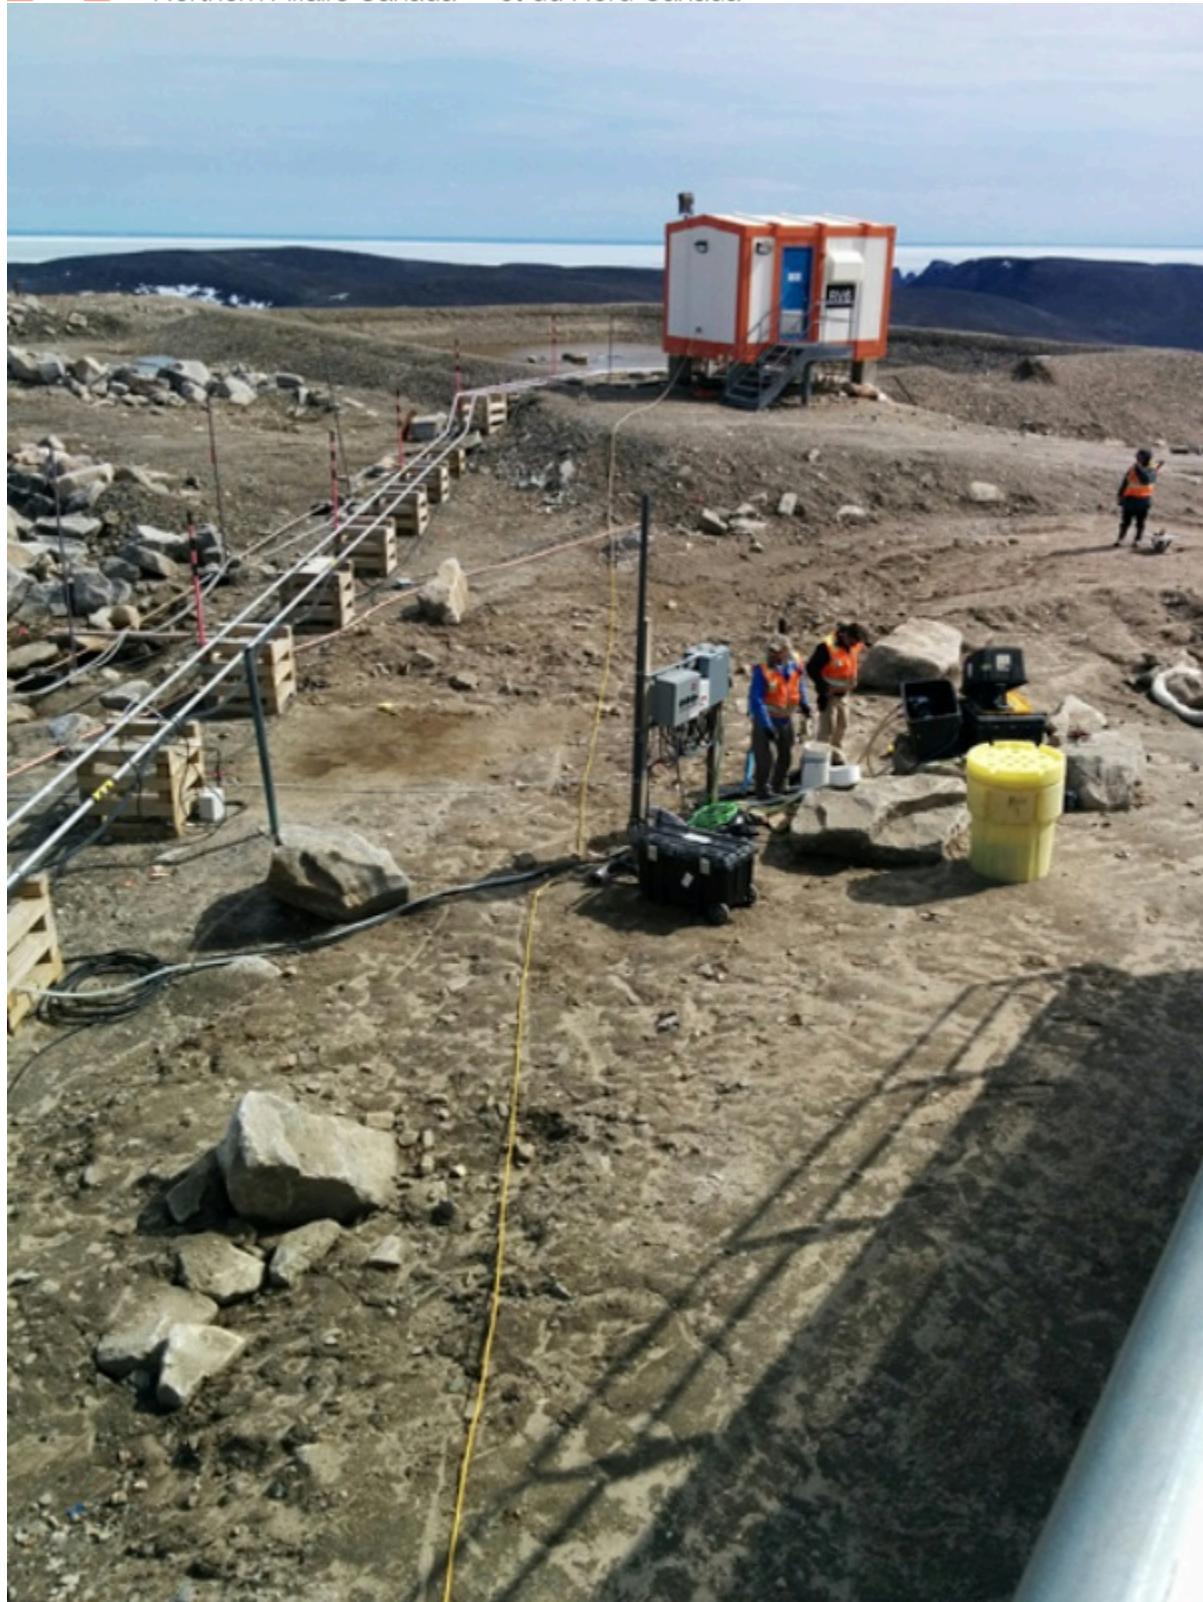
- Up to 7 monitoring wells (some left from the 2007 and 2011 spills were being monitored for both free product and the movement of ground water.
- The diversion trench had been filled in at the time of the Inspection and a vapor extraction system (forced air) is in place to promote the additional use of Ozone in this treatment system.

Figure 25 Site of L Trench where Ozone infusion treatment is underway A.Winegardener

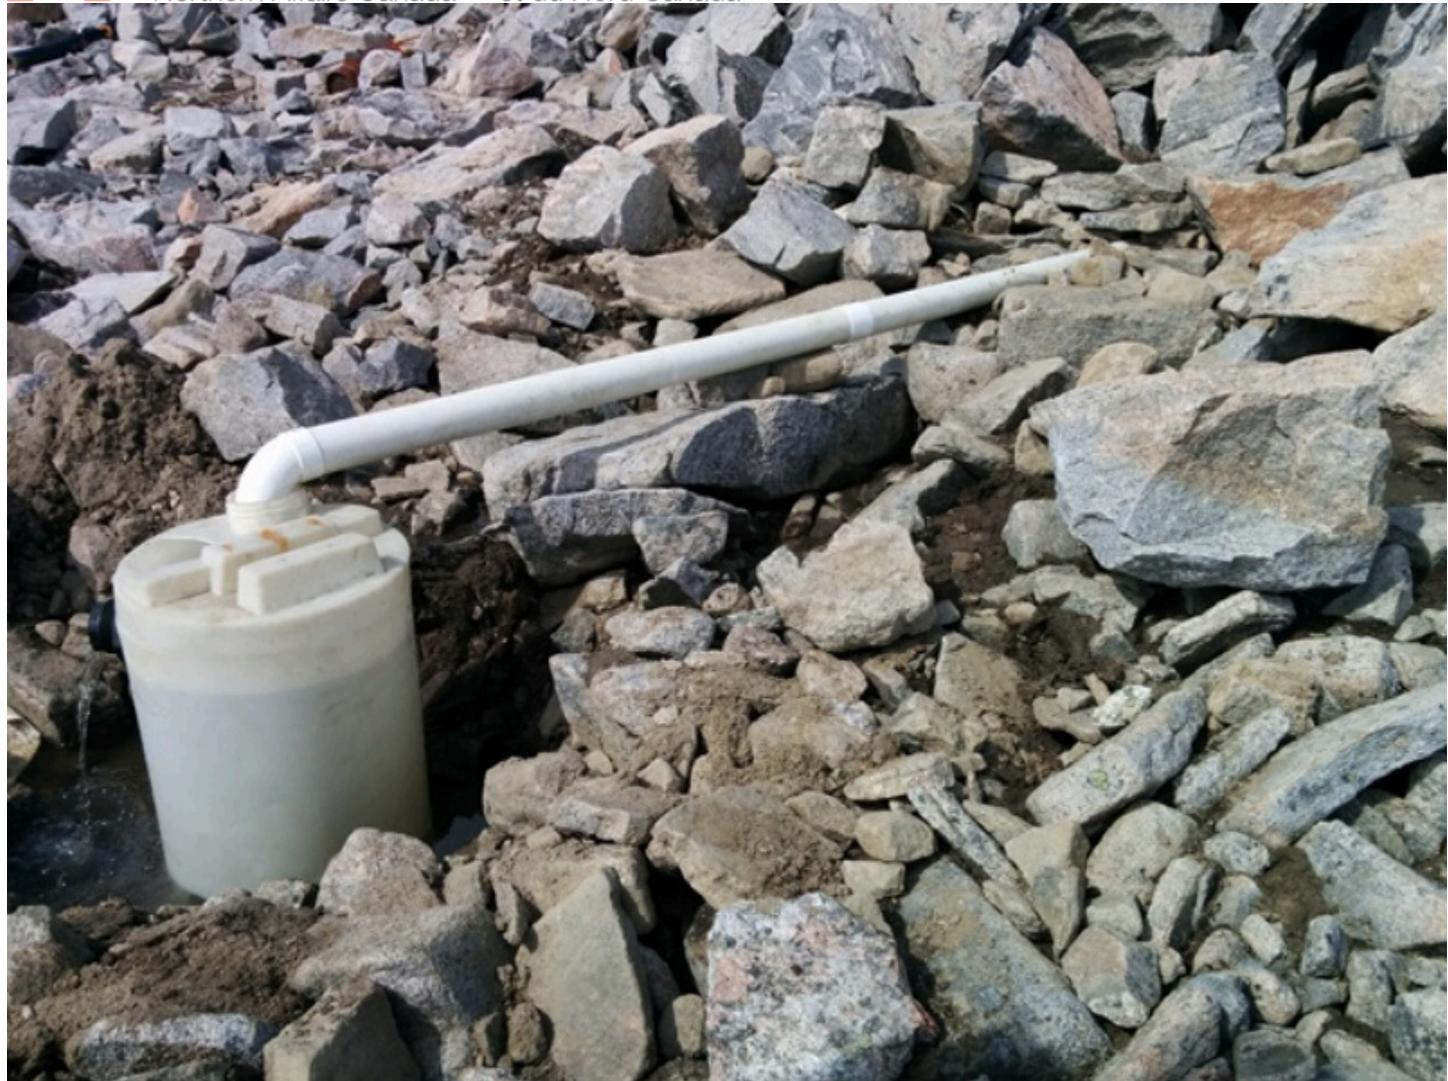
- There were obvious signs of staining throughout the site and free product was found in 5 of seven wells. It was also noted that some free product was identified moving south of the spill site into the boulder field and an ad hoc oil/water separator was installed to catch this material.

Figure 26 Oil Trap installed on south side to catch surface flow A.Winegardener

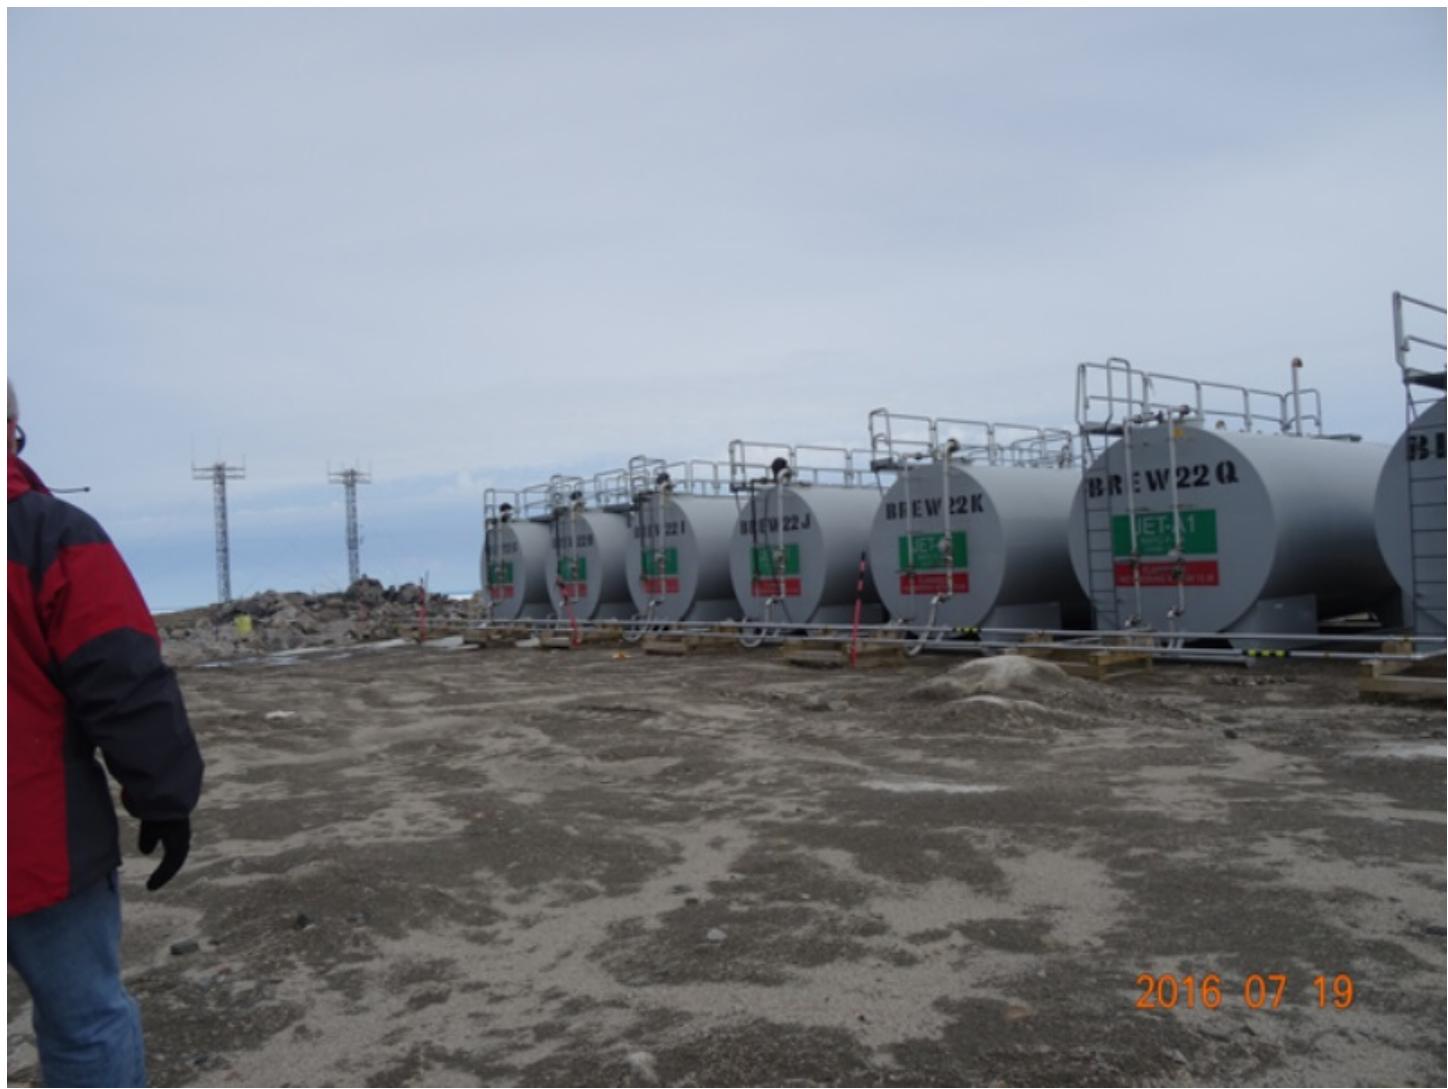
Figure 27 Tank installation at summit of baf-3
