## WATER LICENCE INSPECTION FORM

Licensee Major Creighton North Warning System Office 455 Boulevard de la Carrière, Gatineau, Quebec, J8Y 6W6		Licensee Representative Scott Charland – NWS A/Environmental officer - NWS Don Beattie – Raytheon Manager, Environmental, Health and Safety- Raytheon Canada	
Licence No. / Expiry 3BC-BAF0919		Representative's Title Acting Environmental Officer	
Land / Other Authorizations NIL		Land / Other Authorizations Nil	
Date of Inspection July 19, 2016		Inspector A.Keim	
Activities Inspected <input checked="" type="checkbox"/> Camp <input type="checkbox"/> Roads/Hauling		<input type="checkbox"/> Drilling <input type="checkbox"/> Mining <input type="checkbox"/> Construction <input type="checkbox"/> Reclamation <input type="checkbox"/> Fuel Storage <input type="checkbox"/> Other: Water Discharge <input type="checkbox"/> Other: Municipal

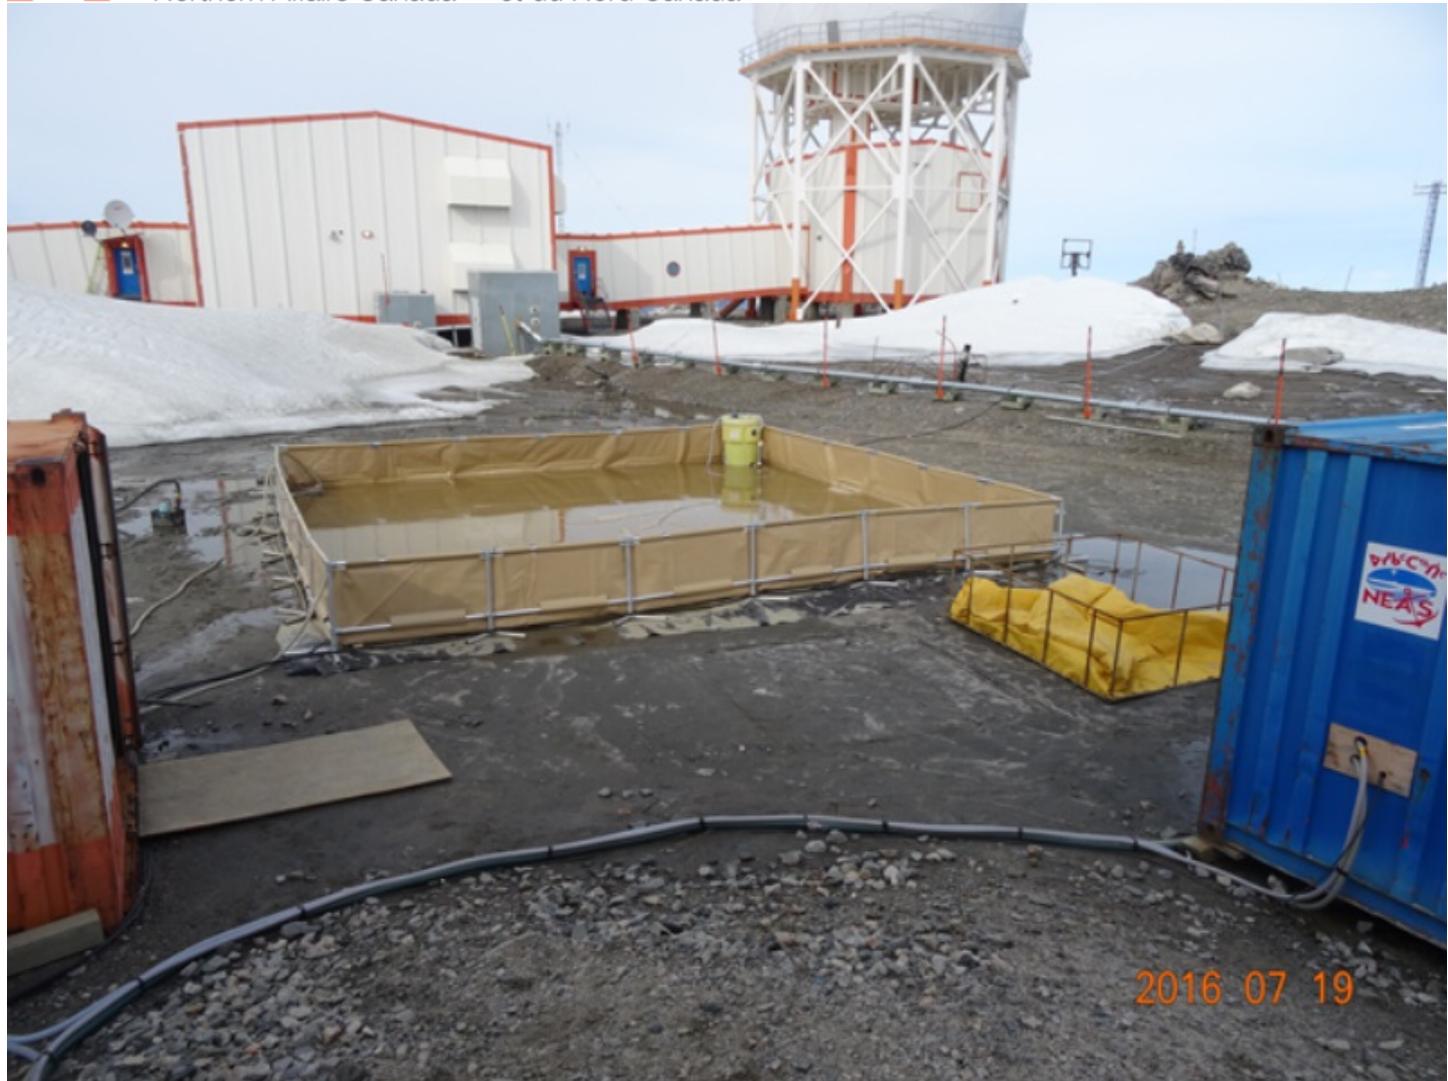
Figure 28 Influent berm

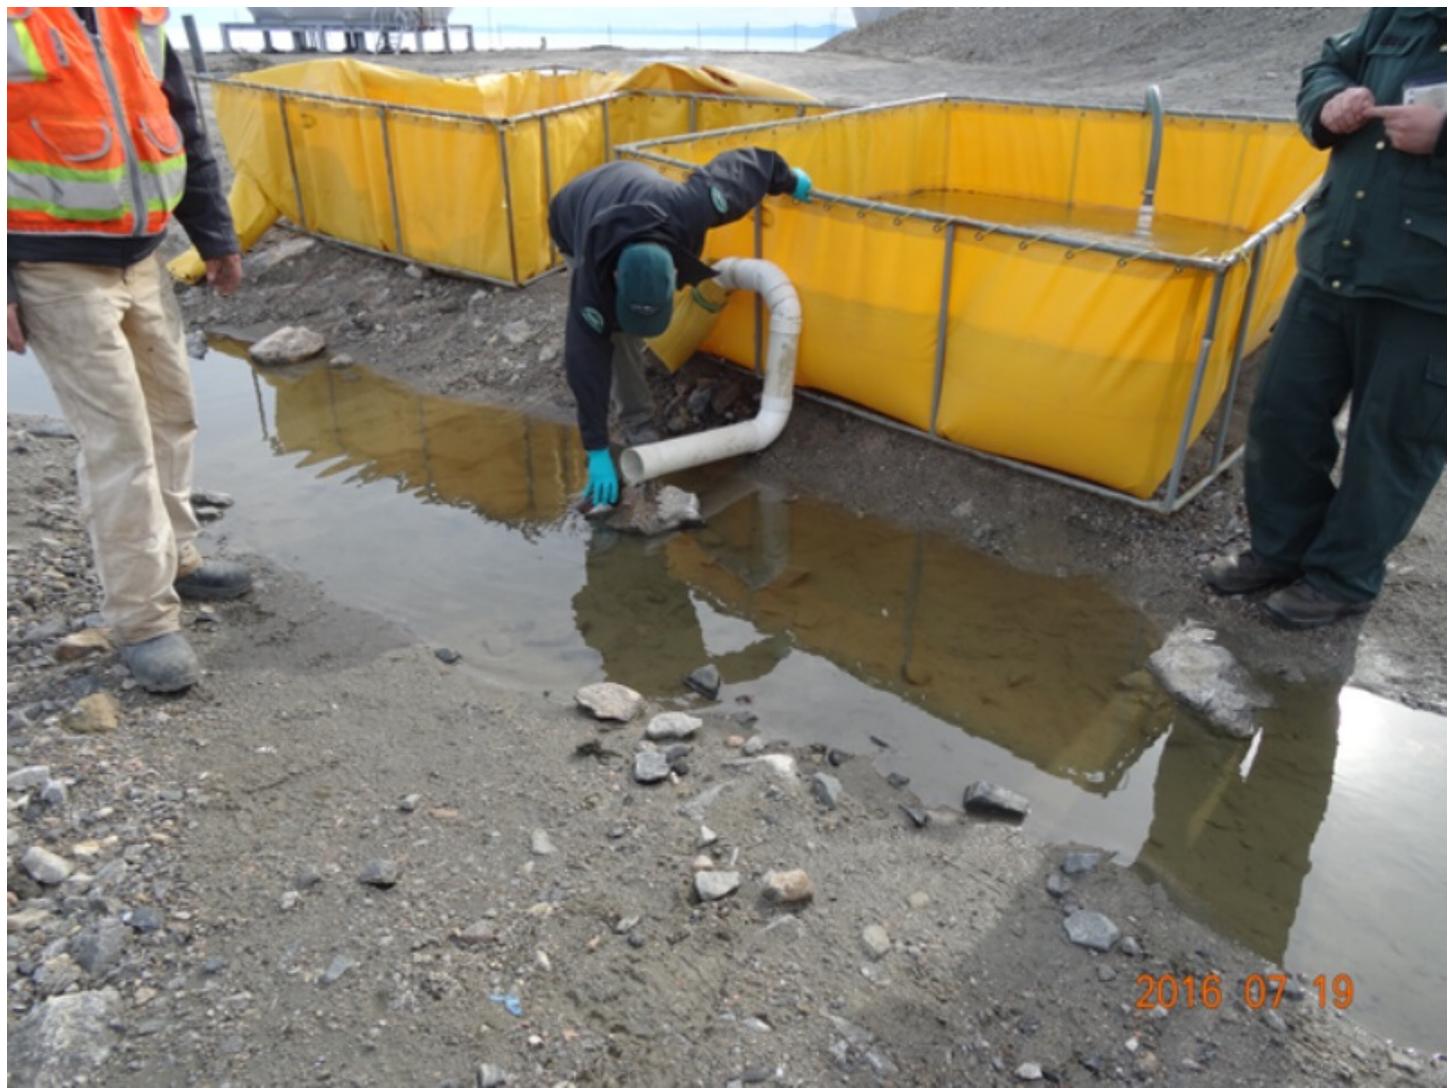
Figure 29 Sampling discharge
