WATER LICENCE INSPECTION FORM

| 3BC-BAF0919 | | Environmental Officer | |
| 08/24/2017 | | Jonathan Mesher | |

| <p>On August 23, 2017, a water licence inspection was conducted at the North Warning Site BAF-3, Qikiqtani Region, Nunavut. The Licence 3BC-BAF0919 allows the camp to use 1,750 cubic metres annually and to dispose of effluent at the sewage Disposal Facility.</p> | | | |

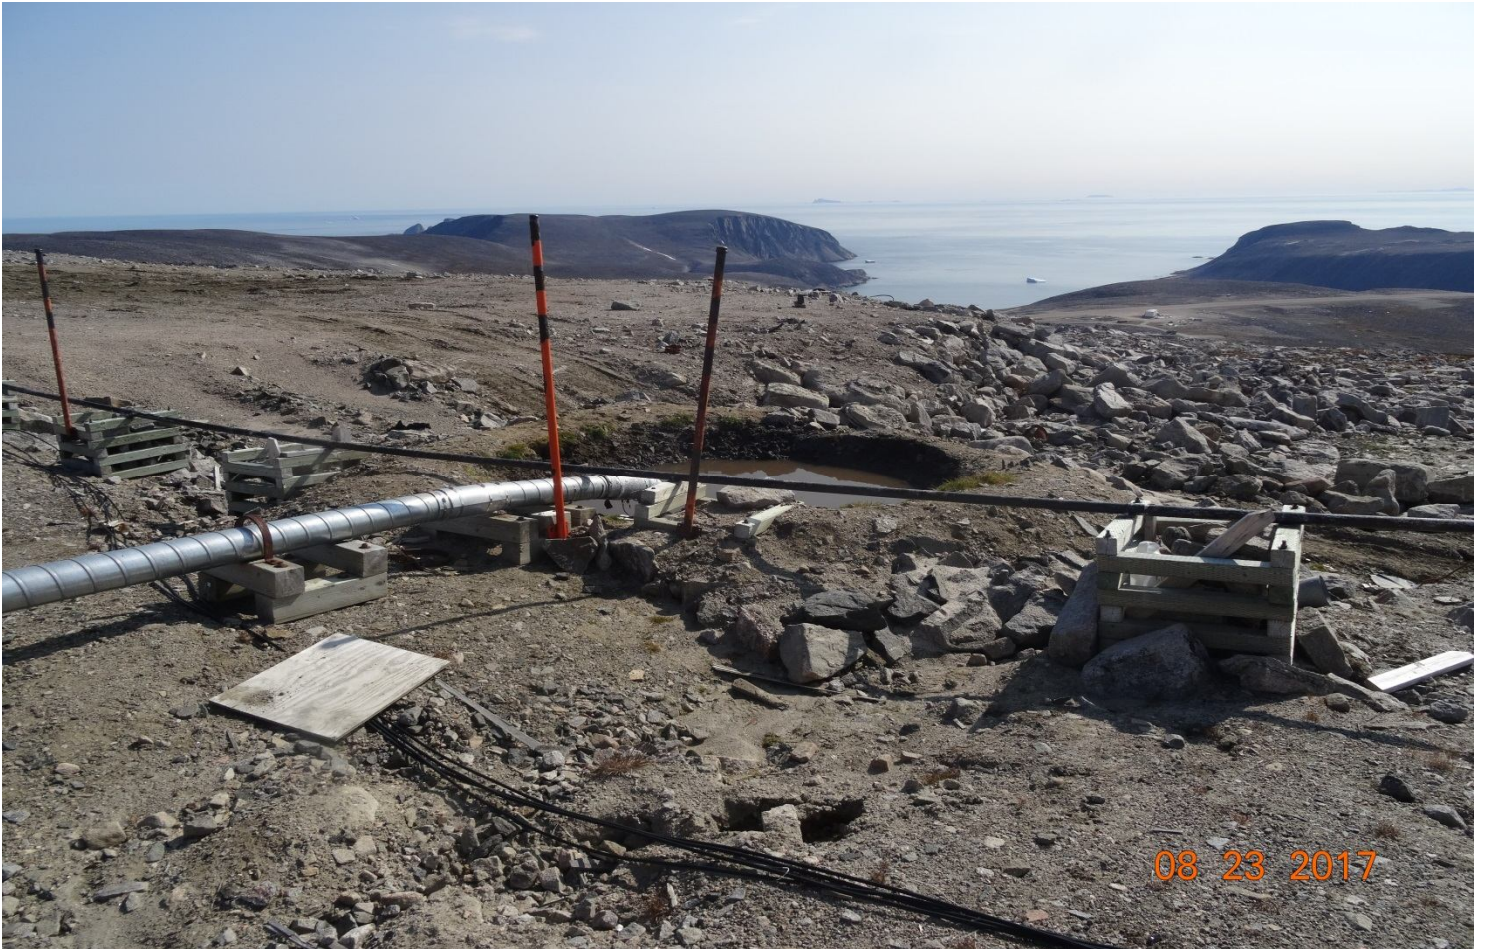
| <p><b>2. Sewage Disposal Facility.</b></p> <p>a) The Licensee pumps effluent and grey water from a settling tanks into a sump near the facility (see figure 1 for a picture of the sump).</p> <p>b) The facility appears to be operating as intended at the time of the inspection and no issues were noted.</p> <p>c) It does not appear to the inspector that his facility affects inland waters.</p> | | | |

Figure 1: Sewage disposal facility

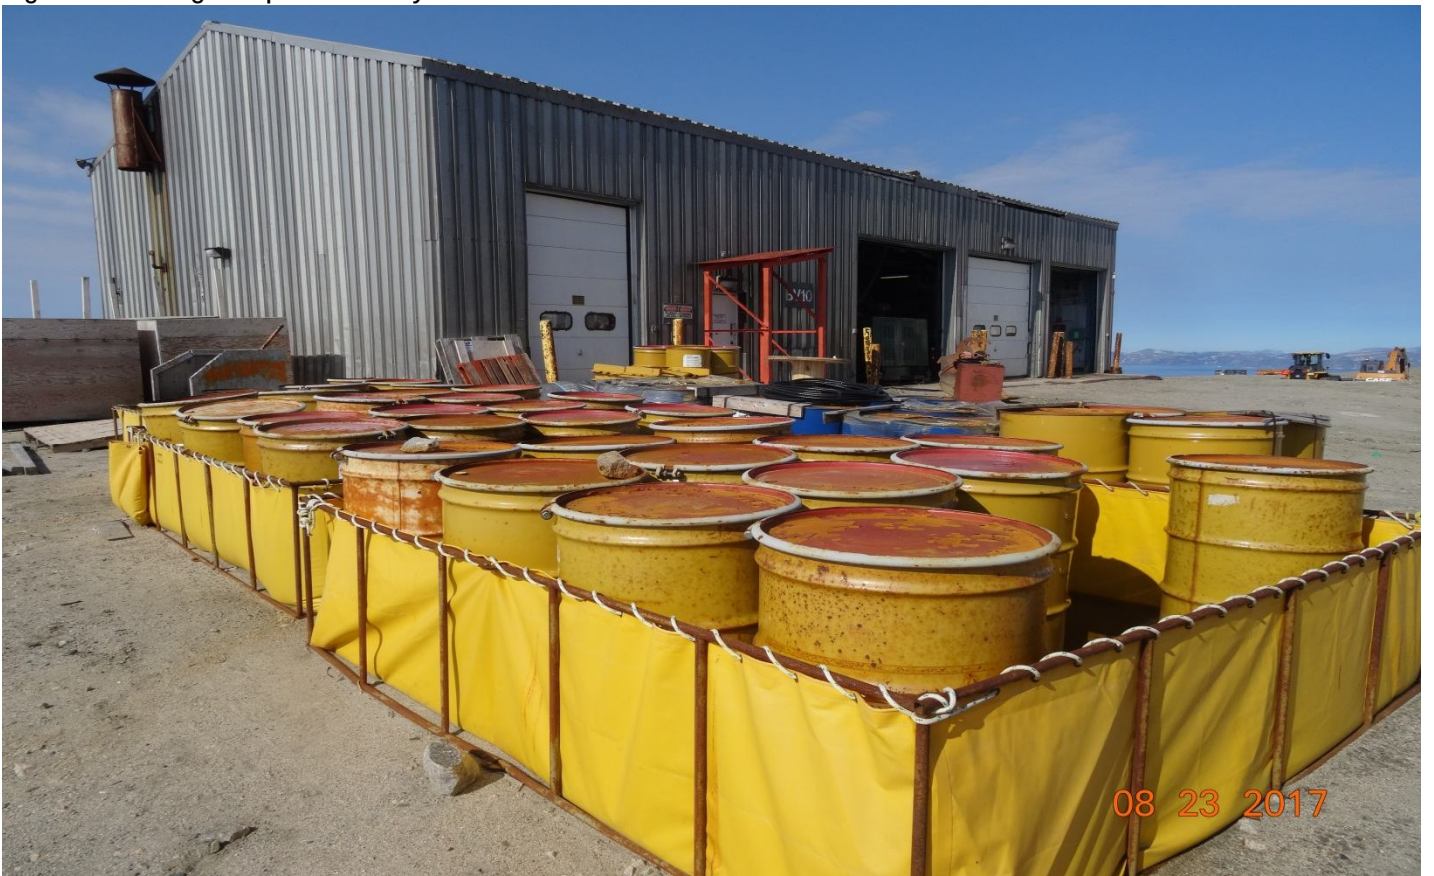
| <p><b>3. Hazardous waste.</b></p> <p>a) The licensee stores hazardous waste from surrounding sites at Baf-3 before shipping it to a disposal facility in Quebec.</p> <p>b) The licensee stores it hazardous waste in berms near the main camp.</p> <p>c) No concerns were noted about this storage of hazardous waste.</p> <p>d) See figure 2 for hazardous waste storage.</p> | | | |

Figure 2: Hazardous waste storage

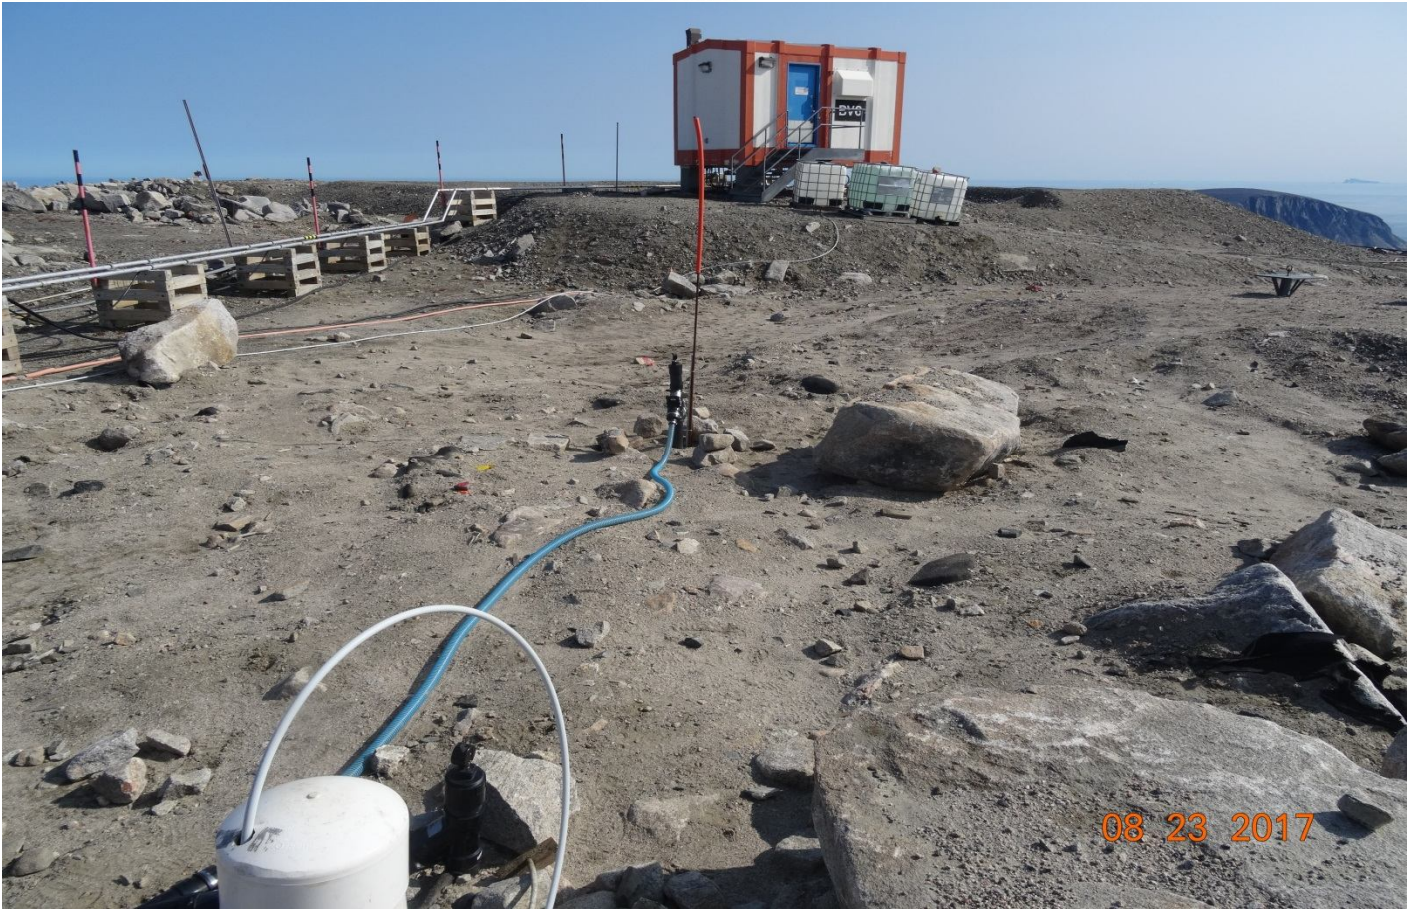
- a) The Licensee is currently conducting clean up on a spill from 2015 near the main camp.
- b) They are currently using the following methods to clean up the spill; Hydrogen peroxide, Fume extraction, Test pits, and they are monitoring natural drainages and depressions in order to determine the flow path. See figure 3 and 4 for treatment at the time of the inspection.
- c) No concerns were noted at the time of the inspection.

Figure 3: vapour extraction.

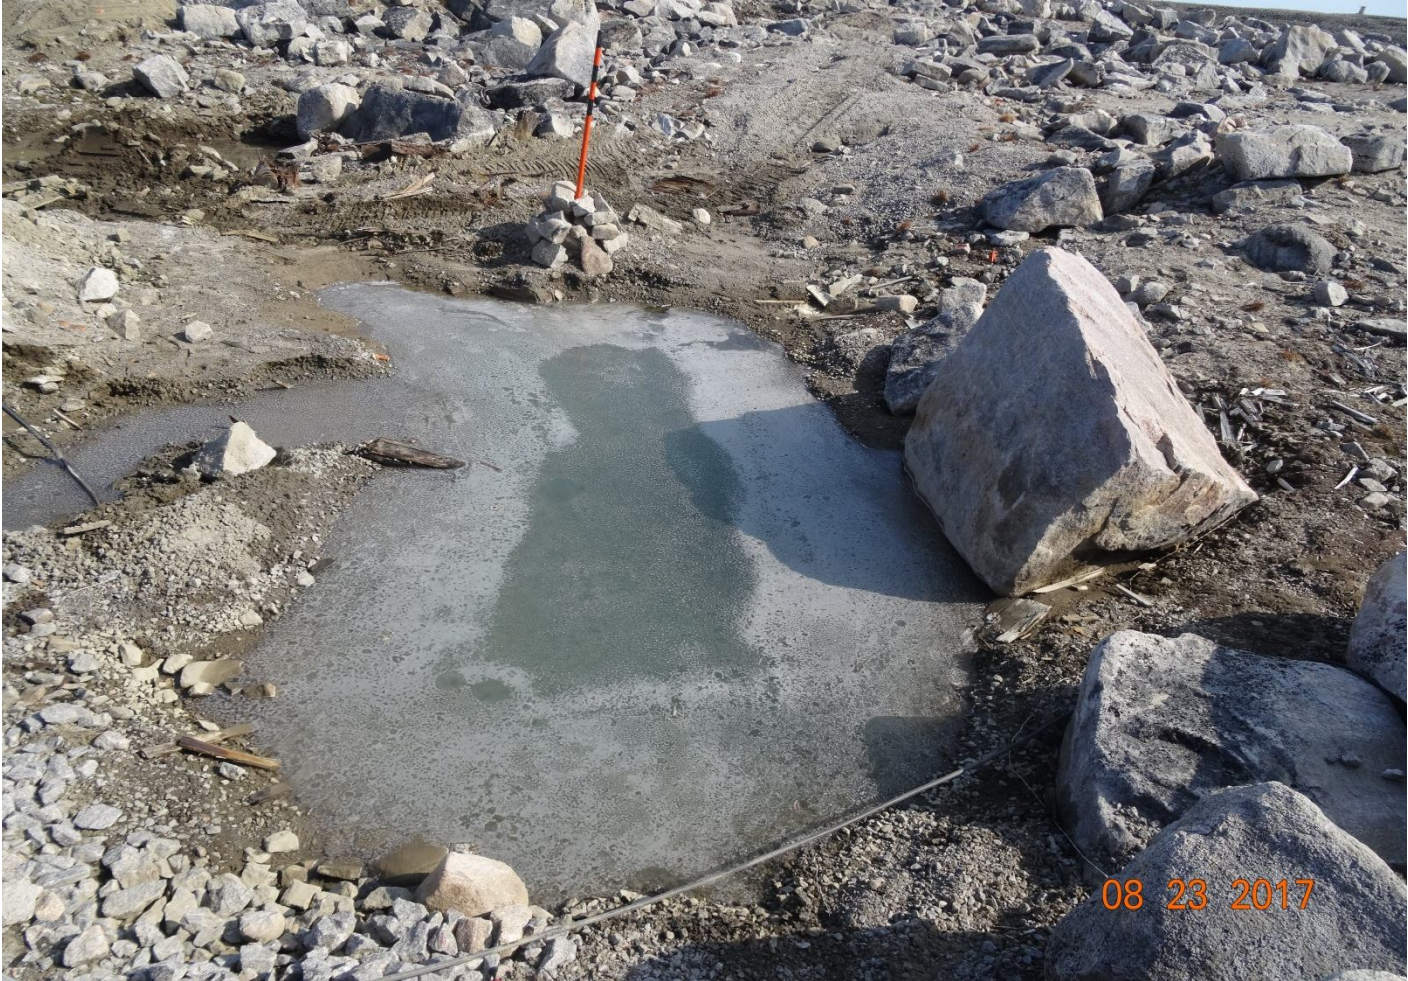
Figure 4: Hydrogen peroxide treatment.
