## WATER LICENCE INSPECTION FORM

Licensee Department of National Defence	Licensee Representative Don Beattie
Licence No. / Expiry 3BC-BAFA0919	Representative's Title Environmental Officer
Land / Other Authorizations	Land / Other Authorizations
Date of Inspection September 3, 2018	Inspector Joseph Monteith
Activities Inspected <input type="checkbox"/> Camp <input type="checkbox"/> Drilling <input type="checkbox"/> Mining <input type="checkbox"/> Construction <input type="checkbox"/> Reclamation <input type="checkbox"/> Fuel Storage <input type="checkbox"/> Roads/Hauling <input checked="" type="checkbox"/> Other: Potable Water Source, Solid Waste Facility, Sewage Disposal Facility <input type="checkbox"/> Other:

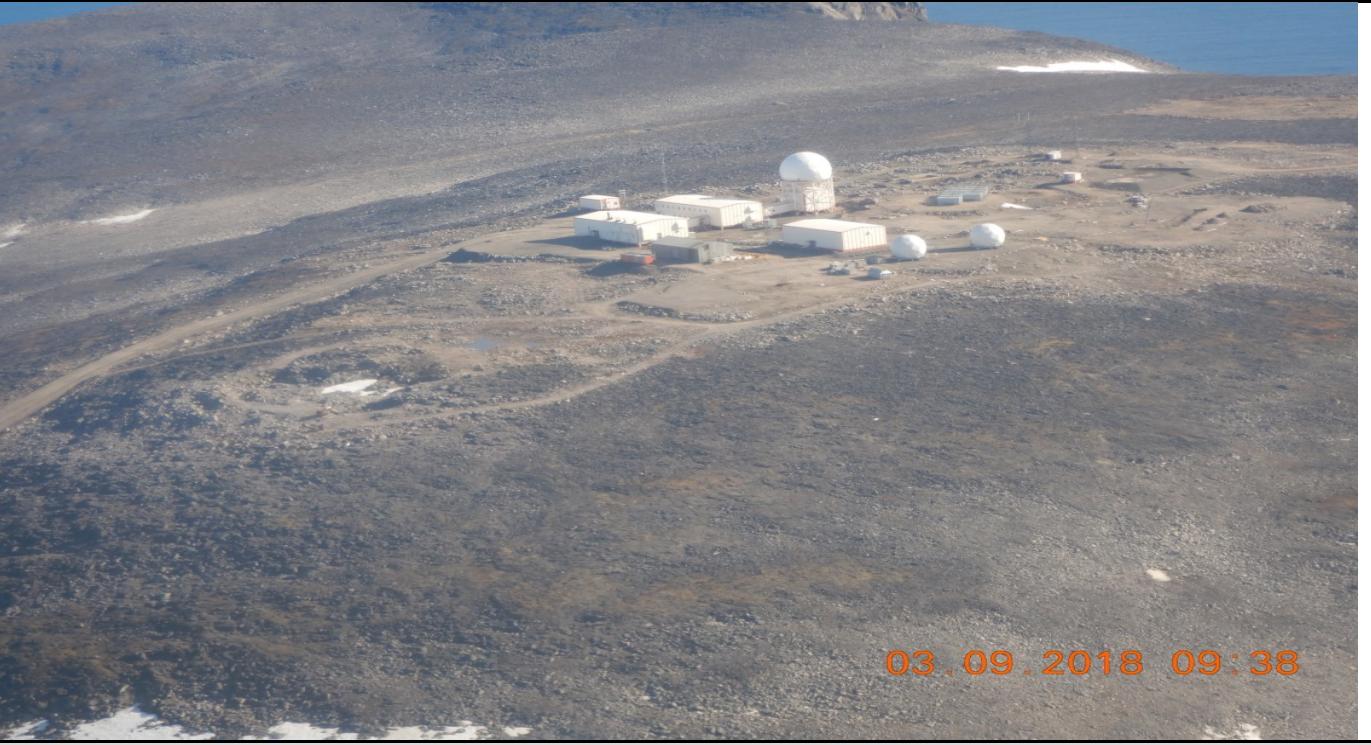
Date	Camera	Inspector
September 3, 2018	Nikon Coolpix	Joseph Monteith
<b>Photo Log #1</b>		<b>Location</b>
Photo 1		Breevort Island, NU

03.09.2018 09:38		
<b>Description:</b> BAF-3, Breevort Island

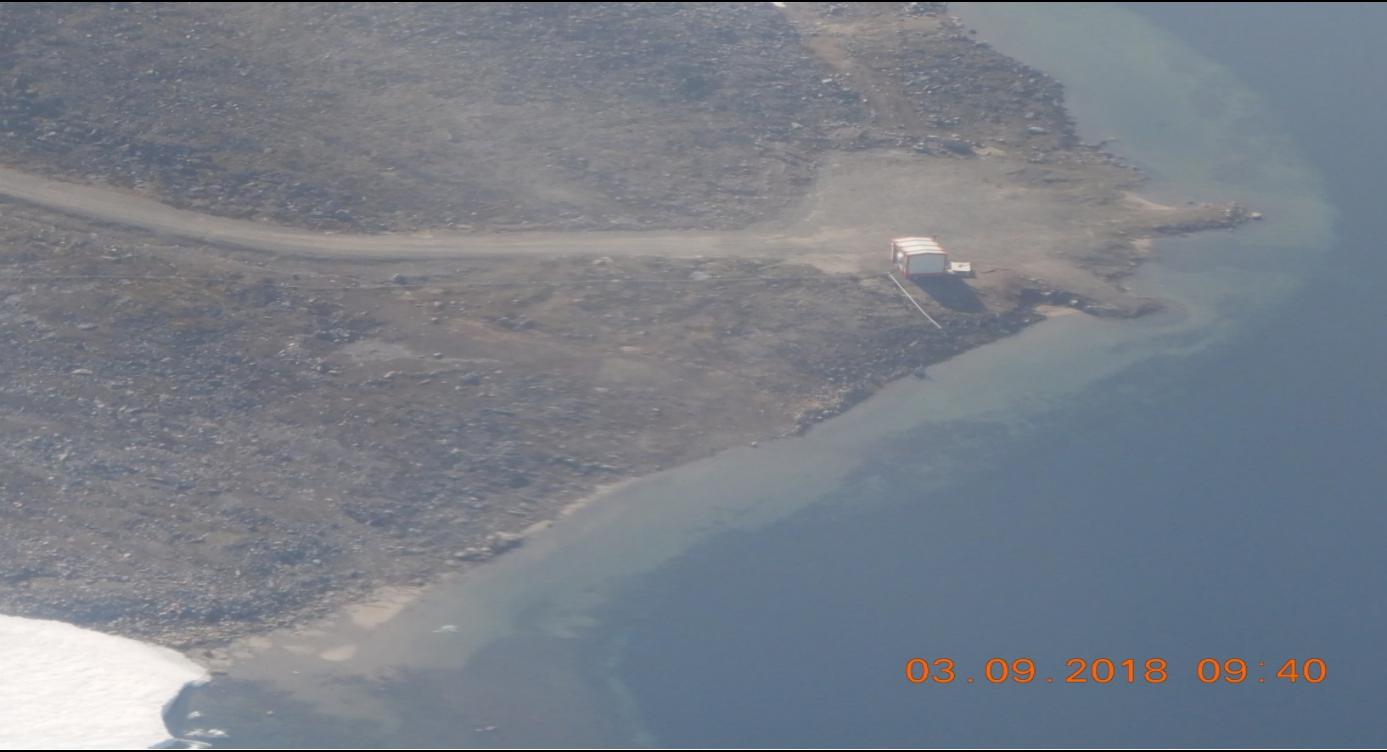
Photo Log	Location
Photo 2	Breevort Island

03.09.2018 09:40	
<b>Description:</b> Pump house recharges pipes which transfers water to the BAF-3 facility.

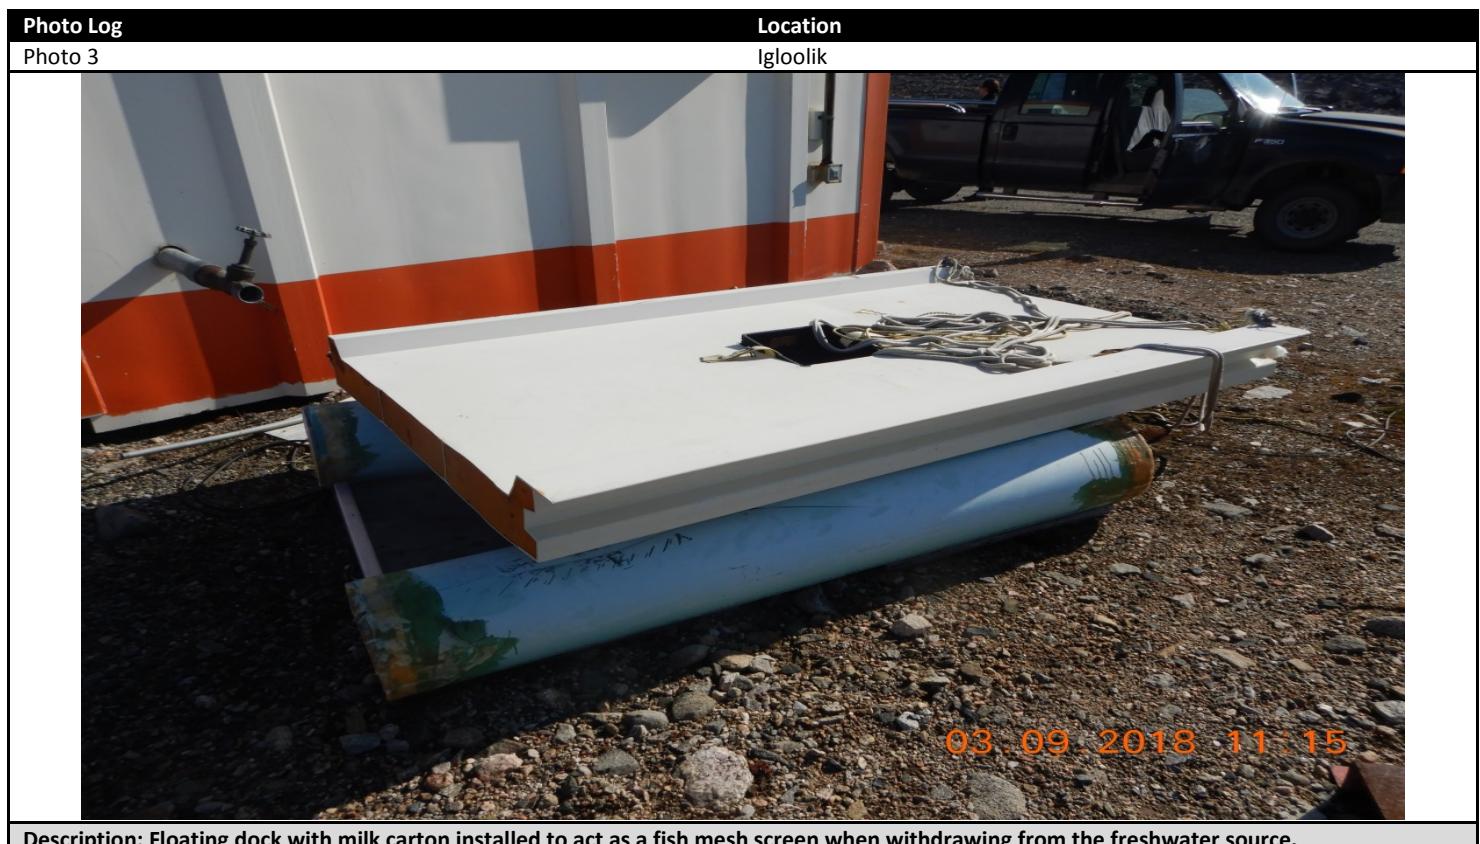
Description: Floating dock with milk carton installed to act as a fish mesh screen when withdrawing from the freshwater source.

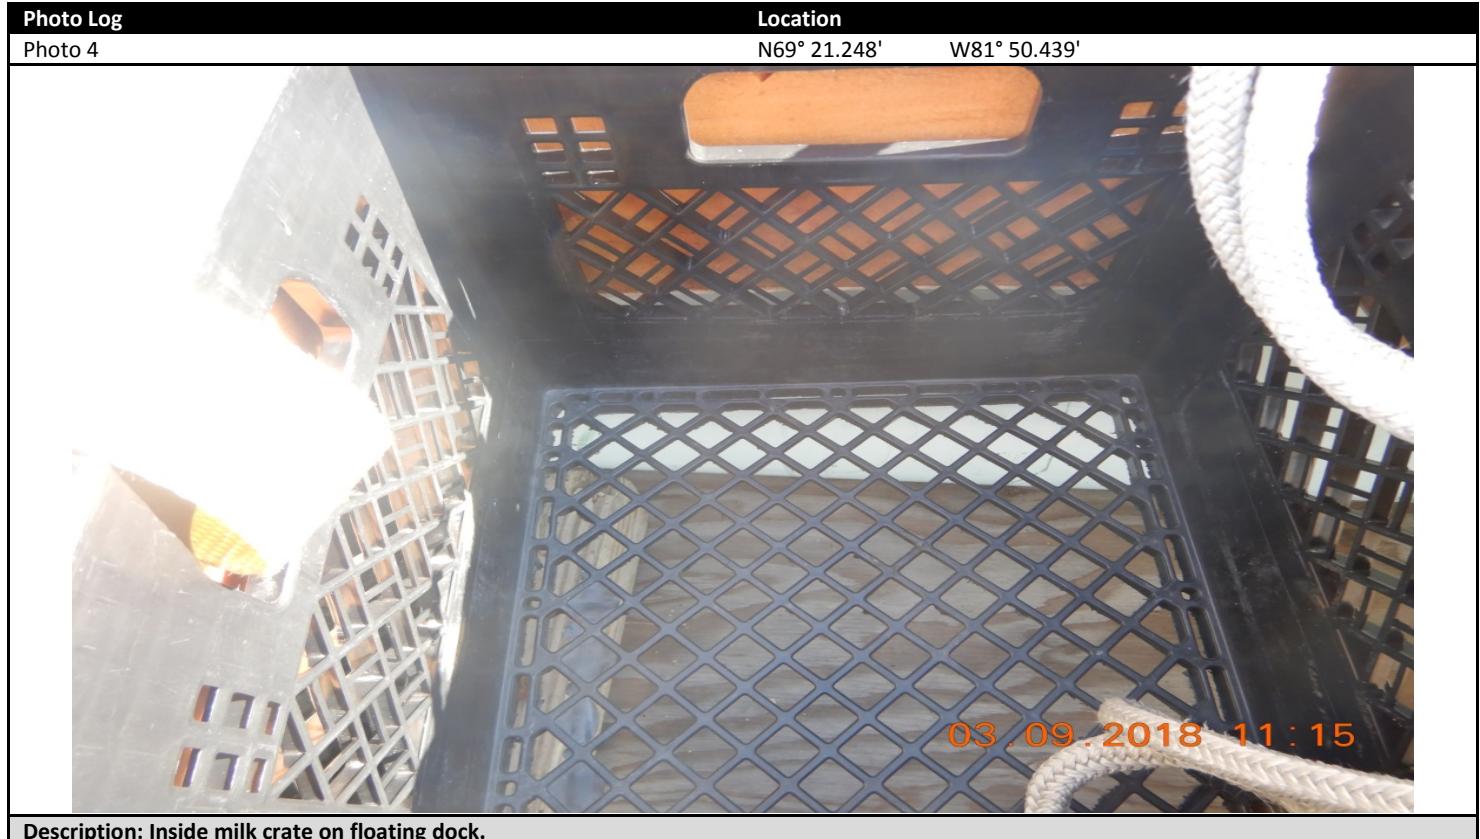
Description: Inside milk crate on floating dock.

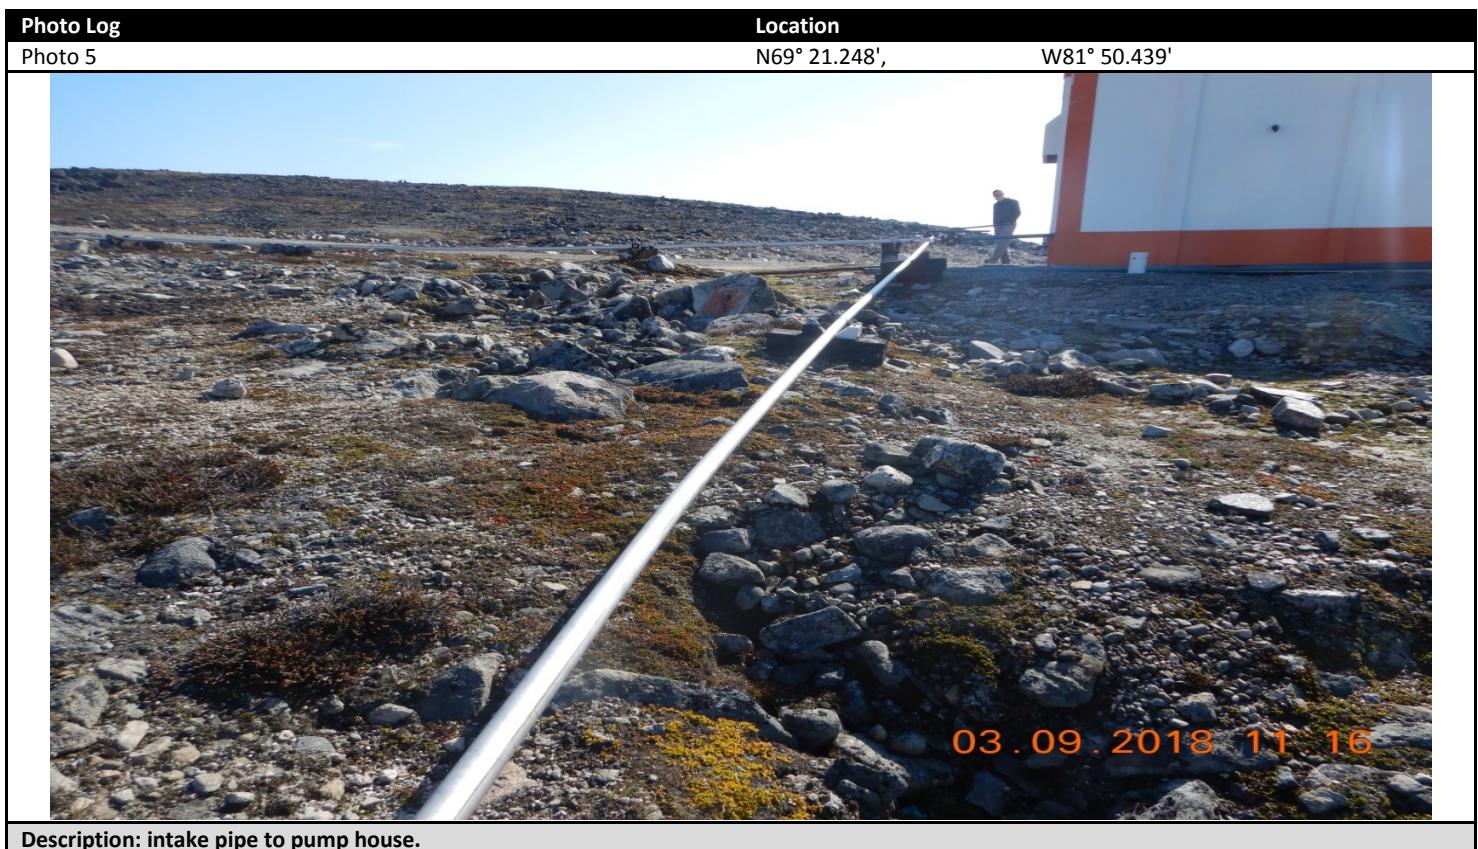
Description: intake pipe to pump house.

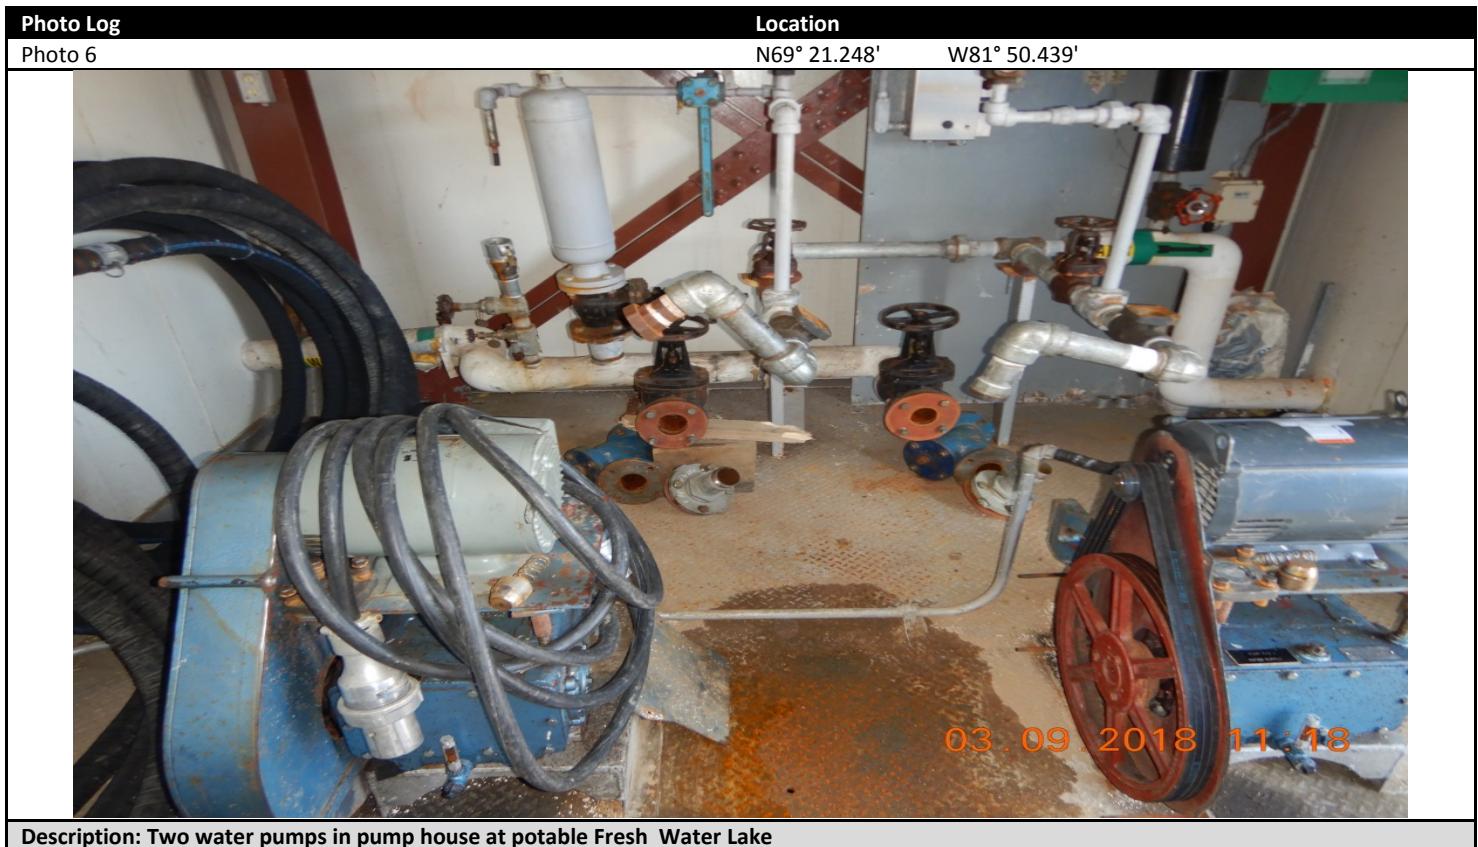
Description: Two water pumps in pump house at potable Fresh Water Lake

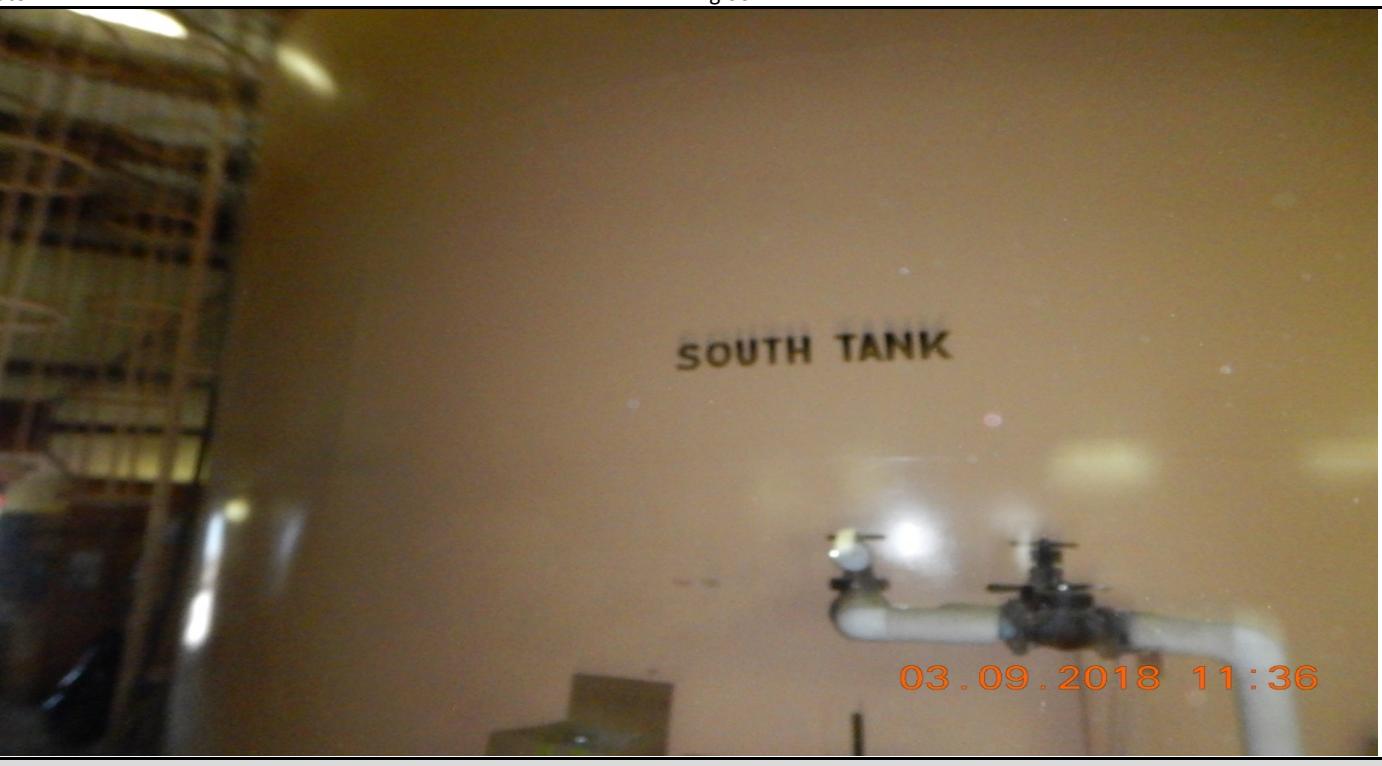
Photo Log	Location
Photo 7	Igloolik

7. The Water Storage Building has two 984 m³ Water Storage Tanks (see photo 7 and 8).
8. A Water Meter was observed on site, and read 91271.2 Gallons (see photo 9).

SOUTH TANK 03.09.2018 11:36

Description: Water Storage Tank South. Capacity 984,000

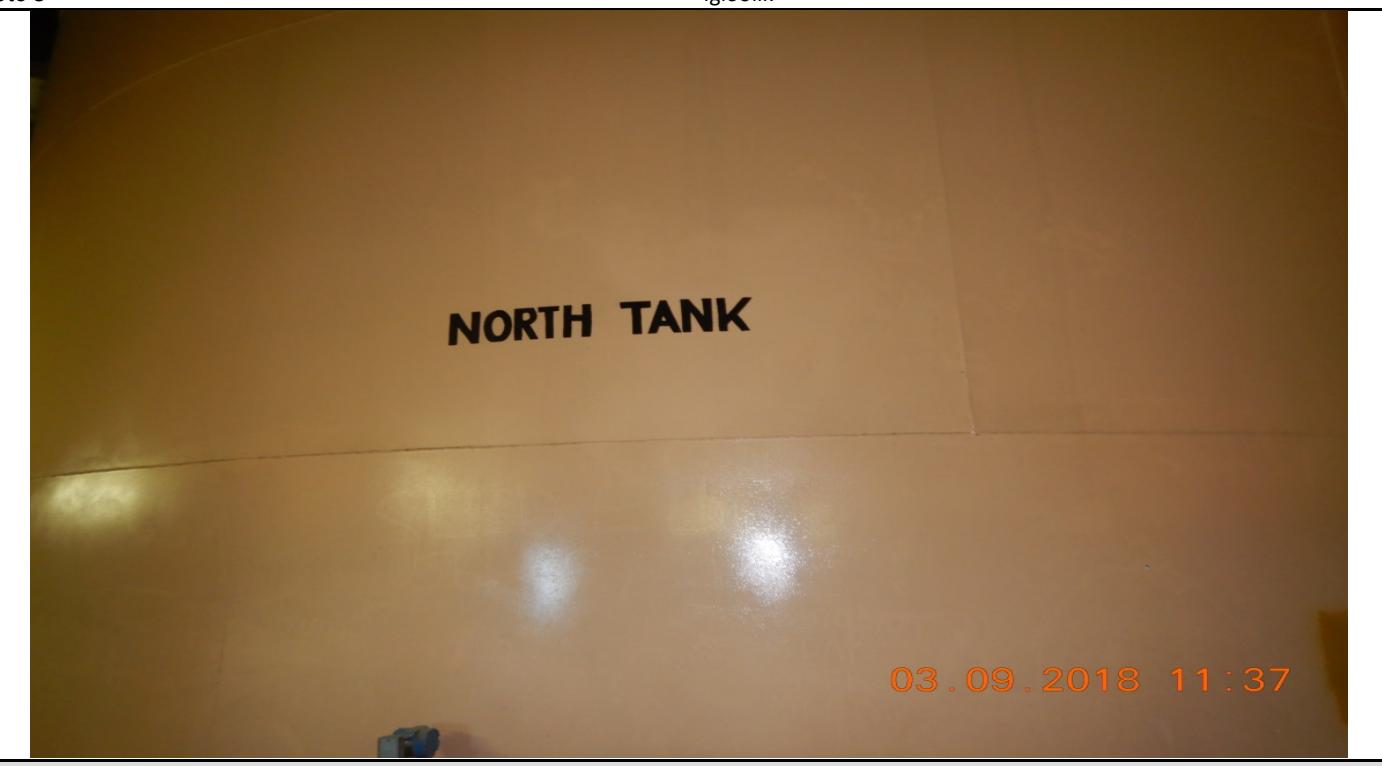
Photo Log	Location
Photo 8	Igloolik

NORTH TANK 03.09.2018 11:37

Description: Water Storage Tank South. Capacity 984,000

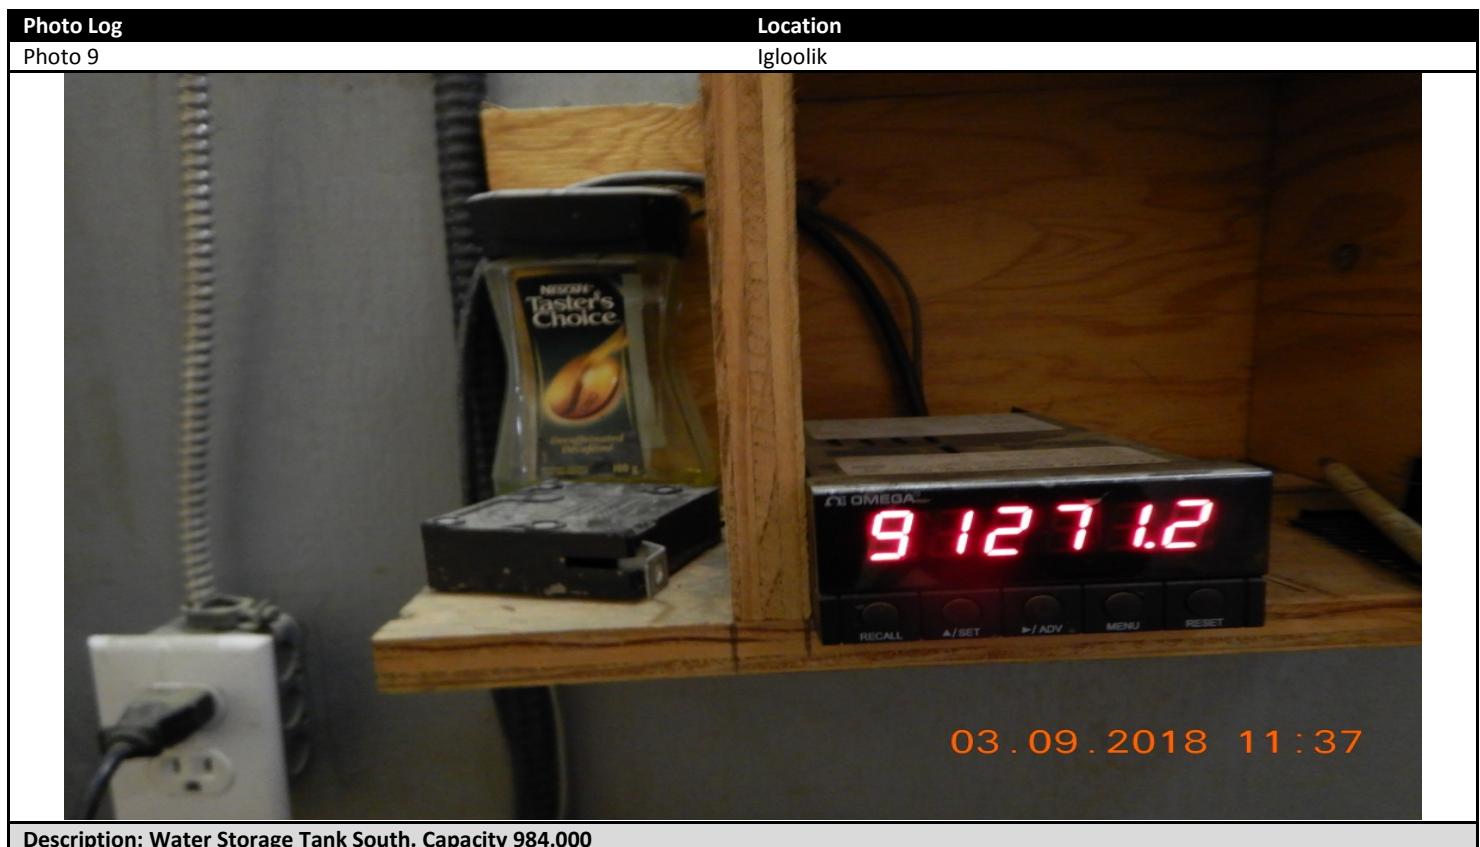
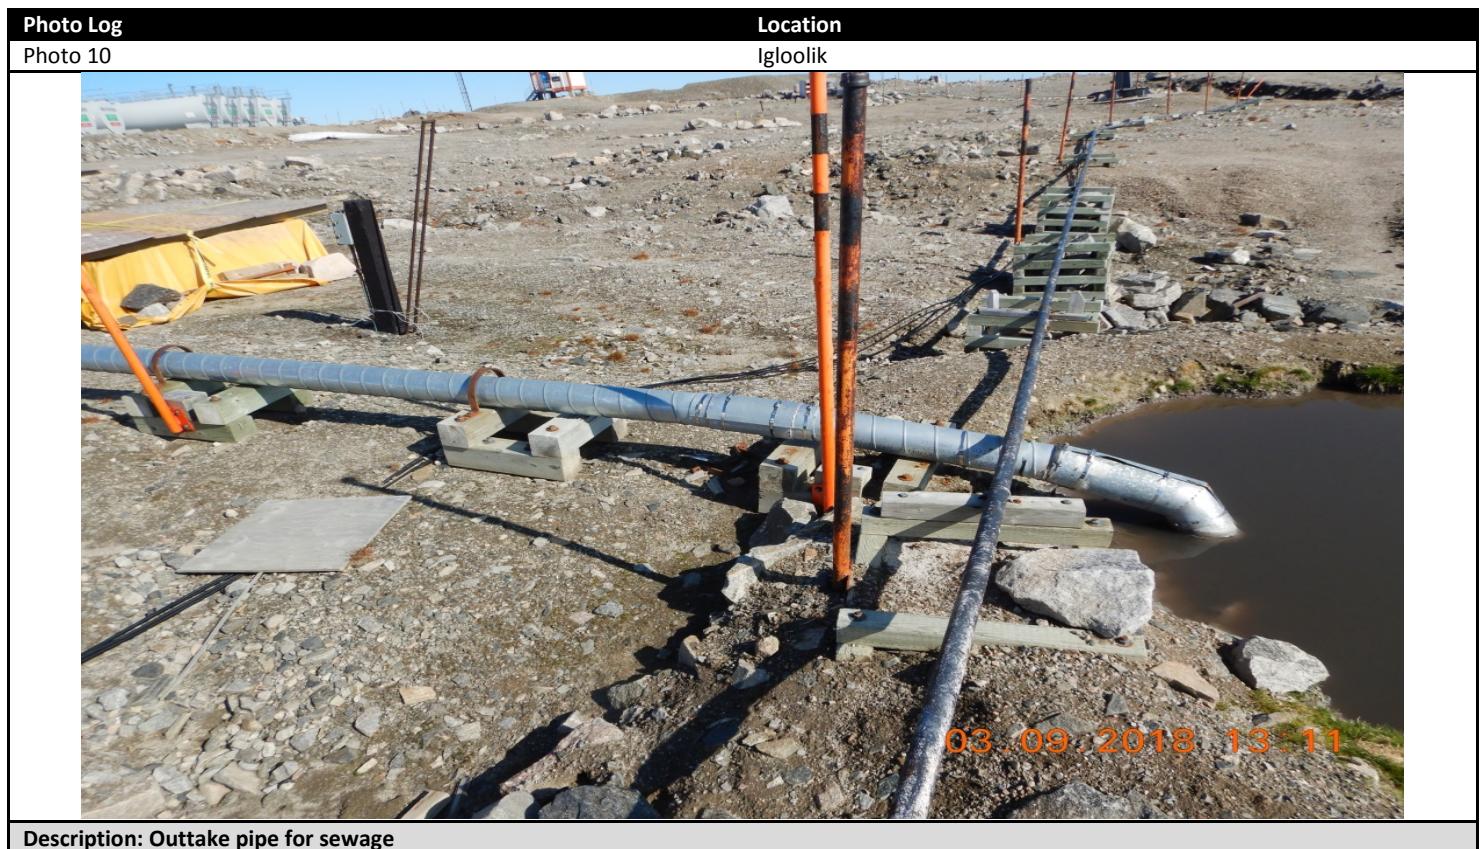
9. The Sewage system consists of a septic tank, and an outfall pipe that drops its waste into a sump.
10. No observations were made of the septic tank during the inspection.
11. The outfall pipe end was below the sewage waste water table in the sump. (See photo 10).
12. The Sump pit appeared to be full, and was built up on one side of the wall with rocks. Seepage appears to have leaked through the rocks (See photo 11).

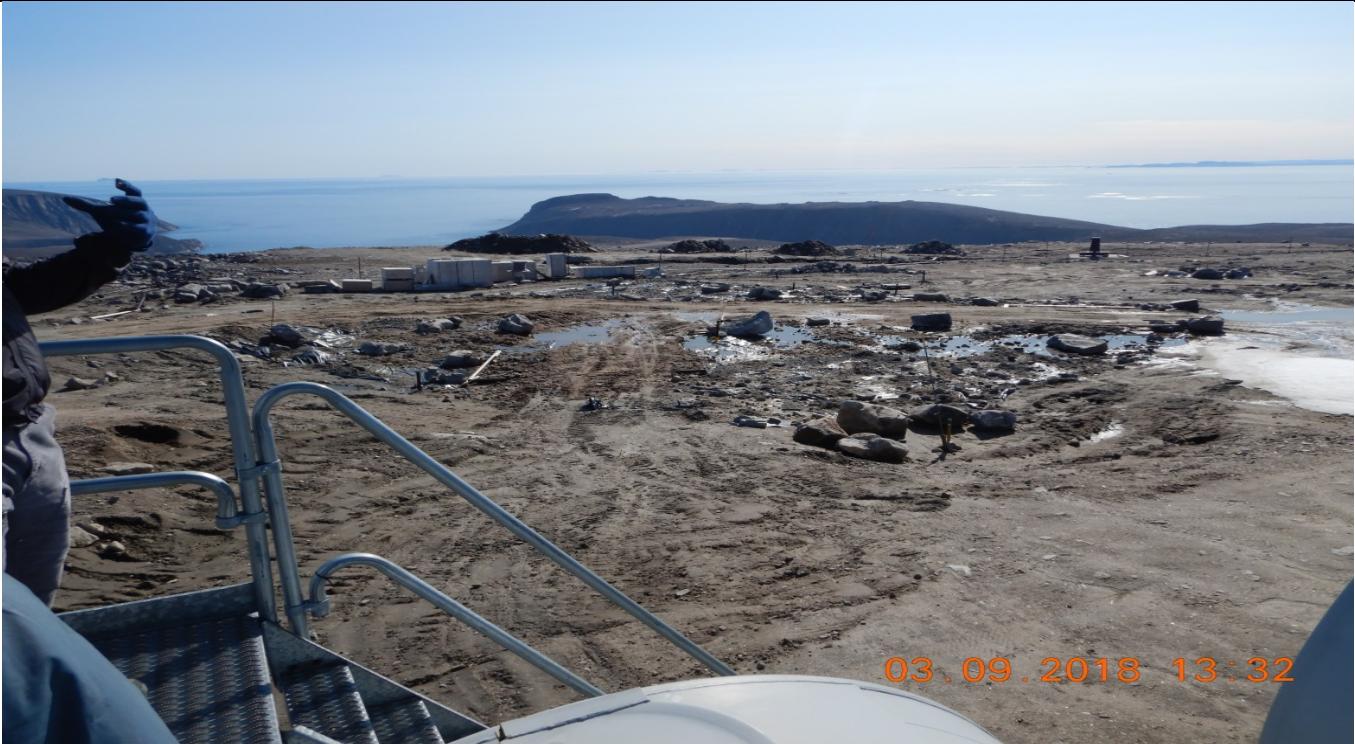
Photo 13

Description: Site of remediation from on top of the storage tank responsible for the spill source.

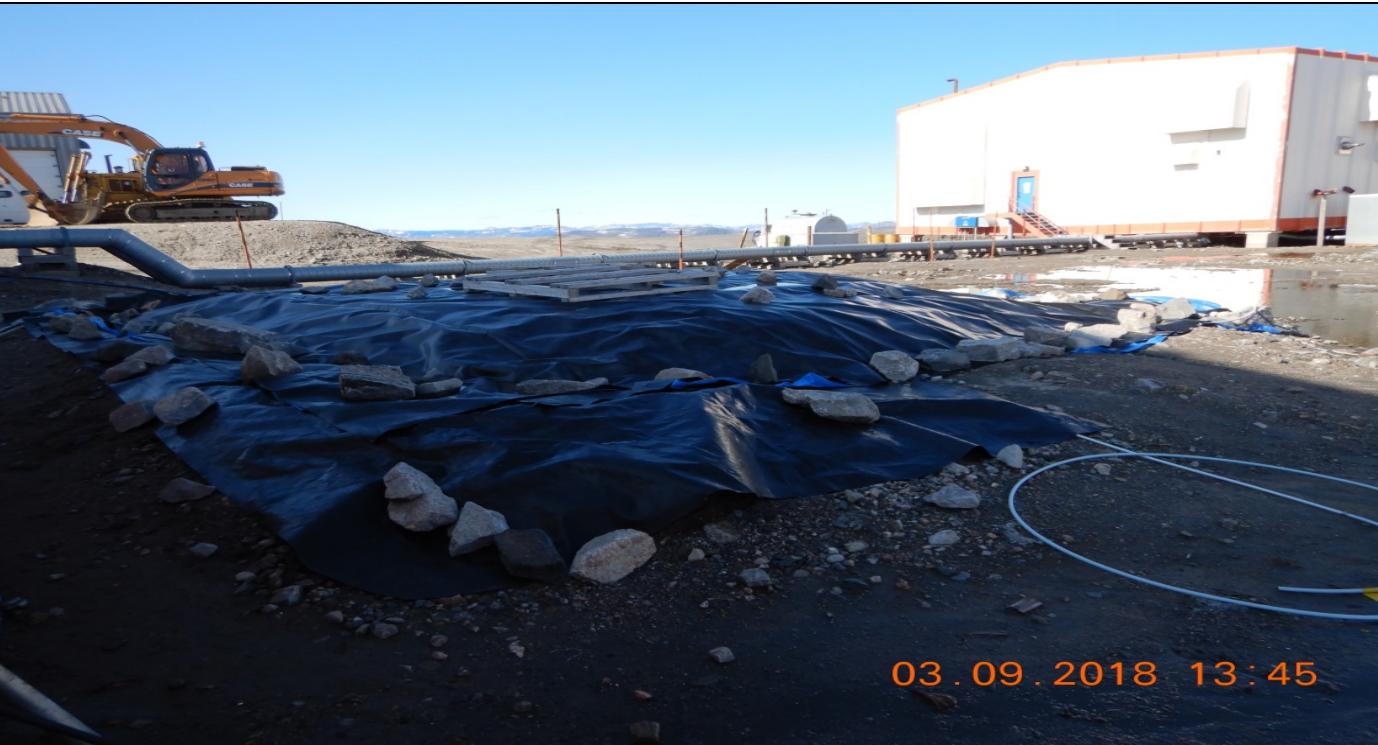
Photo 14

Description: A hydro carbon puffer, creates a negative pressure room, and sucks the hydro carbons out of the soil.

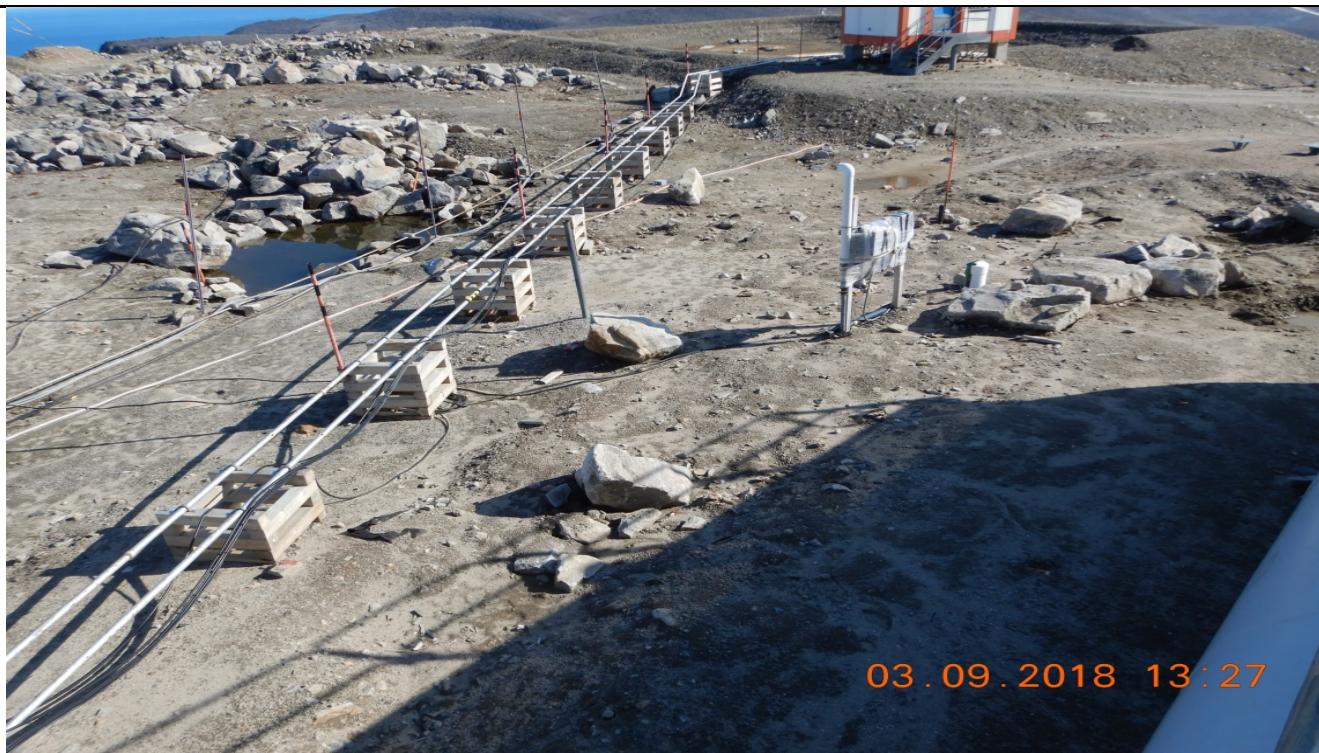
Photo 15

Description: Migration of spill also went north east of the storage tank. The water in the photo is a result of the creation of a trench to capture fuel spill and stop the migration.
