2015 ANNUAL NUNAVUT WATER BOARD REPORT FOR BAF-3

North Warning System

Document Number
FM-EHS-13, Rev 1, 17-Mar-2016

Reference: BAF-3 2015 Summit and Middle Site Monitoring and Strategic Closure Plan Development

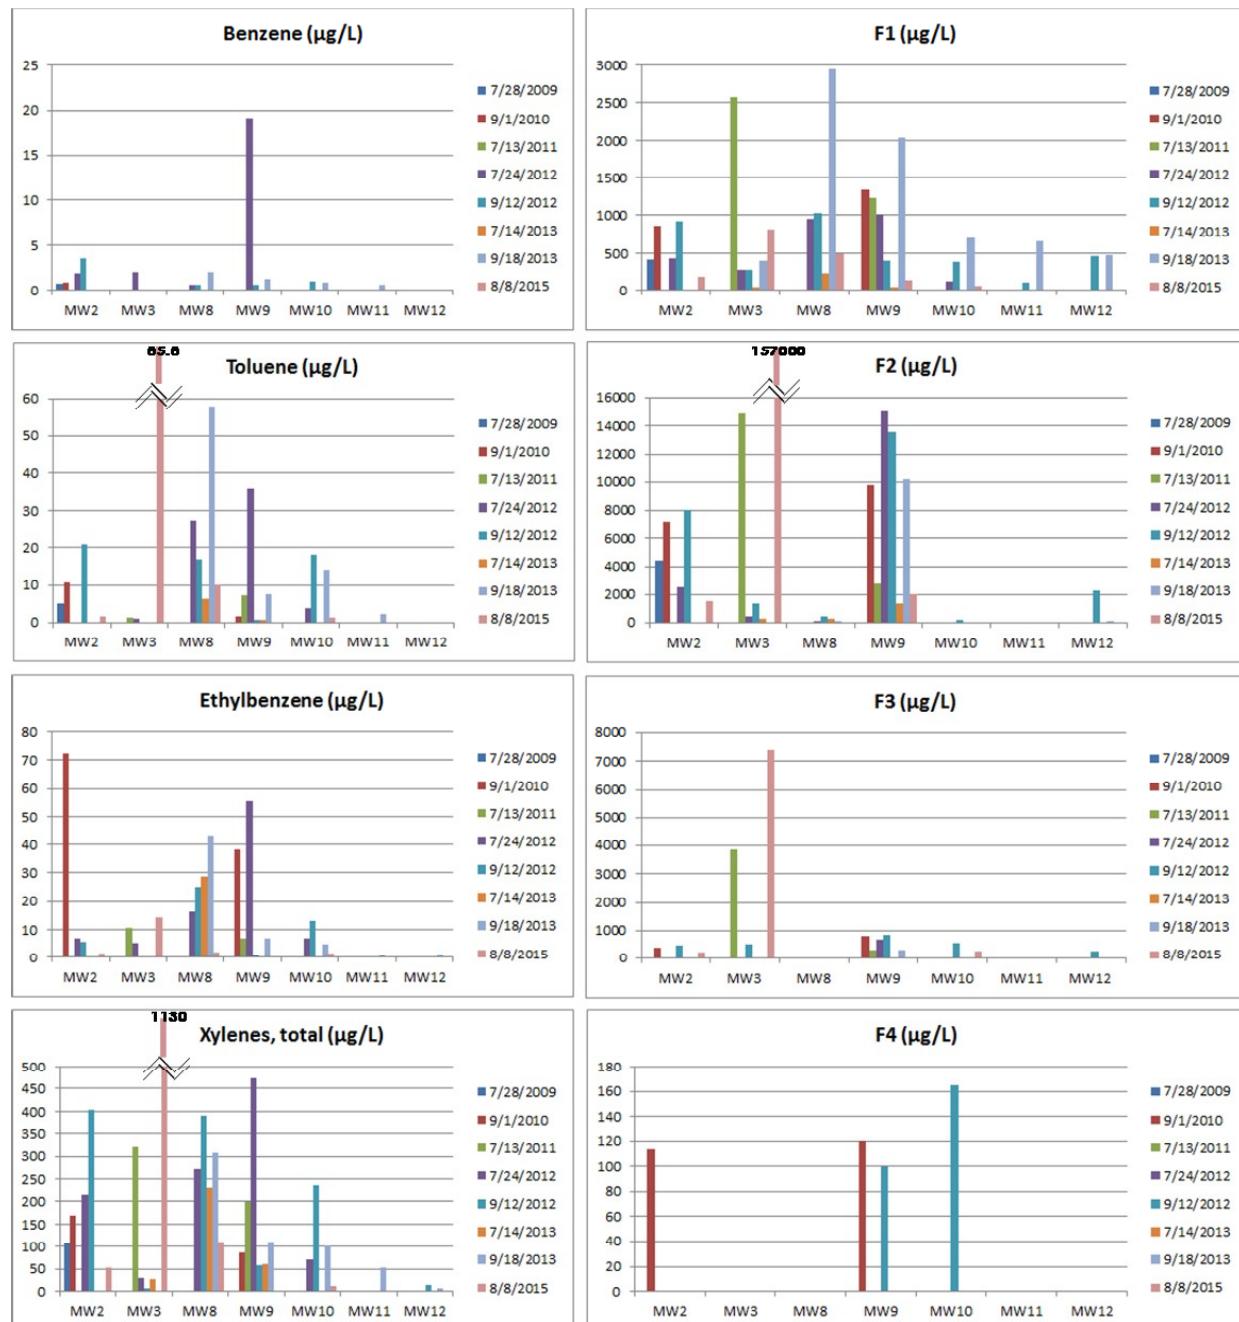
Figure 1. Groundwater Monitoring Results 2009-2015

Of the five upper site monitoring wells sampled, free product was found to be present in MW 3, as observed during the field sampling event and confirmed by the laboratory result. After purging and recovery this well was sampled, to provide a record of the product observed.

It is likely that the dissolved component of the new spill (July 2015) has not yet progressed as far as the remaining MWs. Based upon the observed behaviour of the 2007 spill, it would be expected that the lighter PHC components would reach the MWs sequentially with time in a downgradient pattern. The next nearest wells to the spill point after MW 3 are MW 2 to the north and MW 9 to the south. This was demonstrated in our past sampling where free product was observed in MW 3 in 2009, in MW 2 in 2010 and in MW 9 in 2012. All three of these wells showed no recovery of free

- Upper Site Groundwater Monitoring:
 - A recent refueling spill has occurred next to the TSM, as reported by RCL on-site support staff – this recent spill is the likely cause of the observed free product in MW 3

- No trends can be drawn from MW 3 as a result of having been impacted by the new spill
 - Remaining sampled MWs at the upper site (MWs 2, 8, 9 and 10) appear to not yet show impacts from the new spill. Although MWs 2, 8, 9 and 10 can show a single event reduction in COC concentrations from the past sampling event (2013), no trends can yet be established, and, based upon the progression of observed impacts from the 2007 spill, it is expected that MWs 2 and 9 will show evidence of impacts from the July 2015 spill in the next year or so. No trends for MWs 2 and 9 will likely be able to be drawn in future years because of the July 2015 release

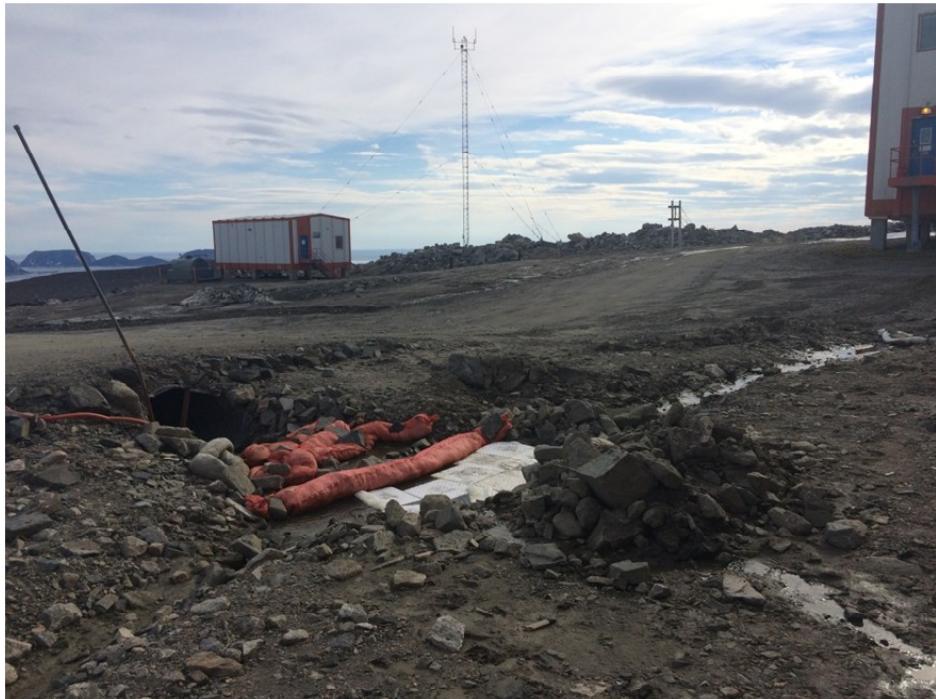
Photo 1. North of TSM looking NE, booms and pads placed downgradient in evidence. August 8, 2015.

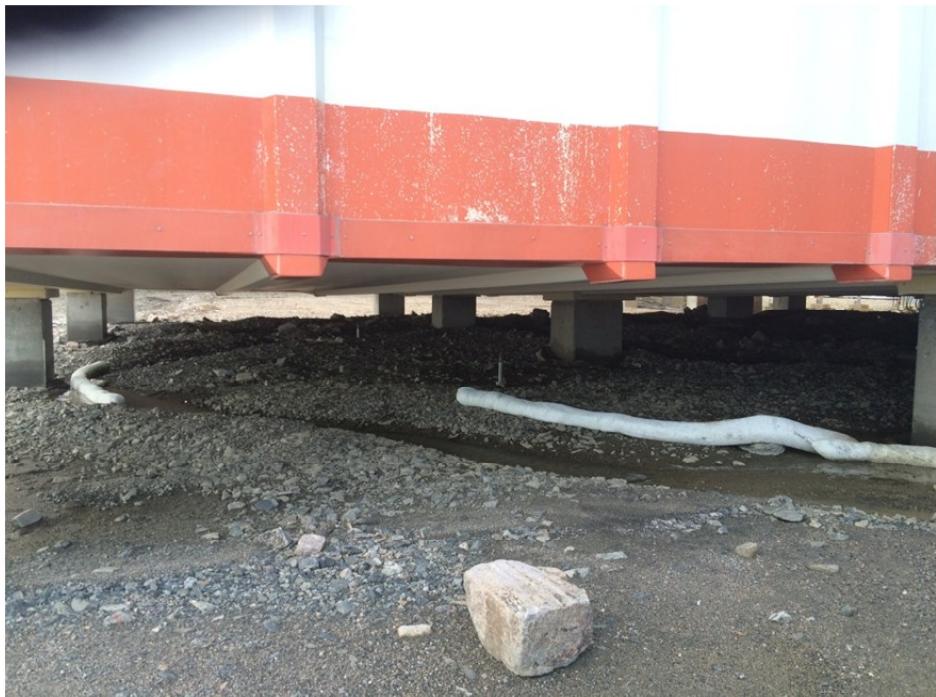
Photo 2. Looking under north end of TSM, showing MWs 2 (foreground) and 10. August 8, 2015.

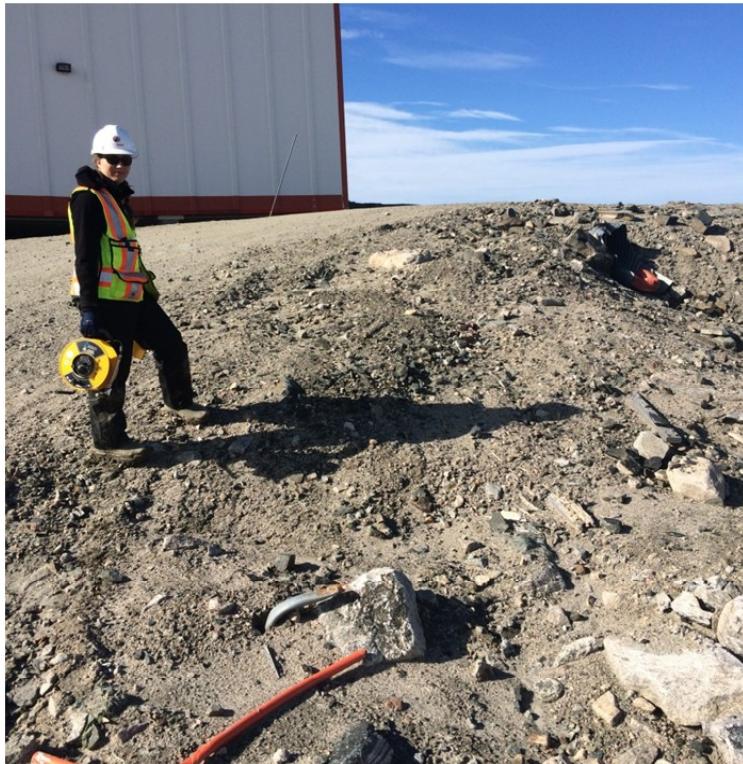
Photo 3. North of TSM at location of former MW 11. August 8, 2015.

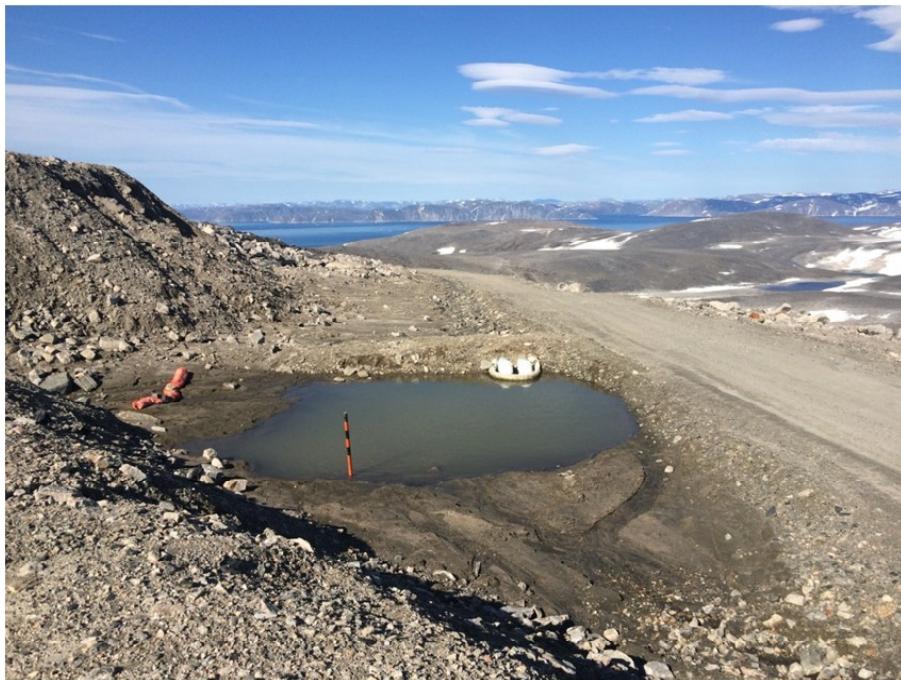
Photo 4. Stormwater pond with intact underflow dam north of TSM. August 8, 2015.

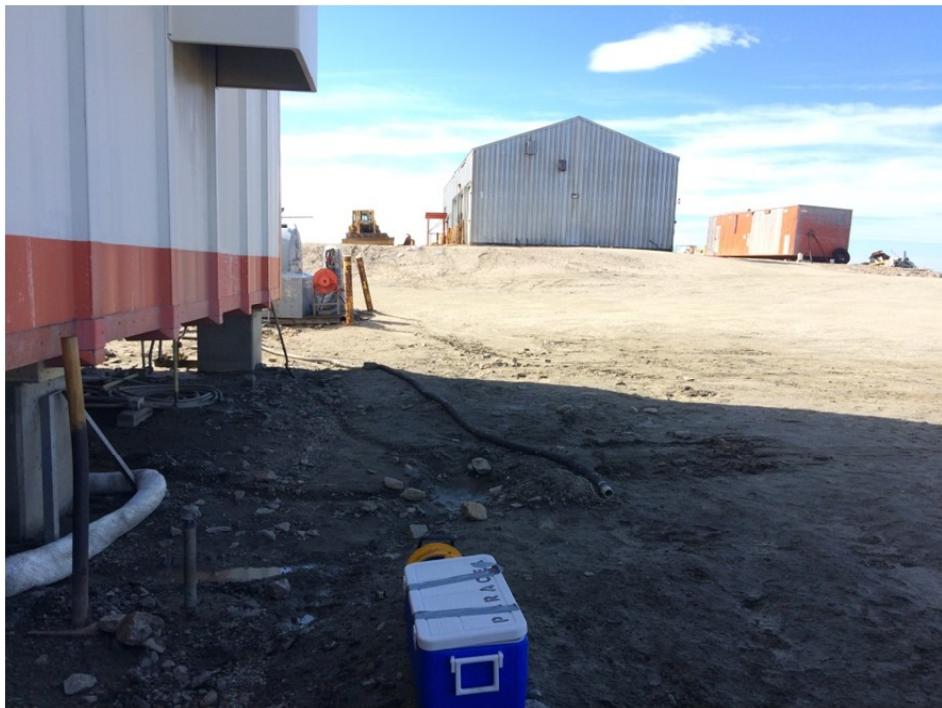
Photo 5. West side of TSM by MW 3. August 8, 2015.

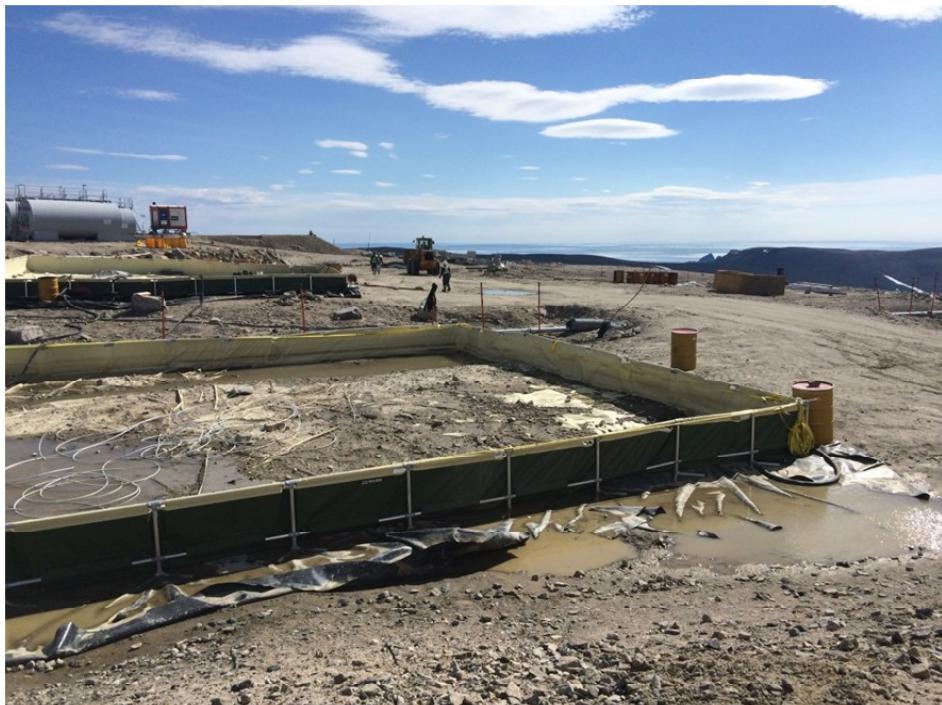
Photo 6. Flex tank located on top of MW 12 location. August 8, 2015.

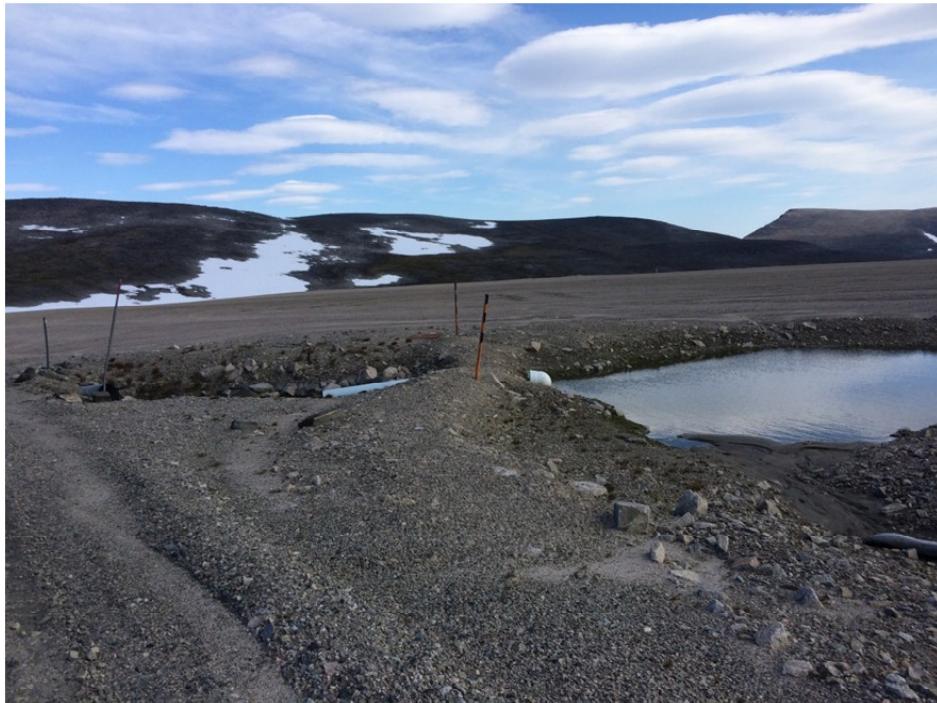
Photo 7. Stormwater pond and underflow dam at middle site. August 8, 2015.

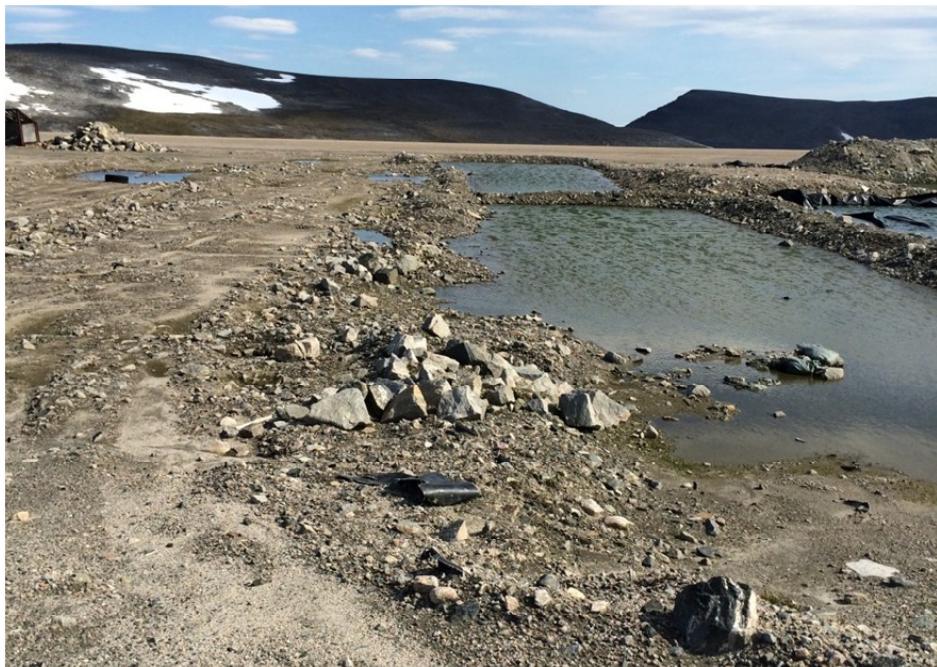
Photo 8. Middle site showing water-filled footprints of former BPs 11 and 13. August 8, 2015.
