WATER LICENCE INSPECTION FORM

Licensee Raytheon	Licensee Representative William Wyman
Licence No. / Expiry 8BC-DYE1929	Representative's Title Raytheon Environmental Services Officer
Land / Other Authorizations	Land / Other Authorizations
Date of Inspection July 29, 2019	Inspector Joseph Monteith
Activities Inspected <input type="checkbox"/> Camp <input type="checkbox"/> Drilling <input type="checkbox"/> Mining <input type="checkbox"/> Construction <input type="checkbox"/> Reclamation <input type="checkbox"/> Fuel Storage <input type="checkbox"/> Roads/Hauling <input checked="" type="checkbox"/> Other: Water Treatment Facility, Waste Water Utilidor Hazardous Waste Facility	<input type="checkbox"/> Other:

On July 29, 2019 at 1:45pm, A Water Licence Inspection was conducted by Water Resource Officer (WRO) Joseph Monteith at Cape Dyer, Qikiqtani Region, Nunavut, for water licence 8BC-DYE1929. The inspection was complete by 3:10pm on July 29, 2019.

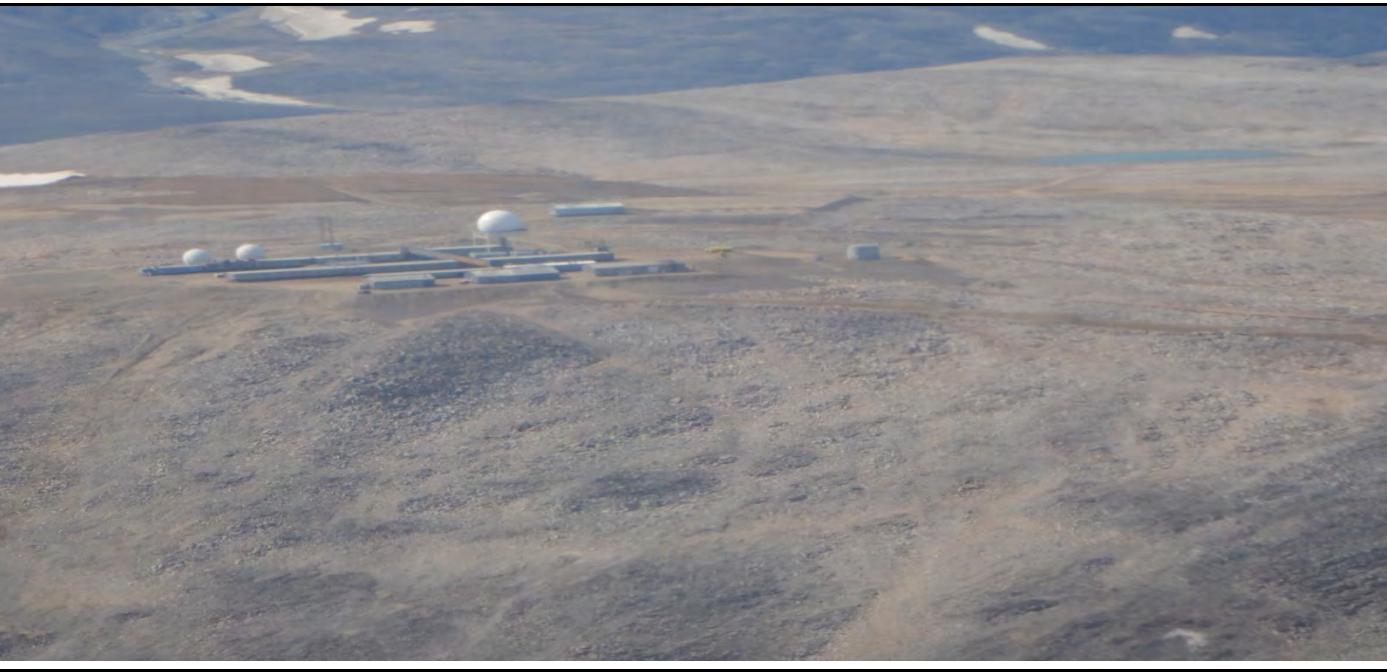
Date	Camera	Inspector
July 29, 2019	Nikon Cool Pix	Joseph Monteith
Photo Log #	Location	
Photo 1	Cape Dyer

Description: Summit Site

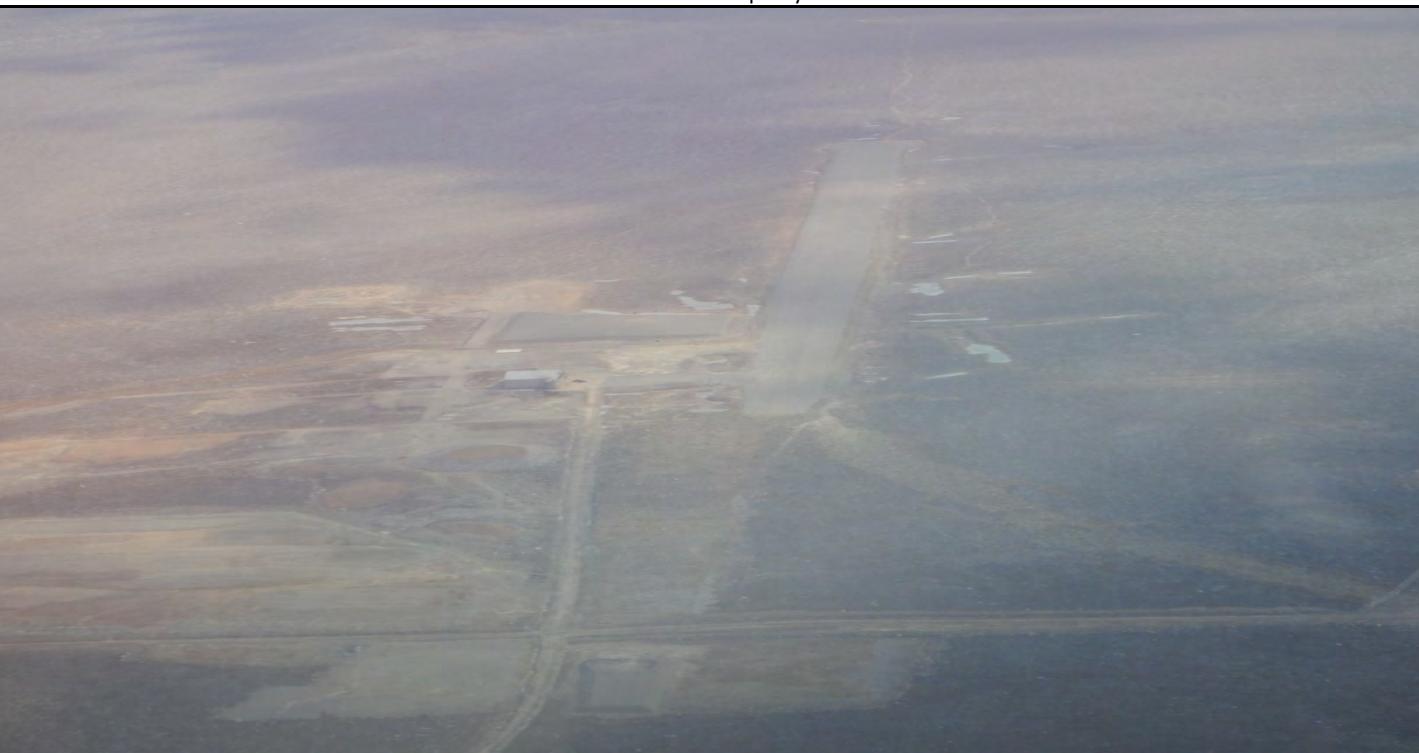
Photo Log #	Location
Photo 2	Cape Dyer

Description: Cape Dyer Airstrip and Hanger.

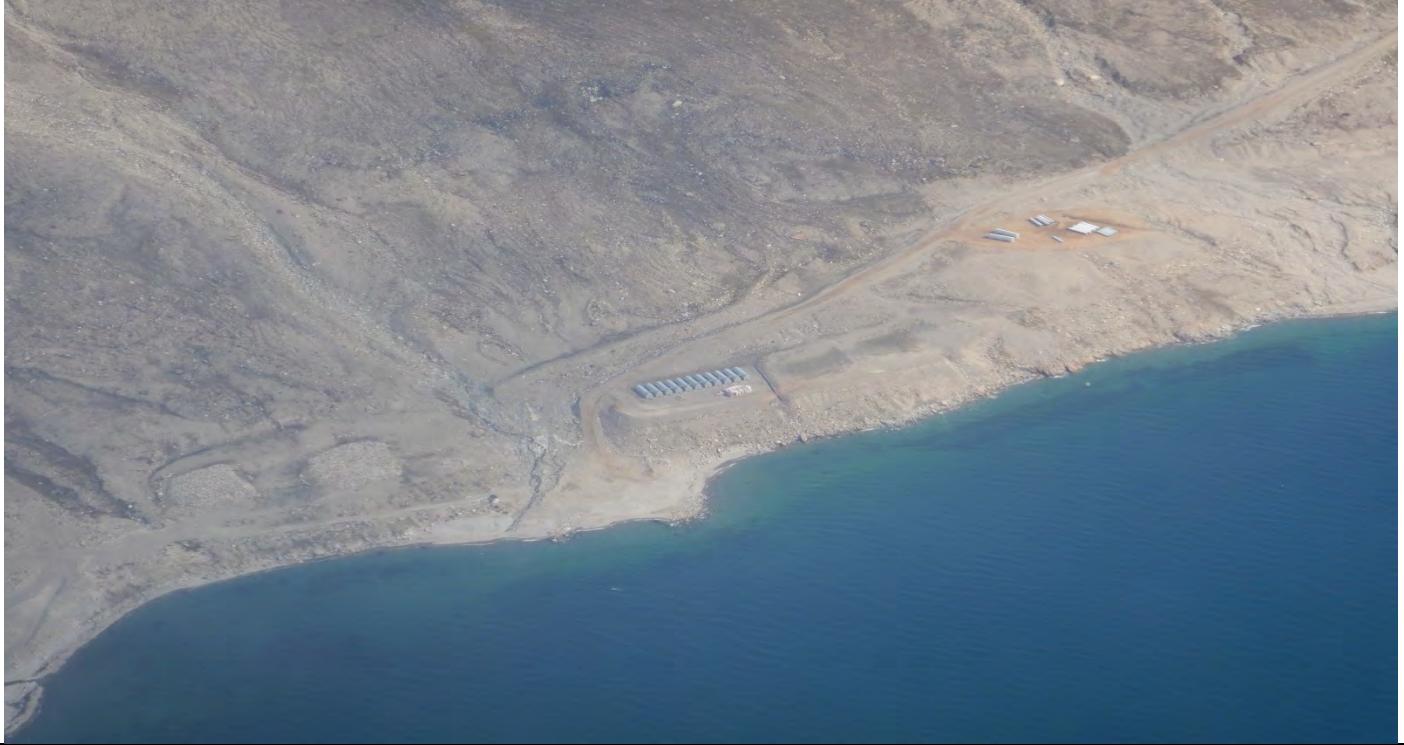
Photo Log #	Location
Photo 3	Cape Dyer

Description: Cape Dyer Beach. 12 storage tanks with built in secondary containment. Road washed out. Repair, and installation of new culverts

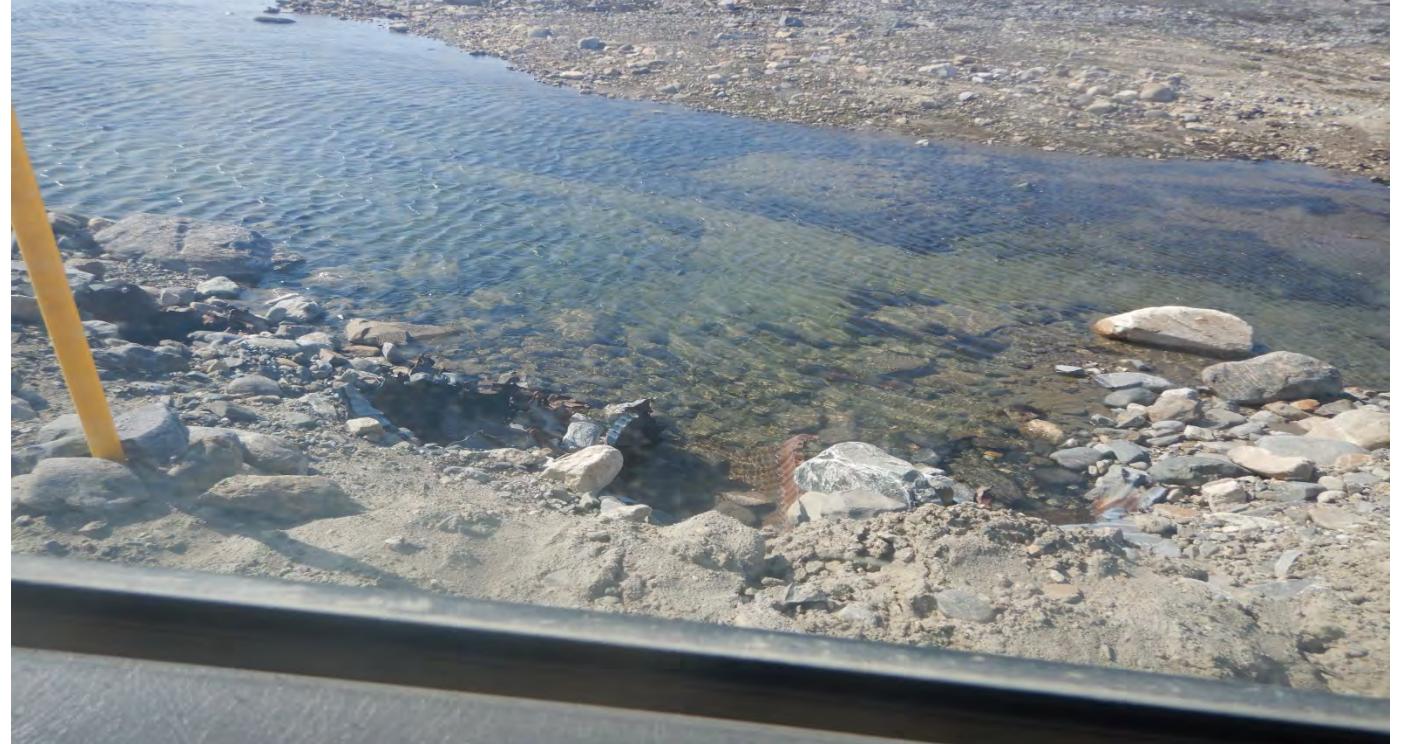
Photo Log #	Location
Photo 4	Cape Dyer

Description: Cape Dyer emergency water withdrawal site .

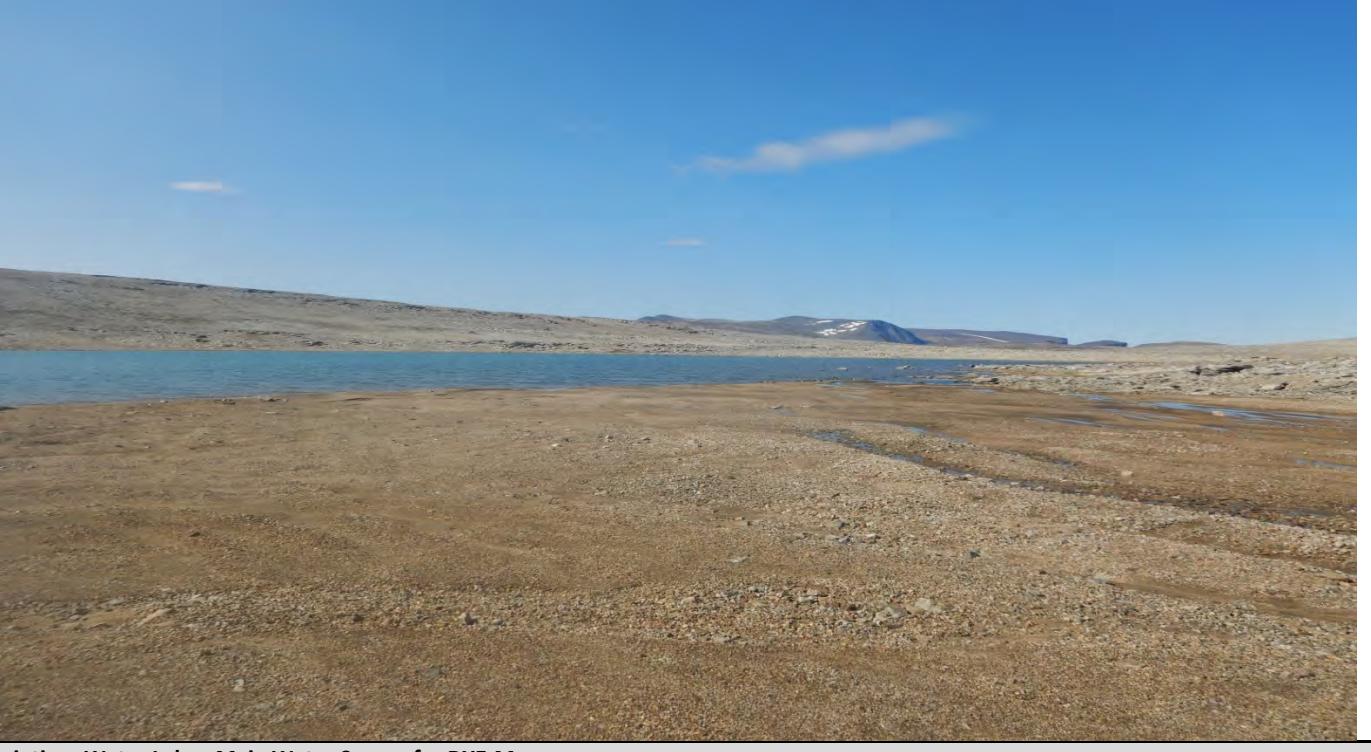
Photo Log #	Location
Photo 5	Cape Dyer

2. Water withdrawal is conducted from Water Lake (photo 5) to the Water Storage Reservoir (photo 11 & 12). The Water from South Lake is recharged by annual snow melt. Water is transferred from South Lake to the reservoir by a water truck (photo 6) to 4x 10,000 Litre storage tanks. (See photo 12 & 13).
3. During the inspection their logs showed total of 35m³ withdrawn from both trucked service (see photo 4).
4. Fox-M treats water through 3 x granular carbon filters, a multimedia filter and two UV filter lamps (see photo 9).
5. Water Use Logs - Water usage Logs. 11 water withdrawal events for 2019. The last event on July 24, 2019 reads 3.2030 litres start, 3.6080 litres finish

Description: Water Lake. Main Water Source for DYE-M.

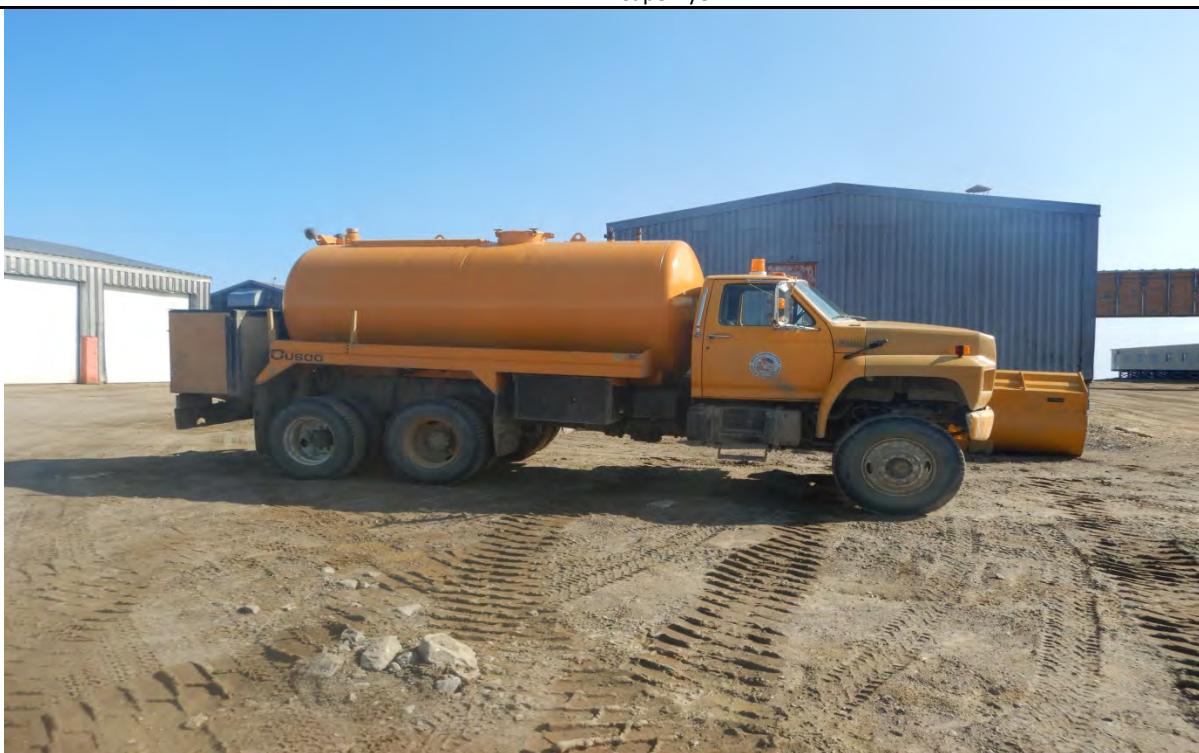
Photo Log #	Location
Photo 6	Cape Dyer

Description: Water Truck, used to withdrawal and transport water to the Water Storage Tanks at summit site.

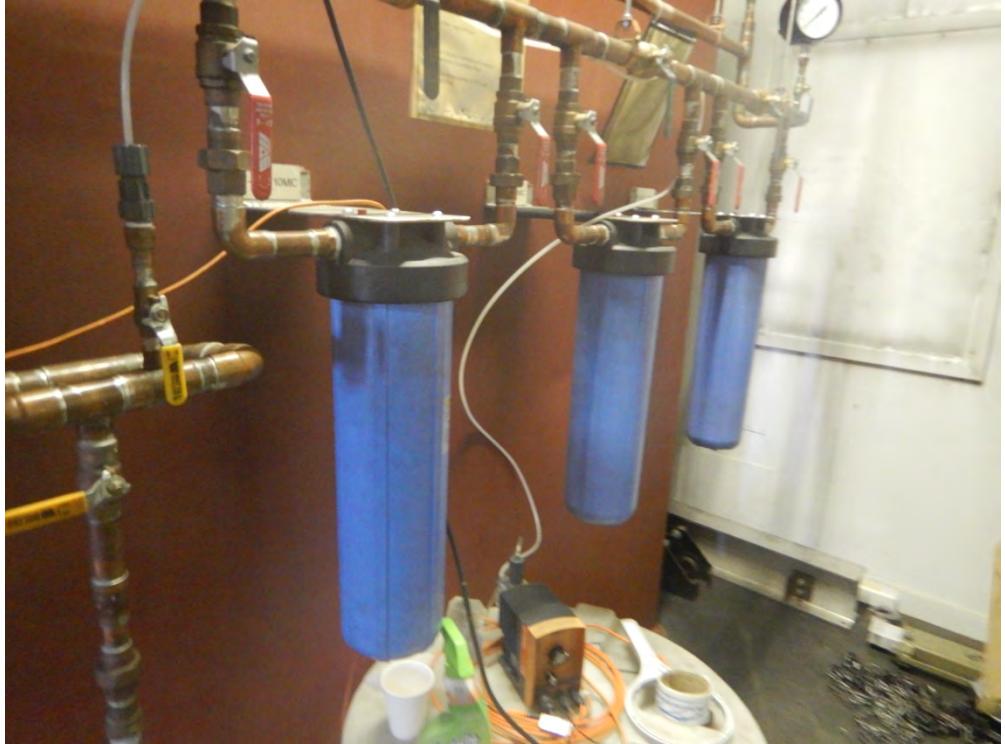
Photo Log #	Location
Photo 9	Cape Dyer

Description: 3 x water filters. Chlorine mixing tank

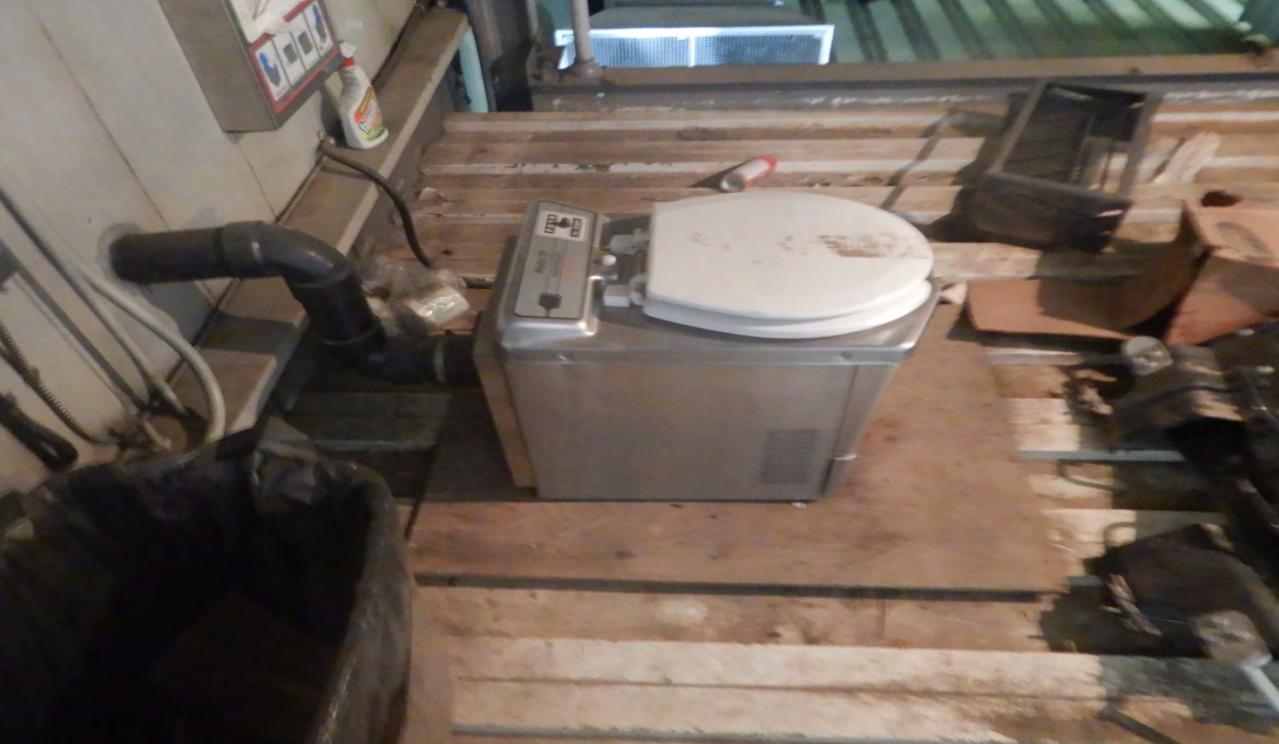
Photo Log #	Location
Photo 10	Cape Dyer

Description: insta pack toilet in emergency warehouse

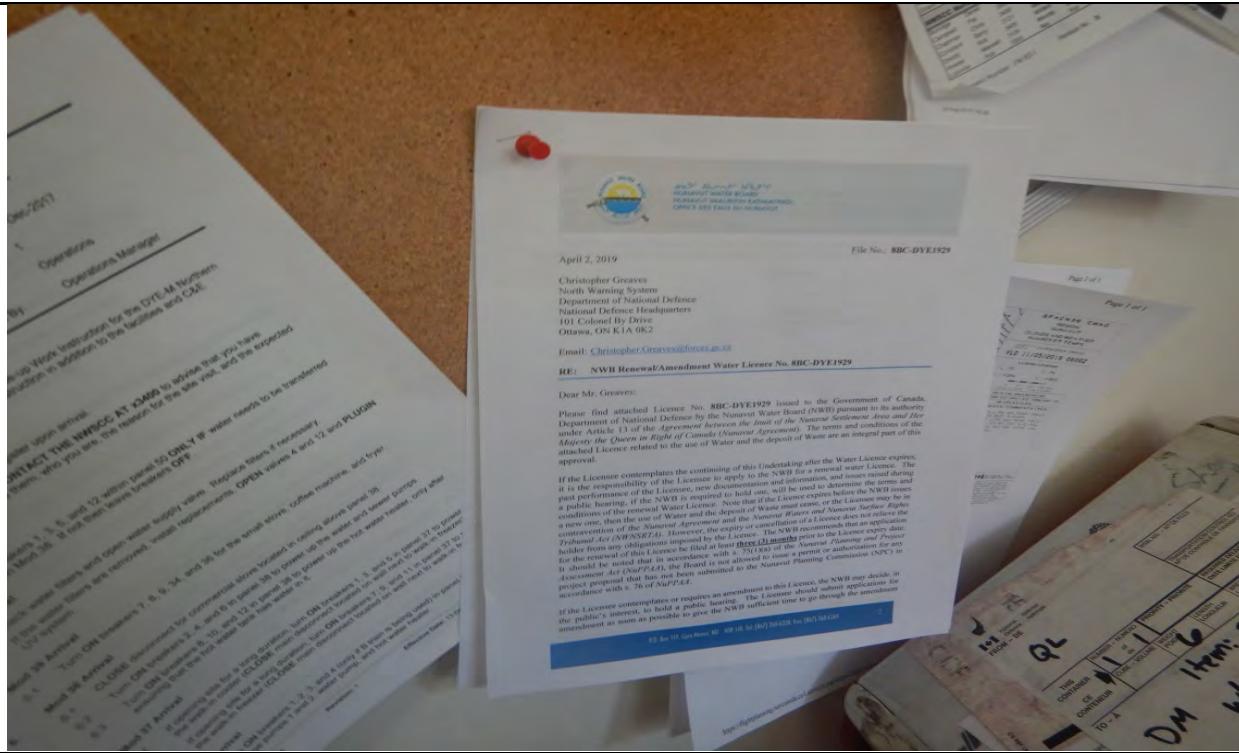
Photo 15

Description: water licence 8BC-DYE1929 posted on-site.

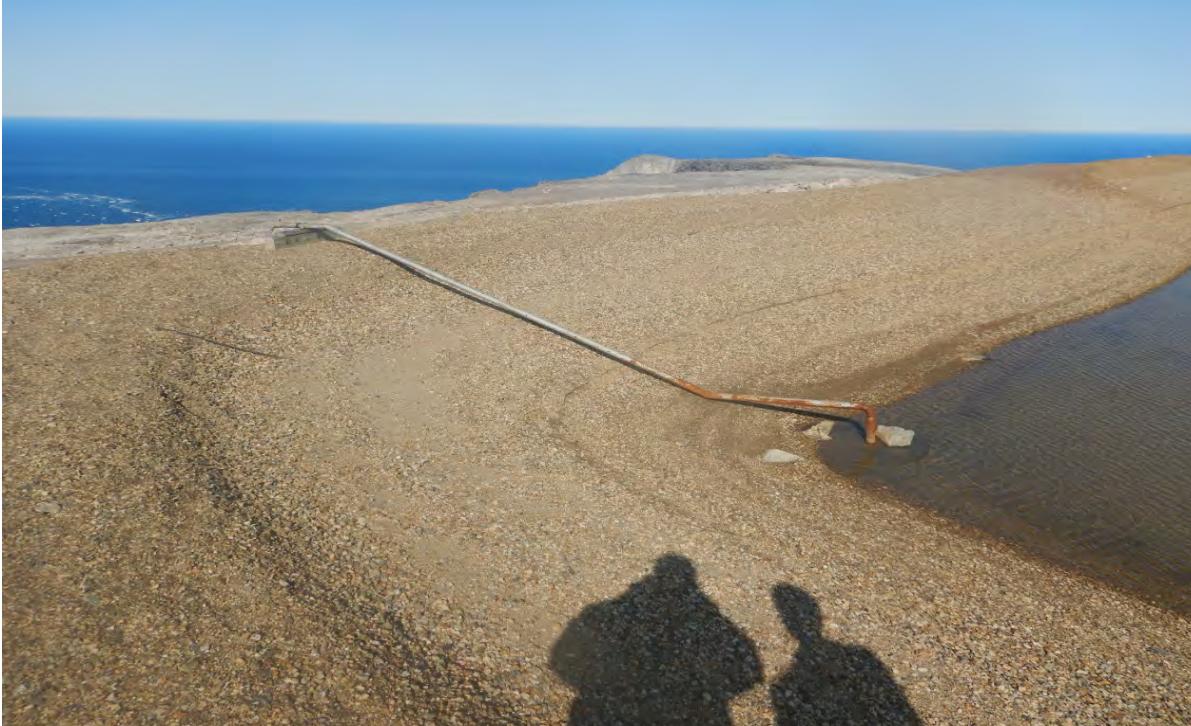
Photo Log #	Location
Photo 17	Cape Dyer

Description: Fuel Storage Tank berm water. Discharge pipe over berm walls.

SECTION 2	<input type="checkbox"/> Comments	<input type="checkbox"/> Non-Compliance with Act or Licence	<input checked="" type="checkbox"/> Action Required
Do the following items below to bring yourself back into compliance:			
Ensure berm was within the discharge criteria outlined in 8BC-DYE1929			
SECTION 3	<input checked="" type="checkbox"/> Comments	<input checked="" type="checkbox"/> Non-Compliance with Act or Licence	<input type="checkbox"/> Action Required
This site was compliant with all conditions of the water licence. No concerns with any non-compliance issues.
