WATER LICENCE INSPECTION FORM

| 8BC-DYE1929 | Raytheon Environmental Services Officer |
| July 29, 2019 | Joseph Monteith |

On July 29, 2019 at 1:45pm, A Water Licence Inspection was conducted by Water Resource Officer (WRO) Joseph Monteith at Cape Dyer, Qikiqtani Region, Nunavut, for water licence 8BC-DYE1929. The inspection was complete by 3:10pm on July 29, 2019.

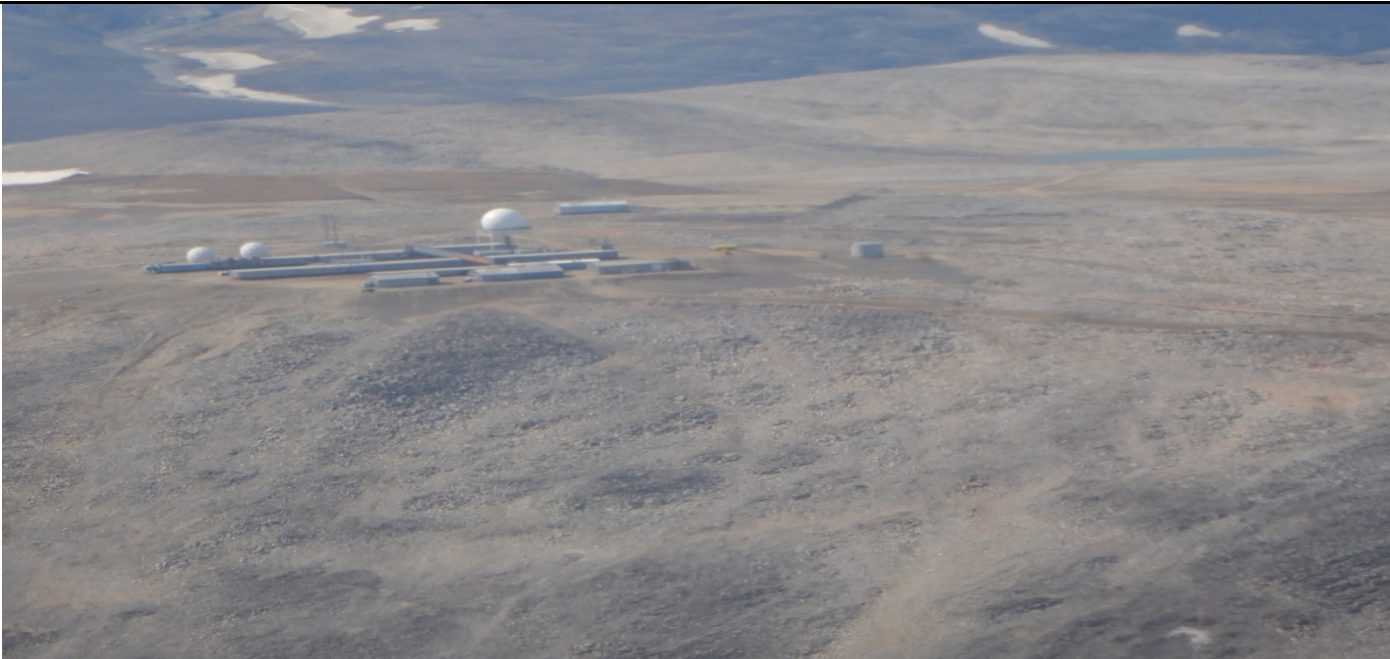
| Date | Camera | Inspector |
|---|---|---|
| Photo 1 | Cape Dyer | |

| Date | Camera | Inspector |
|---|---|---|
| Description: Summit Site | | |

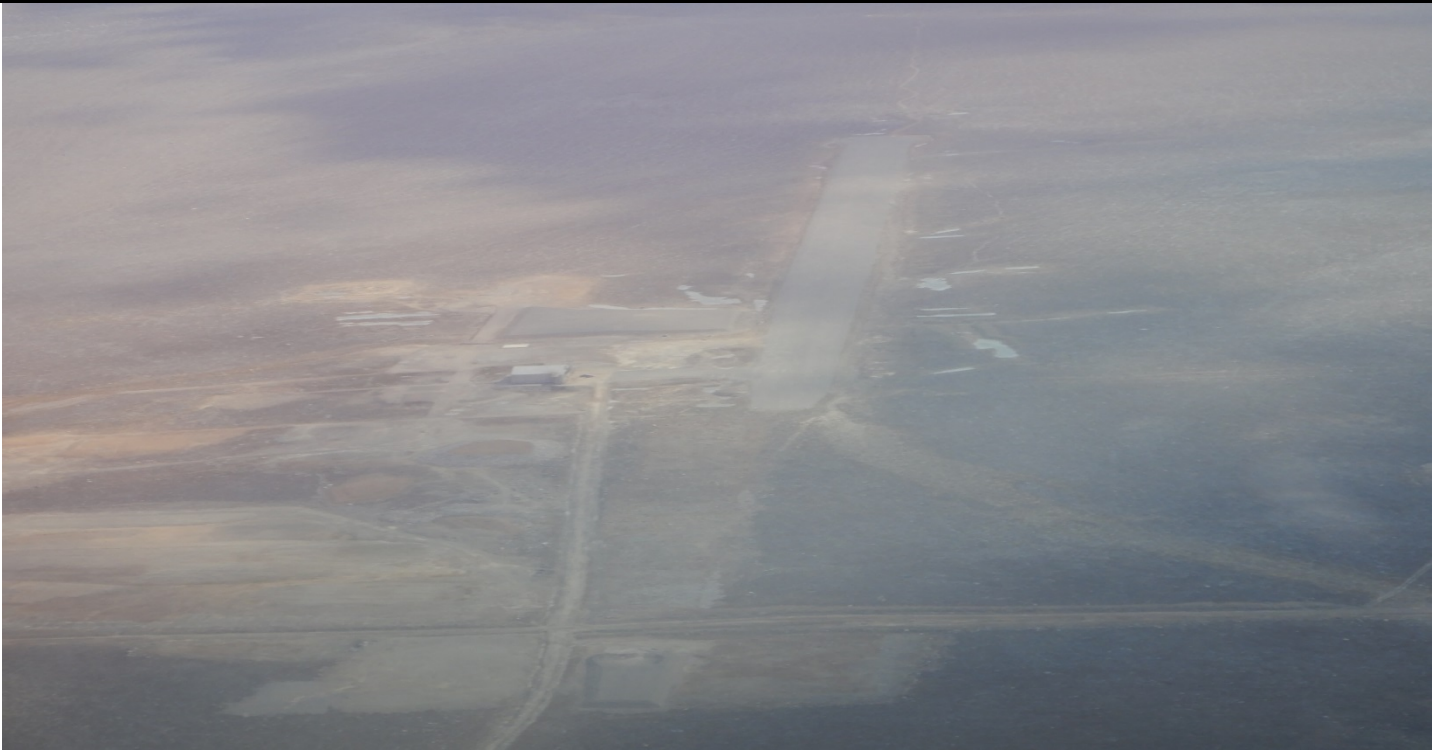
| Photo Log # | Location |
|---|---|
| Photo 2 | Cape Dyer |

| Photo Log # | Location |
|---|---|
| Description: Cape Dyer Airstrip and Hanger. | |

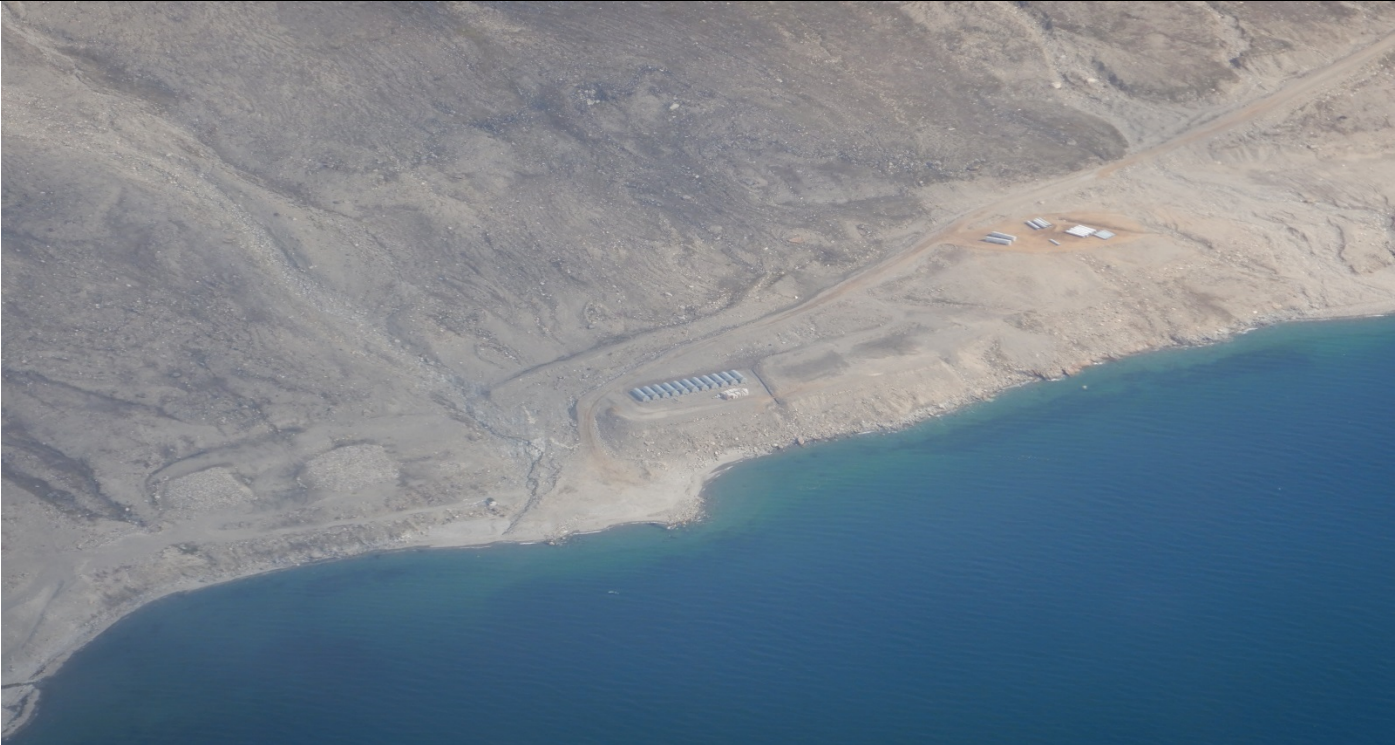
| Photo Log # | Location |
|---|---|
| Photo 3 | Cape Dyer |

| Photo Log # | Location |
|---|---|
| Description: Cape Dyer Beach. 12 storage tanks with built in secondary containment. Road washed out. Repair, and installation of new culverts | |

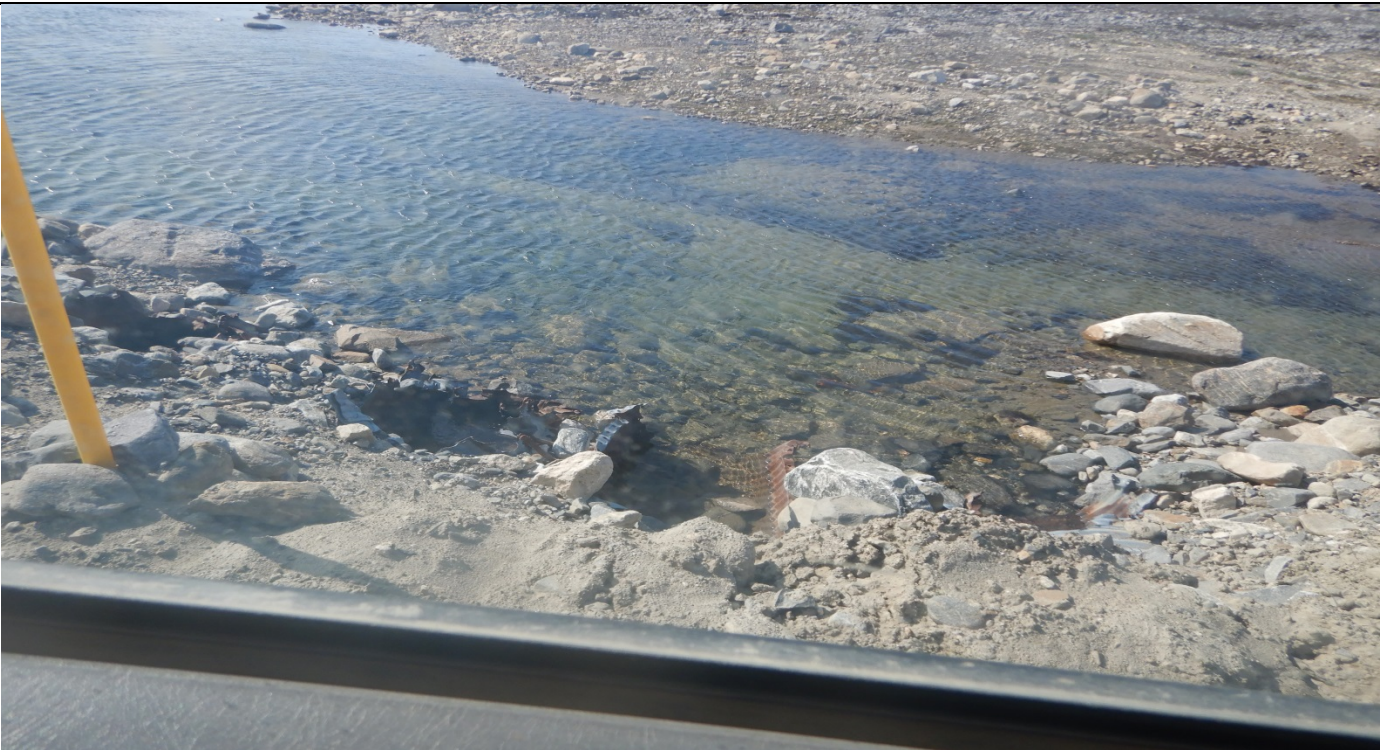
| Photo Log # | Location |
|---|---|
| Photo 4 | Cape Dyer |

| Photo Log # | Location |
|---|---|
| Description: Cape Dyer emergency water withdrawal site . | |

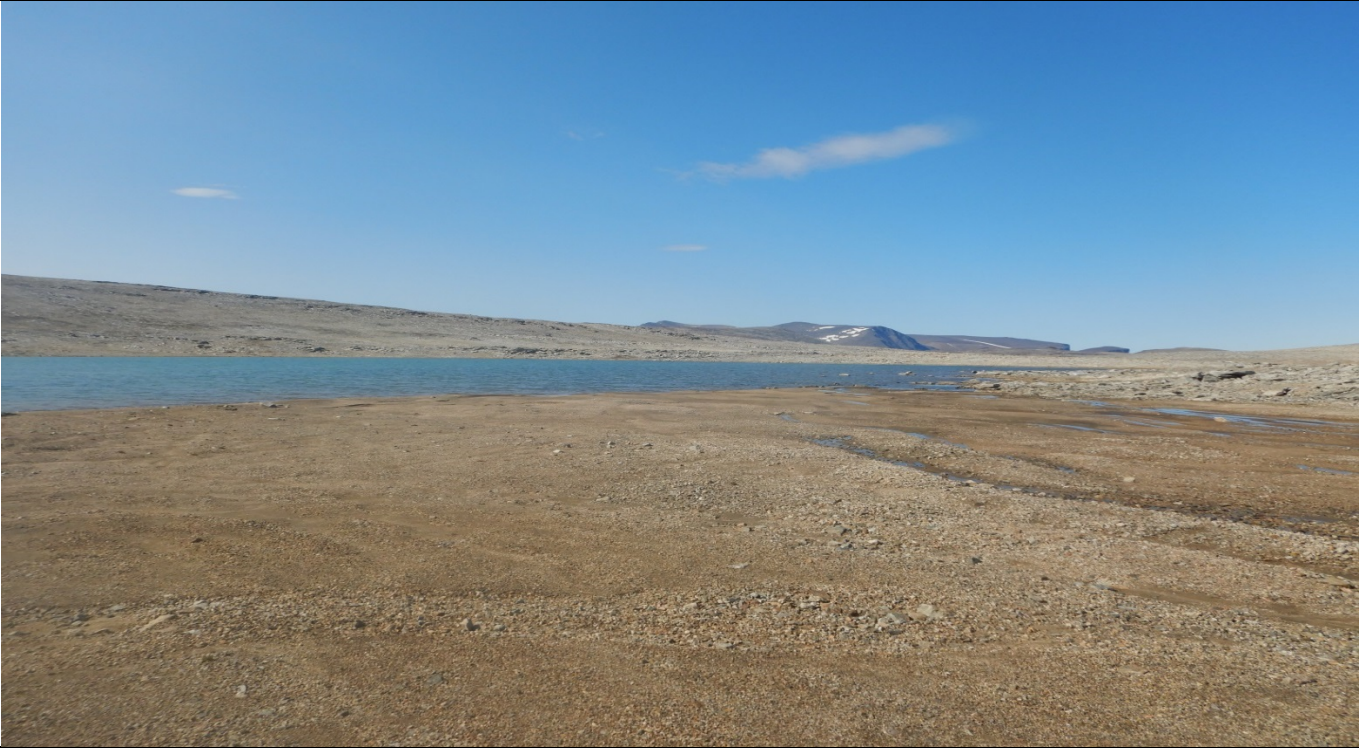
| Photo Log # | Location |
|---|---|
| Photo 5 | Cape Dyer |

- 2. Water withdrawal is conducted from Water Lake (photo 5) to the Water Storage Reservoir (photo 11 & 12). The Water from South Lake is recharged by annual snow melt. Water is transferred from South Lake to the reservoir by a water truck (photo 6) to 4x 10,000 Litre storage tanks. (See photo 12 & 13).
- 3. During the inspection their logs showed total of 35m³ withdrawn from both trucked service (see photo 4).
- 4. Fox-M treats water through 3 x granular carbon filters, a multimedia filter and two UV filter lamps (see photo 9).
- 5. Water Use Logs - Water usage Logs. 11 water withdrawal events for 2019. The last event on July 24, 2019 reads 3.2030 litres start, 3.6080 litres finish

| Photo Log # | Location |
|---|---|
| Description: Water Lake. Main Water Source for DYE-M. | |

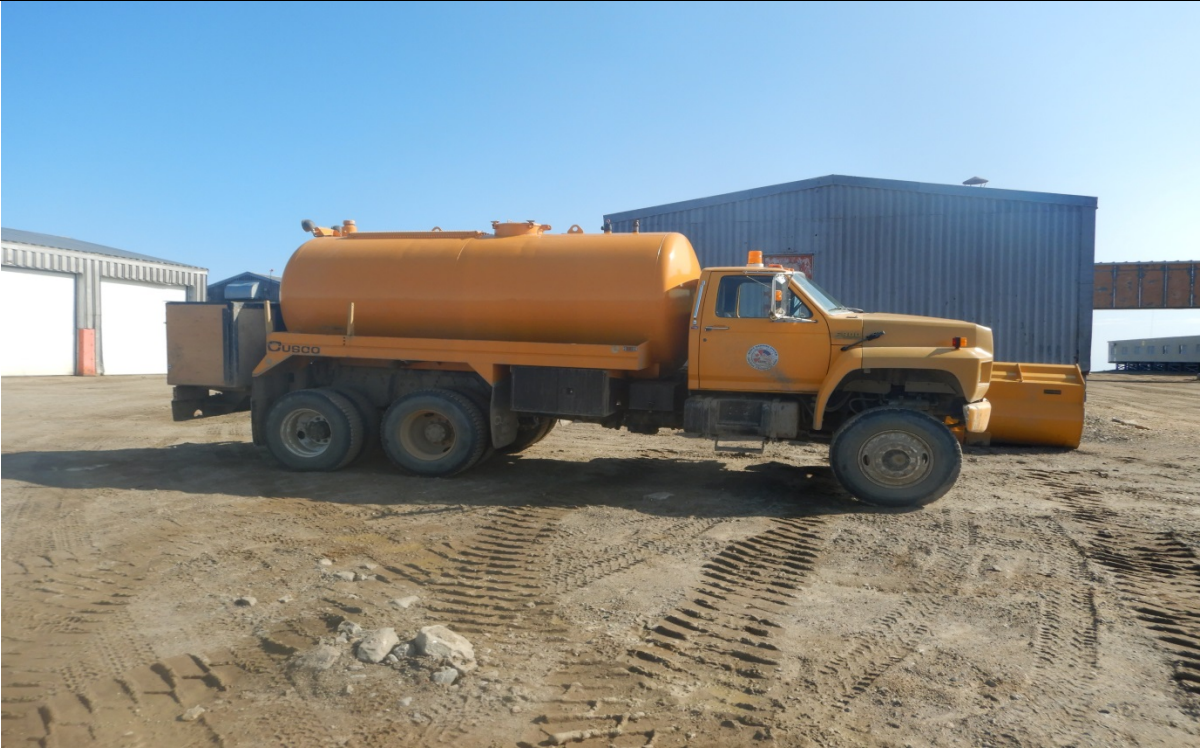
| Photo Log # | Location |
|---|---|
| Photo 6 | Cape Dyer |

| Photo Log # | Location |
|---|---|
| Description: Water Truck, used to withdrawal and transport water to the Water Storage Tanks at summit site. | |

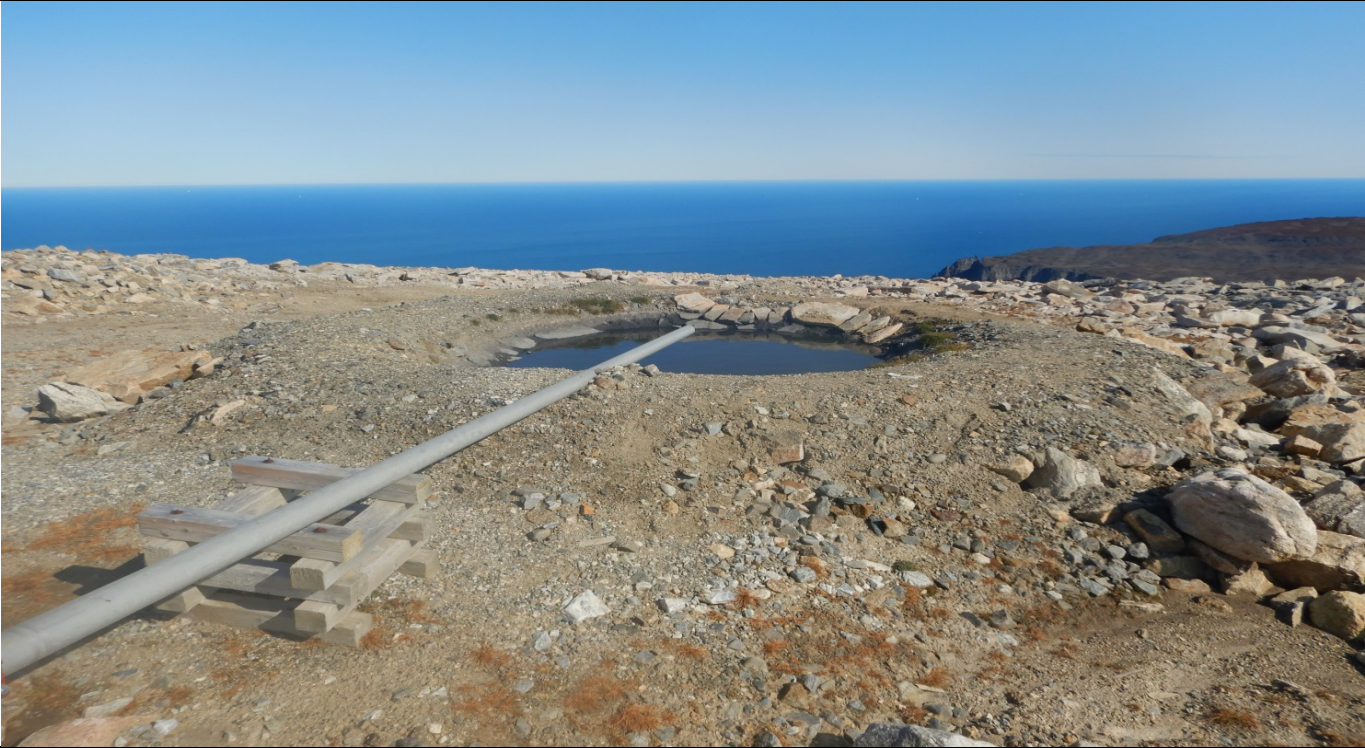
| Photo Log # | Location |
|---|---|
| Photo 7 | Cape Dyer |

- 8. Sewage waste is discharged to two sewage sumps for settling and exfiltration (see photo 7 & 8).

| Photo Log # | Location |
|---|---|
| Description: Discharge Location #1 Outfall pipe into a sump pit. Treatment is settling, and exfiltration to the receiving environment. | |

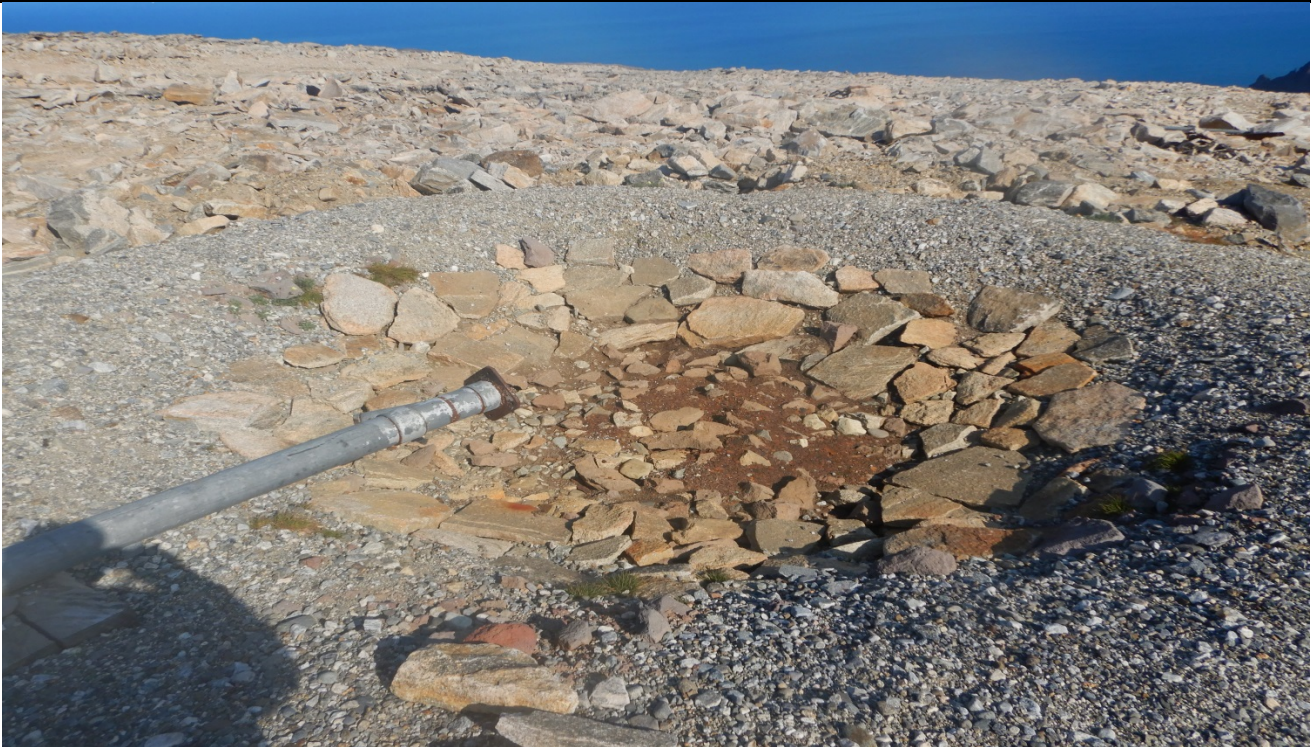
| Photo Log # | Location |
|---|---|
| Photo 8 | Cape Dyer |

| Photo Log # | Location |
|---|---|
| Description: Discharge Location #2 Outfall pipe into a sump pit. Treatment is settling, and exfiltration to the receiving environment. | |

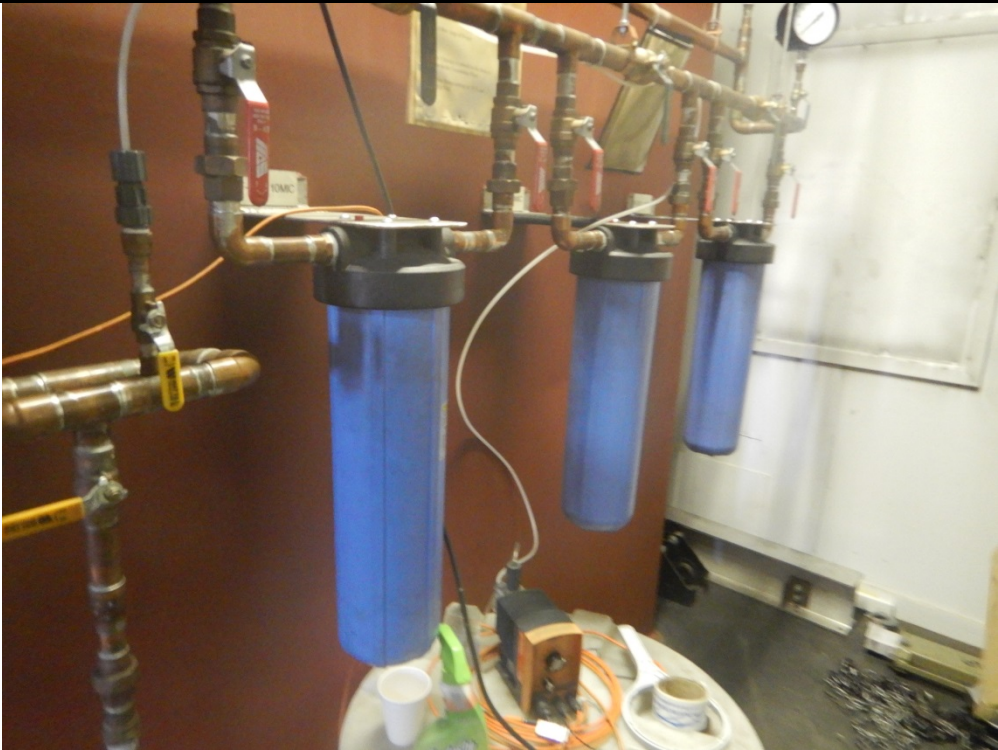
| Photo Log # | Location |
|---|---|
| Photo 9 | Cape Dyer |

| Photo Log # | Location |
|---|---|
| Description: 3 x water filters. Chlorine mixing tank | |

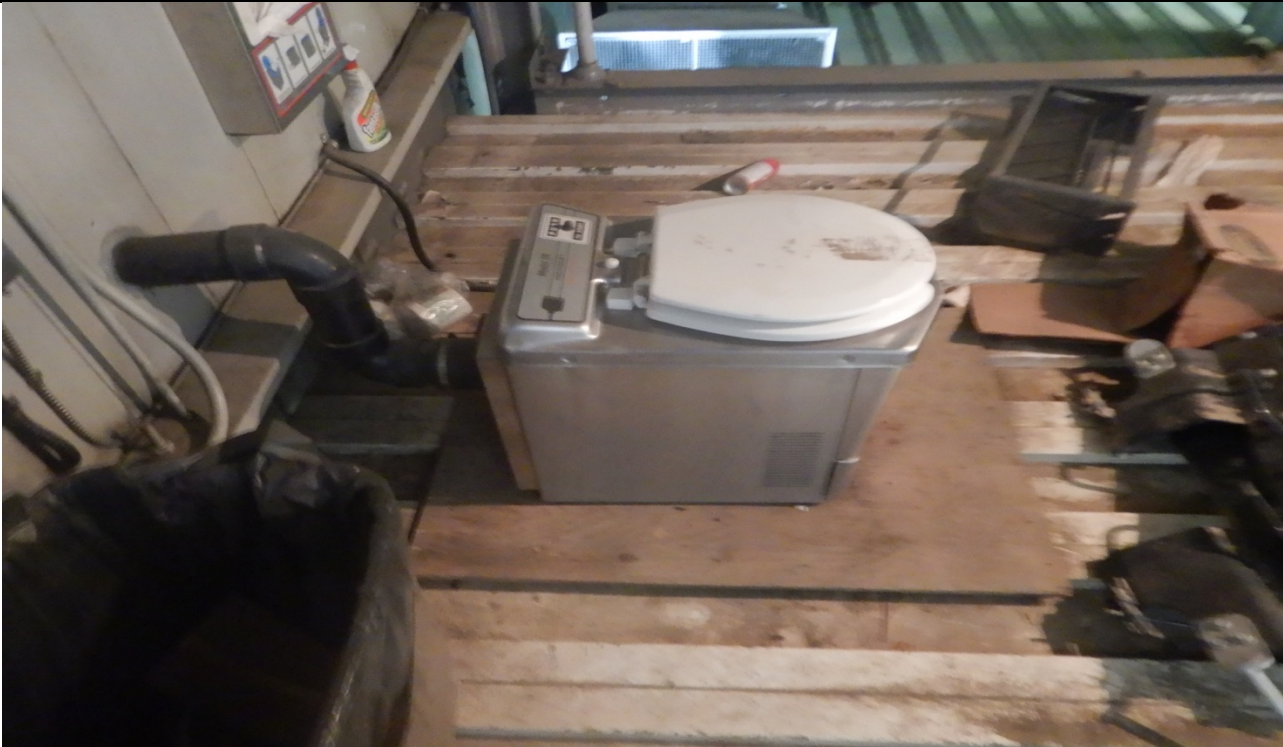
| Photo Log # | Location |
|---|---|
| Photo 10 | Cape Dyer |

| Photo Log # | Location |
|---|---|
| Description: insta pack toilet in emergency warehouse | |

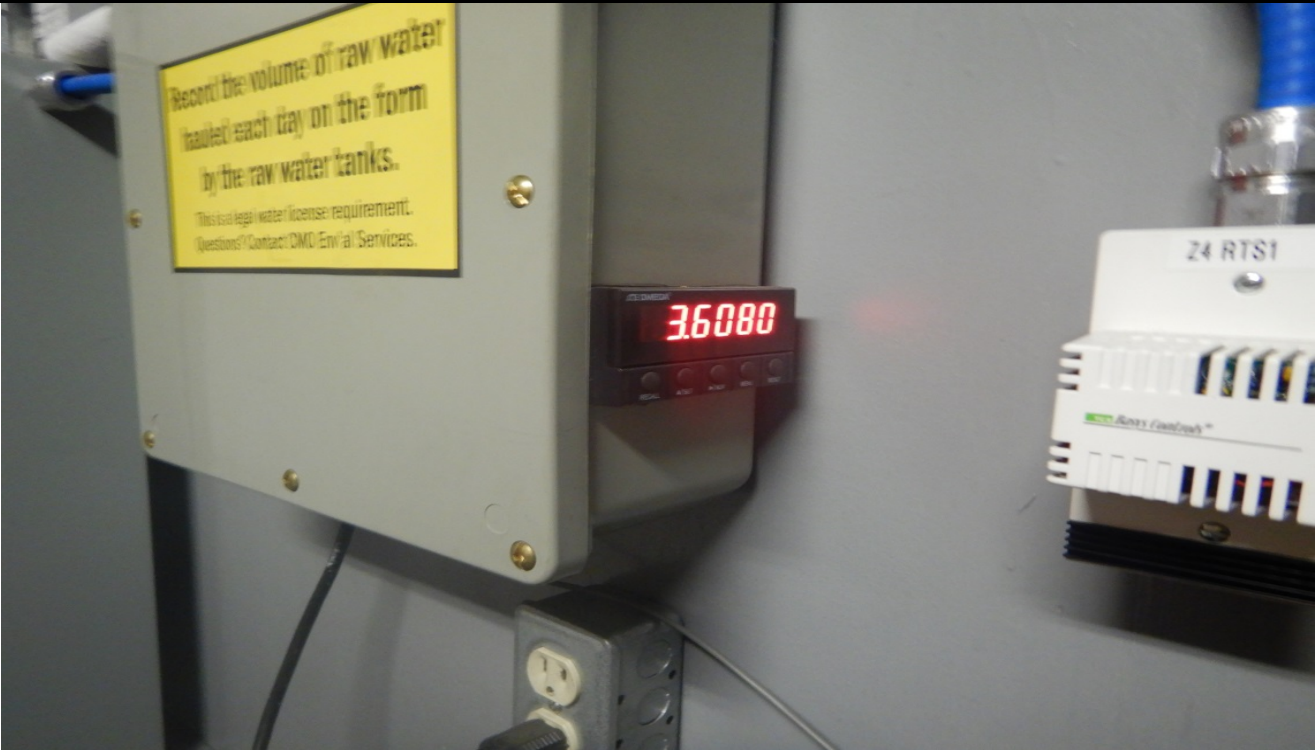
| Photo Log # | Location |
|---|---|
| Photo 11 | Cape Dyer |

| Photo Log # | Location |
|---|---|
| Description: meter reads 3.6080 | |

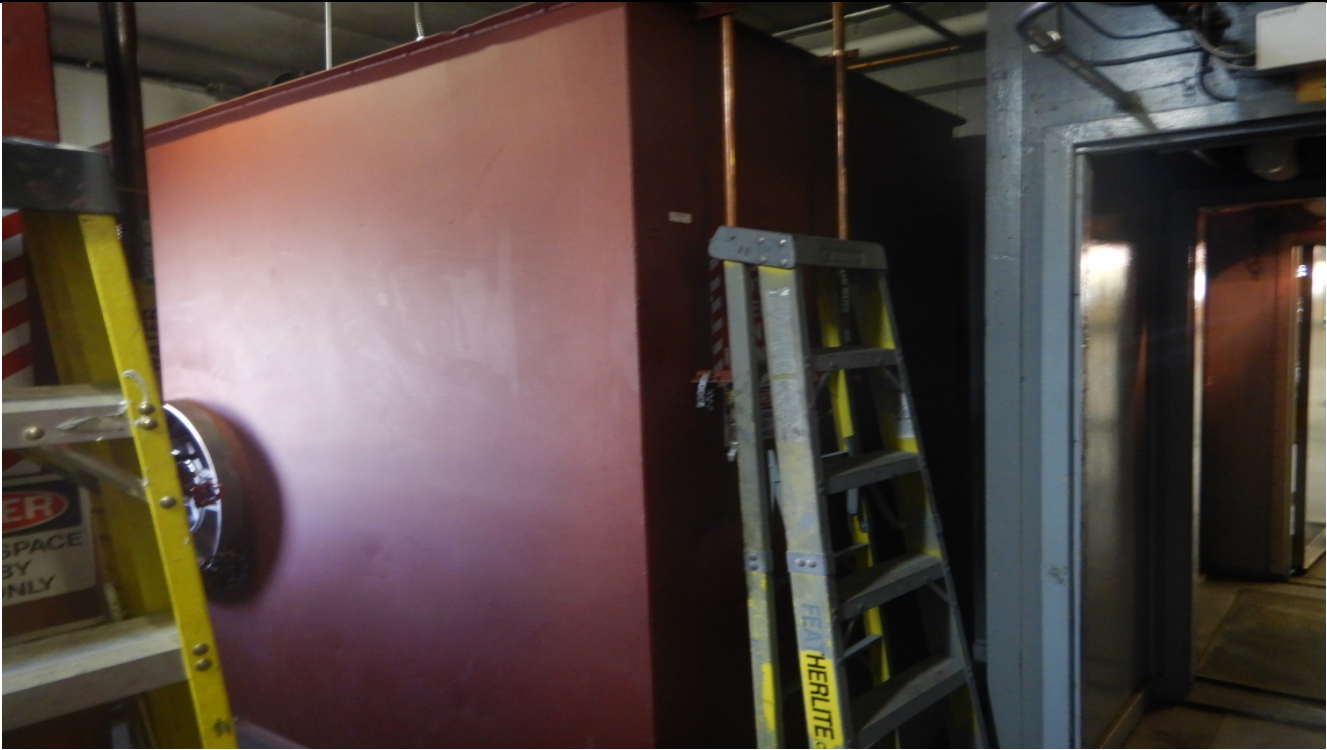
| Photo Log # | Location |
|---|---|
| Photo 12 | Cape Dyer |

| Photo Log # | Location |
|---|---|
| Description: 1 of 4 10,000 Litre Water Storage Tanks | |

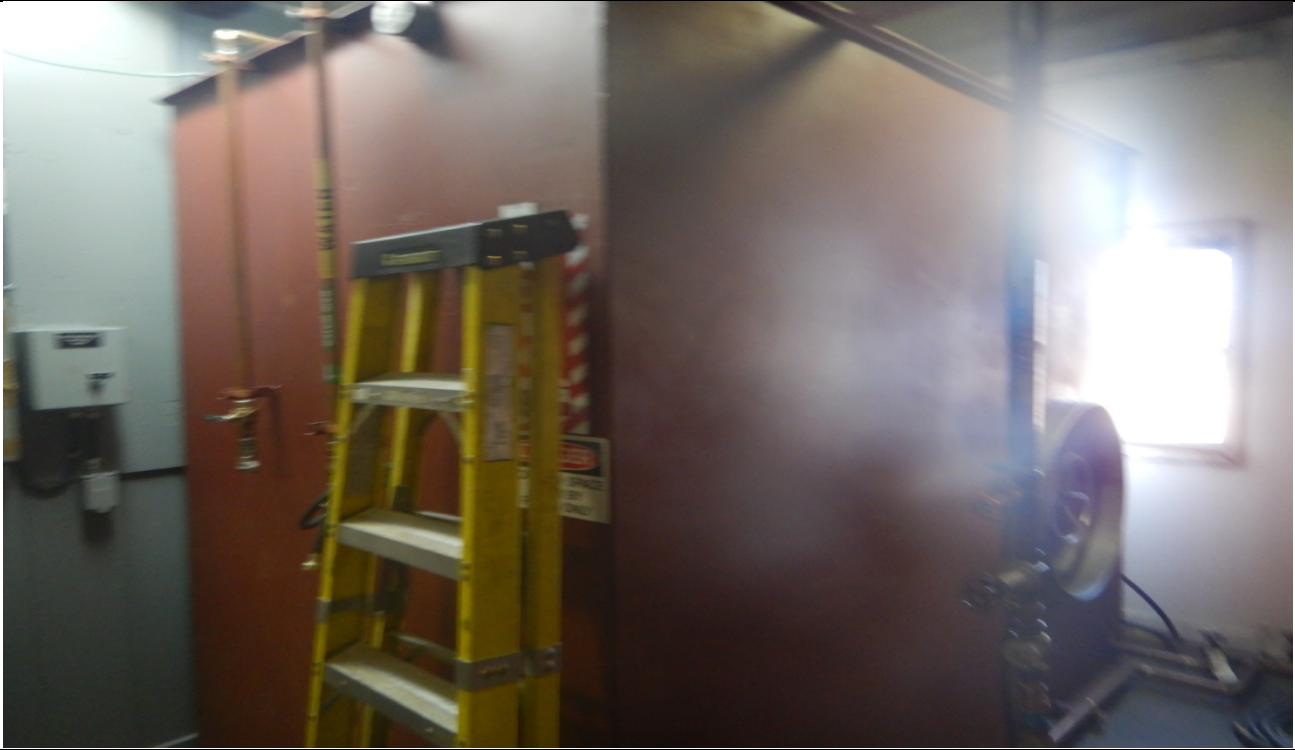
Photo 13

Description: 2 of 4 10,000 Litre Water Storage Tanks

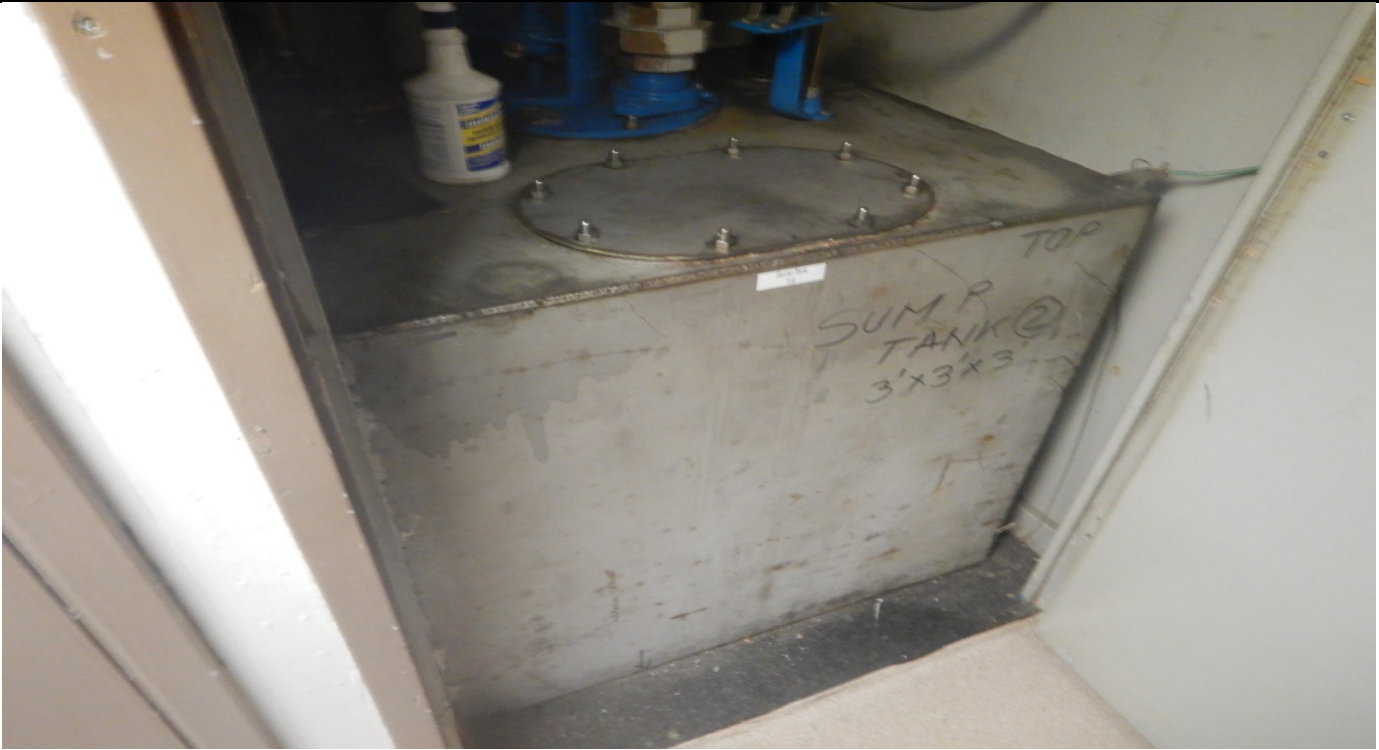
Photo 14

Description: Septic Tank

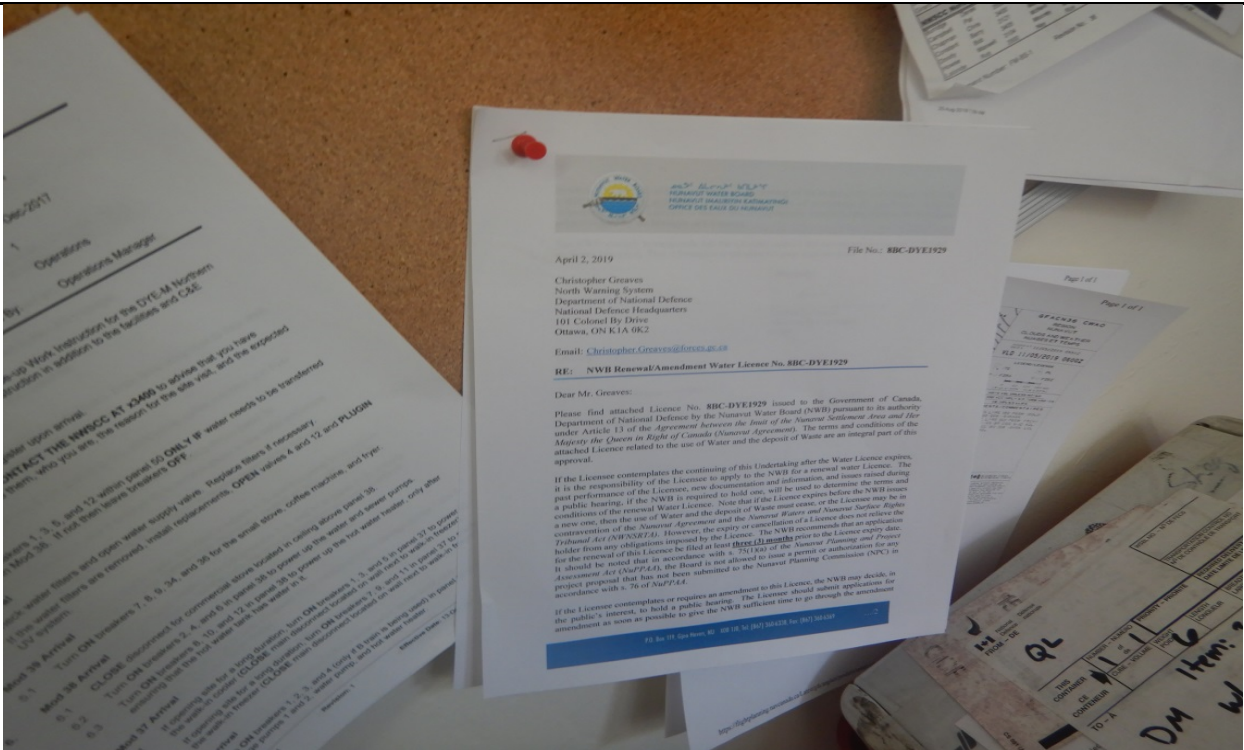
Photo 15

Description: water licence 8BC-DYE1929 posted on-site.

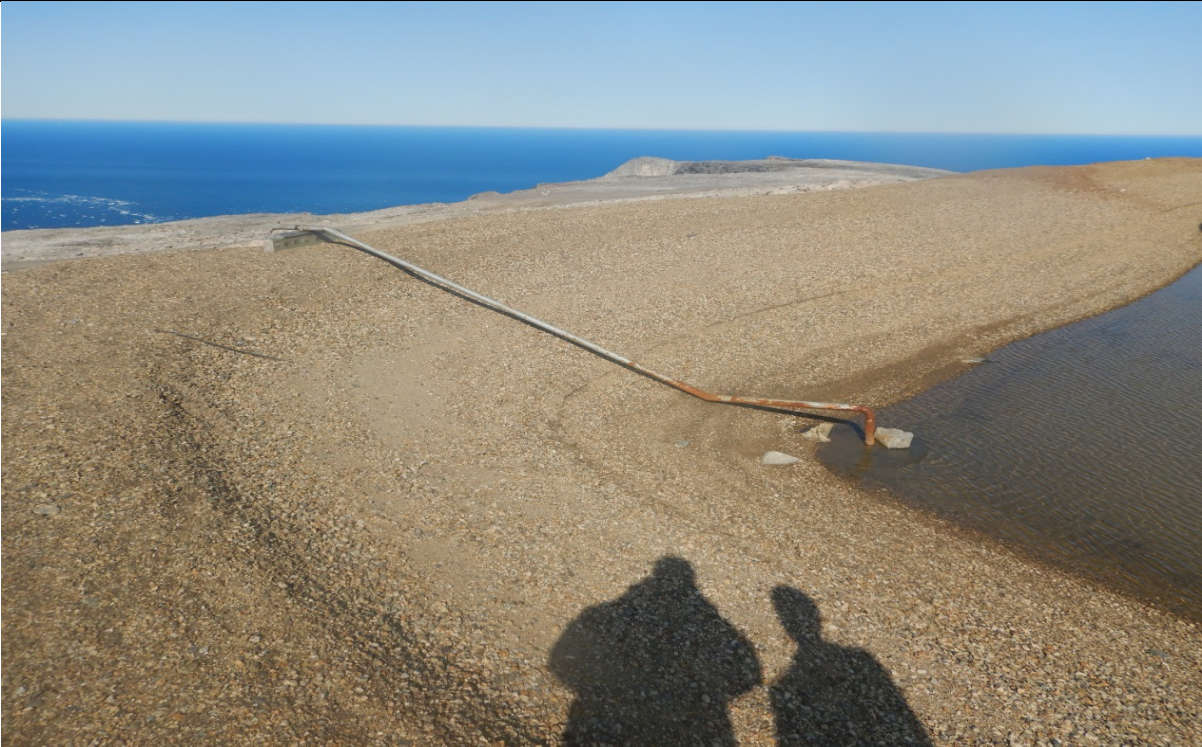
Photo 17

Description: Fuel Storage Tank berm water. Discharge pipe over berm walls.

| Do the following items below to bring yourself back into compliance:<br>Ensure berm was is within the discharge criteria outlined in 8BC-DYE1929 | | | |
