WATER LICENCE INSPECTION FORM

Licensee	Licensee Representative
Department of National Defence	Don Beattie
Licence No. / Expiry	Representative's Title
8BC-FOD0919	Environmental Officer
Land / Other Authorizations	Land / Other Authorizations
Date of Inspection	Inspector
September 4, 2018	Joseph Monteith
Activities Inspected <div style="display: flex; justify-content: space-around; font-size: small;"> <input type="checkbox"/> Camp <input type="checkbox"/> Drilling <input type="checkbox"/> Mining <input type="checkbox"/> Construction <input type="checkbox"/> Reclamation <input type="checkbox"/> Fuel Storage <input type="checkbox"/> Roads/Hauling <input checked="" type="checkbox"/> Other: Potable Water Source, Solid Waste Facility, Sewage Disposal Facility <input type="checkbox"/> Other: </div>

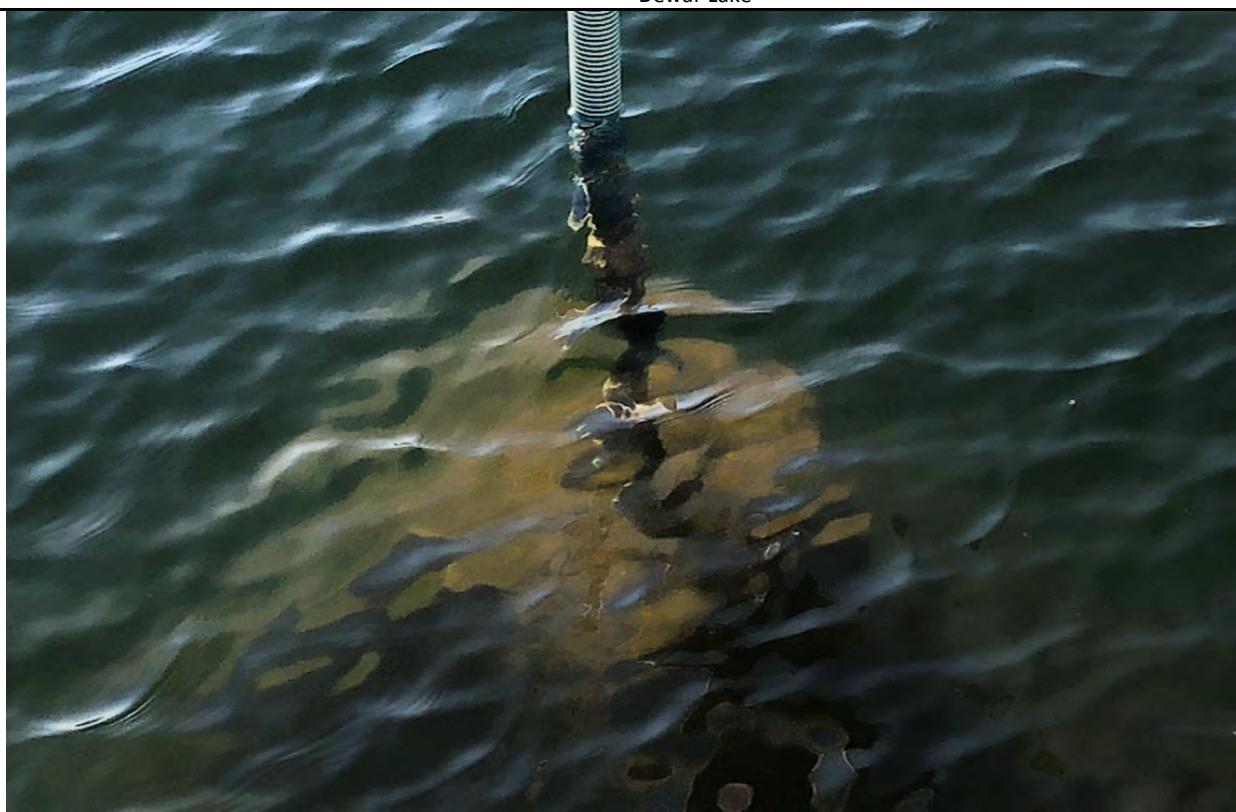
Photo 3

Compliance with General Conditions of the Licence <p>On February 6, 2019 WRO Monteith received an email from Richard Dwyer, Manager of Licensing, Nunavut Water Board with a link to the submission of the 2018 Annual Report.</p>			
Water Use and Related Structures <p>Water Lake</p> <ol style="list-style-type: none"> 1. The licensee is permitted to withdrawal 1440 cubic metres from Water Lake. 2. The licensee withdraws water from the Water Lake and trucks the water to six raw water tanks within the main facility. (see photo 2) 3. Fish Mesh Screen visible from surface (see photo 3).

Description: Fish Mesh Screen

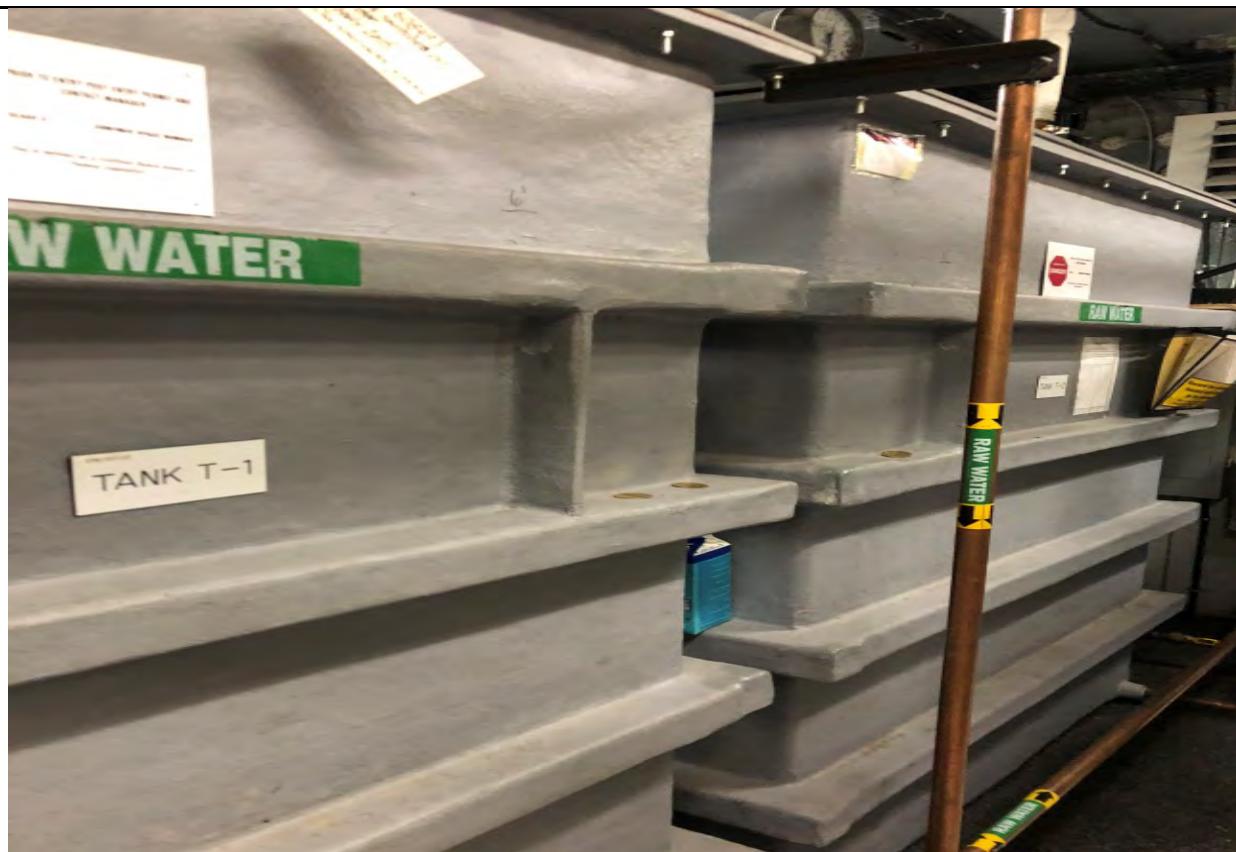
Photo 4

7. Four 10,000 Litre Water Storage Tanks (see photo 4 and 5).
8. Water Meter reads 10794 Litres (see photo 6).

Description: Water Storage Tank T-1, and T-2

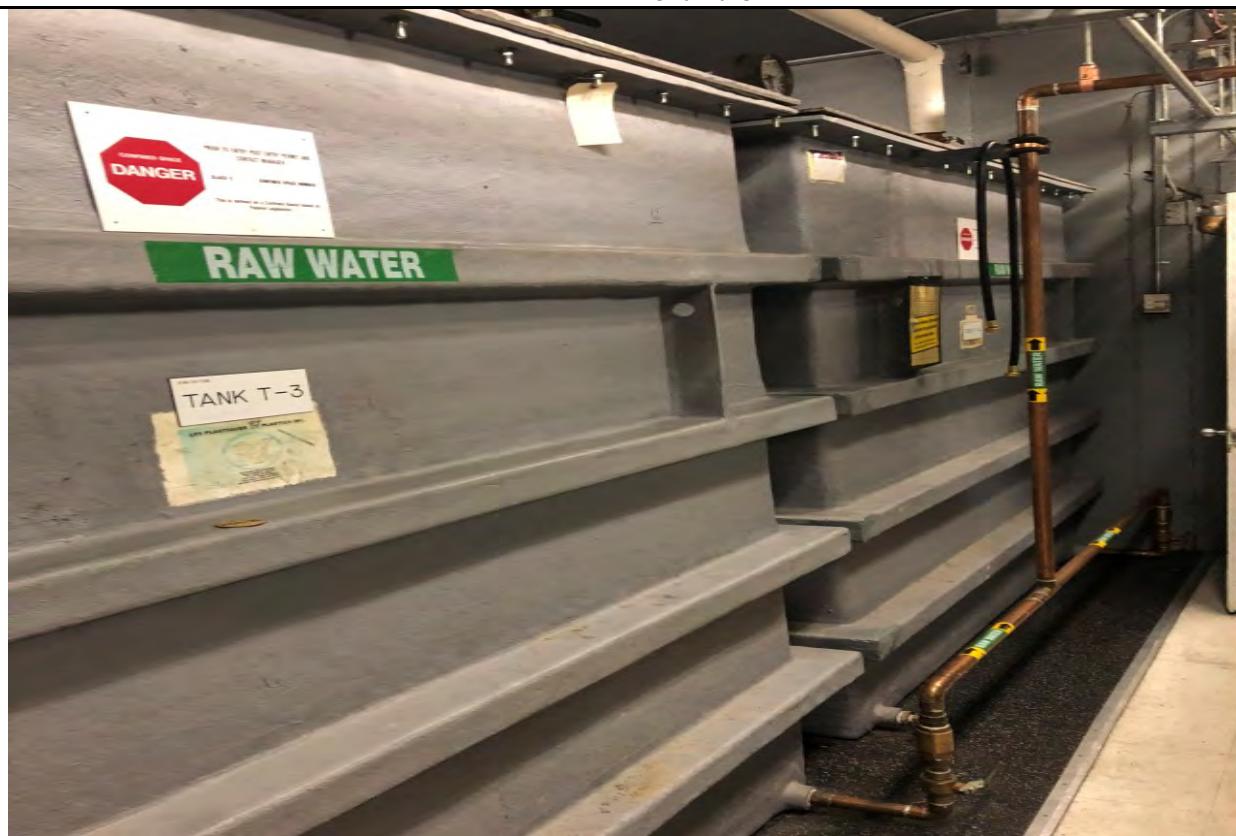
Photo 5

Description: Trucks recharge Water Storage Reservoir

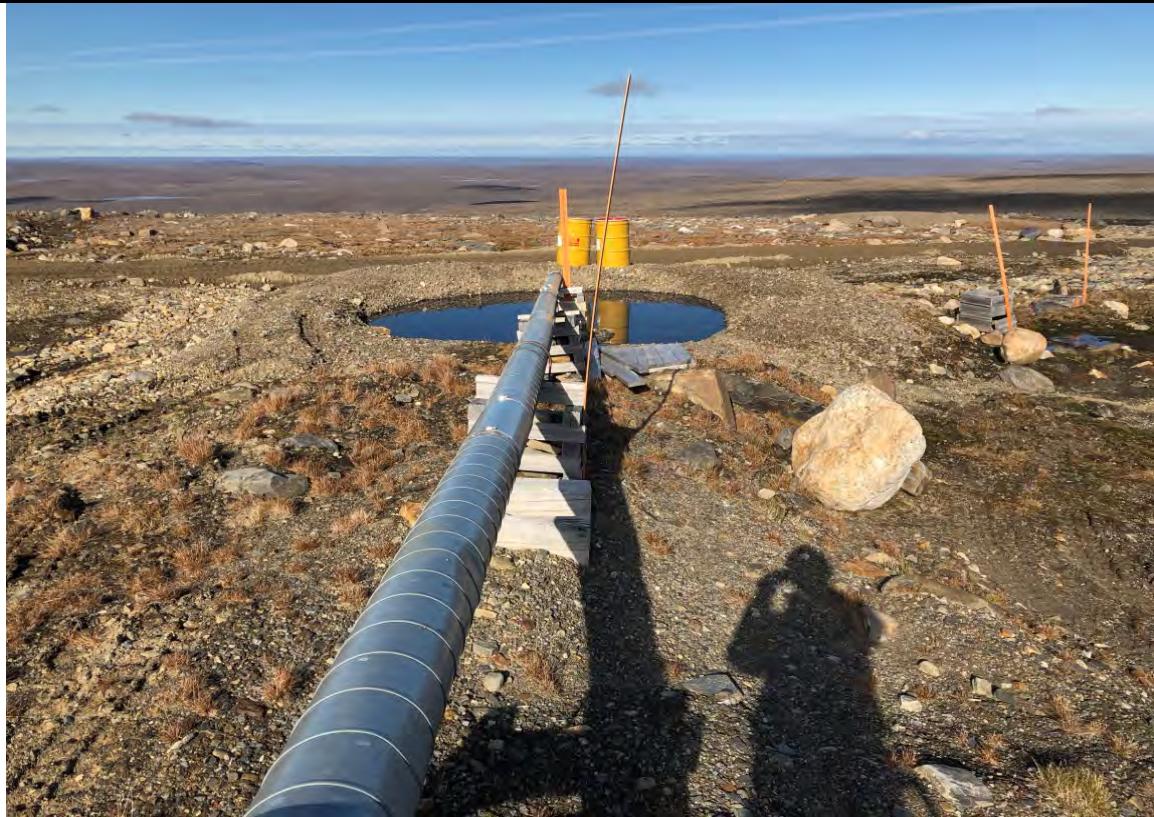
Photo 7

9. The Licensee treats the sewage inside the main facility using incinerator toilets and septic tanks and disposes it in a sump.
10. The Licensee treats the sewage inside the main facility using incinerator toilets and a septic tank system.
11. It is discharged through an outfall pipe that leads to a sump (see photos 7 and 8).

Description: Outtake Pipe leading to a sump pit. A couple of spill kits

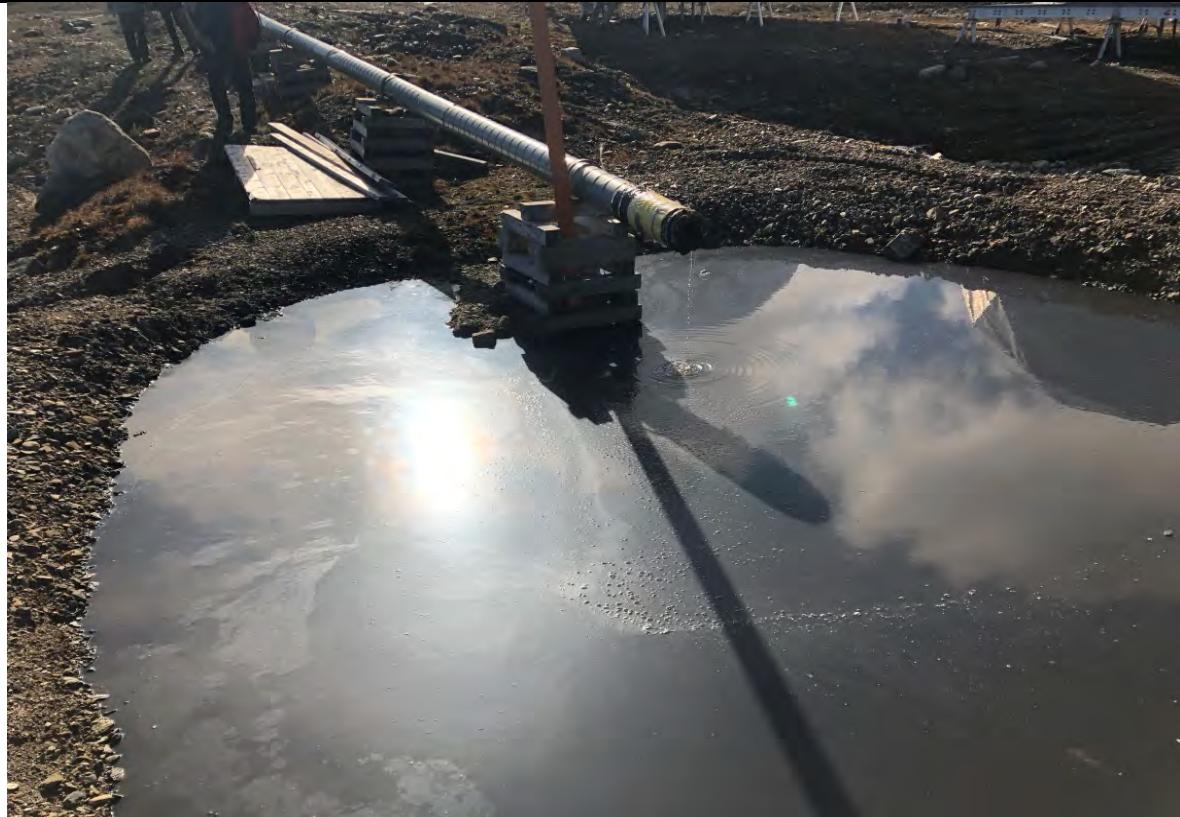
Photo 8

Description: discharge point for sewage. Sump pit walls appear to be operating as intended

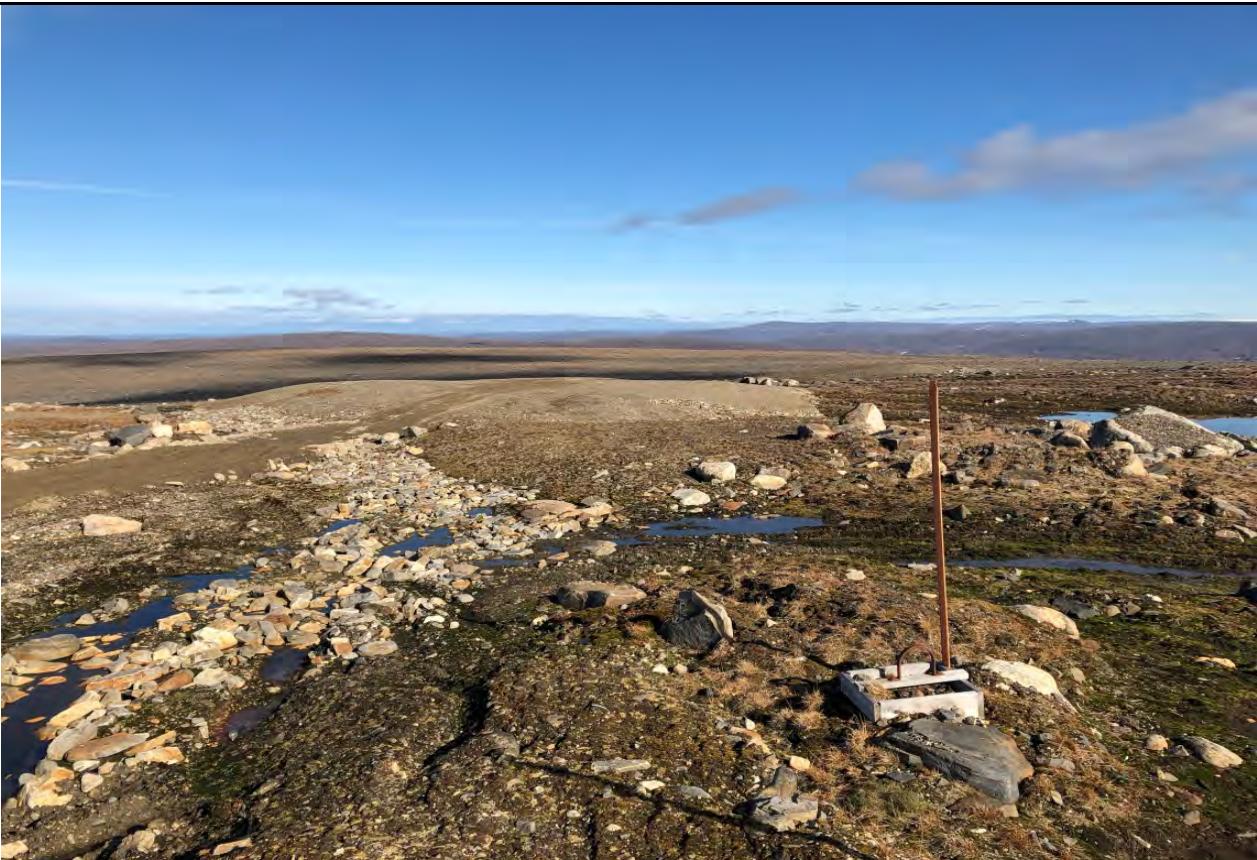
Photo Log	Location
Photo 9	Dewar Lake e

Description: Location of crash site is capped with gravel.

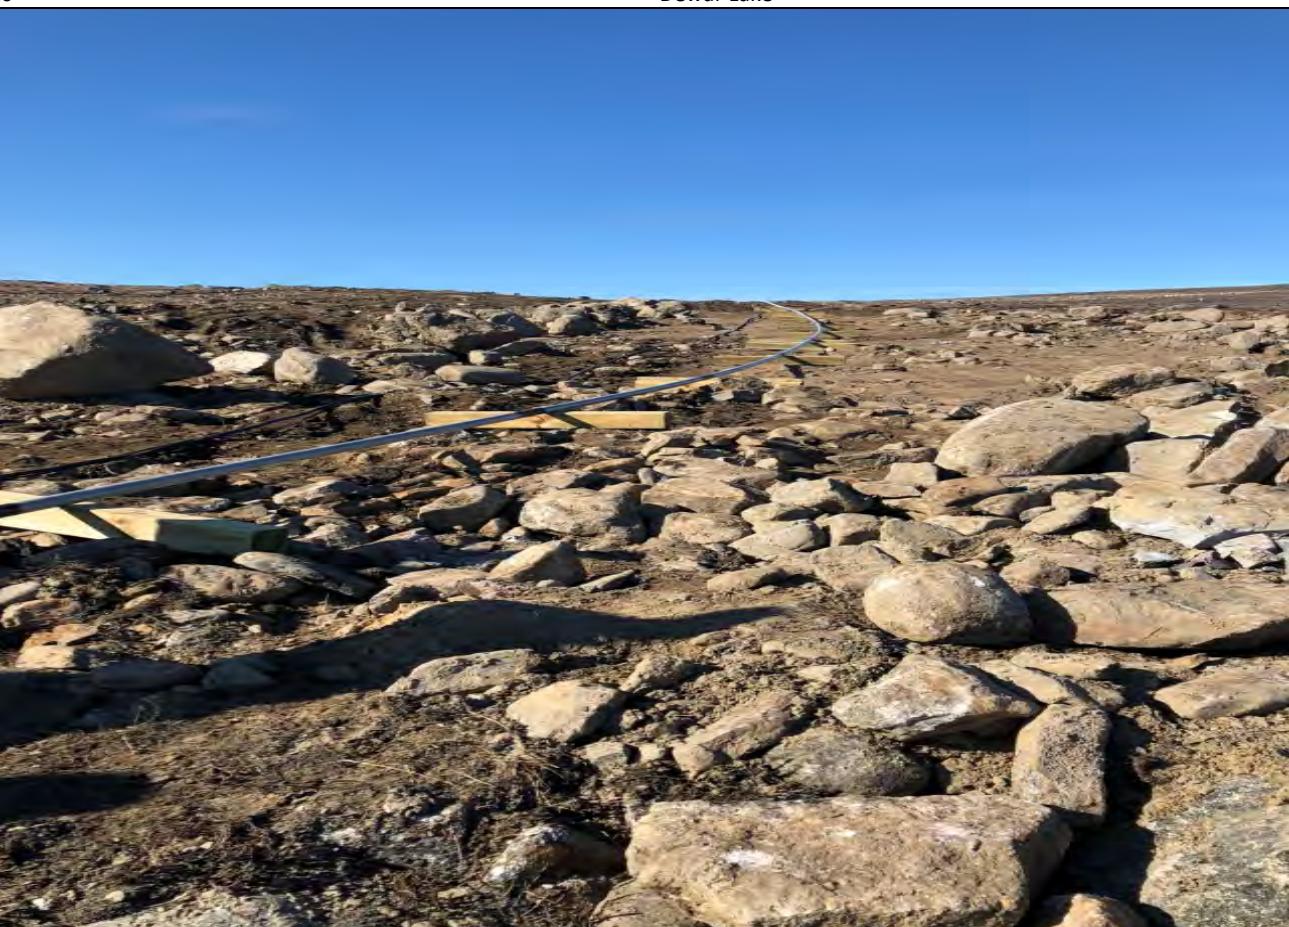
Photo Log	Location
Photo 10	Dewar Lake

12. Past inspection reports document two spills.
13. Fuel pipe line failure reported on July 9, 2009 which released an unknown quantity from a 3 mm crack in the apron-to-summit pipeline. No samples were taken.
14. An amendment was requested of the licensee in order to construct an engineered land farm in 2017.
15. A helicopter crash on May 13, 2013 Spill Report 2013-145 that released 917 litres of Jet-A1. The Helicopter site appears to be remediated after capturing contaminated soil, and capping the area with gravel (see photo 9).
16. The fuel pipeline also appears to be remediated having removed contaminated soil, and capped the surrounding area with gravel. The pipe was repaired and operating at the time of the inspection (see photo10).

Description: Site of pipe line spill is capped.

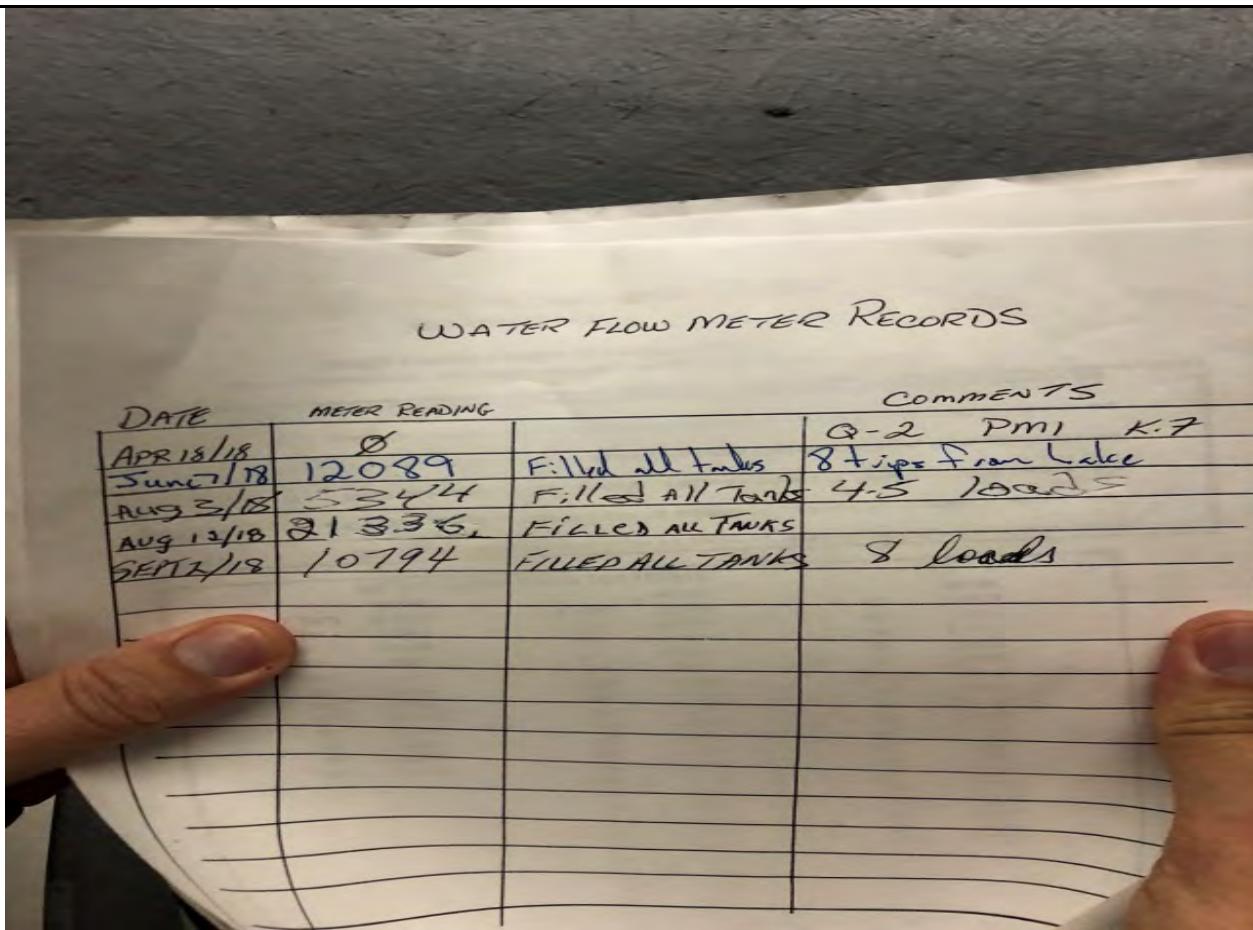
Photo 11

17. On site request for documentation produced Water Flow Meter Records, Emergency Plans, and a Spill Contingency Plan.
18. Water Flow Meter Records (see photo 11).
19. Emergency Plan (See photo 12).
20. Spill Contingency Plan (see photo 13).

Description: Water Flow Meter Record dated April 18, 2018 to September 12, 2018

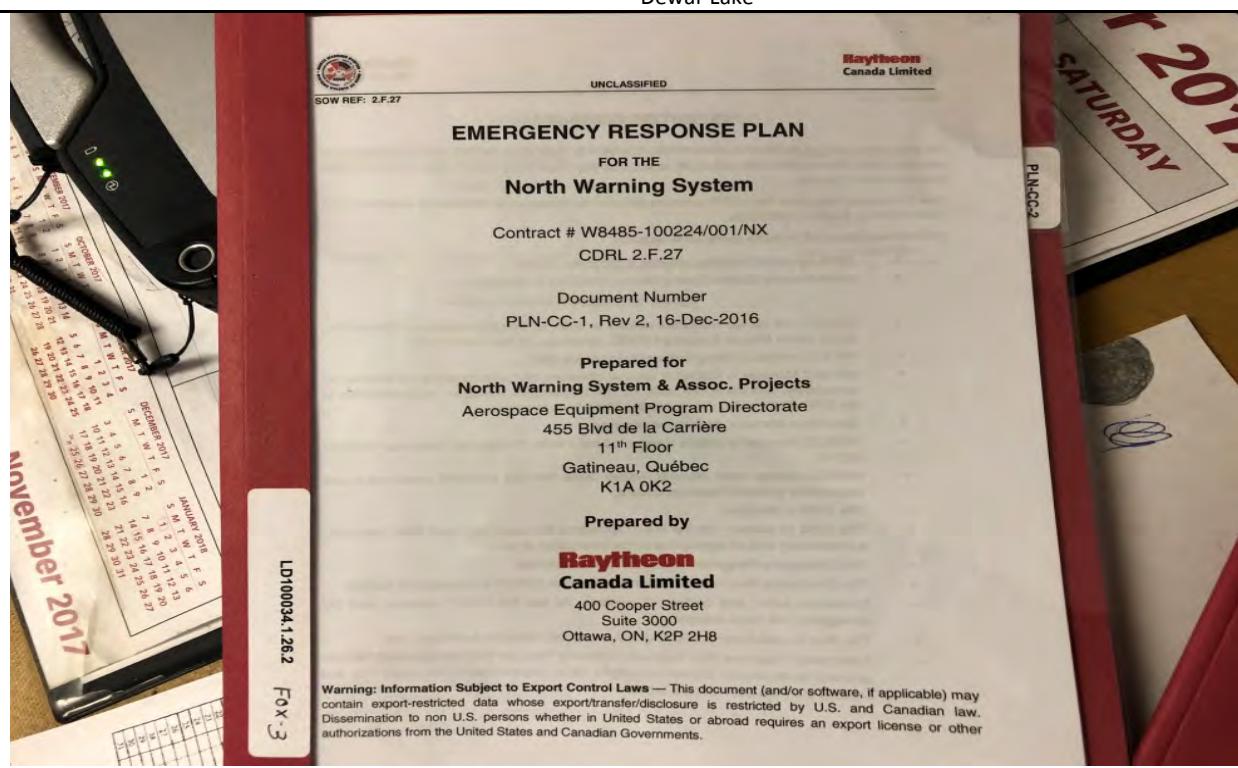
Photo 12

Description: Emergency Response Plan

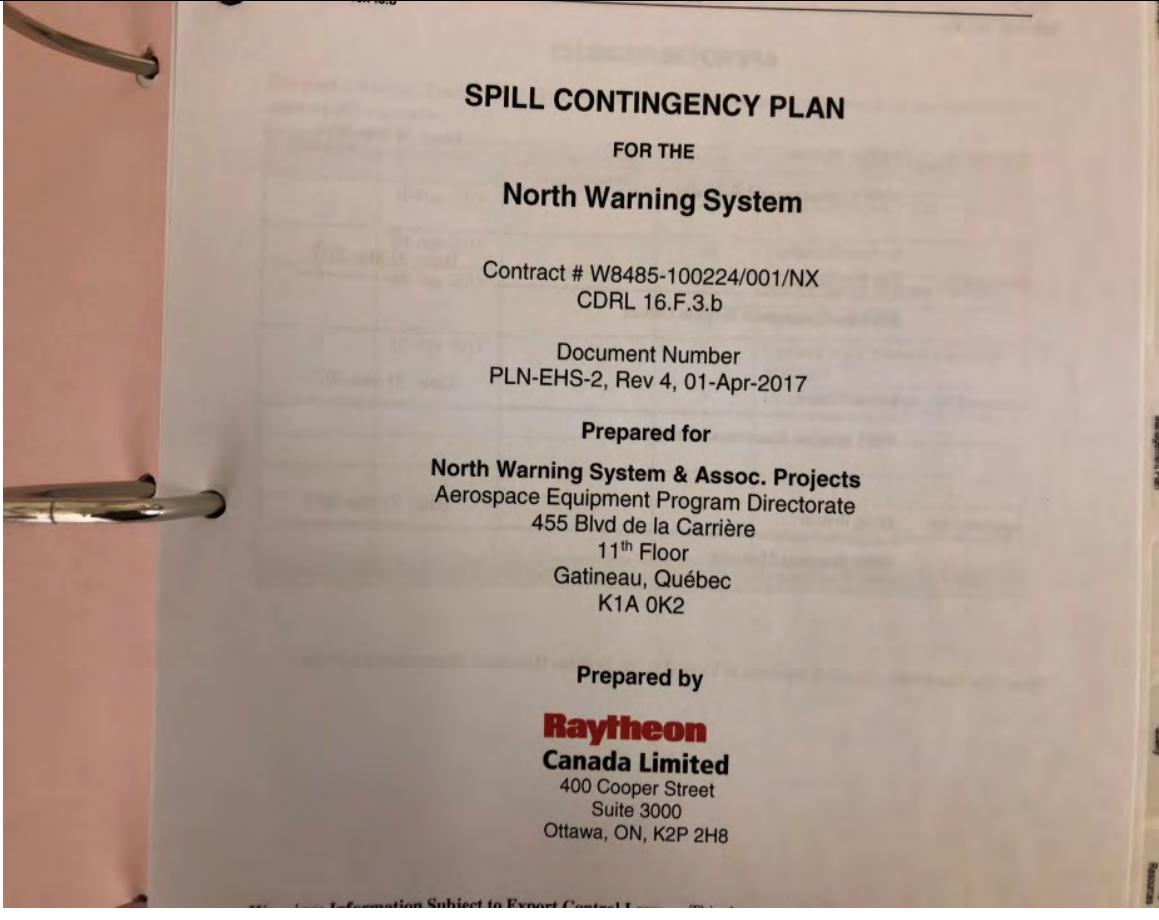
Photo Log	Location
Photo 13	Dewar Lake

Description: Spill Contingency Plan
