**WATER LICENCE INSPECTION FORM**

Licensee		Licensee Representative		
North Warning System Office 455 Boulevard de la Carriere, Gatineau, Quebec, J8Y 6W6		Don Beattie		
Licence No. / Expiry 3BC-FOD0919		Representative's Title Environmental Officer		
Land / Other Authorizations				
Date of Inspection 08/25/2017		Inspector Jonathan Mesher		
Activities Inspected				
<input type="checkbox"/> Municipality <input type="checkbox"/> Roads/Hauling		<input type="checkbox"/> Drilling <input checked="" type="checkbox"/> Other: Camp	<input type="checkbox"/> Mining <input type="checkbox"/> Construction <input type="checkbox"/> Other:	<input type="checkbox"/> Reclamation <input type="checkbox"/> Fuel Storage

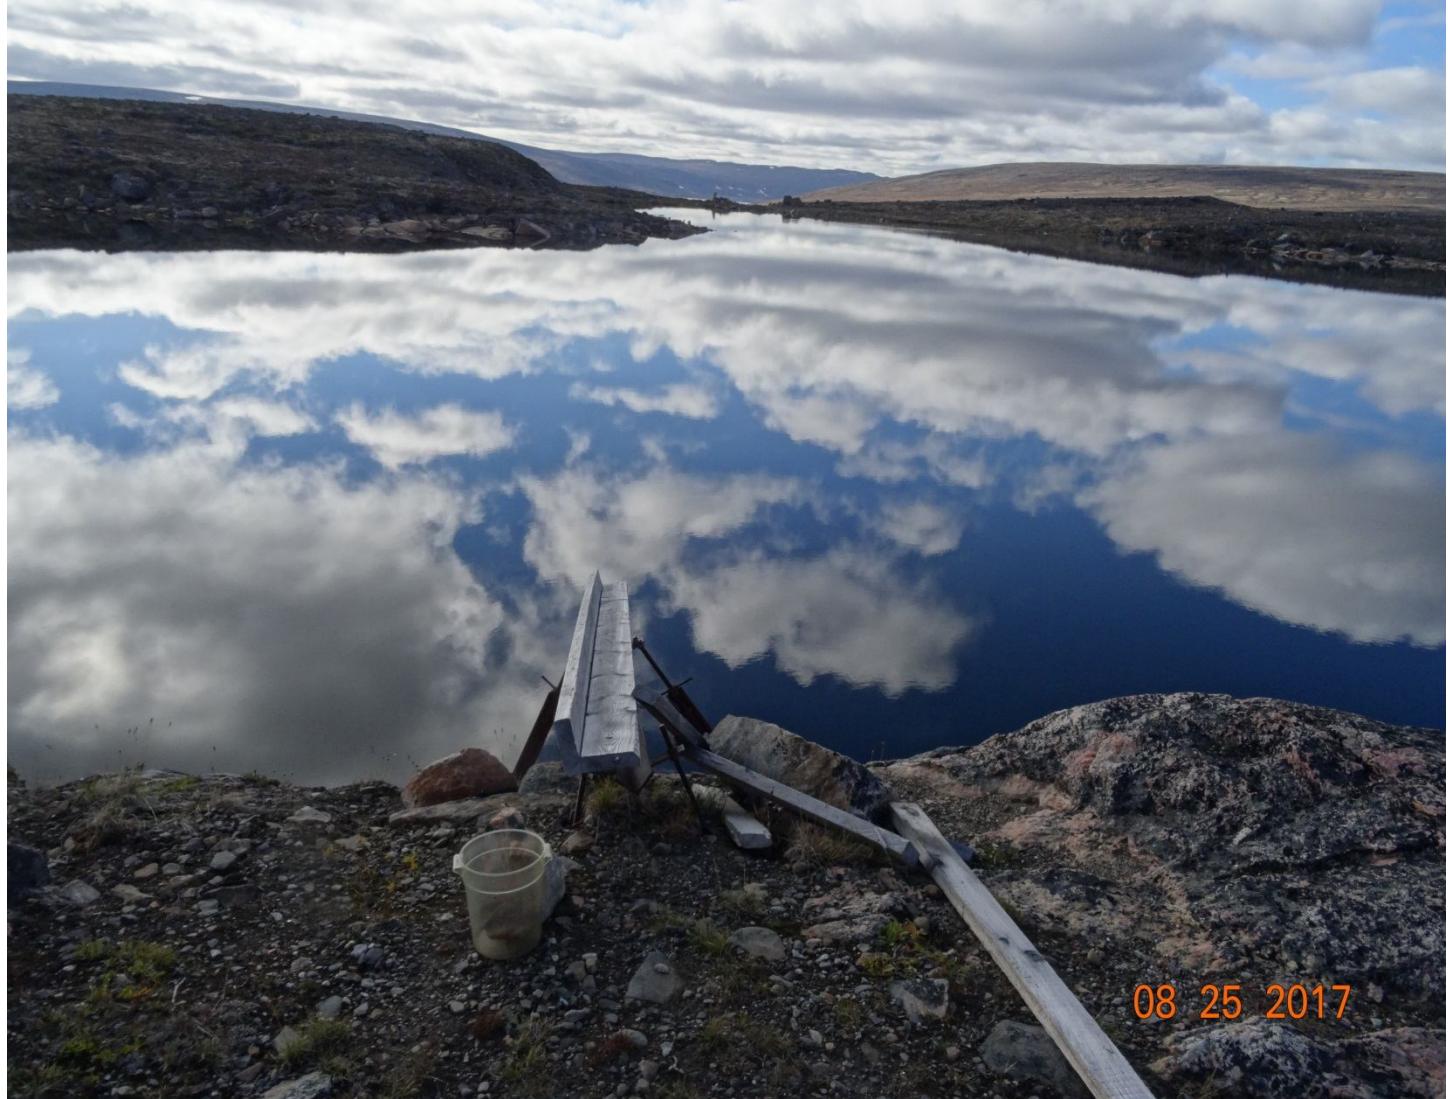
Figure 1: raw water source.

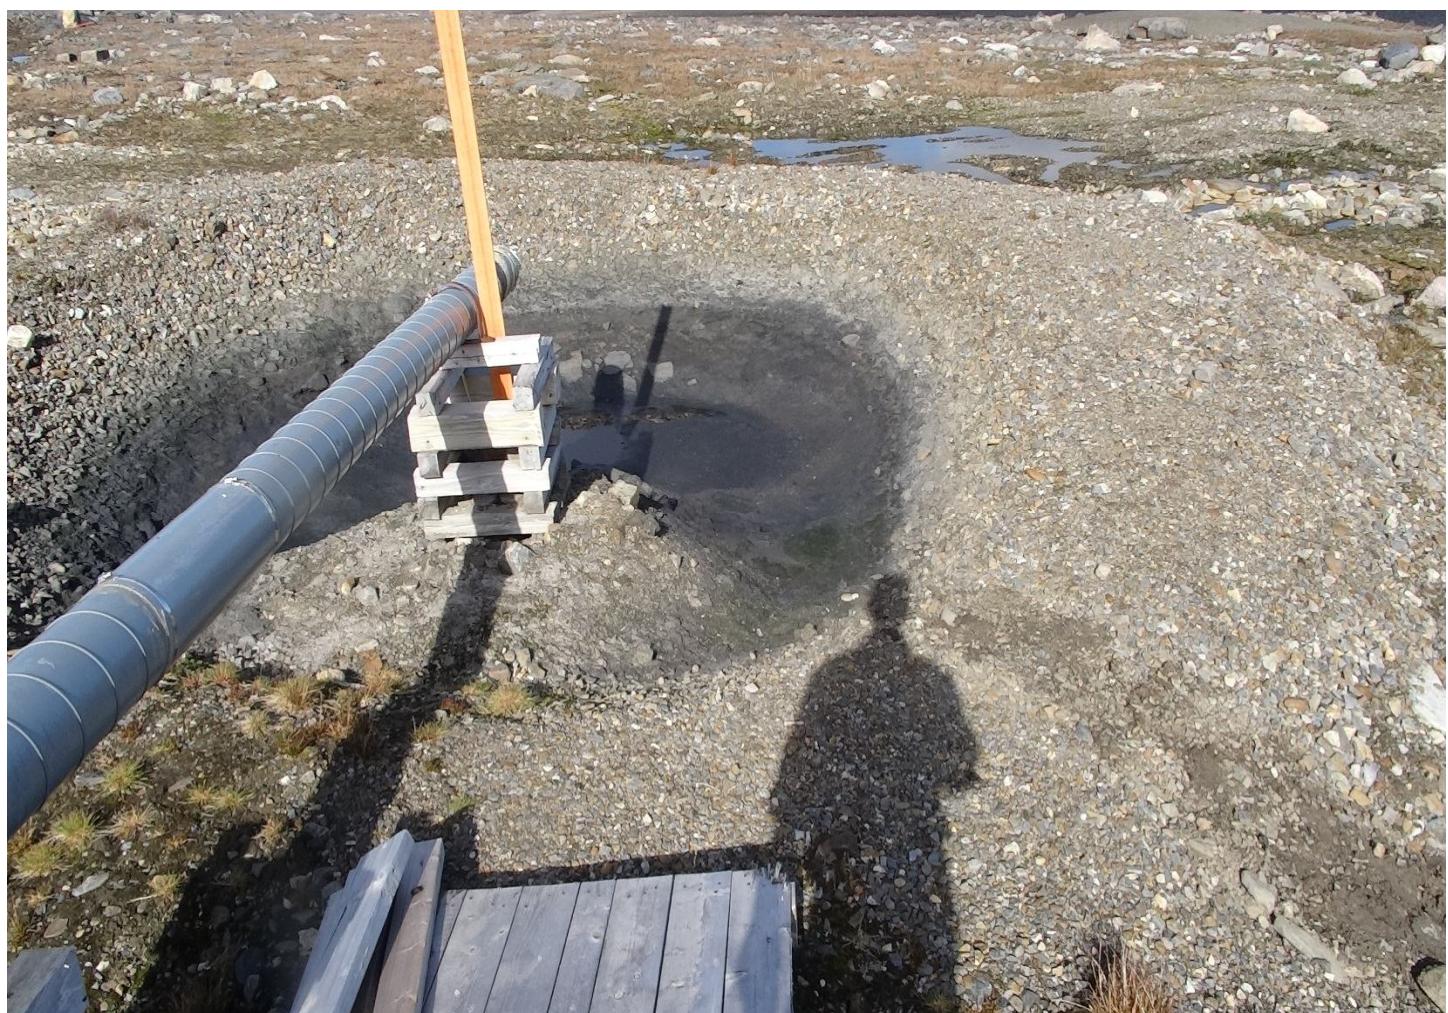
Figure 2: sewage disposal facility.

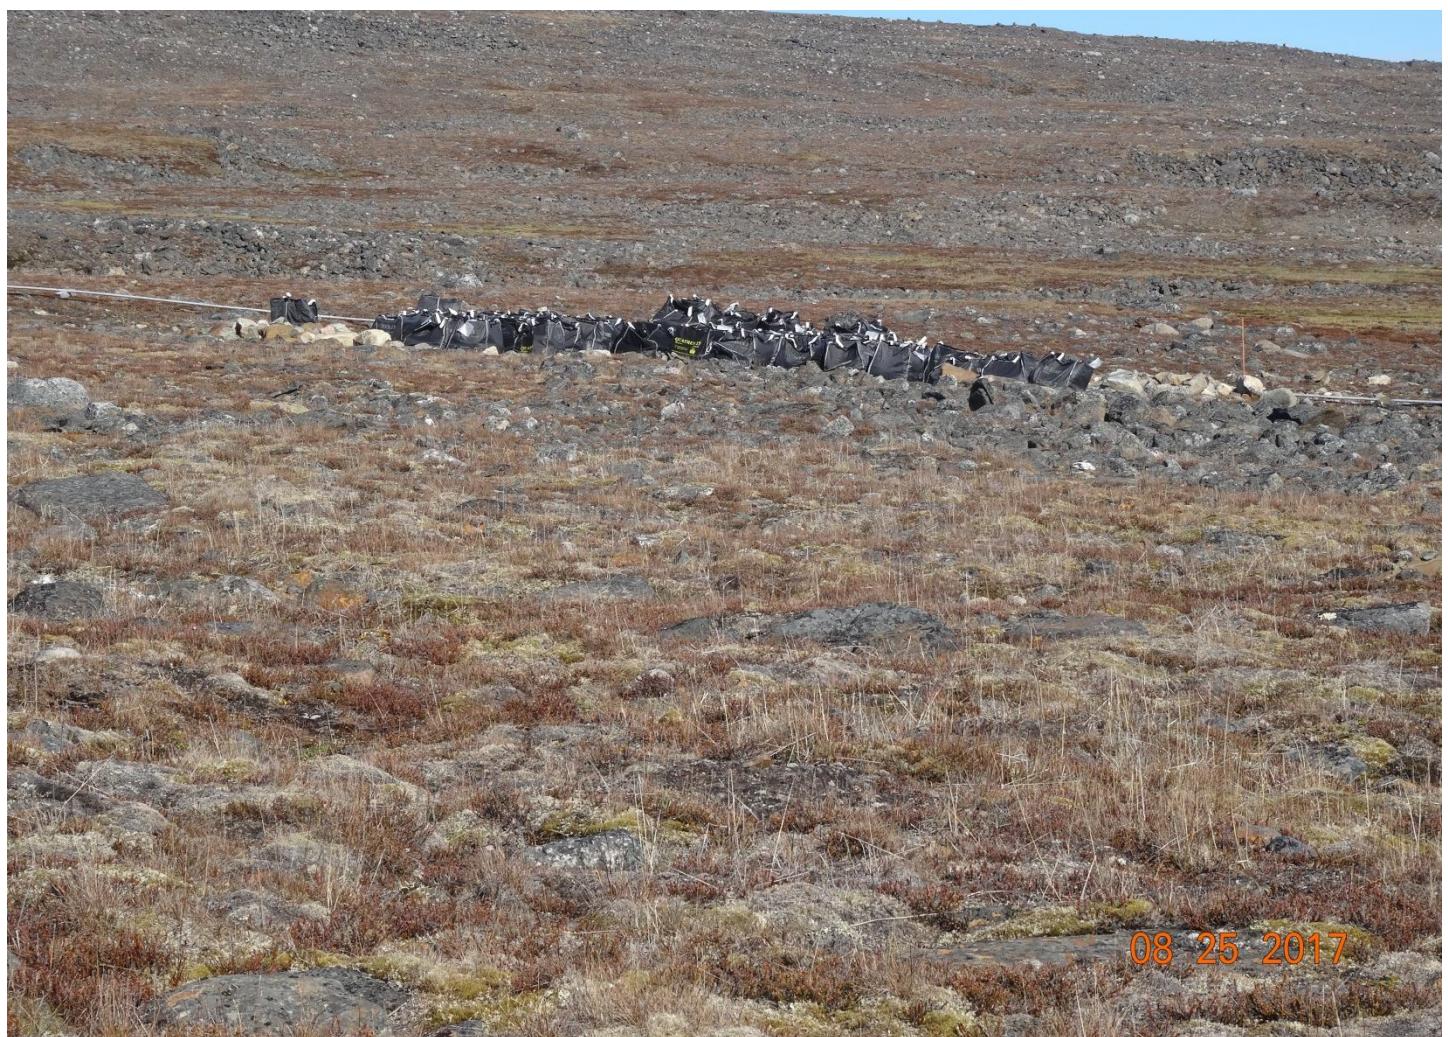
SECTION 1	<input checked="" type="checkbox"/> Comments	<input type="checkbox"/> Non-Compliance with Act or Licence	<input type="checkbox"/> Action Required
Background			
Water Licence 3BC-FOD0919 issued to the Government of Canada Department of National Defence for the use of water not exceeding 1440m ³ annually and the deposit of waste during the operation and maintenance of the FOX-3 Long Range Radar Station located north of Dewar Lakes on Baffin Island within the Qikiqtani Region, Nunavut.			
Inspection			
<p>1. Water Lake</p> <ul style="list-style-type: none"> a) The licensee trucks water from the Water Lake to 6 (six) raw water tanks within the main facility. b) No signs of drawdown or erosion were noted during the inspection. c) This facility appears to be working as intended. See figure 1 for the water source. <p>2. Sewage disposal facility</p> <ul style="list-style-type: none"> a) The Licensee treats the sewage inside the main facility and disposes of it in a sump. b) This deposit of waste does not appear to effect inland waters, the nearest body of water is approximately 7Km from the sump. c) No issues were noted about this deposit of waste. See figure 2 for the sump. <p>3. Historical spills</p> <ul style="list-style-type: none"> a) On site there are two spills that are concerning, one being a pipe line failure and the other a helicopter crash. b) Both spills have been mentioned in past Water Licence inspection reports and remain in the same state. c) The Licensee had intention of constructing a engineered land farm in order to remediate the soil on site in 2017 but, a technical advisor at the NWB requested they get an amendment to their licence in order to construct a land farm. d) This request from the NWB has delayed the remediation of the spills until 2018. e) See figure 3 and 4 for the spill sites.

Figure 4: Pipeline line spill
