## WATER LICENCE INSPECTION FORM

Licensee	Licensee Representative				
Department of National Defence	Don Beattie				
License No. / Expiry	Representative's Title				
8BC-FOD0919	Environmental Officer				
Land / Other Authorizations	Land / Other Authorizations				
Date of Inspection	Inspector				
September 4, 2018	Joseph Monteith				
Activities Inspected					
<input type="checkbox"/> Camp	<input type="checkbox"/> Drilling	<input type="checkbox"/> Mining	<input type="checkbox"/> Construction	<input type="checkbox"/> Reclamation	<input type="checkbox"/> Fuel Storage
<input type="checkbox"/> Roads/Hauling	<input checked="" type="checkbox"/> Other: Potable Water Source, Solid Waste Facility, Sewage Disposal Facility	<input type="checkbox"/> Other:

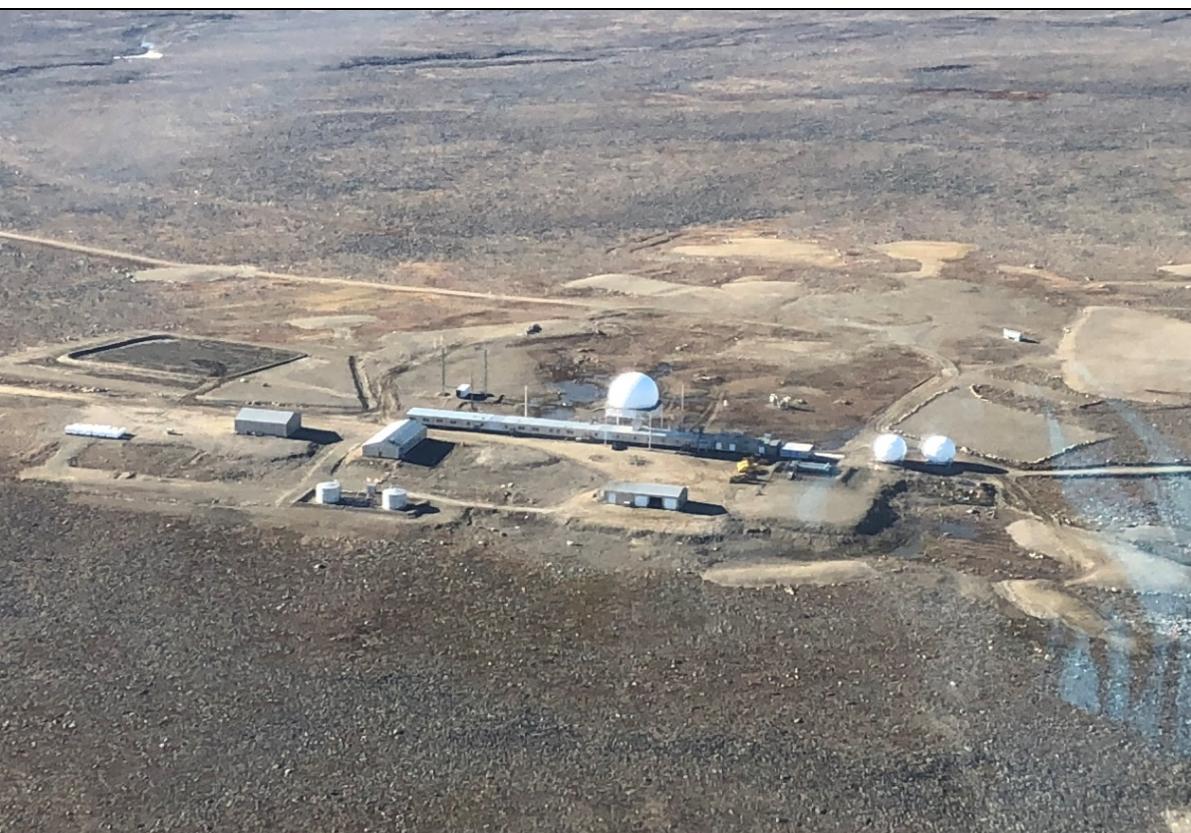
Date	Camera	Inspector
September 4, 2018	Nikon Coolpix	Joseph Monteith
Photo Log	Location	
Photo 1	Dewar Lake

#### *Fox-3 North Warning Site(see photo 1)*

Description: Fox-3 Dewar Lake, Qikiqtani Region, Nunavut

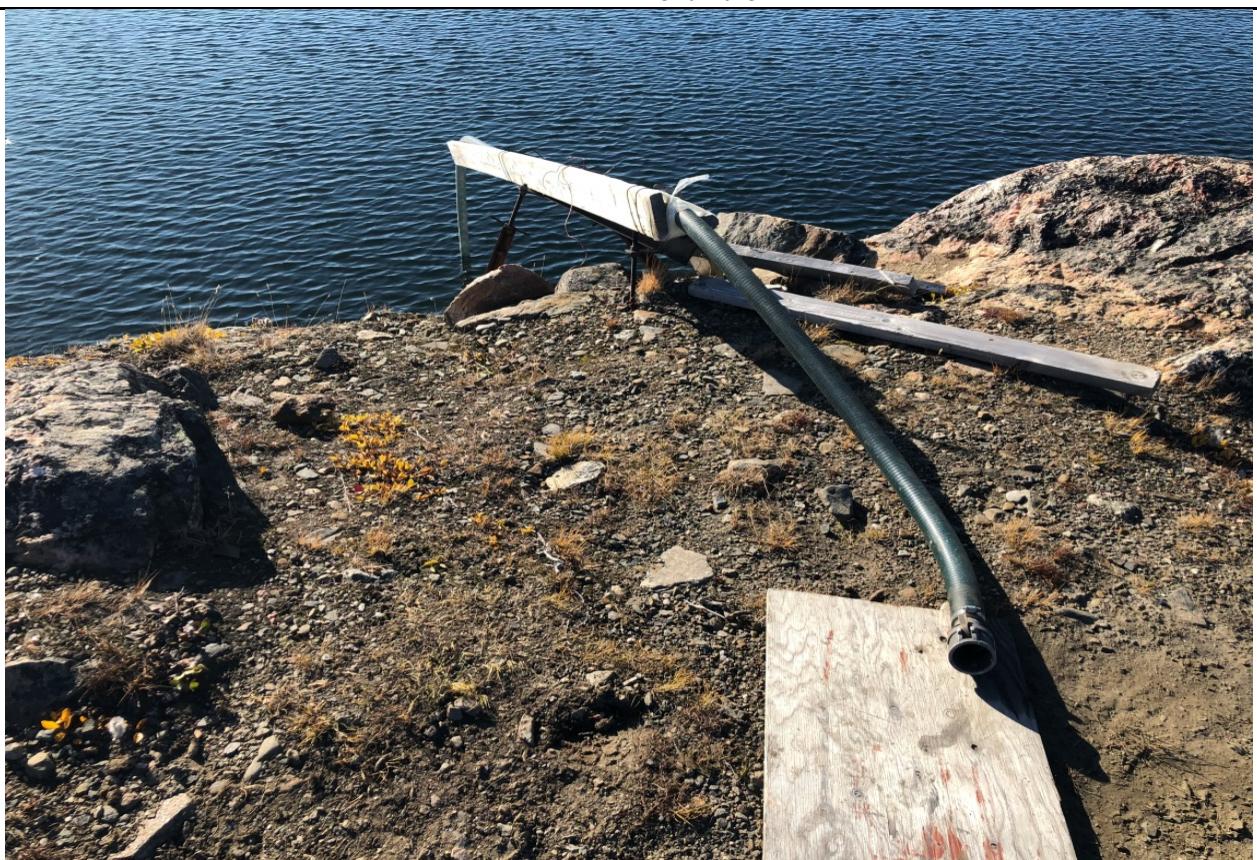
Photo Log	Location
Photo 2	Dewar Lake

<b>Compliance with General Conditions of the Licence</b>			
On February 6, 2019 WRO Monteith received an email from Richard Dwyer, Manager of Licensing, Nunavut Water Board with a link to the submission of the 2018 Annual Report.			
<b>Water Use and Related Structures</b>			
<b>Water Lake</b>			
<ol style="list-style-type: none"> <li>1. The licensee is permitted to withdrawal 1440 cubic metres from Water Lake.</li> <li>2. The licensee withdraws water from the Water Lake and trucks the water to six raw water tanks within the main facility. (see photo 2)</li> <li>3. Fish Mesh Screen visible from surface (see photo 3).</li> </ol>

Description: Water Lake and Withdrawal hose.

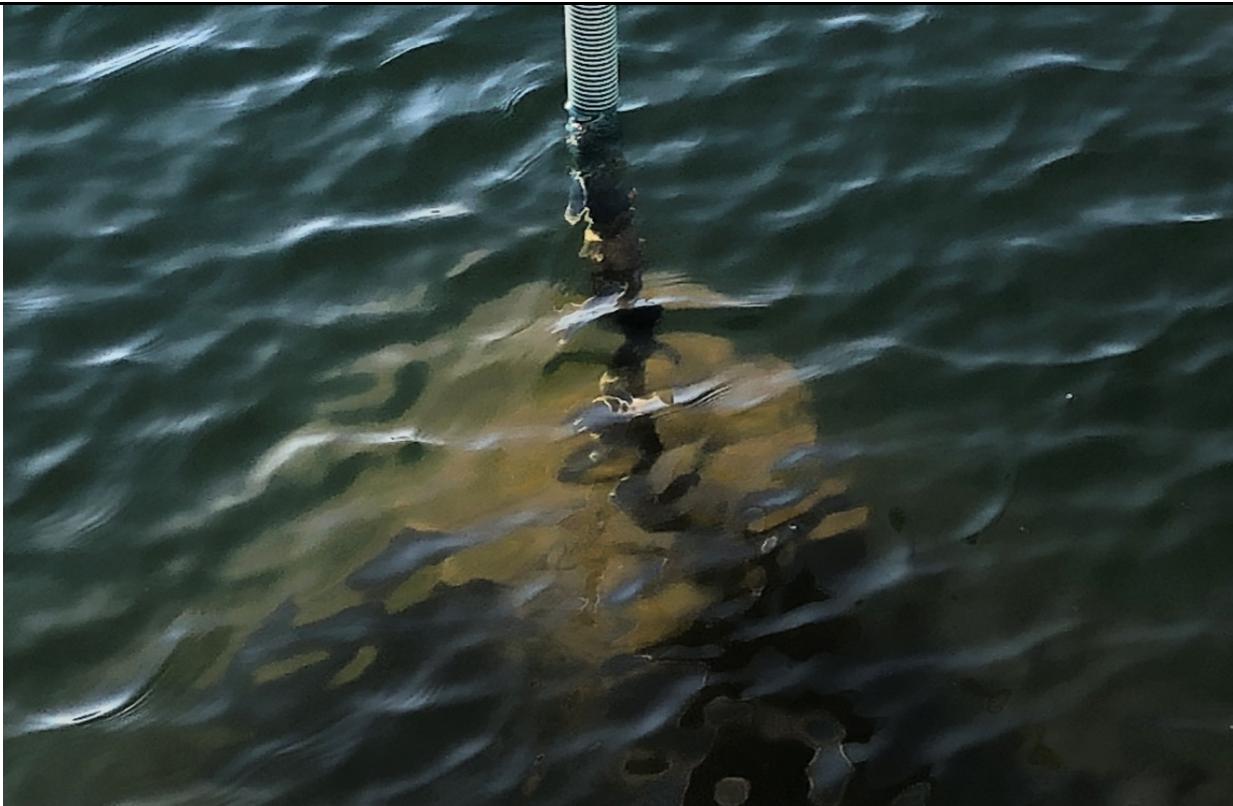
Photo Log	Location
Photo 3	Dewar Lake

Description: Fish Mesh Screen

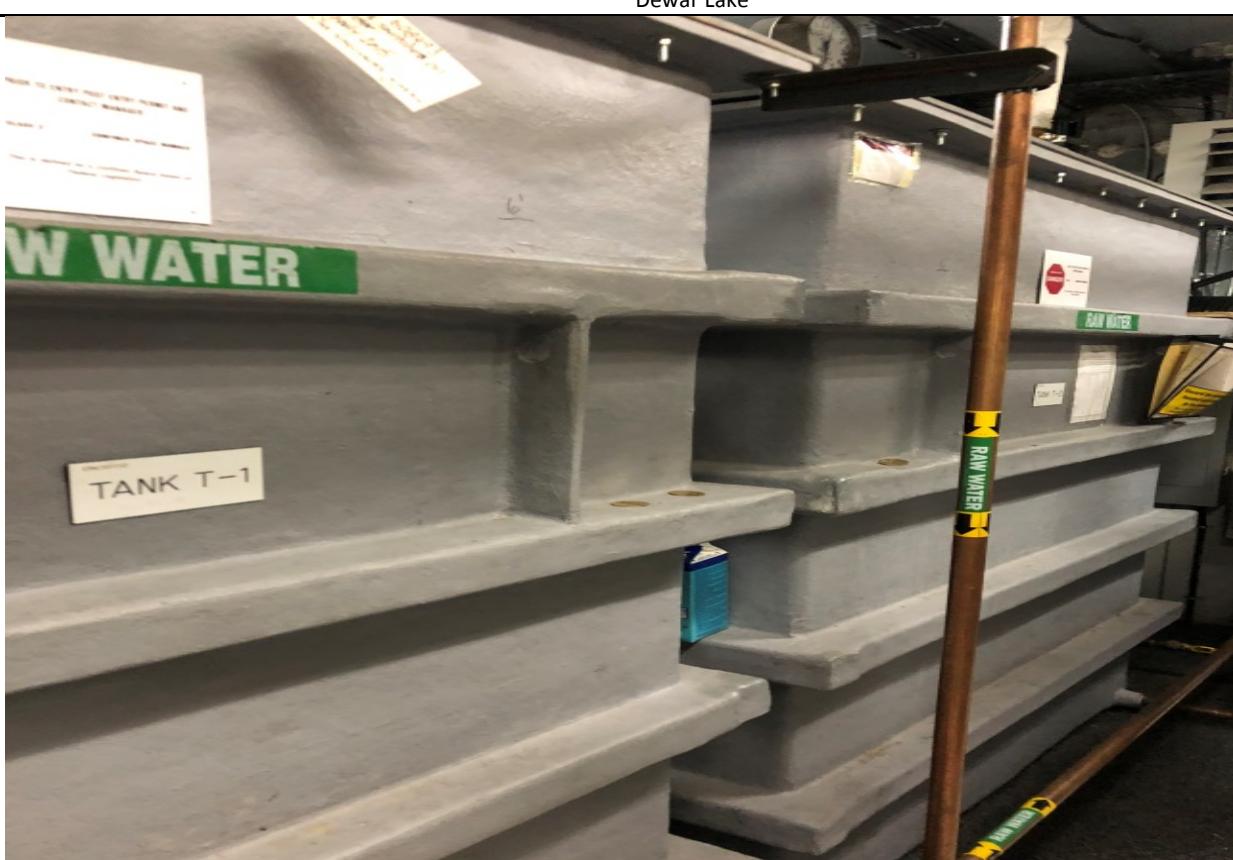
Photo Log	Location
Photo 4	Dewar Lake

7. Four 10,000 Litre Water Storage Tanks (see photo 4 and 5).
8. Water Meter reads 10794 Litres (see photo 6).

Description: Water Storage Tank T-1, and T-2

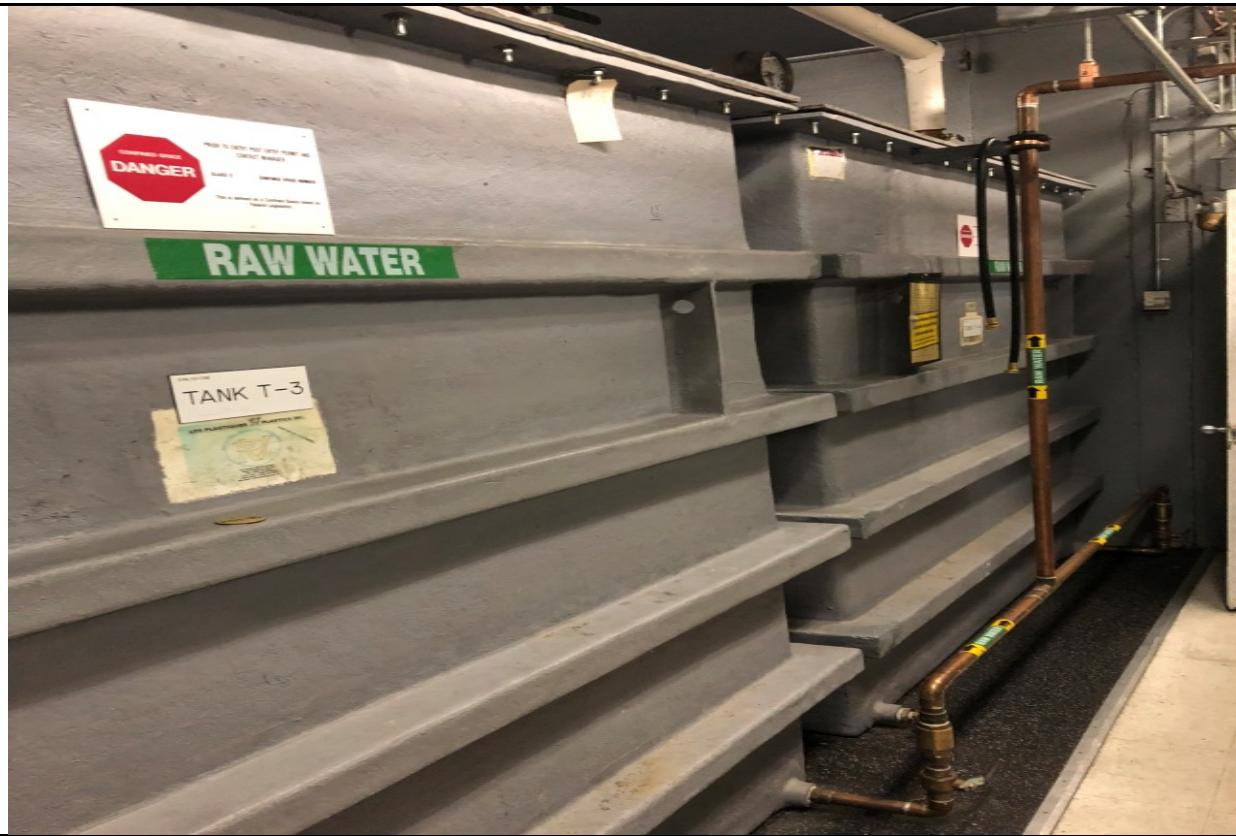
Photo 5

Description: Trucks recharge Water Storage Reservoir

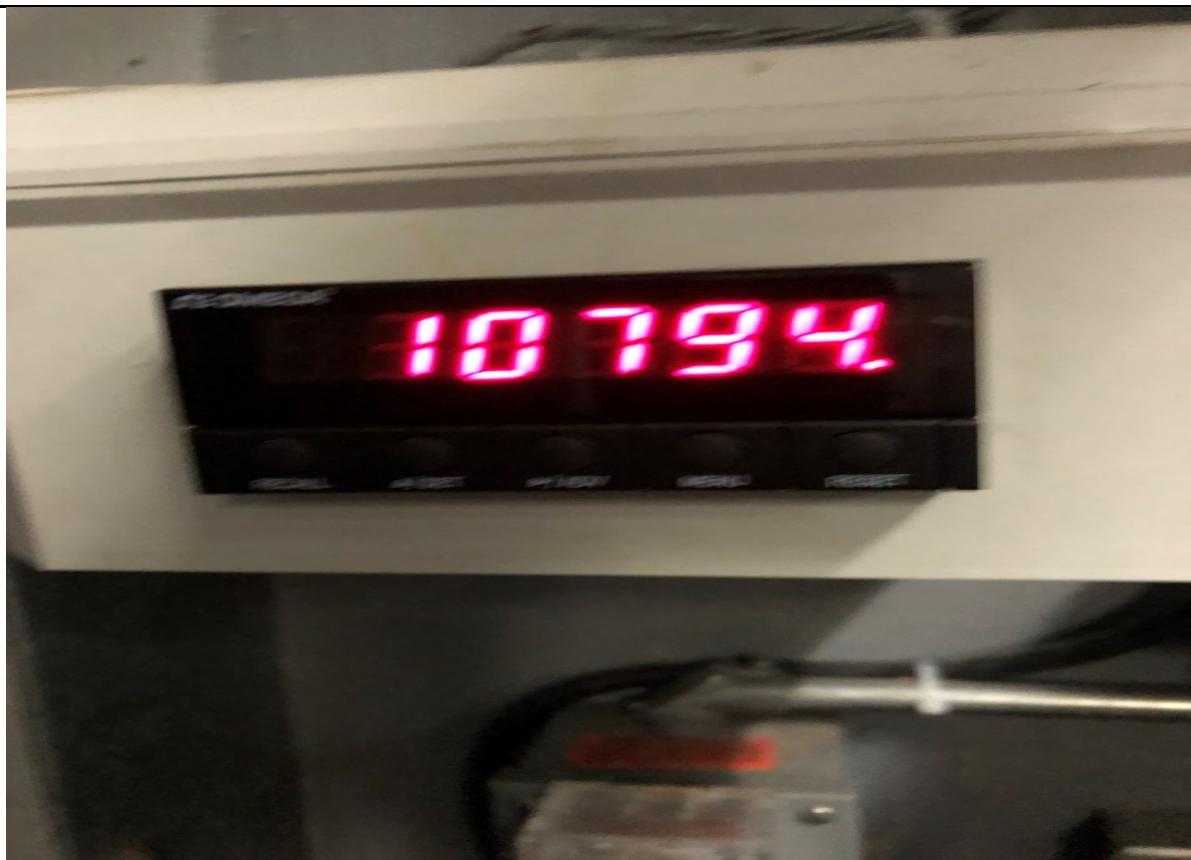
Photo 6

Description: Trucks recharge Water Storage Reservoir

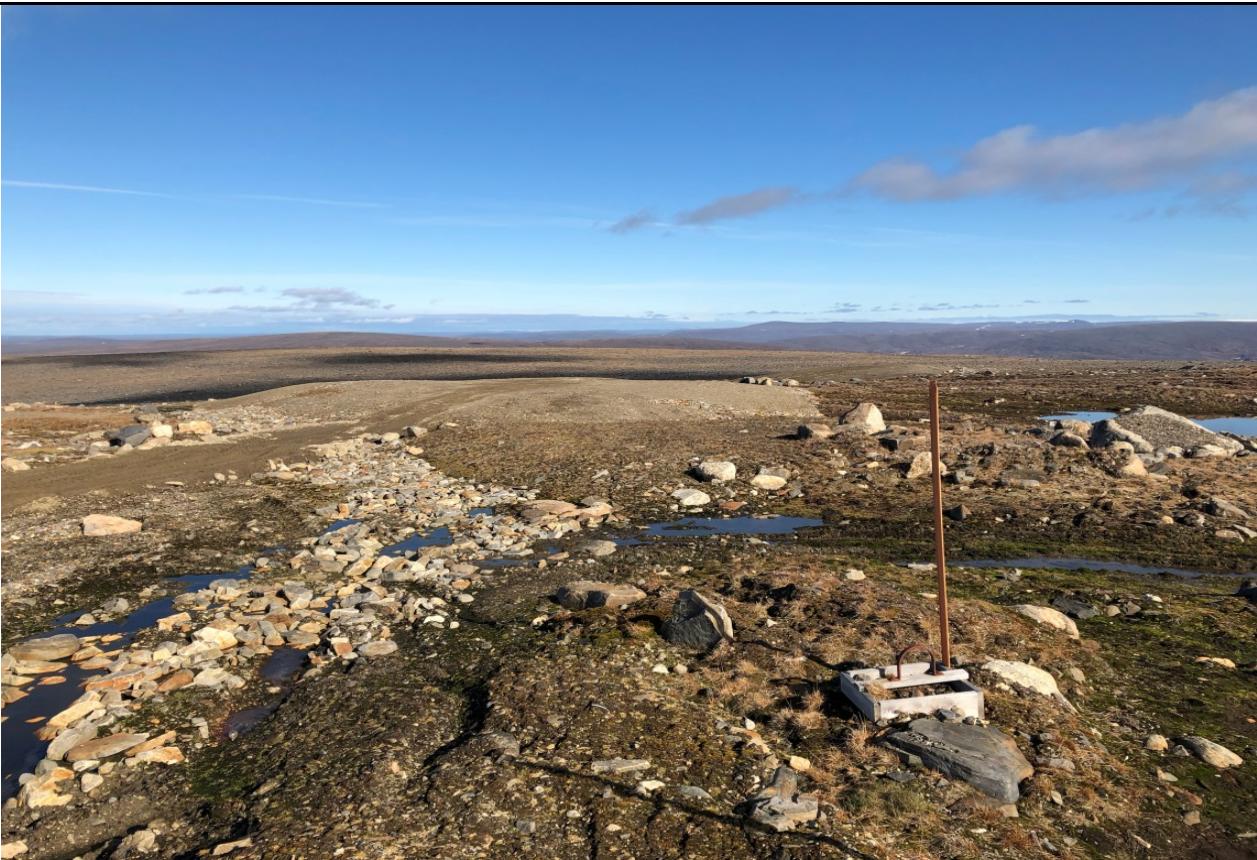
Photo Log	Location
Photo 9	Dewar Lake e

Description: Location of crash site is capped with gravel.

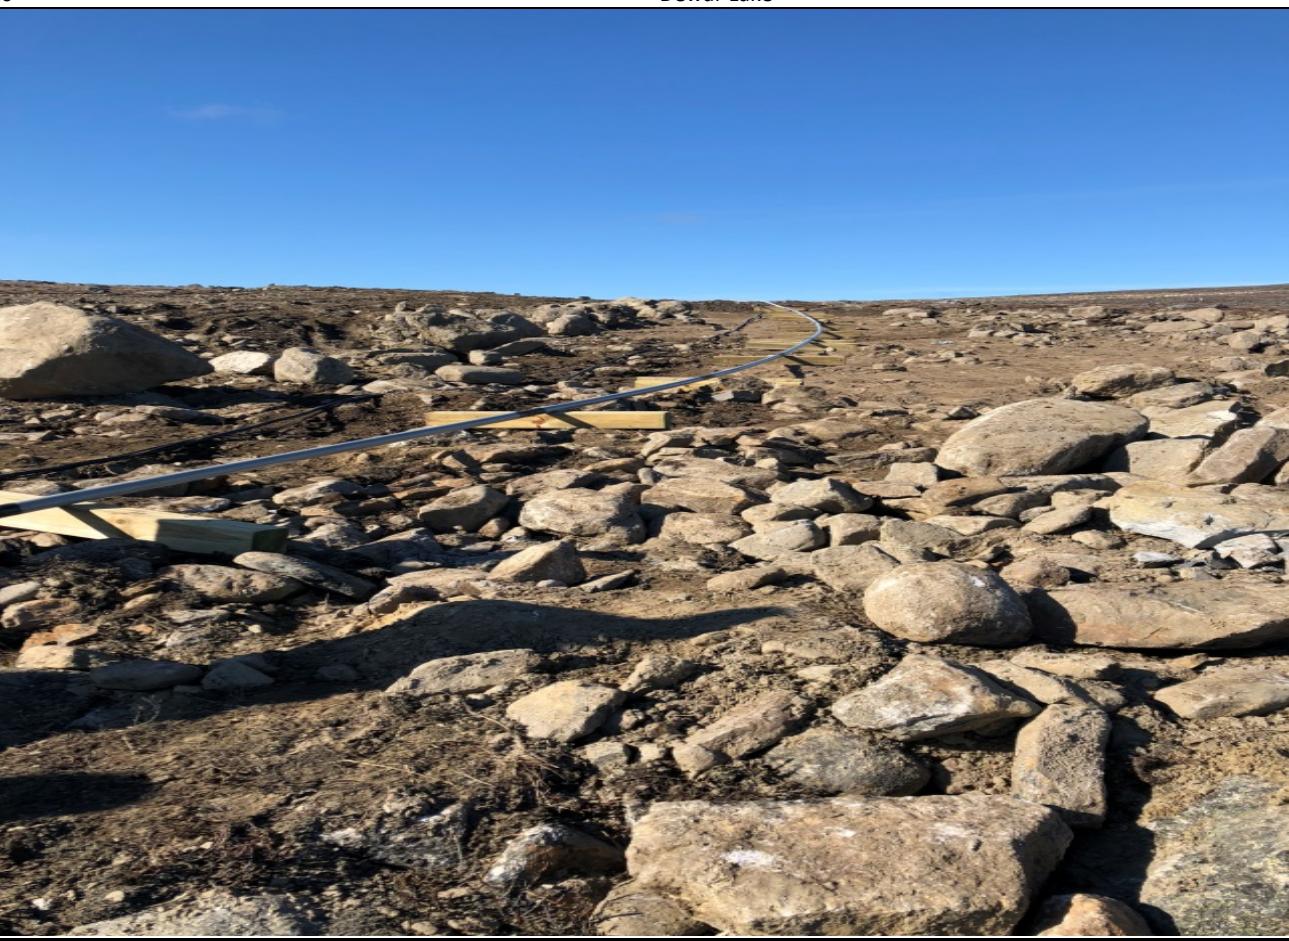
Photo Log	Location
Photo 10	Dewar Lake

12. Past inspection reports document two spills.
13. Fuel pipe line failure reported on July 9, 2009 which released an unknown quantity from a 3 mm crack in the apron-to-summit pipeline. No samples were taken.
14. An amendment was requested of the licensee in order to construct an engineered land farm in 2017.
15. A helicopter crash on May 13, 2013 Spill Report 2013-145 that released 917 litres of Jet-A1. The Helicopter site appears to be remediated after capturing contaminated soil, and capping the area with gravel (see photo 9).
16. The fuel pipeline also appears to be remediated having removed contaminated soil, and capped the surrounding area with gravel. The pipe was repaired and operating at the time of the inspection (see photo10).

Description: Site of pipe line spill is capped.

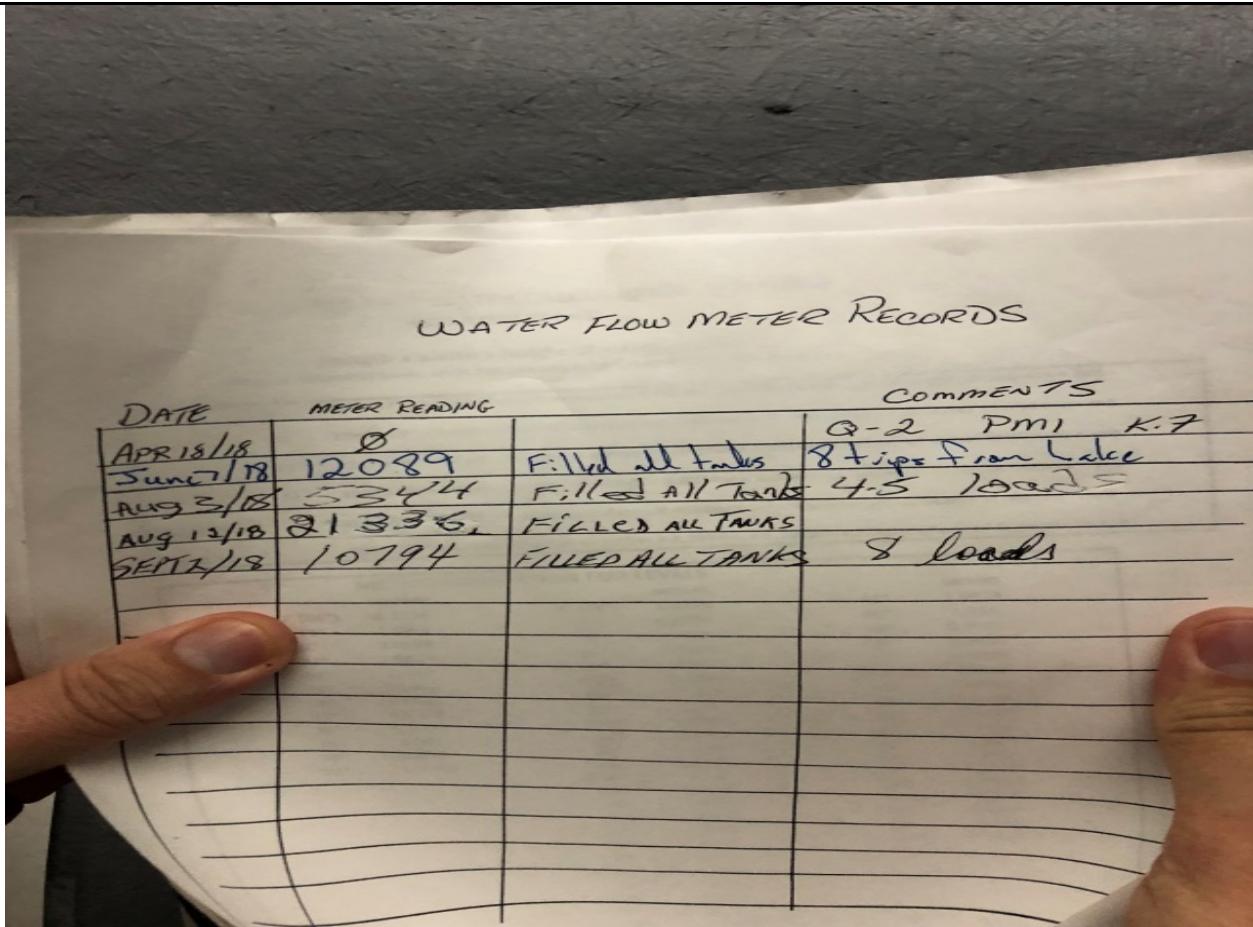
Photo 11

4. No signs of drawdown or erosion were noted during the inspection.
5. This facility appears to be working as intended.
6. Water Flow Meter Records were observed on site (see photo 11).

17. On site request for documentation produced Water Flow Meter Records, Emergency Plans, and a Spill Contingency Plan.
18. Water Flow Meter Records (see photo 11).
19. Emergency Plan (See photo 12).
20. Spill Contingency Plan (see photo 13).

Description: Water Flow Meter Record dated April 18, 2018 to September 12, 2018

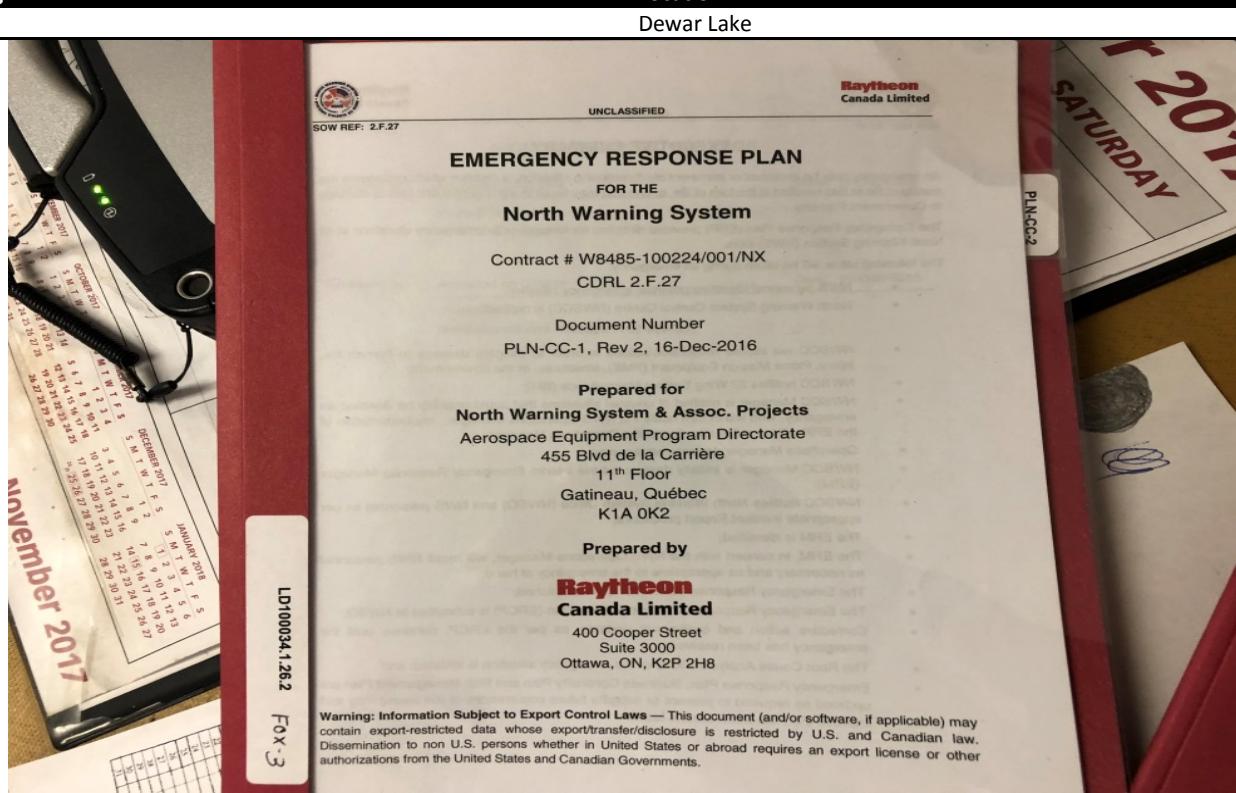
Photo 12

Description: Emergency Response Plan

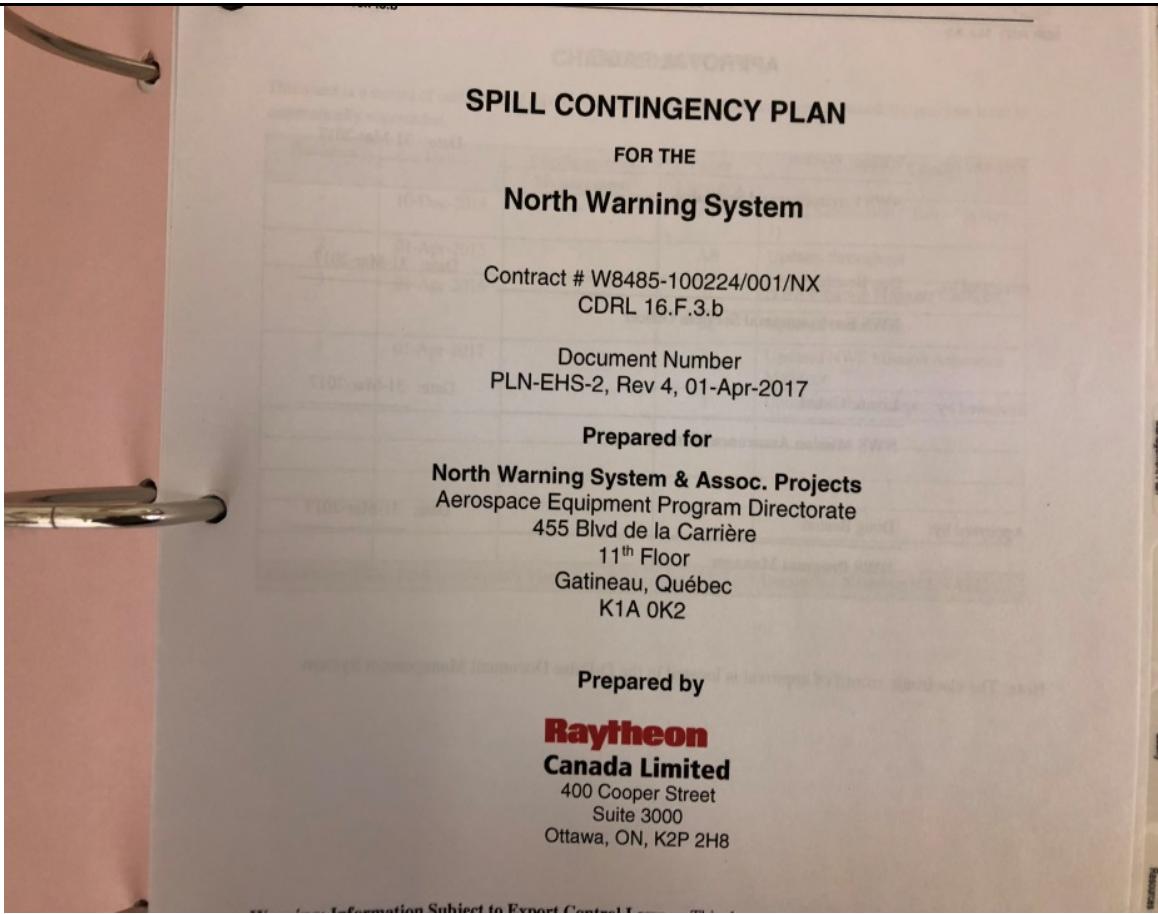
Photo Log	Location
Photo 13	Dewar Lake

Description: Spill Contingency Plan
