WATER LICENCE INSPECTION FORM

Licensee Major Creighton North Warning System Office 455 Boulevard de la Carrière, Gatineau, Quebec, J8Y 6W6		Licensee Representative Scott Charland – NWS A/Environmental officer - NWS Don Beattie – Raytheon Manager, Environmental, Health and Safety- Raytheon Canada	
Licence No. / Expiry 3BC-FOD0919		Representative's Title Acting Environmental Officer	
Land / Other Authorizations Nil		Land / Other Authorizations Nil	
Date of Inspection July 20, 2016		Inspector A.Keim	
Activities Inspected <input checked="" type="checkbox"/> Camp <input type="checkbox"/> Roads/Hauling		<input type="checkbox"/> Drilling <input type="checkbox"/> Mining <input type="checkbox"/> Construction <input type="checkbox"/> Reclamation <input checked="" type="checkbox"/> Fuel Storage <input type="checkbox"/> Other: Water Discharge <input type="checkbox"/> Other: Municipal

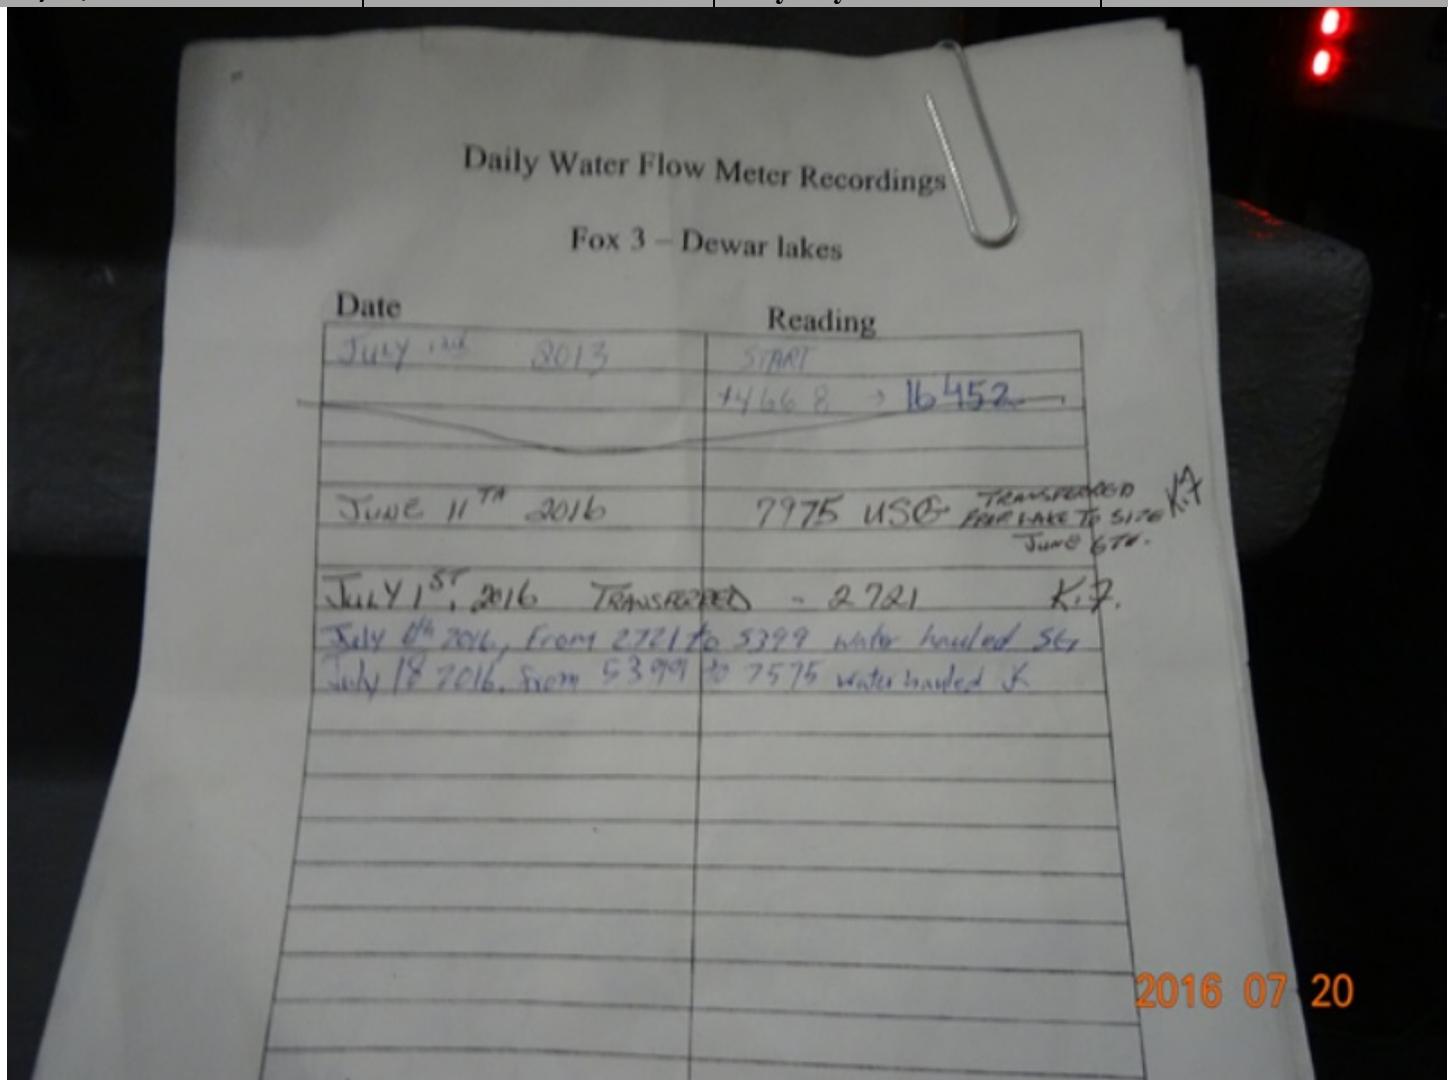
Figure 1 Water usage/ Intake log

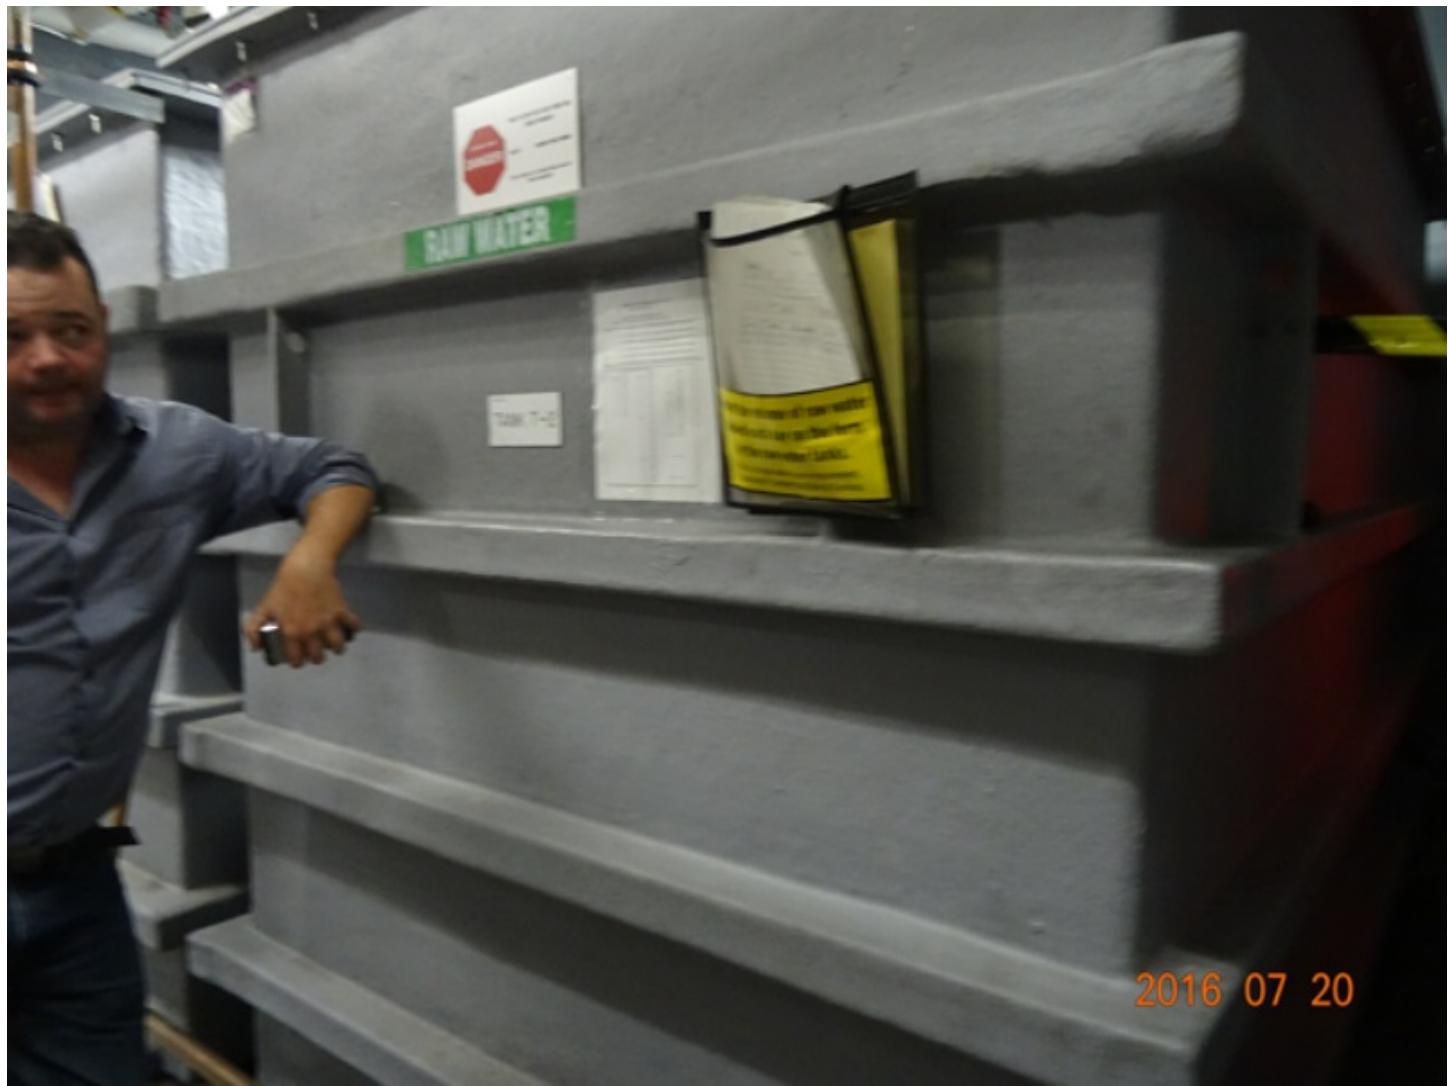
Figure 2 Water tanks in accommodation train

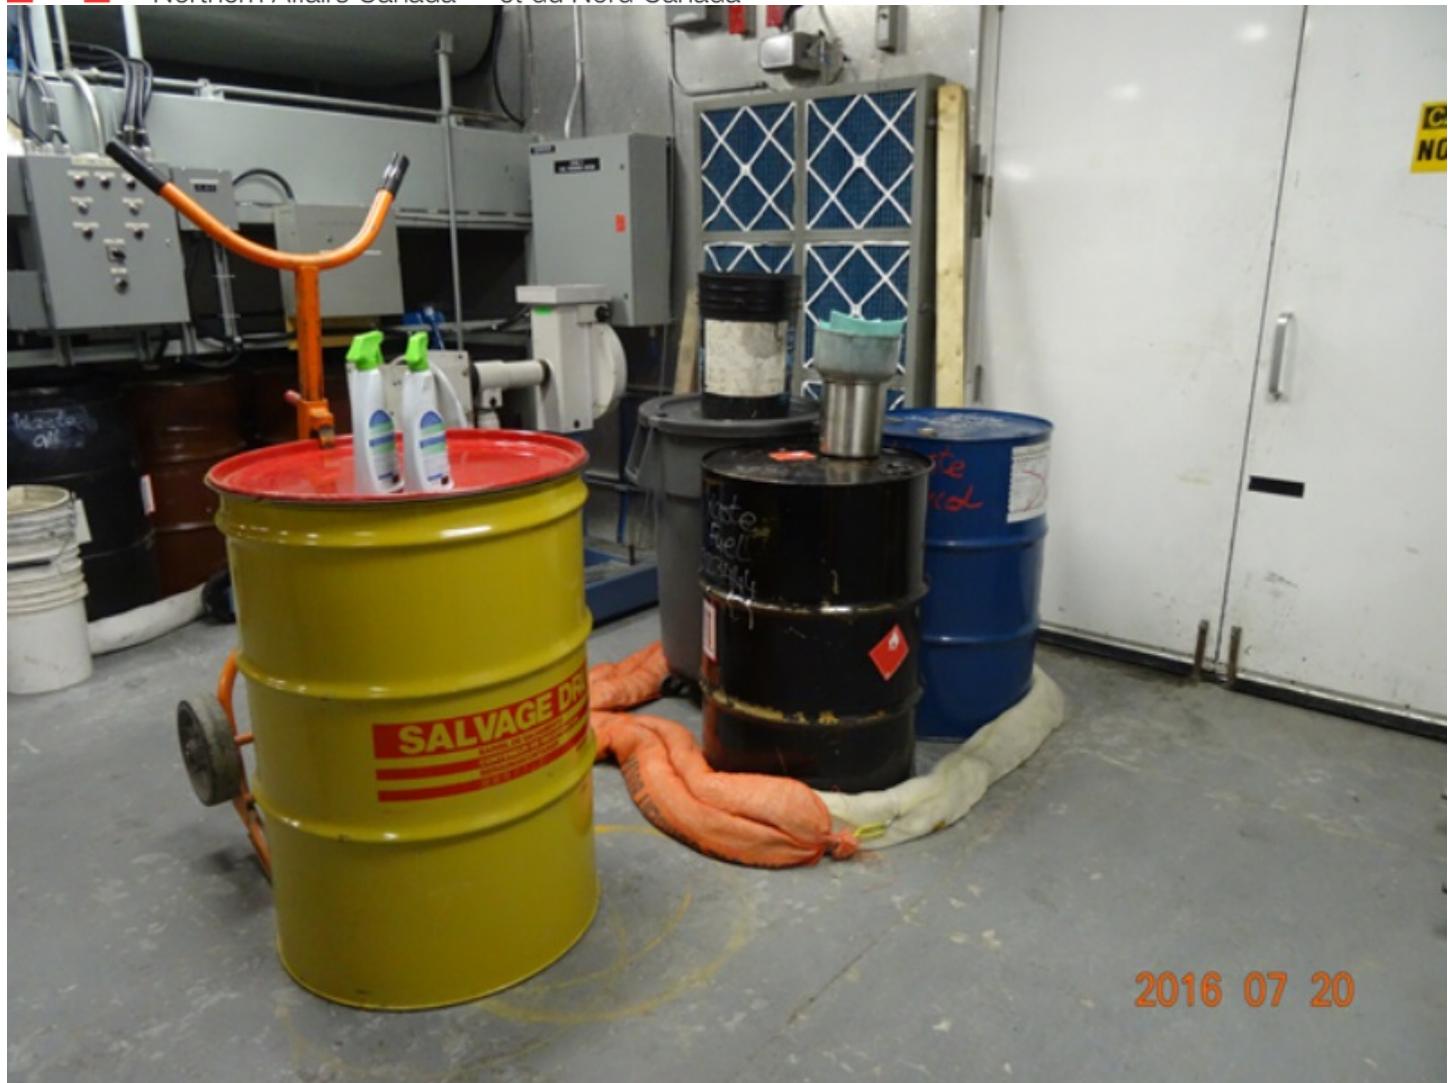
Figure 3 Chemical storage

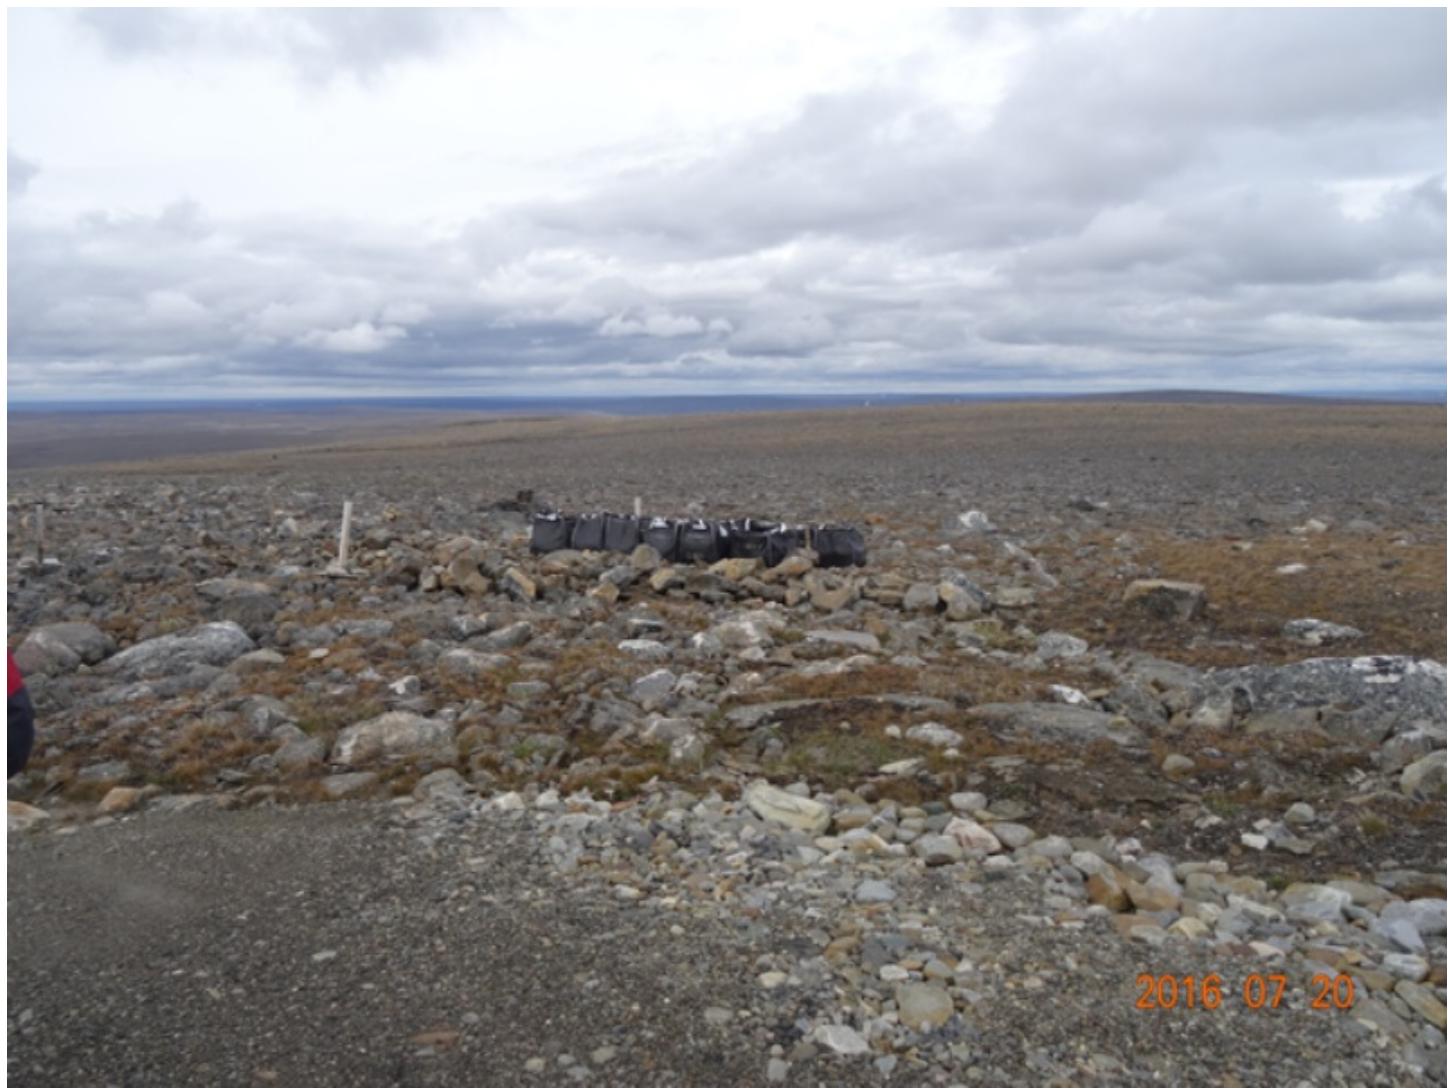
- Quatrex bags of PHC soils from the 2013-145 (helo crash) remain on site. Biogene , the contractor hired to clean up this spill did write a report outlining the remaining remedial work to be completed including the marshalling of the contaminated soils collected back following the incident.

Figure 4 Site of 2013-145 Quatex Bags of contaminated soils remain on site. Remedial work remain incomplete

The failure of the operator to remediate these sites in a reasonable amount of time is of concern to the Inspector but is now academic as that operator is no longer on site. The licensee has indicated that another contractor is being brought in to evaluate these spills and affect a cleanup including the removal of the contaminated soils. It is unclear if this work is complete at this time.

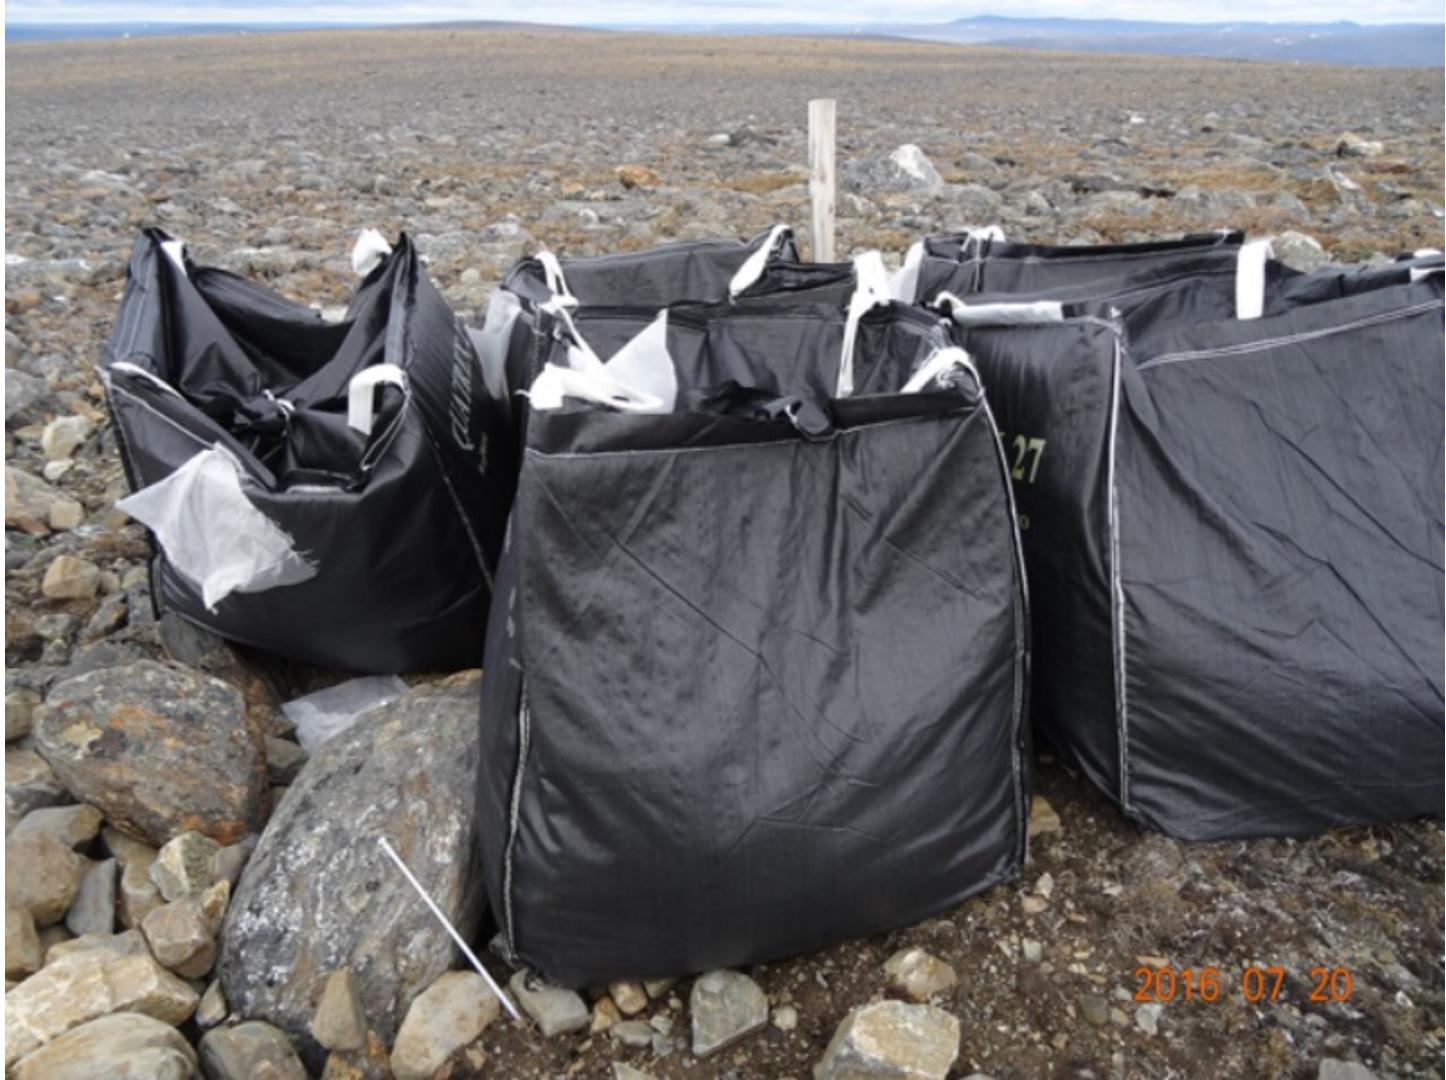
Figure 5 2013-145 - PHC soils

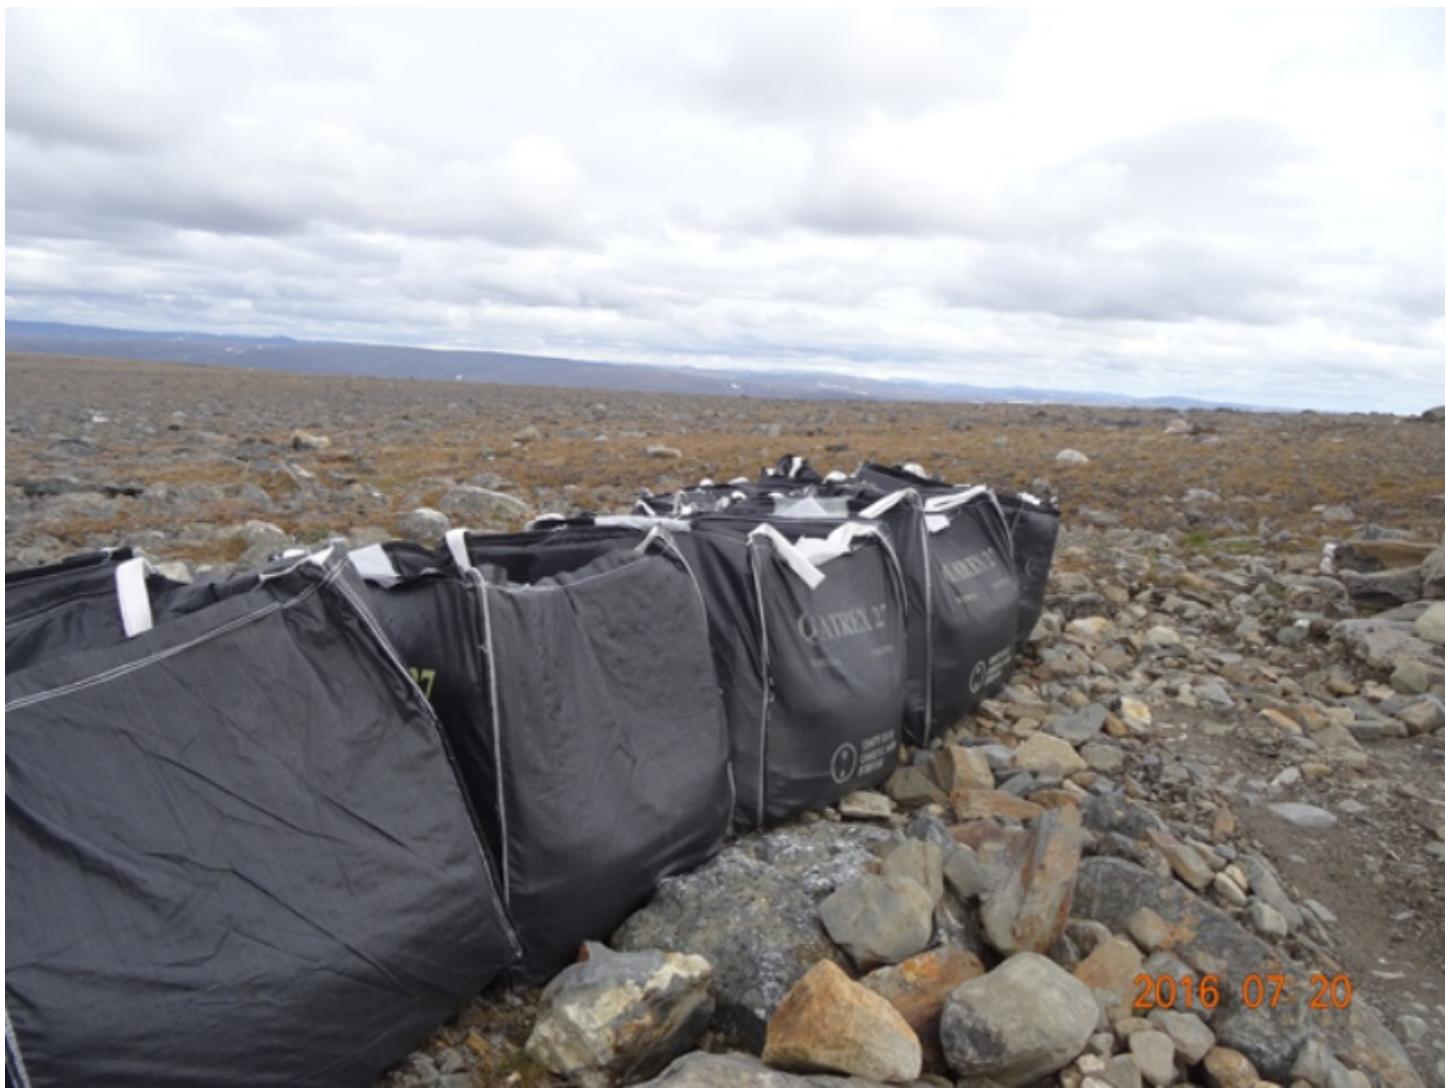
Figure 6 2013-145 - PHC soils 2

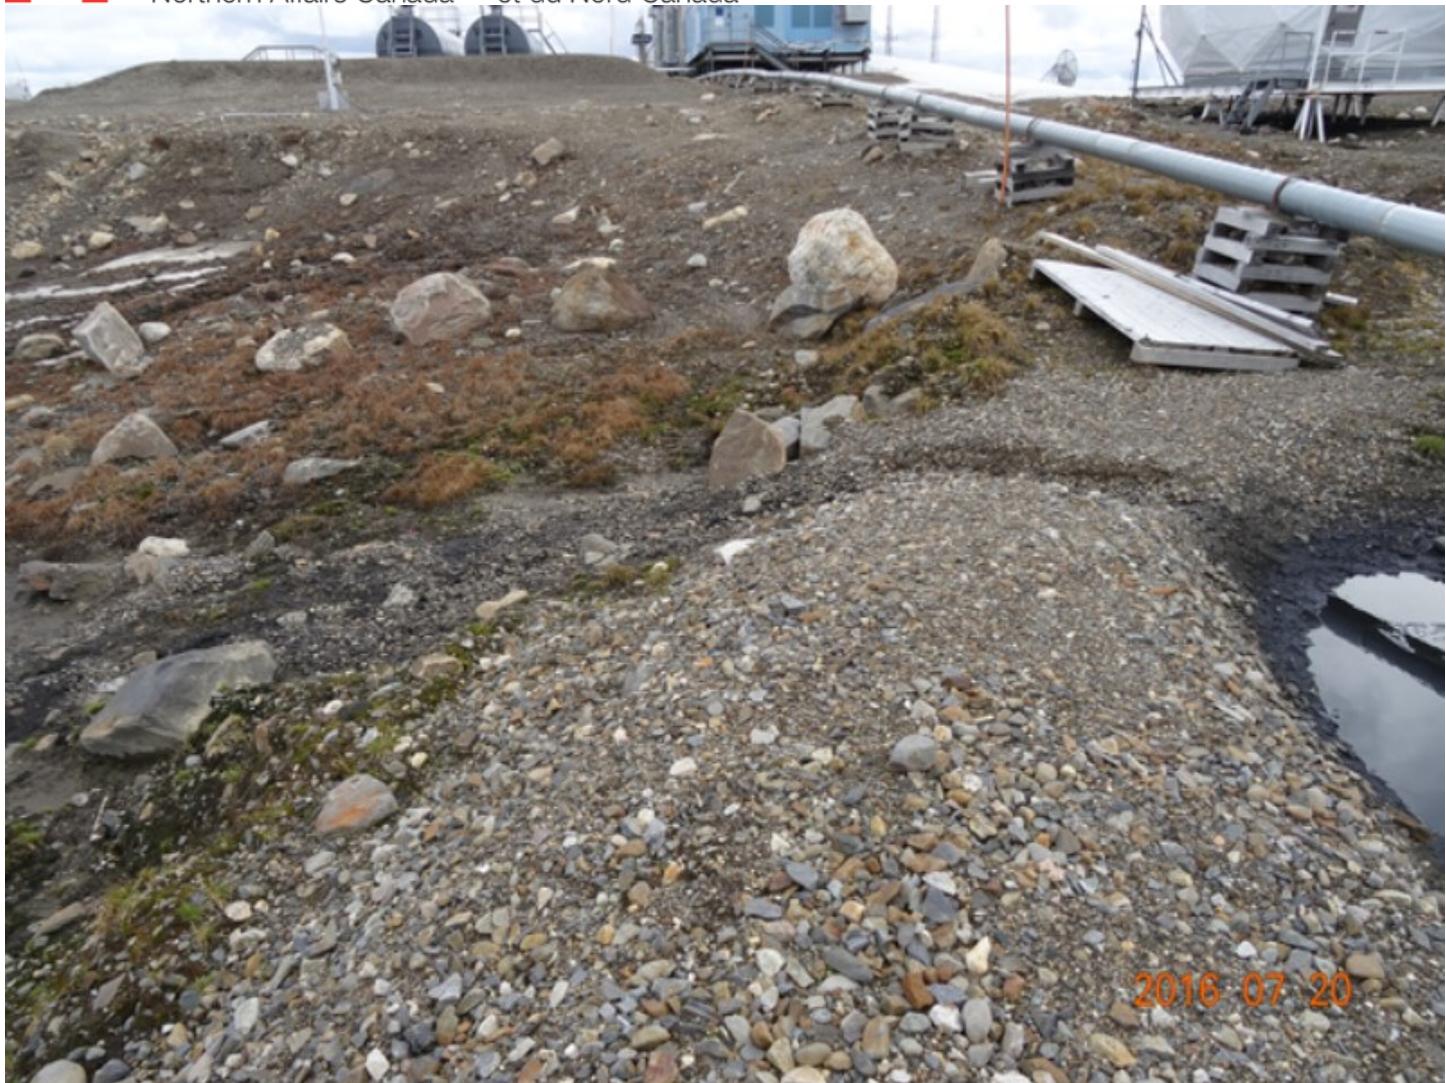
- The Effluent Lagoon is to be maintained in such a manner that it does not overtop or allow the contents of the lagoon to directly flow into the environment. The Licensee is to provide confirmation that work to maintain the lagoon walls has been completed.

Figure 7 Effluent lagoon - signs of over topping and erosion

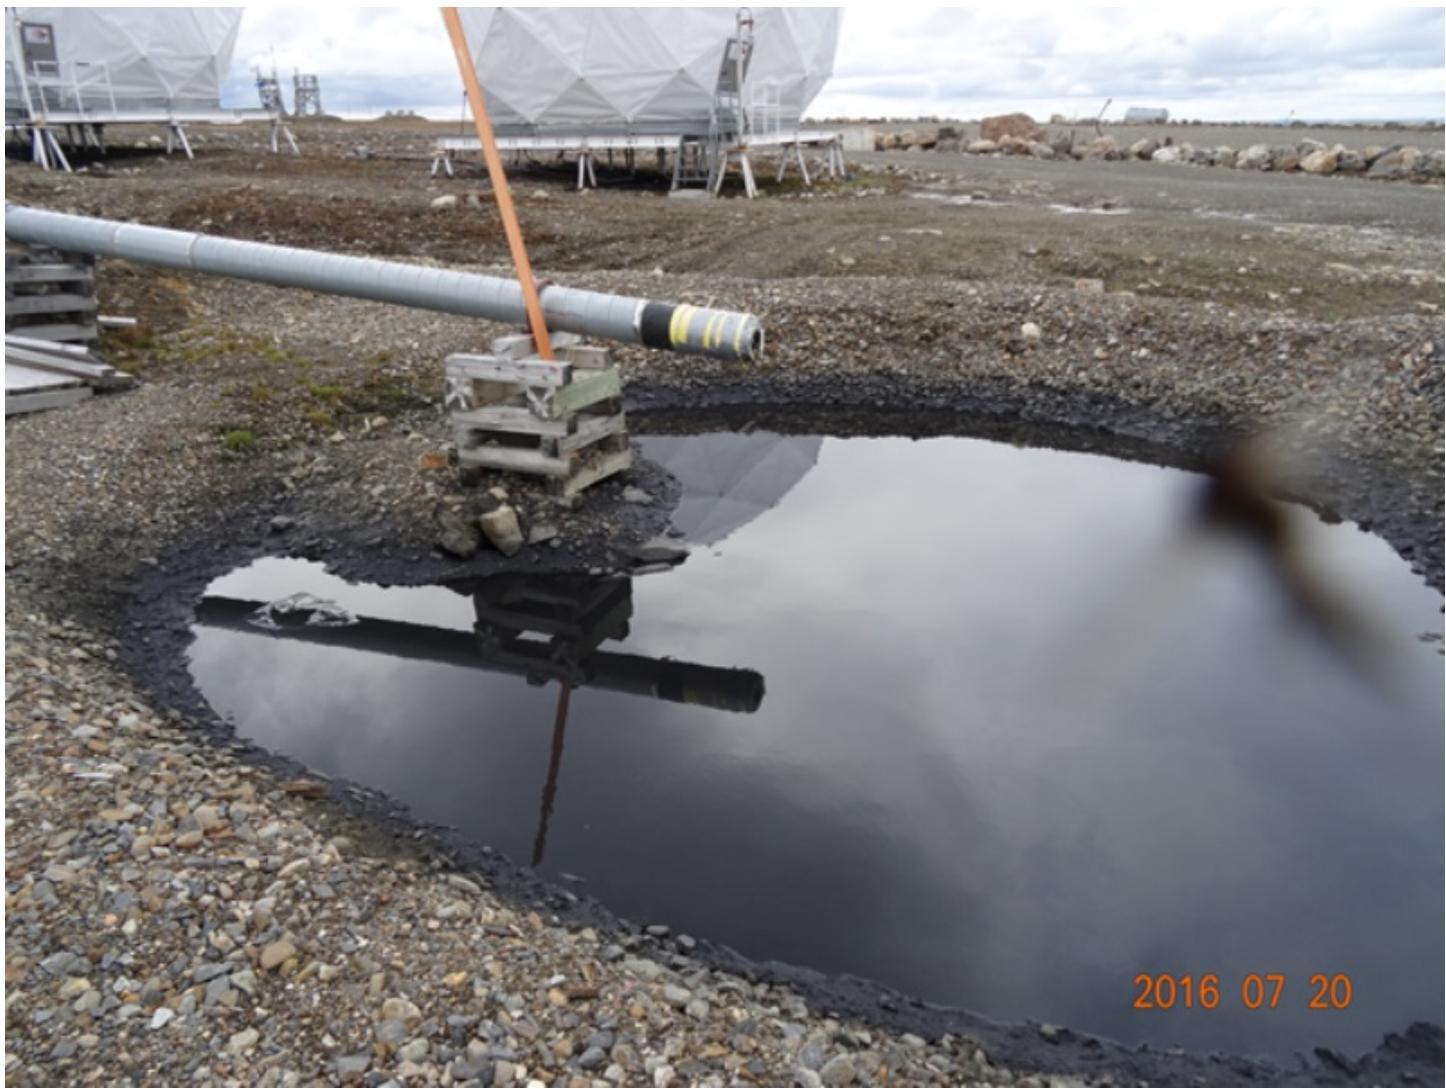
Figure 8 Effluent lagoon - very black color

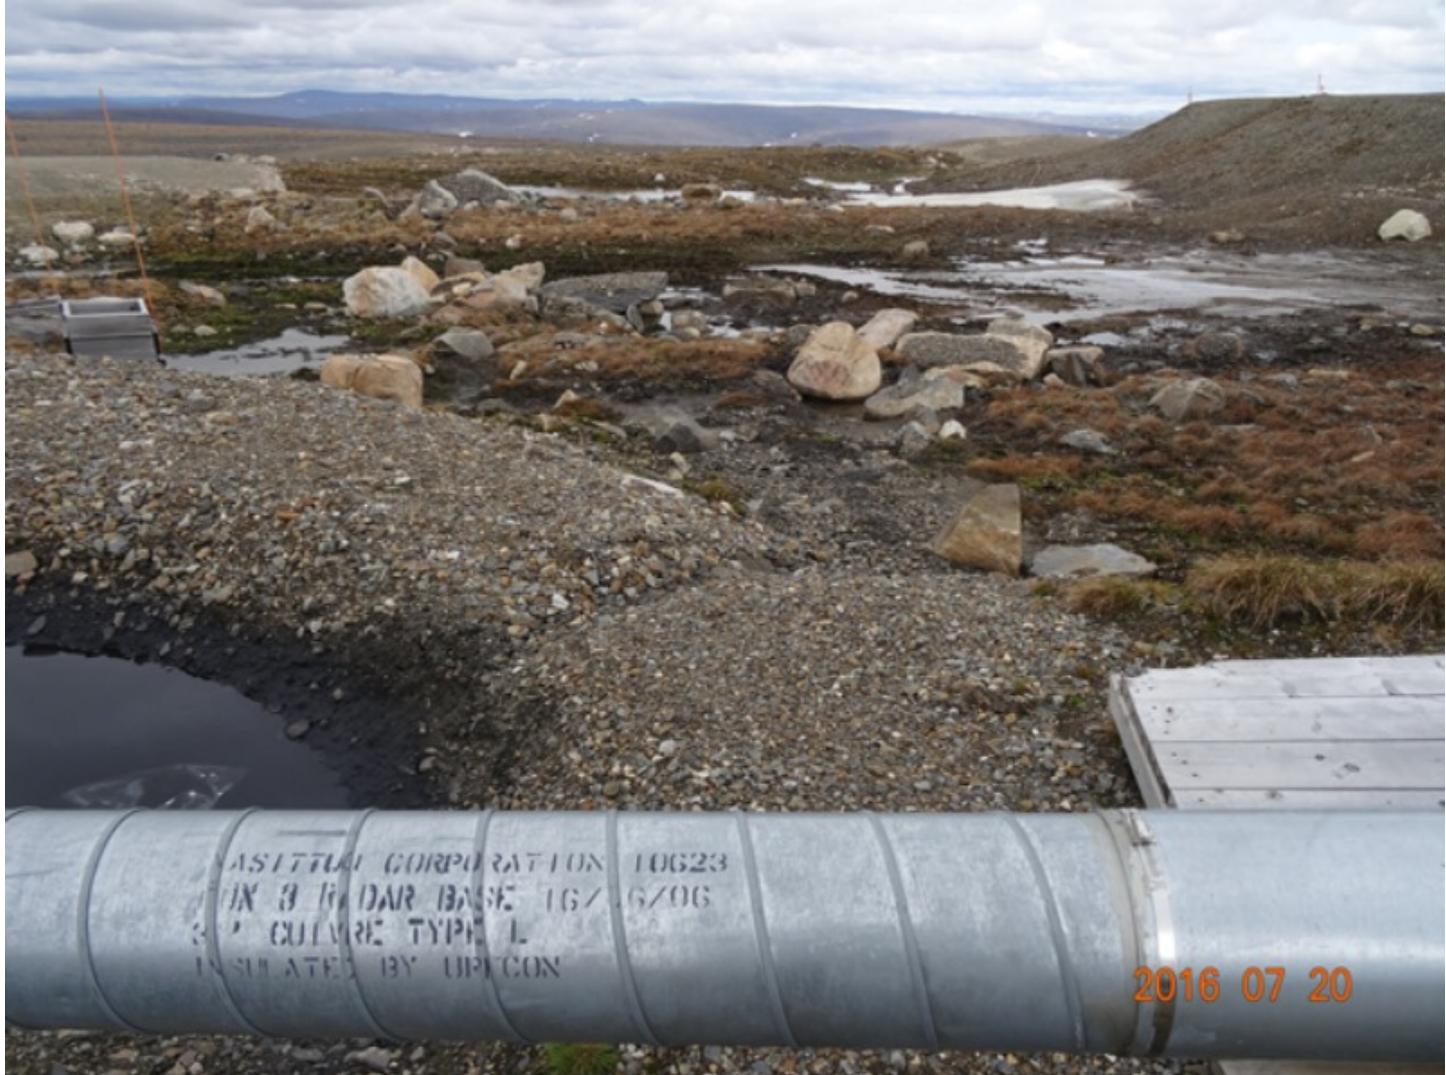
Figure 9 Effluent lagoon - over-topping

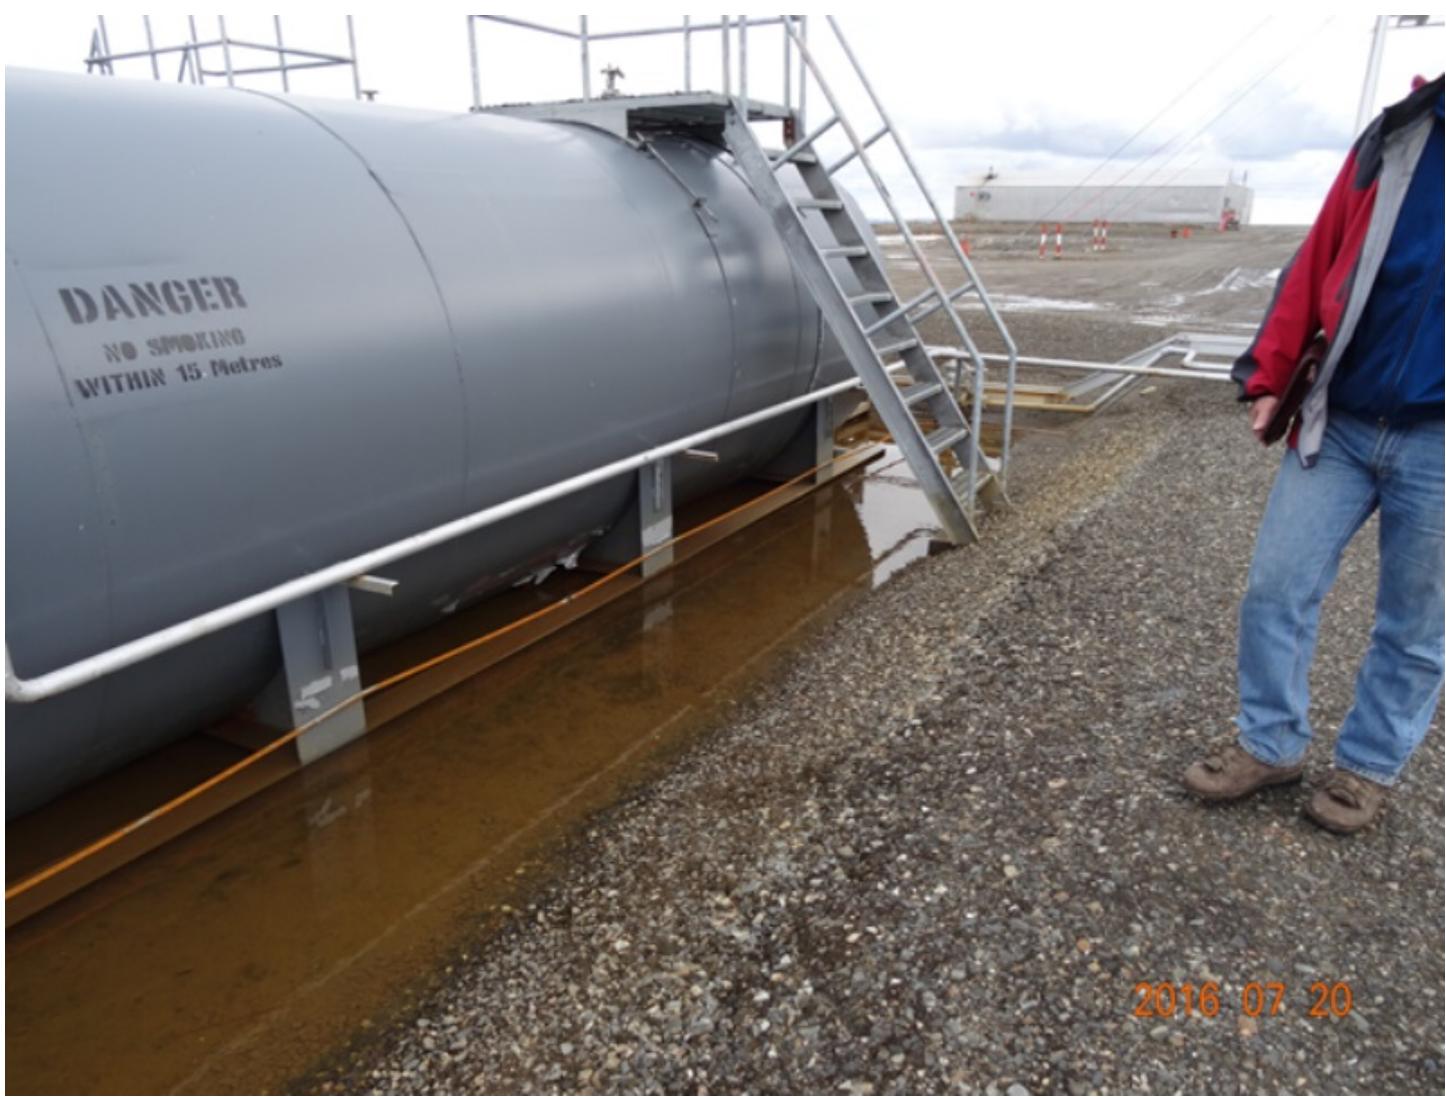
Figure 10 Summit bulk fuel storage

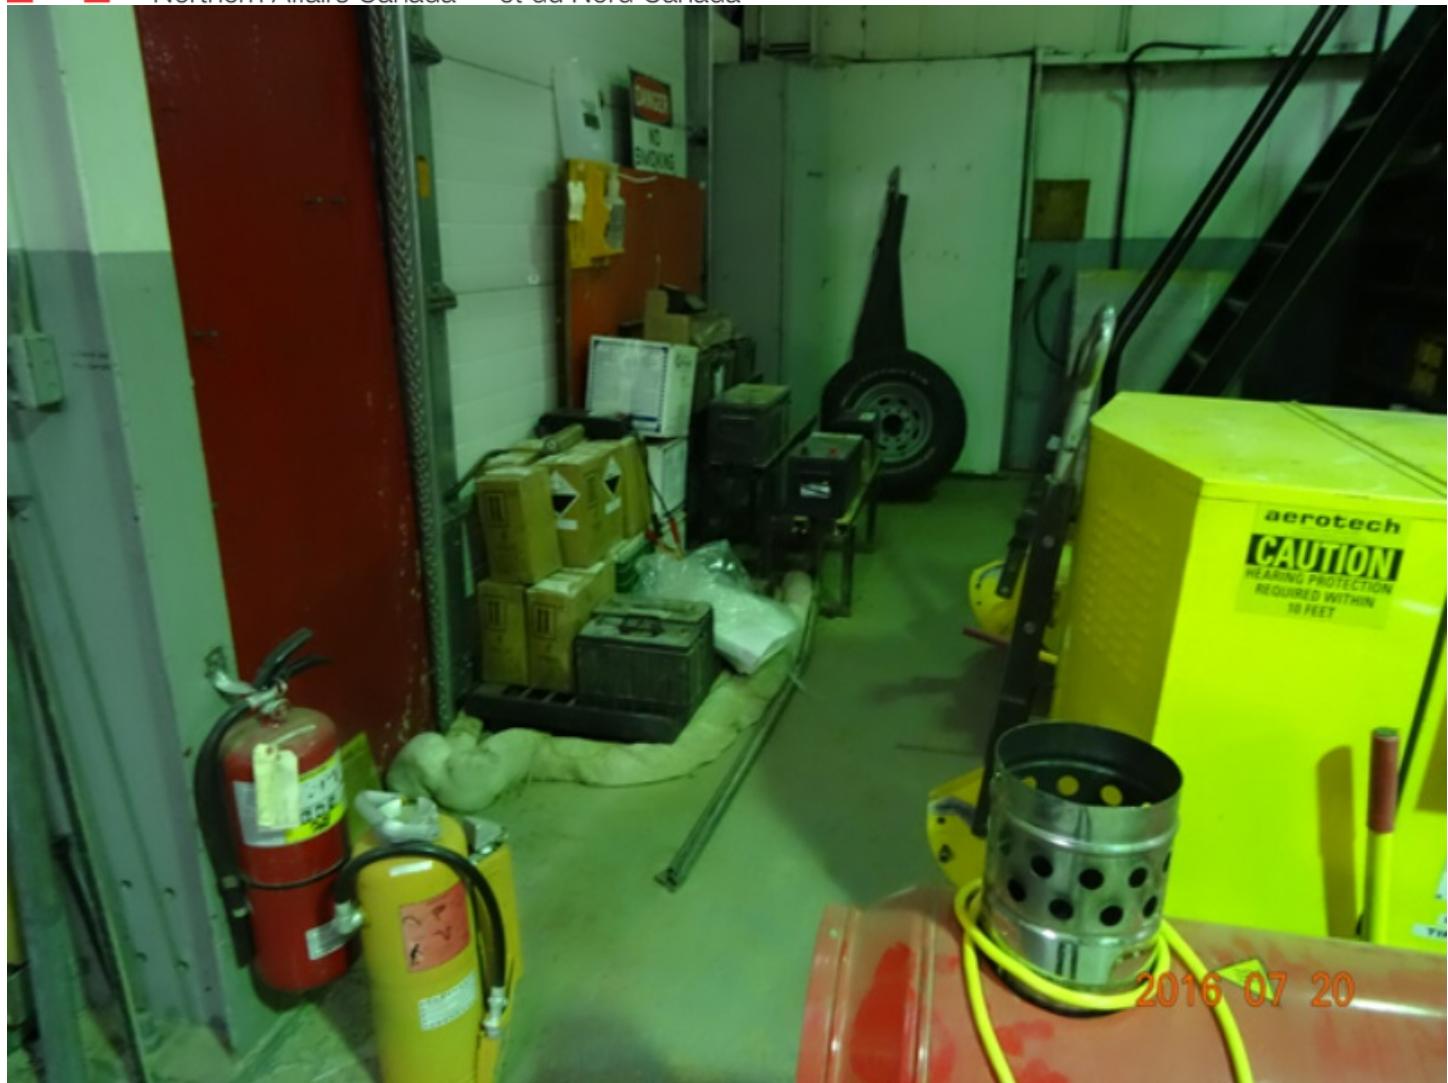
Figure 11 Garage - battery storage

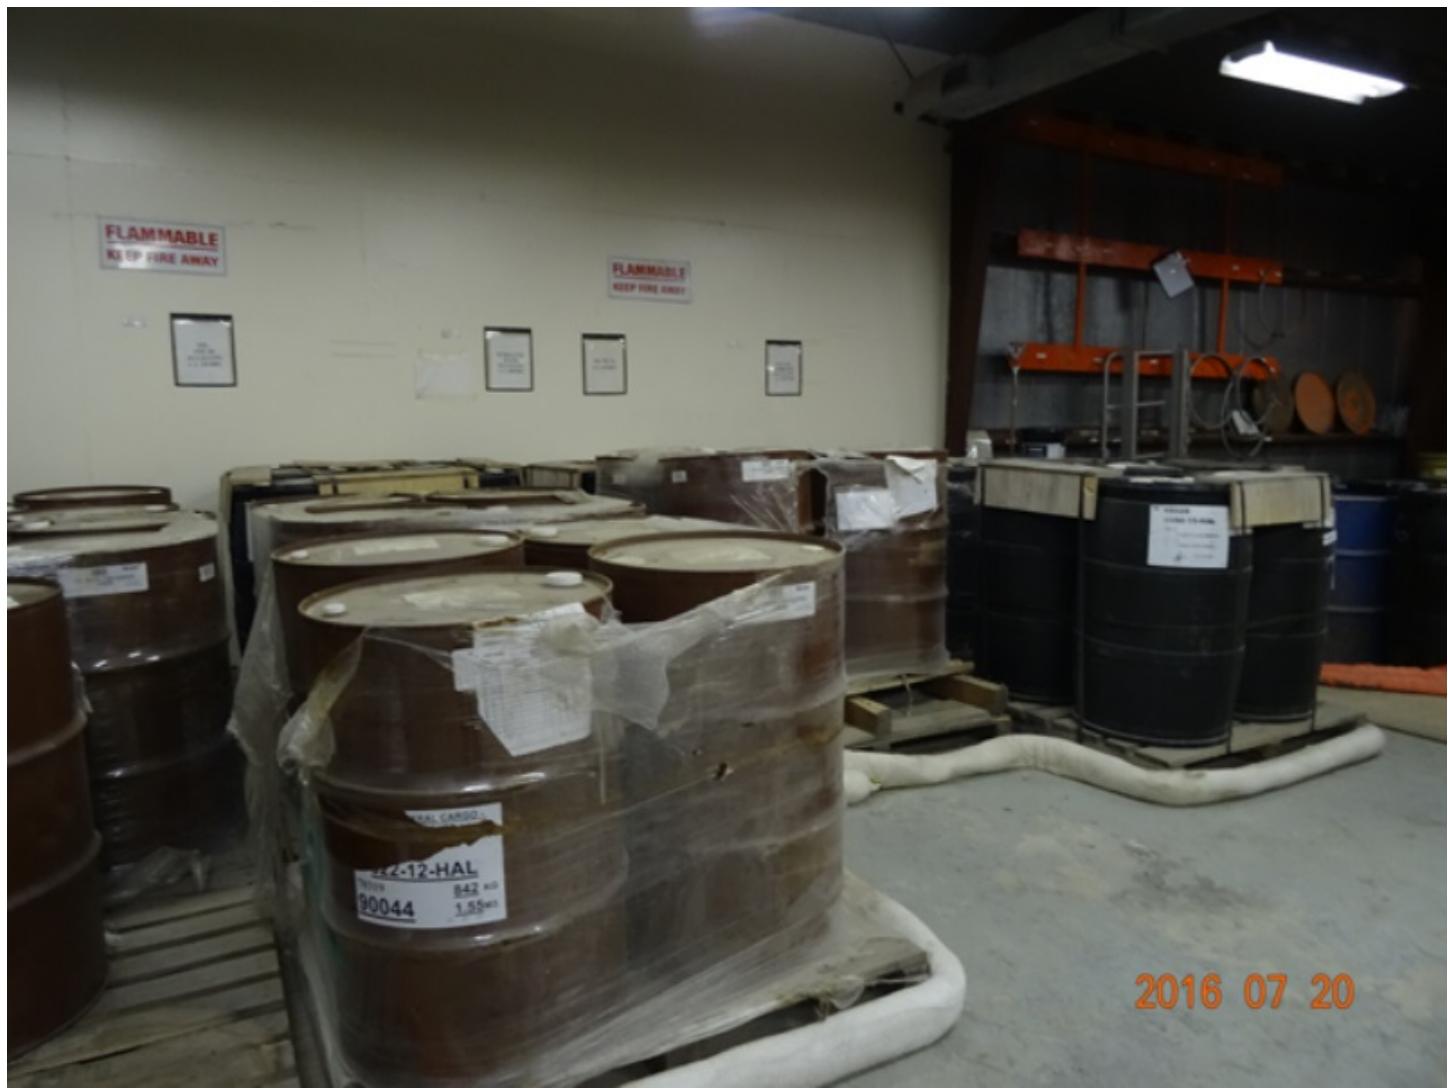
Figure 12 Hazardous waste and chemical storage area

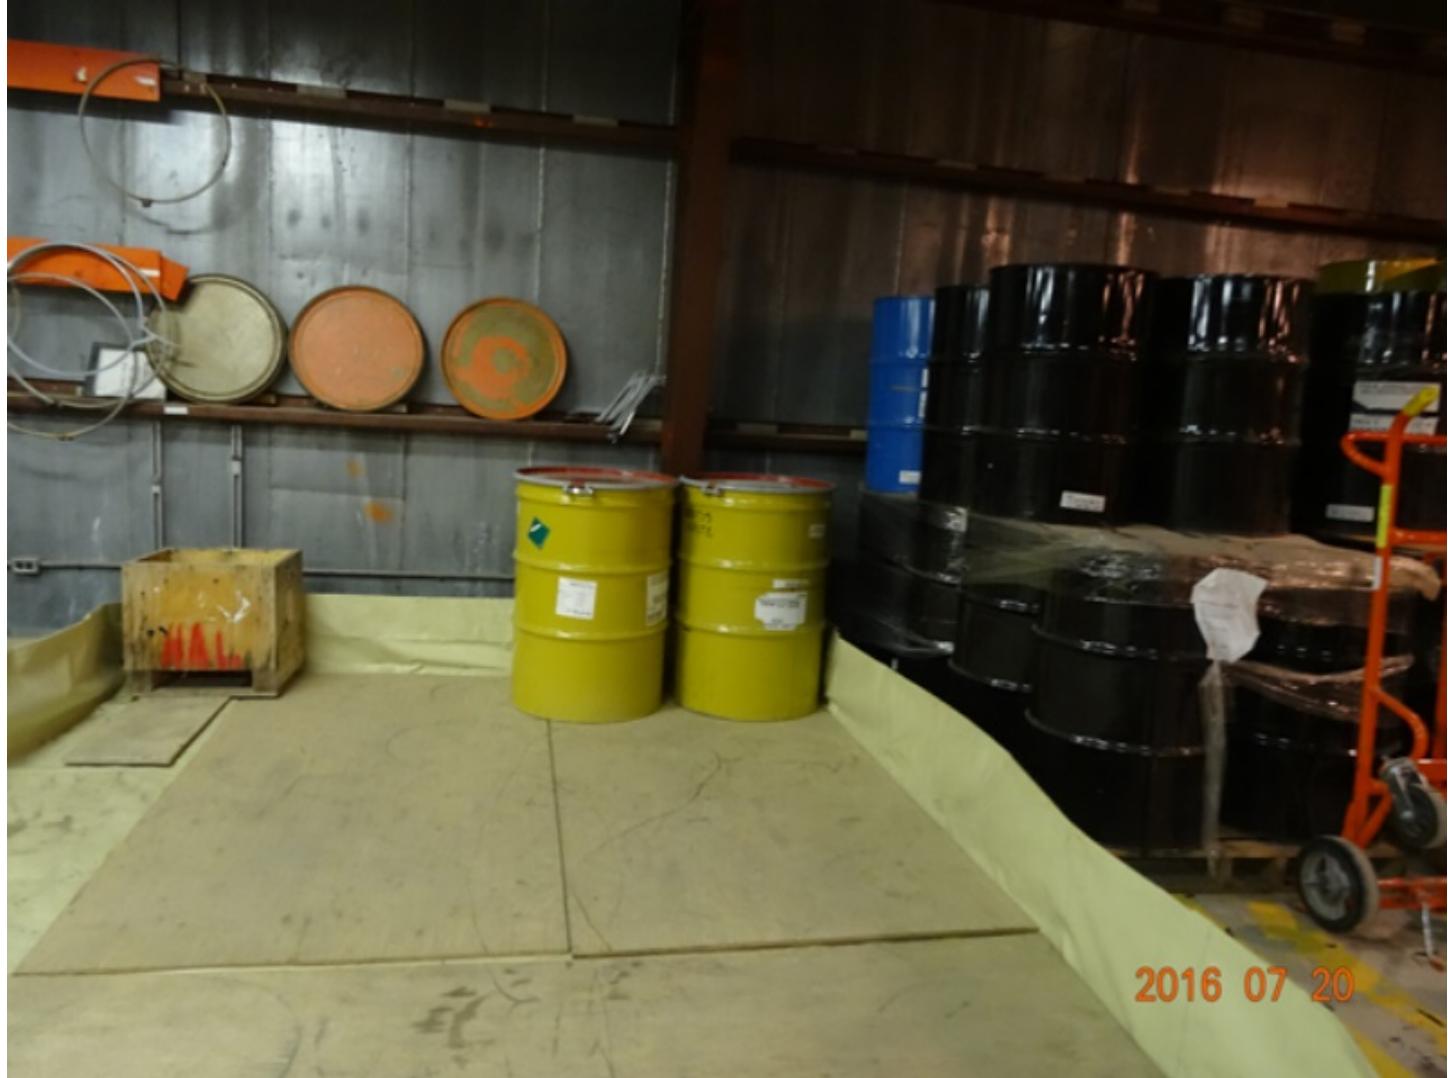
- Water use records were found on site. No issues with Water usage were identified during the Inspection
- Waste Management on site :
 - Hazardous wastes are marshaled off site to Fox main and then shipped out of the territory from there. It is unclear what Hazardous wastes originated from this site as the transfer manifests are not available for review. This is to be addressed by the period of the next Inspection.

Figure 13 Haz waste marshalling and packaging area

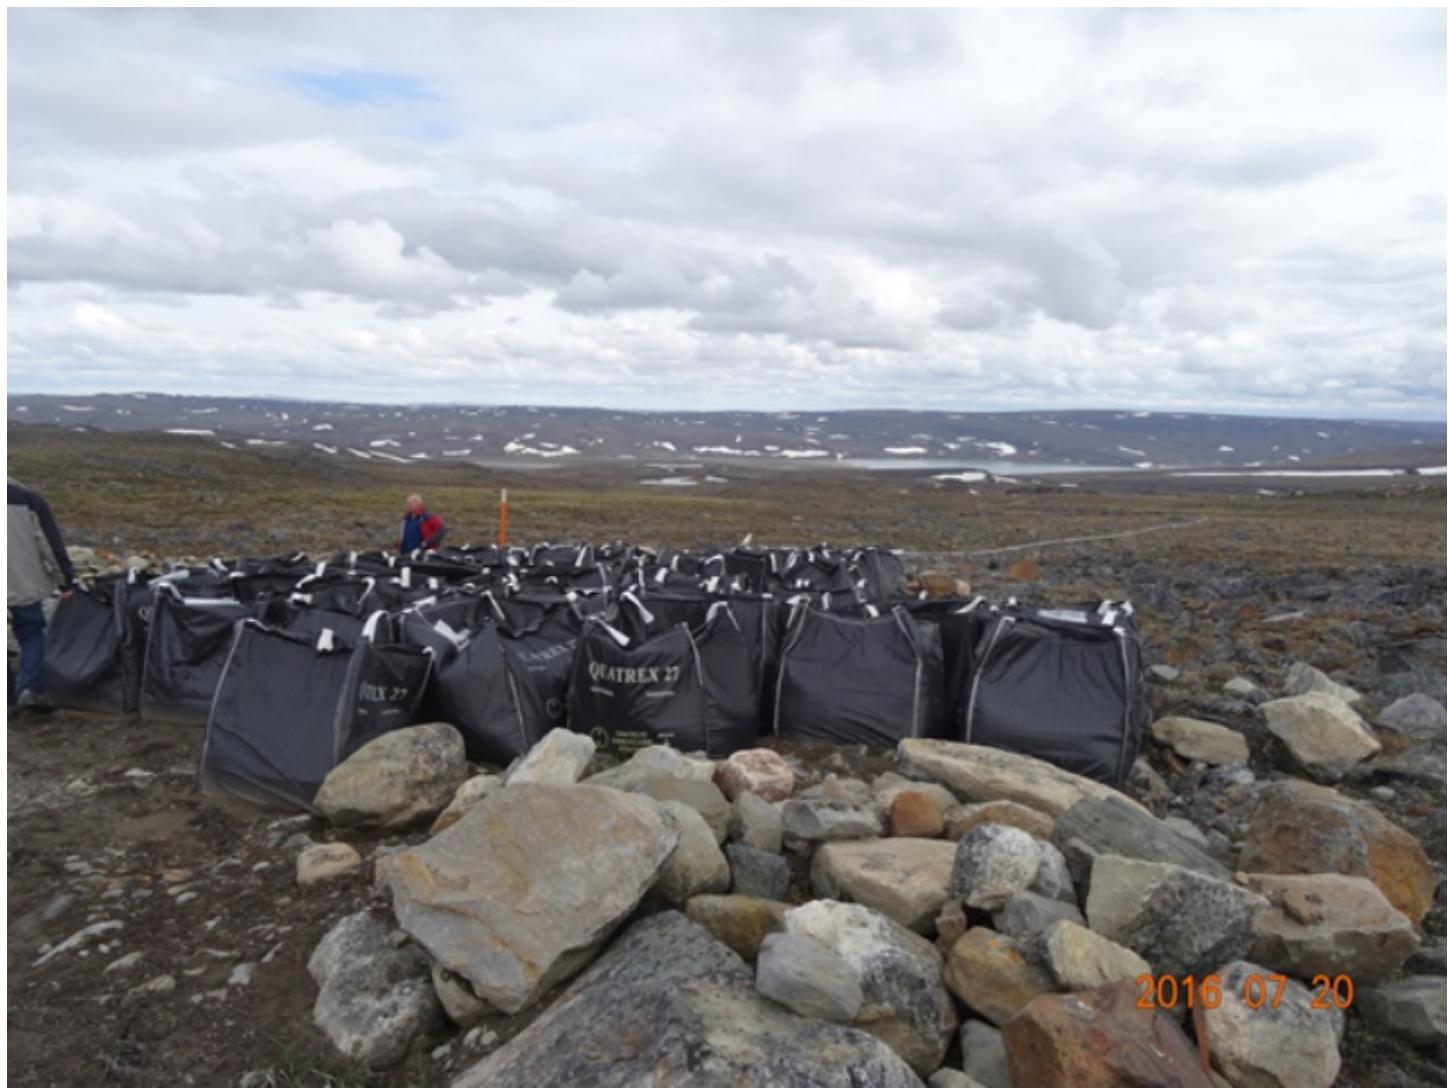
- An excavation that included the repaired pipeline, pallets to support the pipeline and approximately 30 Quatrex Bags (each about half full) of soils. It is expected that these are the PHC impacted soils removed during the remediation efforts made in 2011 and 2013 by Qikiqtani Environmental and Biogene. (It is noted that the report produced by Biogene was made available for review following the inspection. The report clearly outlines the remaining work needing to be completed although the Appendix D – Excavation logs are complete gibberish)
- The Water Supply Lake was found in good order. The licensee draws water via pump and tank as necessary.

Figure 14 2009-341 - Quatrex bags of PHC soils on pipeline
