WATER LICENCE INSPECTION FORM

Licensee Major Creighton North Warning System Office 455 Boulevard de la Carrière, Gatineau, Quebec, J8Y 6W6		Licensee Representative Scott Charland – NWS A/Environmental officer - NWS Don Beattie – Raytheon Manager, Environmental, Health and Safety- Raytheon Canada	
Licence No. / Expiry 3BC-FOD0919		Representative's Title Acting Environmental Officer	
Land / Other Authorizations Nil		Land / Other Authorizations Nil	
Date of Inspection July 20, 2016		Inspector A.Keim	
Activities Inspected <input checked="" type="checkbox"/> Camp <input type="checkbox"/> Roads/Hauling		<input type="checkbox"/> Drilling <input type="checkbox"/> Mining <input type="checkbox"/> Construction <input type="checkbox"/> Reclamation <input checked="" type="checkbox"/> Fuel Storage <input type="checkbox"/> Other: Water Discharge <input type="checkbox"/> Other: Municipal

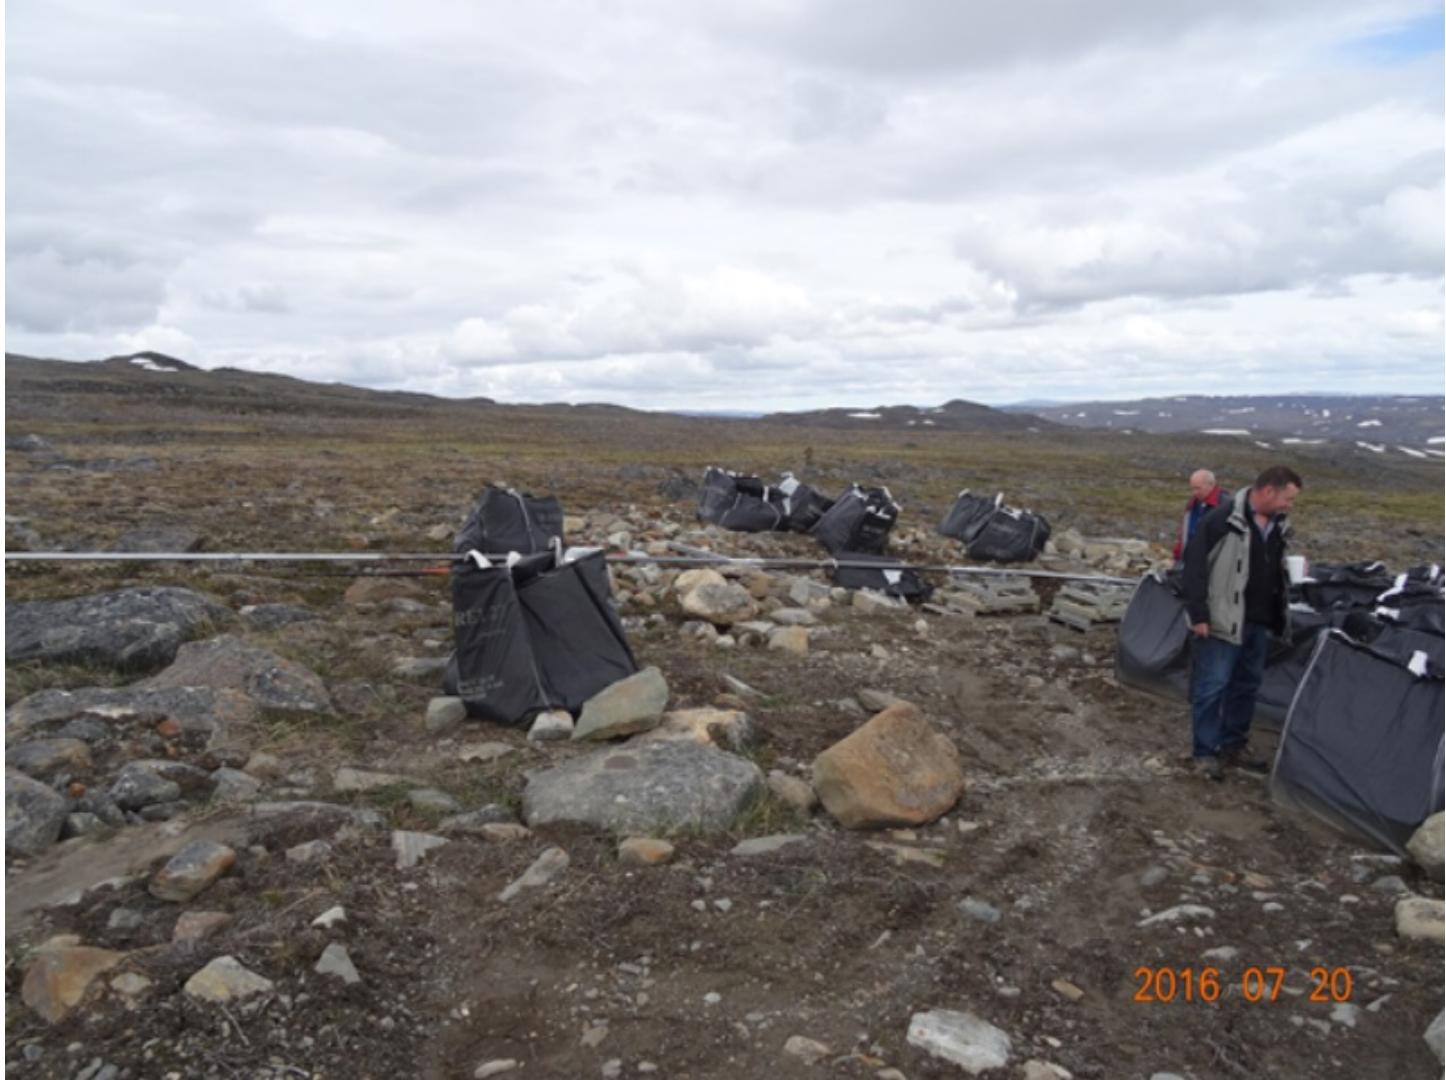
Figure 15 2009-341 - Clean up and remedial efforts on-going

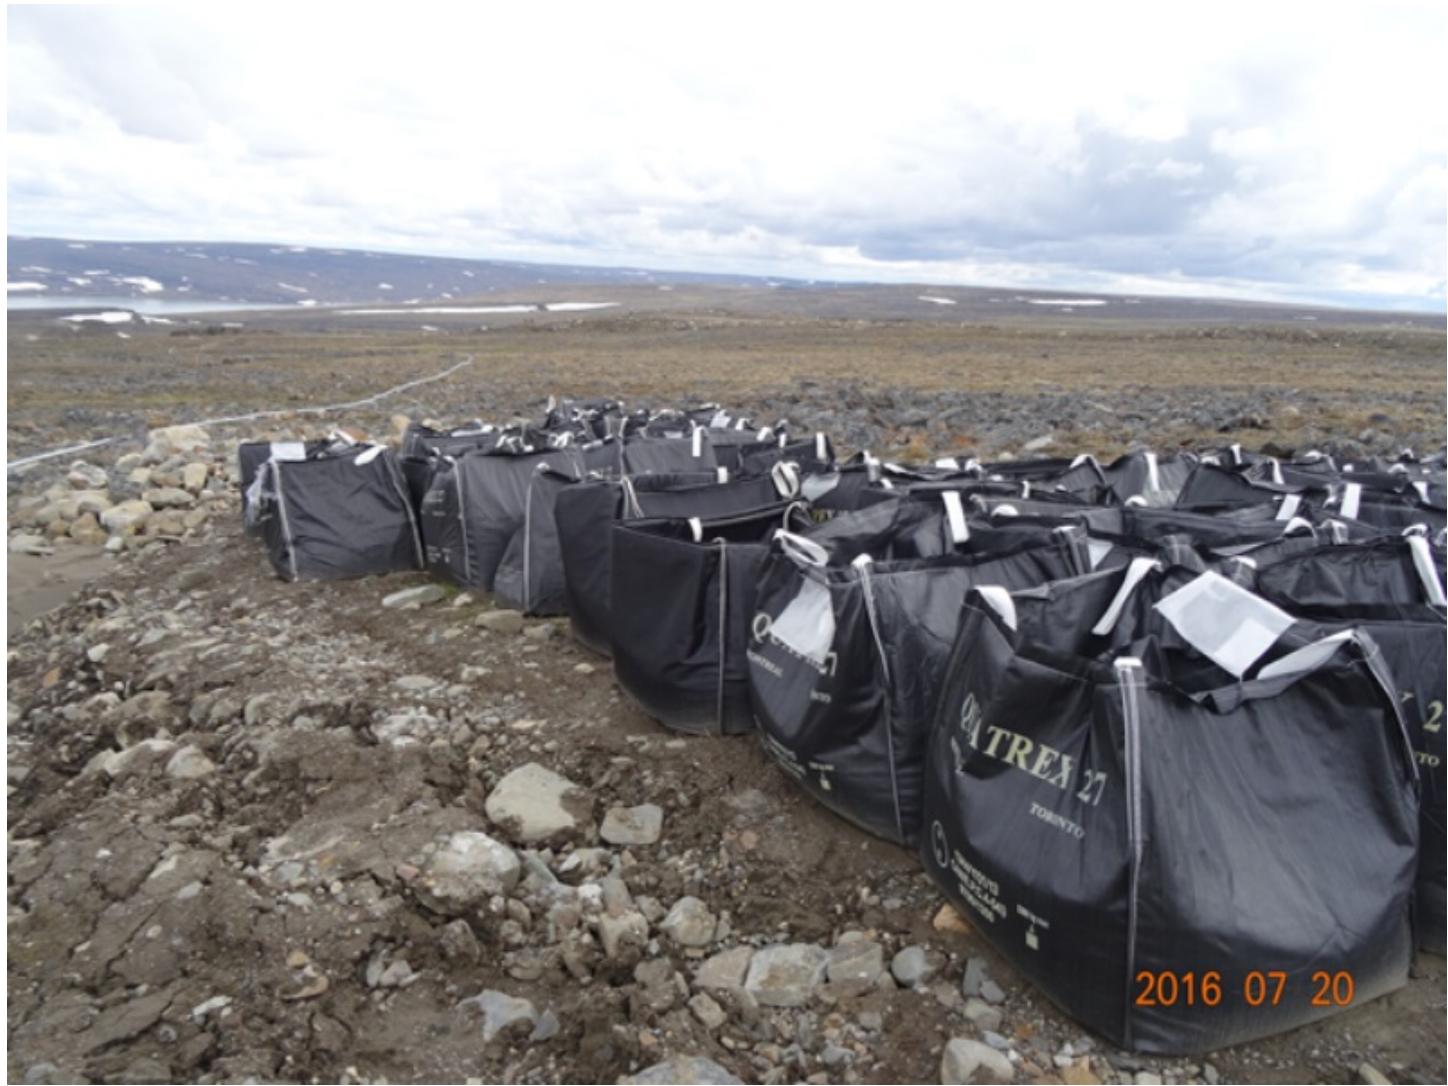
Figure 18 2009-341 Bags of PHC soils (2)
