WATER LICENCE INSPECTION FORM

| 3BC-FOH0919 | Environmental Officer |
| July 11, 2018 | Joseph Monteith & Jonathan Mesher |

| <p>On July 11, 2018 A water licence inspection was conducted on was conducted at 3BC-FOH0919, also known as the North Warning Site (NWS) FOX-M in Hall Beach, Qikiqtani Region, Nunavut.</p> | | | |

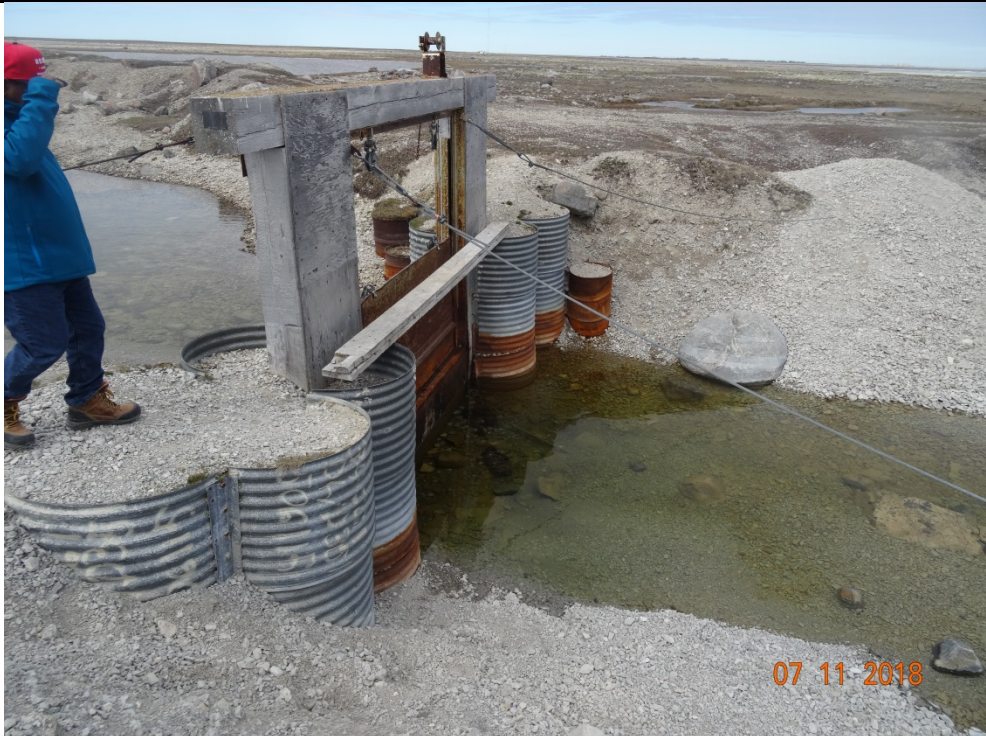
| Date | Camera | Inspector |
|---|---|---|
| Photo 1 | Hall Beach -<br>North Warning<br>Site FOX-M | |

| <p>2. Water withdrawal is conducted from South Lake (photo 1) to the Water Storage Reservoir. The Water from South Lake is recharged by opening up a gate on a dyke which is also a man-made reservoir. The lined Storage Reservoir has a capacity of 60,000m³ (See photo 2).</p> | | | |

| Date | Camera | Inspector |
|---|---|---|
| Description: South Lake in the background, with the pump house in the mid ground, and piping in the foreground | | |

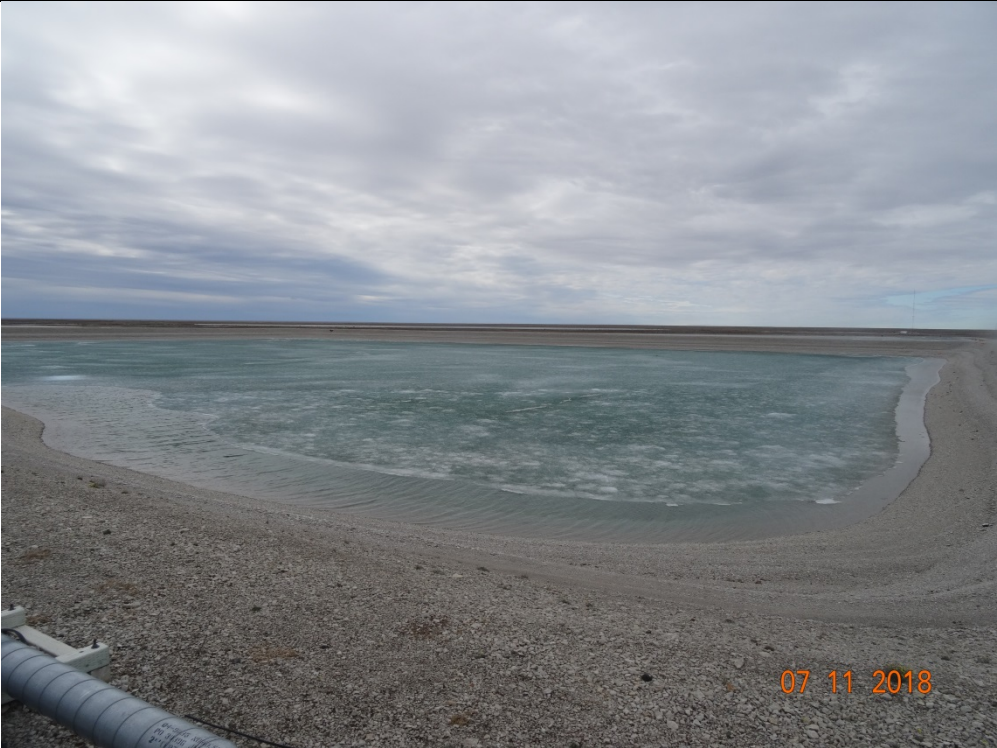
| Photo Log # | Location |
|---|---|
| Photo 2 | FOX-M |

| Photo Log # | Location |
|---|---|
| Description: Pump house recharges Trucks with the fresh water from South Lake. | |

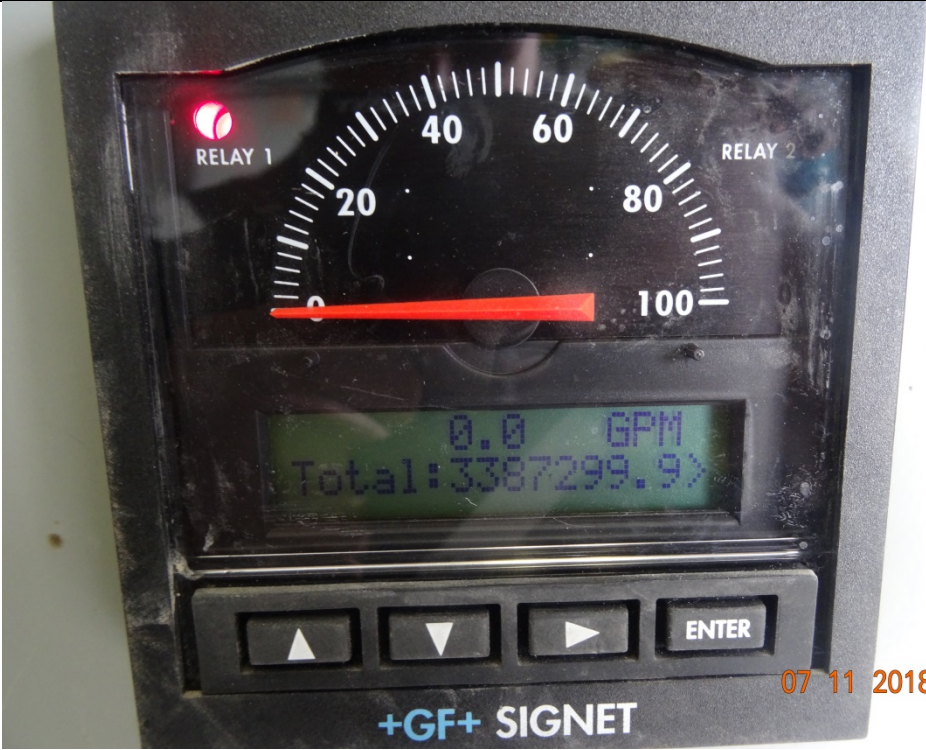
Photo 3

| <p>3. The pump house was operating at the time of the inspection. Logs showed that both trucked and pump house meter were used to calculate water usage at the time of the inspection (see photo 3).</p> | | | |

Description: Water meter reads 3387299.9

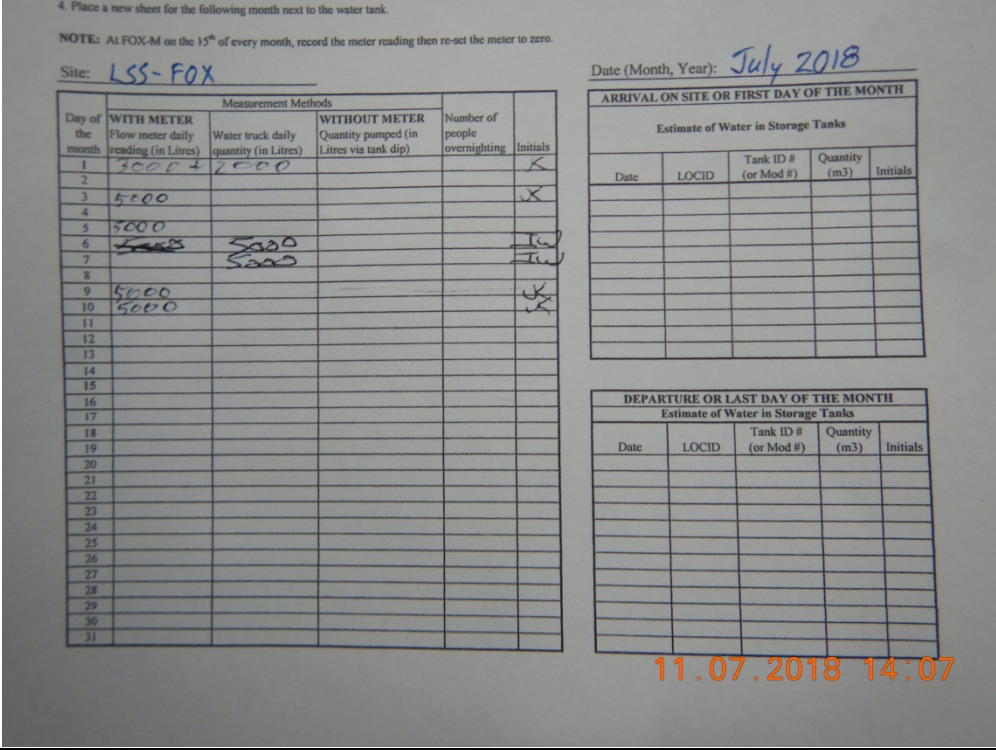
Photo 4

| <p>4. During the inspection their logs showed total of 35,000 litres withdrawn from both trucked service, and through the pump house water meter (see photo 4).</p> | | | |

Description: July water usage log – 35,000 Litres withdrawn in July. 12,000 Litres of trucked withdraw, and 23,000 litres withdrawn from the pump house.

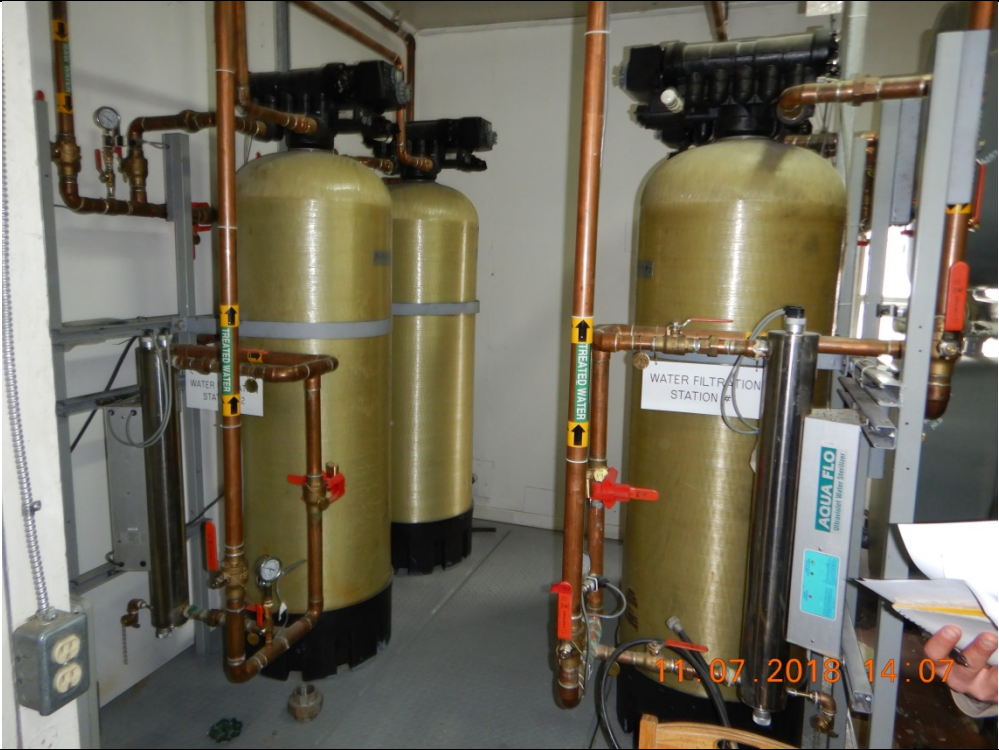
Photo 5

5. Fox-M treats water through granular carbon filter, a multimedia filter and two UV filter lamps (see photo 5).

Description: 4 x water filters, 2 x Aqua Flo Ultra Violet Lamps

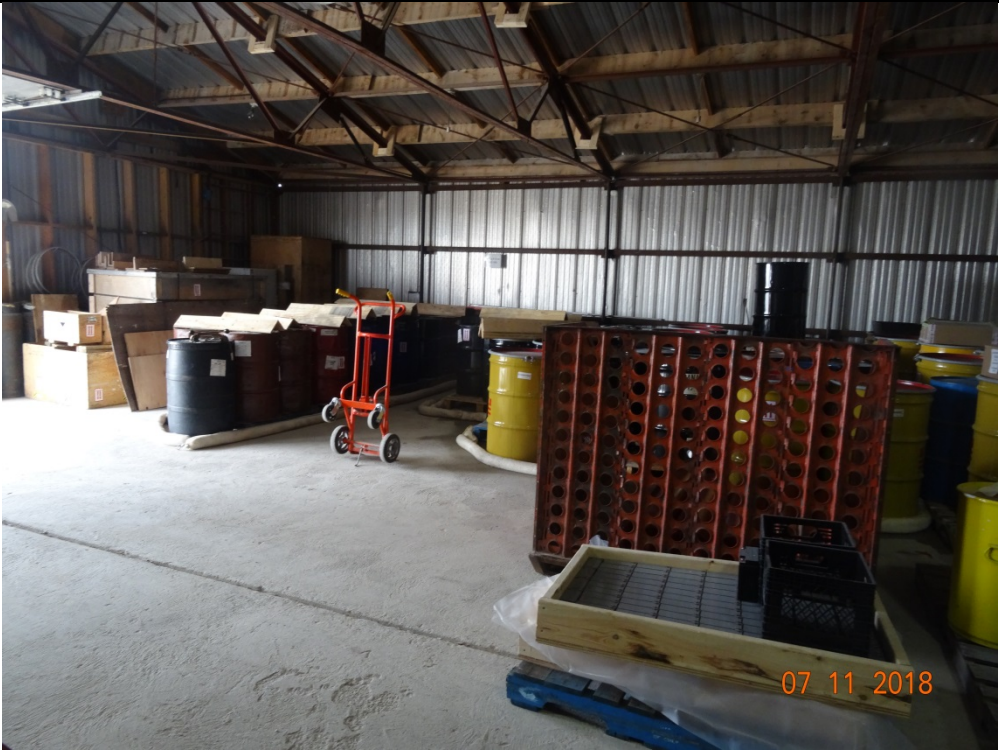
Photo 6

6. Solid waste is disposed of at the Hamlet of Hall Beach’s Land Fill.
7. Hazardous Waste is disposed of by palleting the waste, store them in a warehouse to backhaul them to an approved hazardous waste Disposal Facility (see photo 6).
8. Copies of Hazardous Waste Manifest observed on site(See photo 7 )

Description: Hazardous Waste, in drums awaiting to be palletted and shipped out to an approved waste disposal site.

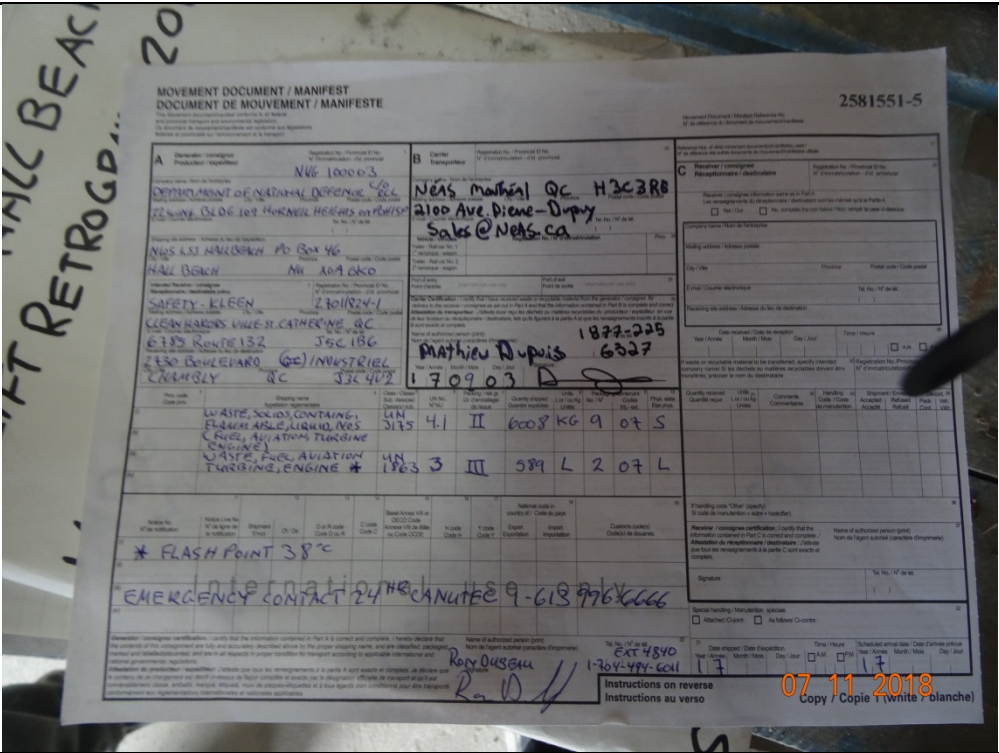
Photo 7

Description: Movement Document/ Manifest – Hazardous Waste Manifest

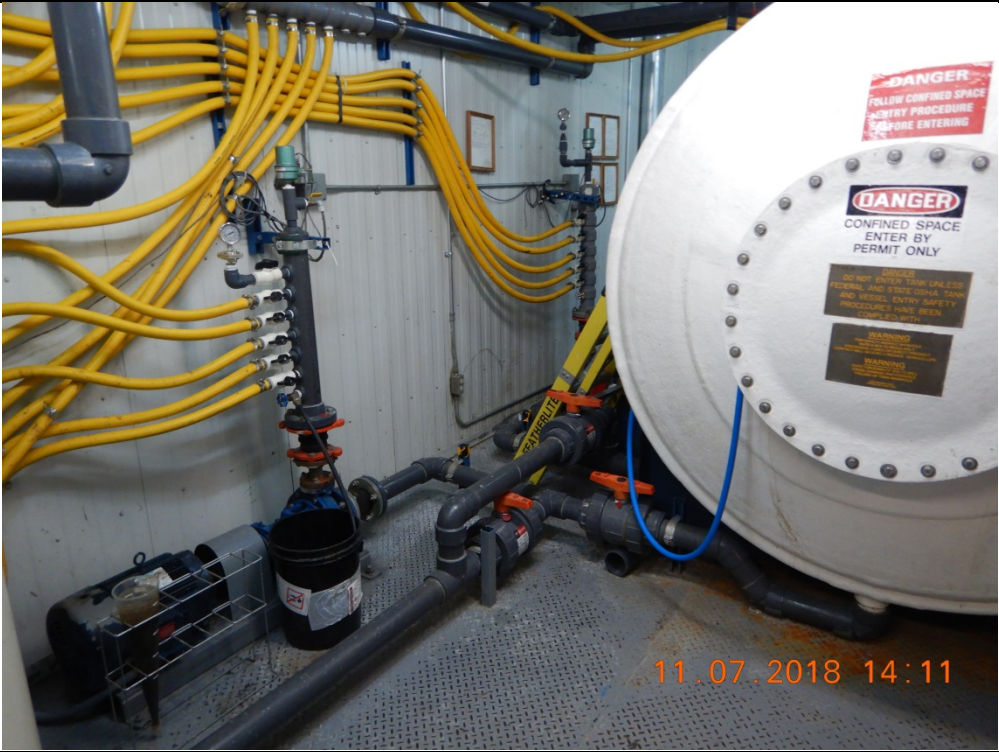
Photo 8

9. Sewage Waste is treated on site using a bio-reactor, sodium hydroxide injection system, membranes, and processing pumps, and activated carbon absorbers to remove color. This is all to recycle water for use in toilets and urinals (see photo 8 & 9).
10. After the waste water is treated it is used as toilet water. The excess treated water due to the input of showers, kitchens, wash basins, toilets and urinals, is discharged to the receiving environment (see photo 10).

Description: Bio Reactor

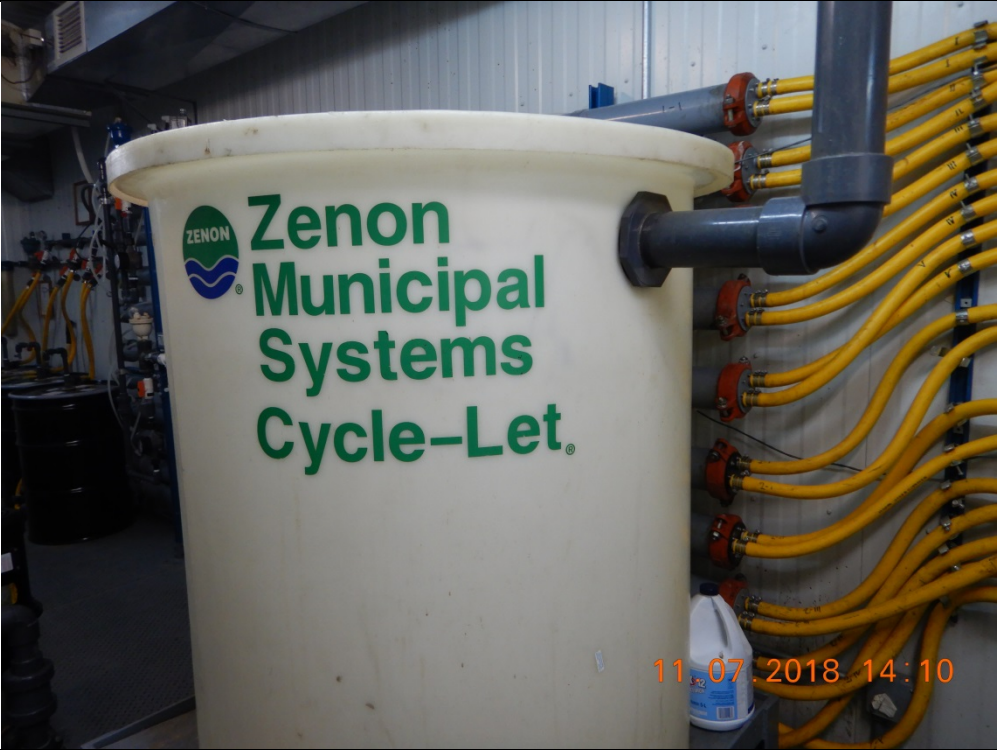
| Photo Log # | Location |
|---|---|
| Photo 9 | FOX-M |

| Photo Log # | Location |
|---|---|
| Description: Cycle-Let Sump contain for excess treated waste water | |

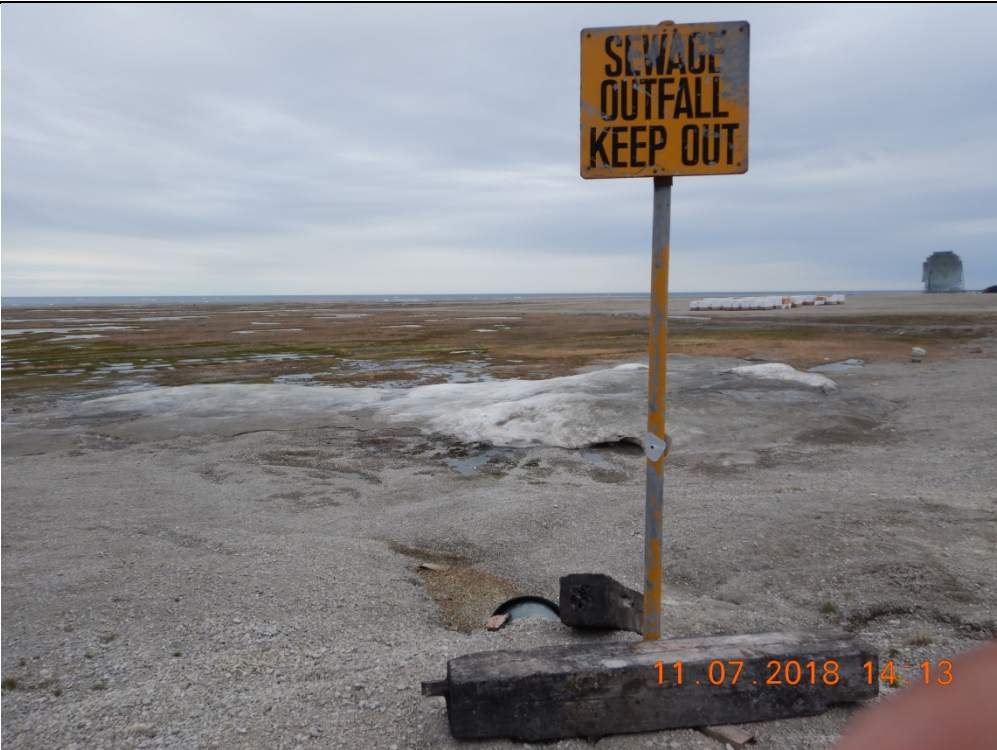
| Photo Log # | Location |
|---|---|
| Photo 10 | FOX-M |

| Photo Log # | Location |
|---|---|
| Description: Discharge point of treated waste water excess | |
