## WATER LICENCE INSPECTION FORM

Licensee DND-Raytheon	Licensee Representative Vincent Millaire
License No. / Expiry 3BC-SHE0919	Representative's Title Environmental Officer
Land / Other Authorizations 2 associated Spill Files #16-226 & #17-234	Land / Other Authorizations
Date of Inspection July 6, 2017	Inspector Baba Pedersen
Activities Inspected	
<input type="checkbox"/> Camp <input type="checkbox"/> Drilling <input type="checkbox"/> Mining <input type="checkbox"/> Construction <input checked="" type="checkbox"/> Reclamation <input checked="" type="checkbox"/> Fuel Storage <input type="checkbox"/> Roads/Hauling <input checked="" type="checkbox"/> Other: Fuel Spills <input type="checkbox"/> Other: Operational NWS Site

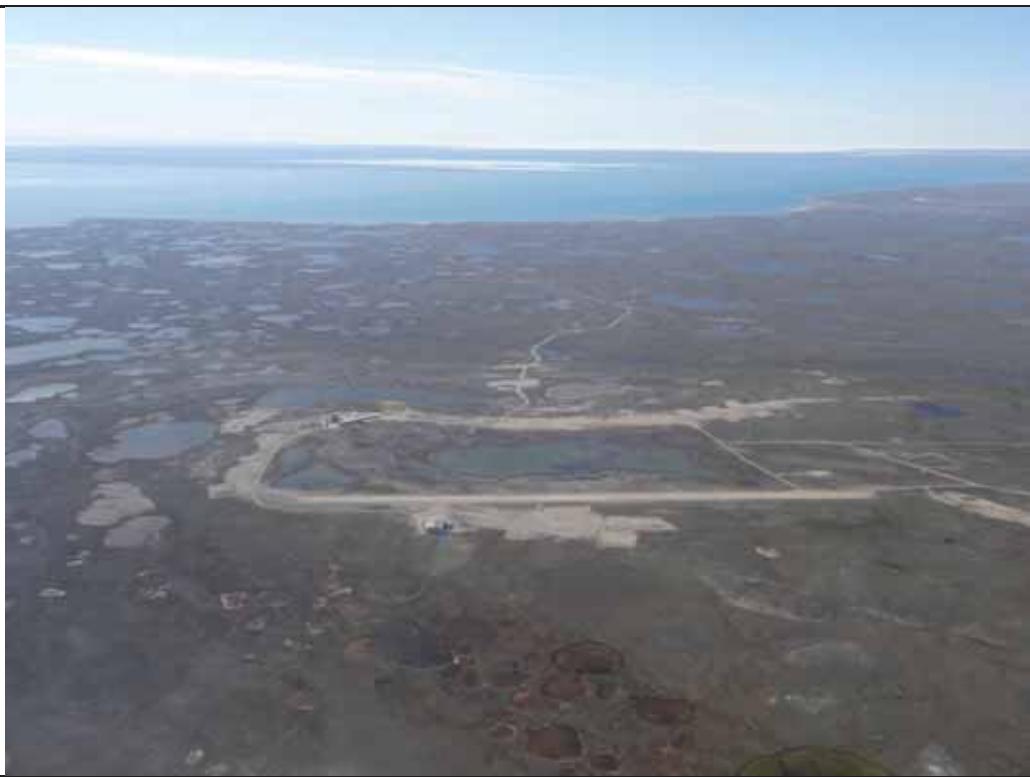
Date	Camera	Inspector	Authorization
2017 July 6		Baba Pedersen	3BC-SHE0919
<b>Photo Log # DSC09756</b>			Location (N 68° 47' 36.1" W 093° 26' 26.5")
Photo 1

I Inspected the Water License 3BC-SHE0919 and 2 associated Fuel Spills (#16-226 & #17-234) on July 6, 2017. All of these are located on the CAM-3 NWS Site (Photo 1) at Shepherd Bay, Nunavut. I was accompanied by Don Beattie, Environmental Officer with Raytheon Canada

Description: CAM-3 Shepherd Bay NWS Site – Aerial View

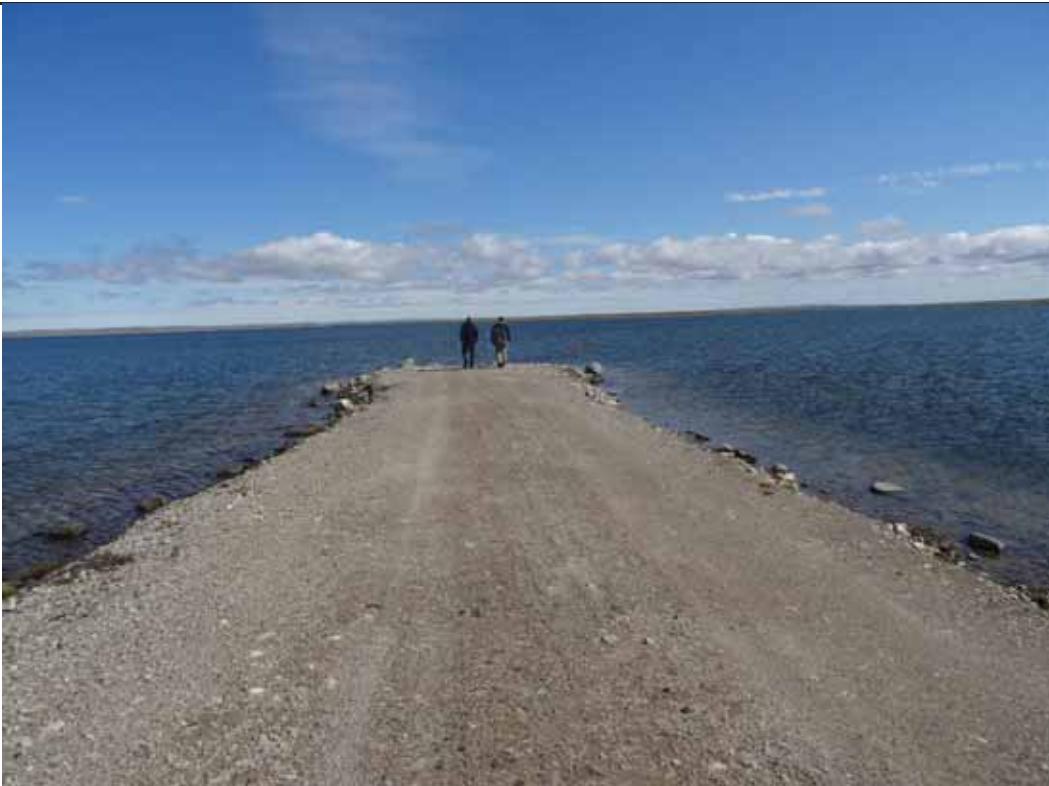
Photo 2

1. There was no Signage to identify and indicate where the Water Source area (Photo 2) was. 2. There was no Signage to Identify and Indicate where the Final Discharge Grey Water Sump (Photos 3 & 4) area was. 3. The Fuel Storage Tanks W22A (Photo 5) and W22C & W22D (Photo 8) were all Secure and well Marked. Both Containment Berms were clean and dry and in good condition with no signs of leakage. 4. All Hazardous Material (Photos 6 & 7) was securely stored in the Wharehouse. 5. Spill #16-226 (Photo 9) under the main module has been Cleaned Up satisfactorily. 6. Spill #17-234 (Photo 10) at the Heli Pad has been Cleaned Up satisfactorily.

Description: Water Intake area – showing No Signage

1. Appropriate Signage must be installed in order to indicate and identify where the Water Source Sample area is prior to July 2018. 2. Appropriate Signage must be installed in order to indicate and identify where the Final Discharge Grey Water Sump Sample area is prior to July 2018. 5. I recommend Closure of Spill #16-226. 6. I recommend Closure of Spill #17-234.

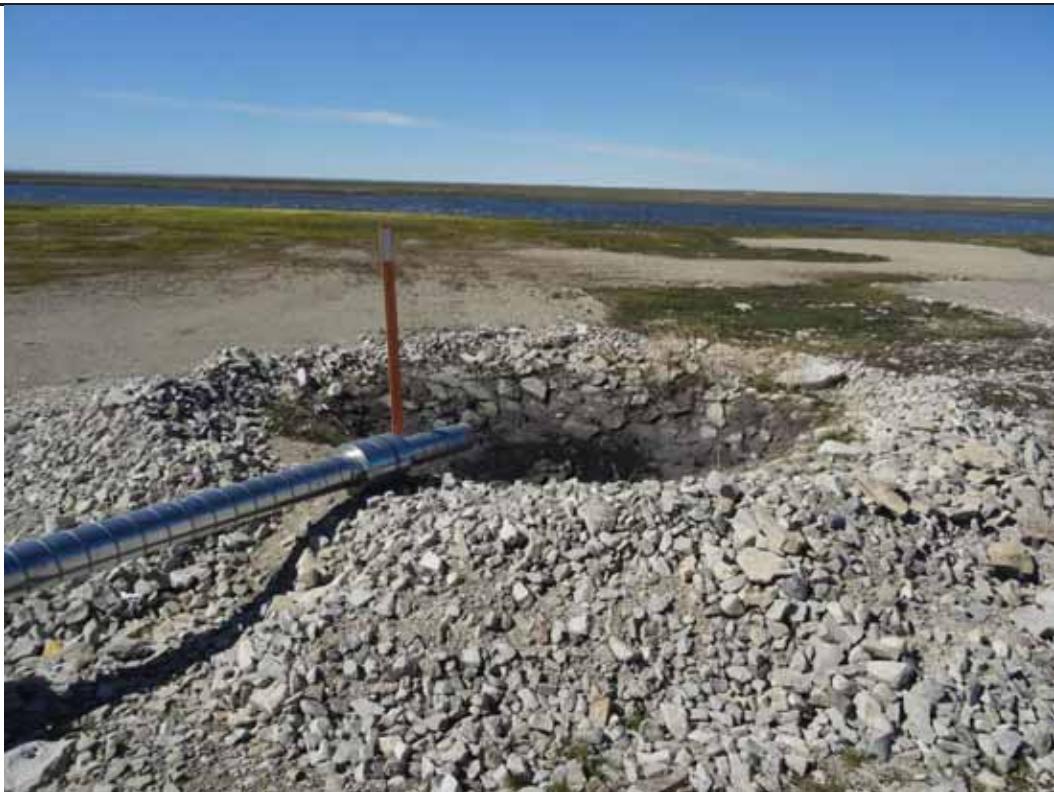
Photo 3

Description: Final Discharge Sump showing No Signage

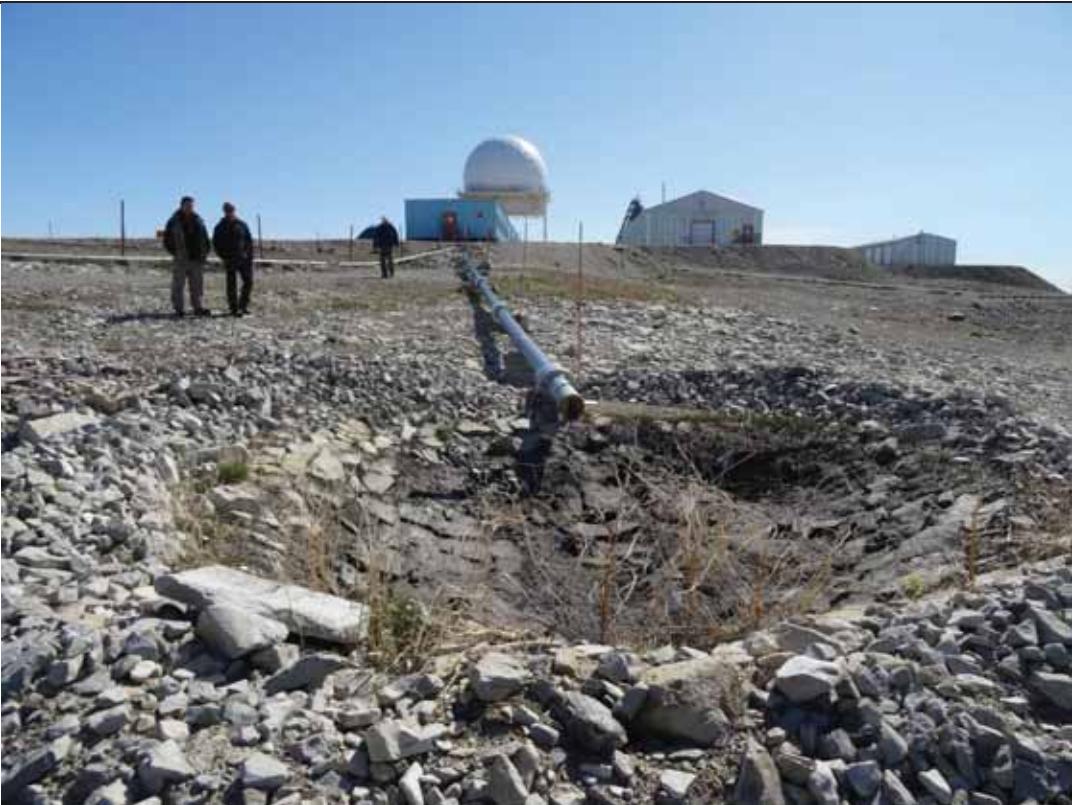
Photo 4

Description: Final Discharge Sump showing No Signage

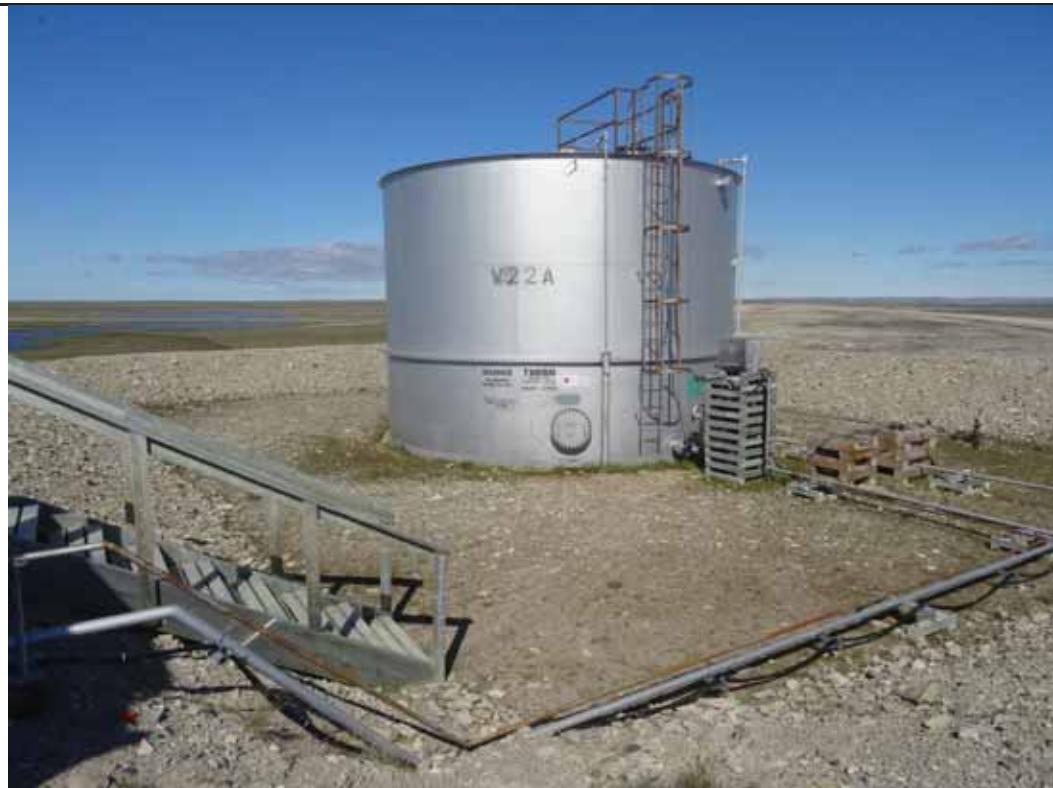
Photo 5

Description: Tank W22A – at NWS Site Area - Well Marked – Berm in Good Condition, Clean and Dry inside

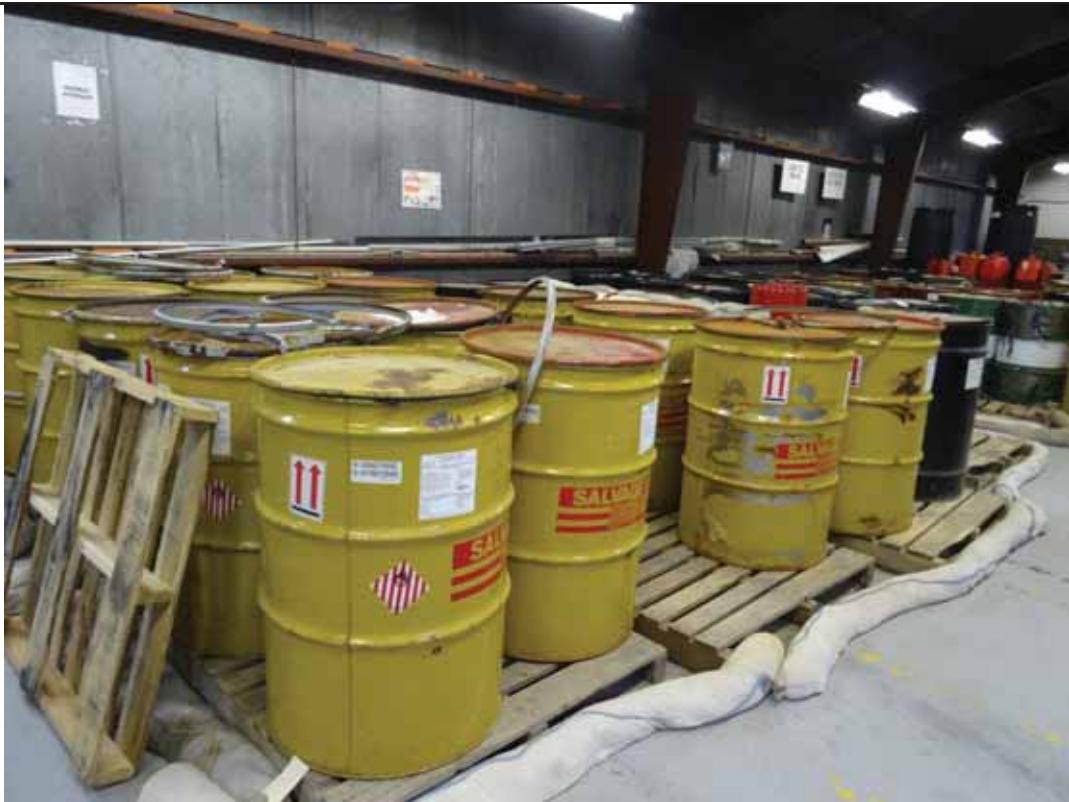
Photo 6

Description: Hazardous Materials Storage inside Wharehouse

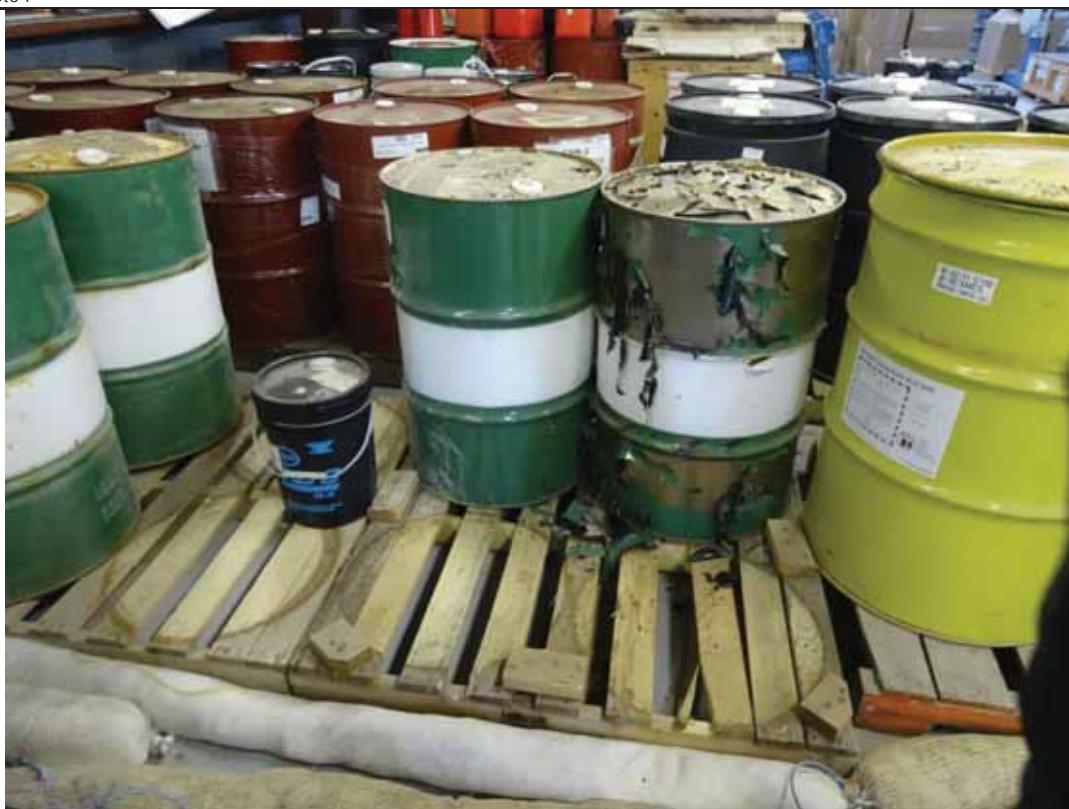
Photo 7

Description: Hazardous Materials Storage inside Wharehouse

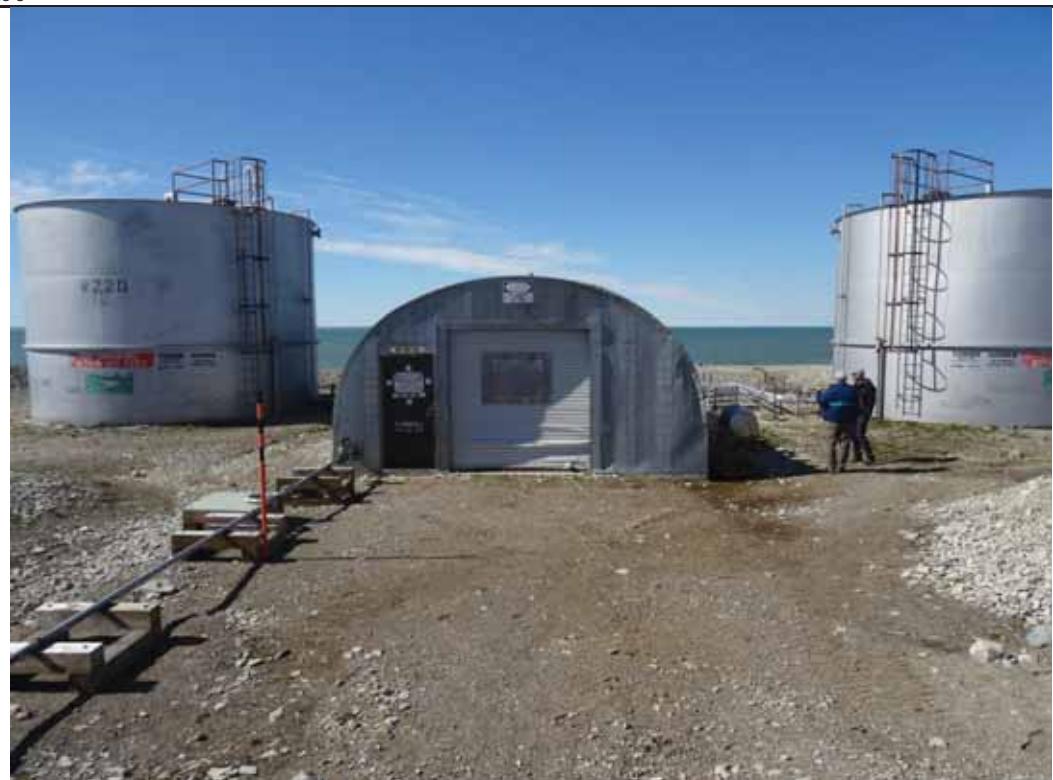
Photo 8

Description: Tanks W22C & W22D- at Beach Area-Well Marked – Berm in Good Condition, Clean and Dry inside

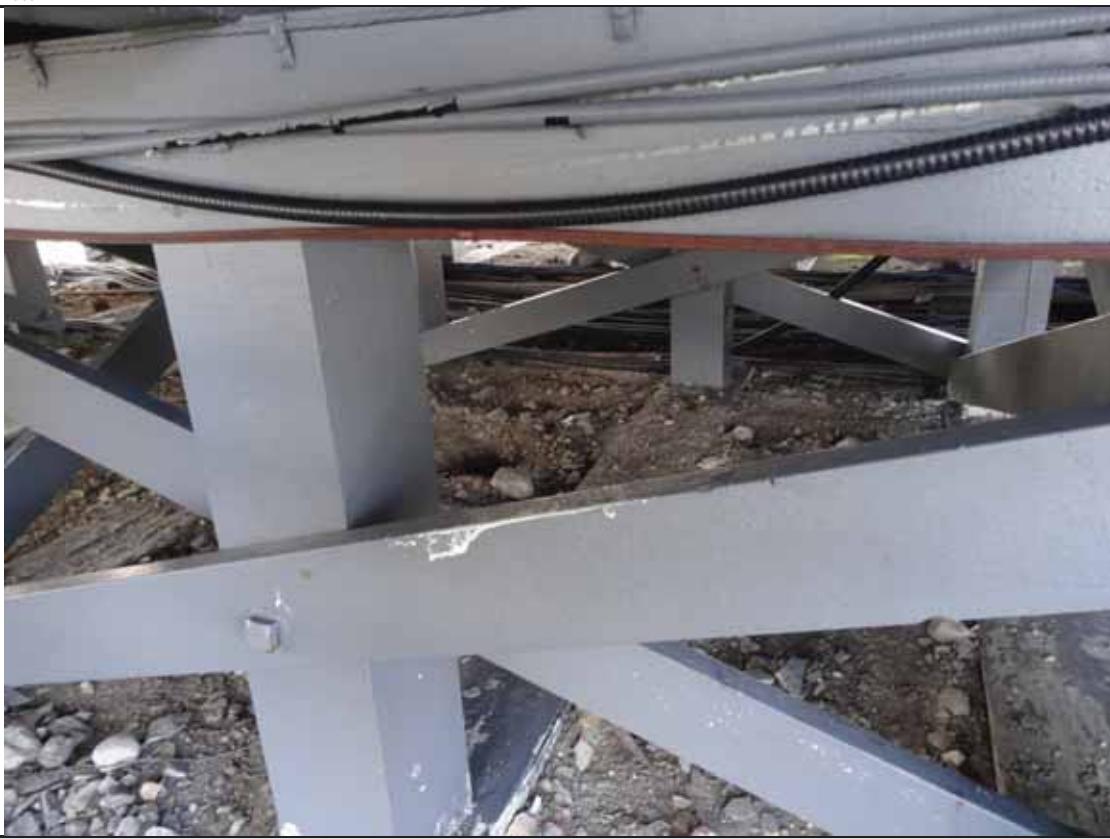
Photo 9

Description: Spill # 16-226 – Under Main Module Building - Cleaned up very nicely, I recommend Closure

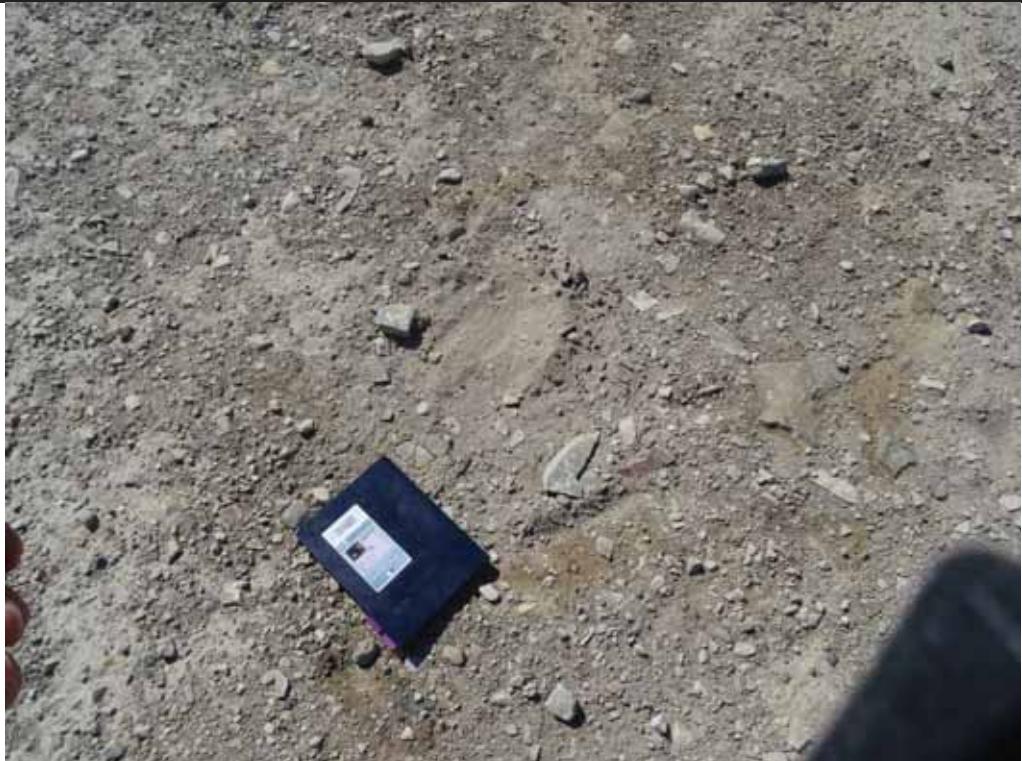
Photo 10

Description: Spill # 17-234 – At Heli Pad - Cleaned up very nicely, I recommend Closure
