WATER LICENCE INSPECTION FORM

On May 10th, 2017 Indigenous and Northern Affairs Canada's, Water Resource Officer (WRO), Christine Wilson conducted a regularly scheduled compliance inspection of Agnico Eagle Mines Limited, Amaruq Exploration Access Road ('AEAR'), water licence 8BC-AEA1525. The following report was prepared using the information noted during that inspection.

PHOTO LOG

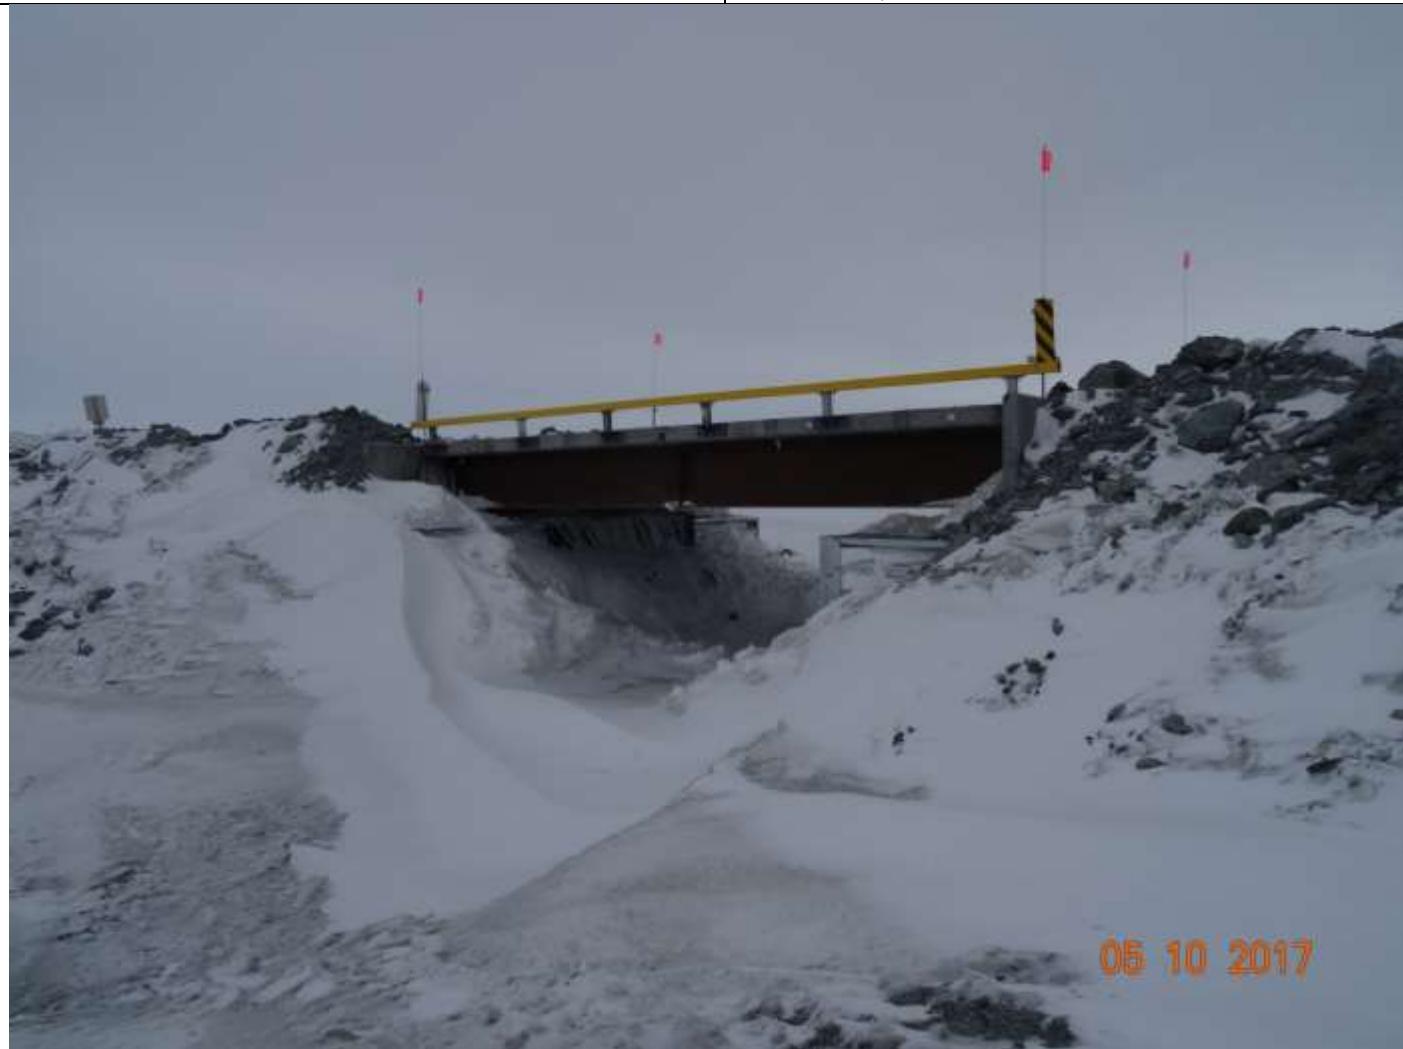
Photo 3

3. As per the freshet action plan the snow is removed from under the bridge to allow water to flow (photo 3).
4. Bridge at 10.7KM is complete (photo 4).

Bridge 3.4KM. snow removed from the under the bridge.

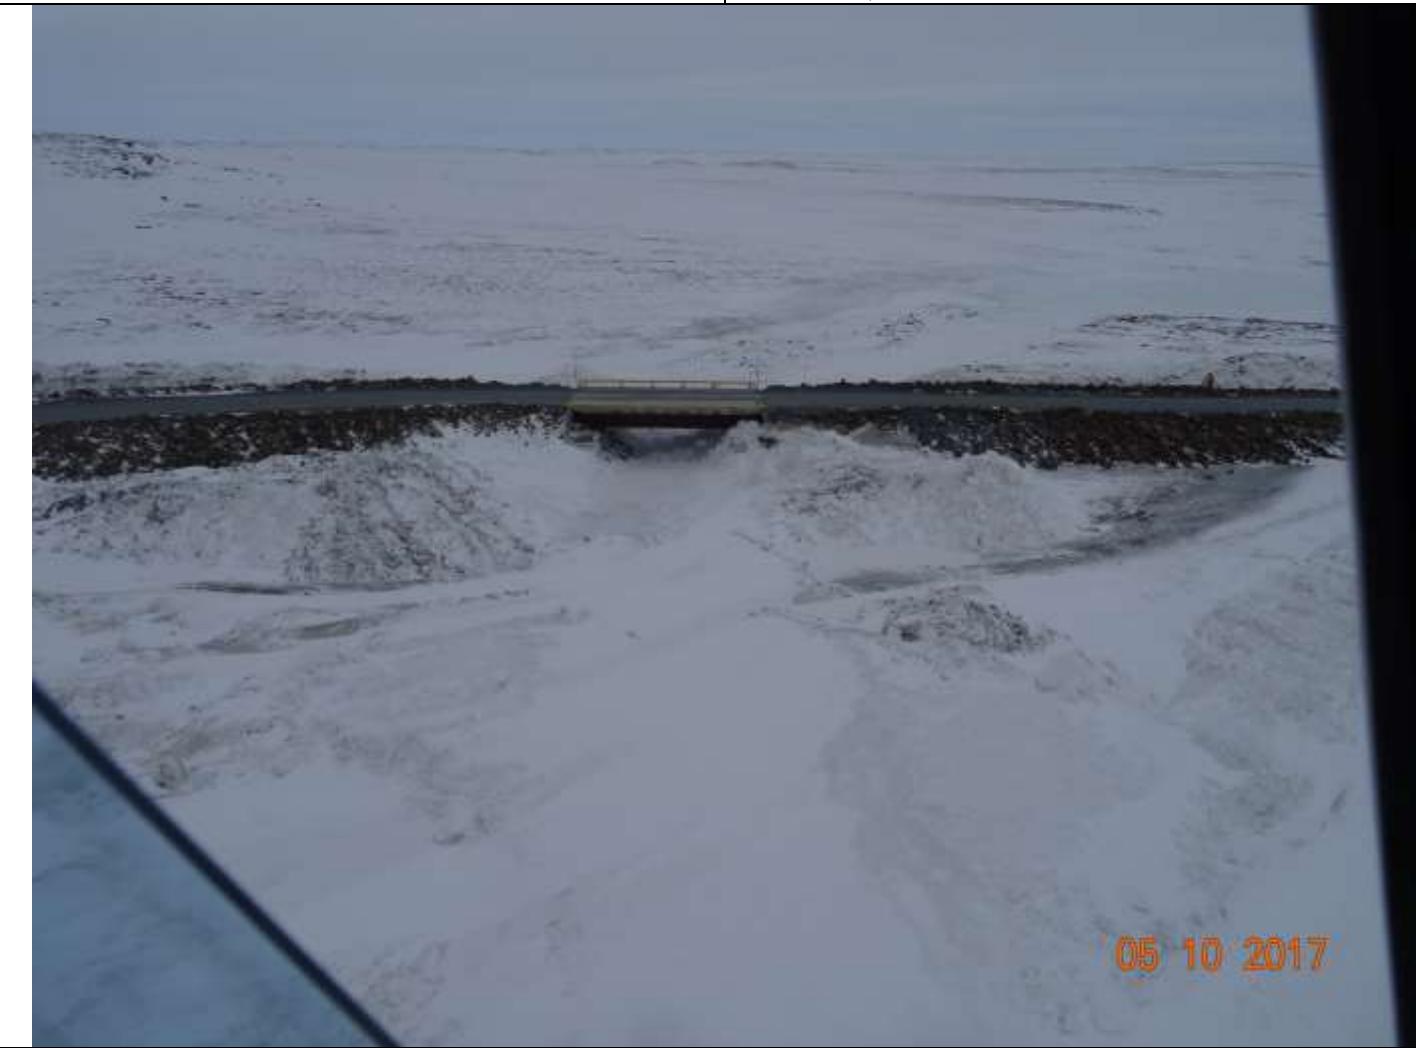
Photo 4

Bridge 10.7KM

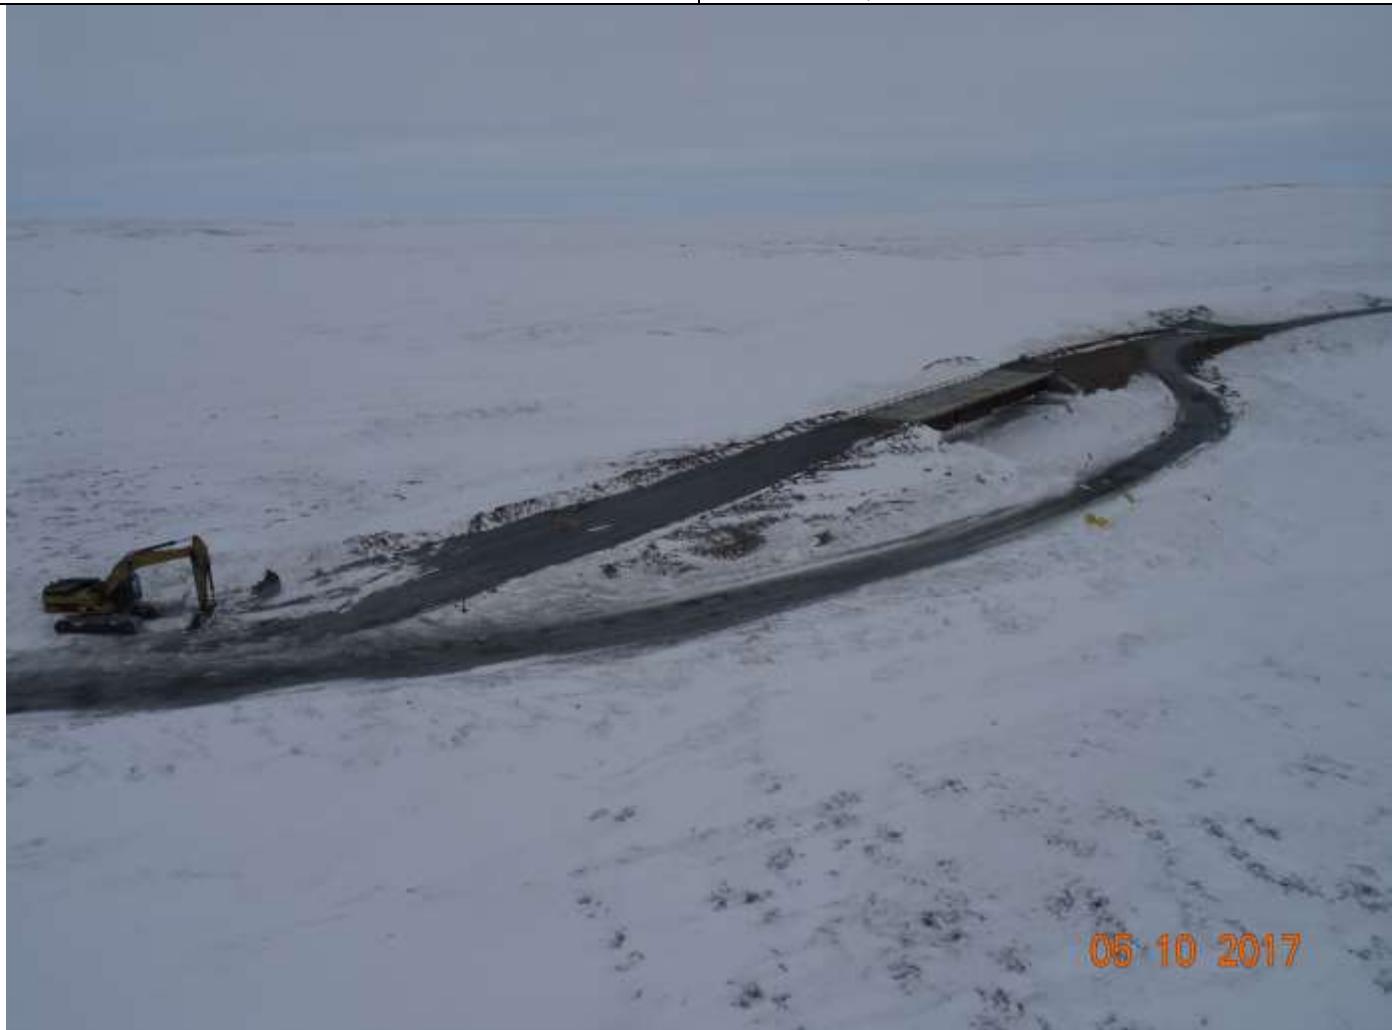
Photo 5

5. Bridge 16KM is almost complete, should be done this month. The ice bridge will be removed once the bridge is finalized (photo 5).
6. Esker 1 is active, no concerns noted.

Bridge 16KM. Not complete, ice bridge still in place.

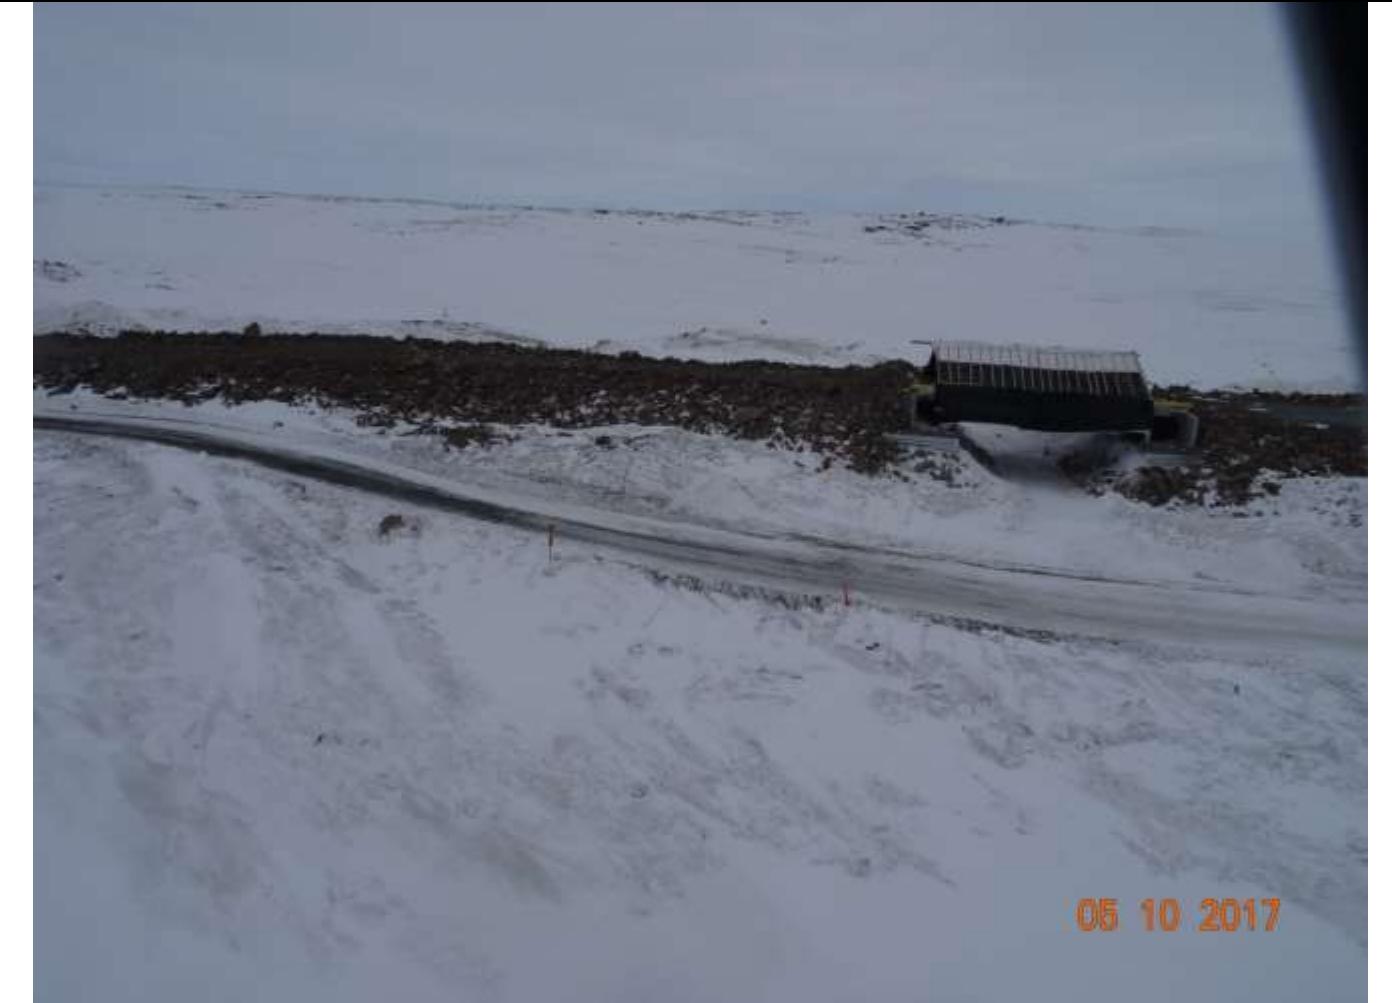
Photo 6

7. A temporary construction office is located at N65° 12' 19.4", W96° 11' 49.3".
8. Bridge 20KM is still under construction (photo 6).
9. Bridge 26.1KM is still under construction (photo 7).

Bridge 20 KM, structure is not complete. The ice bridge still remains.

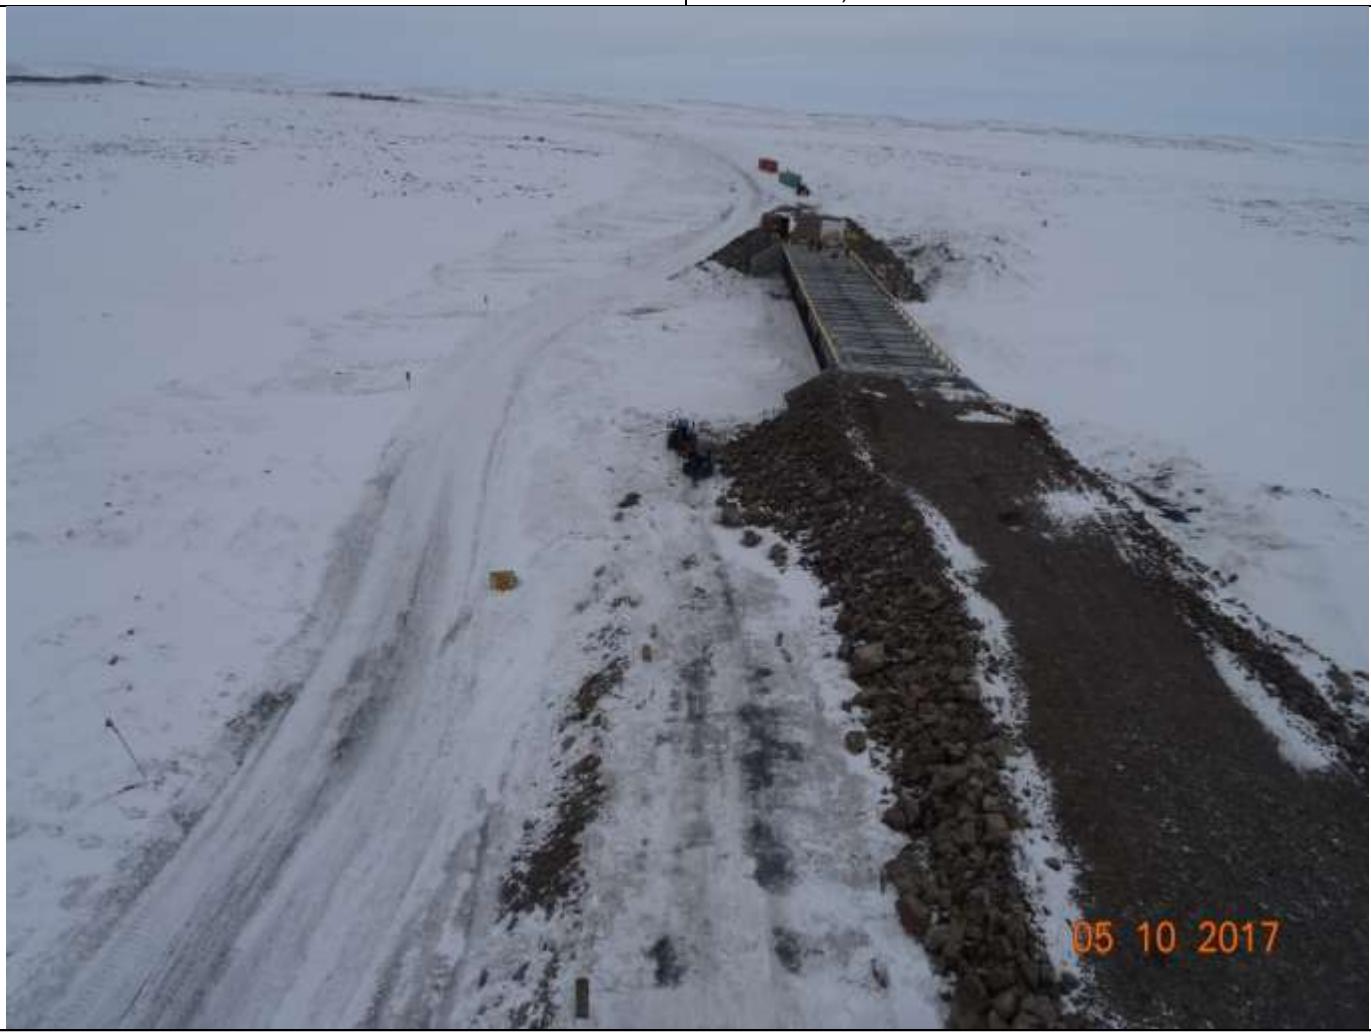
Photo 7

Bridge 26.1KM snow removed from the under the bridge.

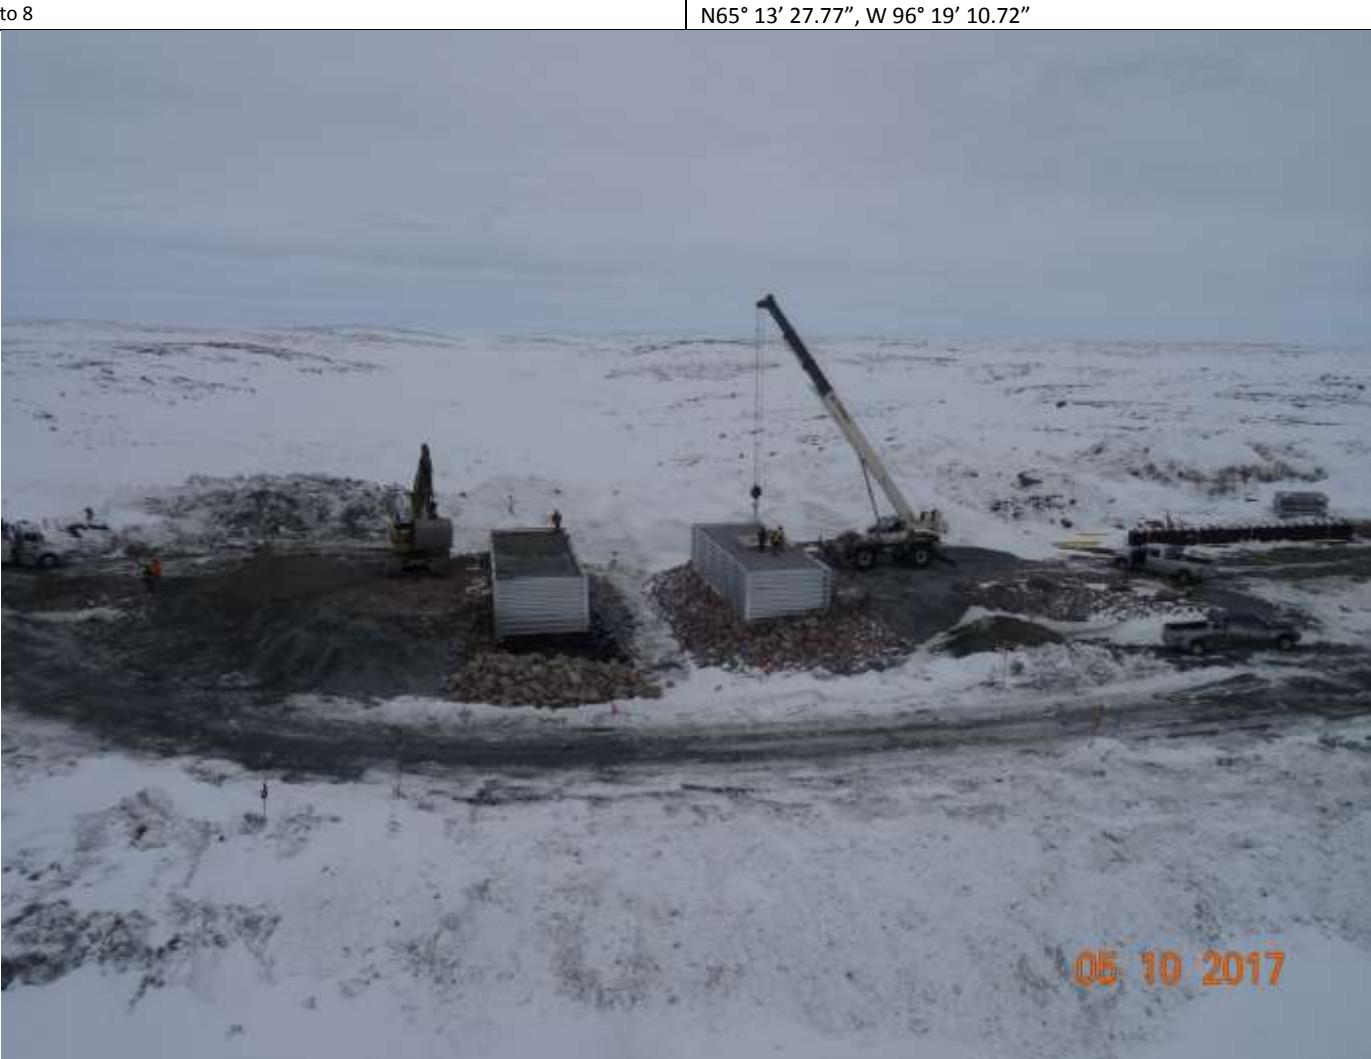
Photo 8

10. Bridge 32.2KM's abutments are being constructed, the ice bridge is the only crossing. This bridge will not be completed until next fall. (photo 8)
11. Bridge 43.5KM construction has started, with the temporary bridge that will be used for this season. Water was open at this location year around (photo 9).

Bridge 32.3KM installation of abutments

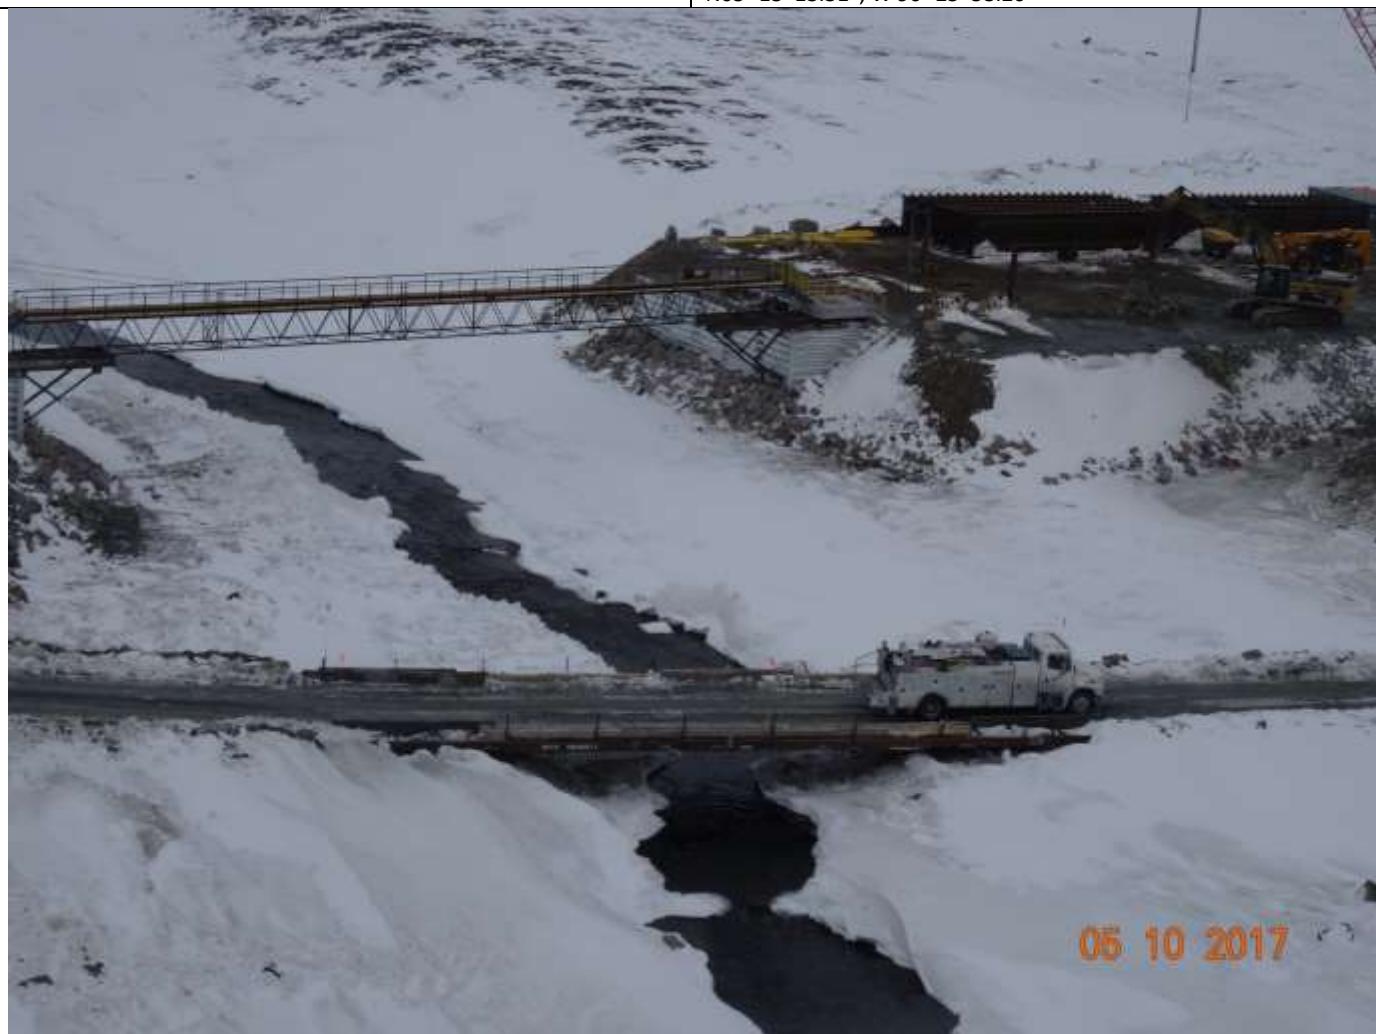
Photo 9

Bridge 43.5 KM

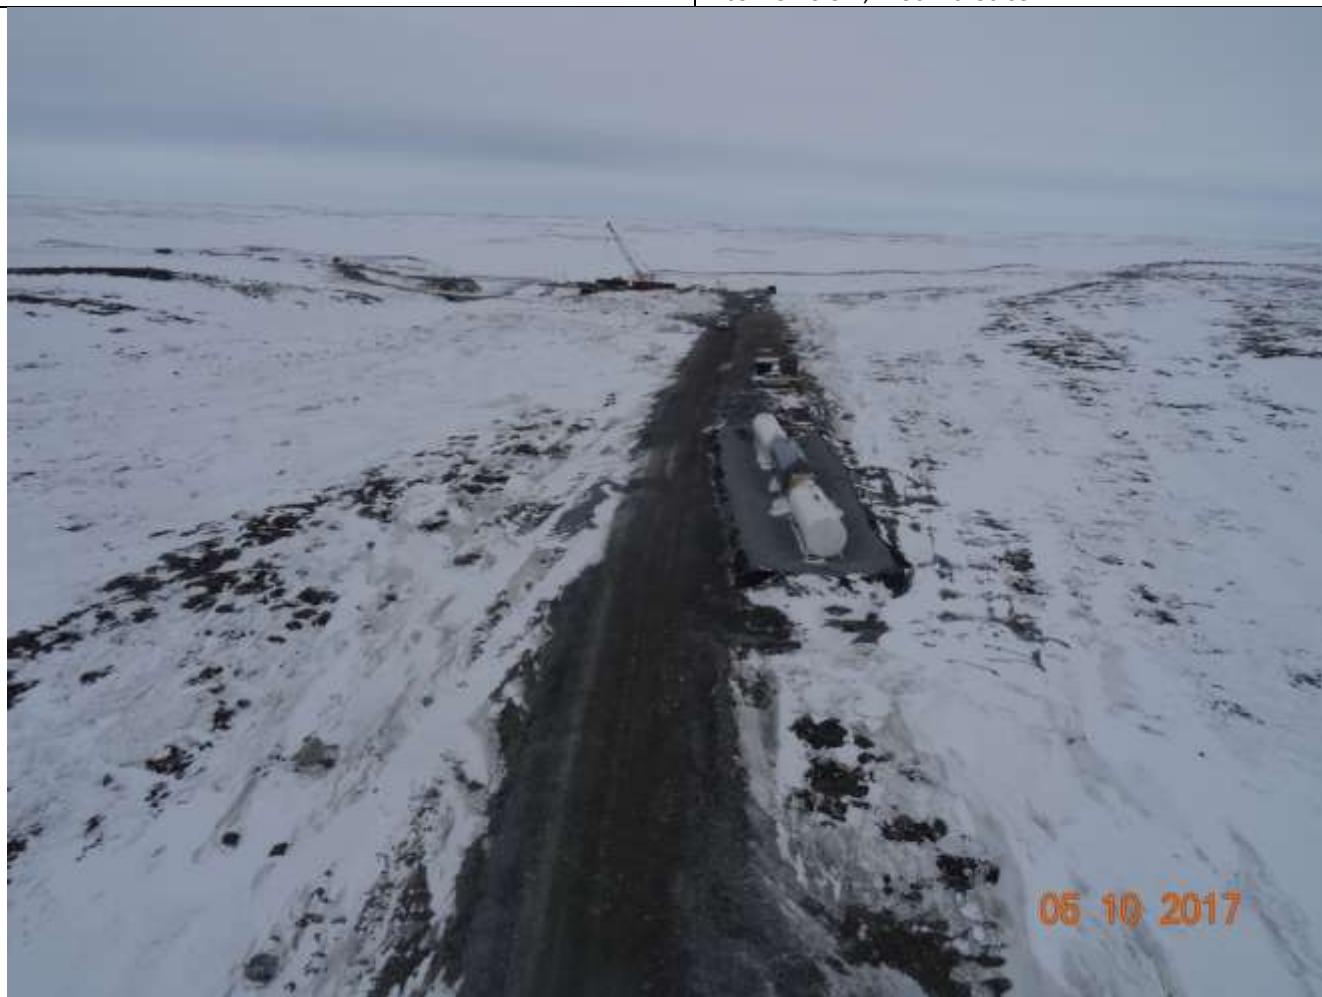
Photo 10

12. A temporary fuel storage structure was located near KM 44 (photo 10).
13. Blasting activity at approximate Quarry KM 45 has caused a great deal of dust to spread out from this location (photo 11).

Temporary fuel storage near KM44

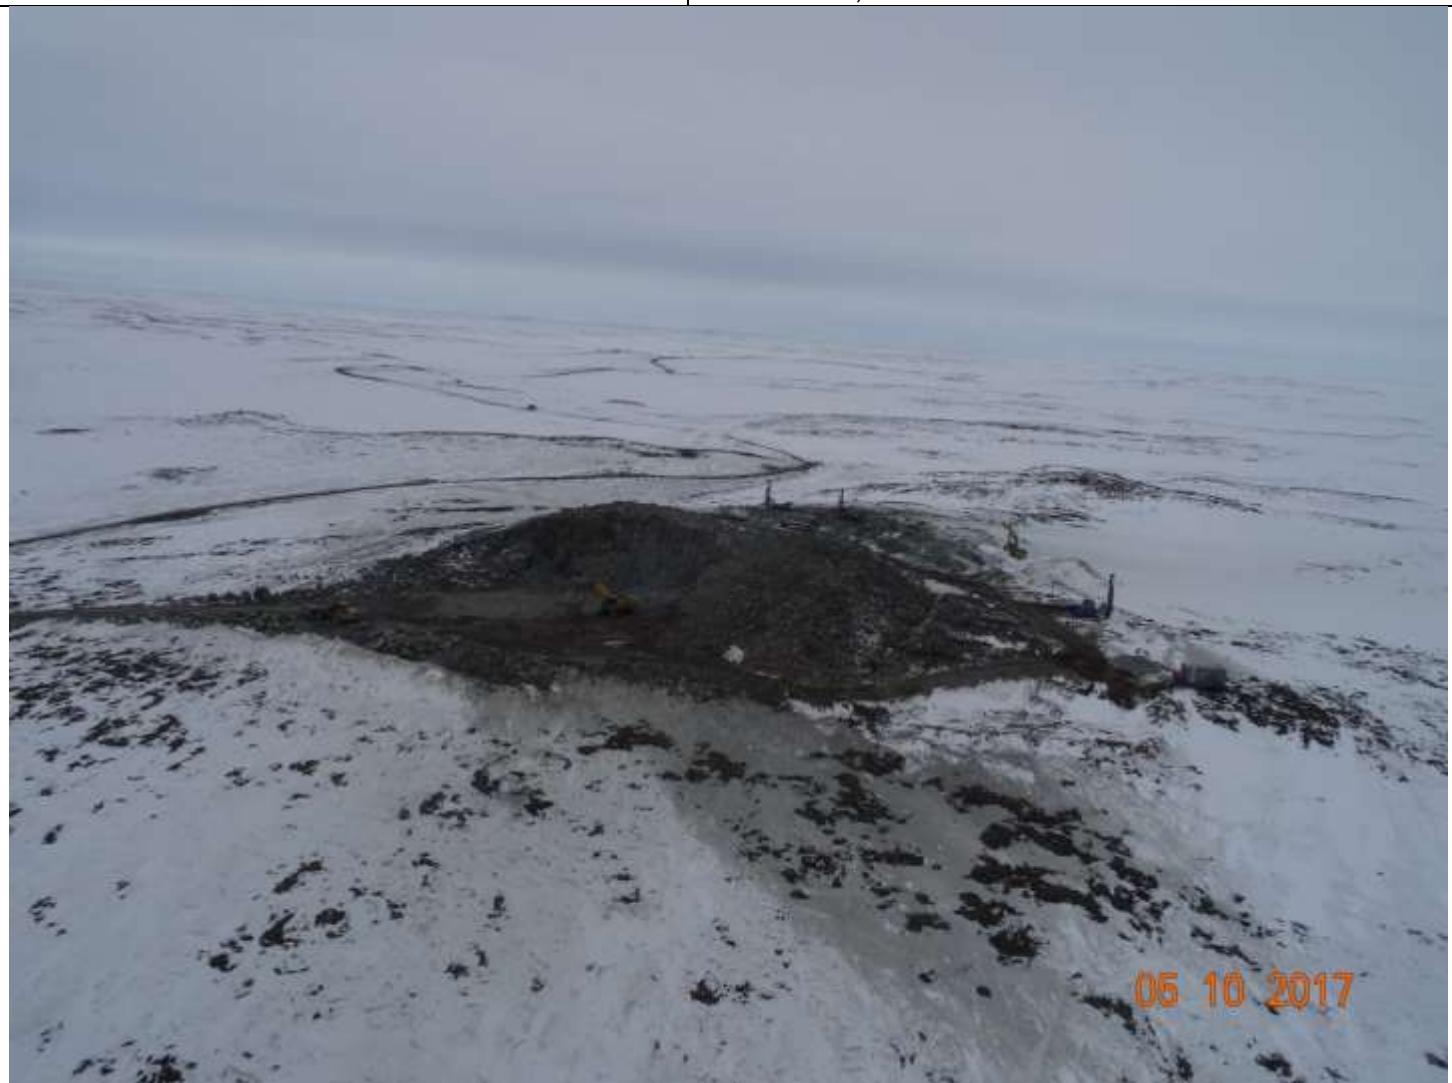
Photo 11

Borrow near 44KM , some dust leaving the site from blasting.

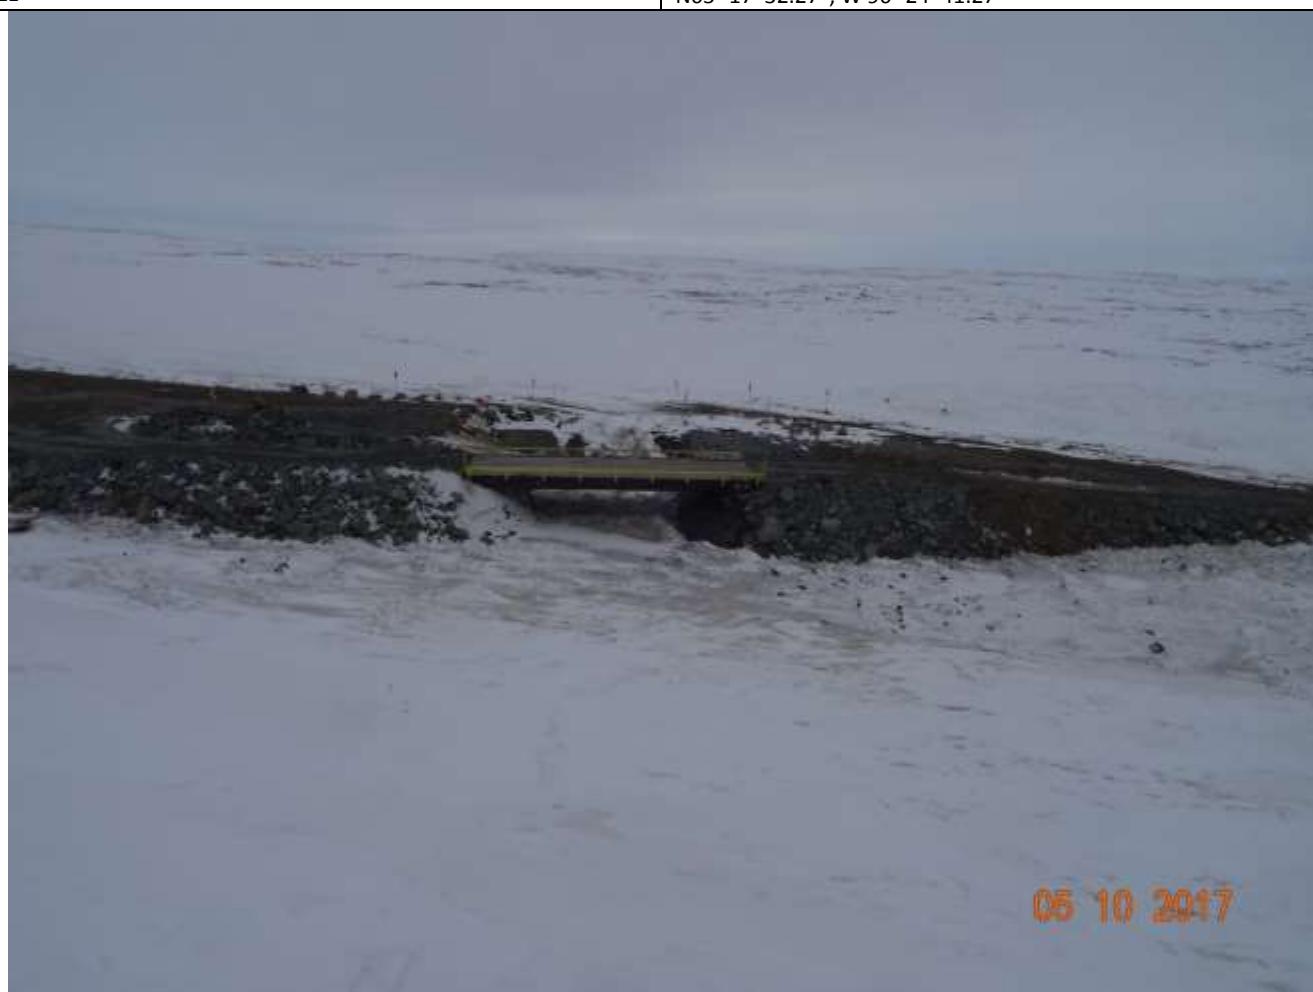
Photo 12

14. Bridge 44.8KM temporary bridge is complete, the ice bridge is still to be removed (photo 12).

Bridge 44.8KM , temporary bridge complete. Ice bridge to be removed
