Regulator Inspection Report

Kivalliq Inuit Association

Site Inspection Report

Company: Agnico Eagle Mines Ltd
Site Contact: Nicolas Saucier, Jean-Francois Beland
Location: Amaruq Access Road, NU
Coordinates: 65° 04.787' N, 96° 01.219' W
Inspector(s): Jeff Hart
Inspection Date: March 15, 2016

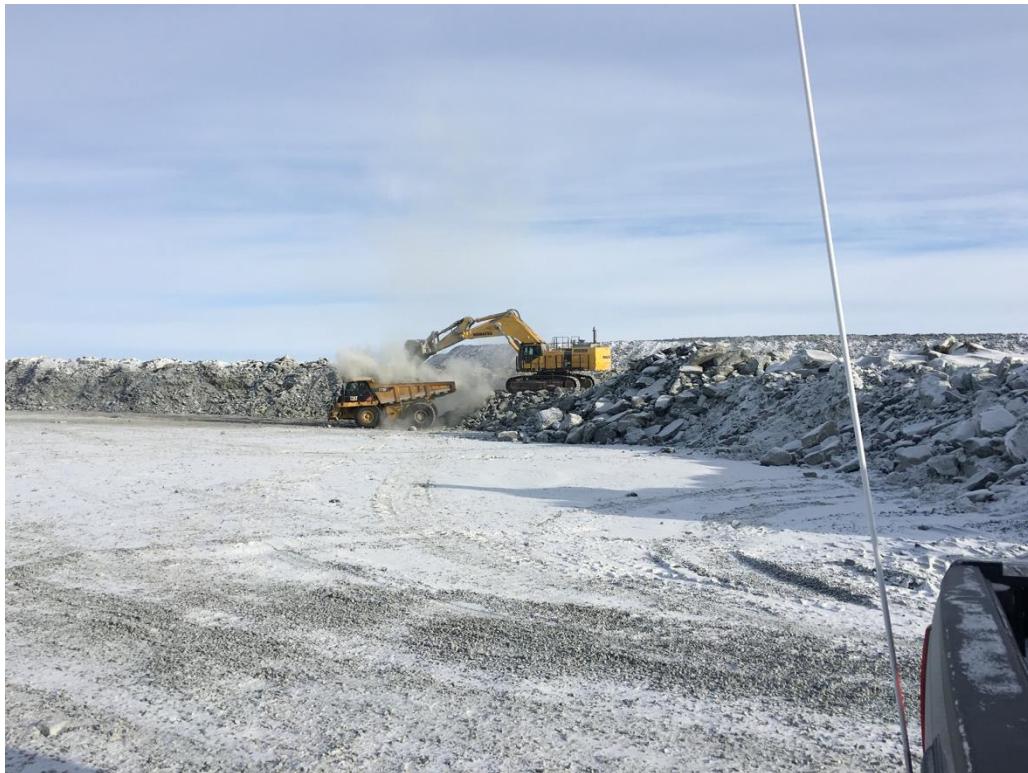
Waste rock from the Vault Pit (Figure 1) is being used for the road material until the first borrow site is reached. On the date of inspection, construction of the foundation of the road had reached a distance of approximately 5,200m and will continue until the end of May. 50-ton haul trucks are loaded with 42 tons of material for safety due to the rough surface of the foundation, finer material will be added in the future for the final surface of the road.

Figure 1 – Road material; Vault Pit waste rock

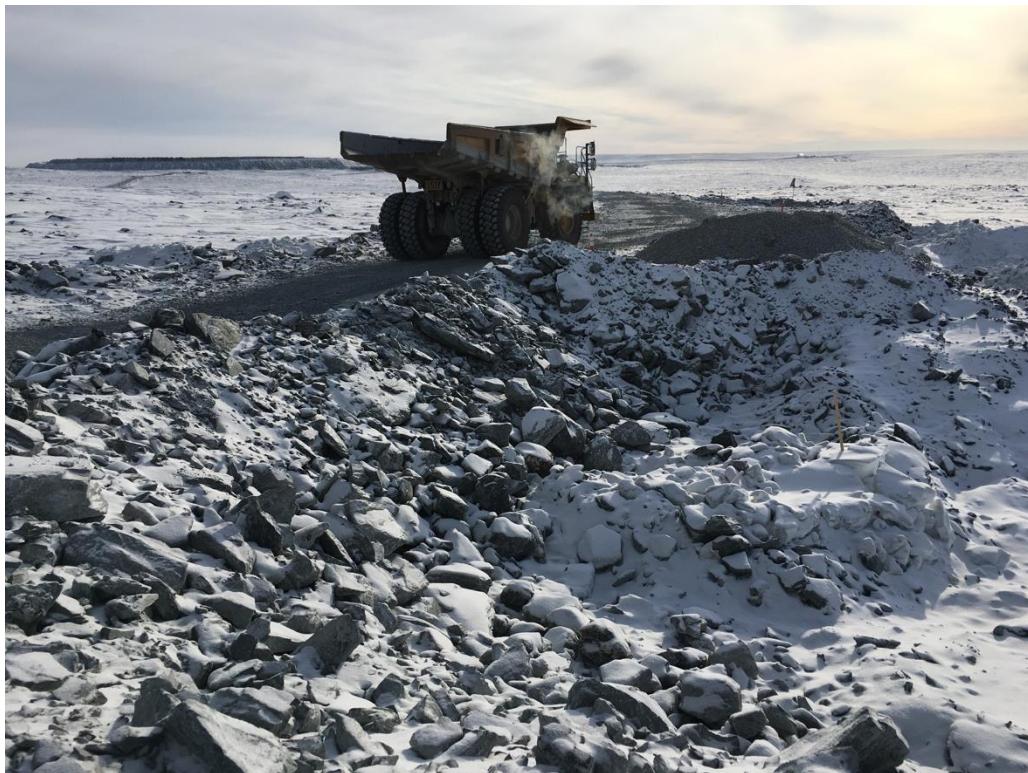
There are several culvert locations ([Figure 2](#)), and the first bridge location ([Figure 3](#)) is at approximately 3,500m. No bridges or culverts are currently in place, the gravel in these locations will be removed before thaw to allow water to flow.

Figure 2 – Culvert Location

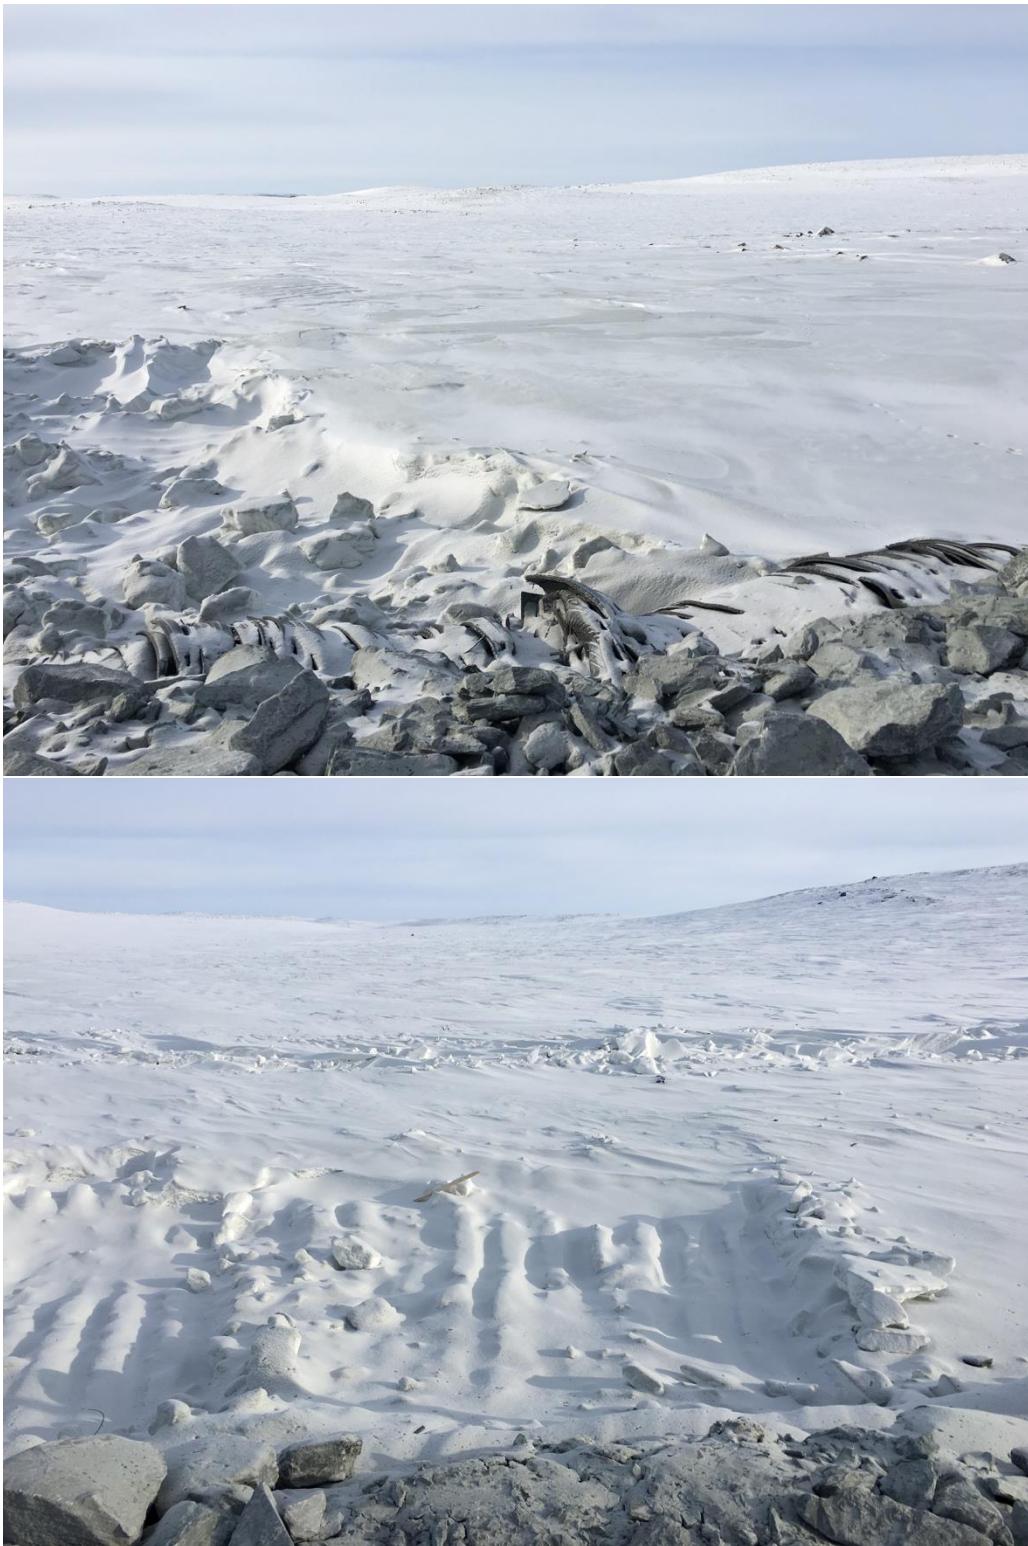
Figure 3 – First bridge ~3,500m (Upstream & Downstream)
