2017 Annual Geotechnical Inspection

February 2018

2017 Annual Geotechnical Inspection Meadowbank Gold Mine, Nunavut

Report Number: 1784282-1574-RPT-Rev0

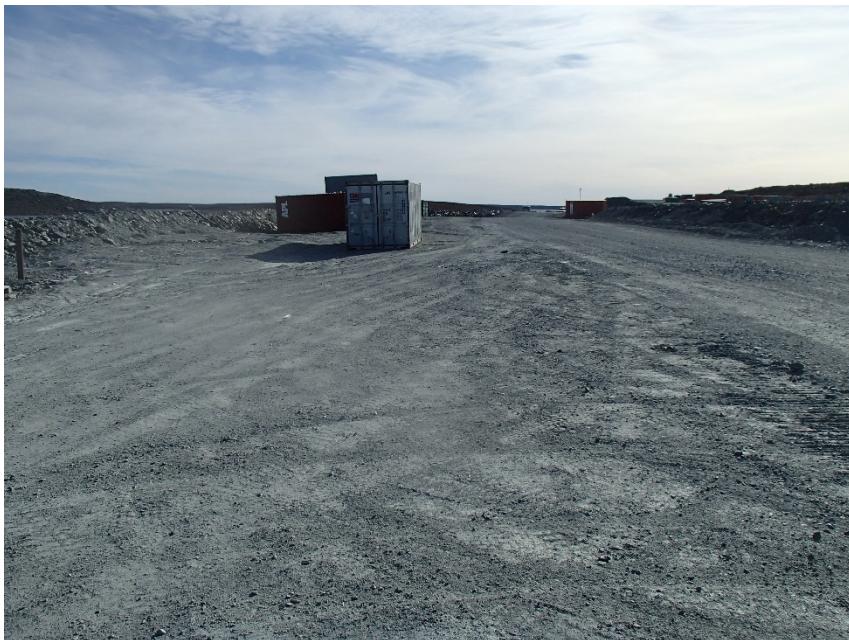
Photograph A1-1 East Dike

Description: From approximately Sta. 60+375, looking south at the crest.

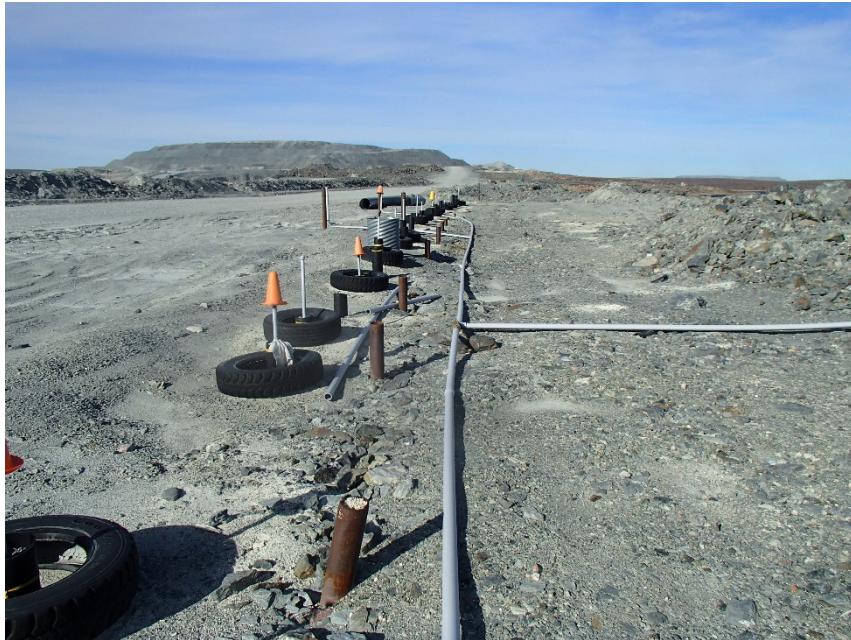
Photograph A1-3 East Dike

Description: From approximately Sta. 60+560, looking north at the crest.

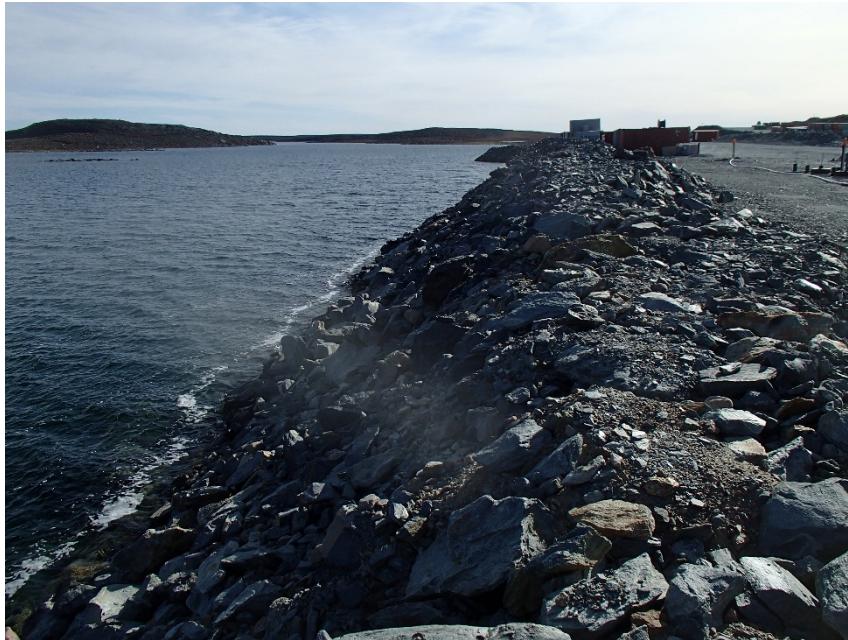
Photograph A1-5 East Dike

Description: From approximately Sta. 60+540 upstream, looking south at the crest and the upstream slope.

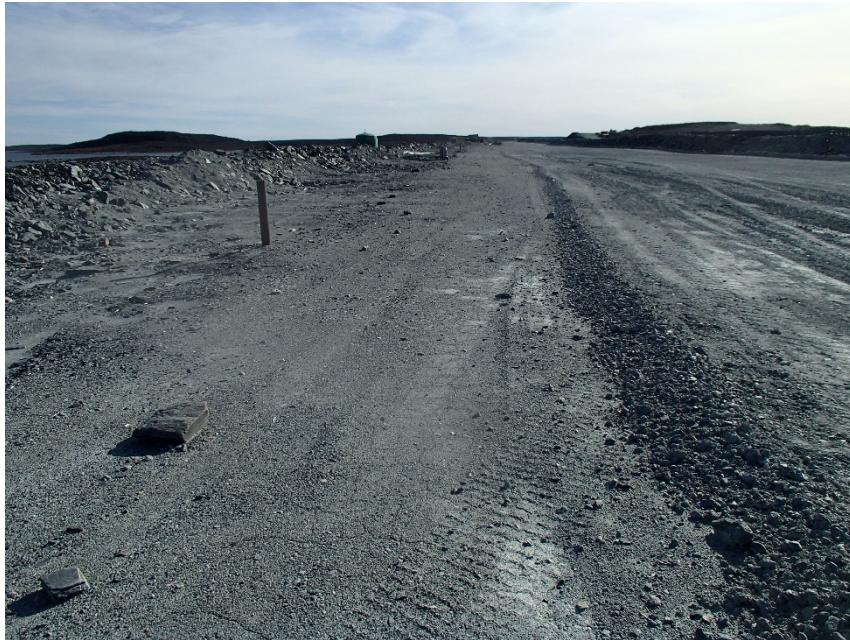
Photograph A1-7 East Dike

Description: From approximately Sta. 60+810, looking south at the crest.

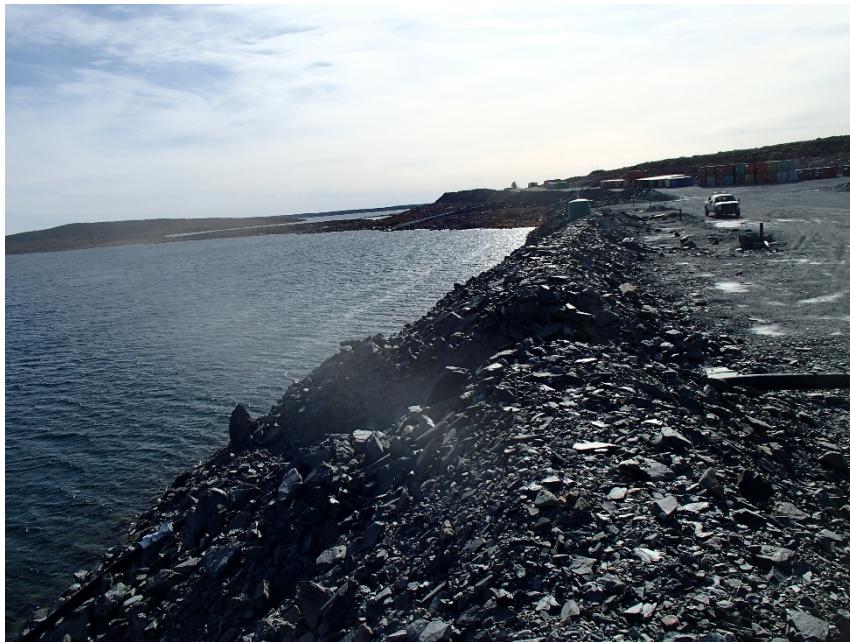
Photograph A1-9 East Dike

Description: From approximately Sta. 60+250 upstream, looking south at the crest and the upstream slope.

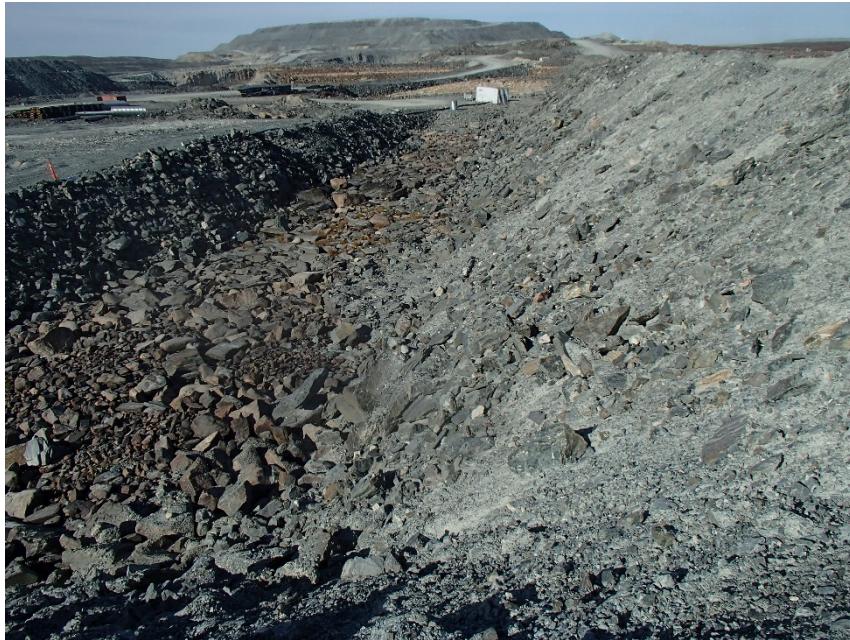
Photograph A1-11 East Dike

Description: From approximately Sta. 60+380, looking north at the downstream side.

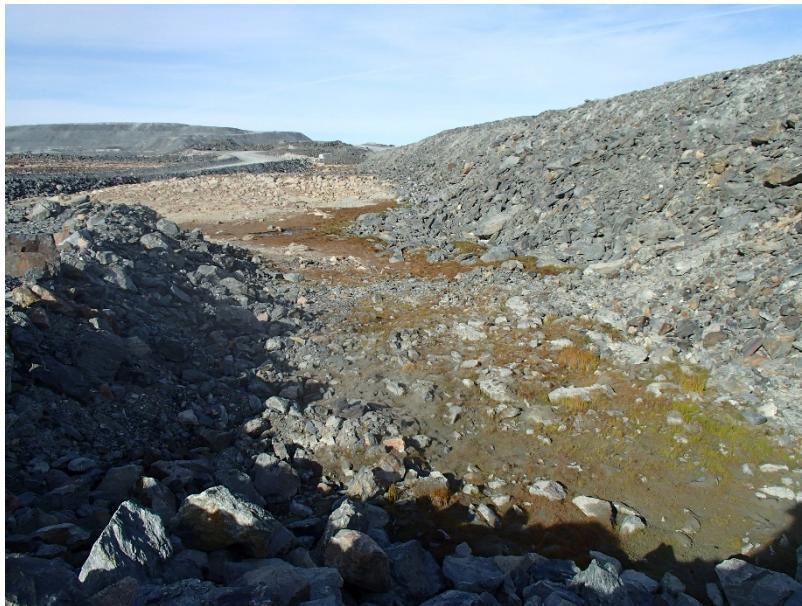
Photograph A1-13 East Dike

Description: From approximately Sta. 60+570 downstream, looking north at the downstream toe.

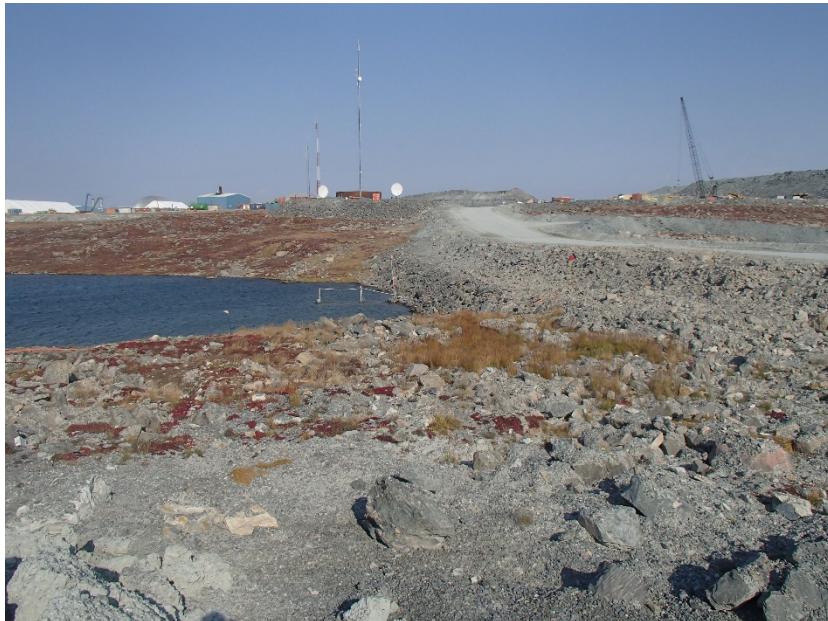
Photograph A2-1 South Camp Dike

Description: From the south abutment, looking north at the upstream slope and the thermistors instrumentation set-up.

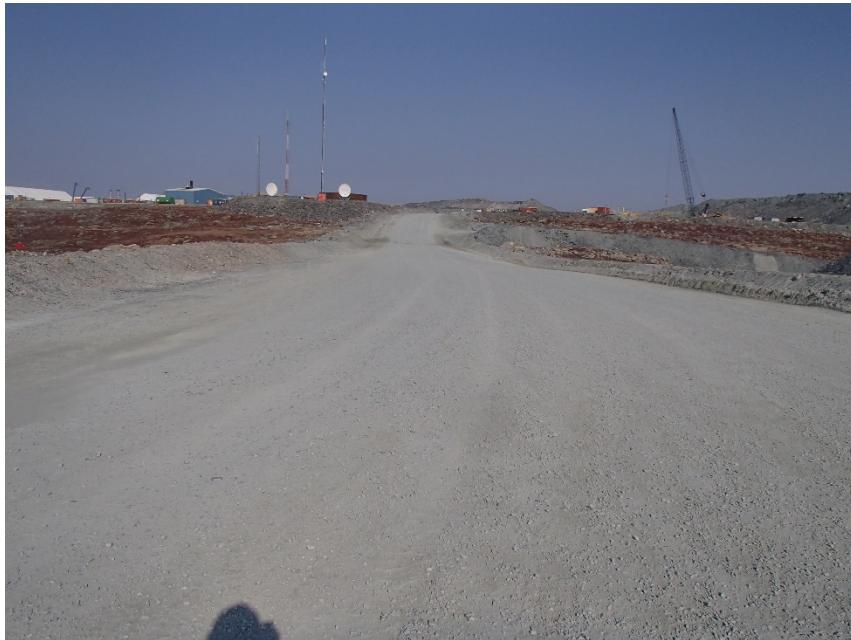
Photograph A2-3 South Camp Dike

Description: From the south abutment, looking north at the crest.
