## APPENDIX D1 CULVERTS ALONG AWPR PHOTOGRAPHIC LOG

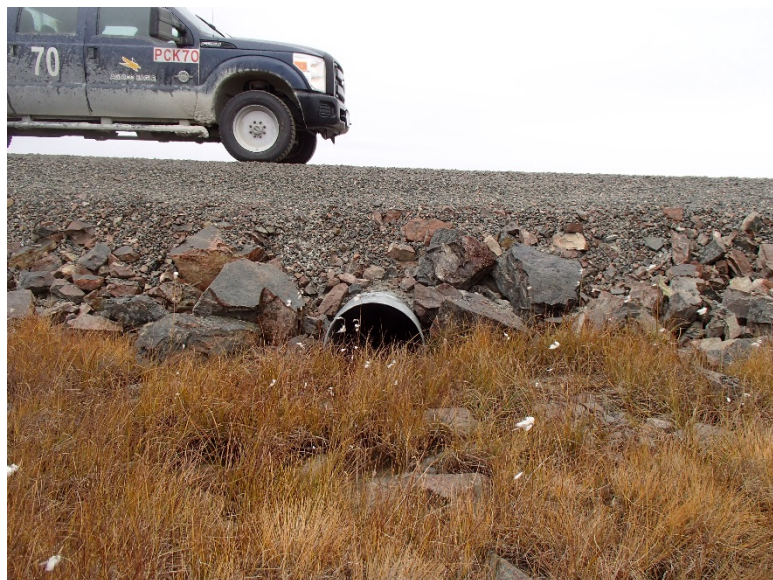
*Photograph D1-17: R-03 km 10+580*

**Description:** View of the culvert inlet. In good condition.

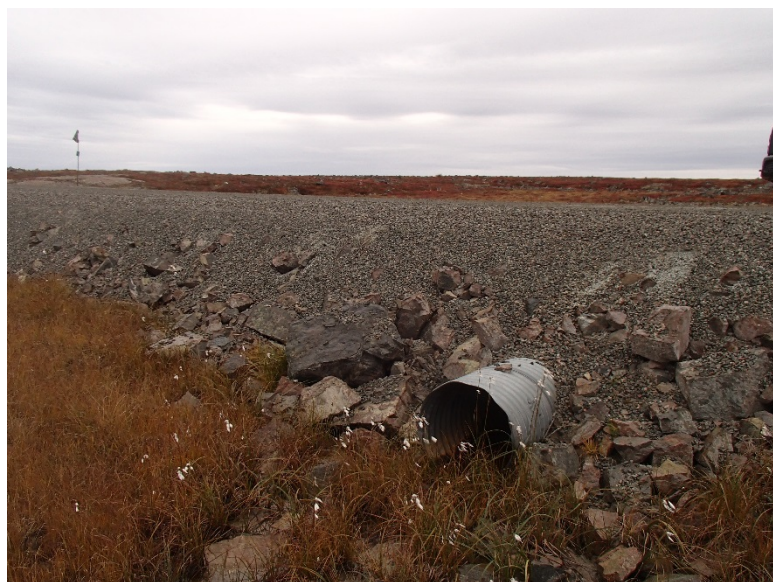
*Photograph D1-18: R-03 km 10+580*

**Description:** View of the culvert outlet. In good condition.

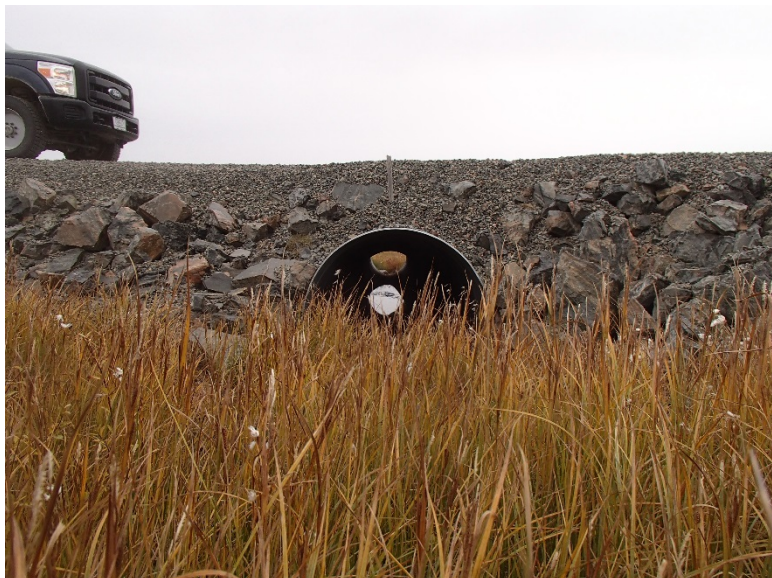
*Photograph D1-19: R-04 km 12+050*

**Description:** View of the culvert inlet. In good condition.

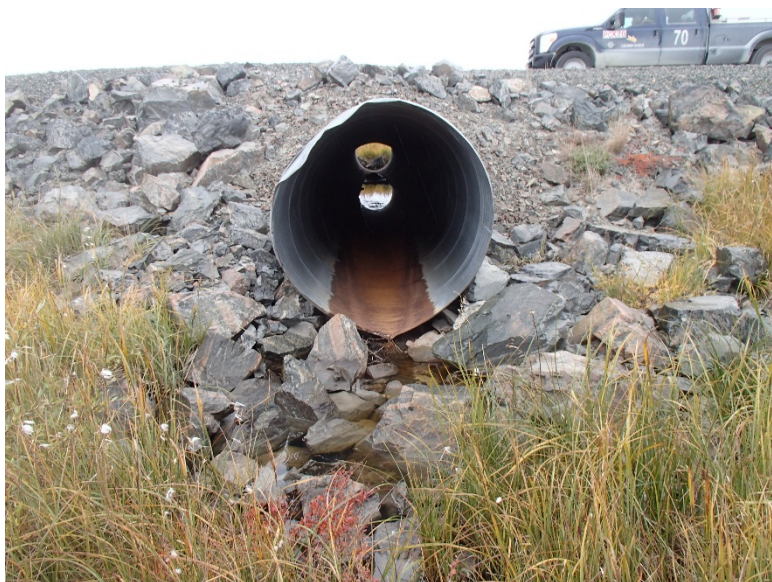
*Photograph D1-20: R-04 km 12+050*

**Description:** View of the culvert outlet. In good condition.

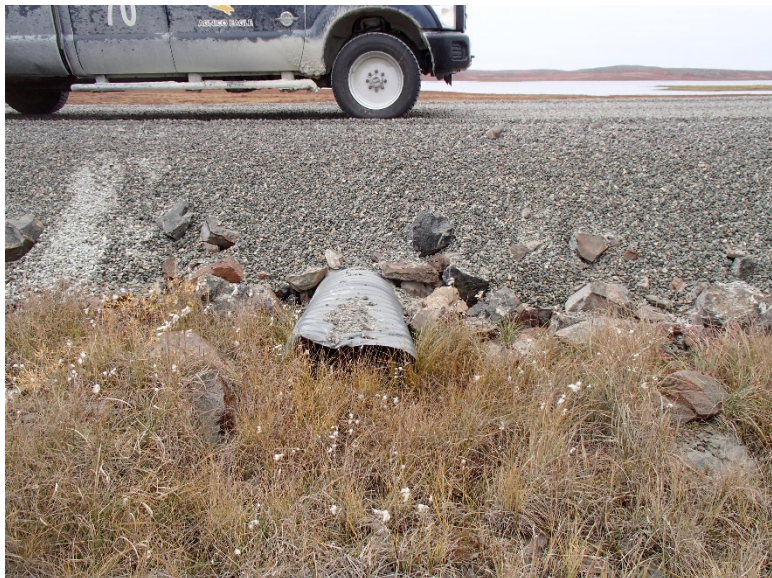
*Photograph D1-21: PC-13 km 12+745*

**Description:** View of the culvert inlet. In good condition.

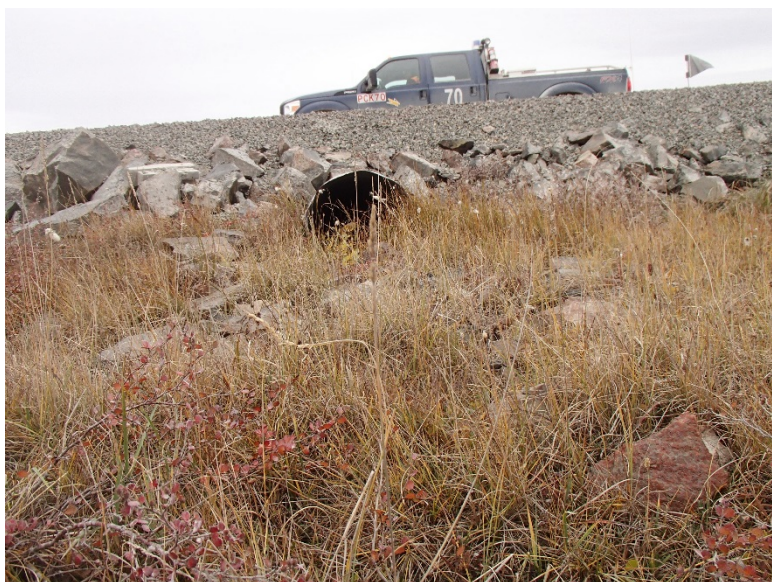
*Photograph D1-22: PC-13 km 12+745*

**Description:** View of the culvert outlet. In good condition.

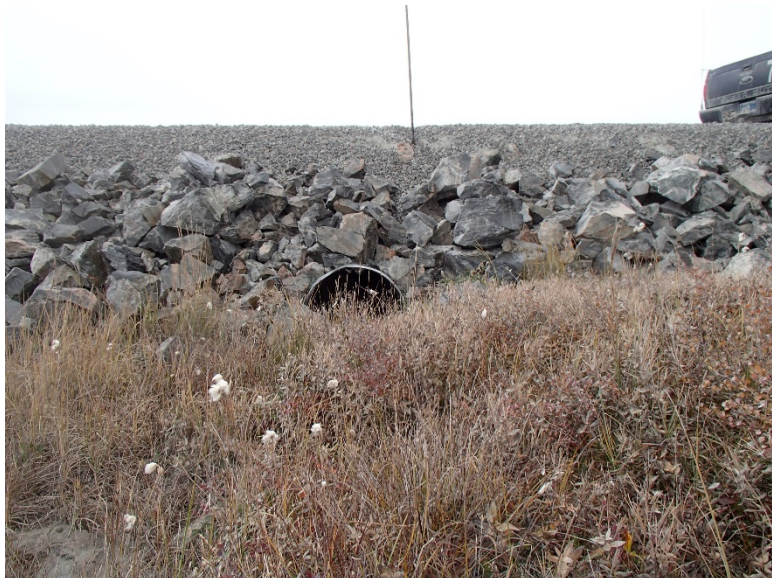
*Photograph D1-23: PC-2 km 13+405*

**Description:** View of the culvert inlet. In good condition.

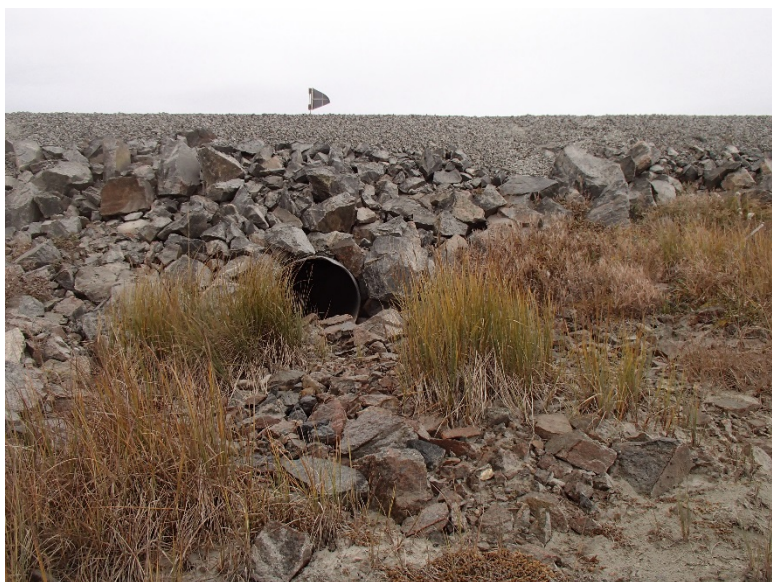
*Photograph D1-24: PC-2 km 13+405*

**Description:** View of the culvert outlet. In good condition.

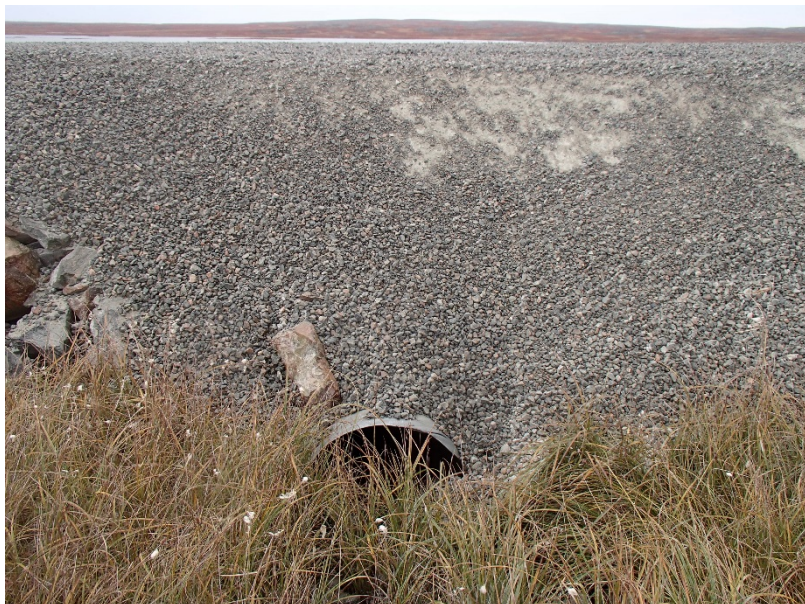
*Photograph D1-25: PC-3 km 13+685*

**Description:** View of the culvert inlet. In good condition.

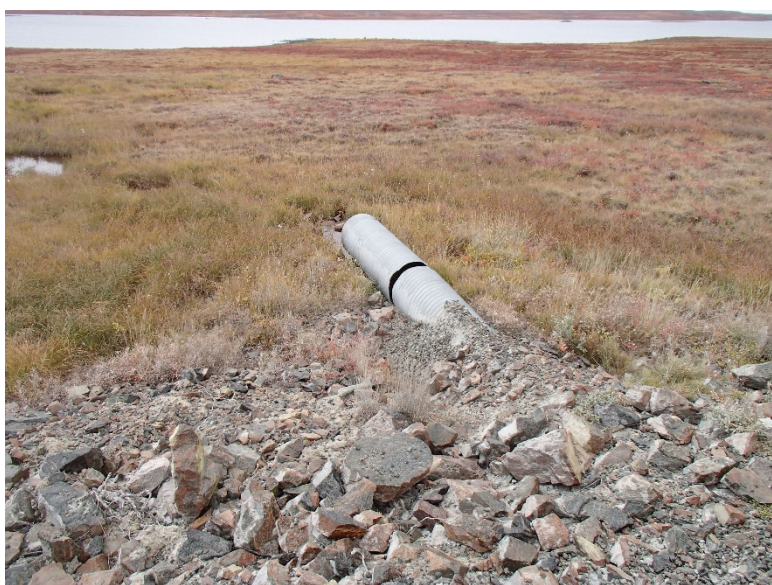
*Photograph D1-26: PC-3 km 13+685*

**Description:** View of the culvert outlet. In good condition.

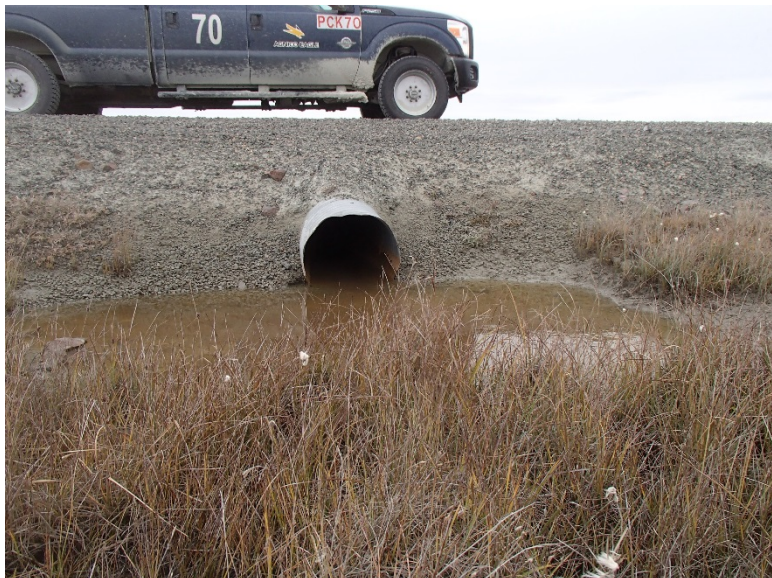
*Photograph D1-27: unnamed km 13+950*

**Description:** View of the culvert inlet. In good condition.

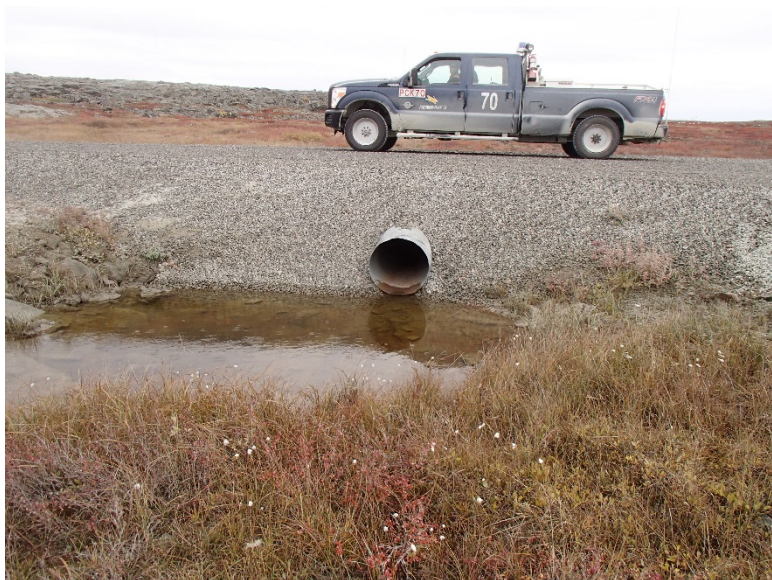
*Photograph D1-28: unnamed km 13+950*

**Description:** View of the culvert outlet. The outlet is in good condition.

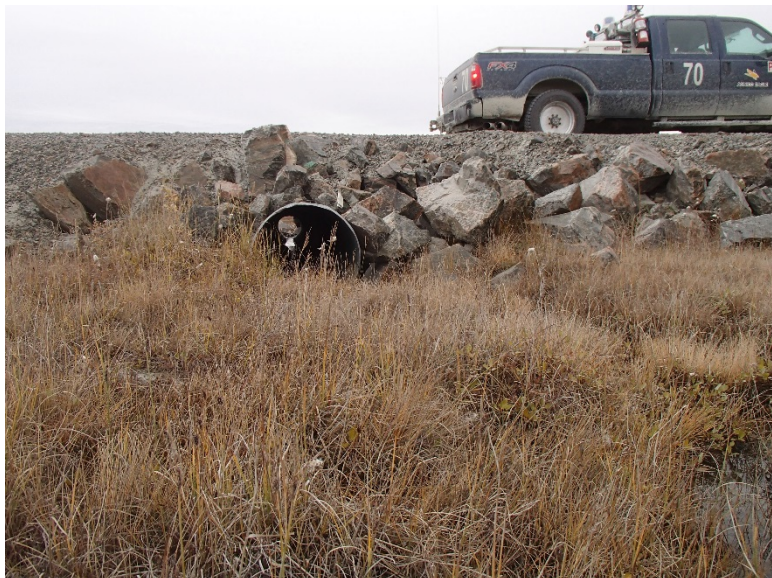
*Photograph D1-29: PC-4 km 14+910*

**Description:** View of the culvert inlet. In good condition.

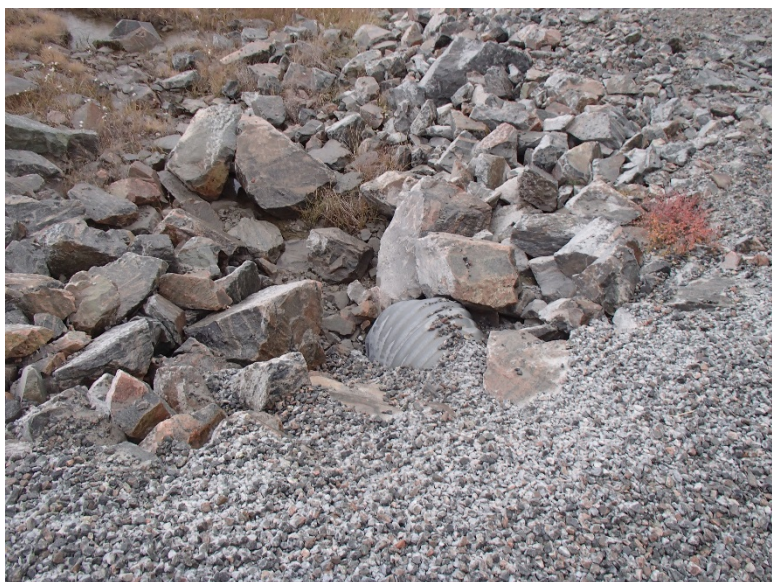
*Photograph D1-30: PC-4 km 14+910*

**Description:** View of the culvert outlet. In good condition. Large boulders around the outlet.

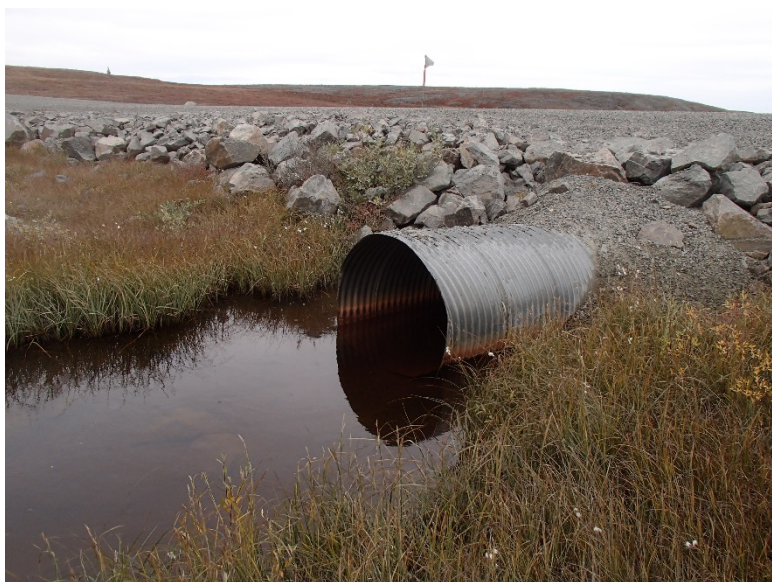
*Photograph D1-32: R-05A km 15+745*

**Description:** View of the culvert outlet. In good condition.

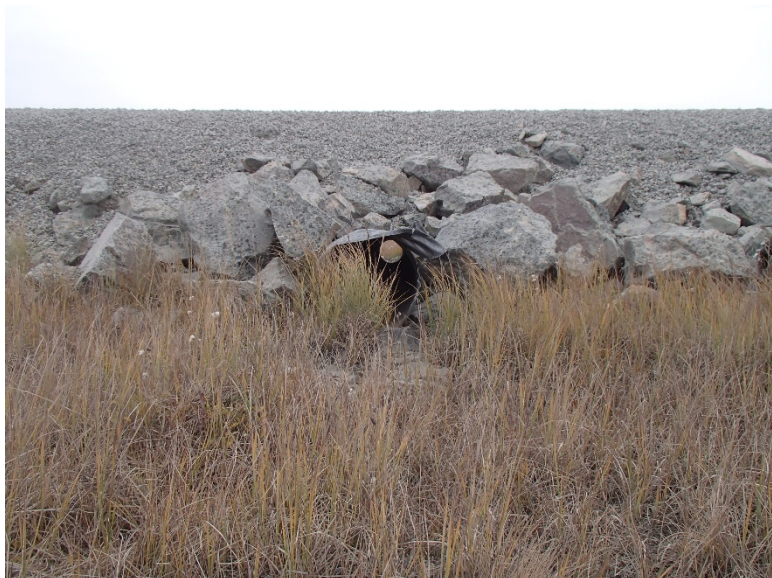
*Photograph D1-33: PC-5 km 18+280*

**Description:** View of the culvert inlet. In good condition.

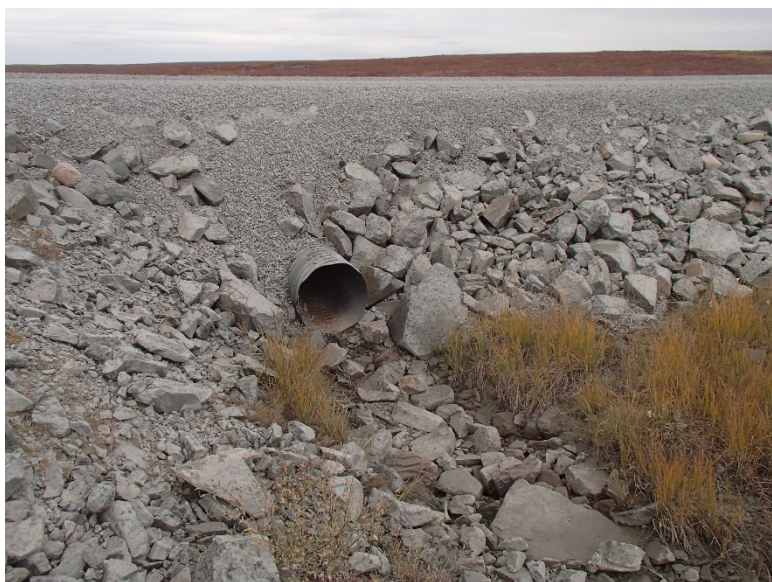
*Photograph D1-34: PC-5 km 18+280*

**Description:** View of the culvert outlet. In good condition.

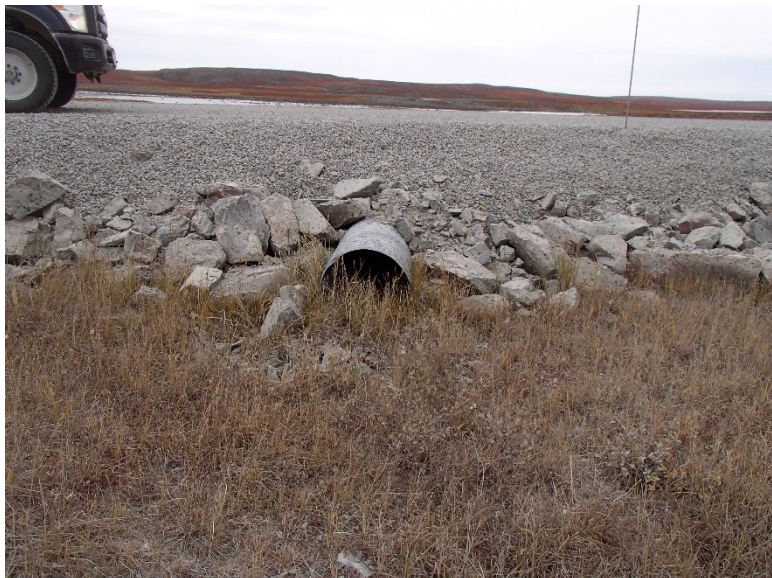
*Photograph D1-35: PC-6 km 18+900*

**Description:** View of culvert inlet. In good condition.

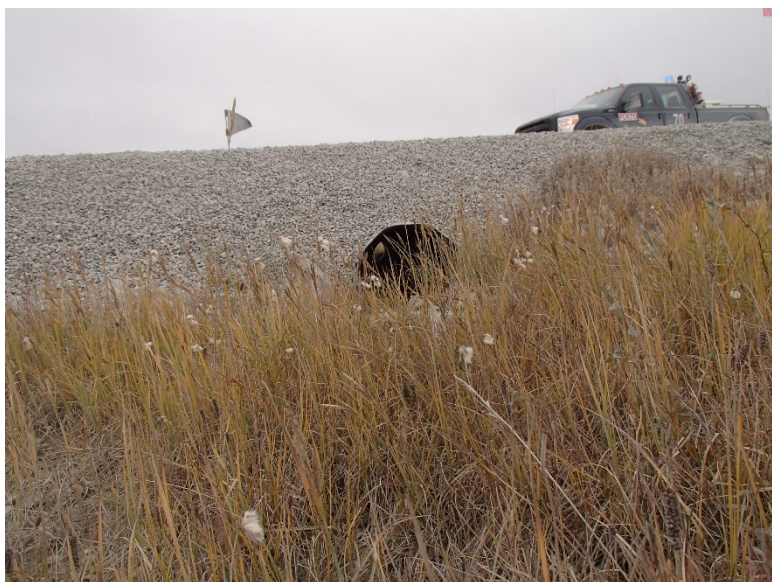
*Photograph D1-36: PC-6 km 18+900*

**Description:** View of culvert outlet. In good condition.

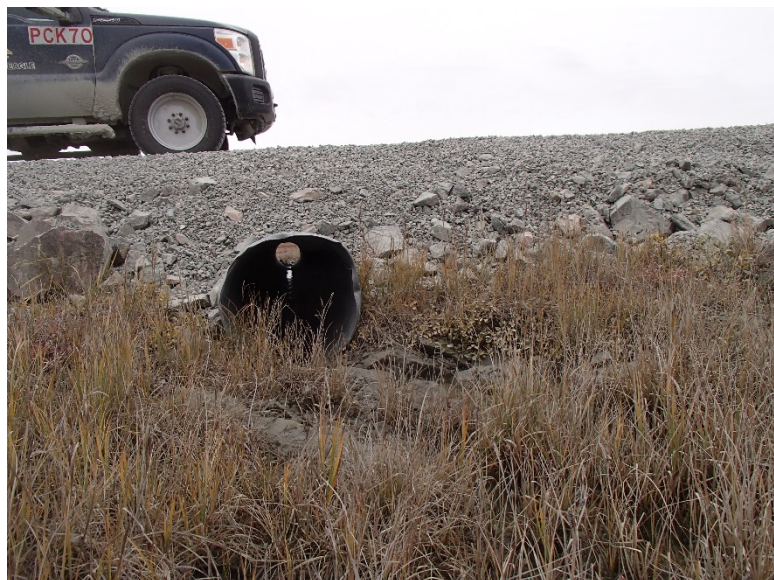
*Photograph D1-39: PC-7 km 20+250*

**Description:** View of the culvert inlet. In good condition.

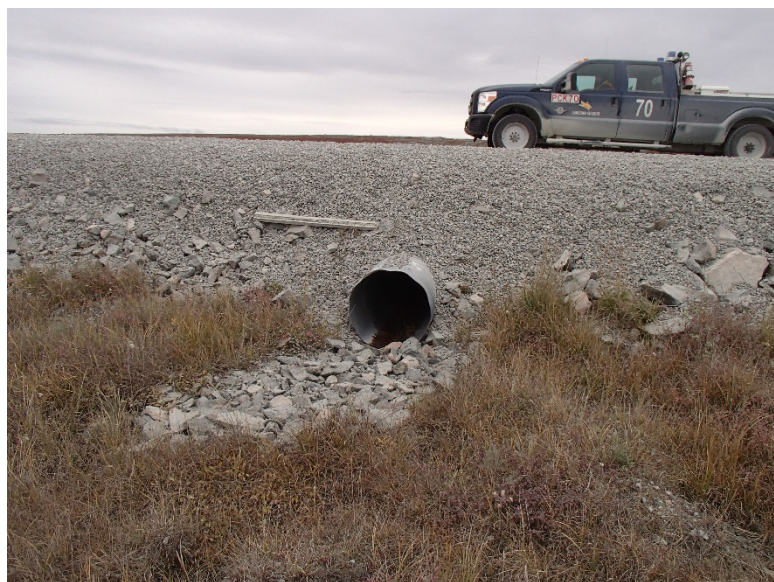
*Photograph D1-40: PC-7 km 20+250*

**Description:** View of the culvert outlet. In good condition.

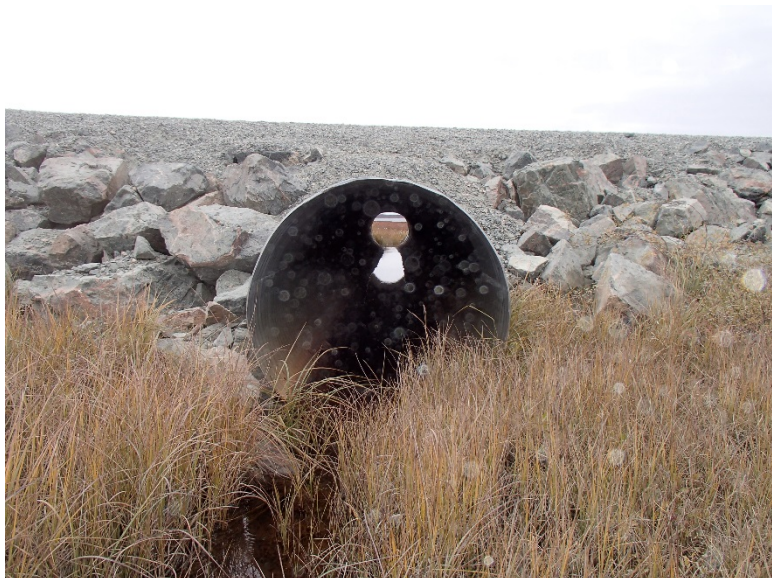
*Photograph D1-41: R-07 km 25+900*

**Description:** View of the culvert inlet. In good condition.

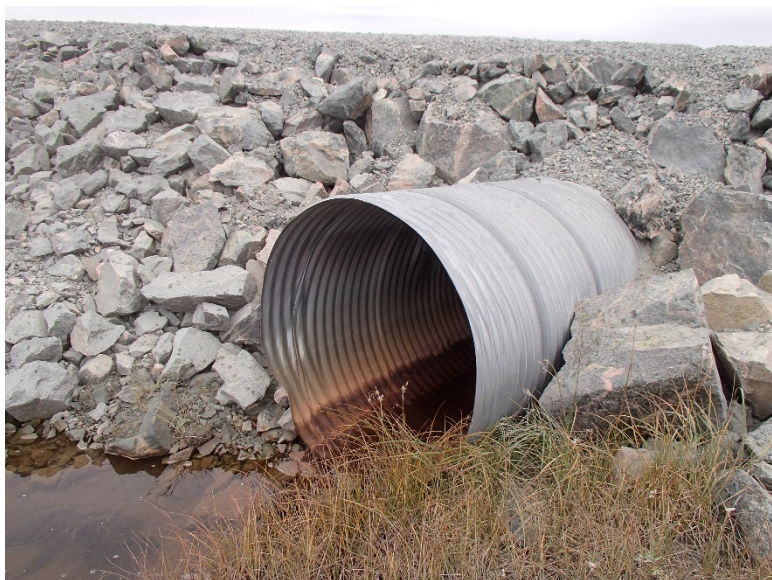
*Photograph D1-42: R-07 km 25+900*

**Description:** View of the culvert outlet. In good condition.

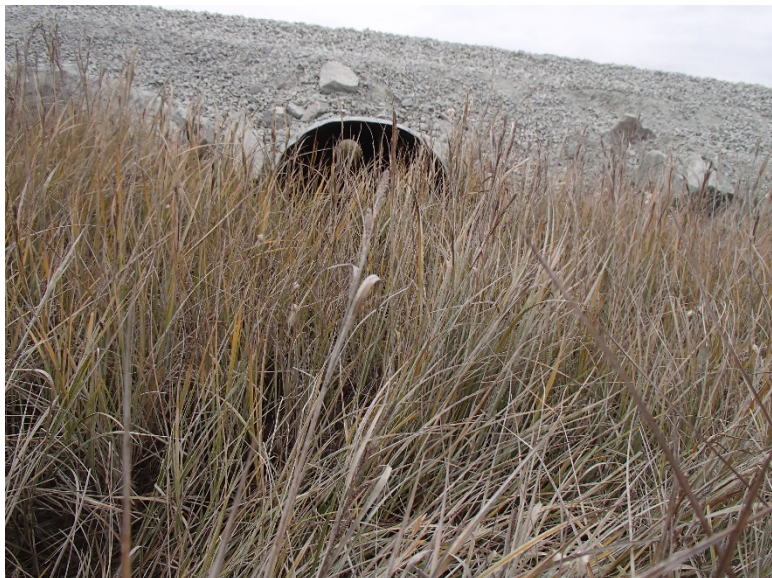
*Photograph D1-43: PC-8 km 29+420*

**Description:** View of the culvert inlet. In good condition.

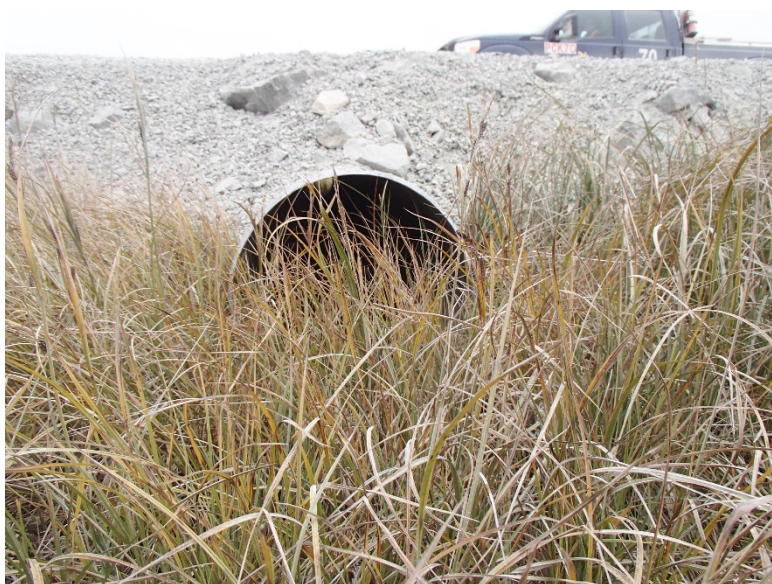
*Photograph D1-44: PC-8 km 29+420*

**Description:** View of the culvert outlet. In good condition.
