APPENDIX D1 CULVERTS ALONG AWPR PHOTOGRAPHIC LOG

2017 ANNUAL GEOTECHNICAL INSPECTION
MEADOWBANK GOLD MINE, NUNAVUT

APPENDIX D2

Bridges Along AWPR Photographic Log

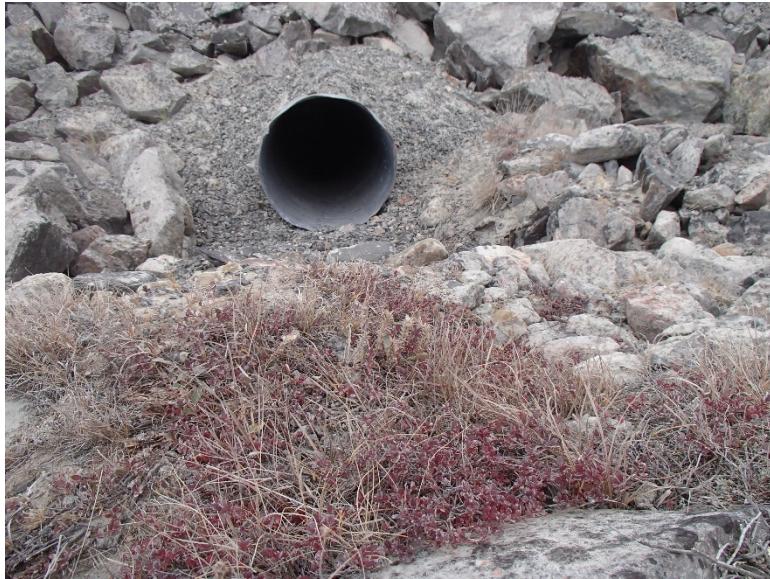
Photograph D1-45: PC-9 km 35+690

Description: View of the culvert inlet. In good condition.

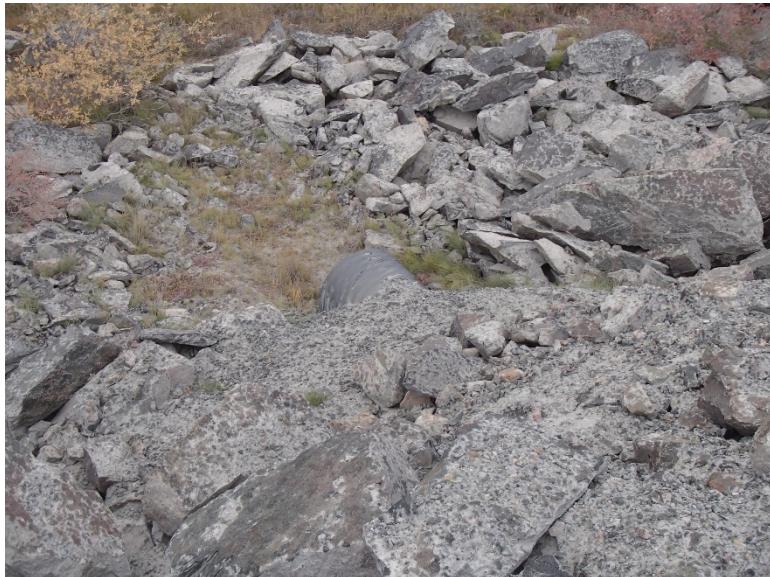
Photograph D1-46: PC-9 km 35+690

Description: View of the culvert outlet. In good condition.

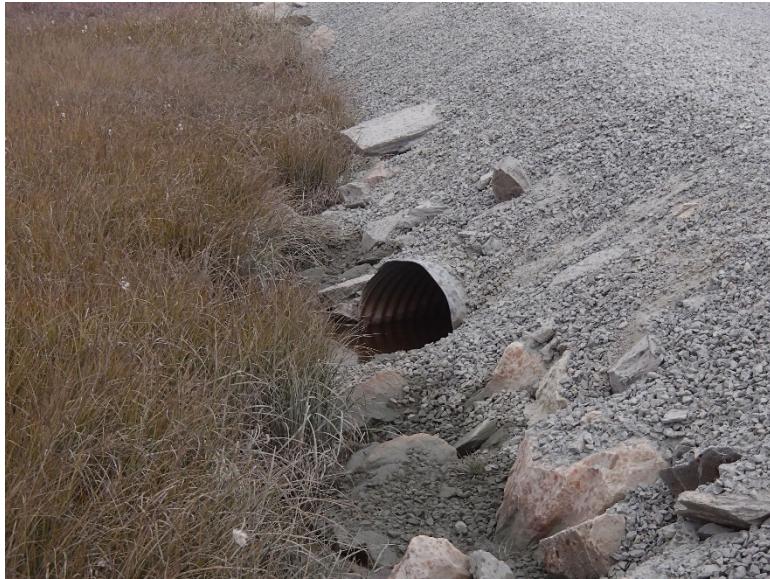
Photograph D1-47: PC-10 km 36+865

Description: View of the culvert inlet. In good condition.

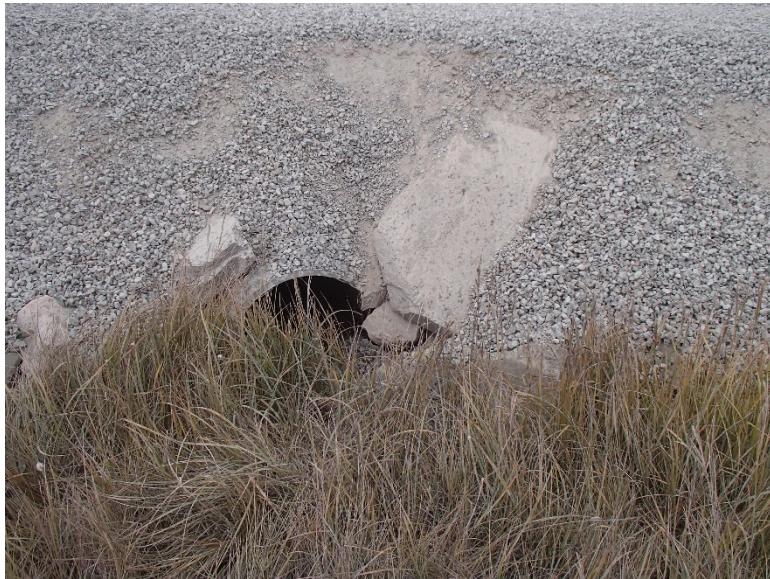
Photograph D1-48: PC-10 km 36+865

Description: View of the culvert outlet. The outlet is partially buried.

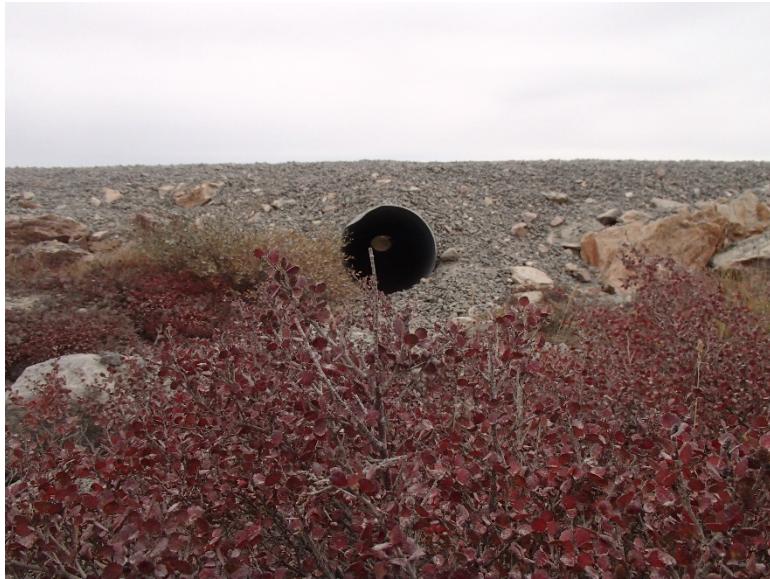
Photograph D1-49: PC-11 km 39+552

Description: View of the culvert inlet. The inlet is too high and water is flowing underneath.

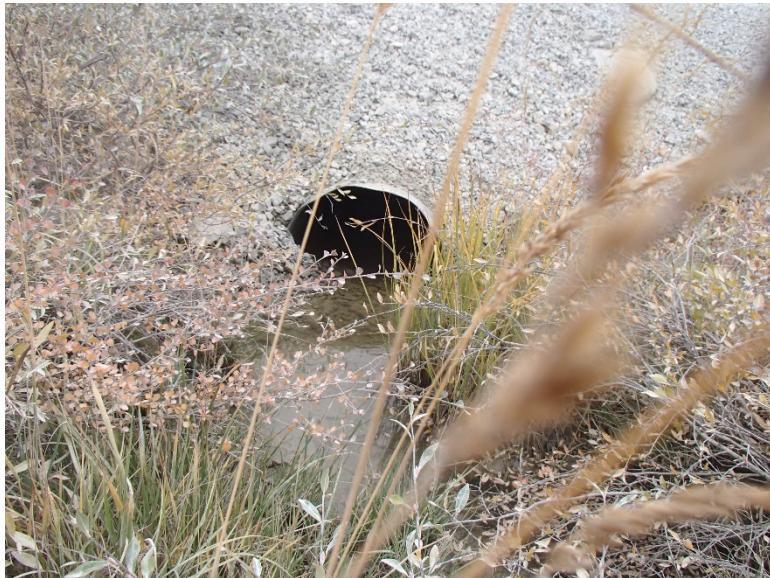
Photograph D1-50: PC-11 km 39+552

Description: View of the culvert outlet. In good condition, almost submerged.

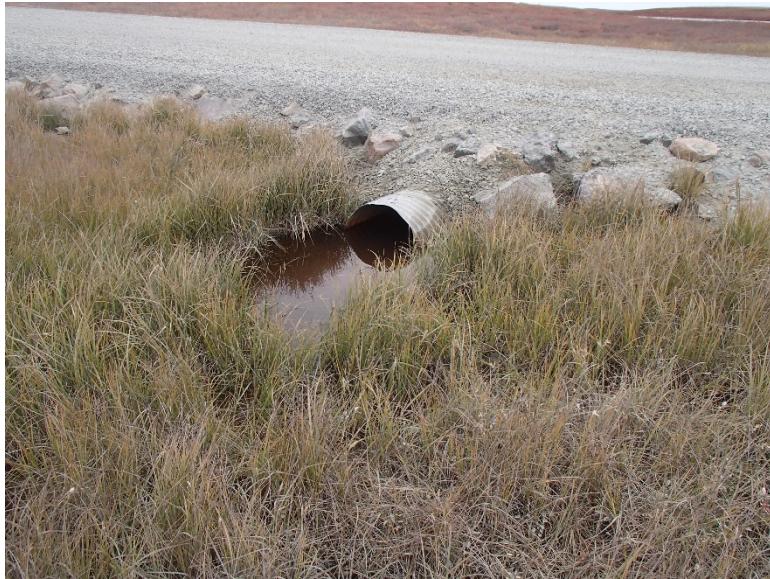
Photograph D1-51: PC-12 km 41+300

Description: View of the culvert inlet. In good condition, almost submerged.

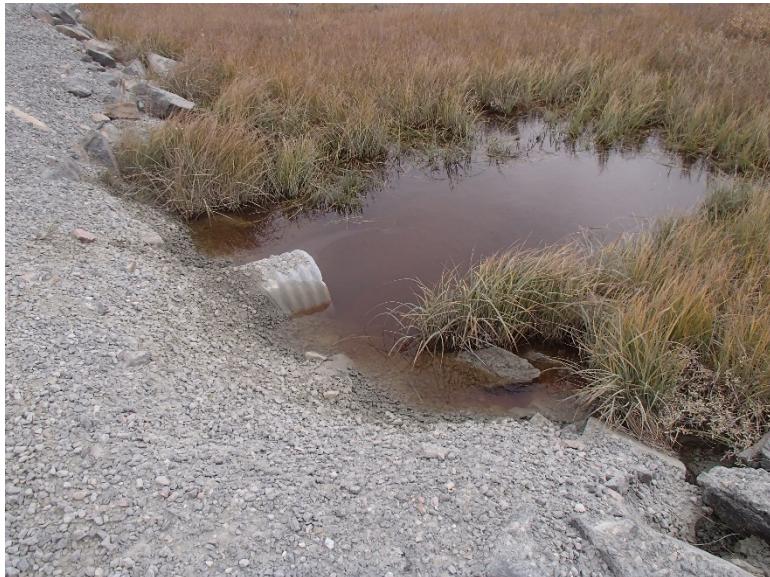
Photograph D1-52: PC-12 km 41+300

Description: View of the culvert outlet. In good condition, almost submerged.

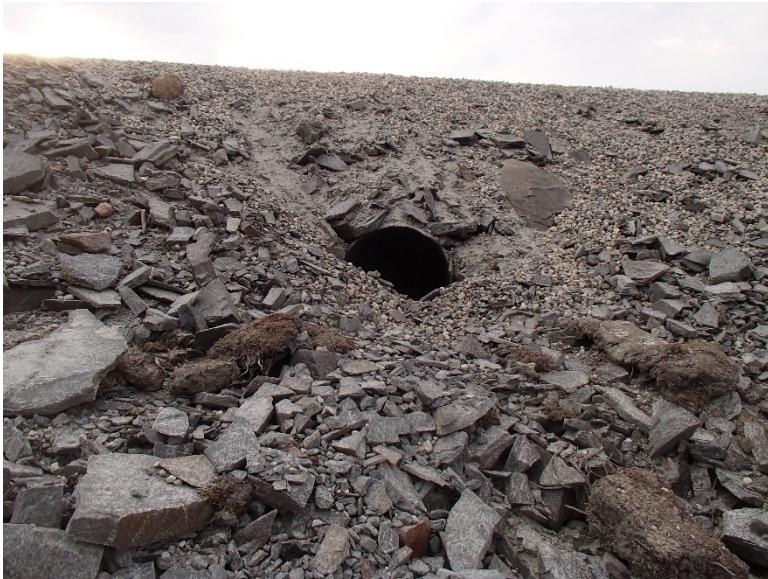
Photograph D1-53: PC-16 km 41+300

Description: View of the culvert inlet. In good condition. Outlet is buried (no photo) and must be cleaned.

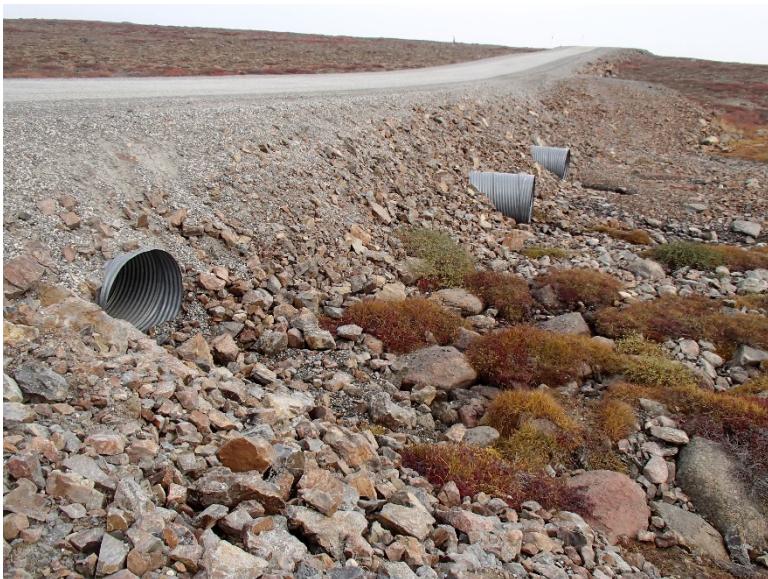
Photograph D1-54: R-14 km 67+840

Description: View of the inlet culverts. Middle and northern culverts are collapsed inside (hole in the middle). Expected to continue performing well.

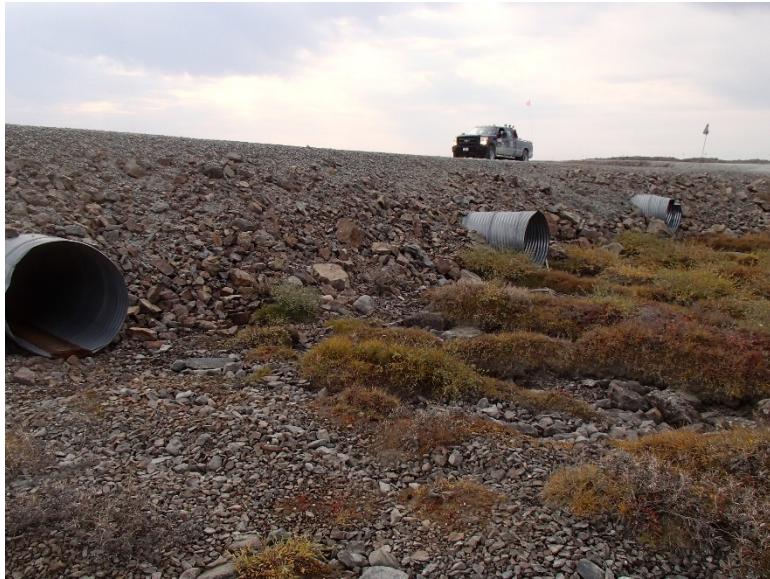
Photograph D1-55: R-14 km 67+840

Description: View of the outlet culverts. The middle and northern culverts show small signs of erosion at the outlet and these culverts are collapsed inside (hole in the middle). Expected to continue performing well.

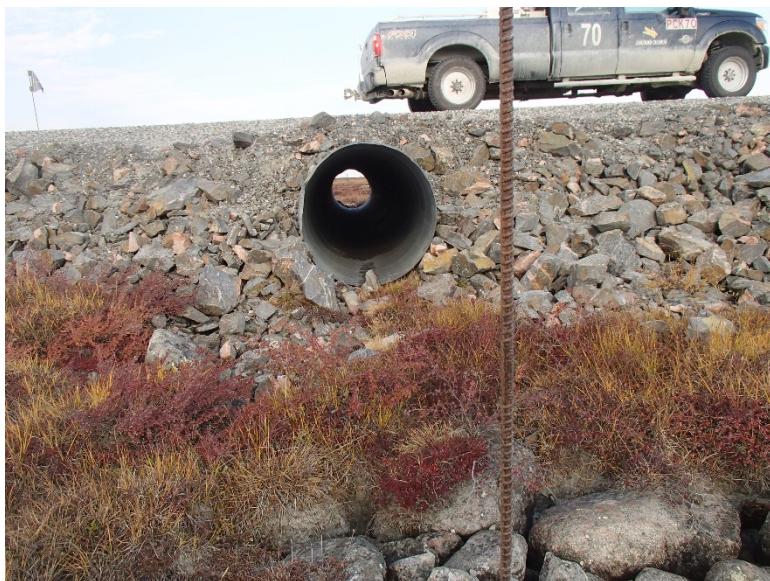
Photograph D1-56: R-17 km 77+440

Description: View of the culvert inlet. In good condition.

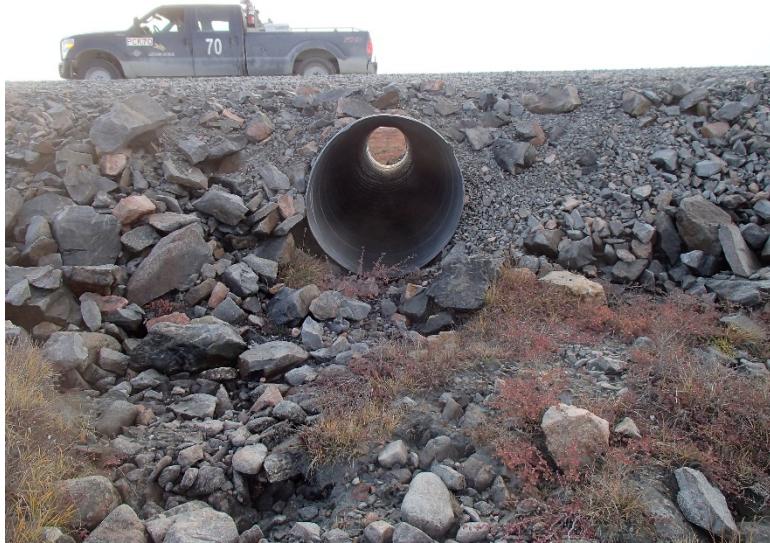
Photograph D1-57: R-17 km 77+440

Description: View of the culvert outlet. In good condition.

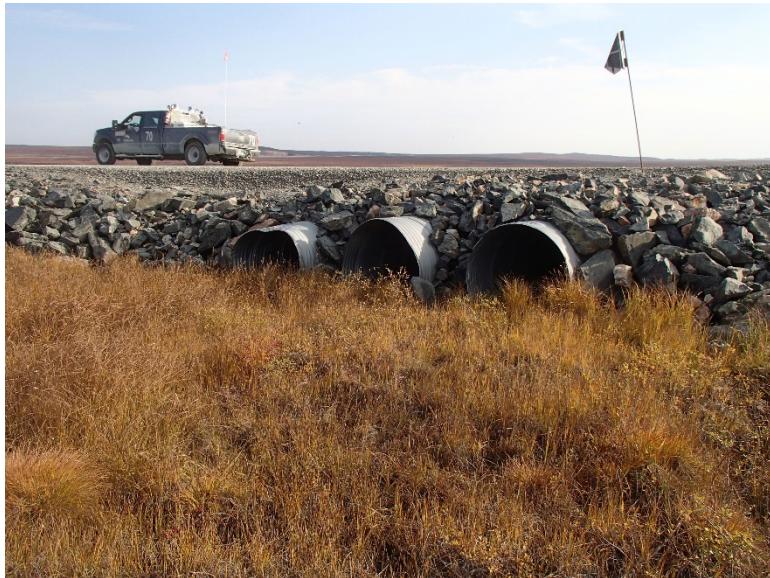
Photograph D1-58: R-18A km 80+950

Description: View of the culverts inlet. In good condition. The southern culvert inlet is partially buried.

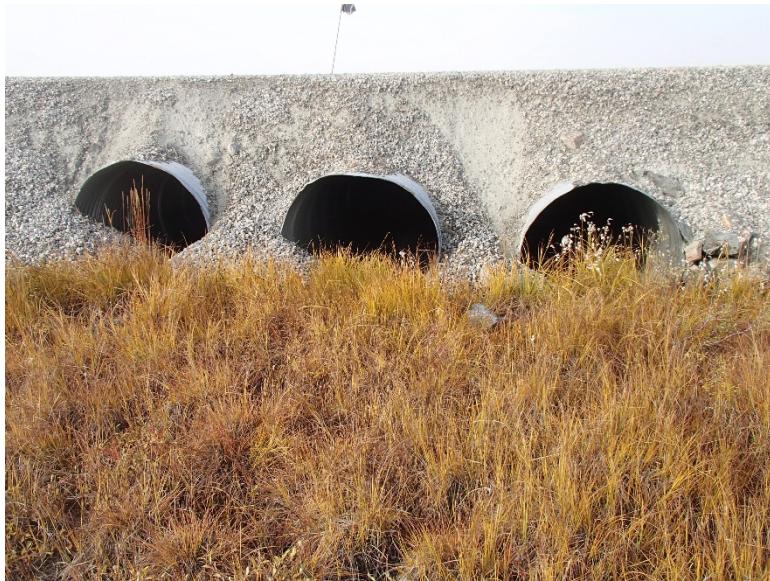
Photograph D1-59: R-18A km 80+950

Description: View of the culverts outlet. In good condition.

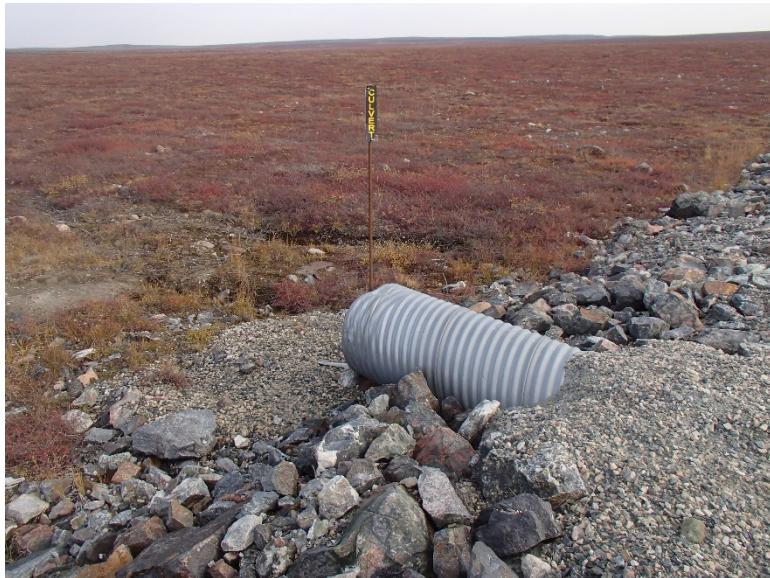
Photograph D1-60: R-18B km 80+950

Description: View of the culverts inlet. In good condition, installed above the ground surface.

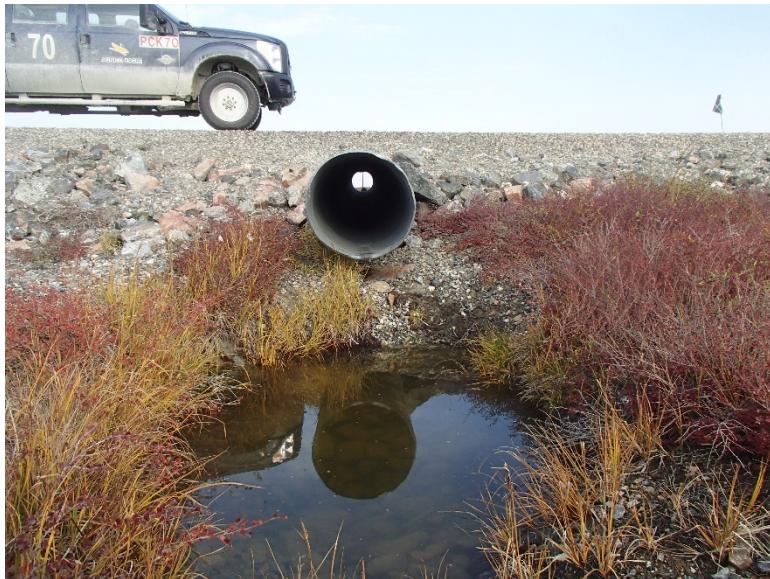
Photograph D1-61: R-18B km 80+950

Description: View of the culverts outlet. In good condition, installed above the ground surface.

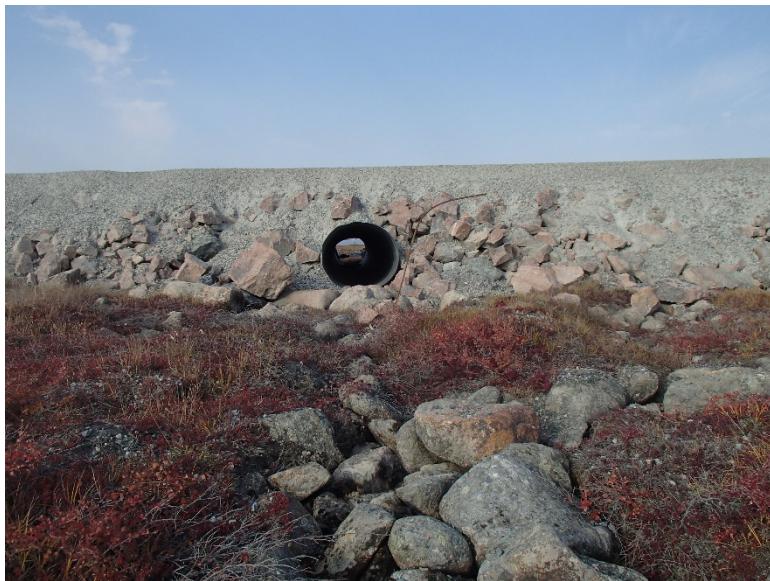
Photograph D1-62: R-20 km 85+490

Description: View of the culvert inlet. The middle of the culvert is slightly collapsed. The inlet is installed above the ground surface and water flows beneath the culvert. The culvert is in stable condition.

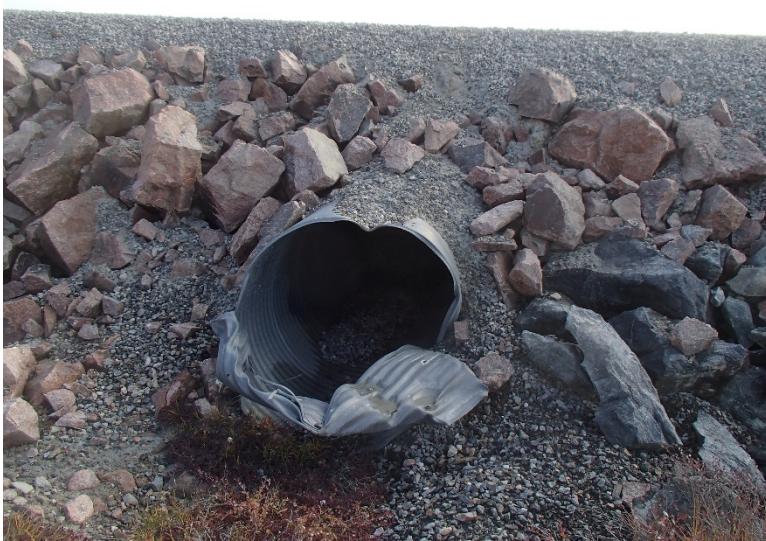
Photograph D1-63: R-20 km 85+490

Description: View of the culvert outlet. Outlet is a little bit twisted. The middle of the culvert is slightly collapsed. Water flows beneath the culvert. The culvert is in stable condition.

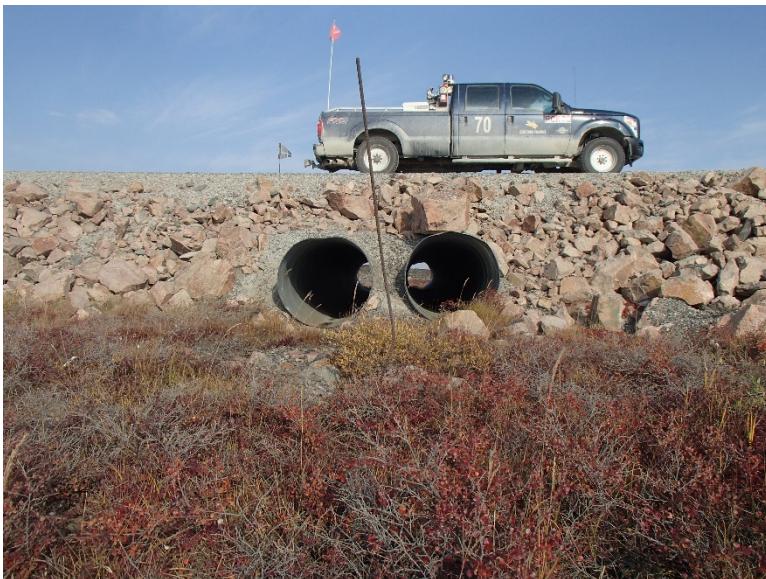
Photograph D1-64: R-21 km 87+300

Description: View of the culverts inlet. Both culverts are slightly collapsed in the middle. In stable condition, but should have been installed lower to avoid erosion issue.

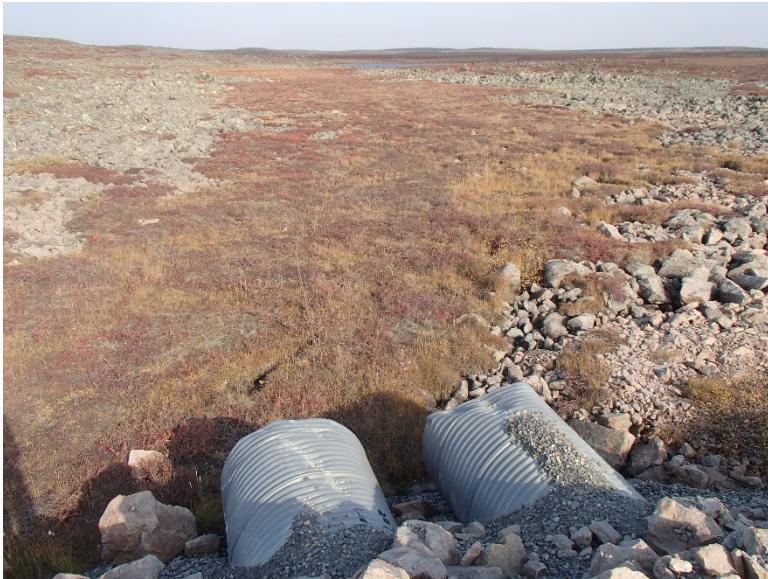
Photograph D1-65: R-21 km 87+300

Description: View of the culverts outlet. Both culverts are slightly collapsed in the middle. In stable condition, but should have been installed lower to avoid erosion issue.

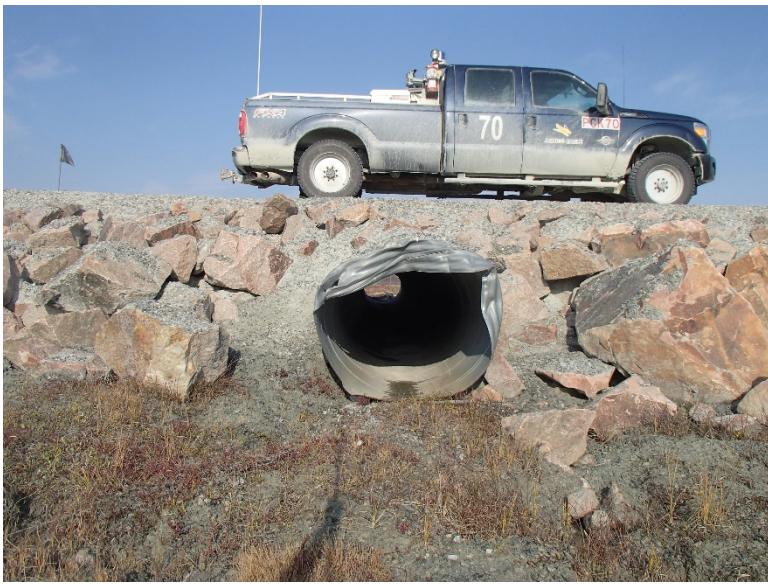
Photograph D1-66: R-23 km 93+600

Description: View of the culvert inlet. The culvert is installed too high and there is a low flow of water through the road rockfill. In good condition.

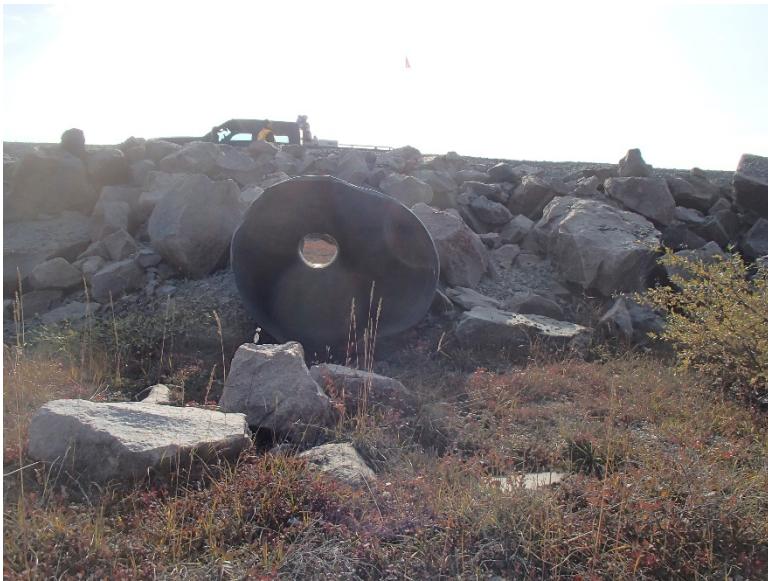
Photograph D1-67: R-23 km 93+600

Description: View of the culvert outlet. The culvert is installed too high and there is a low flow of water through the road rockfill. In good condition.

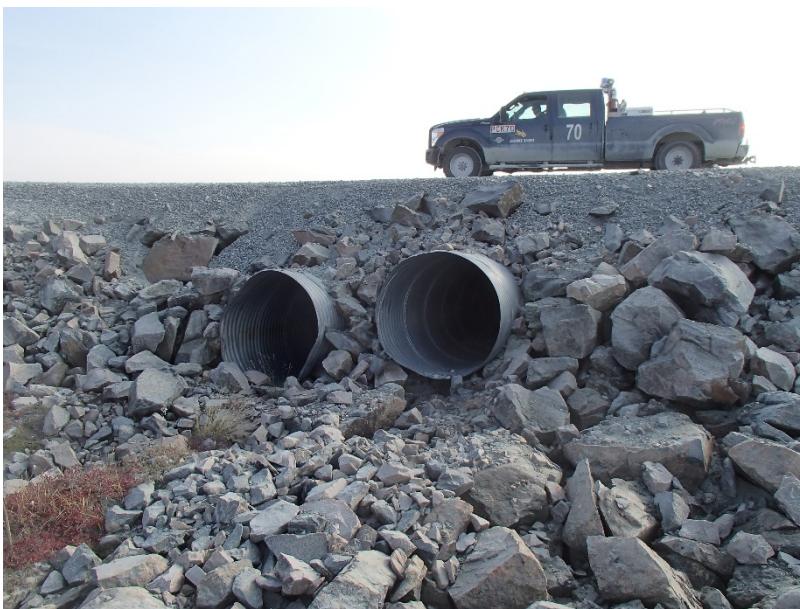
Photograph D1-68: R-24 km 98+100

Description: View of the culverts inlet. South inlet is installed too high. Both culverts show deformation in the upper part.

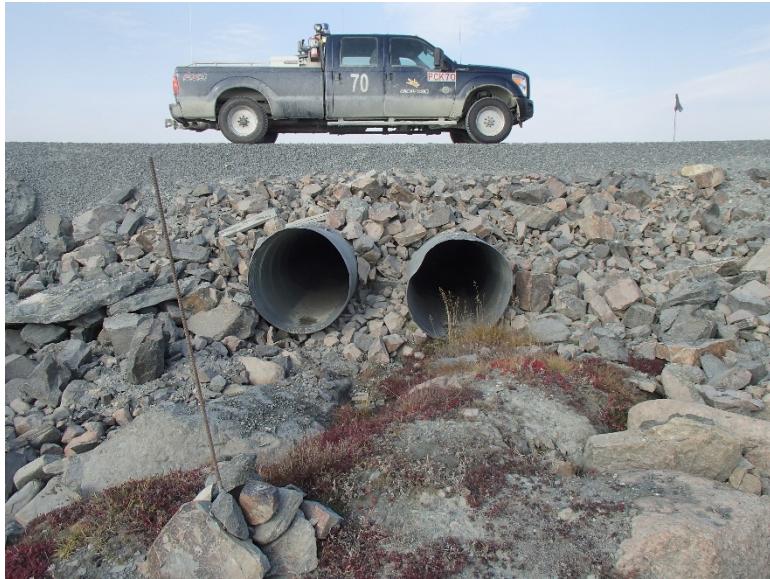
Photograph D1-69: R-24 km 98+100

Description: View of the culverts outlet. Both outlets are installed too high. The outlet of the southern culvert (left) shows signs of erosion. Both culverts show deformation in the upper part.

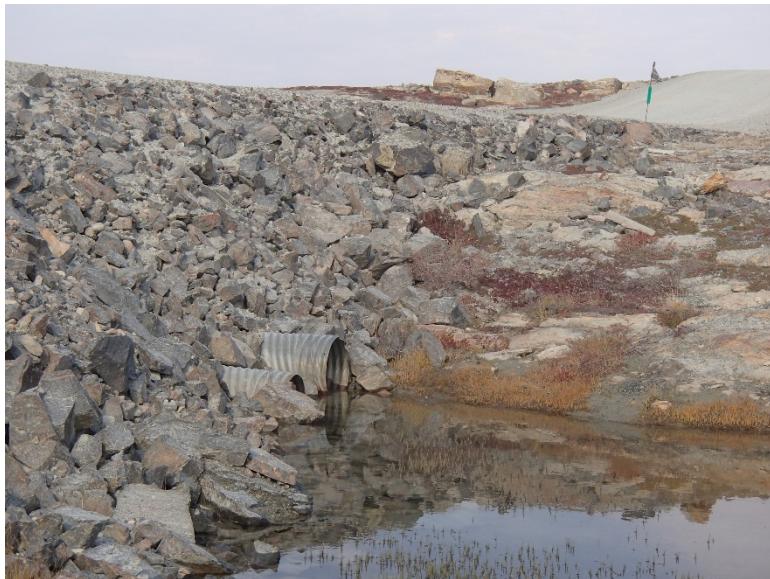
Photograph D1-70: R-25 km 101+950

Description: View of the culverts inlet. In good condition.

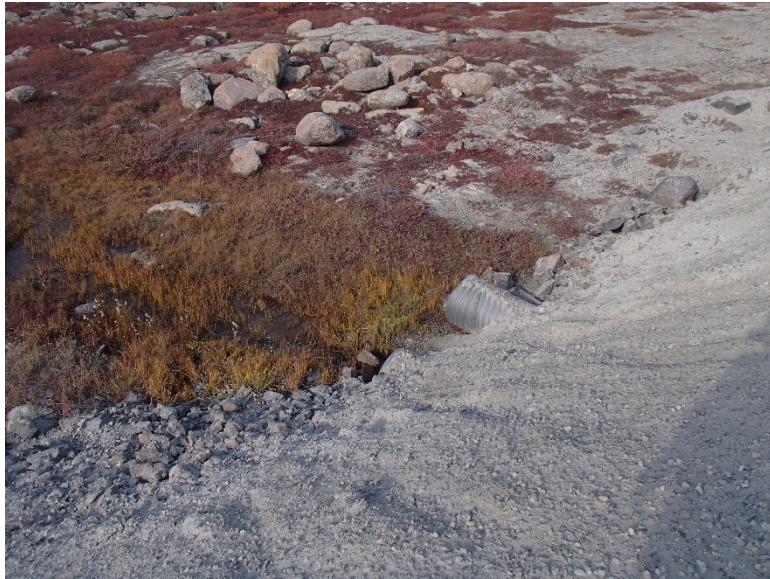
Photograph D1-71: R-25 km 101+950

Description: View of the culverts outlet. In good condition.

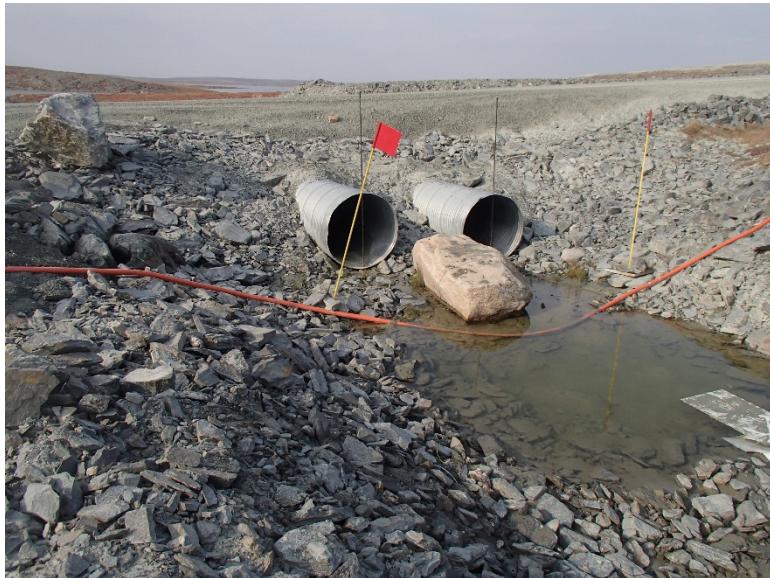
Photograph D1-72: R-26 km 104+400

Description: View of the culverts outlet. In good condition.

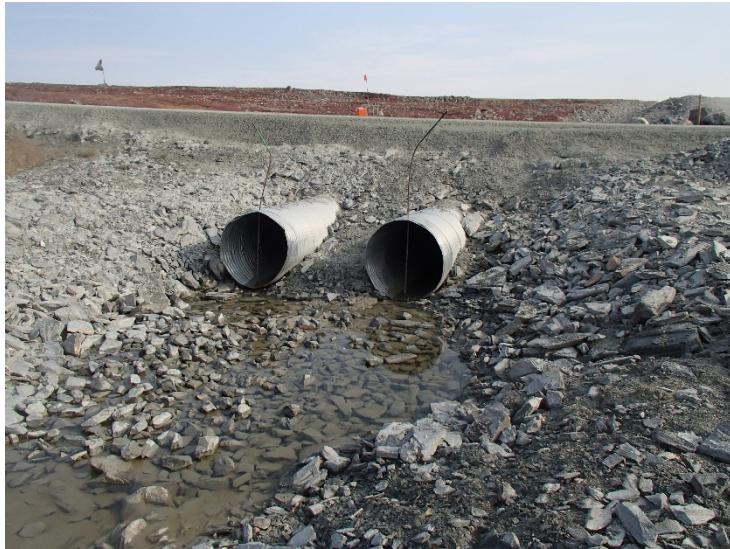
Photograph D1-73: R-26 km 104+400

Description: View of the culverts inlet. In good condition. In good condition.
