## APPENDIX D2

### BRIDGES ALONG AWPR PHOTOGRAPHIC LOG

# **APPENDIX E**

## **Amaruq Road Photographic Log**

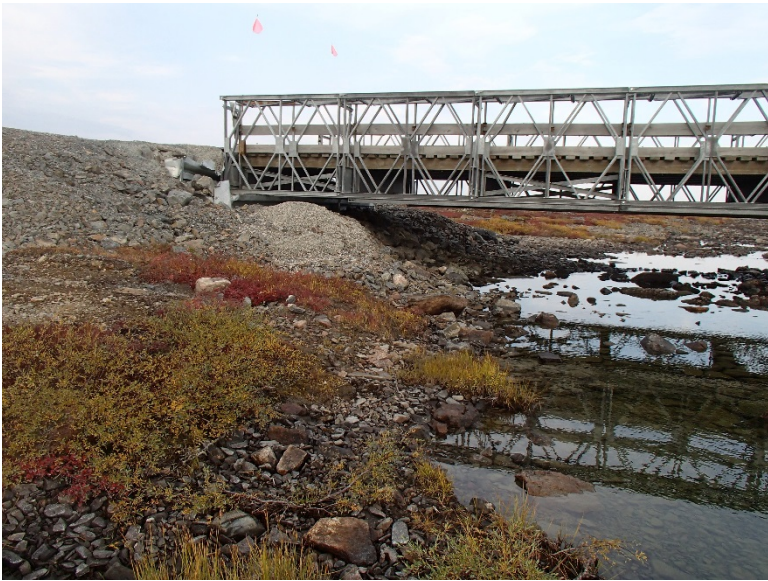
*Photograph D2-19 Bridges 6 – R15 km 69+200*

**Description:** Looking at the south abutment from downstream. Damage to the bin wall likely caused during snow removal activities. Bridge is tipping toward the west side on the abutment.
