## APPENDIX E2 BRIDGES ALONG AMARUQ ROAD PHOTOGRAPHIC LOG

2017 ANNUAL GEOTECHNICAL INSPECTION  
MEADOWBANK GOLD MINE, NUNAVUT

### Quarries along the AWPR Photographic Log

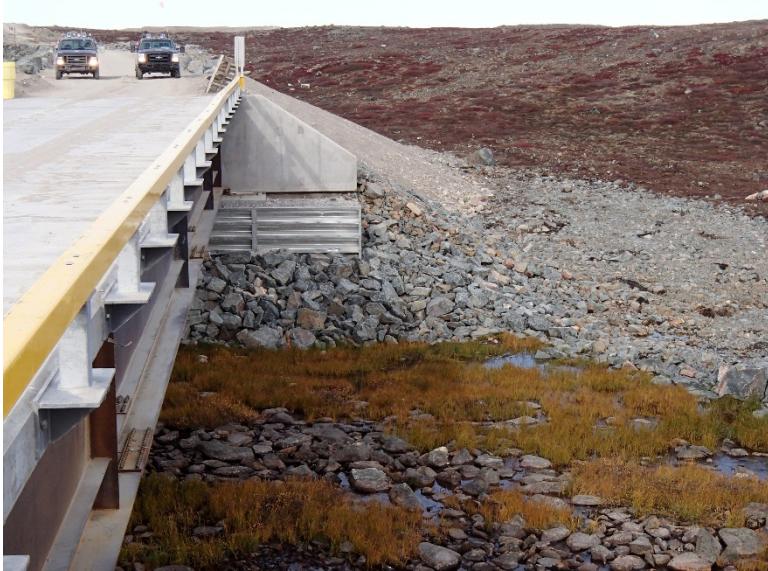
Photograph E2-33 Bridges 9 – km 44+800

Description: Looking at the north abutment from upstream.

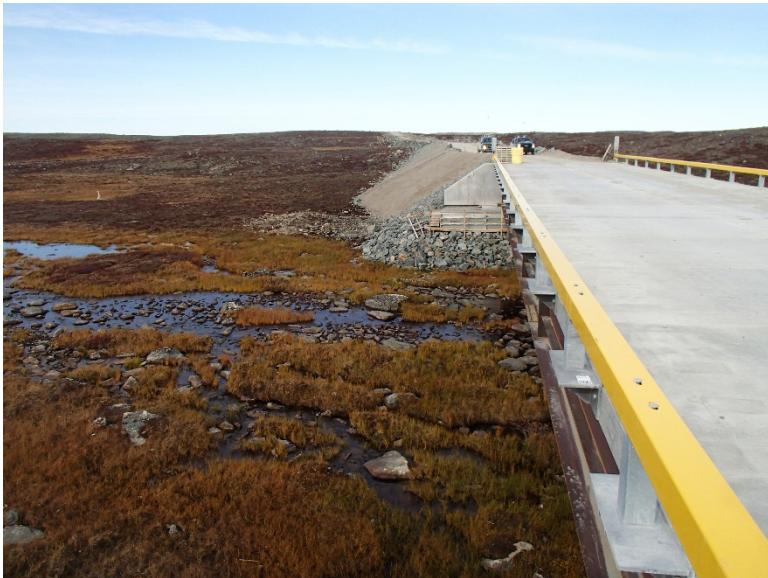
Photograph E2-34 Bridges 9 – km 44+800

Description: Looking at the north abutment from downstream.

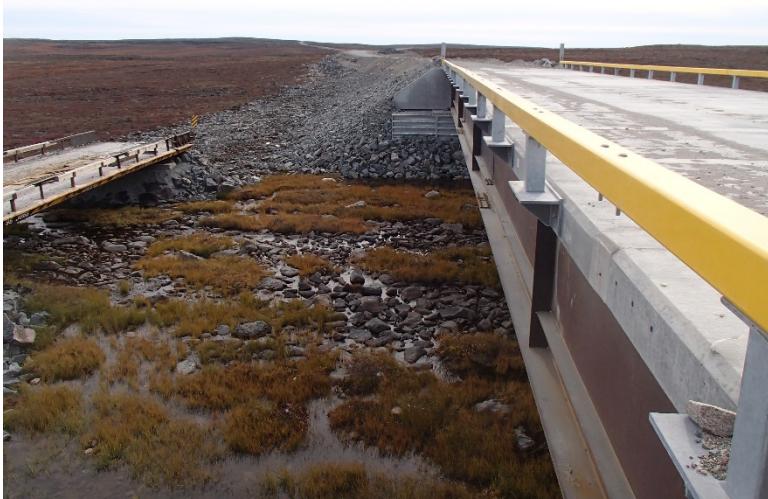
Photograph E2-35 Bridges 9 – km 44+800

**Description:** Looking at the south abutment from upstream.

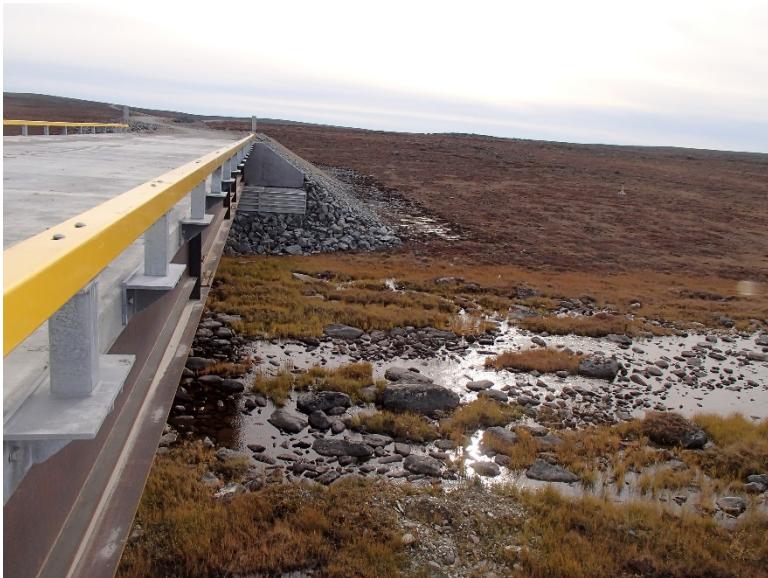
Photograph E2-36 Bridges 9 – km 44+800

**Description:** Looking at the south abutment from downstream.

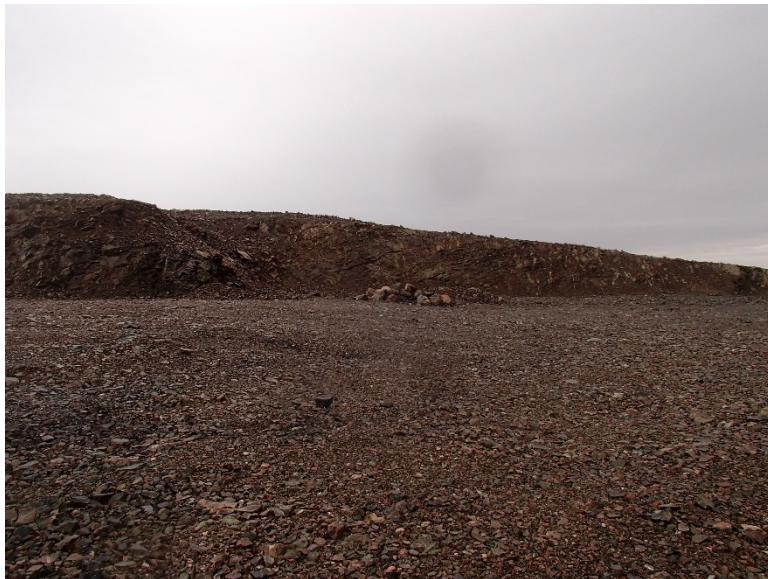
*Photograph F1-1: Quarry 1 – km 5+200*

**Description:** View of south walls.

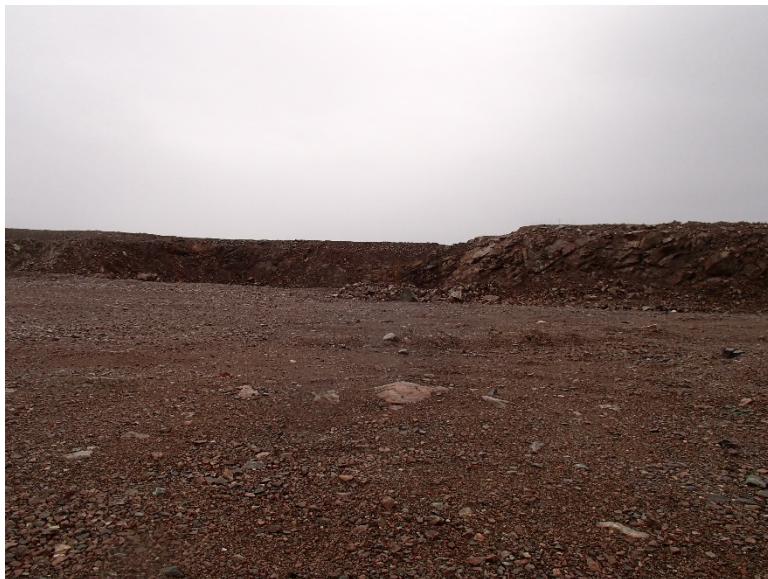
*Photograph F1-2: Quarry 1 – km 5+200*

**Description:** View of south and east walls.

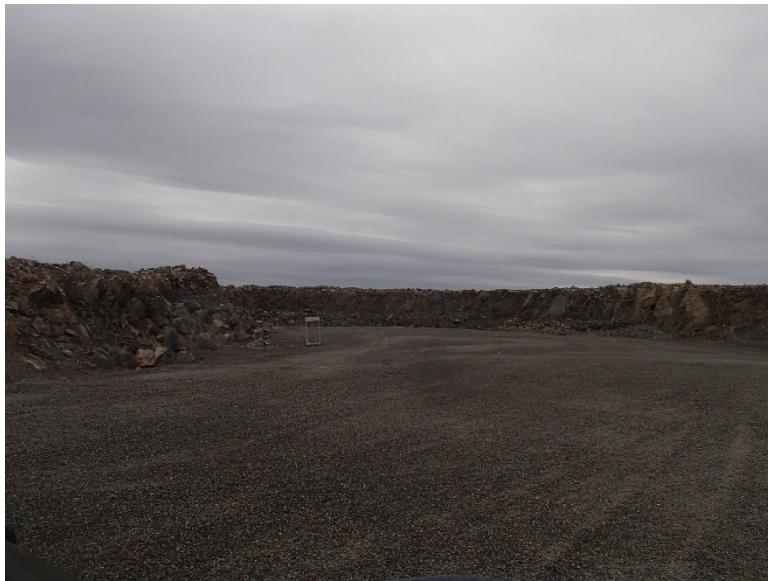
*Photograph F1-3: Quarry 2 – km 13+250*

**Description:** View of north and west walls.

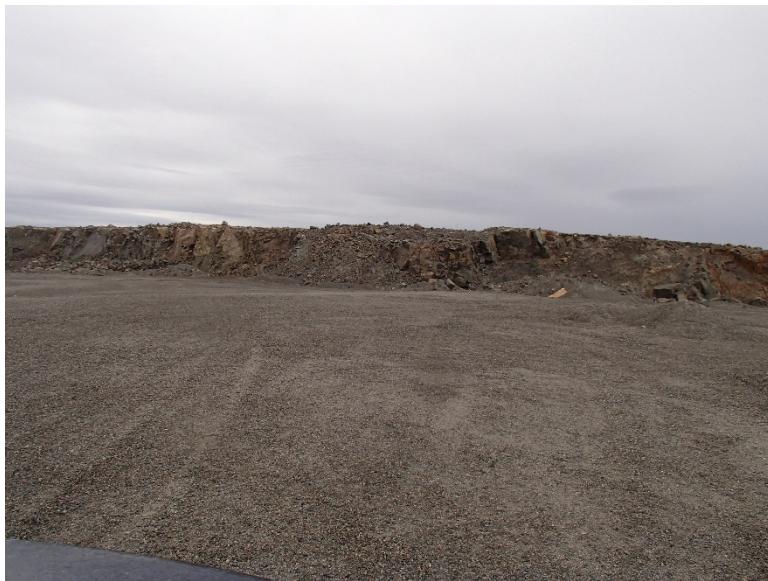
*Photograph F1-4: Quarry 2 – km 13+250*

**Description:** View of north and east walls.

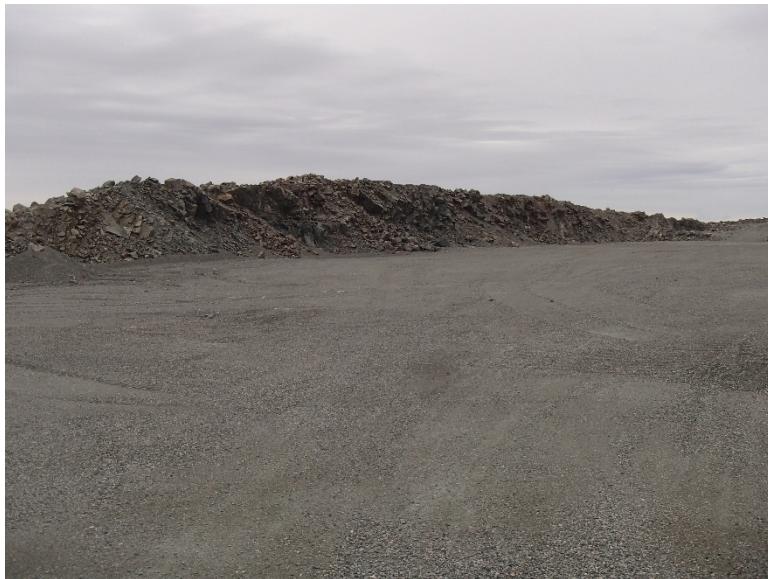
*Photograph F1-5: Quarry 3 – km 23+700*

**Description:** View of east wall.

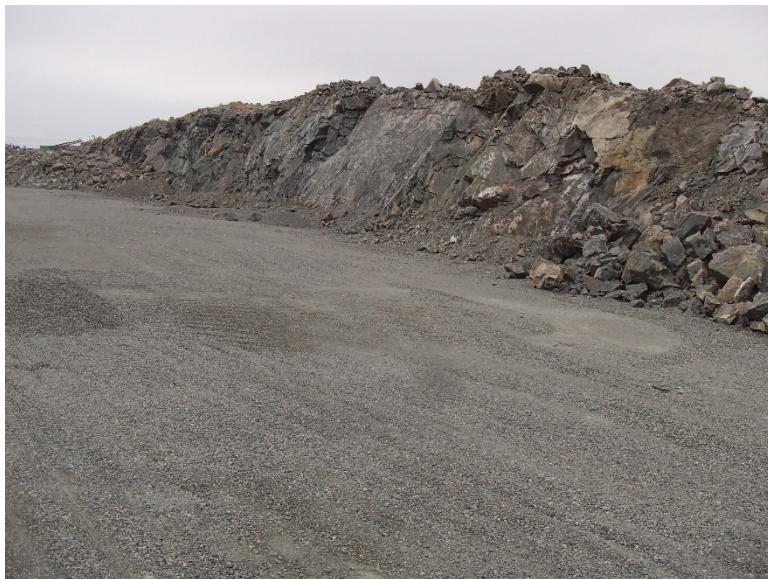
*Photograph F1-6: Quarry 3 – km 23+700*

**Description:** View of west wall. Presence of loose rock along steep wall.

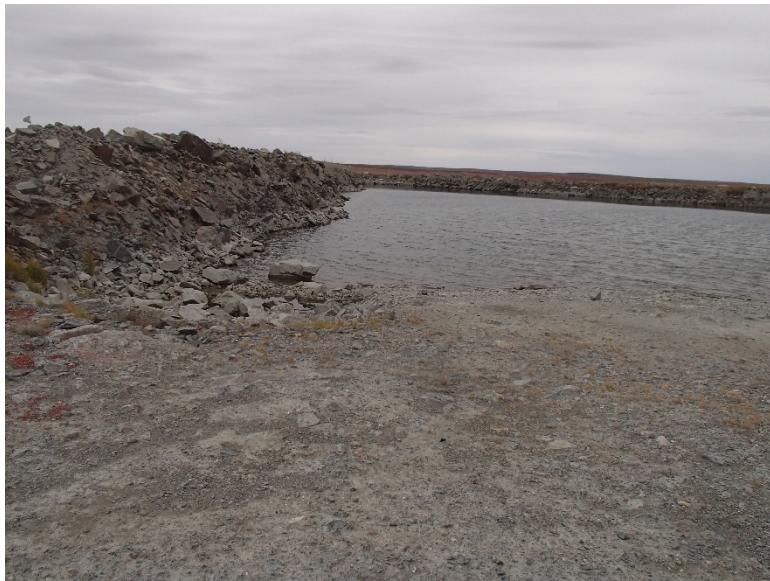
*Photograph F1-7: Quarry 4 – km 31+300*

**Description:** View of the east and south walls of Quarry 4. The quarry is flooded.

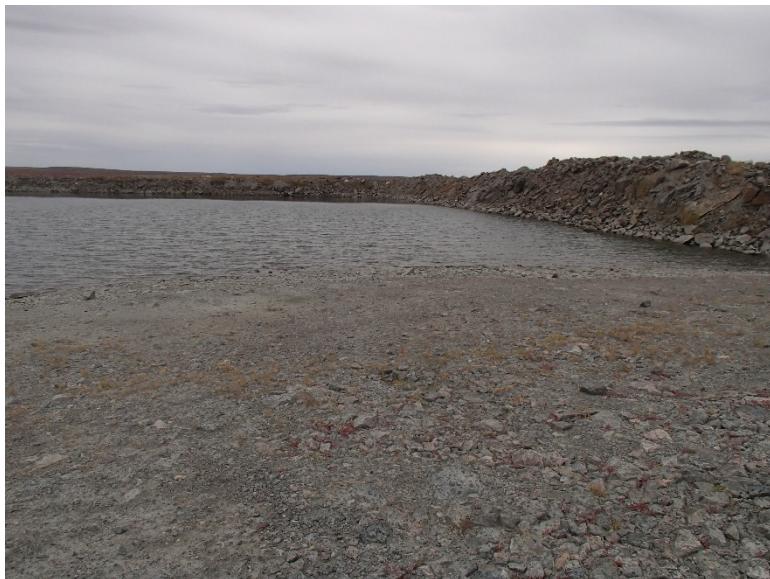
*Photograph F1-8: Quarry 4 – km 31+300*

**Description:** View of the west and south walls of Quarry 4. The quarry is flooded.

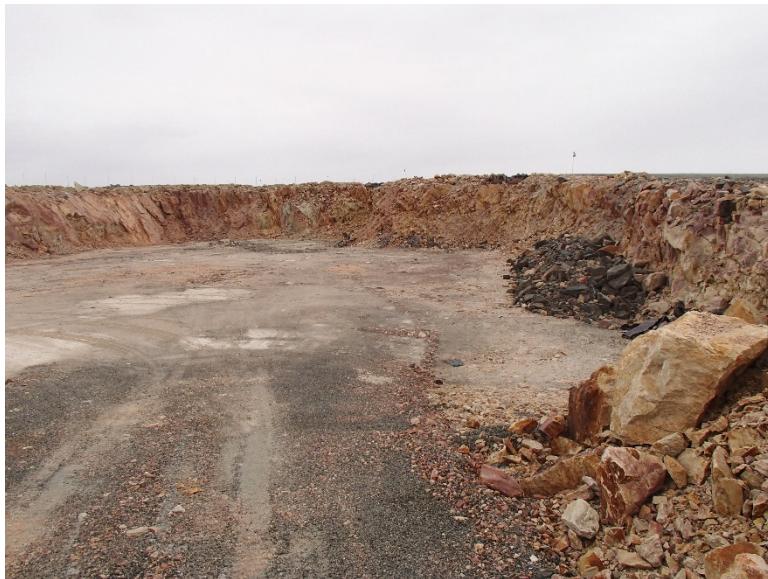
*Photograph F1-9: Quarry 5 – km 34+650*

**Description:** View of north and east walls.

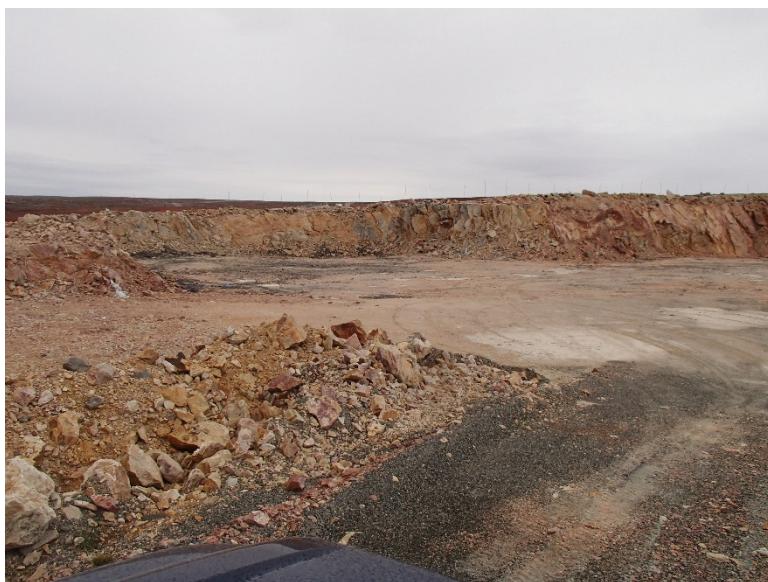
*Photograph F1-10: Quarry 5 – km 34+650*

**Description:** View of north and west walls.

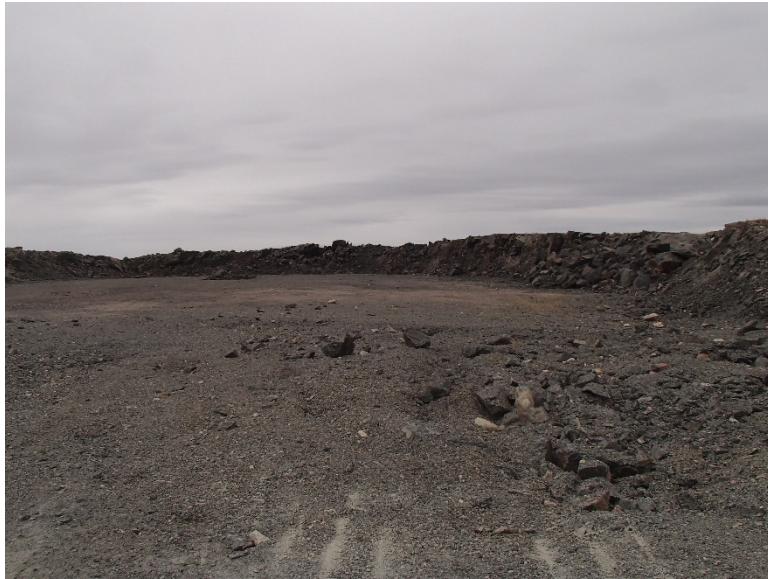
*Photograph F1-11: Quarry 6 – km 36+470*

**Description:** View of south and west walls.

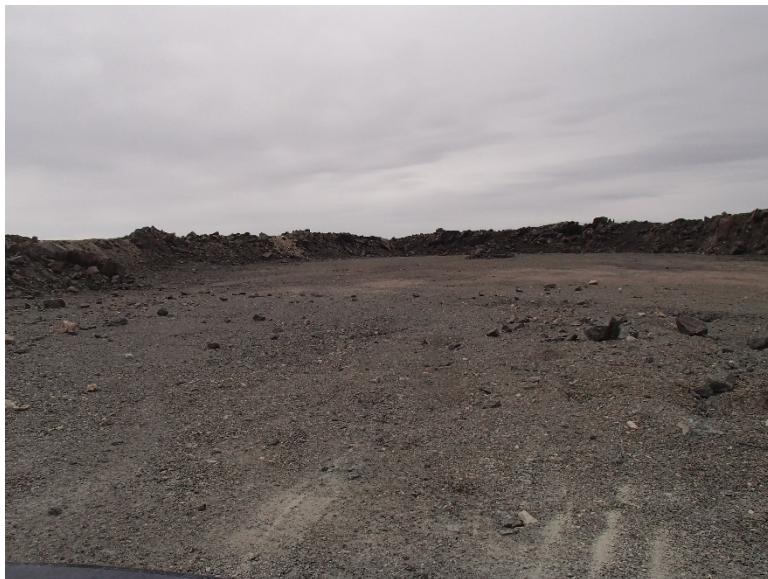
*Photograph F1-12: Quarry 6 – km 36+470*

**Description:** View of south and east walls.

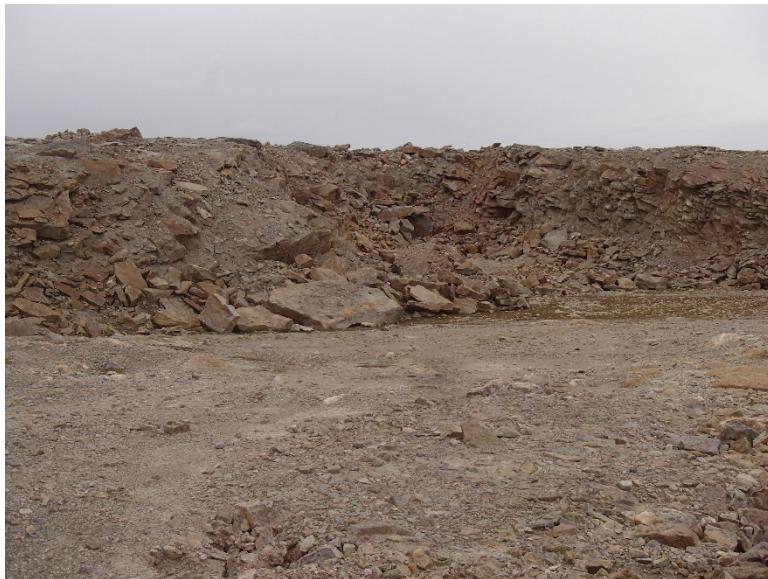
*Photograph F1-13: Quarry 7 – km 39+800*

**Description:** View of west wall. Presence of loose blocks.

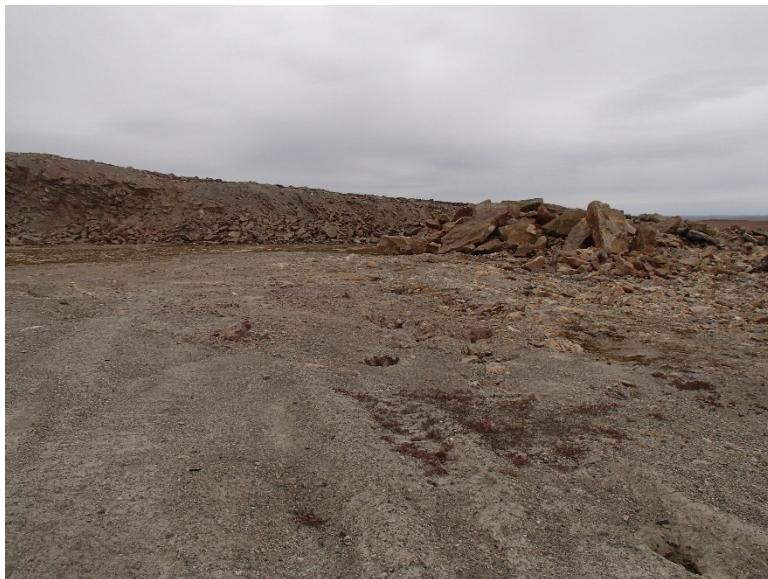
*Photograph F1-14: Quarry 7 – km 39+800*

**Description:** View of north wall. Loose blocks were removed.

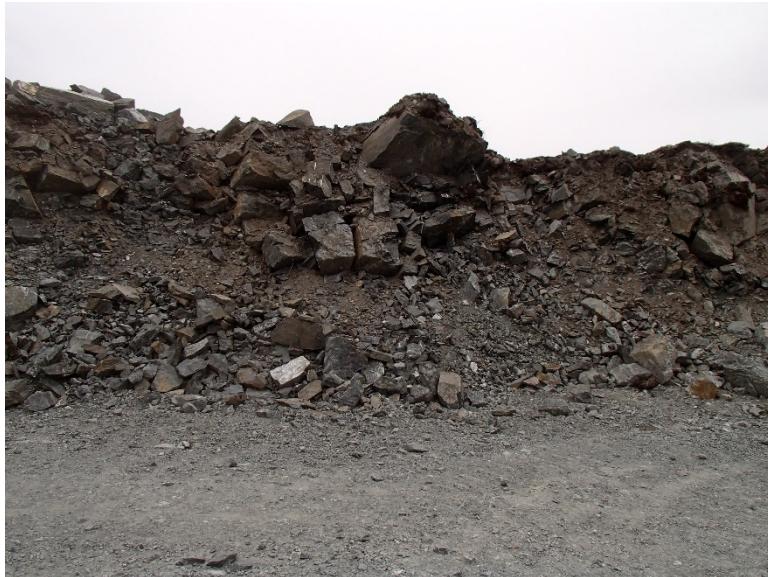
*Photograph F1-15: Quarry 8 – km 42+950*

**Description:** View of south wall. Presence of loose blocks.

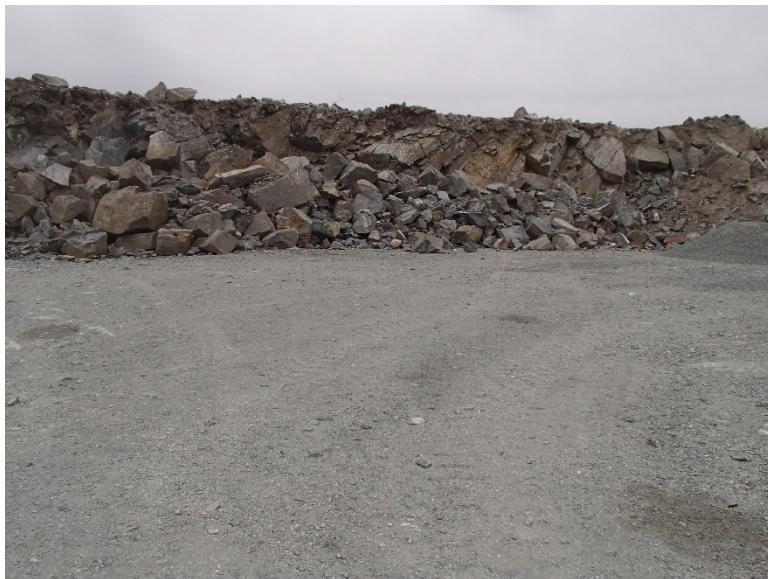
*Photograph F1-16: Quarry 8 – km 42+950*

**Description:** View of west wall.

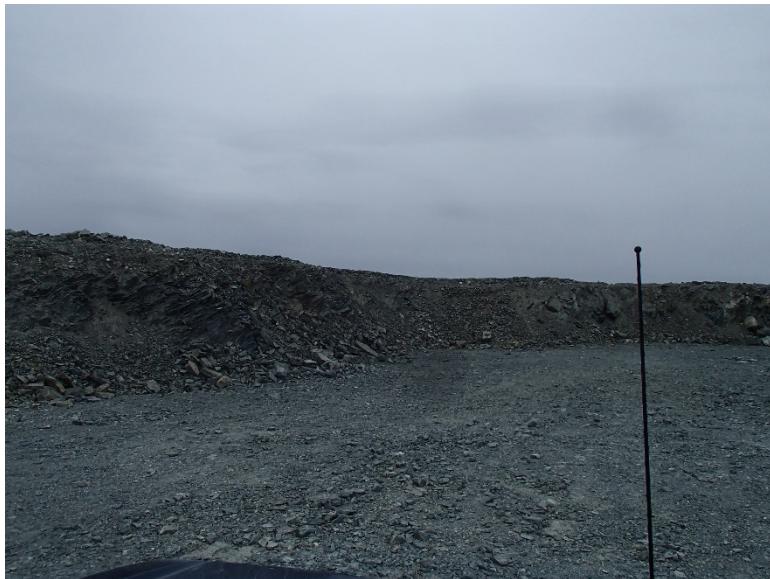
*Photograph F1-17: Quarry 9 – km 44+600*

**Description:** View of west and south walls. Presence of loose blocks at the base of the wall.

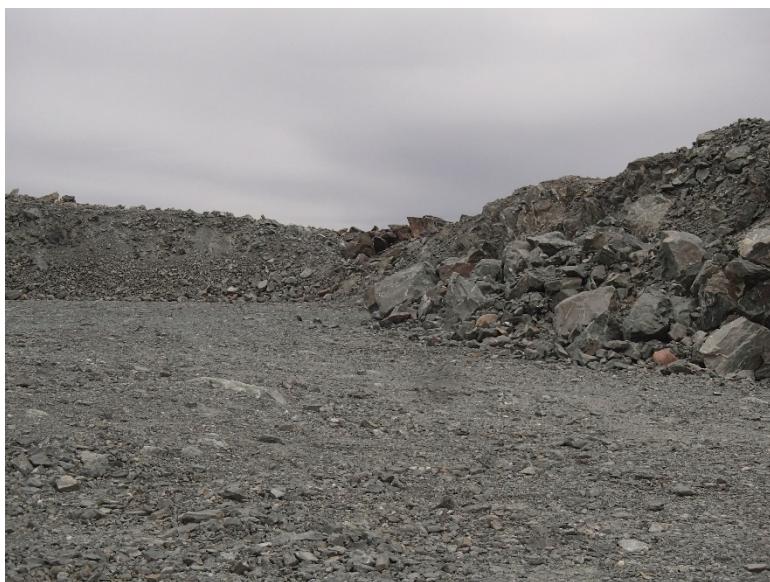
*Photograph F1-18: Quarry 9 – km 44+600*

**Description:** View of north and east walls. View of a pile of loose material.

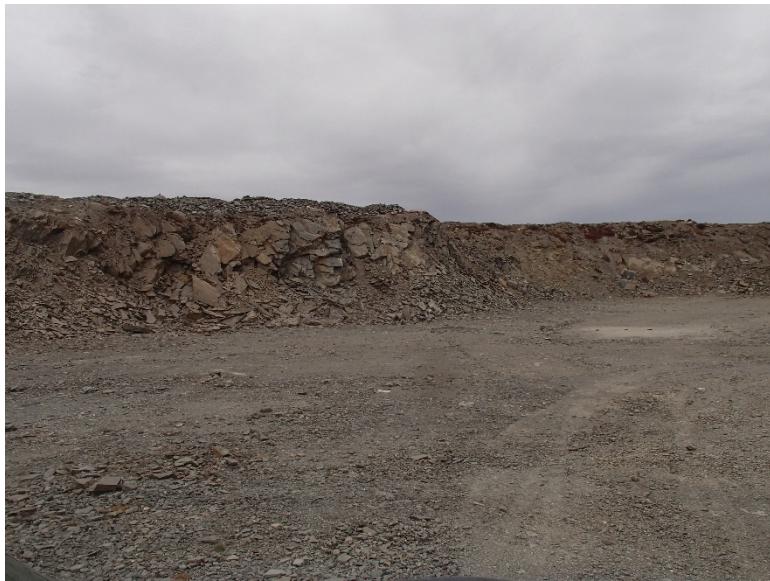
*Photograph F1-19: Quarry 10 – km 48+900*

**Description:** View of the west wall. Presence of unstable blocks.

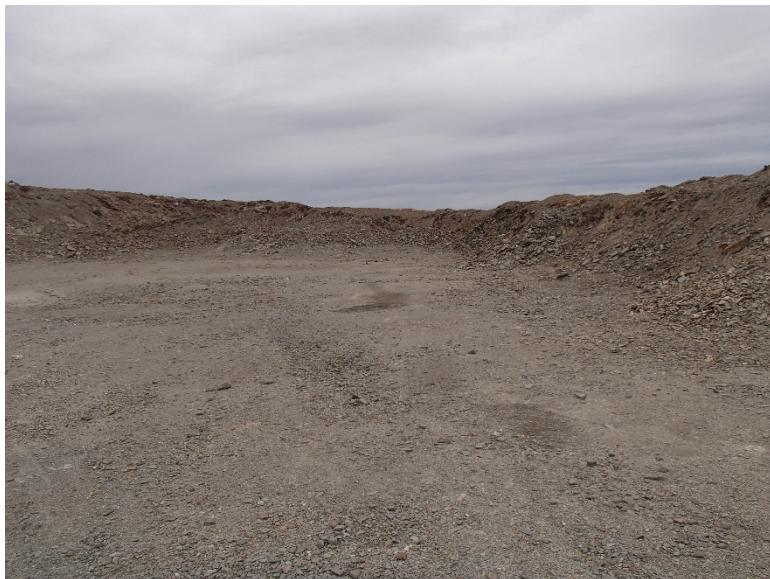
*Photograph F1-20: Quarry 10 – km 48+900*

**Description:** Overview of the quarry looking north at the east and north walls.

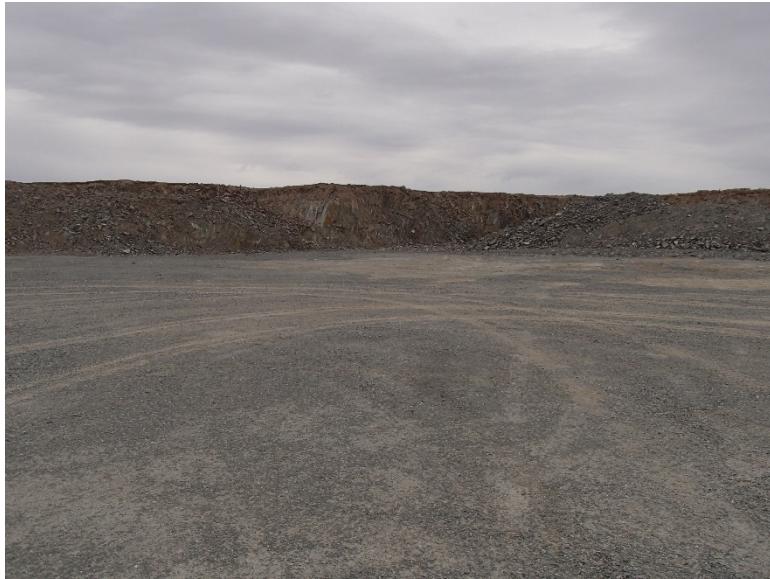
*Photograph F1-21: Quarry 11 – km 53+500*

**Description:** Overview of Quarry 11 looking at the west and north walls.

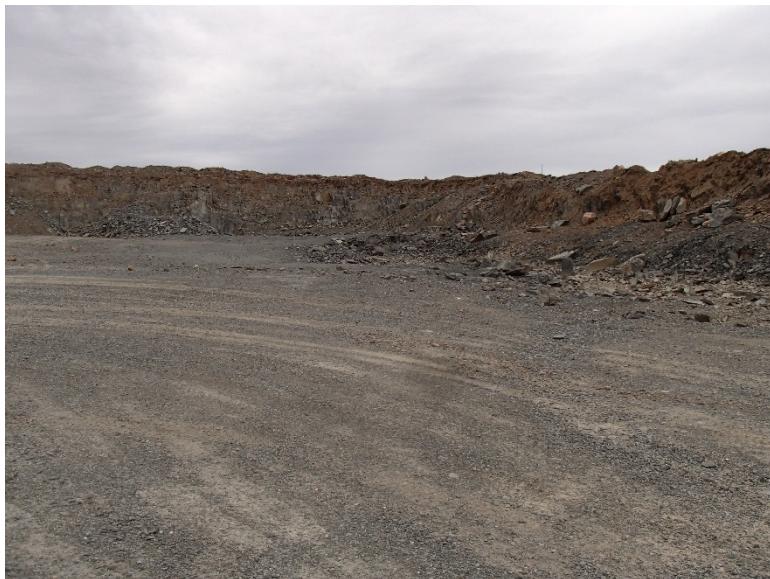
*Photograph F1-22: Quarry 11 – km 53+500*

**Description:** Overview of Quarry 11 looking at the north and east walls.

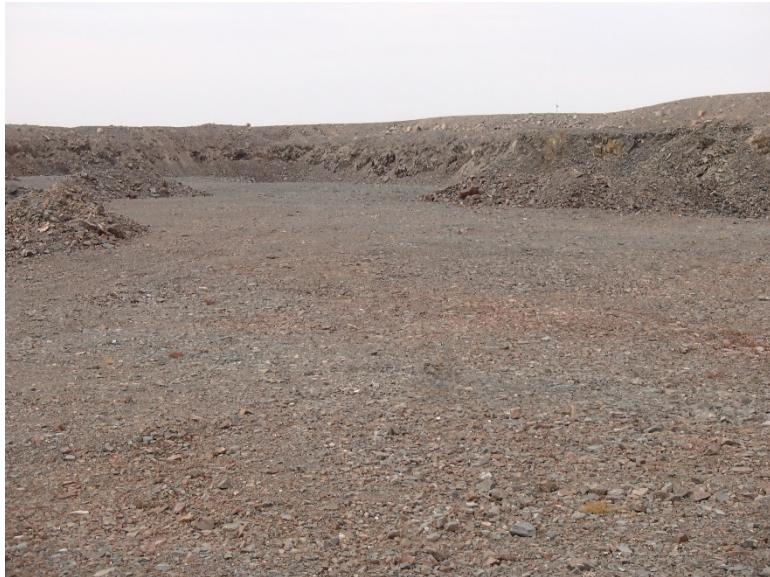
*Photograph F1-23: Quarry 12 – km 58+300*

**Description:** View of the south and east walls.

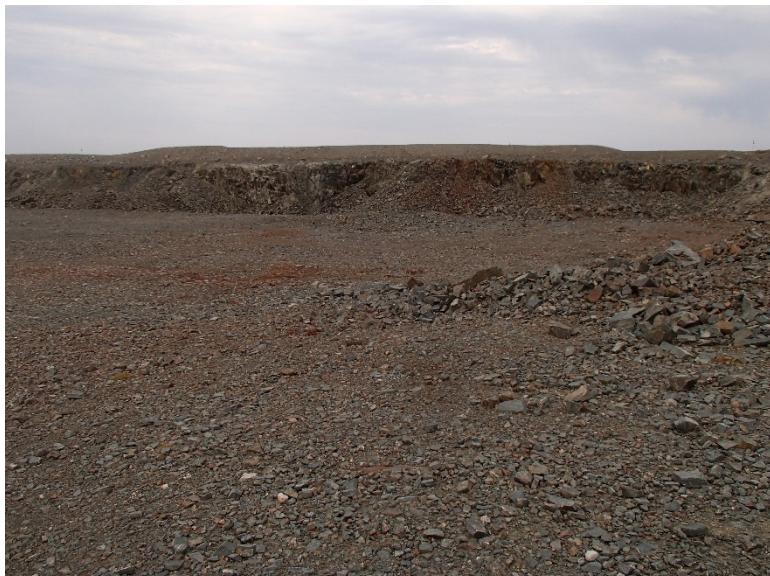
*Photograph F1-24: Quarry 12 – km 58+300*

**Description:** View of the west wall.

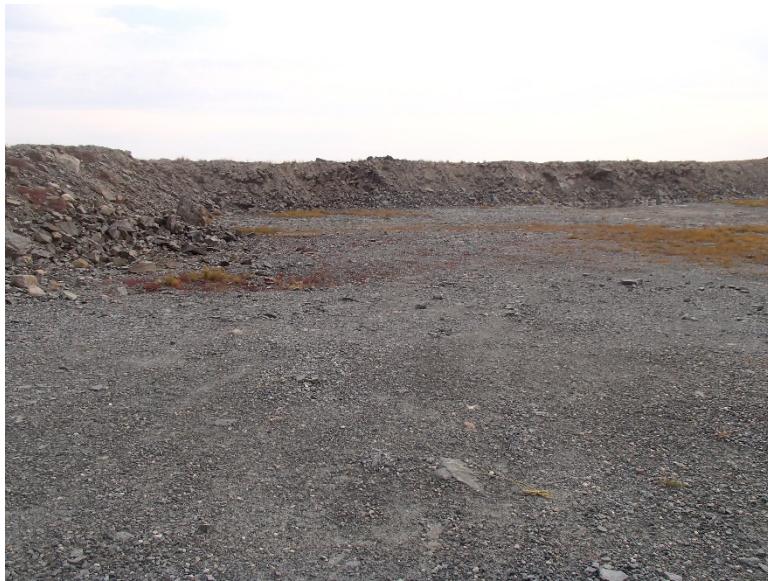
*Photograph F1-25: Quarry 13 – km 62+350*

**Description:** View of the west and north walls.

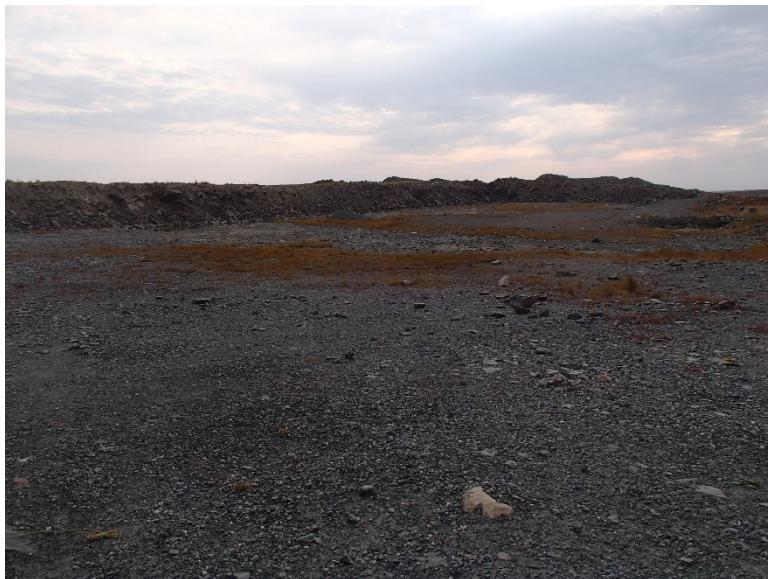
*Photograph F1-26: Quarry 13 – km 62+350*

**Description:** Looking at the south and east walls.

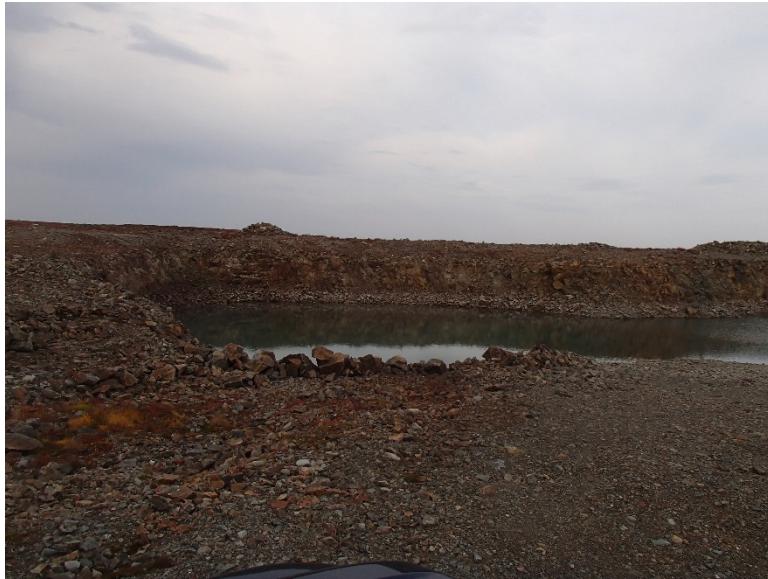
*Photograph F1-27: Quarry 14 – km 65+700*

**Description:** View of west and south walls. Quarry flooded.

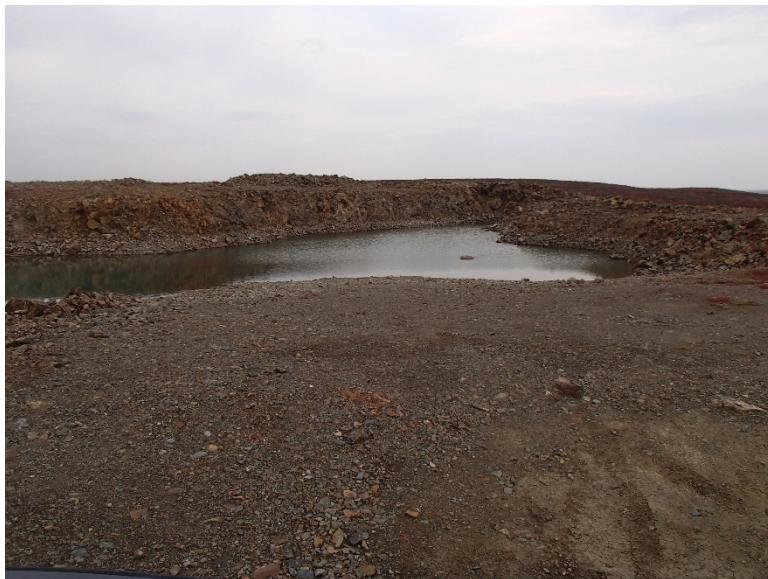
*Photograph F1-28: Quarry 14 – km 65+700*

**Description:** View of north and west walls. Quarry flooded.

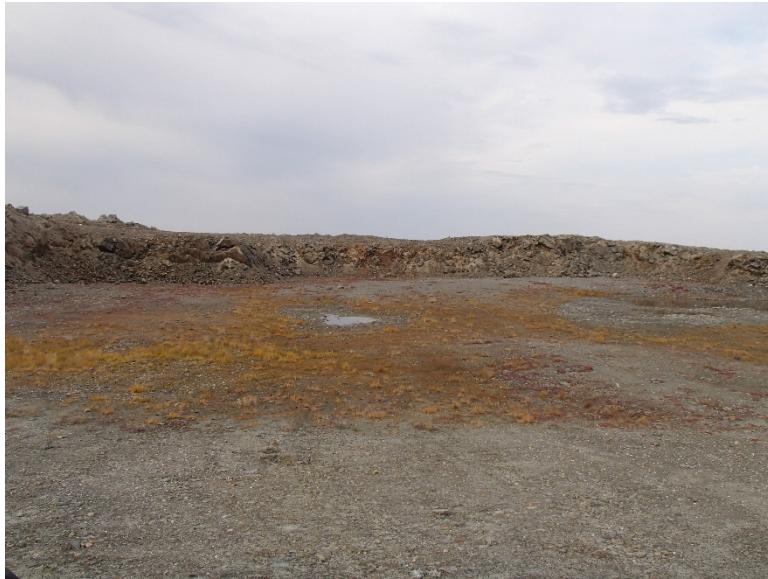
*Photograph F1-29: Quarry 15 – km 67+600*

**Description:** View of the south and west walls.

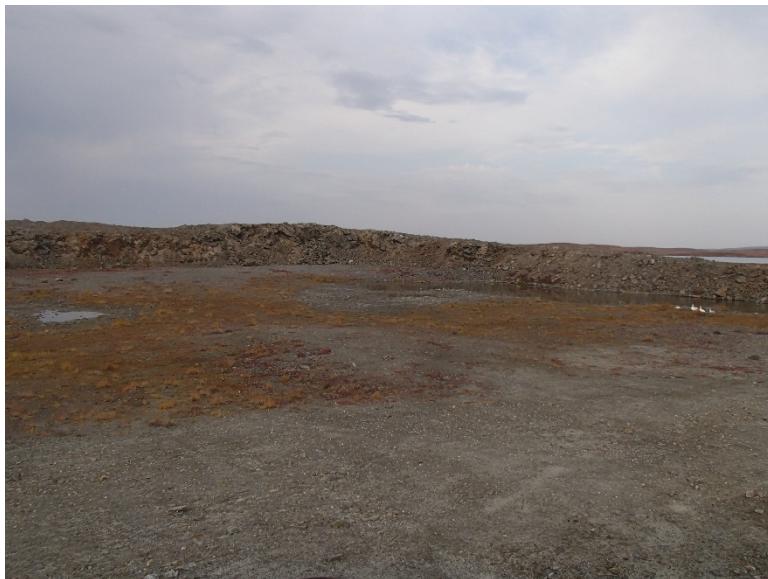
*Photograph F1-30: Quarry 15 – km 67+600*

**Description:** View of the north and west walls. Accumulation of water inside the quarry.

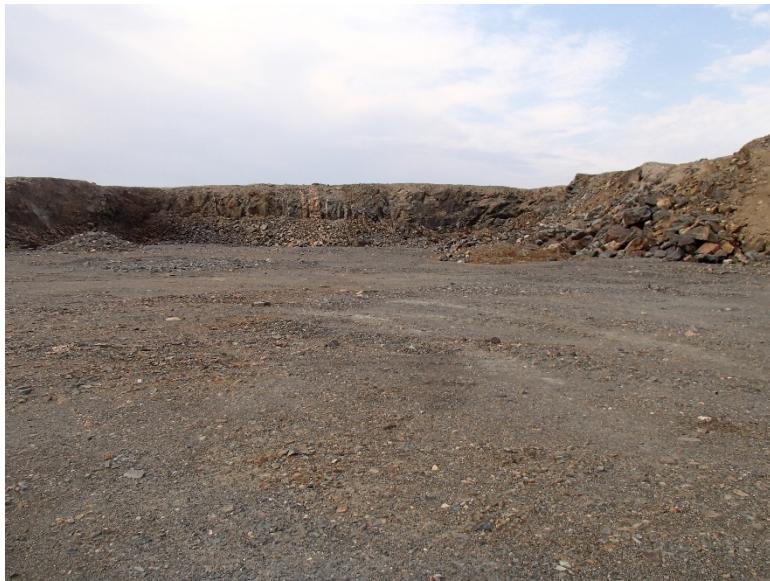
*Photograph F1-31: Quarry 16 – km 70+400*

**Description:** View of the south and west walls. Presence of loose rocks on steep wall.

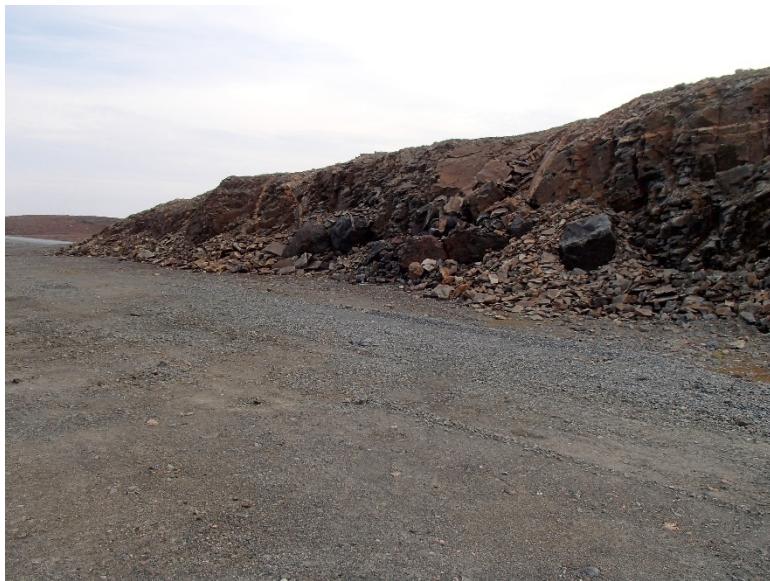
*Photograph F1-32: Quarry 16 – km 70+400*

**Description:** View of the east wall. Presence of loose rocks on steep wall.

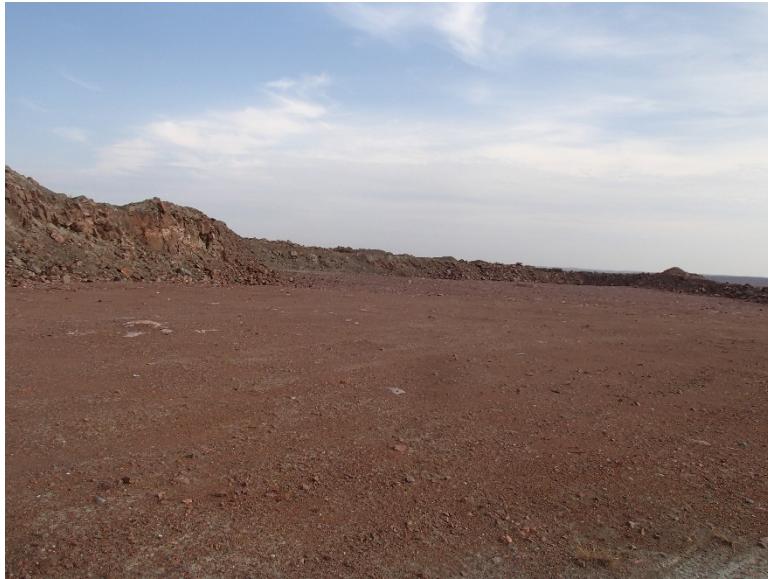
*Photograph F1-33: Quarry 17 – km 72+800*

**Description:** Looking at the north and west walls.

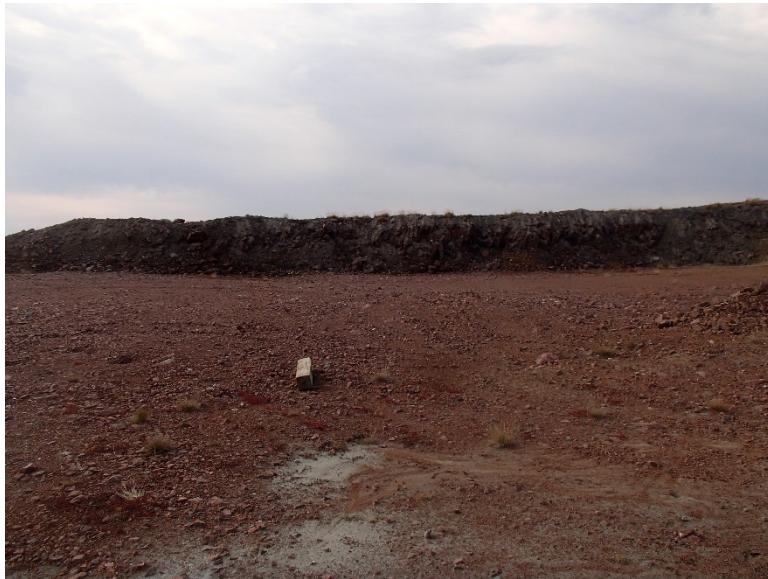
*Photograph F1-34: Quarry 17 – km 72+800*

**Description:** Looking at the south wall.
