## APPENDIX F1 QUARRIES PHOTOGRAPHIC LOG

2017 ANNUAL GEOTECHNICAL INSPECTION  
MEADOWBANK GOLD MINE, NUNAVUT

### Quarries and Eskers along Amaruq Road Photographic Log

### Baker Lake Tank Farm Photographic Log

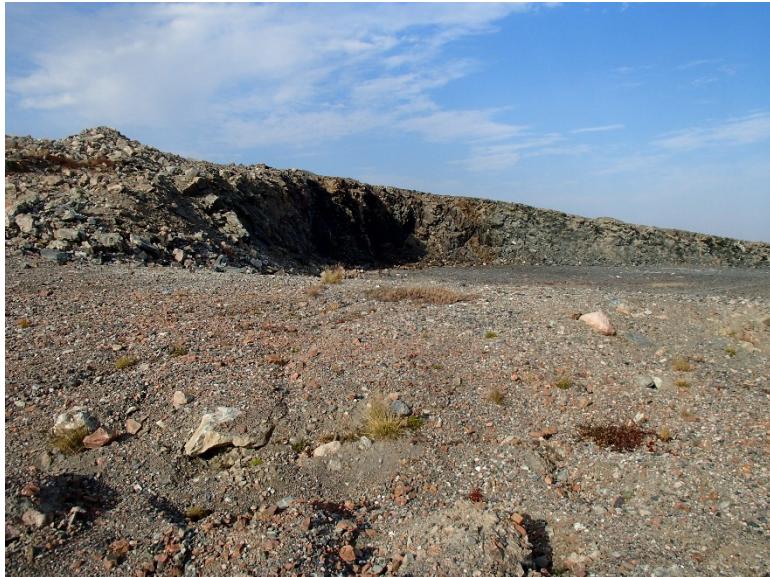
*Photograph F1-35: Quarry 18 – km 80+200*

**Description:** View of the south wall.

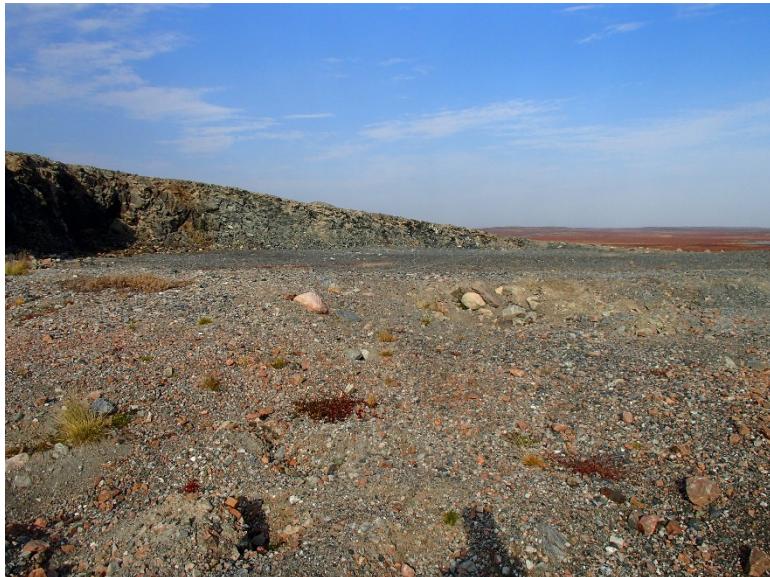
*Photograph F1-36: Quarry 18 – km 80+200*

**Description:** Looking at the north and west walls.

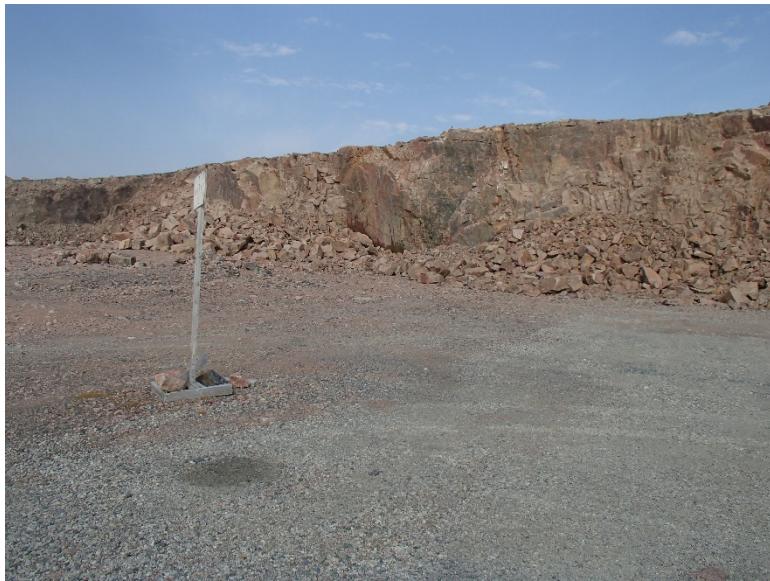
*Photograph F1-37: Quarry 19 – km 84+300*

**Description:** Looking at the north and west walls.

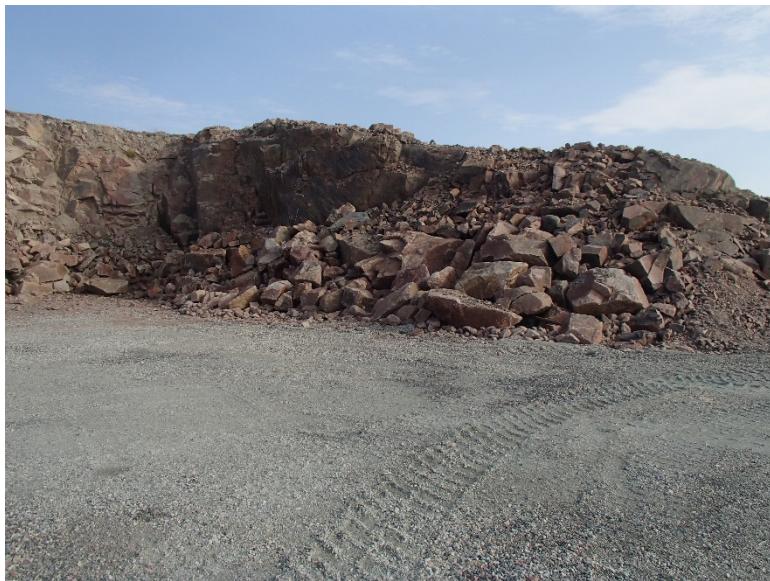
*Photograph F1-38: Quarry 19 – km 84+300*

**Description:** Looking at the north and east walls.

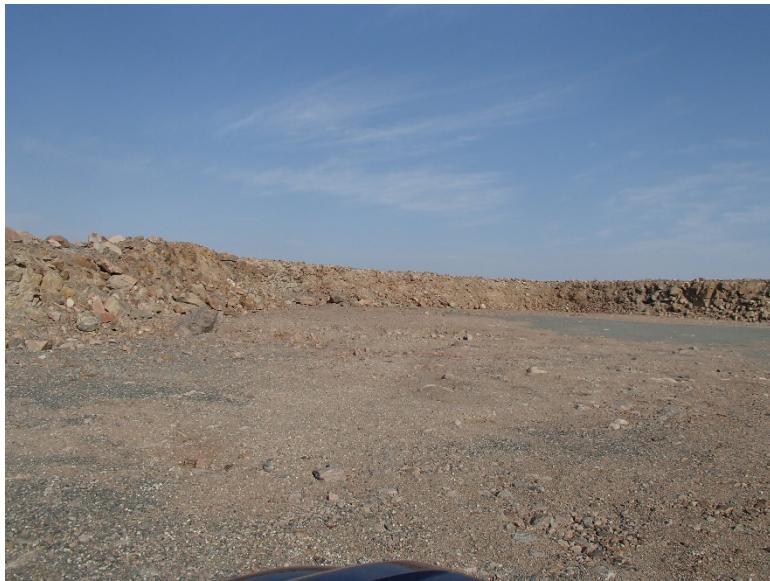
*Photograph F1-39: Quarry 20 – km 89+550*

**Description:** Looking at the north and west walls.

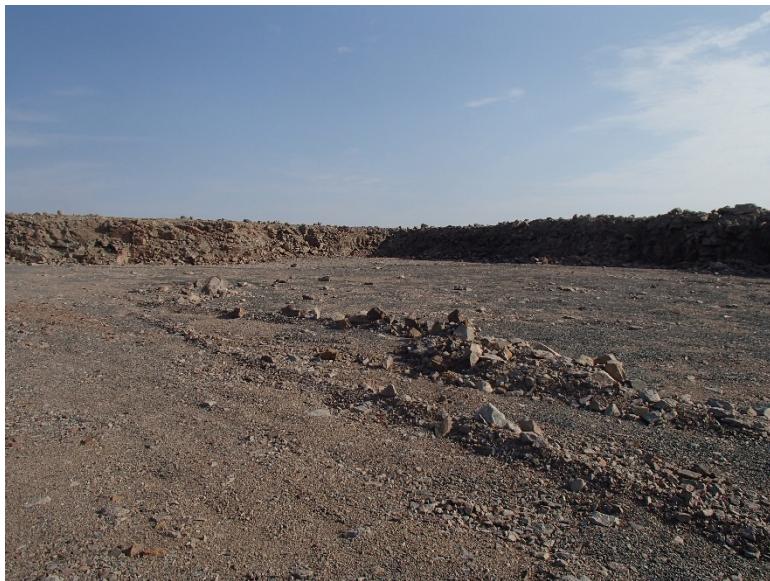
*Photograph F1-40: Quarry 20 – km 89+550*

**Description:** Looking at the north and east wall.

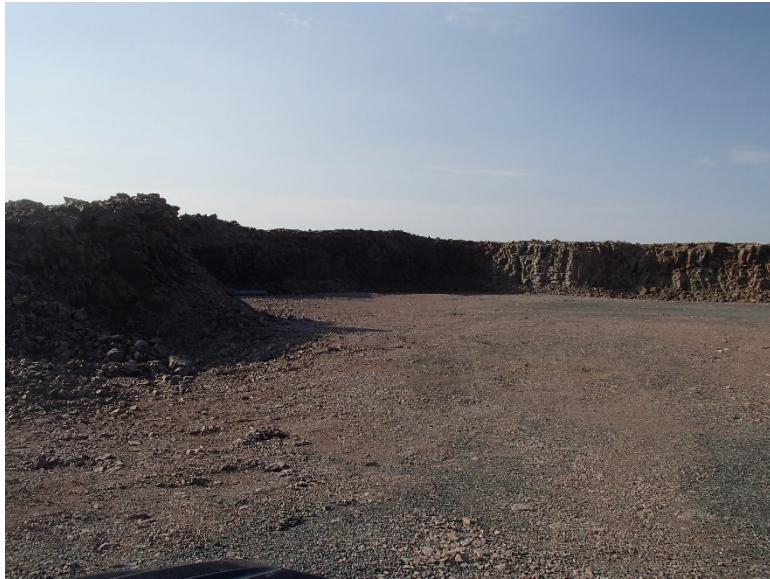
*Photograph F1-41: Quarry 21 – km 93+400*

**Description:** Looking at the south and east walls.

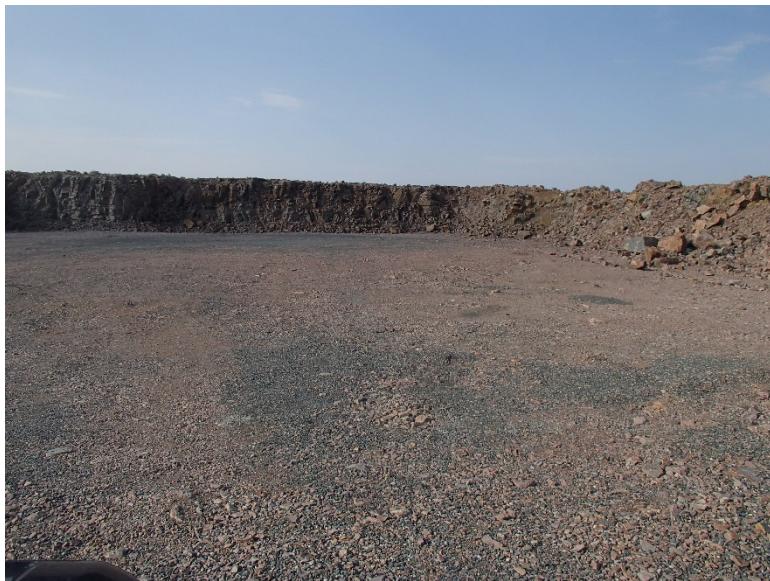
*Photograph F1-42: Quarry 21 – km 93+400*

**Description:** Looking at the north and west walls.

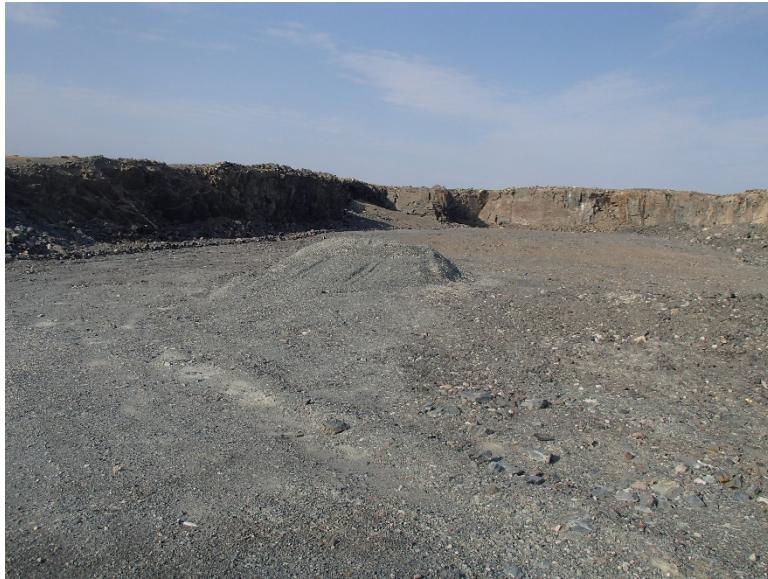
Photograph F1-43: Quarry 22 – km 99+200

Description: View of the south and west walls.

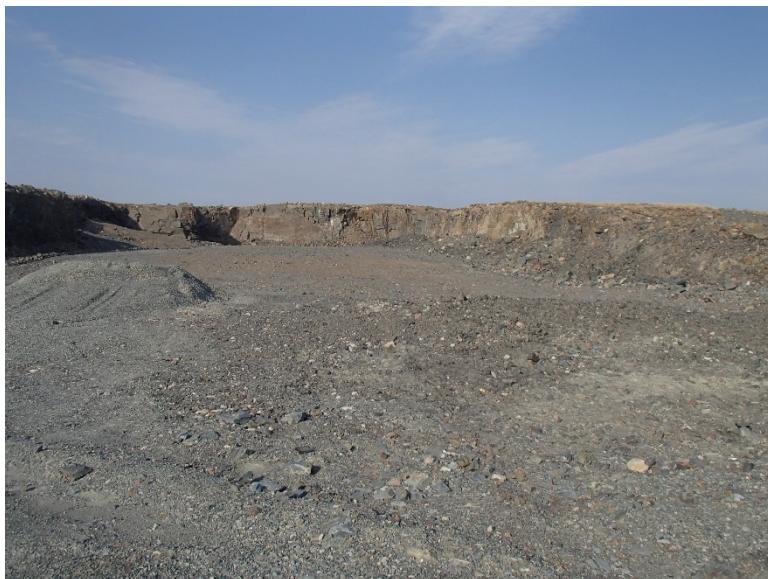
Photograph F1-44: Quarry 22 – km 99+200

Description: Looking at the north and west walls.

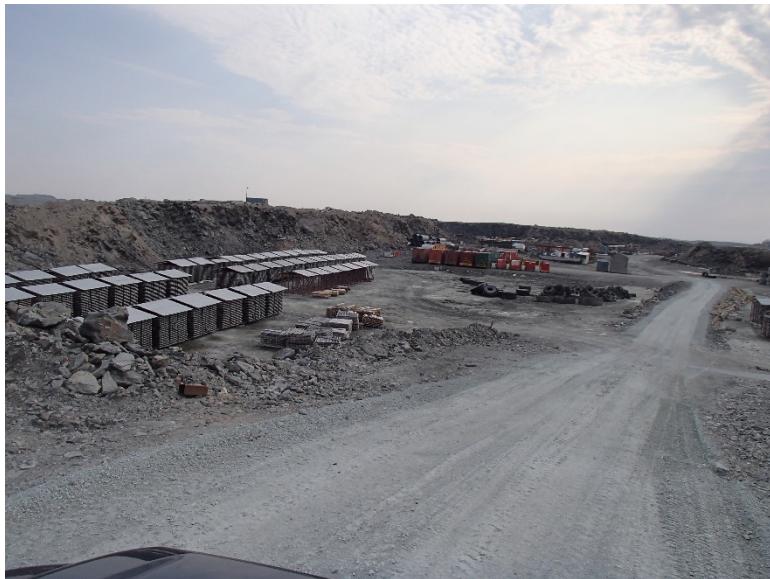
*Photograph F1-45: Quarry 23 (Airstrip Quarry)*

**Description:** Looking at the north wall.

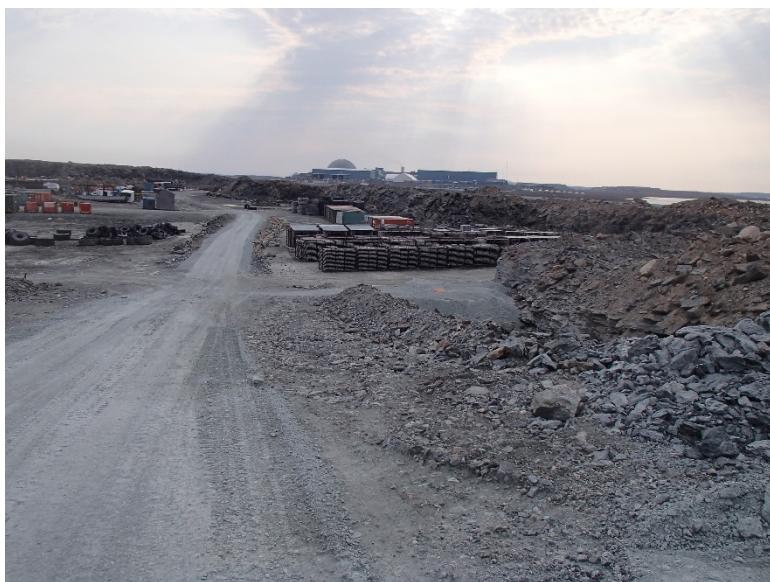
*Photograph F1-46: Quarry 23 (Airstrip Quarry)*

**Description:** Looking at the south wall.

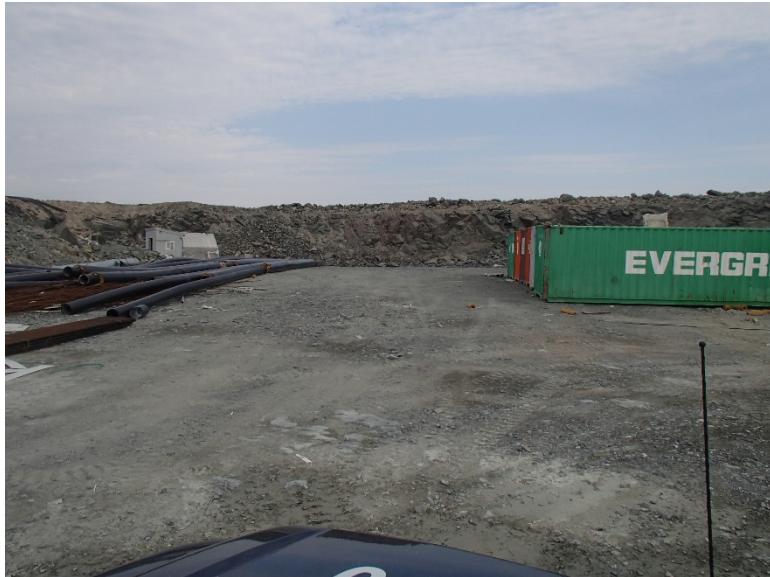
*Photograph F1-47: Quarry 23 (Airstrip Quarry)*

**Description:** Looking at the north wall. Presence of loose rocks along steep wall.

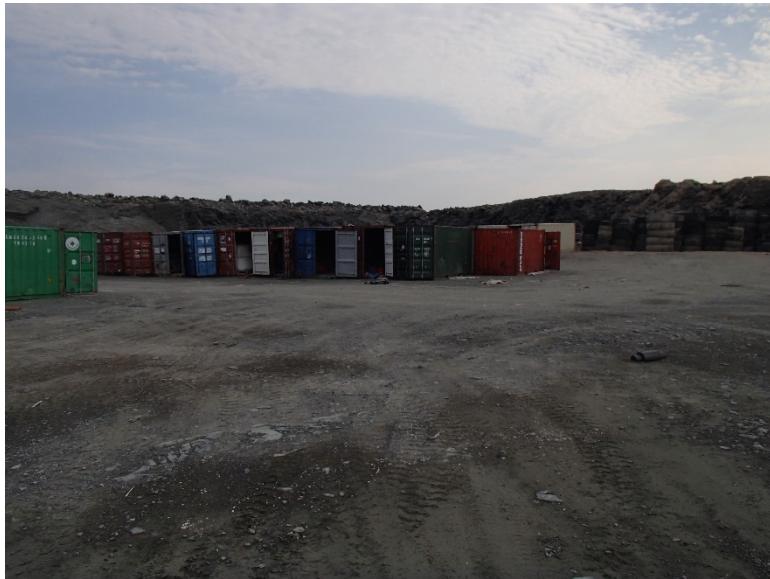
*Photograph F1-48: Quarry 23 (Airstrip Quarry)*

**Description:** Looking at the north and east walls.

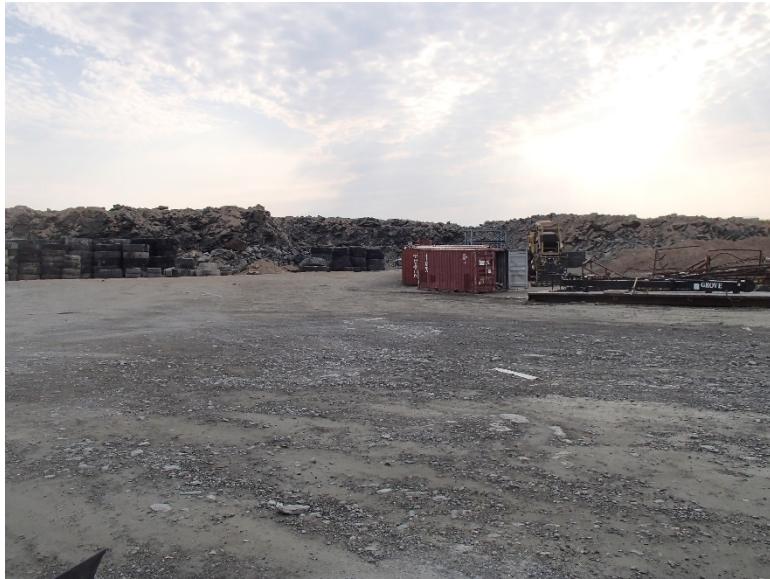
*Photograph F1-49: Quarry 23 (Airstrip Quarry)*

**Description:** Looking at the south and east walls.

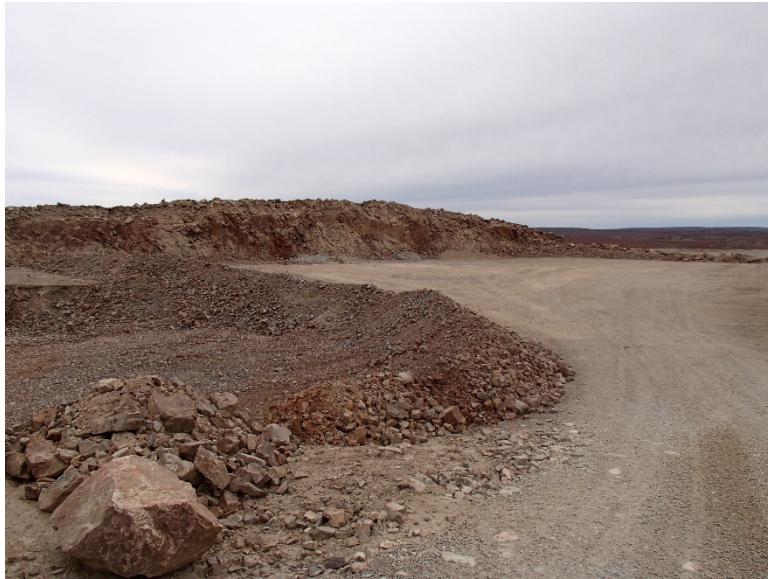
*Photograph F2-1 Eskers and Quarries 1 – km 15+000*

**Description:** View of esker #1. Loose rock is present on the steep wall.

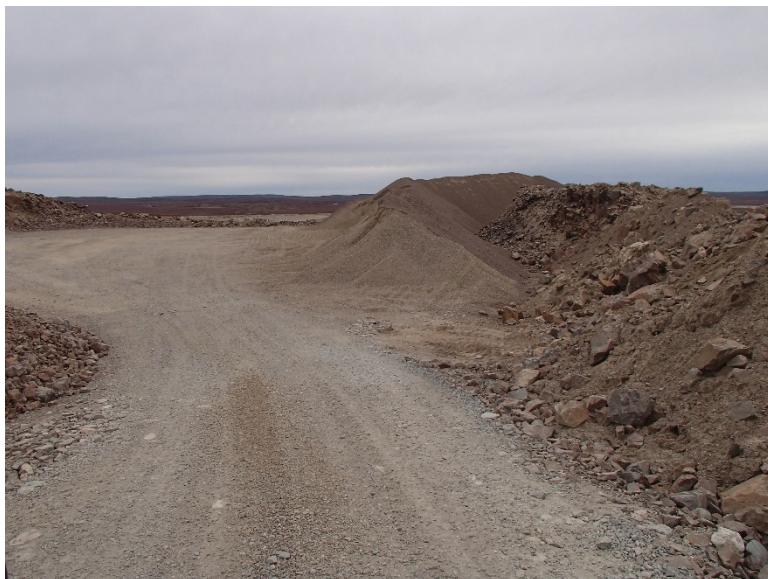
*Photograph F2-2 Eskers and Quarries 1 – km 15+000*

**Description:** View of esker #1. Loose rock is present on the steep wall.

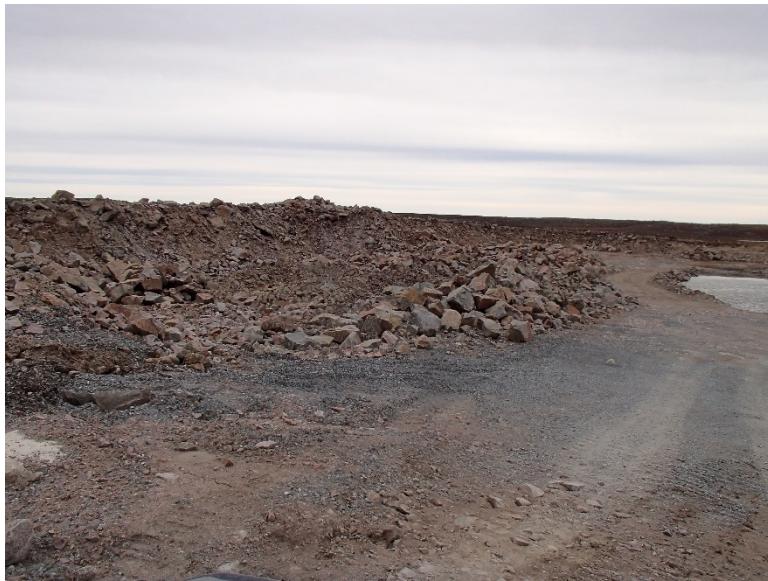
*Photograph F2-3 Eskers and Quarries 2 – km 25+000*

**Description:** View of esker #2. General good condition but some steep walls and loose rocks.

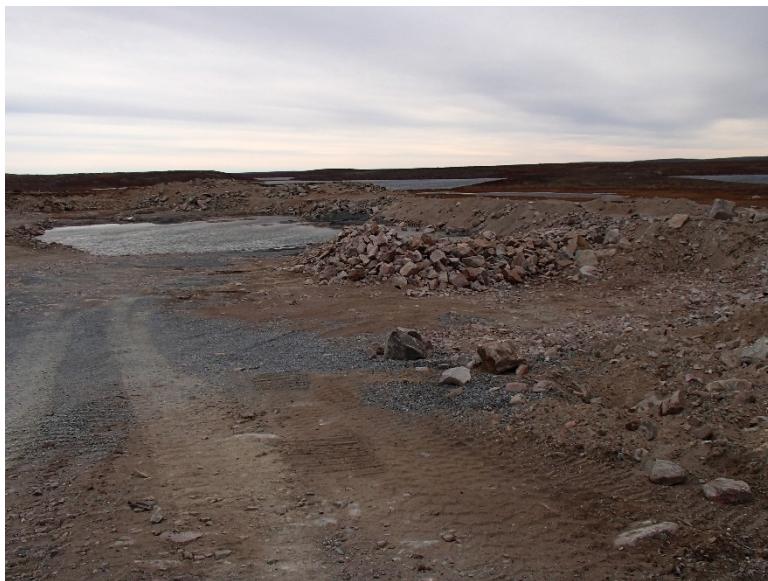
*Photograph F2-4 Eskers and Quarries 2 – km 25+000*

**Description:** View of esker #2. General good condition but some steep walls and loose rocks.

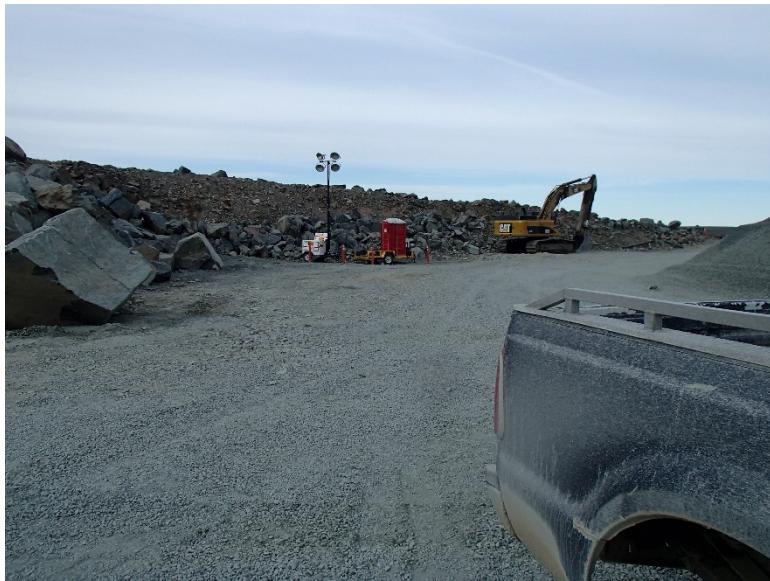
Photograph F2-5 Eskers and Quarries 3 – km 35+000

**Description:** View of the rock quarry at km 35. Unstable walls subject to rockfalls.

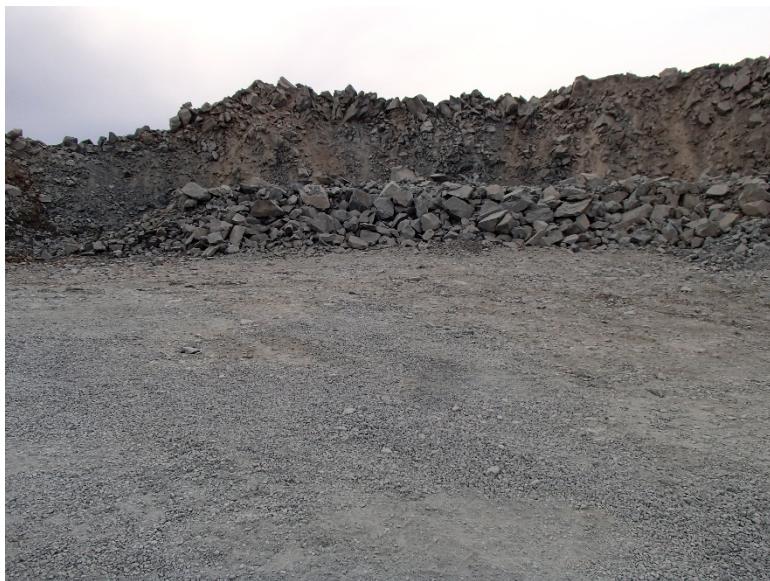
Photograph F2-6 Eskers and Quarries 3 – km 35+000

**Description:** View of the rock quarry at km 35. Unstable walls subject to rockfalls.

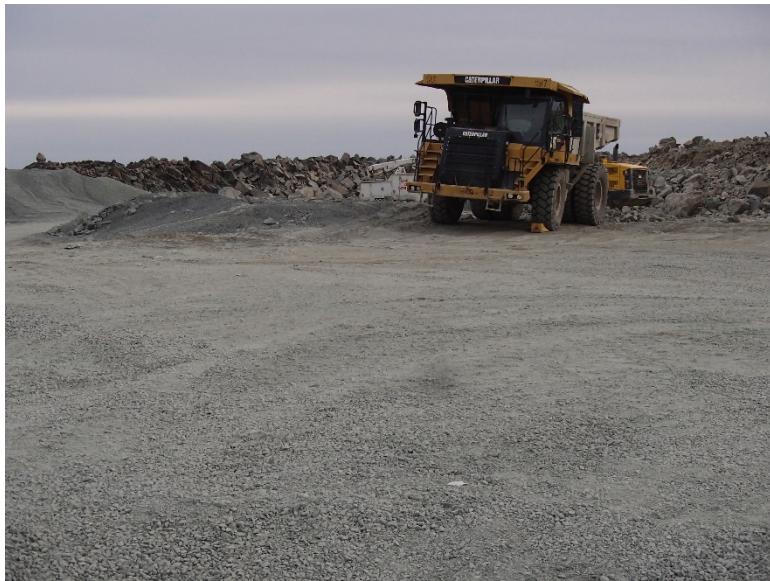
*Photograph F2-7 Eskers and Quarries 3 – km 35+000*

**Description:** View of the rock quarry at km 35. Unstable walls subject to rockfalls.

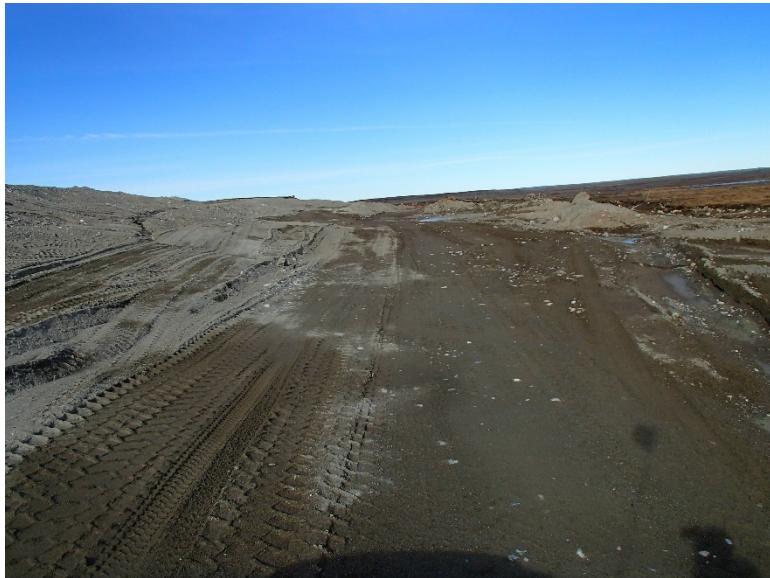
*Photograph F2-8 Eskers and Quarries 4 – km 46+000*

**Description:** View of esker #3. The 2-m high steep soil slopes are unstable.

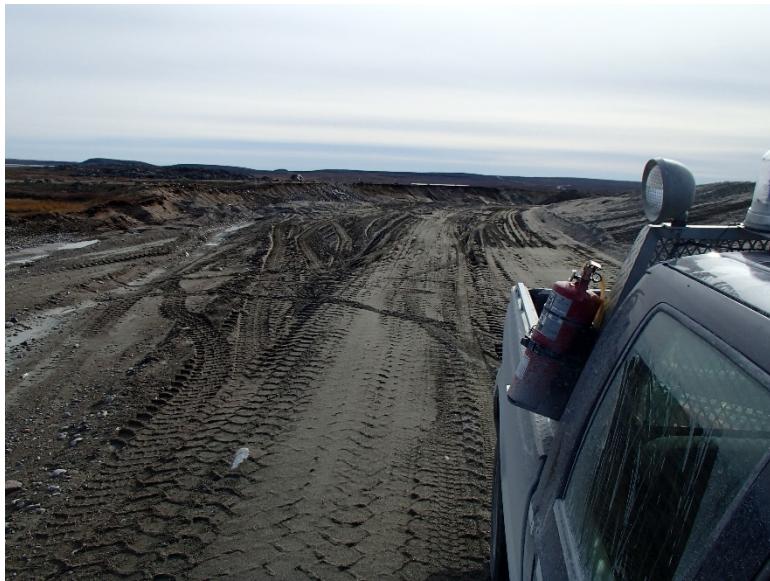
*Photograph F2-9 Eskers and Quarries 4 – km 46+000*

**Description:** View of esker #3. The 2-m high steep soil slopes are unstable.

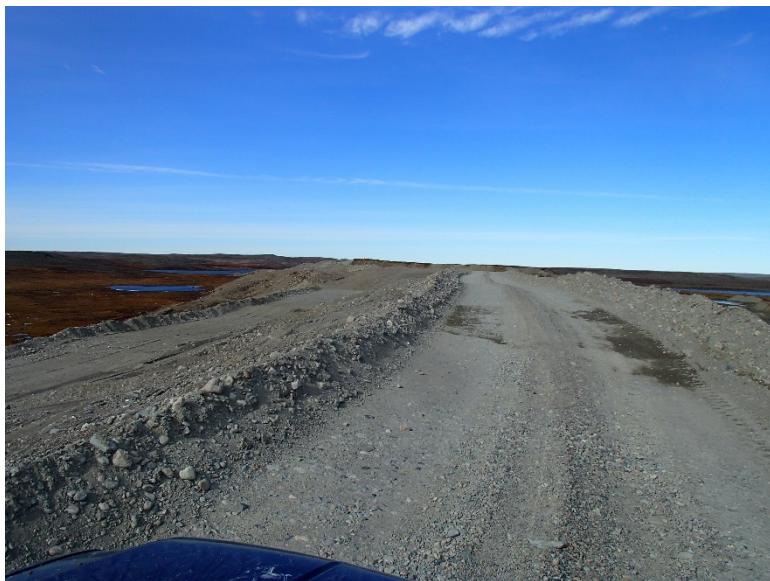
*Photograph F2-10 Eskers and Quarries 4 – km 46+000*

**Description:** View of esker #3. The 2-m high steep soil slopes are unstable.

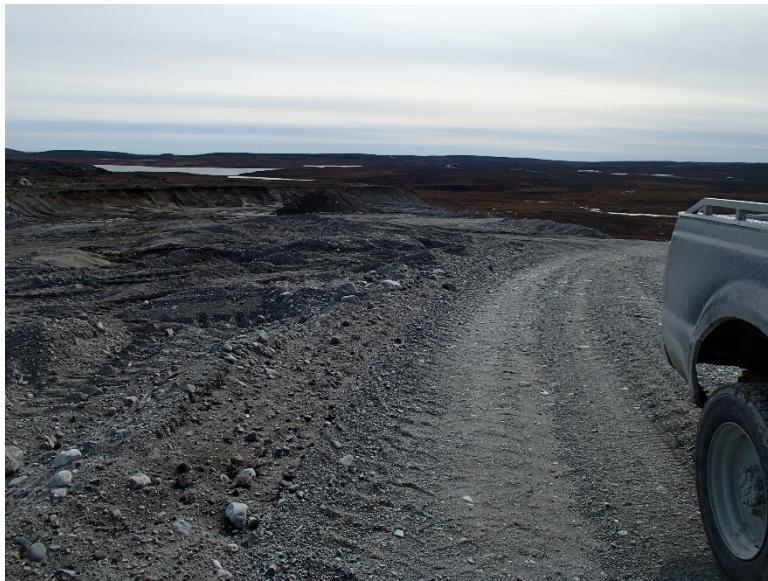
*Photograph F2-11 Eskers and Quarries 4 – km 46+000*

**Description:** View of esker #3. The 2-m high steep soil slopes are unstable.

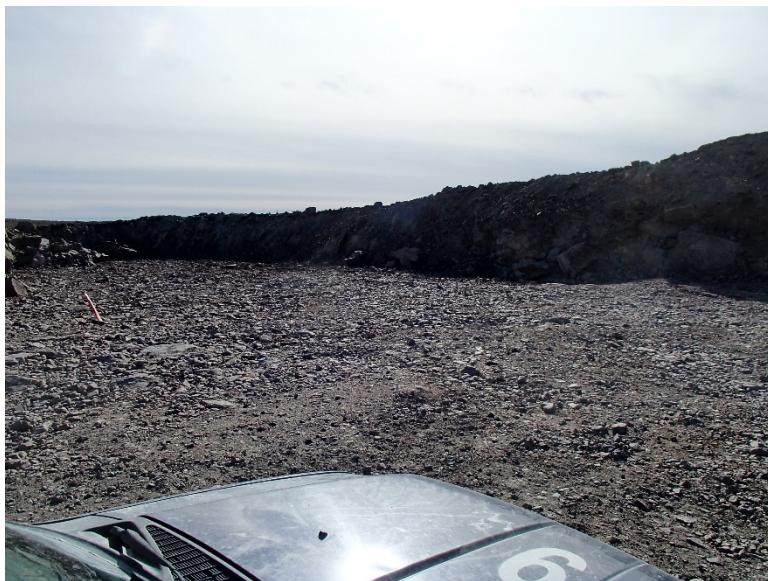
*Photograph F2-12 Eskers and Quarries 5 – km 52+000*

**Description:** View of the rock quarry at km 52. In good conditions with loose blocks on the north wall.

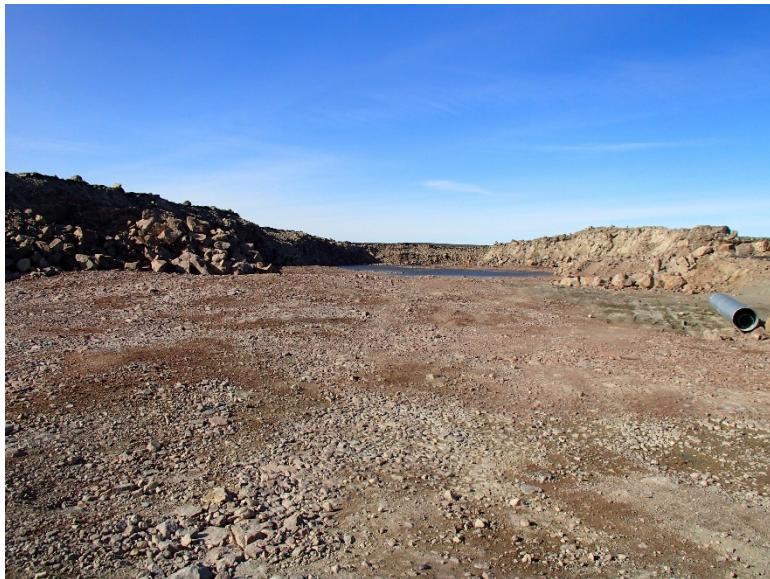
*Photograph F2-13 Eskers and Quarries 5 – km 52+000*

**Description:** View of the rock quarry at km 52. In good conditions with loose blocks on the north wall.

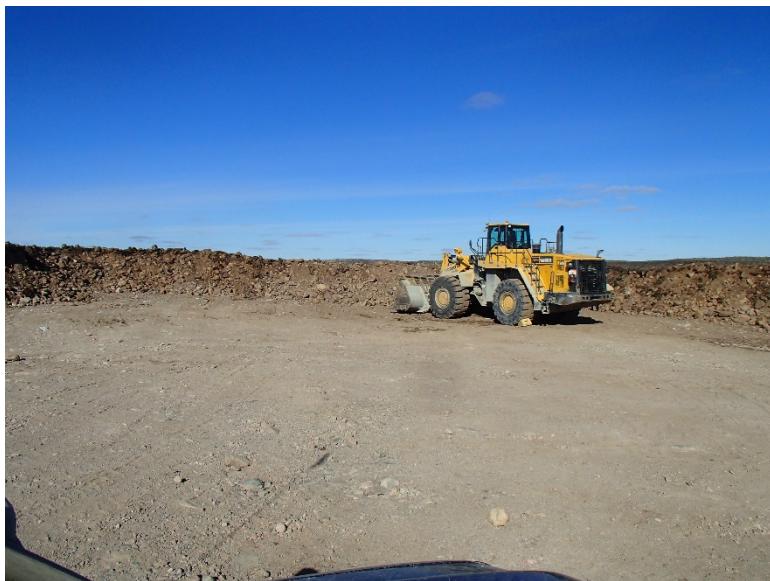
*Photograph F2-14 Eskers and Quarries 6 – km 62+000*

**Description:** View of esker #6C (north borrow pit). The 2-m high steep soil slopes are unstable.

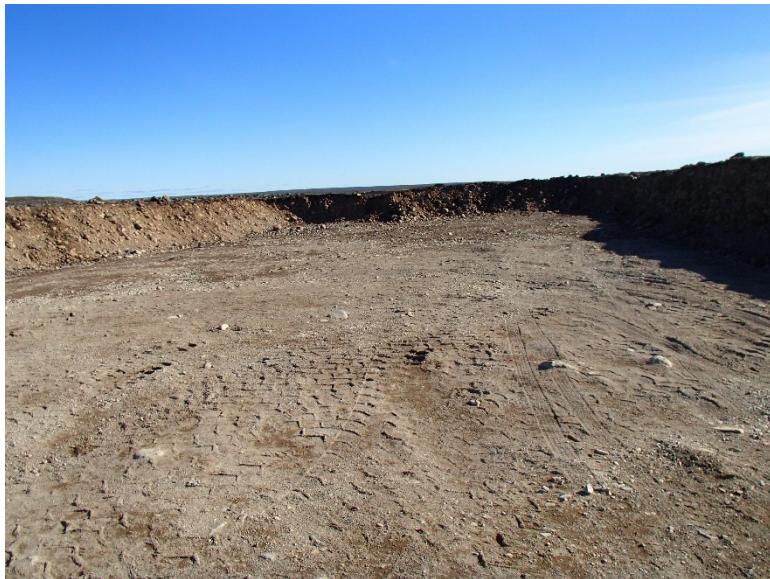
*Photograph F2-15 Eskers and Quarries 6 – km 62+000*

**Description:** View of esker #6C (north borrow pit). The 2-m high steep soil slopes are unstable.

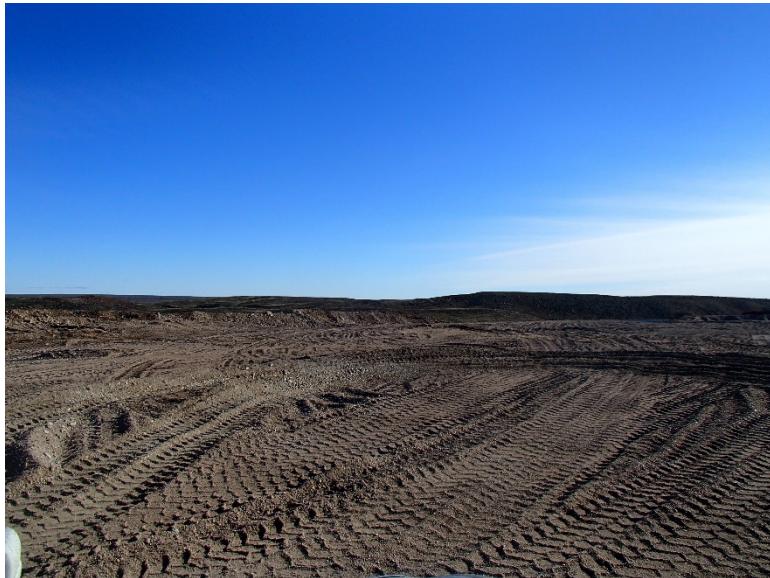
*Photograph F2-16 Eskers and Quarries 6 – km 62+000*

**Description:** View of esker #6B. In good condition.

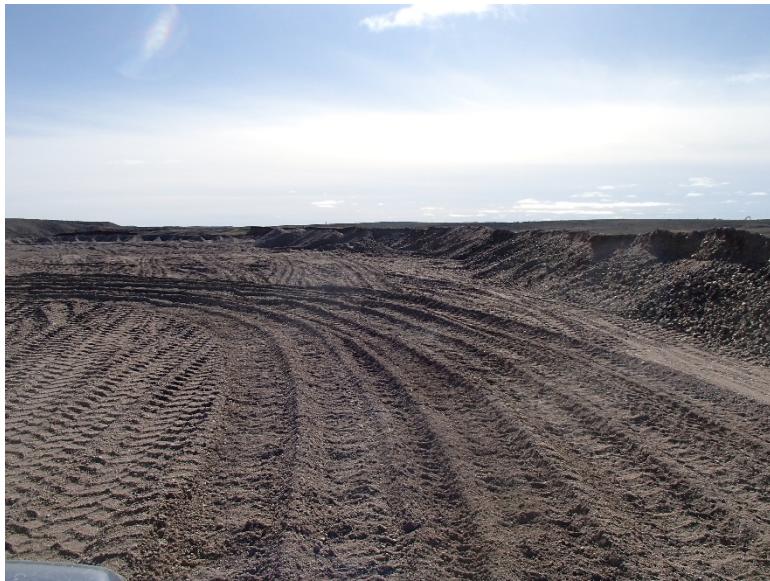
*Photograph F2-17 Eskers and Quarries 6 – km 62+000*

**Description:** View of eskers #6A and #6D. In good condition.

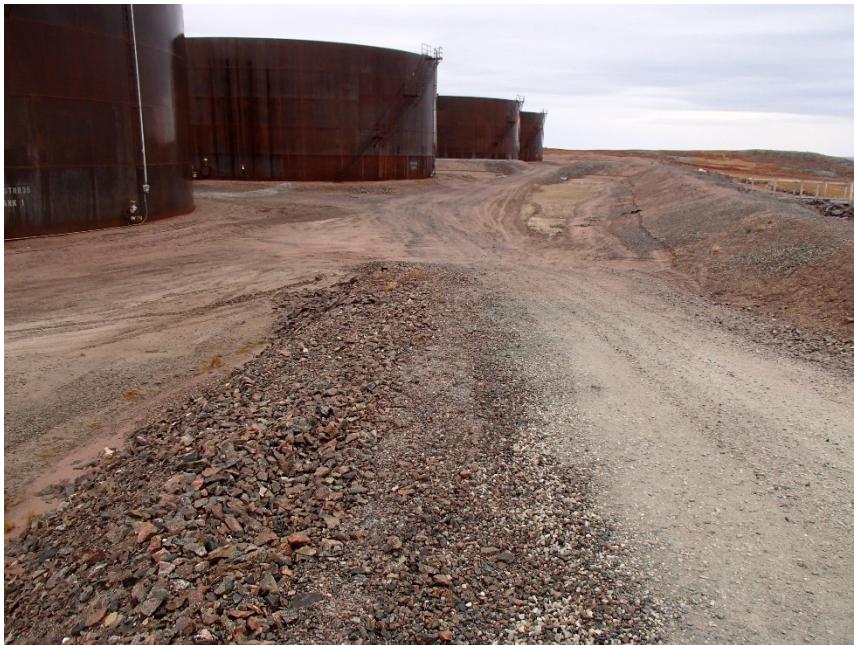
*Photograph G1-1 Baker Lake Tank Farm*

**Description:** From the south side of Tank 1, looking southeast at Tanks 1, 2, 3, and 4. Presence of water ponding.

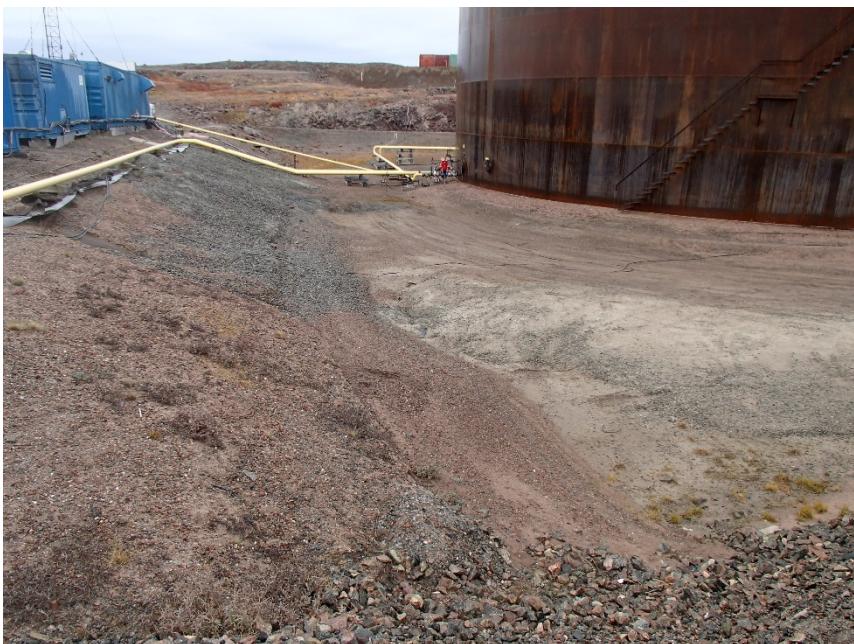
*Photograph G1-2 Baker Lake Tank Farm*

**Description:** Looking at the southwestern corner of Tank 1.
