## APPENDIX G1 BAKER LAKE TANK FARM PHOTOGRAPHIC LOG

2017 ANNUAL GEOTECHNICAL INSPECTION  
MEADOWBANK GOLD MINE, NUNAVUT

## APPENDIX G2

### Main Camp Tank Farm Photographic Log

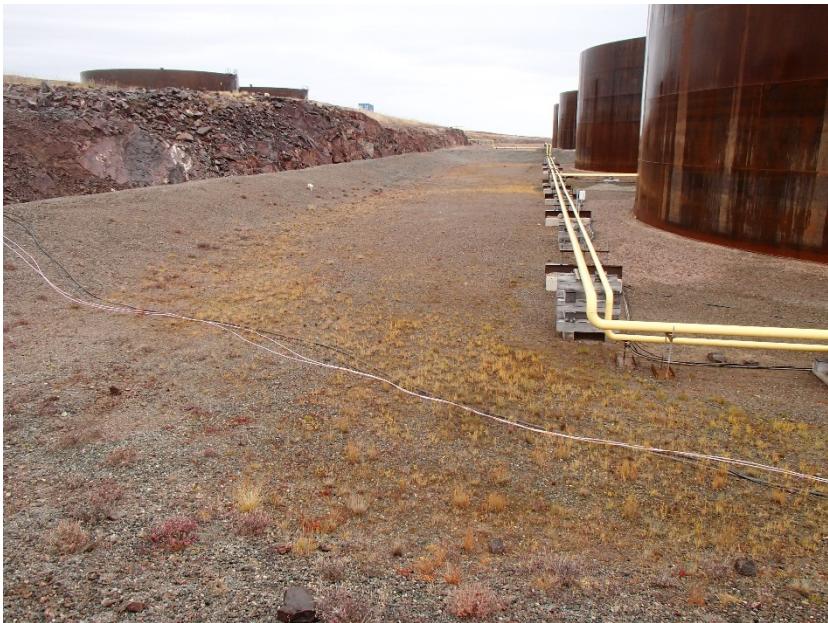
*Photograph G1-3 Baker Lake Tank Farm*

**Description:** From the north side of Tank 1, looking southeast at Tanks 1, 2, 3, and 4.

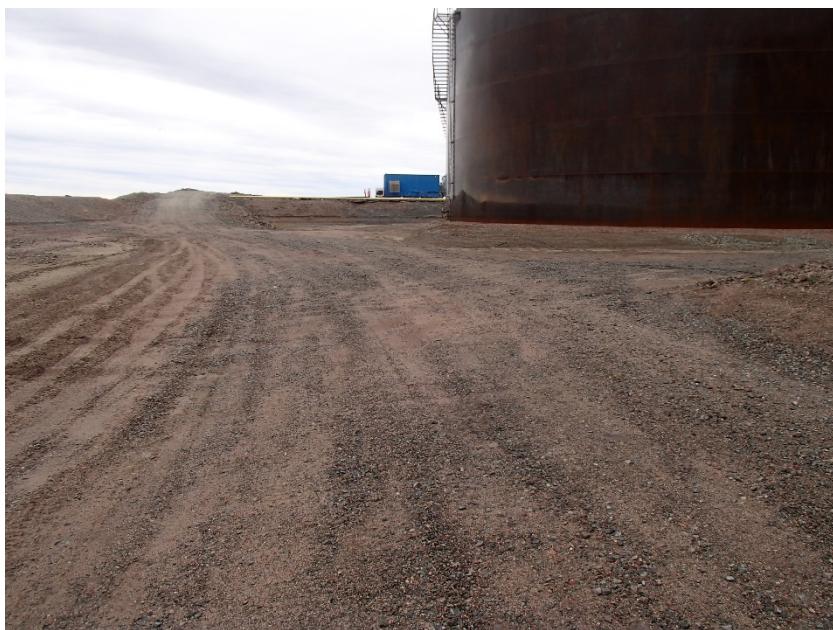
*Photograph G1-4 Baker Lake Tank Farm*

**Description:** Looking northwest toward the south side of Tank 1.

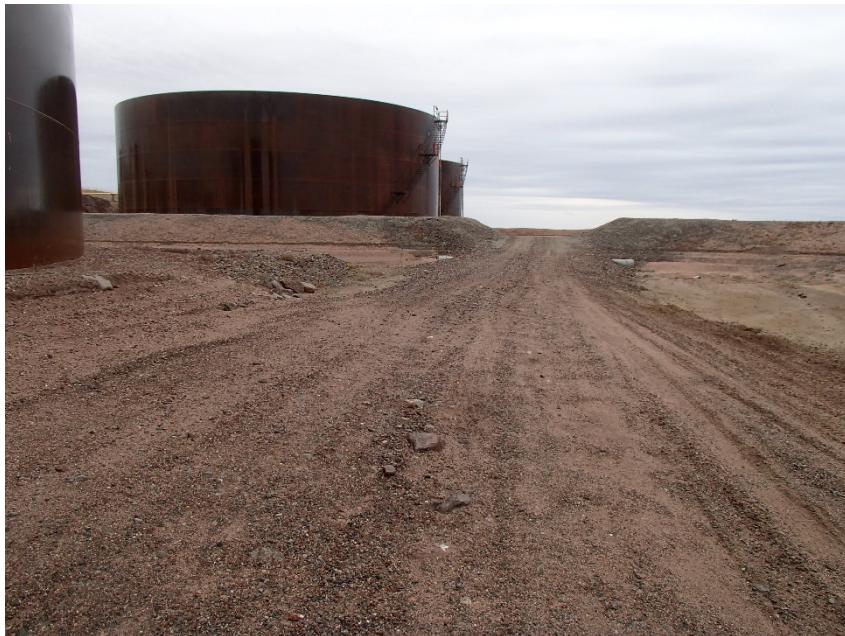
*Photograph G1-5 Baker Lake Tank Farm*

**Description:** Looking northeast toward the south side of Tanks 2 and 3.

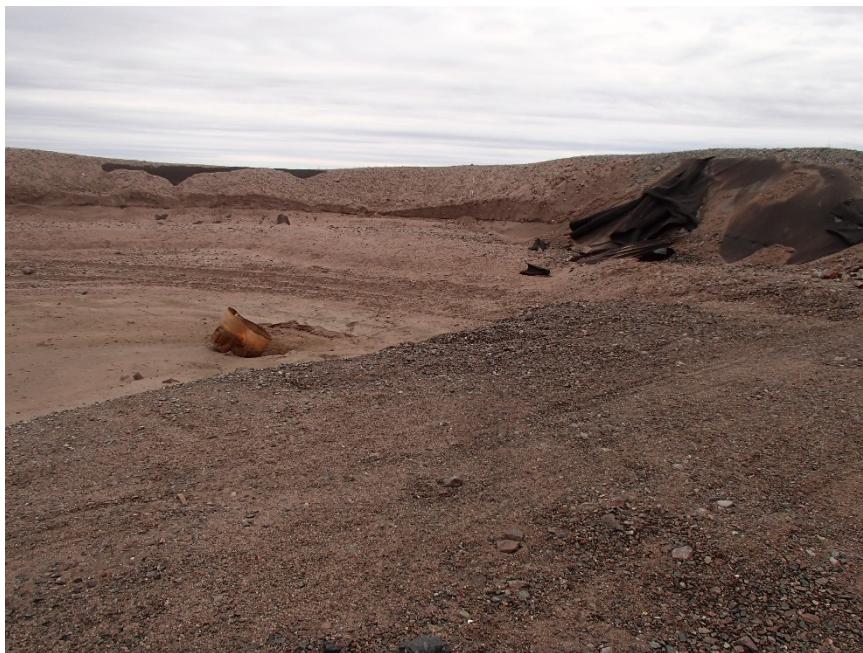
*Photograph G1-6 Baker Lake Tank Farm*

**Description:** Looking south. The geomembrane between the south side of tank 2 and 3 is damaged.

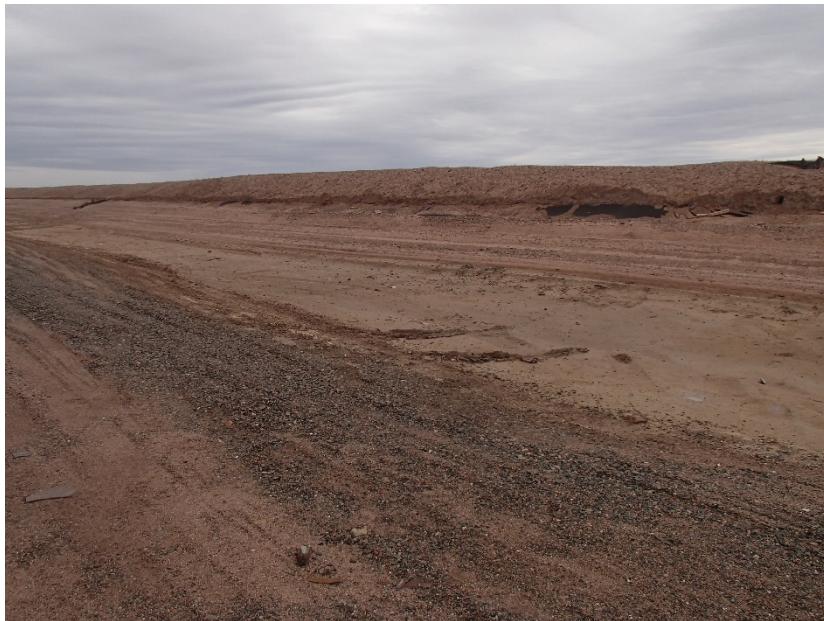
*Photograph G1-7 Baker Lake Tank Farm*

**Description:** From the southwestern corner of Tank 3 looking southeast. View of exposed LLDPE.

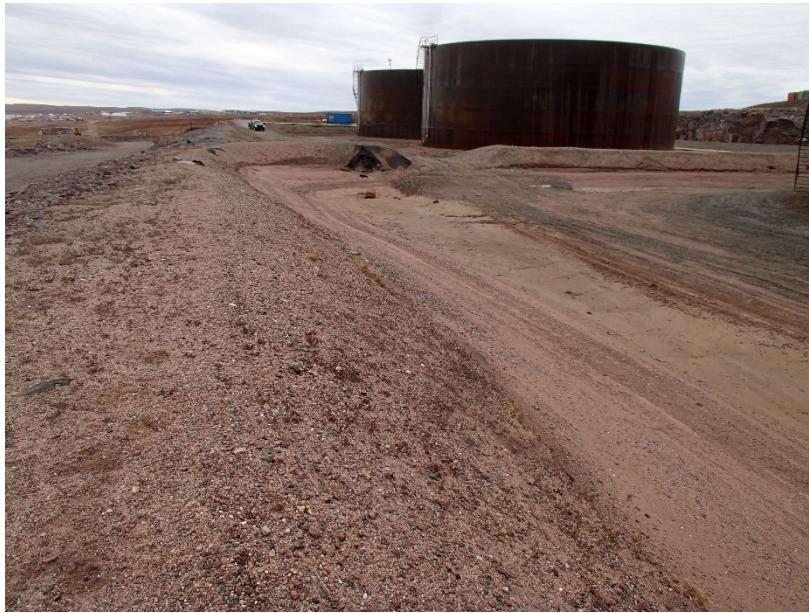
*Photograph G1-8 Baker Lake Tank Farm*

**Description:** From the southeastern corner of Tank 3, looking northwest at the south side of Tank 3, 2 and 1. View of exposed LLDPE.

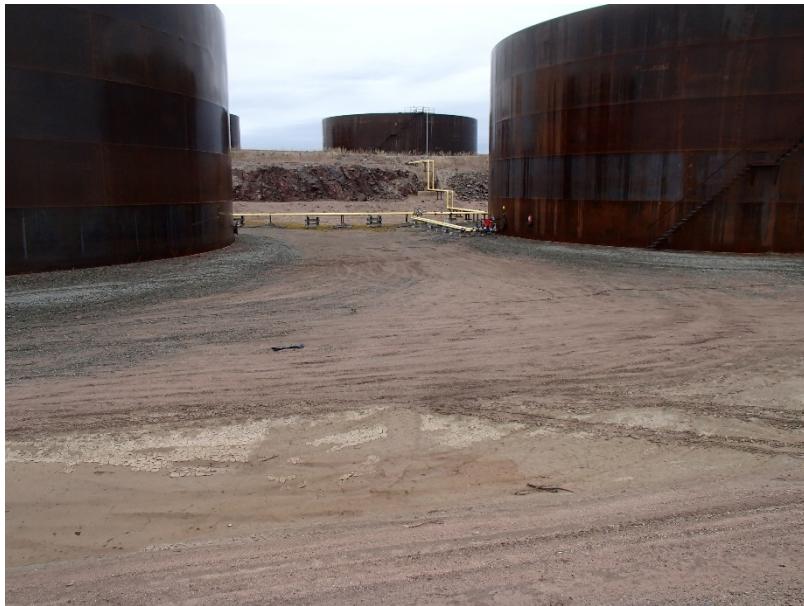
*Photograph G1-9 Baker Lake Tank Farm*

**Description:** From the south portion of the site looking north at the south side of Tank 3, 4 and 5.

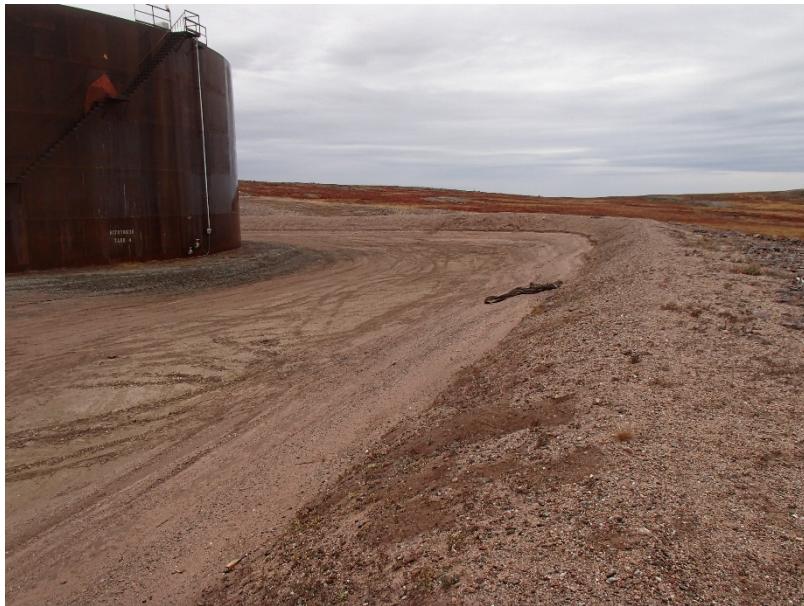
*Photograph G1-10 Baker Lake Tank Farm*

**Description:** From the south portion of the site looking southeast.

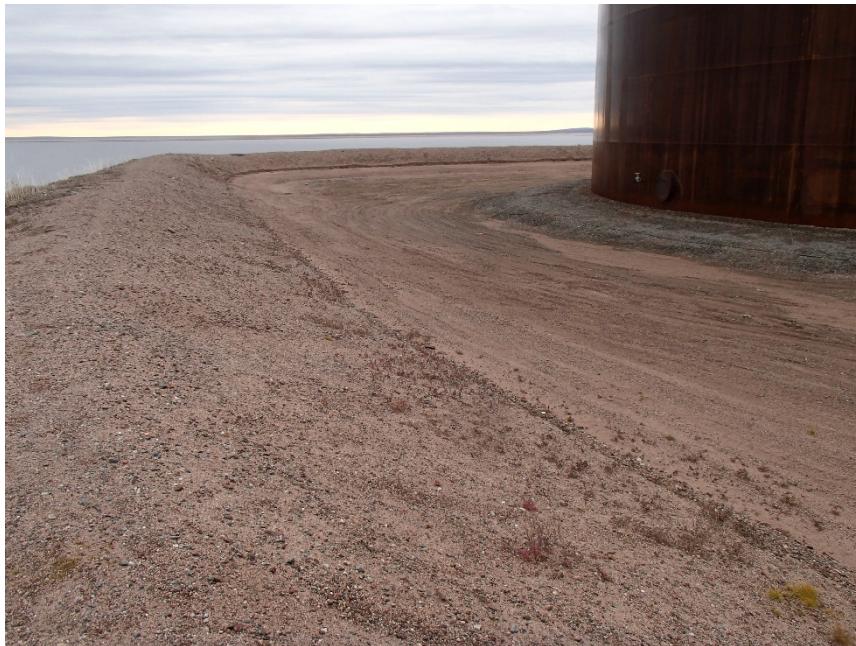
*Photograph G1-11 Baker Lake Tank Farm*

**Description:** From the northeastern corner of Tank 4 looking southwest toward Tank 4.

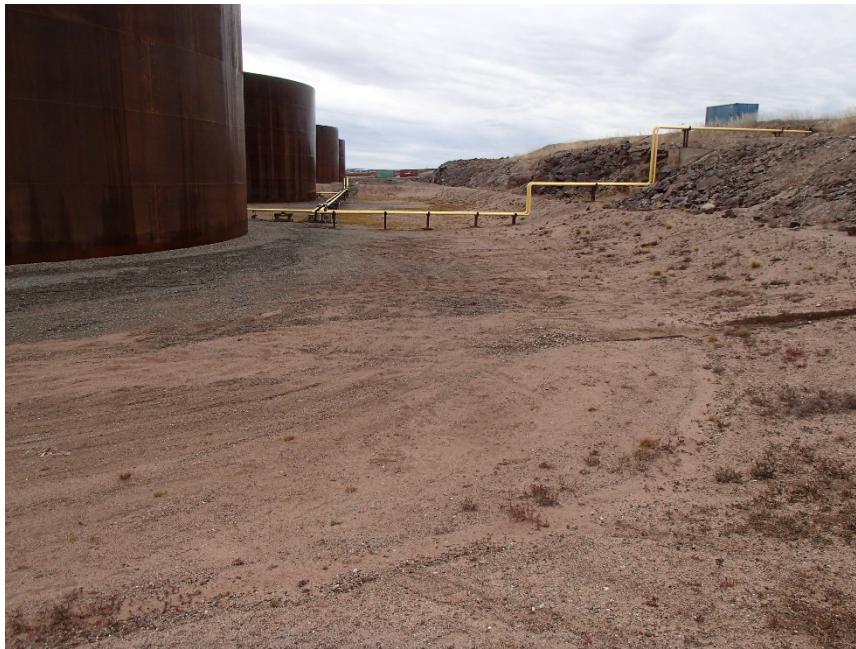
*Photograph G1-12 Baker Lake Tank Farm*

**Description:** From the northern side of Tank 4, looking northwest toward Tanks 4, 3, 2, and 1.

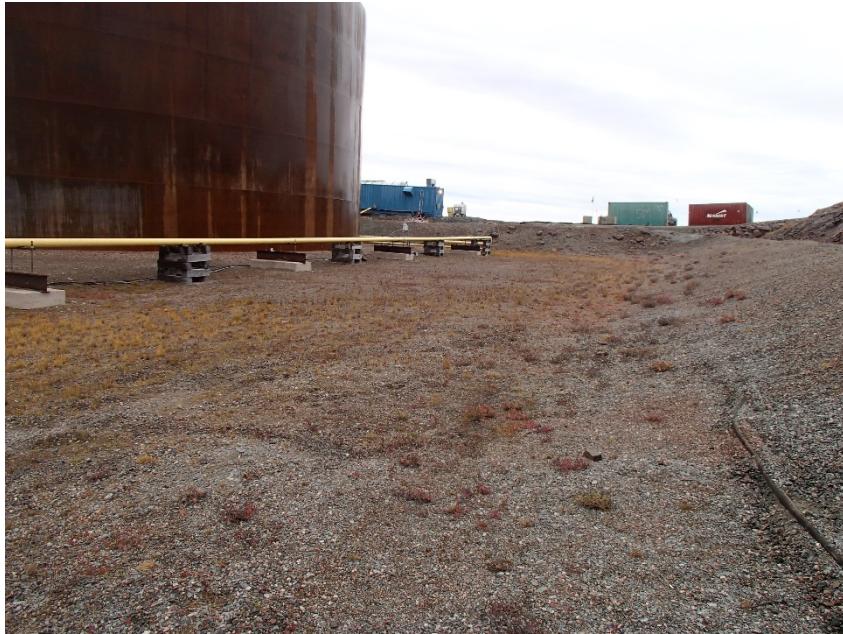
*Photograph G1-13 Baker Lake Tank Farm*

**Description:** From the northern corner of Tank 2 looking west towards the northeastern side of Tank 1.

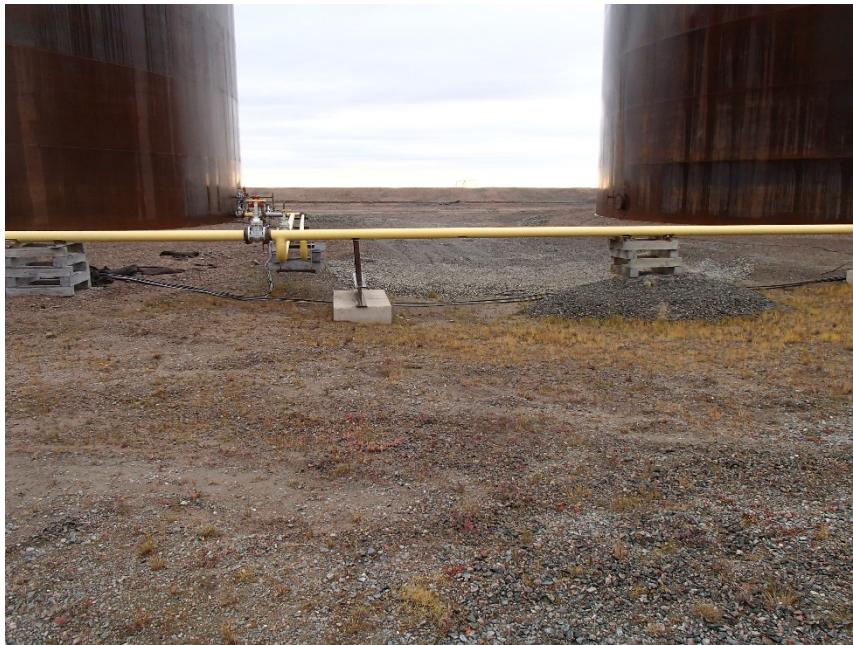
*Photograph G1-14 Baker Lake Tank Farm*

**Description:** From the northern corner of Tank 2 looking southwest between Tanks 1 and 2.

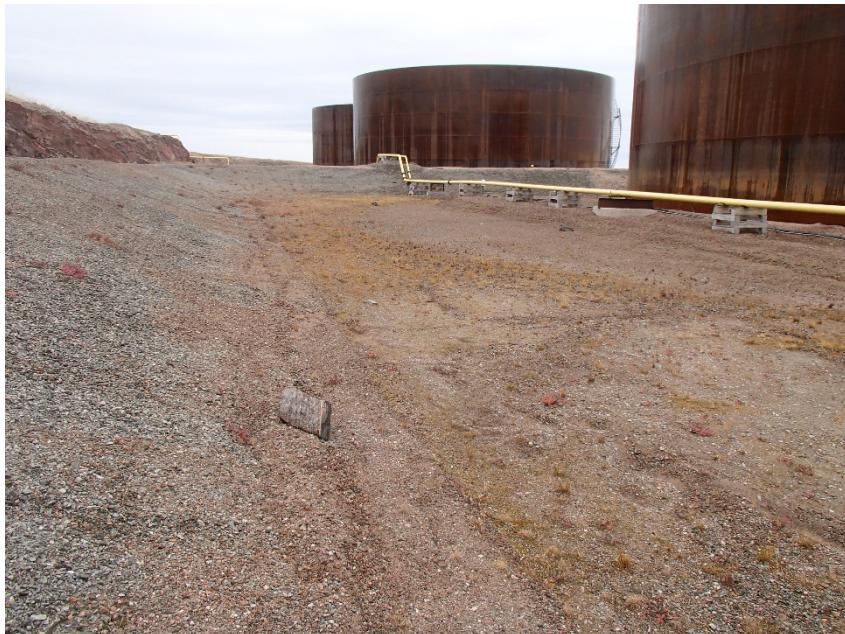
*Photograph G1-15 Baker Lake Tank Farm*

**Description:** From the northern corner of Tank 2 looking southeast towards the northeastern side of Tank 1.

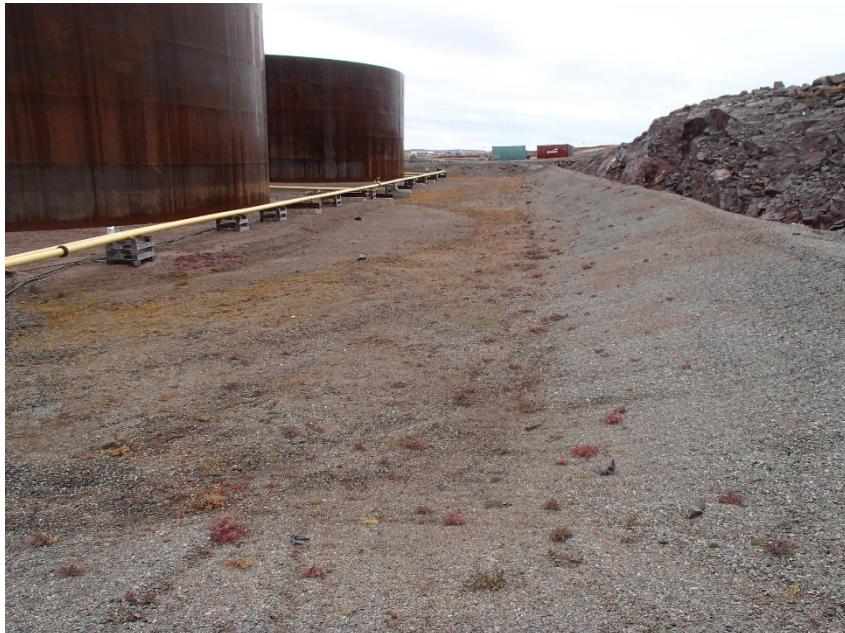
*Photograph G1-16 Baker Lake Tank Farm*

**Description:** From the northeastern corner of Tank 2 looking northwest towards the northeastern side of Tanks 1 and 2.

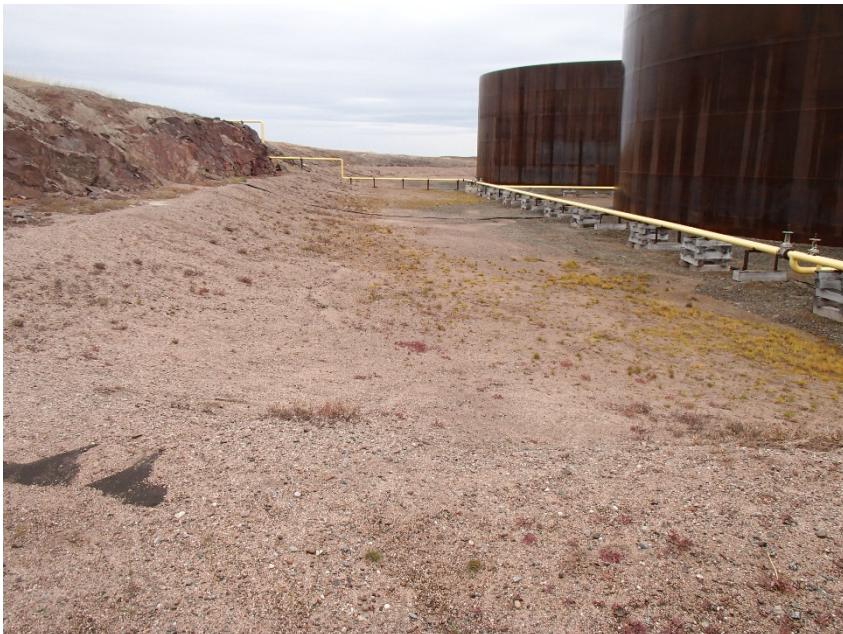
*Photograph G1-17 Baker Lake Tank Farm*

**Description:** From the northwestern corner of Tank 3 looking southeast towards the northeastern side of Tanks 3 and 4.

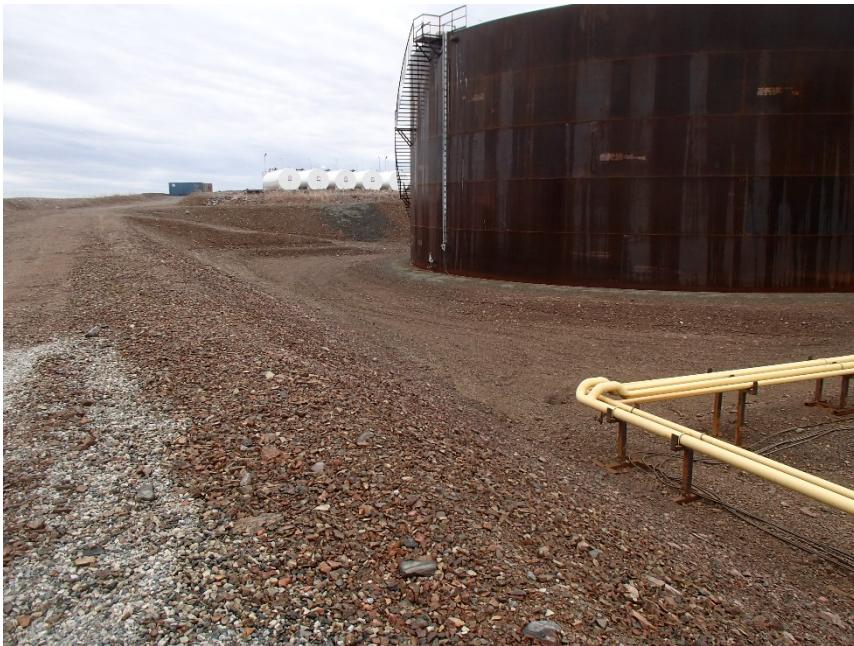
*Photograph G1-18 Baker Lake Tank Farm*

**Description:** Looking northwest at the southern and western sides of Tank 5.

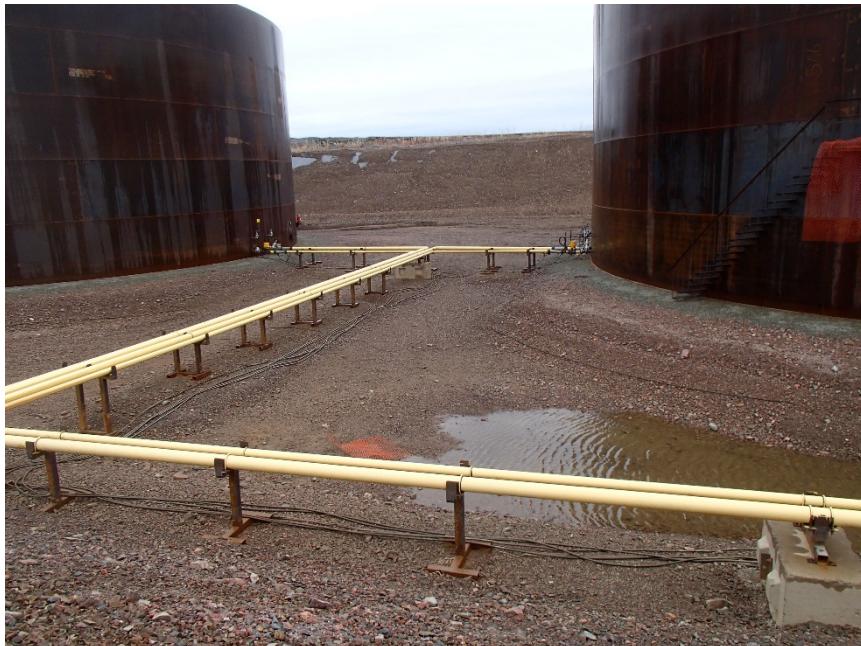
*Photograph G1-19 Baker Lake Tank Farm*

**Description:** Looking north between Tanks 5 and 6. Presence of water ponding.

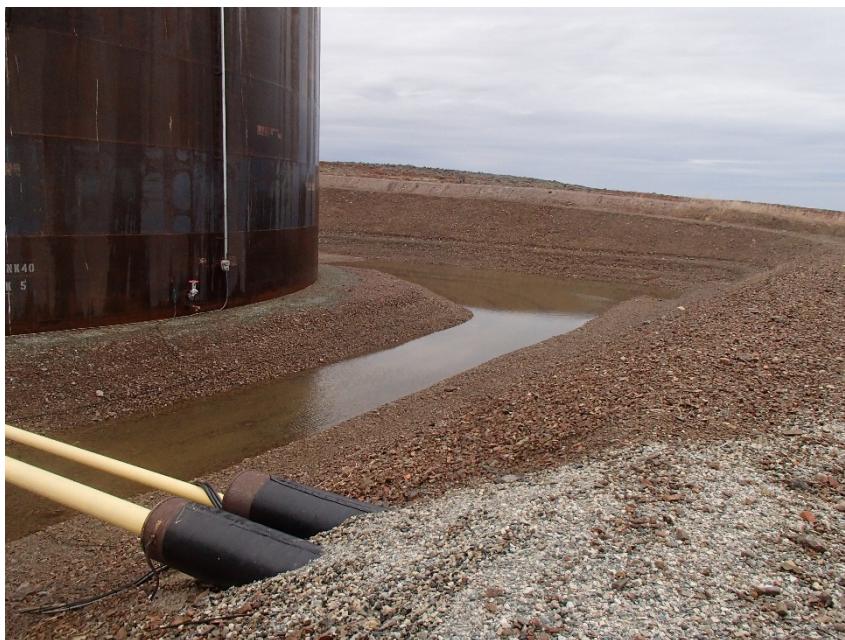
*Photograph G1-20 Baker Lake Tank Farm*

**Description:** Looking northeast at the southern side of Tank 6. Presence of water ponding.

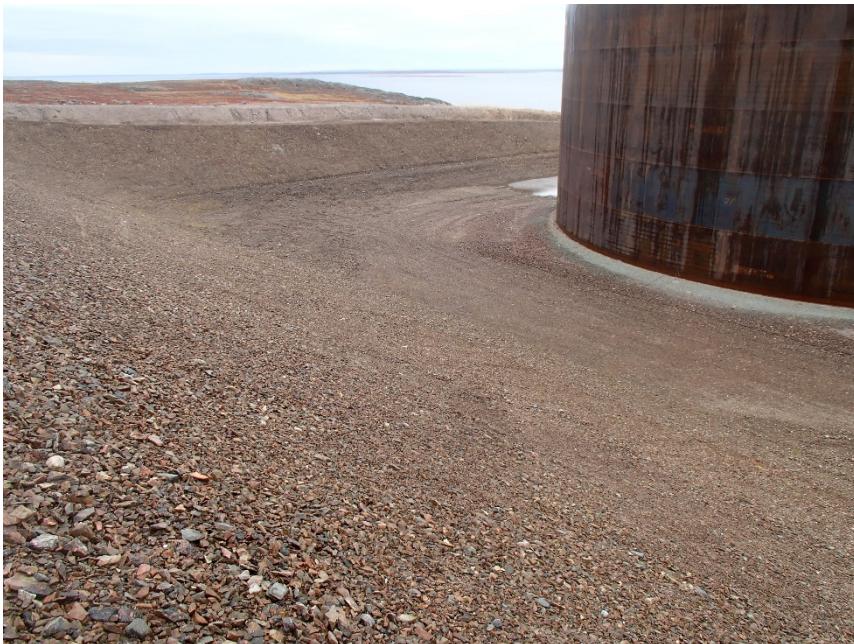
*Photograph G1-21 Baker Lake Tank Farm*

**Description:** Looking southeast at the northeastern side of Tank 6. Presence of water ponding.

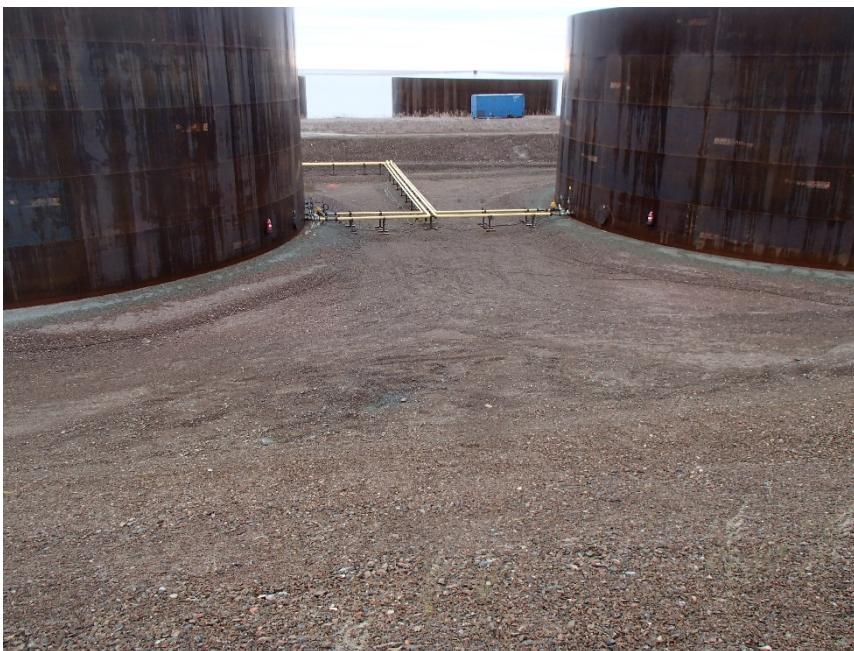
*Photograph G1-22 Baker Lake Tank Farm*

**Description:** Looking south between Tanks 5 and 6.

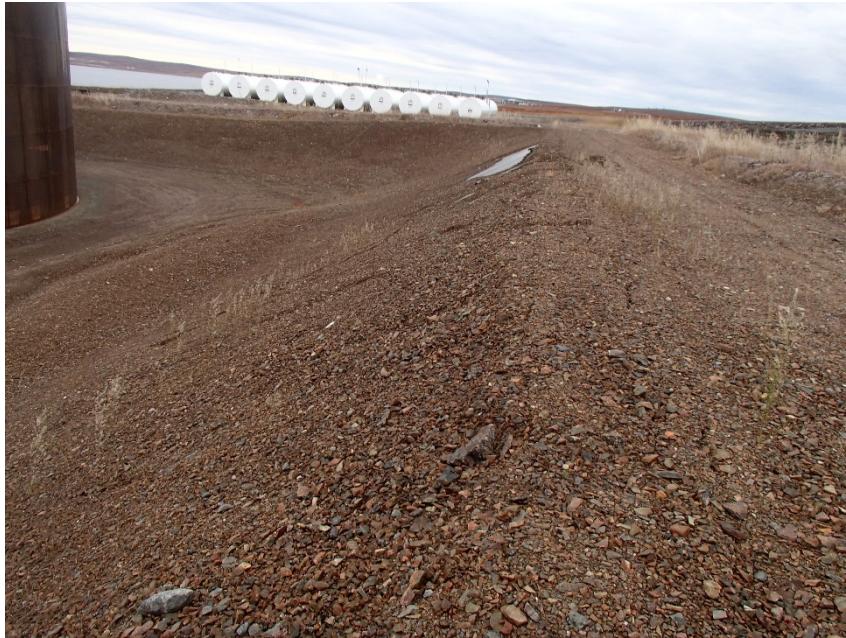
*Photograph G1-23 Baker Lake Tank Farm*

**Description:** Looking west at the northeastern side of Tank 5.

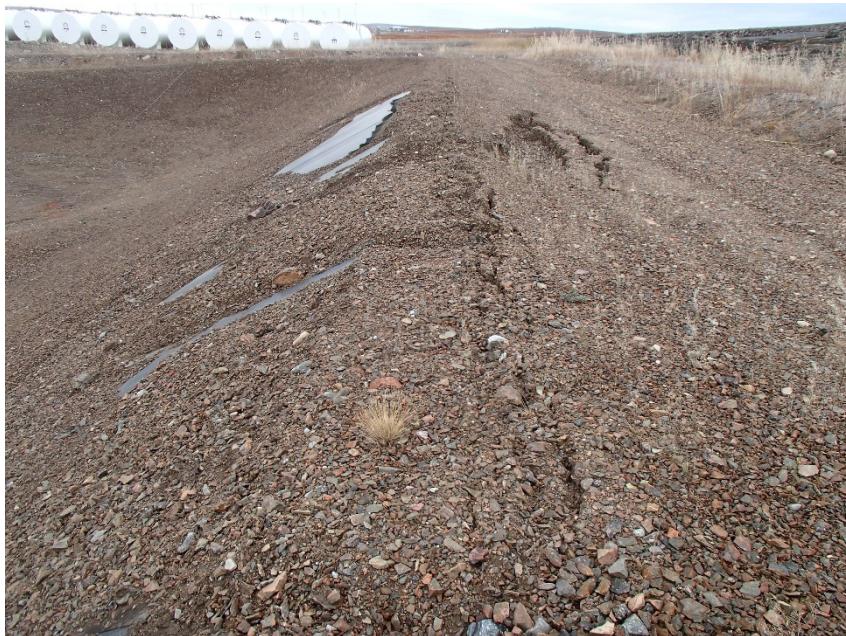
*Photograph G1-24 Baker Lake Tank Farm*

**Description:** Looking northwest at the Jet A fuel tanks.

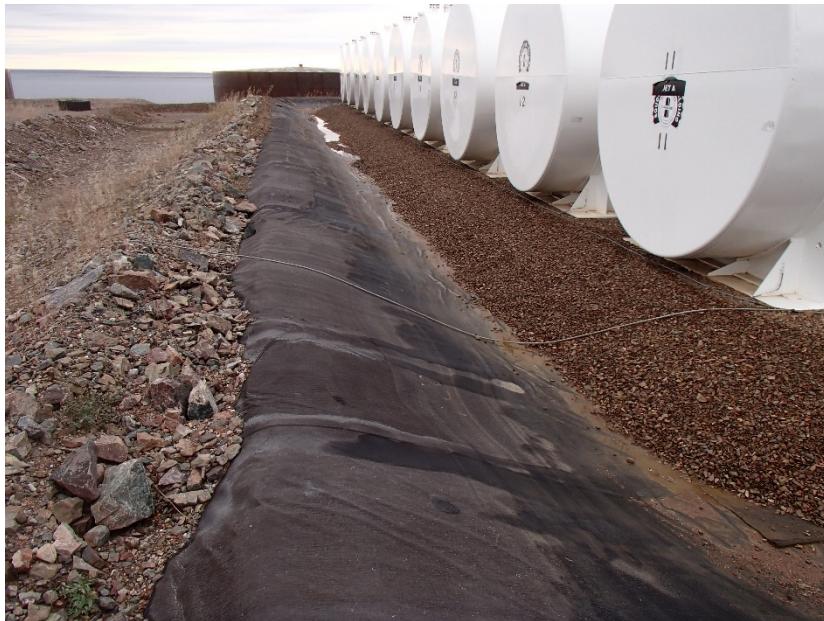
*Photograph G1-25 Baker Lake Tank Farm*

**Description:** From the northeastern corner of the Jet A fuel tanks looking south. Presence of exposed geomembrane.

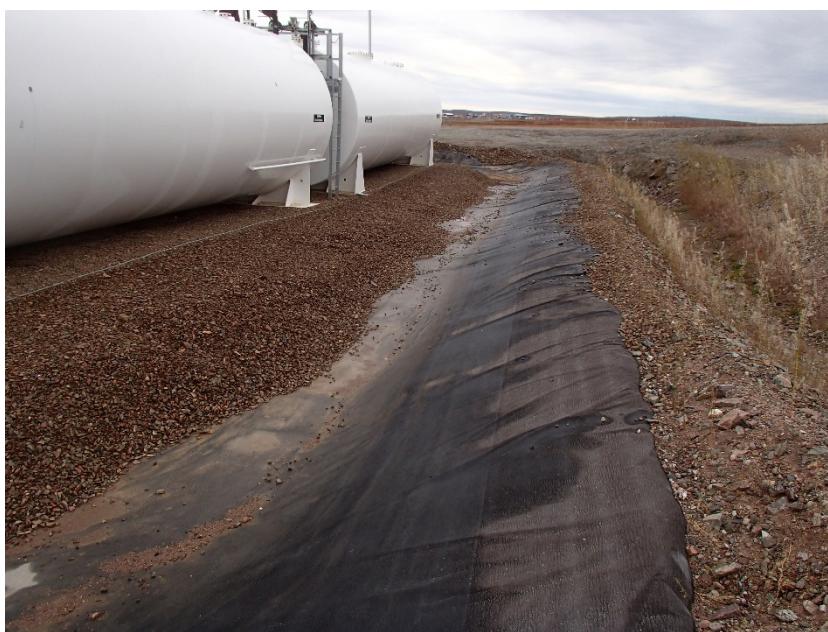
*Photograph G1-26 Baker Lake Tank Farm*

**Description:** From the northeastern corner of the Jet A fuel tanks looking west. Presence of exposed geomembrane.

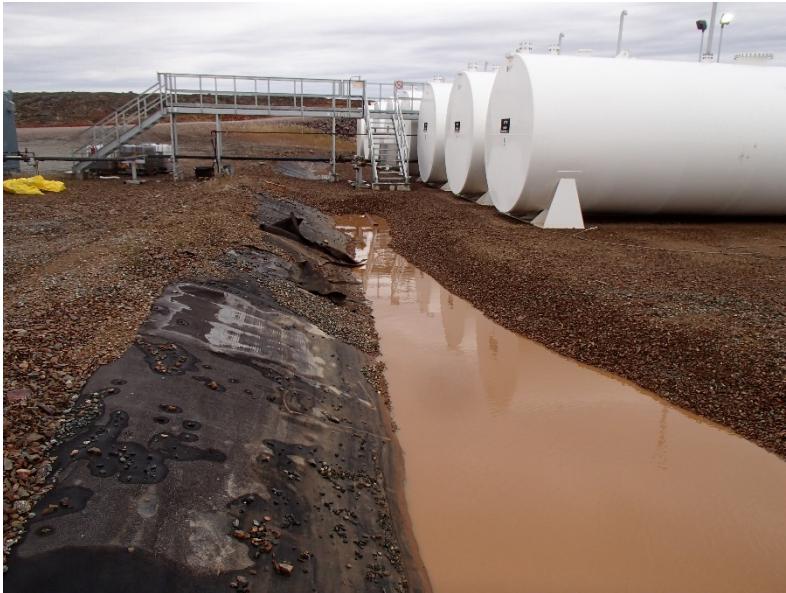
*Photograph G1-27 Baker Lake Tank Farm*

**Description:** From the southwestern corner of the Jet A fuel tanks looking east. Presence of exposed geomembrane and water ponding.

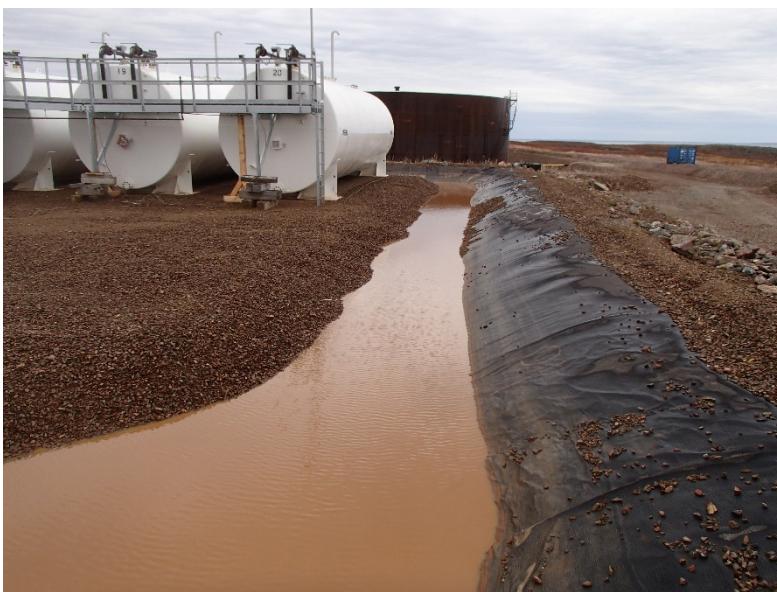
*Photograph G1-28 Baker Lake Tank Farm*

**Description:** From the southwestern corner of the Jet A fuel tanks looking north. Presence of exposed geomembrane and water ponding.

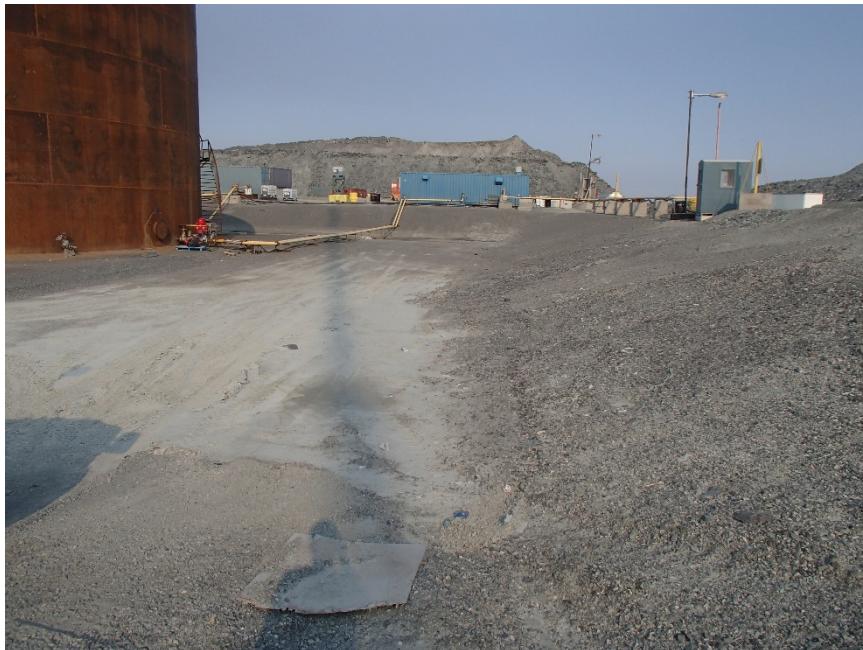
*Photograph G2-1 Meadowbank Tank Farm*

**Description:** From the western corner, looking east at the tank.

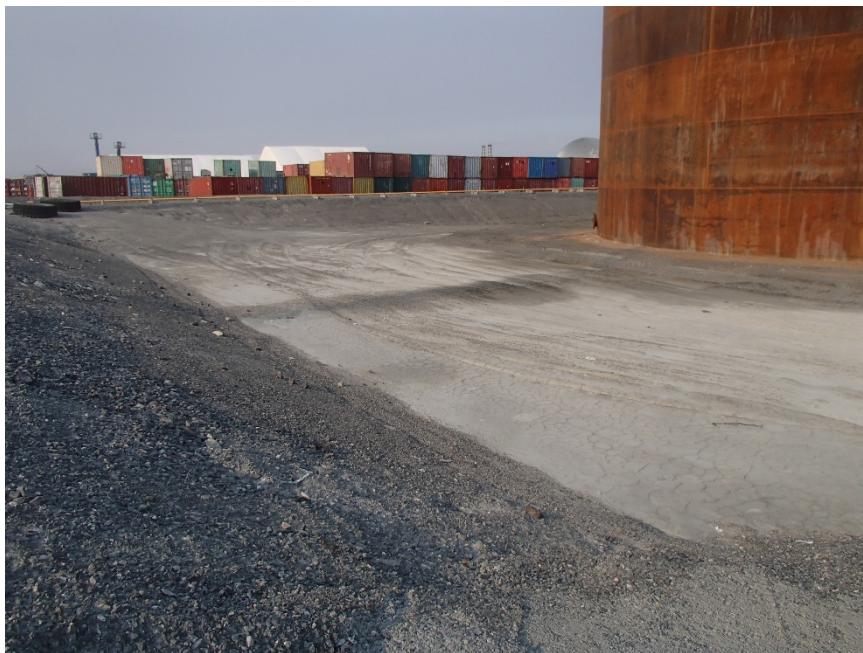
*Photograph G2-2 Meadowbank Tank Farm*

**Description:** From the western corner, looking northeast at the tank.
