## APPENDIX G2 MEADOWBANK TANK FARM PHOTOGRAPHIC LOG

## **Vault Tank Farm Photographic Log**

2017 ANNUAL GEOTECHNICAL INSPECTION  
MEADOWBANK GOLD MINE, NUNAVUT

## **Vault Road Culverts Photographic Log**

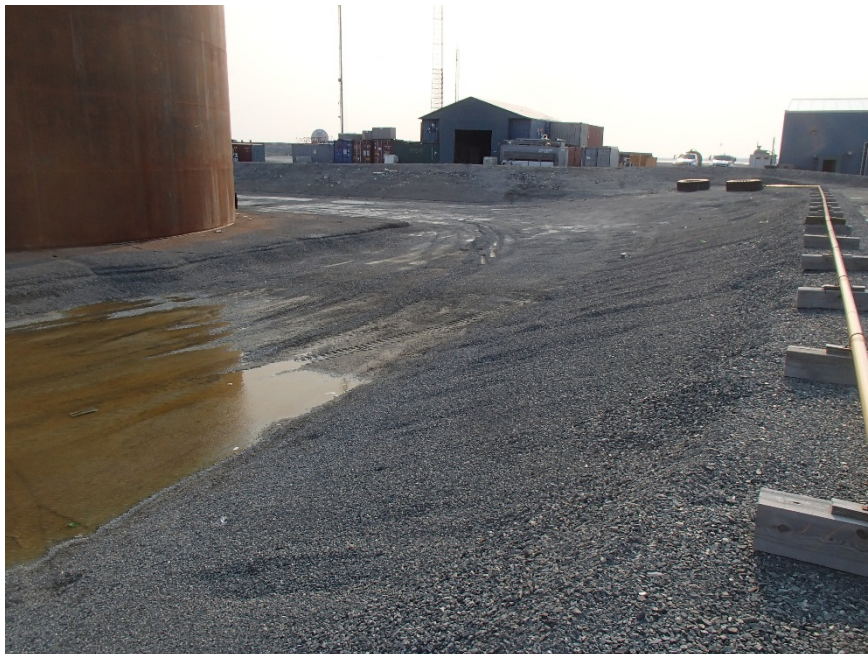
*Photograph G2-3 Meadowbank Tank Farm*

**Description:** From the eastern side, looking northwest.

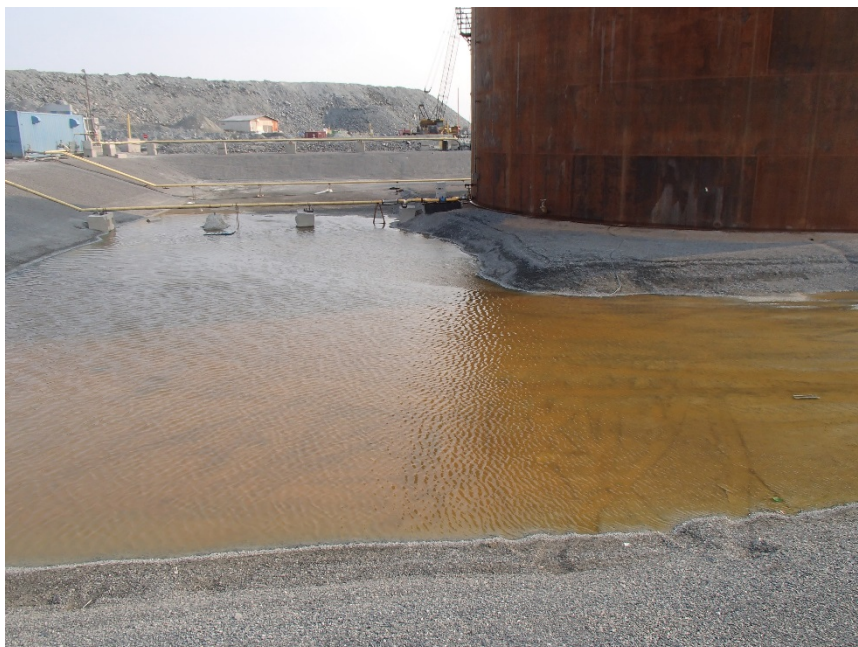
*Photograph G2-4 Meadowbank Tank Farm*

**Description:** From the eastern side looking southwest. Presence of water ponding. A pump is installed.

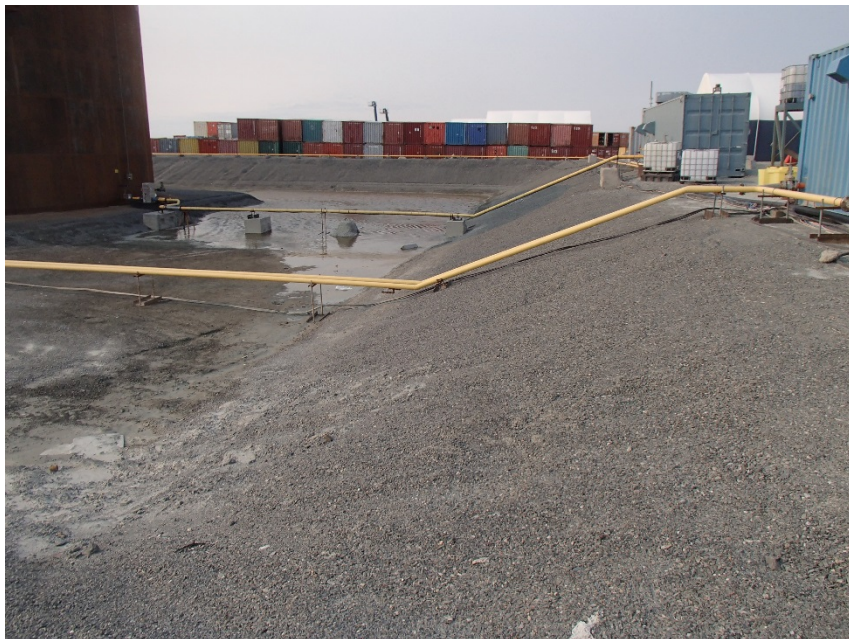
*Photograph G2-5 Meadowbank Tank Farm*

**Description:** Looking northeast from the southern corner. Accumulation of water in the eastern corner.

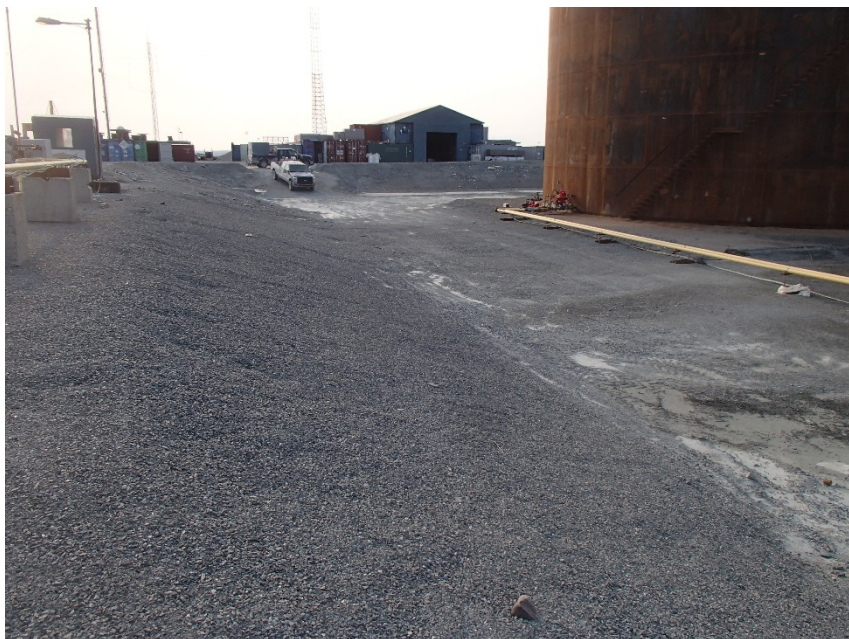
*Photograph G2-6 Meadowbank Tank Farm*

**Description:** Looking northwest from the southern corner.

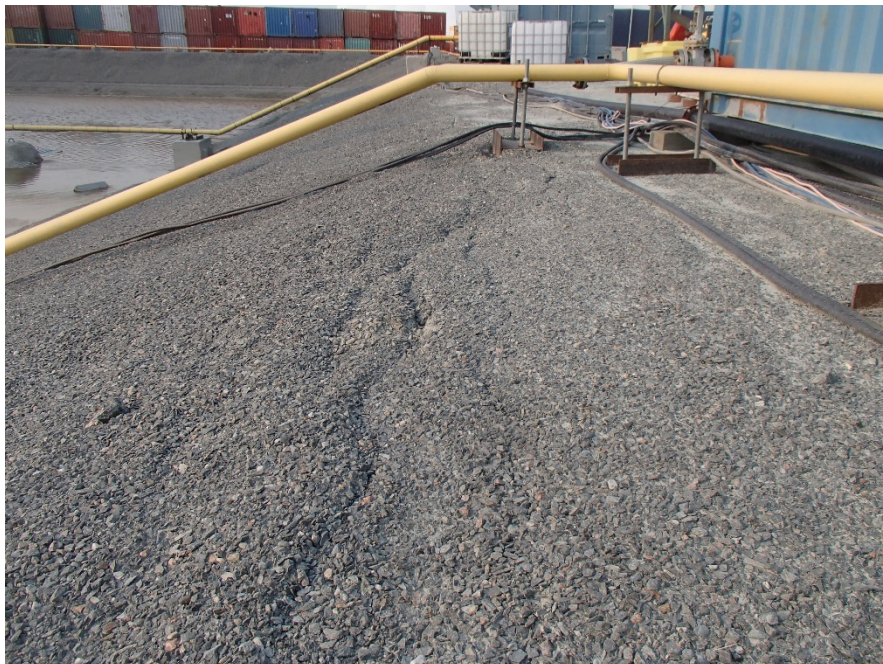
*Photograph G2-7 Meadowbank Tank Farm*

**Description:** From the southern corner: presence of small tension cracks on the crest (about 3 m long).

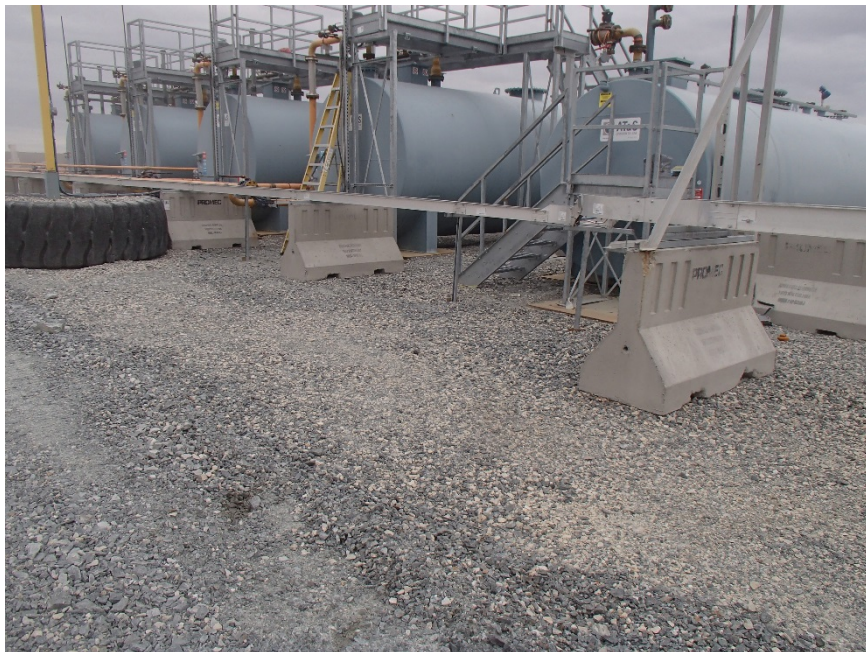
*Photograph G3-1 Vault Tank Farm*

**Description:** From the southeast corner of the Tanks looking northwest toward the Vault Tank Farm.

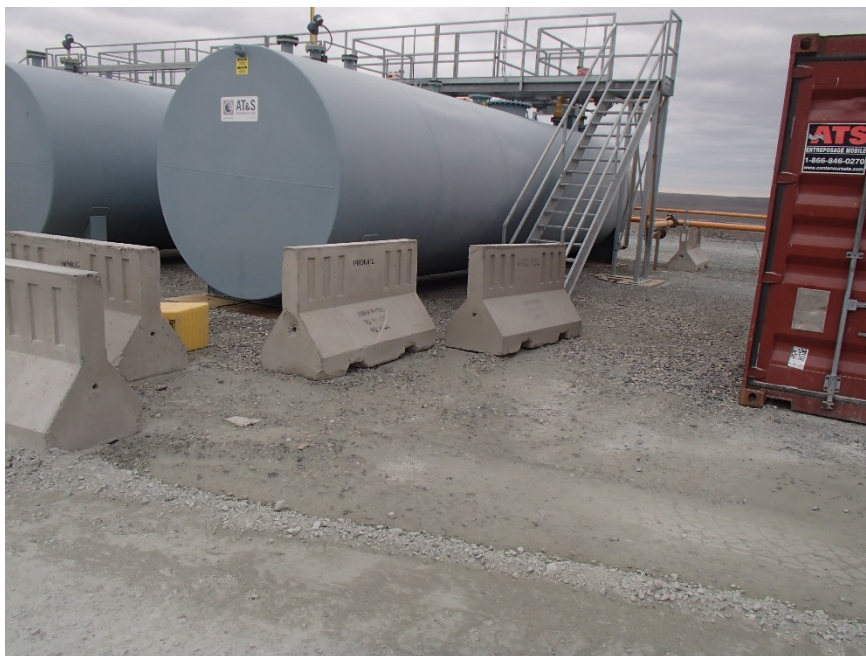
*Photograph G3-2 Vault Tank Farm*

**Description:** From the northwest corner of the Tanks Looking northeast toward the Vault Tank Farm.

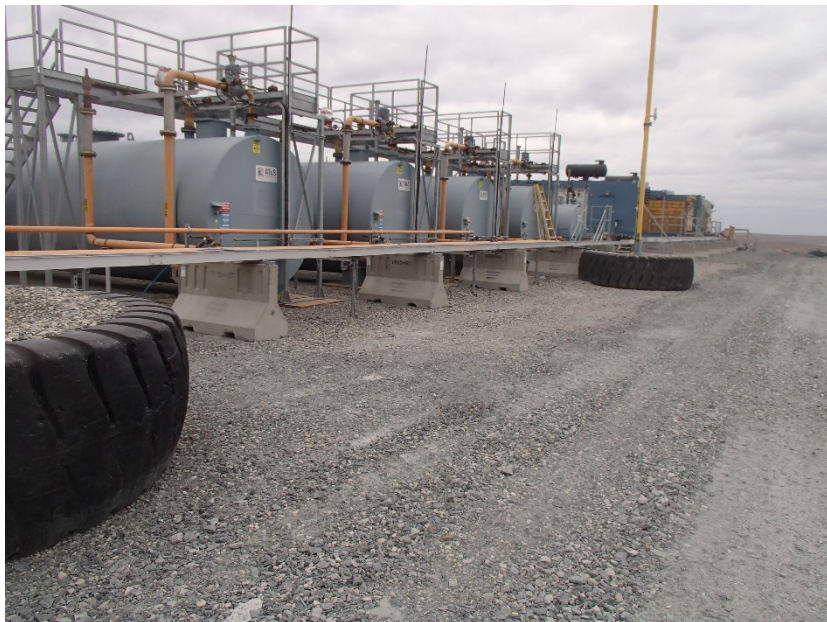
*Photograph G3-3 Vault Tank Farm*

**Description:** From the southwest corner of the Tanks Looking northeast toward the Vault Tank Farm.

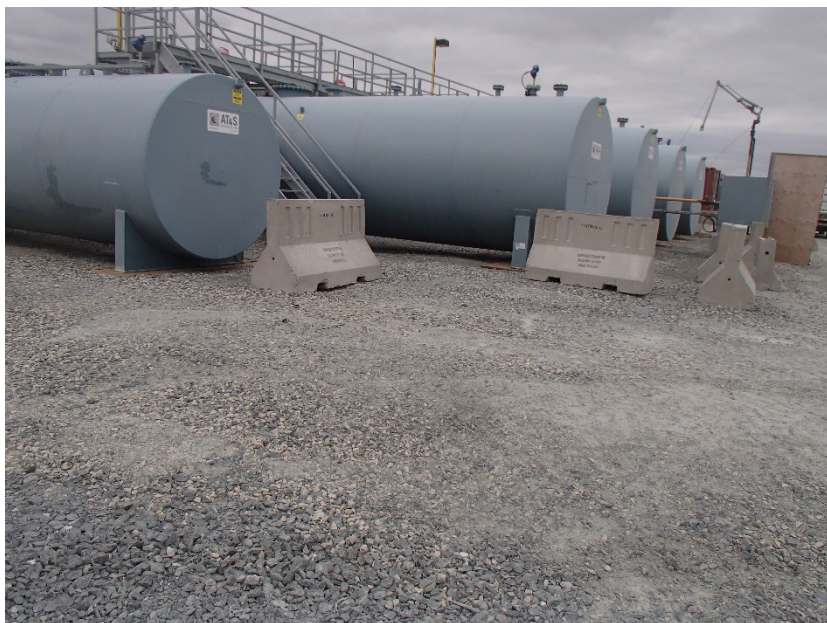
*Photograph G3-4 Vault Tank Farm*

**Description:** From the northeast corner of the Tanks looking southwest toward the Vault Tank Farm.

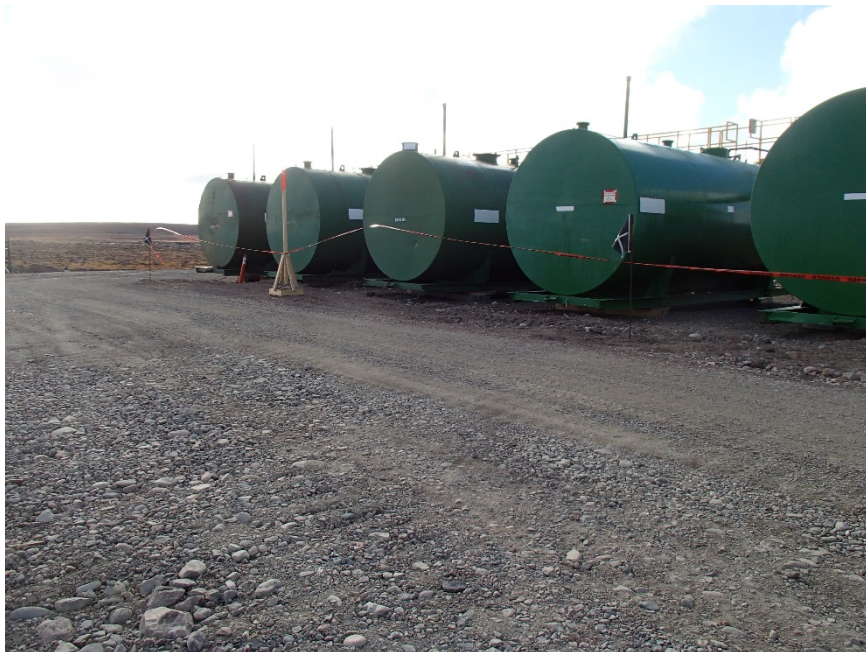
*Photograph G4-1 Amaruq Tank Farm*

**Description:** From the northeast side of the Tanks looking south toward the Amaruq Tank Farm.

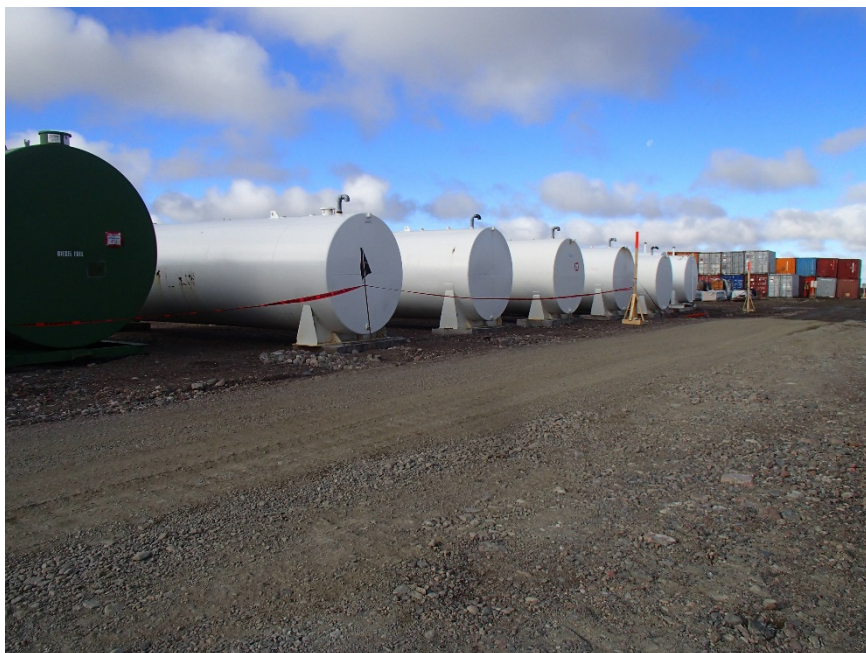
*Photograph G4-2 Amaruq Tank Farm*

**Description:** From the northeast side of the Tanks looking west toward the Amaruq Tank Farm.

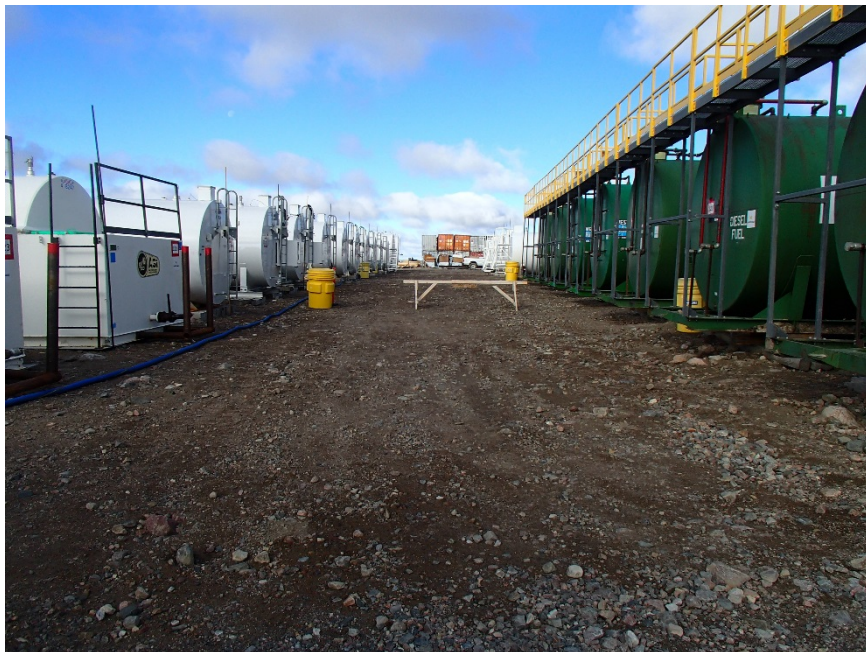
*Photograph G4-3 Amaruq Tank Farm*

**Description:** From the southeast side of the Tanks looking northwest toward the Amaruq Tank Farm.

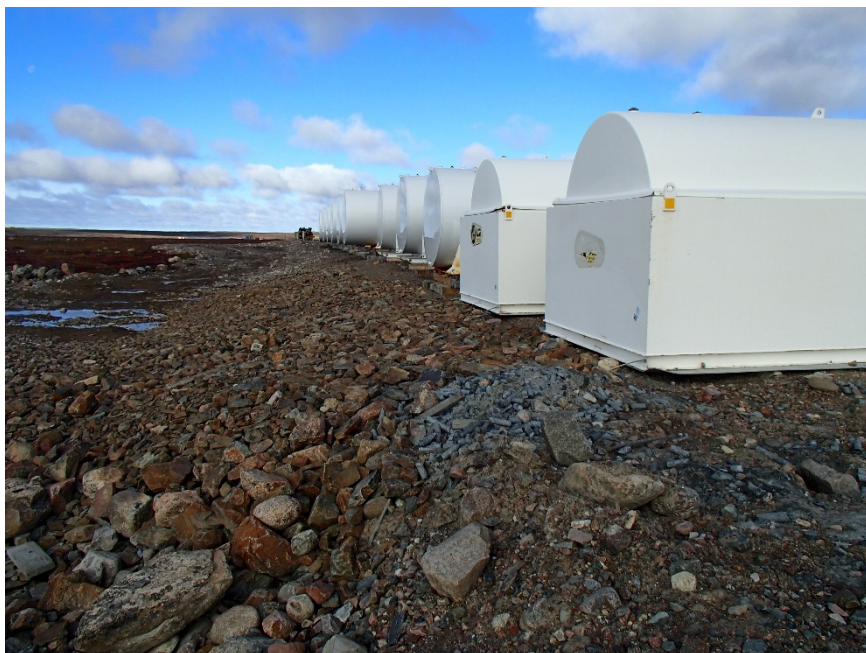
*Photograph G4-4 Amaruq Tank Farm*

**Description:** From the southeast corner of the Tanks looking northwest toward the Amaruq Tank Farm.

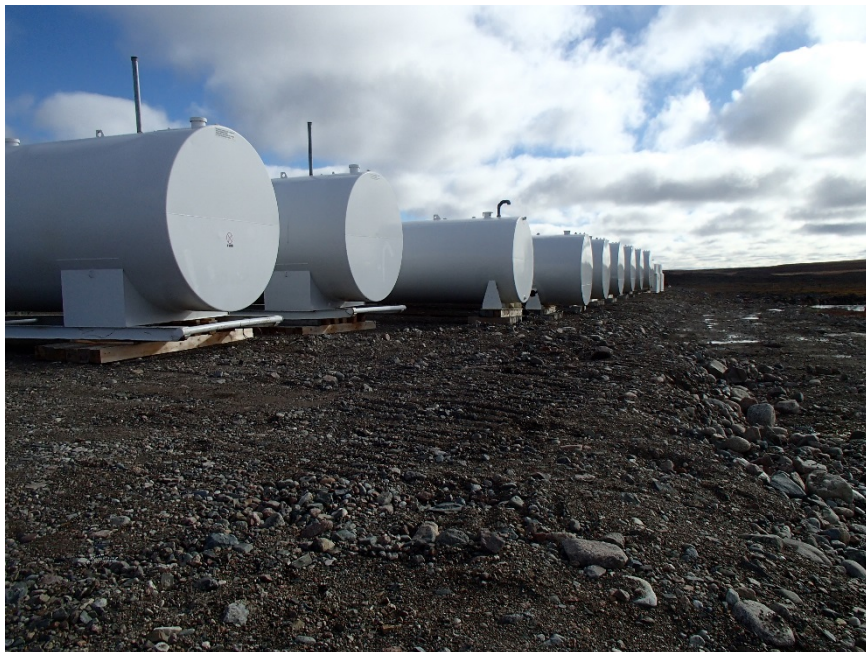
*Photograph G4-5 Amaruq Tank Farm*

**Description:** From the northwest corner of the Tanks looking southeast toward the Amaruq Tank Farm.

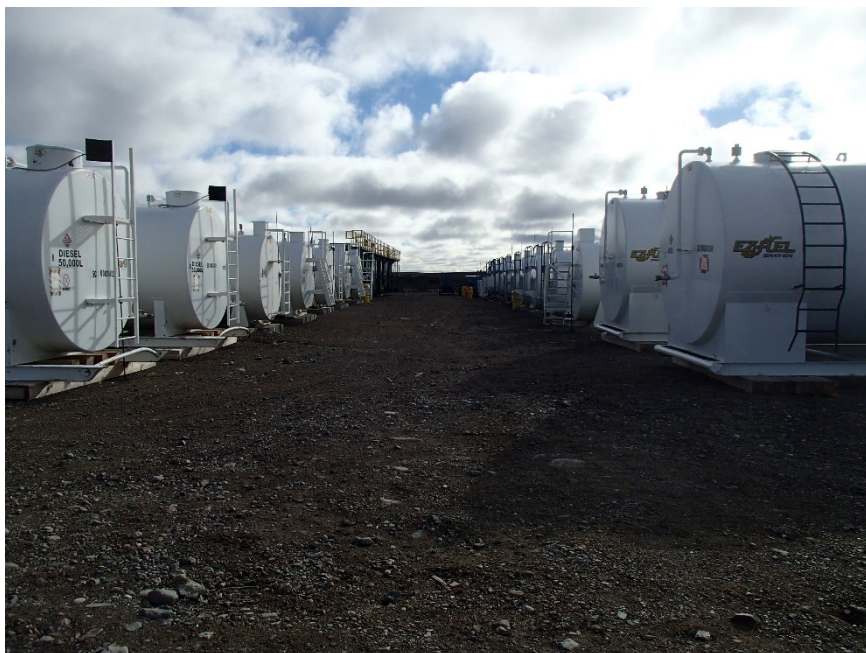
*Photograph G4-6 Amaruq Tank Farm*

**Description:** From the northwest side of the Tanks looking southeast toward the Amaruq Tank Farm.

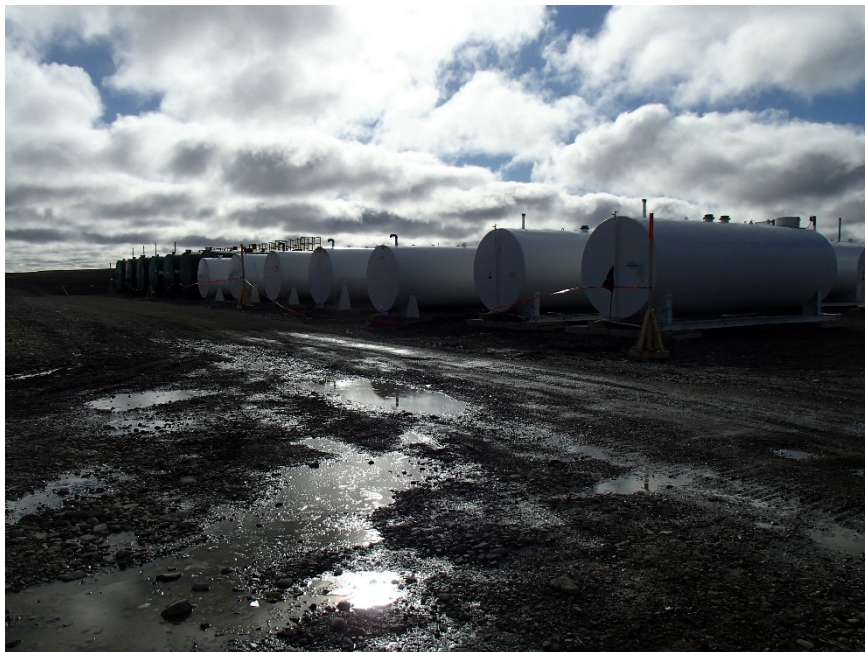
*Photograph G4-7 Amaruq Tank Farm*

**Description:** From the northeast corner of the Tanks looking south toward the Amaruq Tank Farm.

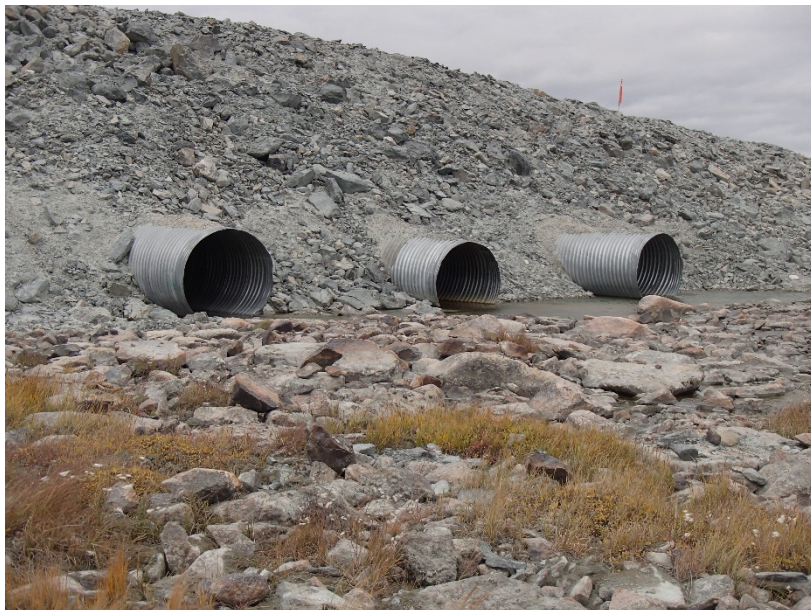
*Photograph H1-1 Vault Road Culverts*

**Description:** Looking at the outlet of the three culverts located on Vault Road at 640964E/7217466N. All of them are deformed in the middle.

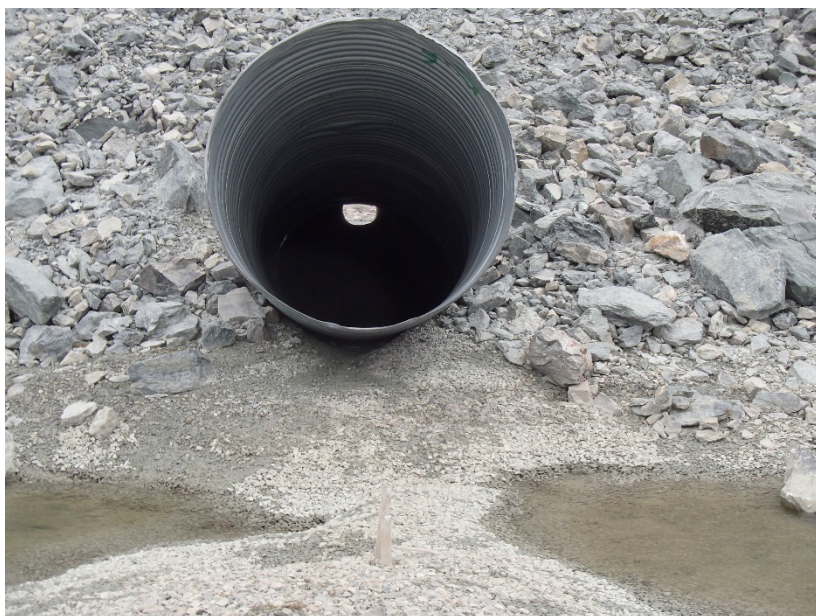
*Photograph H1-2 Vault Road Culverts*

**Description:** From the inlet side of the three culverts located on Vault Road at 640964E/7217466N. Looking inside the southern culvert. The culvert is slightly deformed on top in the middle.

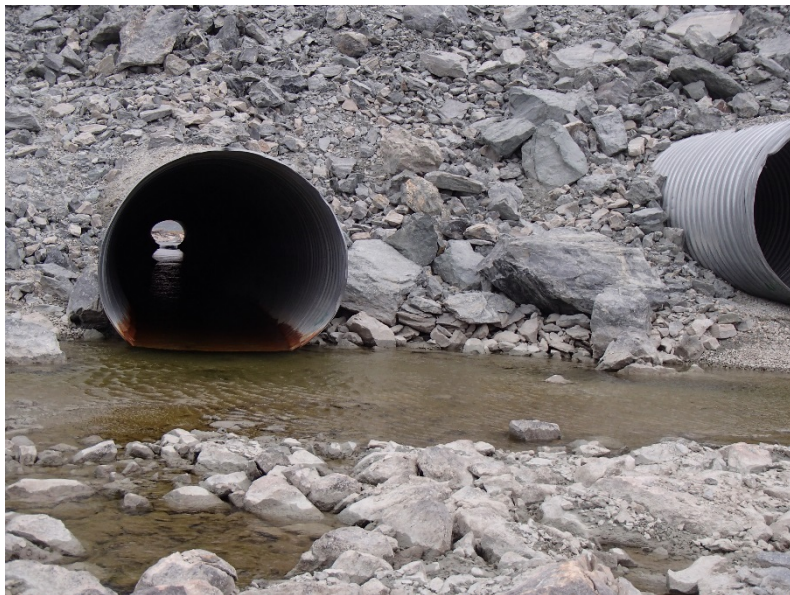
*Photograph H1-3 Vault Road Culverts*

**Description:** From the inlet side of the three culverts located on Vault Road at 640964E/7217466N. Looking inside the central culvert. The culvert is slightly deformed on top in the middle.

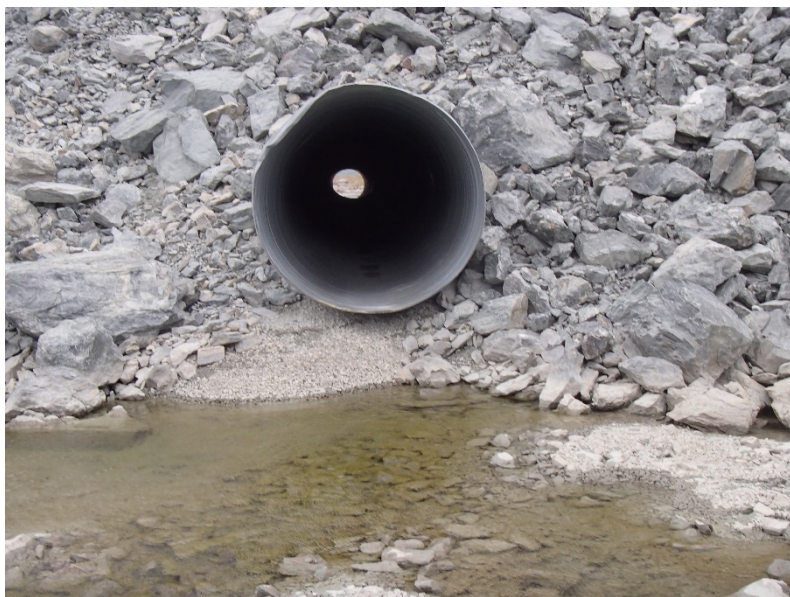
*Photograph H1-4 Vault Road Culverts*

**Description:** From the inlet side of the three culverts located on Vault Road at 640964E/7217466N. Looking inside the northern culvert. The culvert is slightly deformed on top in the middle.

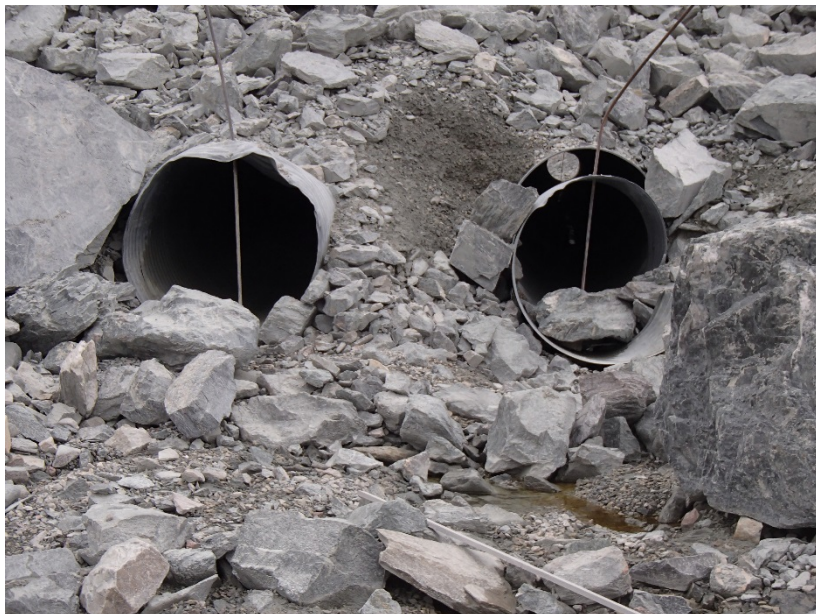
*Photograph H1-5 Vault Road Culverts*

**Description:** Culvert on the NP1 side at 639 214 E / 7 216 189 N on Vault Road. Culvert broken and partially obstructed.

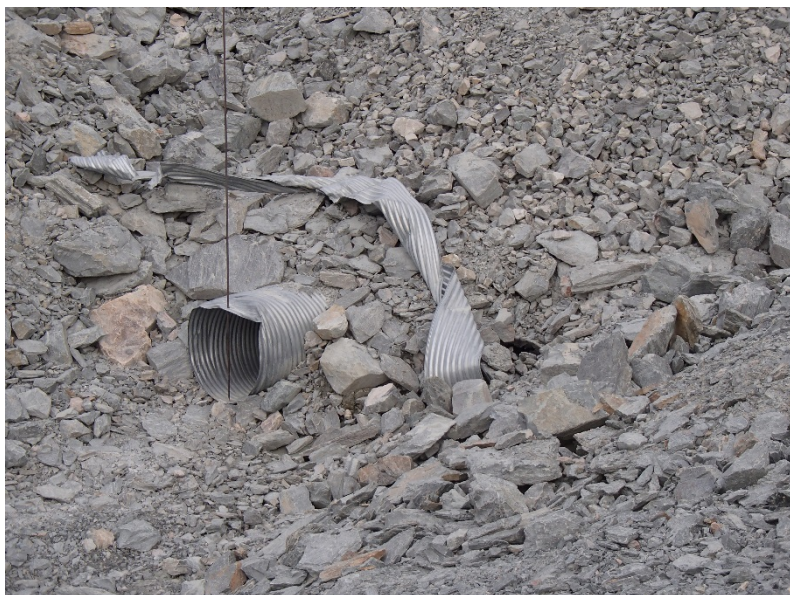
*Photograph H1-6 Vault Road Culverts*

**Description:** Culvert on the NP2 side at 639 214 E / 7 216 189 N on Vault Road. Southern culvert is collapsed.

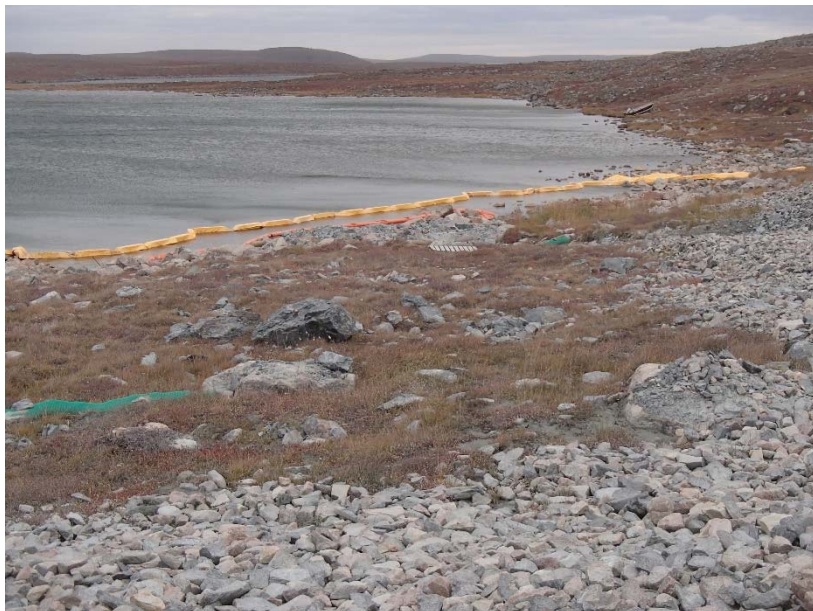
*Photograph H2-1 Diversion Ditch and its Sediment and Erosion Protection Structure*

**Description:** Looking south toward Lake NP1 at the sediment and erosion protection structure. Presence of 2 silt curtains and 3 wooden barrier.

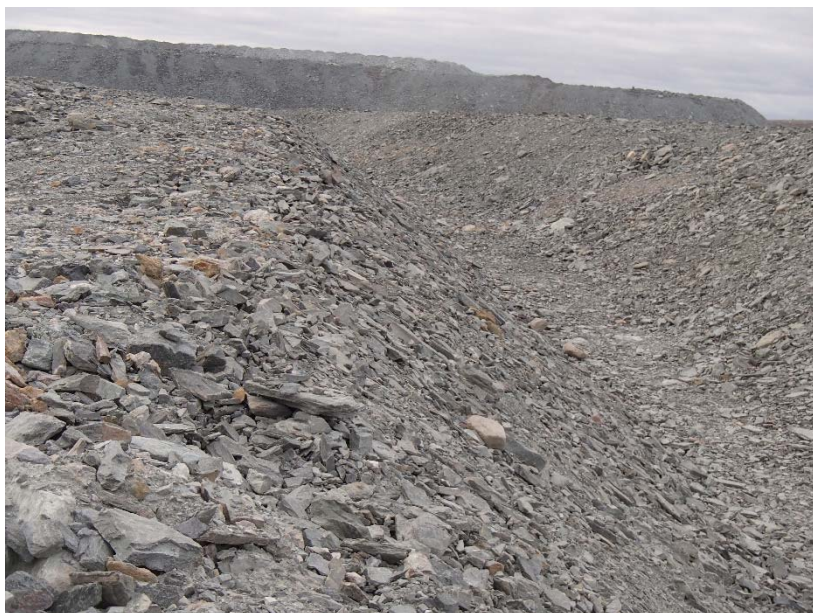
*Photograph H2-2 Diversion Ditch and its Sediment and Erosion Protection Structure*

**Description:** Looking west toward the western diversion ditch.

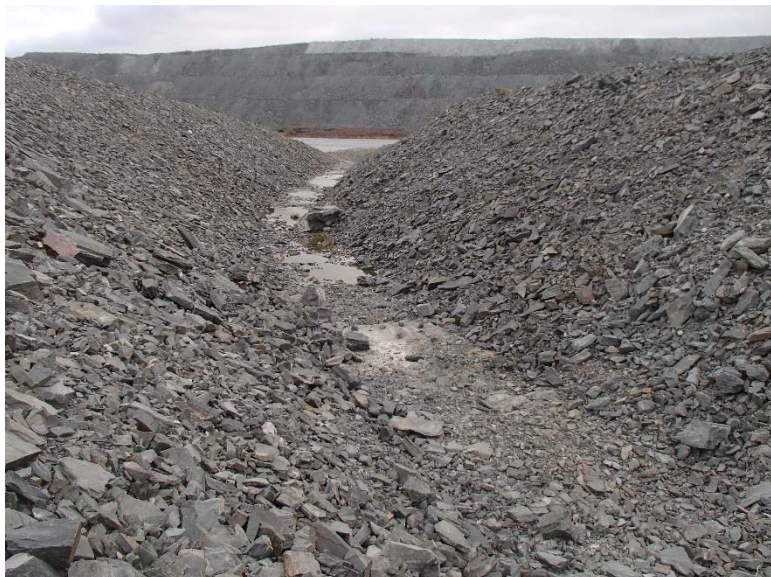
*Photograph H2-3 Diversion Ditch and its Sediment and Erosion Protection Structure*

**Description:** From the eastern diversion ditch looking south toward Lake NP2.

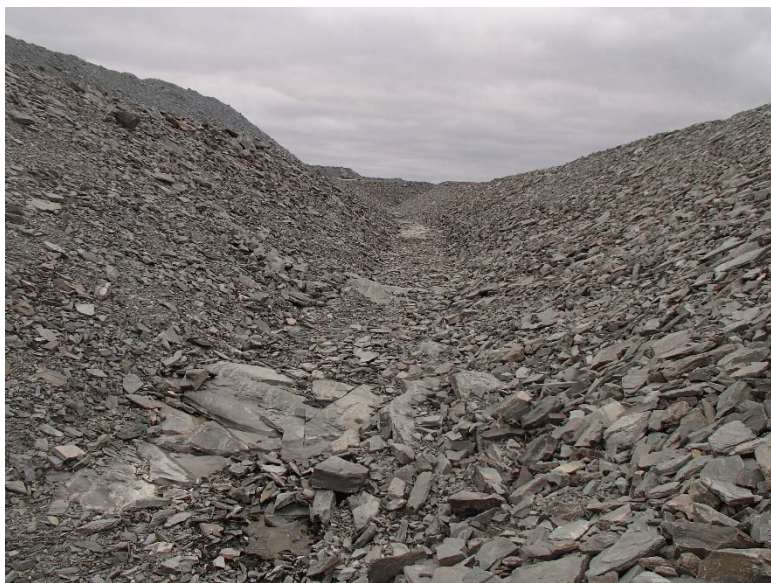
*Photograph H2-4 Diversion Ditch and its Sediment and Erosion Protection Structure*

**Description:** From the eastern diversion ditch looking northwest.

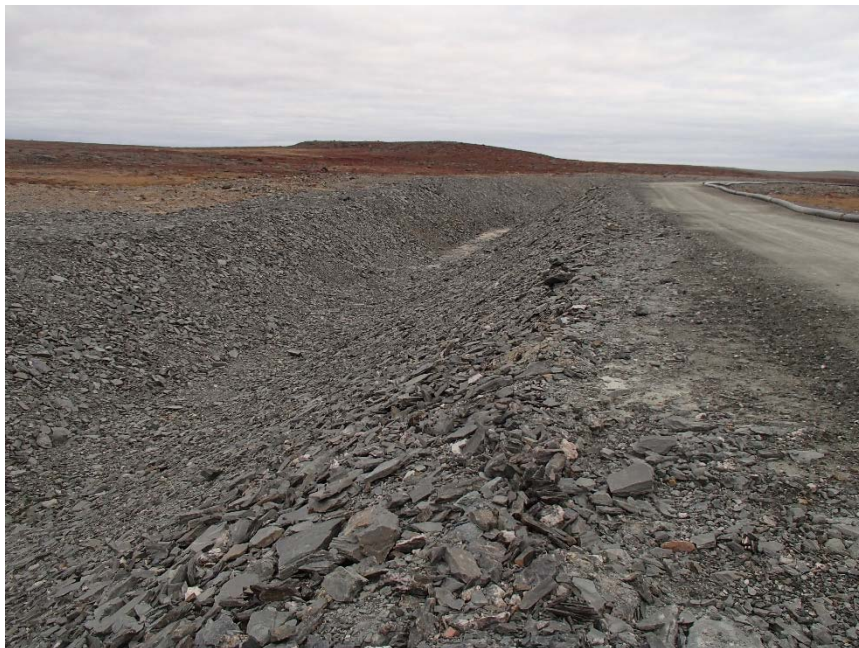
*Photograph H2-5 Diversion Ditch and its Sediment and Erosion Protection Structure*

**Description:** From the eastern diversion ditch, looking east.

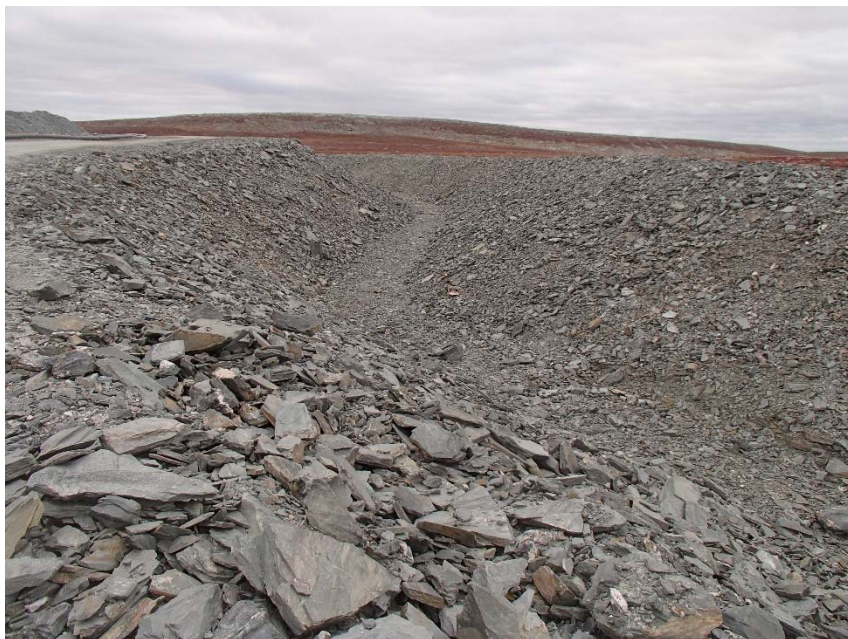
*Photograph H2-6 Diversion Ditch and its Sediment and Erosion Protection Structure*

**Description:** From the eastern diversion ditch, looking northwest.
