## APPENDIX H2

### DIVERSION DITCH AND ITS EROSION AND SEDIMENT PROTECTION STRUCTURE PHOTOGRAPHIC LOG

**2017 ANNUAL GEOTECHNICAL INSPECTION  
MEADOWBANK GOLD MINE, NUNAVUT**

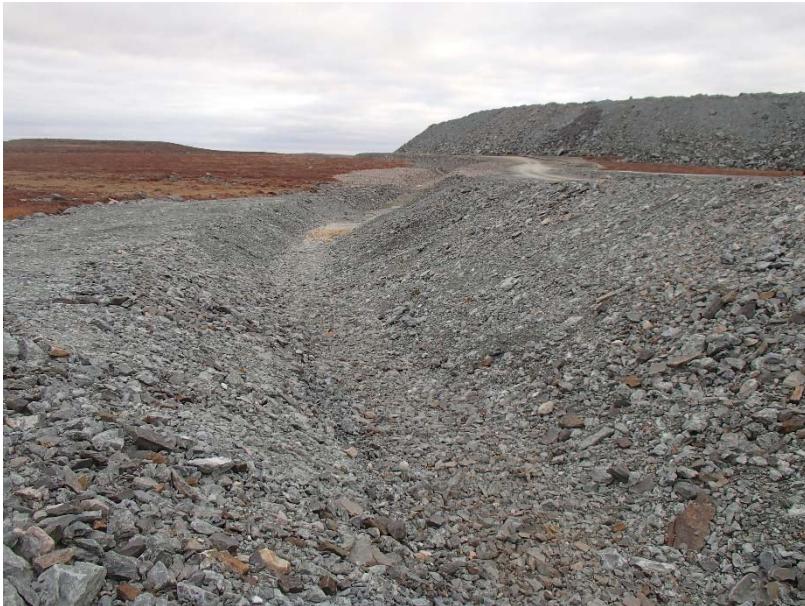
*Photograph H2-7 Diversion Ditch and its Sediment and Erosion Protection Structure*

**Description:** From the northern diversion ditch looking southeast.

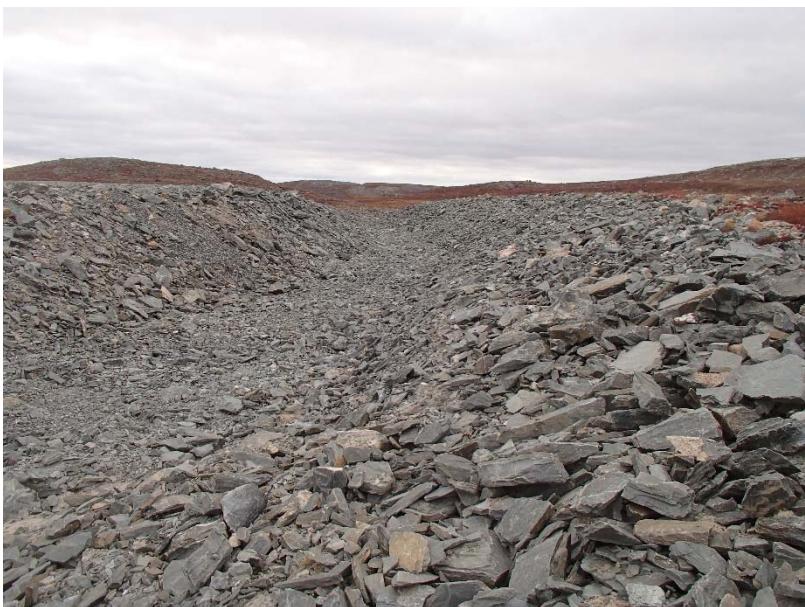
*Photograph H2-8 Diversion Ditch and its Sediment and Erosion Protection Structure*

**Description:** From the northern diversion ditch looking west.

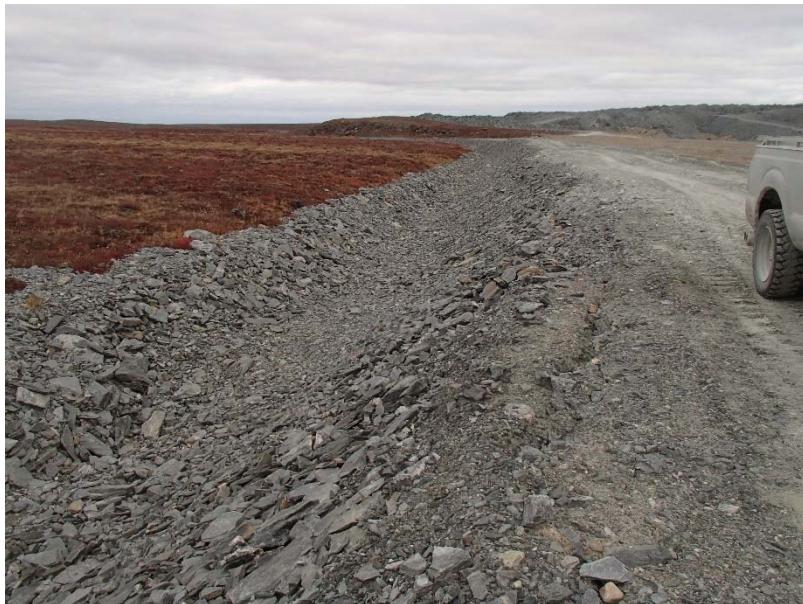
*Photograph H2-9 Diversion Ditch and its Sediment and Erosion Protection Structure*

**Description:** From the northern diversion ditch looking east.

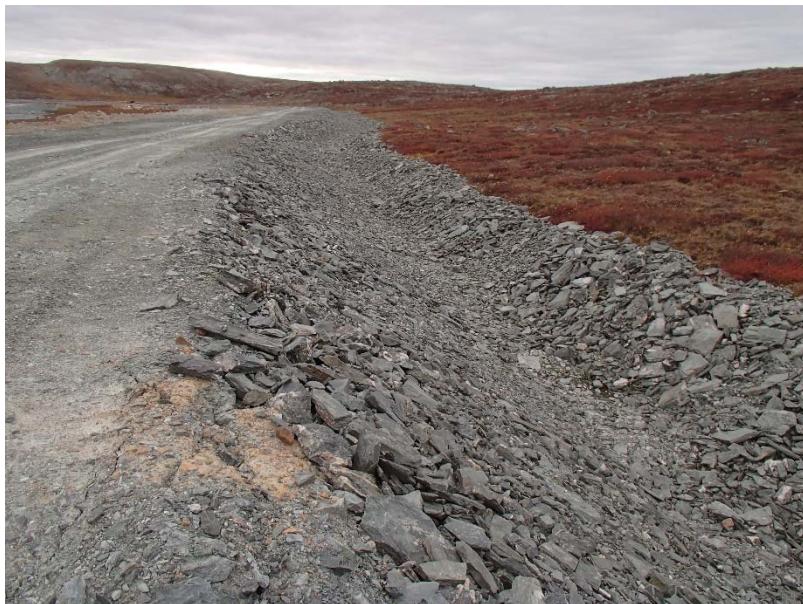
*Photograph H2-10 Diversion Ditch and its Sediment and Erosion Protection Structure*

**Description:** From the northern diversion ditch looking west.

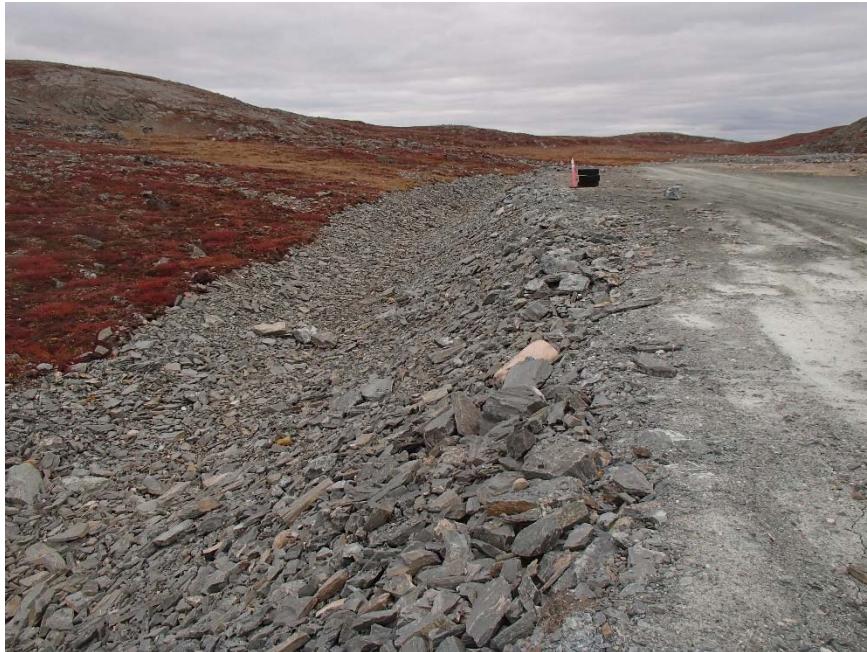
*Photograph H2-11 Diversion Ditch and its Sediment and Erosion Protection Structure*

**Description:** From 637281E/7216790N, looking north. View of the western diversion ditch.

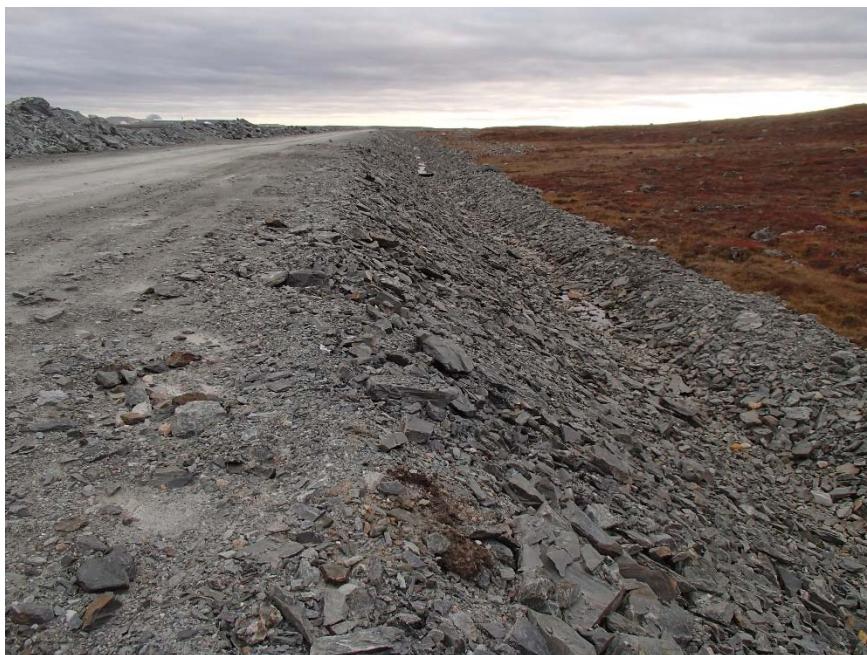
*Photograph H2-12 Diversion Ditch and its Sediment and Erosion Protection Structure*

**Description:** From 637281E/7216790N, looking south at the western diversion ditch.

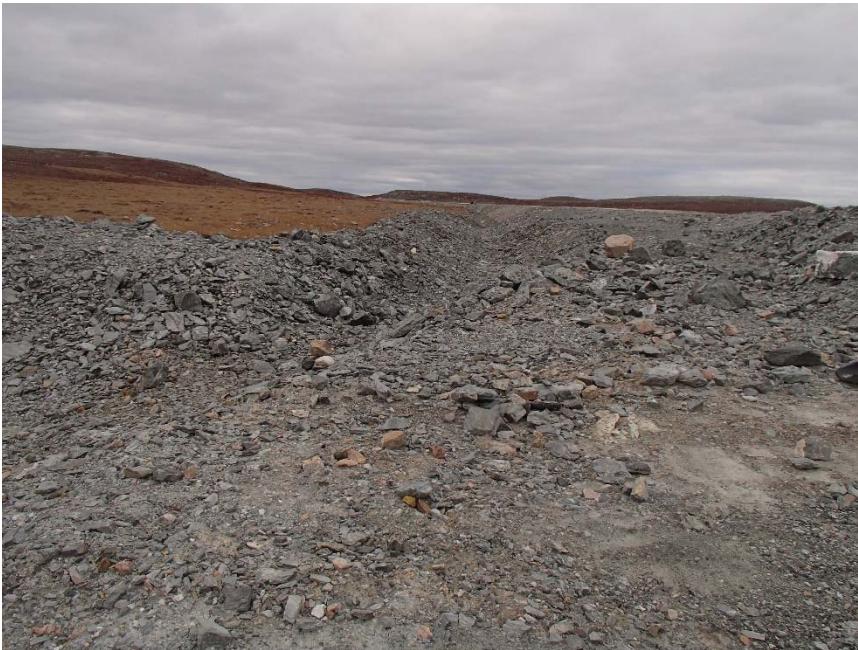
*Photograph H2-13 Diversion Ditch and its Sediment and Erosion Protection Structure*

**Description:** From 637251E/7216171N, looking north at the western diversion ditch.

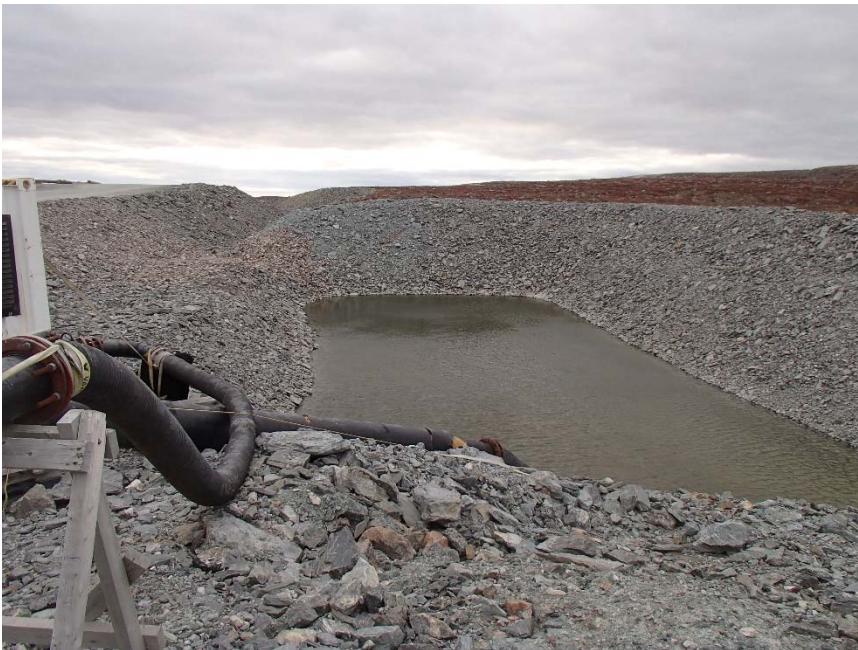
*Photograph H2-14 Diversion Ditch and its Sediment and Erosion Protection Structure*

**Description:** From 637251E/7216171N, looking west at the western diversion ditch and its retention basin.

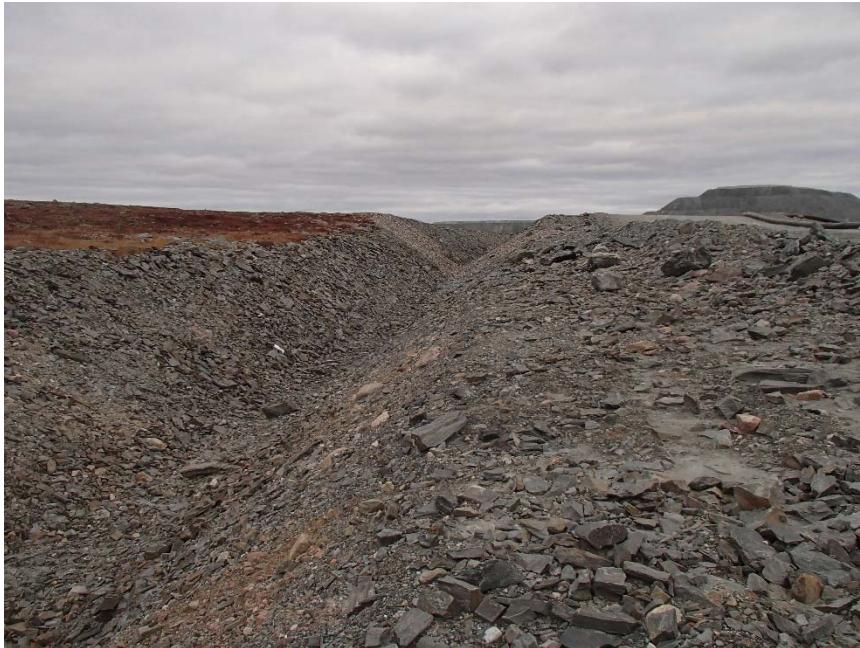
*Photograph H2-15 Diversion Ditch and its Sediment and Erosion Protection Structure*

**Description:** From 637074E/7216157N, looking east at the western diversion ditch.

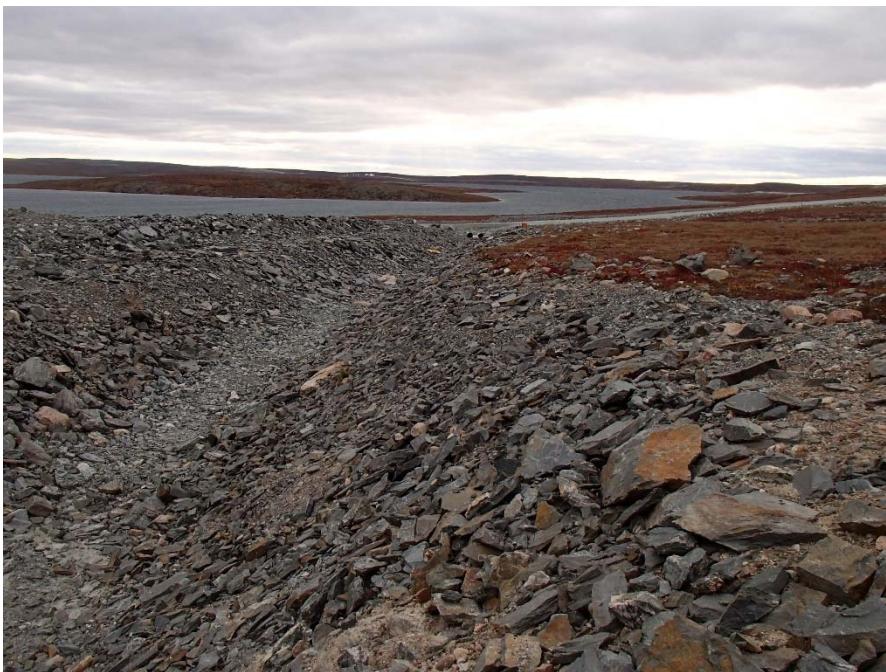
*Photograph H2-16 Diversion Ditch and its Sediment and Erosion Protection Structure*

**Description:** From 637074E/7216157N, looking west at the western diversion ditch.

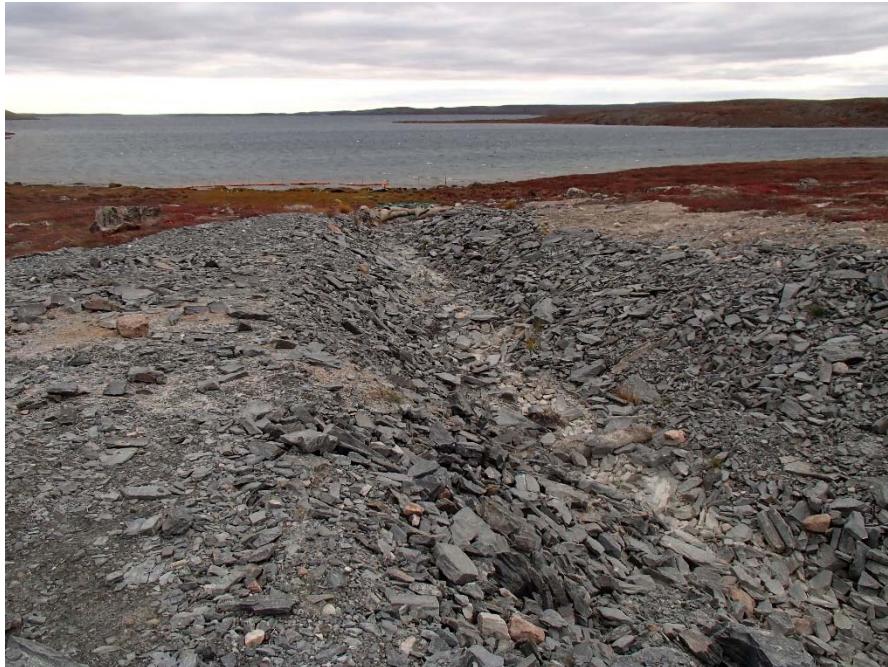
*Photograph H2-17 Diversion Ditch and its Sediment and Erosion Protection Structure*

**Description:** From 0+000, looking southwest at the western diversion ditch.

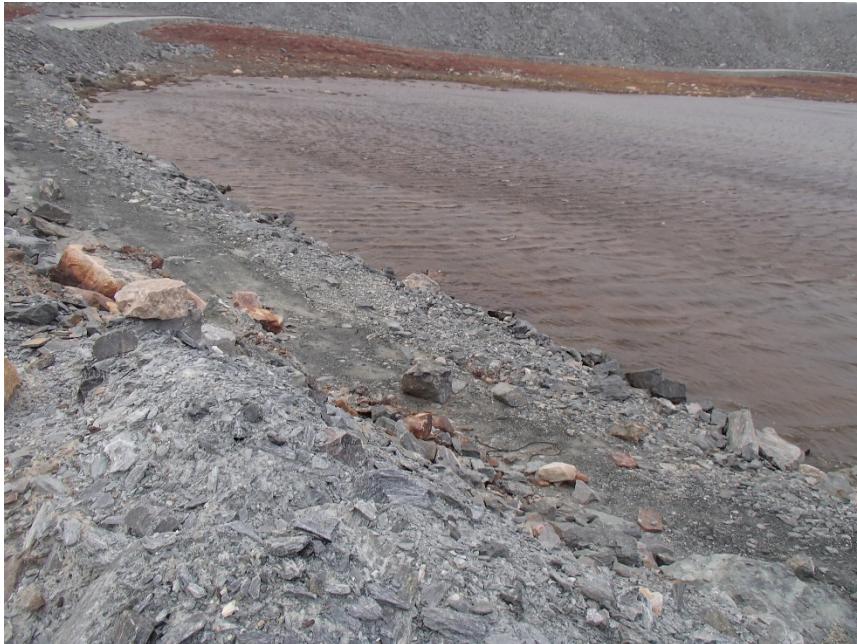
*Photograph H3-1 RSF Till Plug*

**Description:** From the south side of NP2 Lake (north of the diversion ditch) looking west at the RSF till plug.

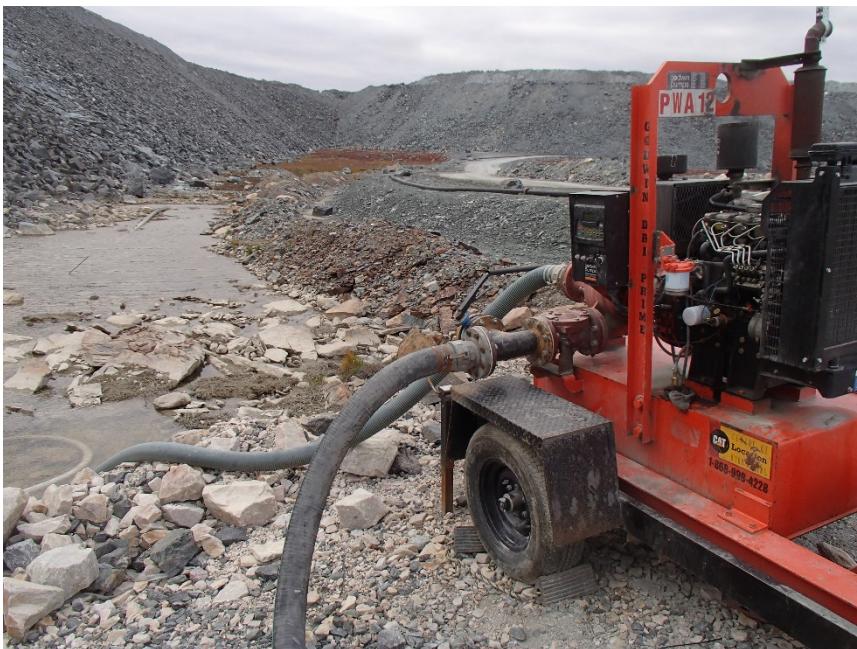
*Photograph H3-2 RSF Till Plug*

**Description:** From the south side of NP2 Lake (south of the diversion ditch) looking west at the RSF till plug.

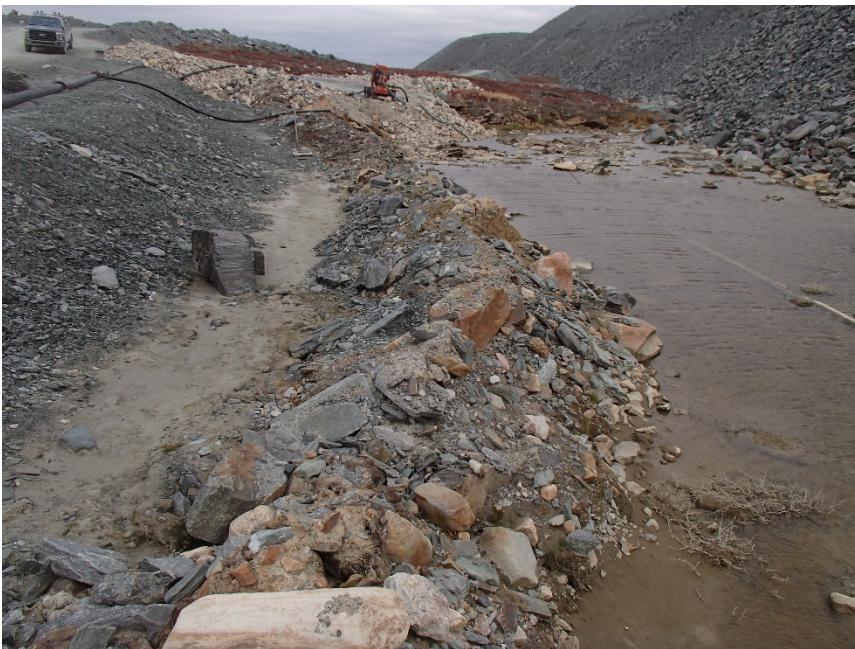
*Photograph H3-3 RSF Till Plug*

**Description:** From the south side of NP2 Lake (south of the diversion ditch) looking southeast at the RSF till plug.

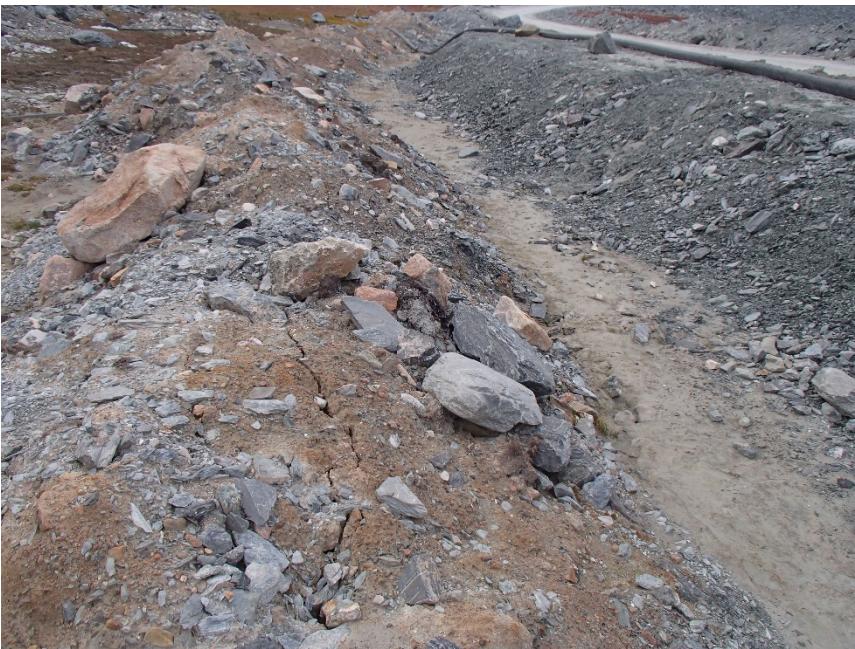
*Photograph H3-4 RSF Till Plug*

**Description:** From the south side of NP2 Lake (south of the diversion ditch) looking northwest at the RSF till plug.

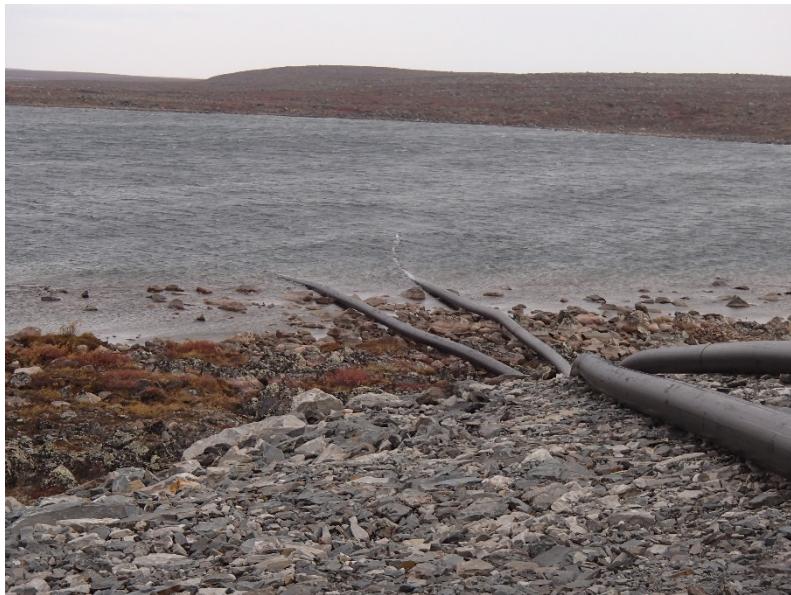
*Photograph H4-1 Diffusers – Vault Diffuser*

**Description:** Looking at the Diffuser at Vault. In good condition.

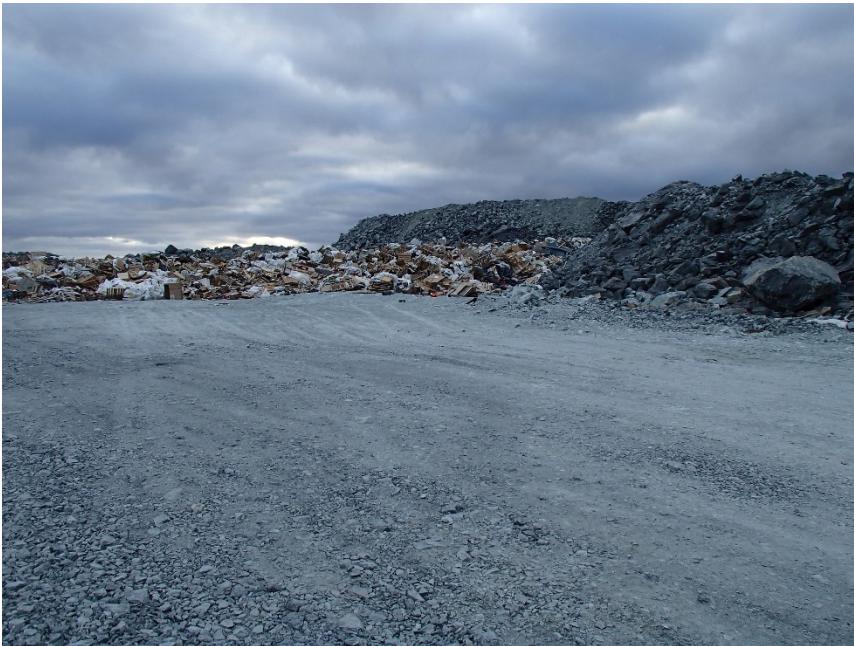
*Photograph H5-1 Landfill*

**Description:** From 638857E/7215767N, looking north at the landfill.

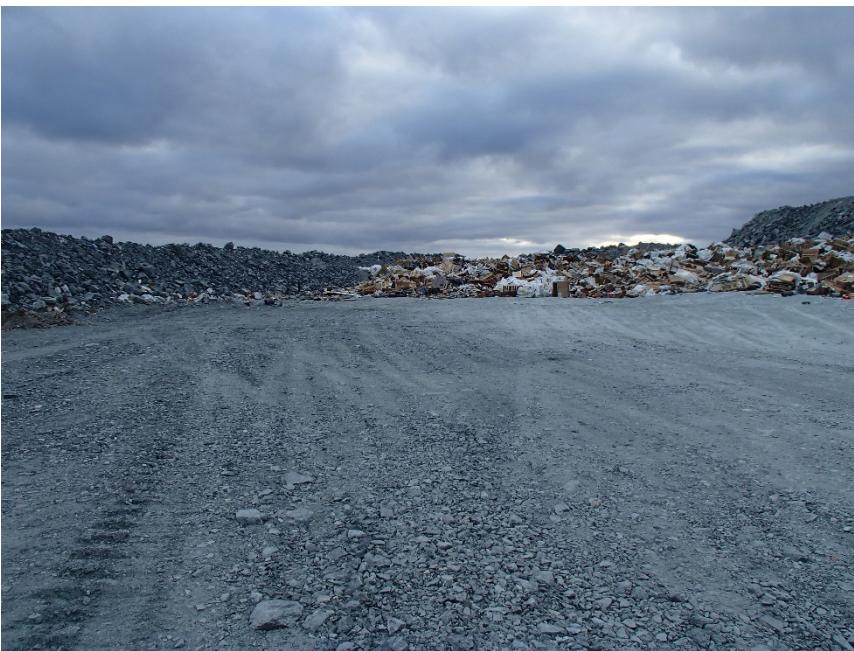
*Photograph H5-2 Landfill*

**Description:** From 638857E/7215767N, looking northwest at the landfill.

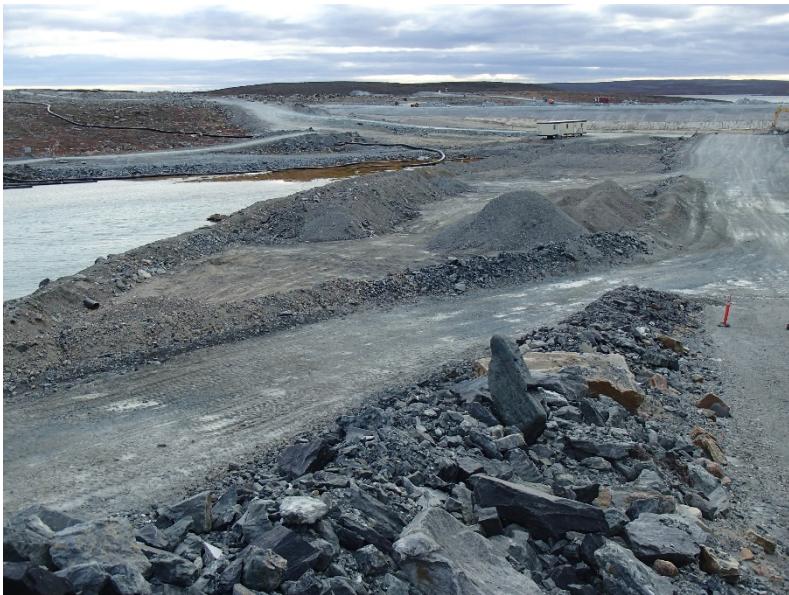
*Photograph H6-1 Contaminated Soil Storage and Bioremedial Landfarm Facility*

**Description:** Looking southwest at the Contaminated Soil Storage and Bioremedial Landfarm Facility located within the South Cell of the TSF.

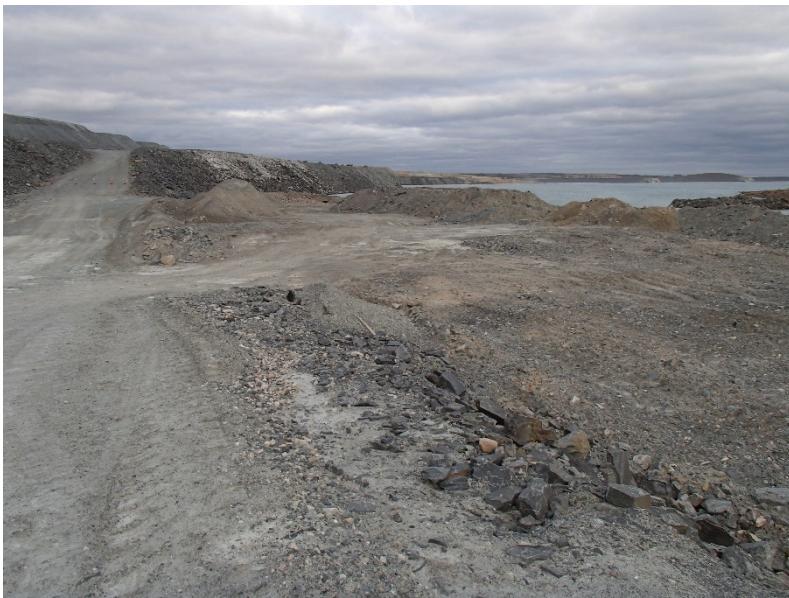
*Photograph H6-2 Contaminated Soil Storage and Bioremedial Landfarm Facility*

**Description:** From the WTP, looking northeast at the Contaminated Soil Storage and Bioremedial Landfarm Facility located within the South Cell of the TSF.

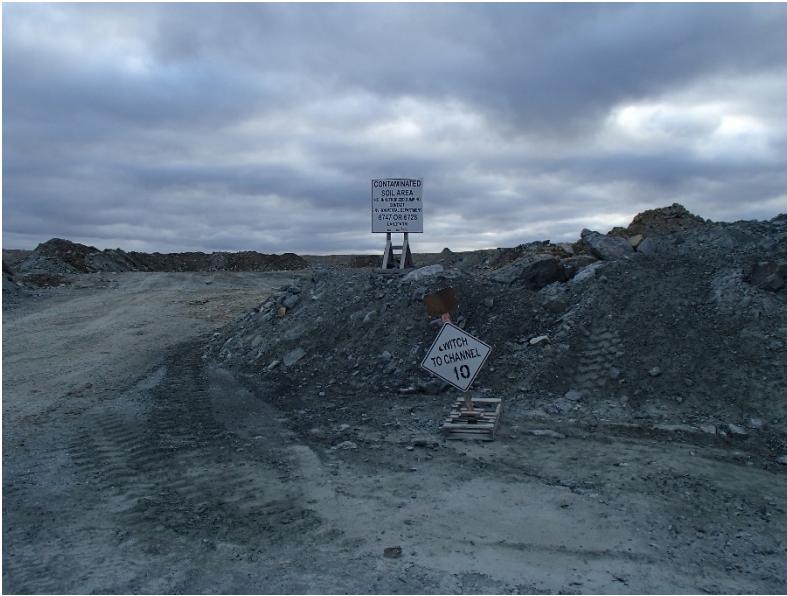
*Photograph H6-3 Contaminated Soil Storage and Bioremedial Landfarm Facility*

**Description:** From the northeast extremity of the South Cell, looking northwest at the new Contaminated Soil Storage and Bioremedial Landfarm Facility located within the South Cell of the TSF, north of Central Dike.

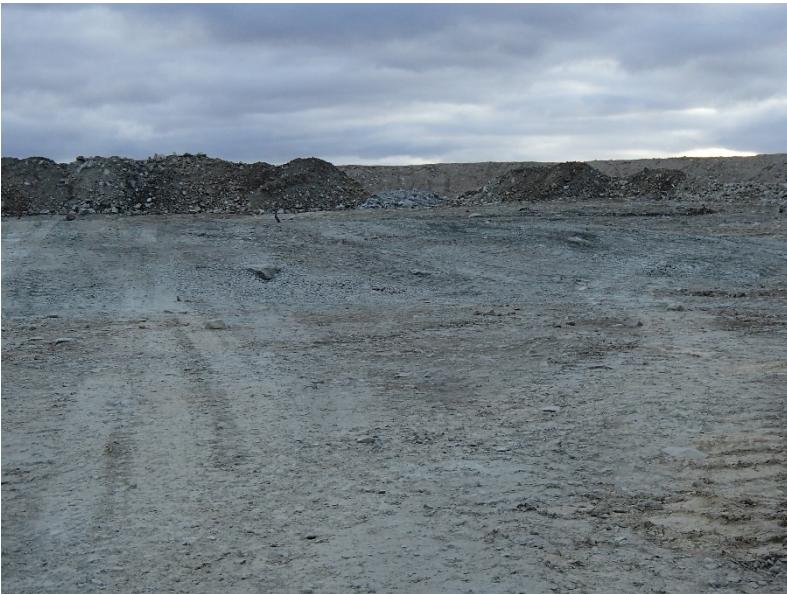
*Photograph H6-4 Contaminated Soil Storage and Bioremedial Landfarm Facility*

**Description:** From the northeast extremity of the South Cell, looking west at the new Contaminated Soil Storage and Bioremedial Landfarm Facility located within the South Cell of the TSF, north of Central Dike.

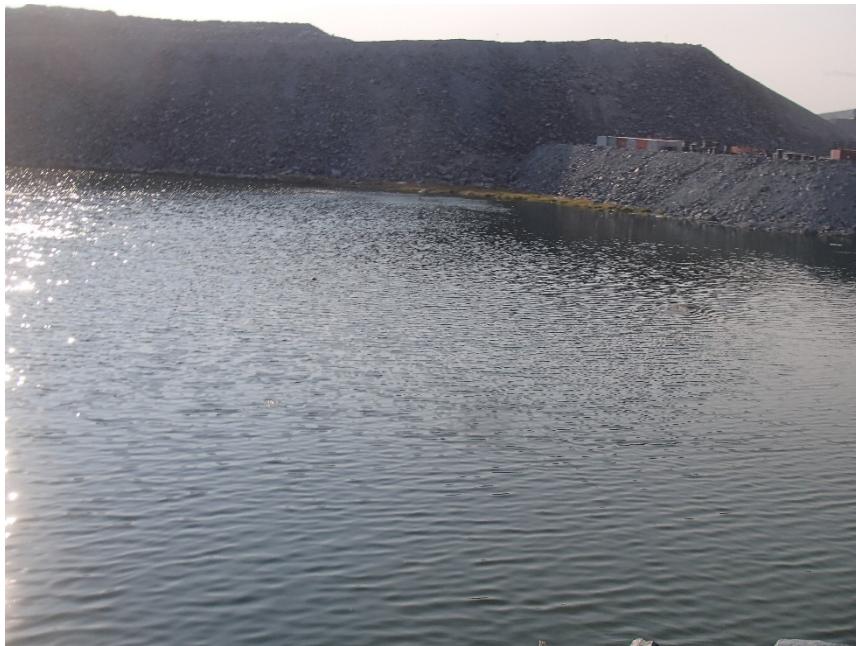
*Photograph H7-1 Stormwater Pond*

**Description:** From the northern side of the pond, looking west at Stormwater Pond and crusher ramp.

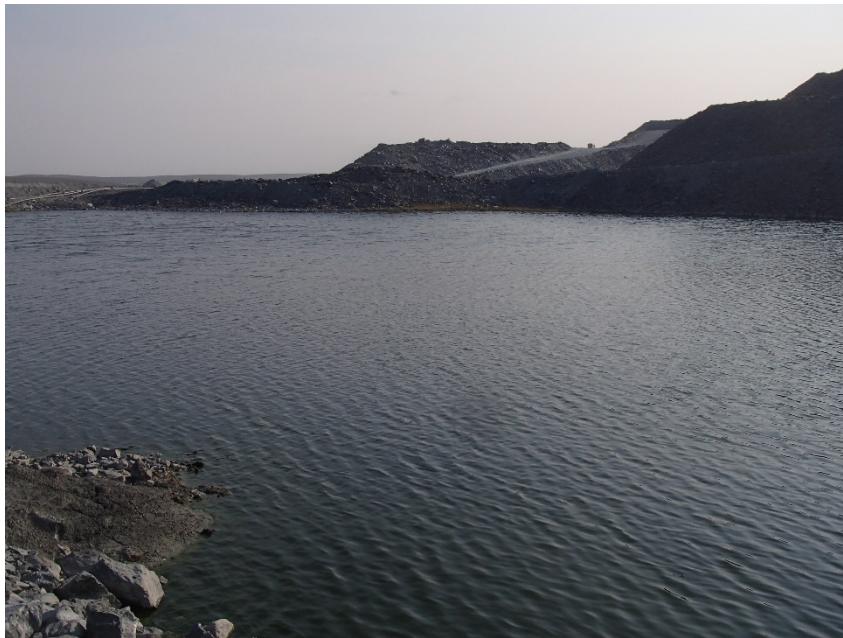
*Photograph H7-2 Stormwater Pond*

**Description:** From the northern side of the pond, looking south at Stormwater Pond and the crusher ramp.

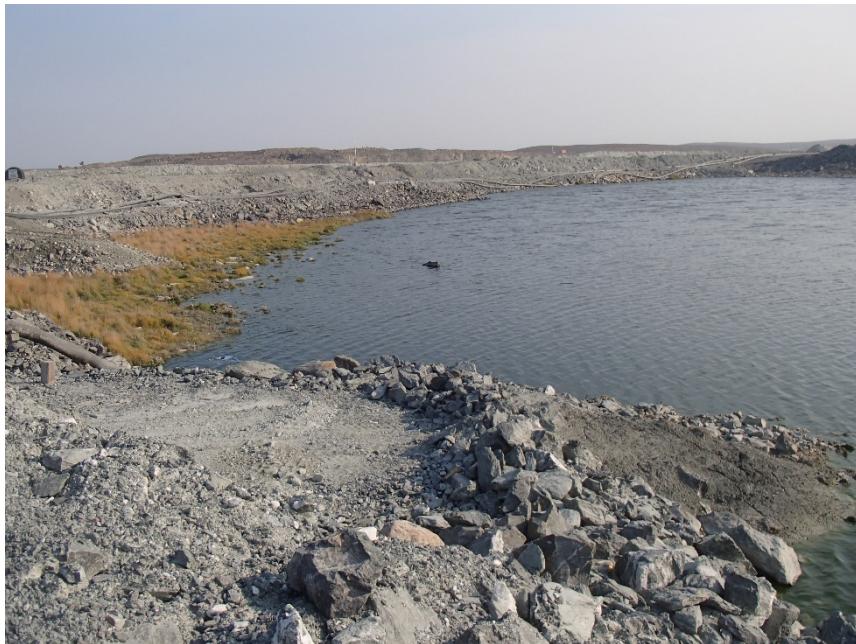
*Photograph H7-3 Stormwater Pond*

**Description:** From the northern side of the pond, looking southeast at Stormwater Pond.

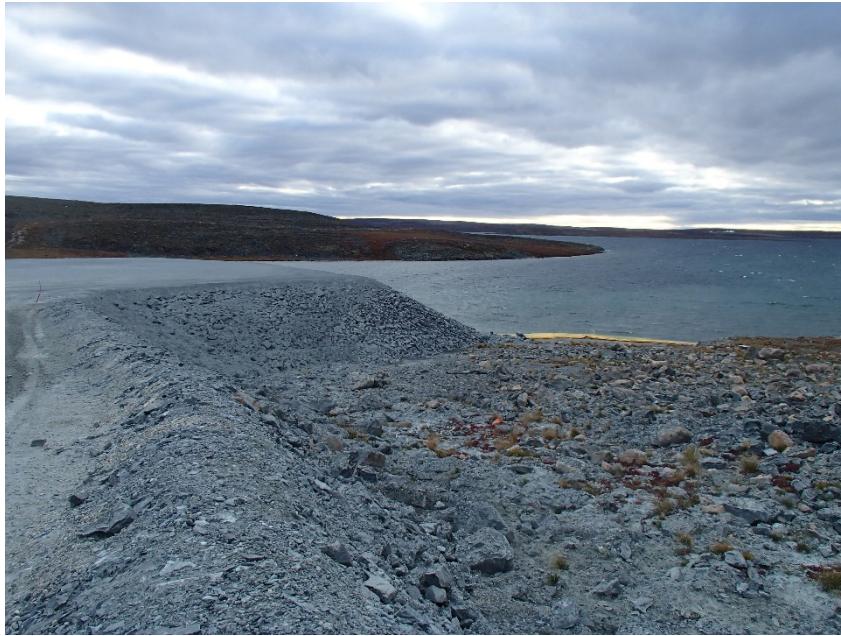
*Photograph H8-1 Airstrip*

**Description:** Looking west at the extremity of the airstrip located within Third Portage Lake.

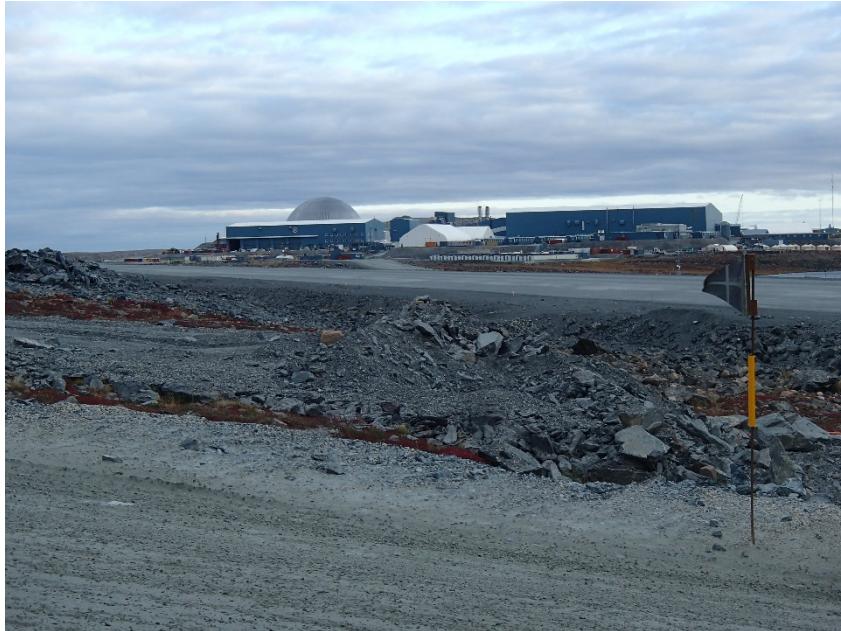
*Photograph H8-2 Airstrip*

**Description:** From the extremity of the airstrip located within Third Portage Lake, looking southeast.

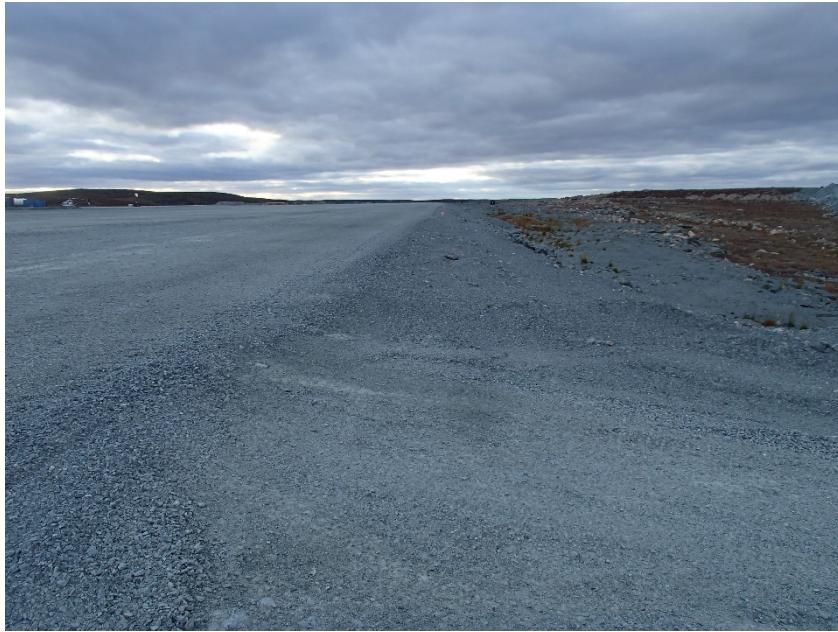
*Photograph H8-3 Airstrip*

**Description:** From the northeast side of the airstrip looking northwest.

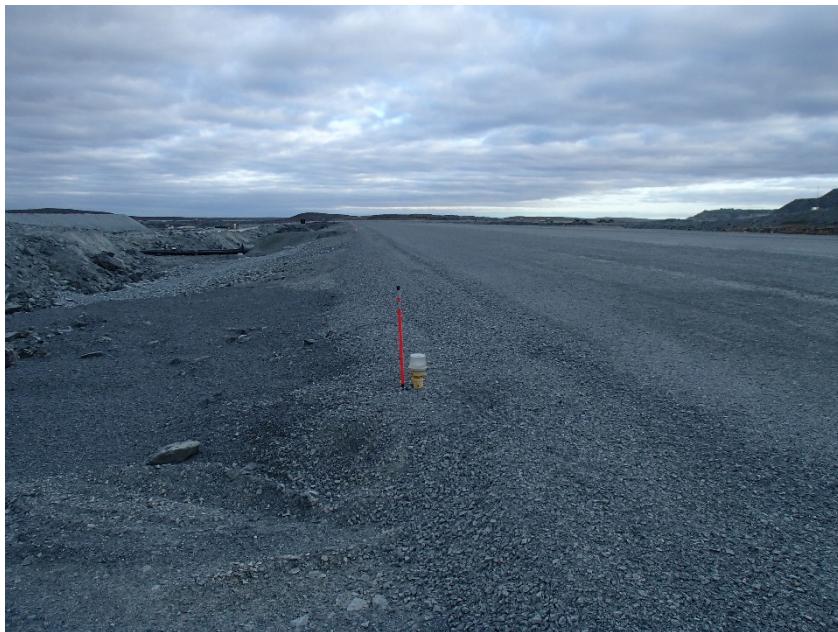
*Photograph H8-4 Airstrip*

**Description:** From the northeast side of the airstrip looking southeast.

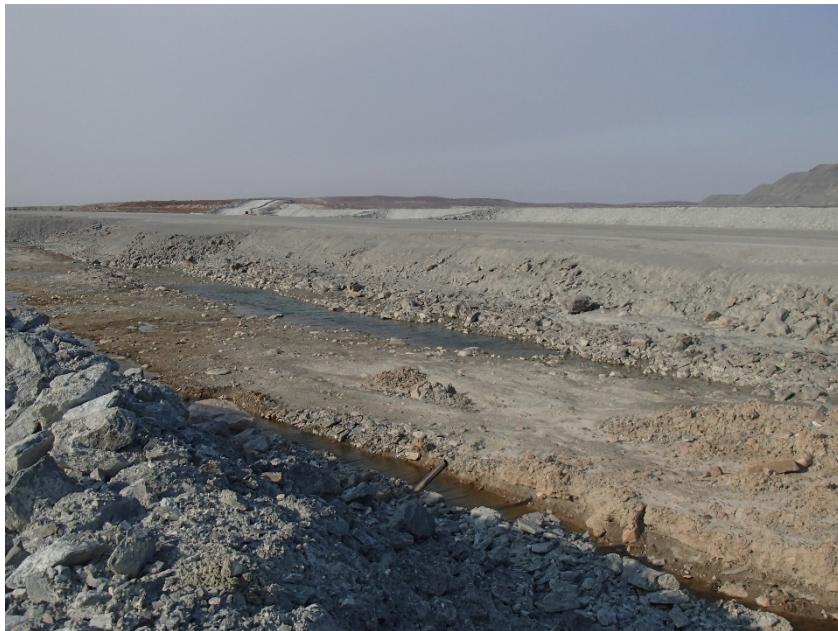
*Photograph H8-5 Airstrip*

**Description:** From the southeast side of the airstrip looking northwest.

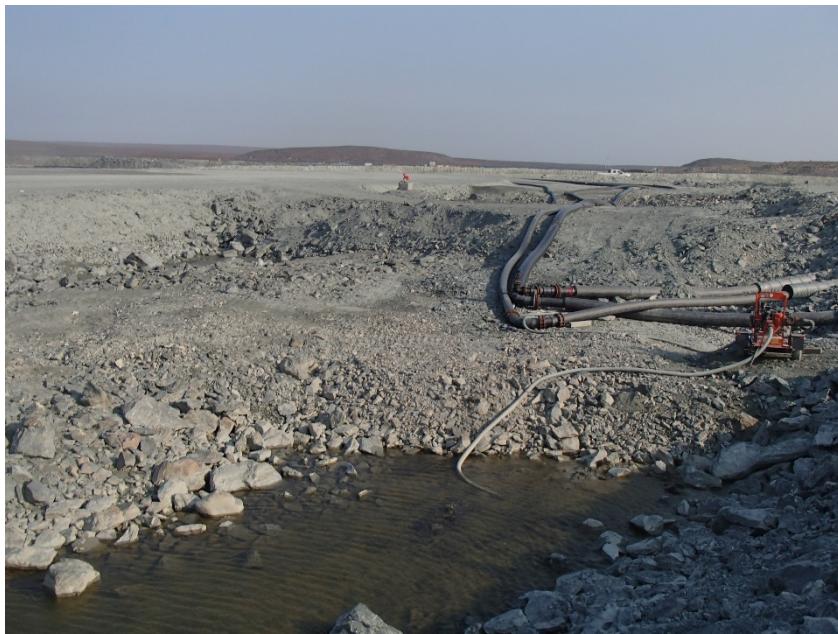
*Photograph H8-6 Airstrip*

**Description:** From the southeast side of the airstrip looking east.
