## APPENDIX A2 SOUTH CAMP DIKE PHOTOGRAPHIC LOG

## **Bay-Goose Dike Photographic Log and Record of Inspection**

**2017 ANNUAL GEOTECHNICAL INSPECTION  
MEADOWBANK GOLD MINE, NUNAVUT**

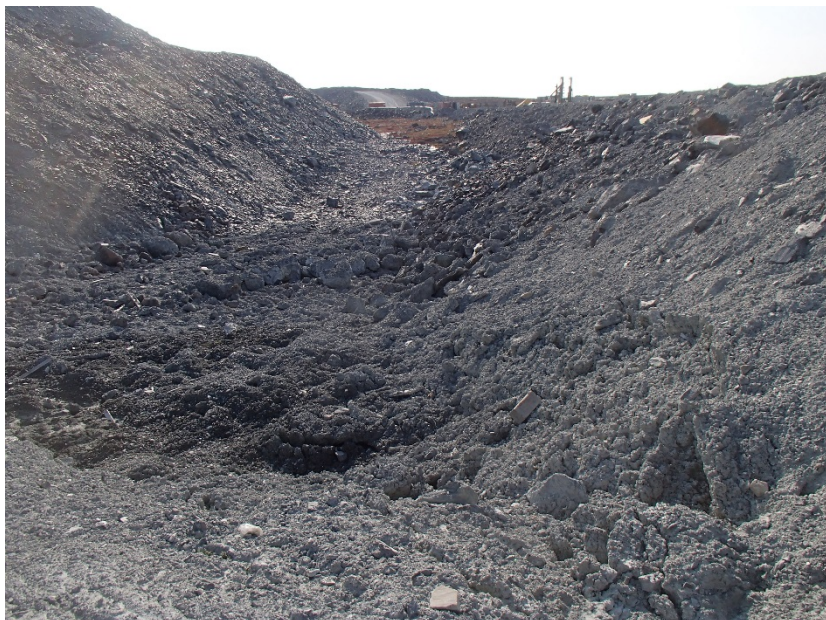
*Photograph A2-5 South Camp Dike*

**Description:** From the north abutment, looking south at the downstream slope.

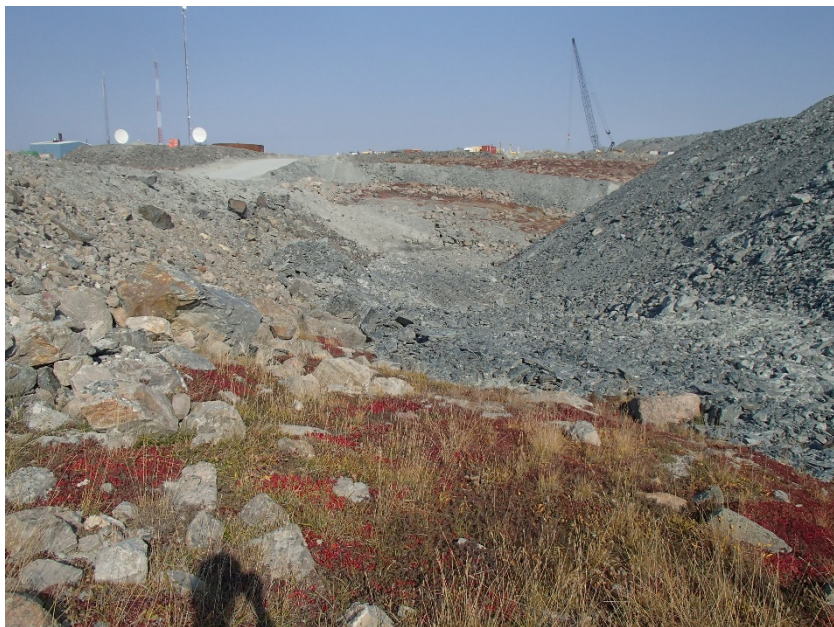
*Photograph A2-6 South Camp Dike*

**Description:** From the south abutment, looking north at the downstream slope.

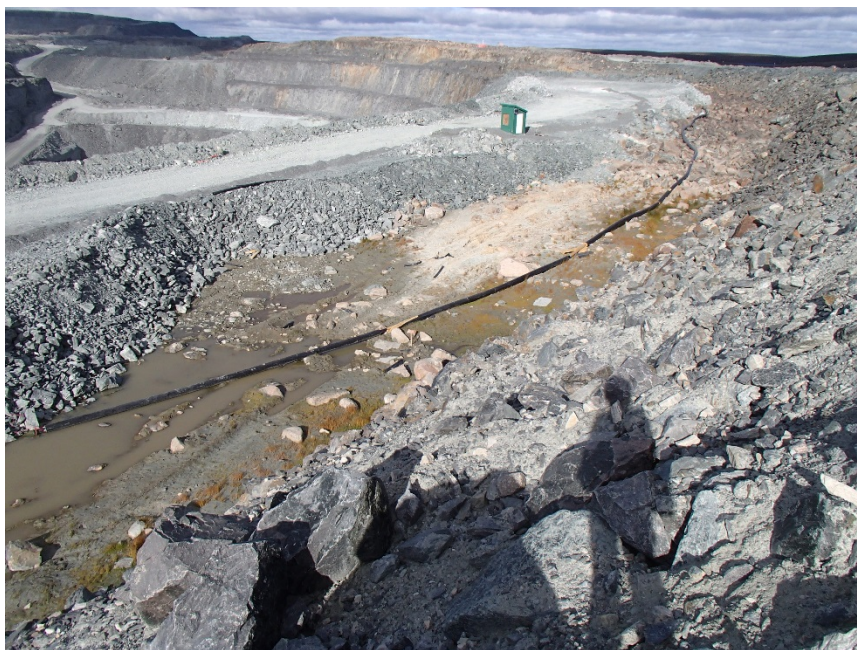
*Photograph A3-4 Bay Goose Dike*

| INSPECTION ITEM | OBSERVATIONS DATA | PHOTO | COMMENTS & OTHER DATA |
|---|---|---|---|
| | North Channel | 325, 329 | Monitored by stations 8 (30+420) and 9 (30+380). Water flowing was observed during the inspection. |

**Description:** From approximately Sta. 30+340, looking northwest at the north seepage channel.

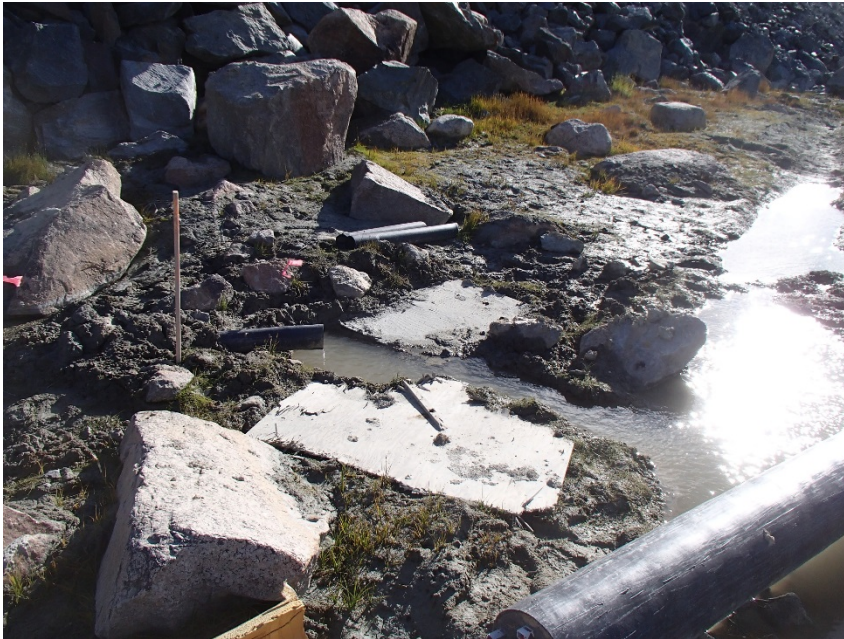
*Photograph A3-5 Bay Goose Dike*

**Description:** From approximately Sta. 30+325 downstream, looking southwest at the North Channel.

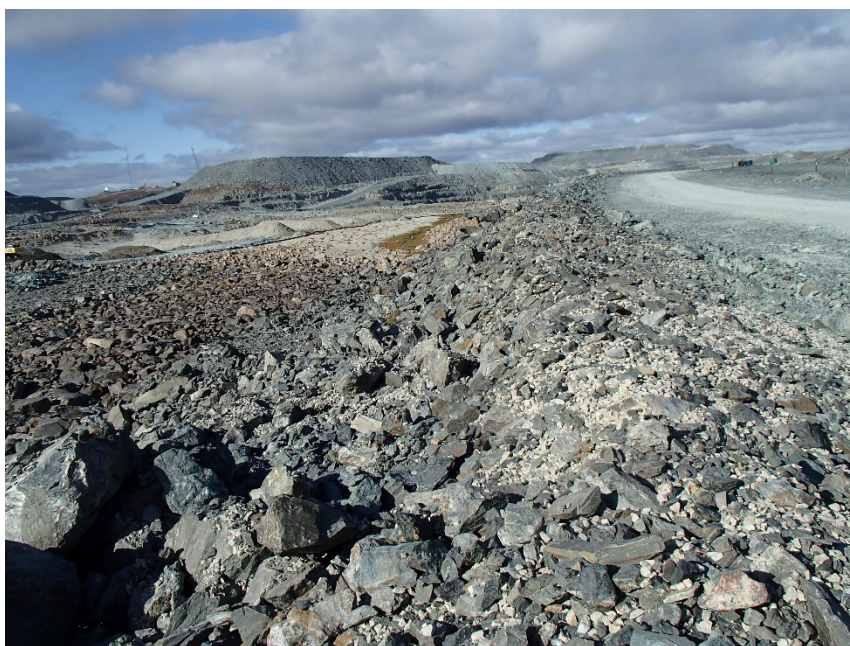
*Photograph A3-12 Bay Goose Dike*

| INSPECTION ITEM | OBSERVATIONS DATA | PHOTO | COMMENTS & OTHER DATA |
|---|---|---|---|
| | Central Shallow | 319 | Presence of 2 seepage channels at 30+650 and 30+625. Flow was observed during inspection at 30+650. Monitored by station 7. |

**Description:** From approximately Sta. 30+680 on the crest, looking north at the downstream slope and toe.

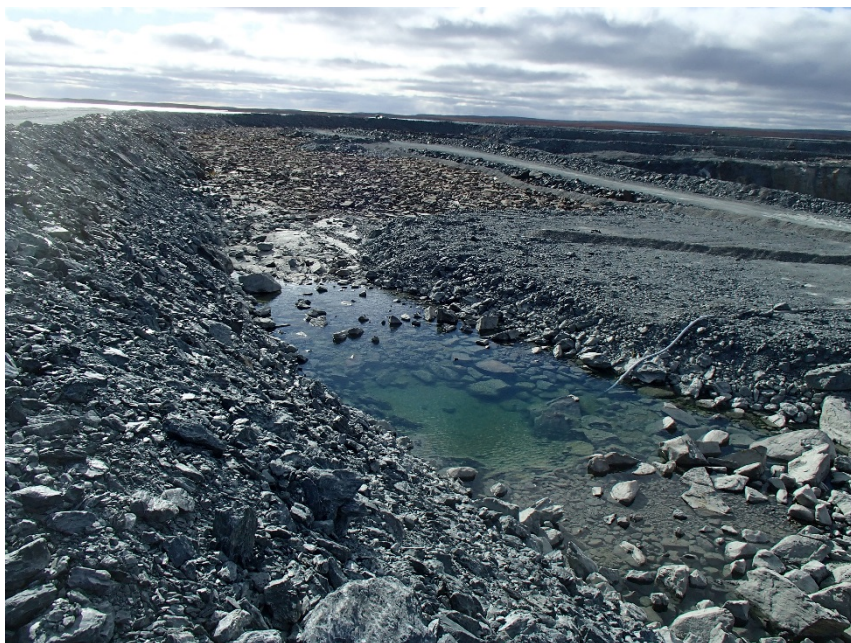
*Photograph A3-17 Bay Goose Dike*

| INSPECTION ITEM | OBSERVATIONS DATA | PHOTO | COMMENTS & OTHER DATA |
|---|---|---|---|
| | Central Channel | 316 | Presence of a seepage channel at Sta. 31+165. Water ponding was observed at the time of the inspection. It was pumped once after freshet only. |

**Description:** From approximately Sta. 31+080 on the crest, looking southwest at the pond of water at Central Channel seepage at Sta. 31+165.
