2017 ANNUAL GEOTECHNICAL INSPECTION
MEADOWBANK GOLD MINE, NUNAVUT

APPENDIX A4 RECORD OF DAM INSPECTION

Client: AEM **By:** Yves Boulianne
Project: Meadowbank **Date:** September 8, 2017
Location: Vault Dike **Reviewed:** Yves Boulianne

APPENDIX A4 VAULT DIKE PHOTOGRAPHIC LOG

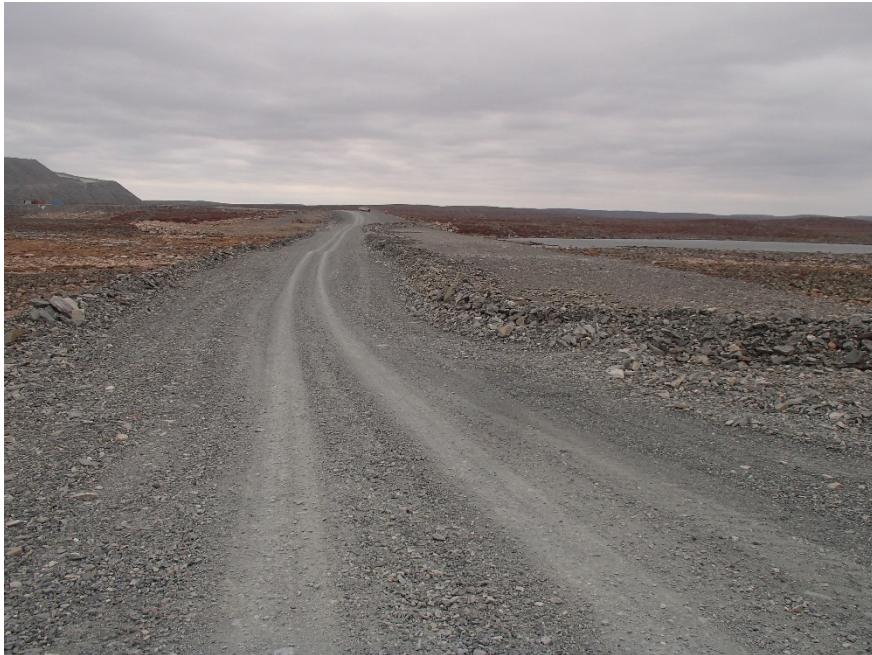
Photograph A4-1 Vault Dike

Description: From the east abutment, looking northwest at the crest.

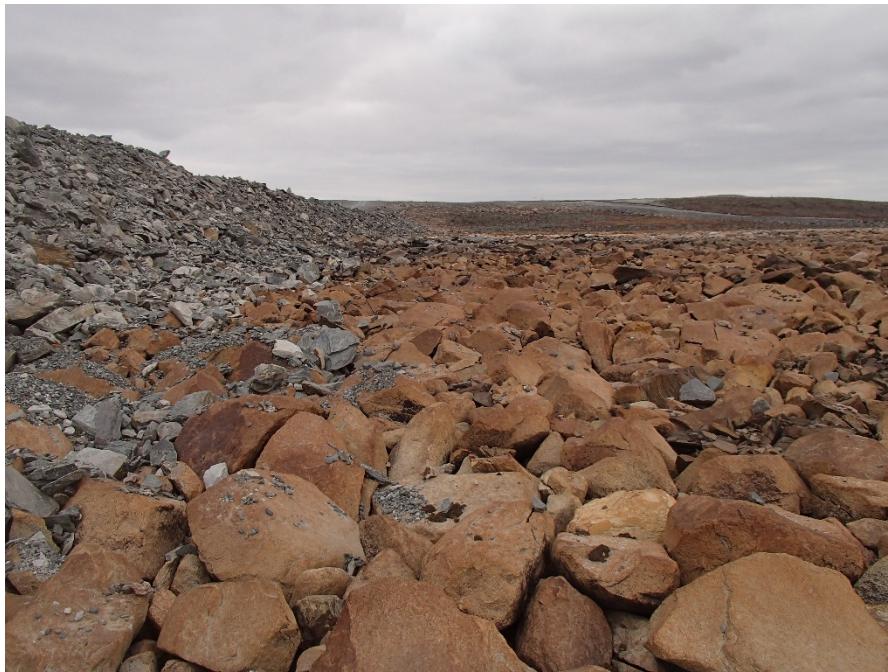
Photograph A4-2 Vault Dike

Description: From downstream, looking southeast at the downstream toe.

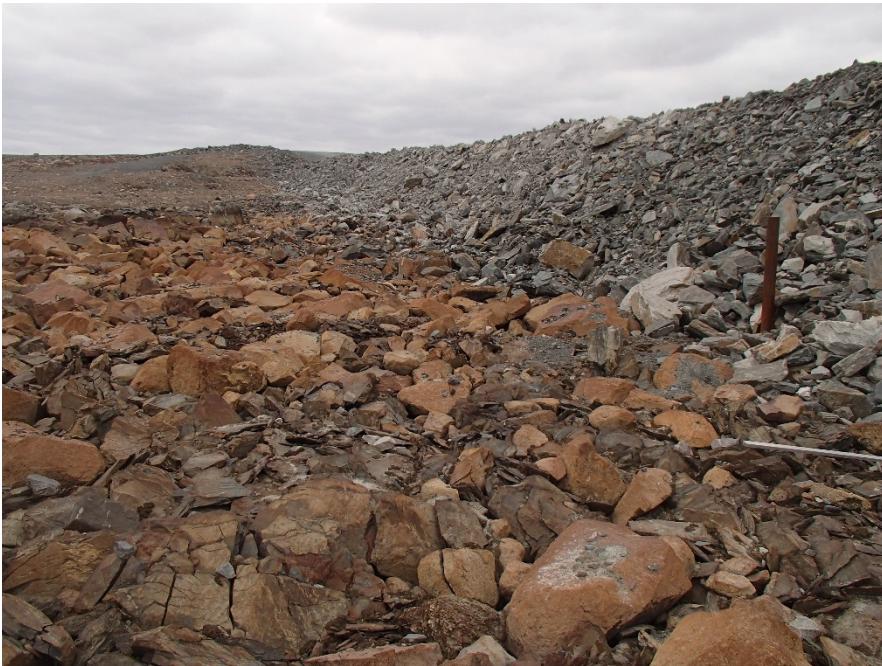
Photograph A4-3 Vault Dike

Description: From downstream, looking northwest at the downstream toe.

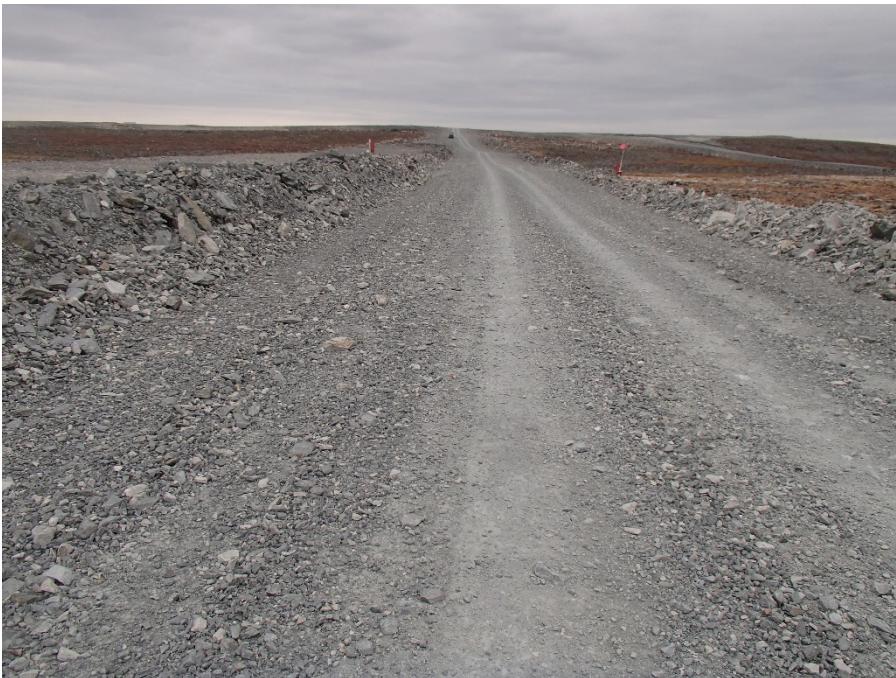
Photograph A4-4 Vault Dike

Description: From the west abutment, looking southeast at the crest.

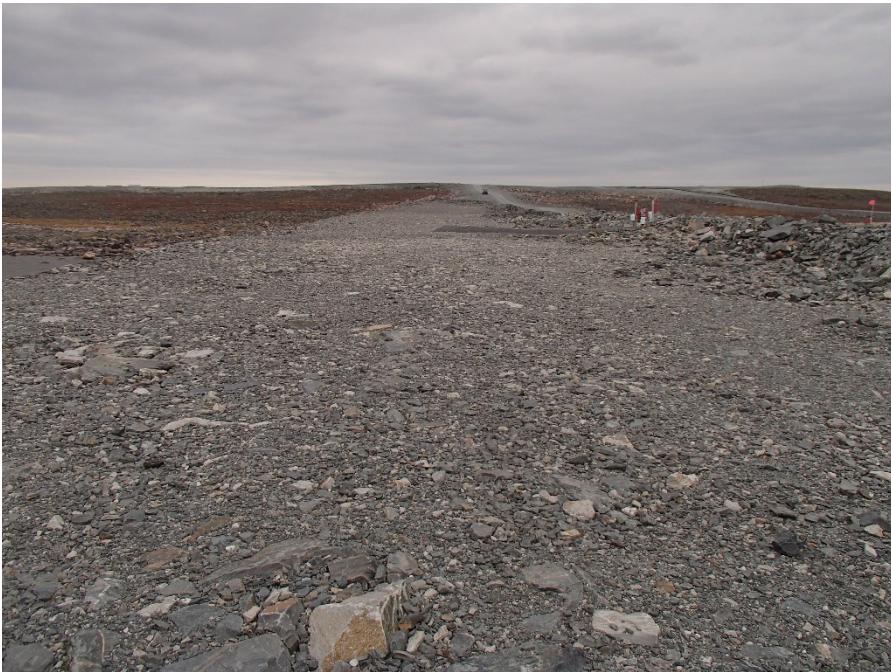
Photograph A4-5 Vault Dike

Description: From the upstream side, looking southeast at the upstream slope.

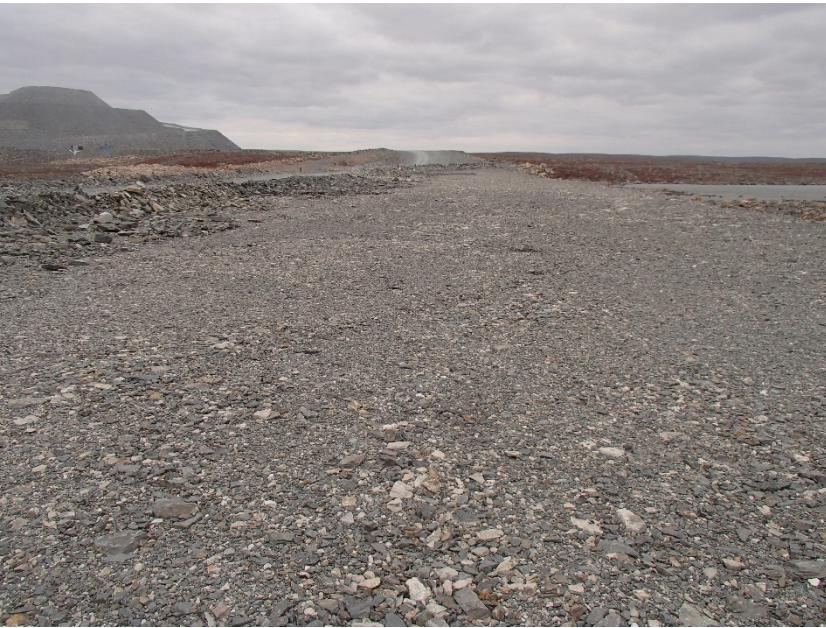
Photograph A4-6 Vault Dike

Description: From the upstream side, looking northwest at the upstream slope.

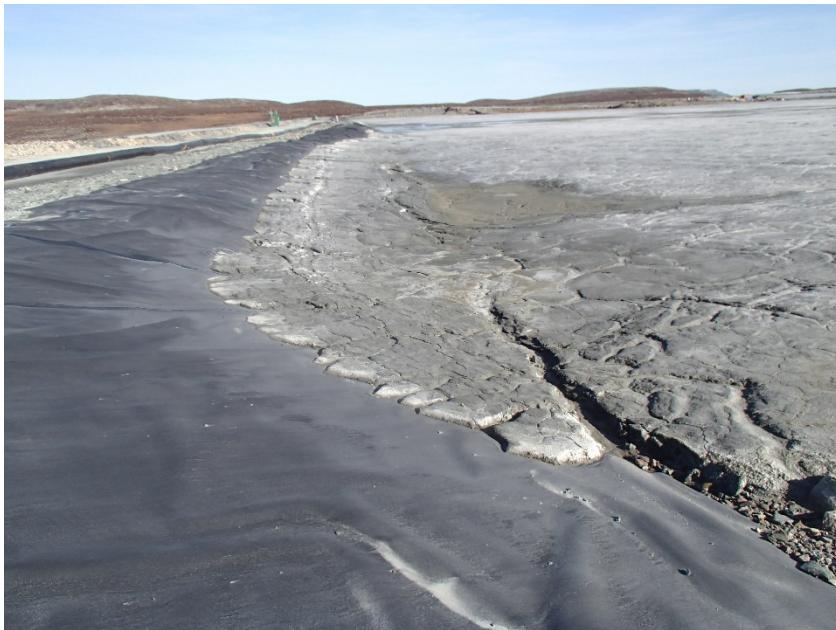
Photograph B1-1 Tailings Storage Facility

Description: From Saddle Dam 1 (approximately Sta. 0+410) looking northeast at the North Cell tailings pond. Adequate tailings beach against SD1.

2.3 Signs of movement (deformation)	None observed		
2.4 Cracks	None observed		
2.5 Face liner condition (if applicable)	In good condition		
2.6 Other unusual conditions	None

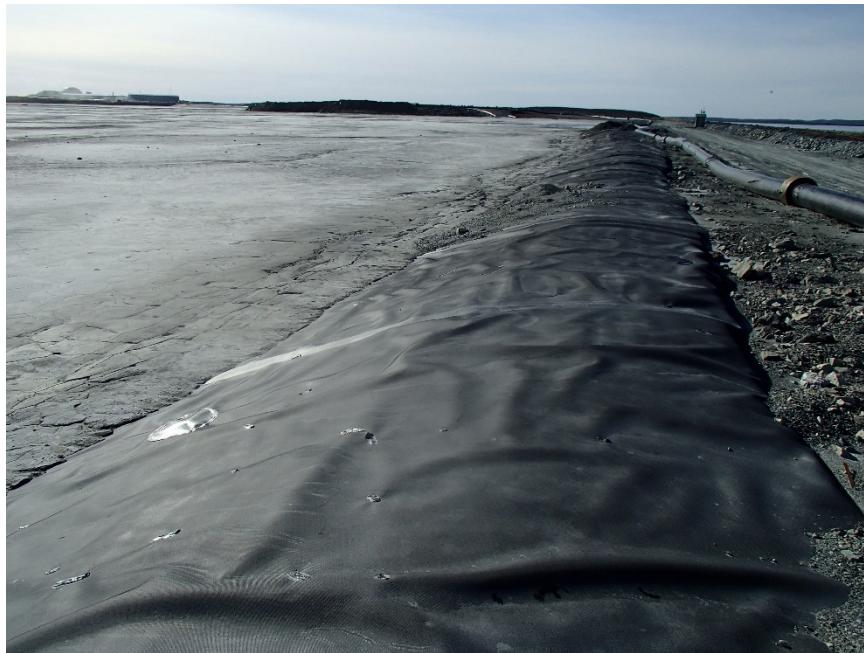
Photograph B1-2 Tailings Storage Facility

Description: From Saddle Dam 1 (approximately Sta. 0+070) looking south at the North Cell tailings pond. Adequate tailings beach against SD1.

INSPECTION ITEM	OBSERVATIONS DATA	PHOTO	COMMENTS & OTHER DATA
1. DAM CREST		560, 563, 564	
1.1 Crest elevation	150 m		Design 150 m
1.2 Reservoir level	149.5 m - tailings		
Current freeboard	0.5 m -tailings		Design 2 m water, 0.5 m tailings

1.3 Distance to tailings pond (if applicable)	>300 m		Tailings beach all along SD1
1.4 Surface cracking	None at time of inspection		
1.5 Unexpected settlement	None observed

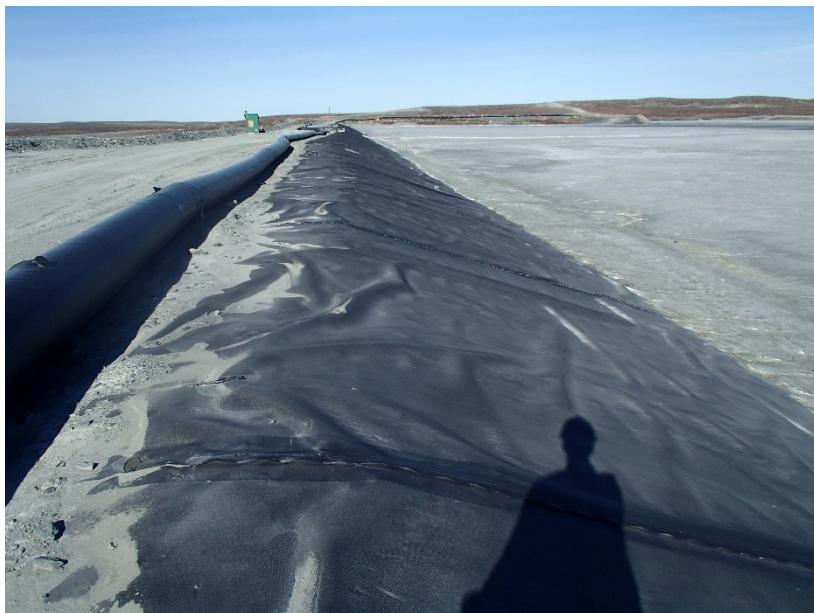
Photograph B1-4 Tailings Storage Facility

Description: From Saddle Dam 2 looking northwest at the North Cell tailings pond. Adequate tailings beach against SD2.

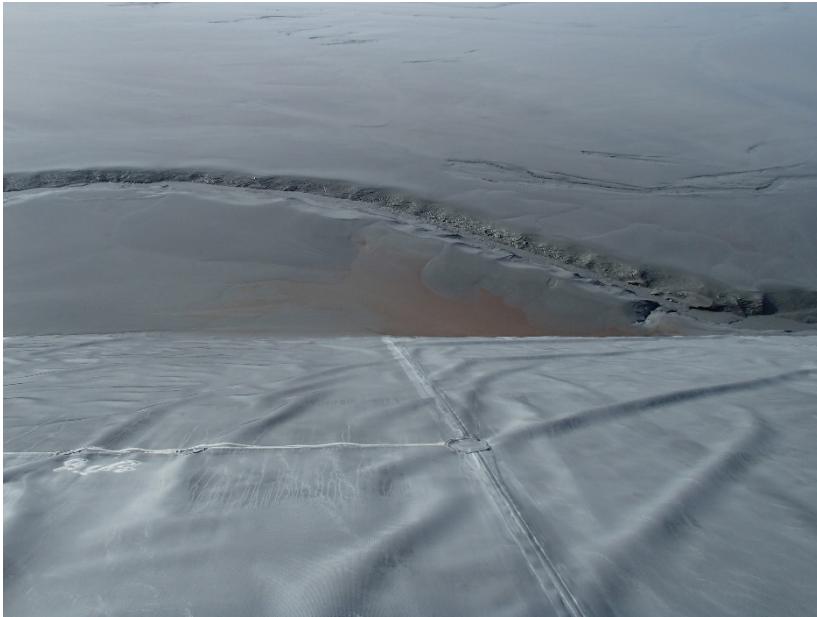
Photograph B1-17 Tailings Storage Facility

Description: From Central Dike looking west at the South Cell. A small pond with an orange colour is present in the tailings.

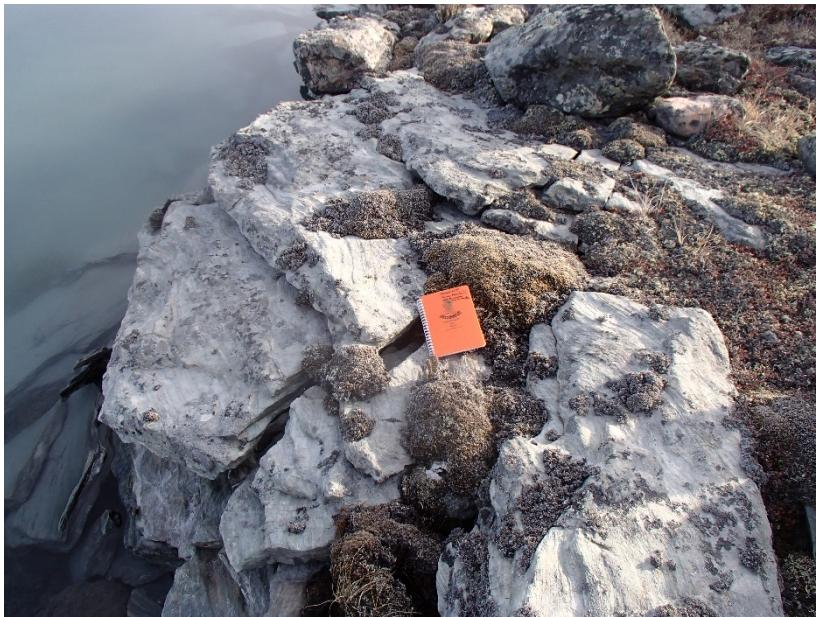
Photograph B1-21 Tailings Storage Facility

Description: View of the bedrock on the northwestern extremity Saddle Dam 4. Important surface cracks are visible.
